## Tarago Action Plan Routine Inspection Checklist

<b>Title:</b> Tarago Rail Yard Inspection	<b>Approved:</b> SM	<b>Project-Nr.:</b> 318001704	<b>Date:</b> 20 February 2024
<b>Site:</b> Tarago, NSW			
<b>Client:</b> UGL Regional Linx

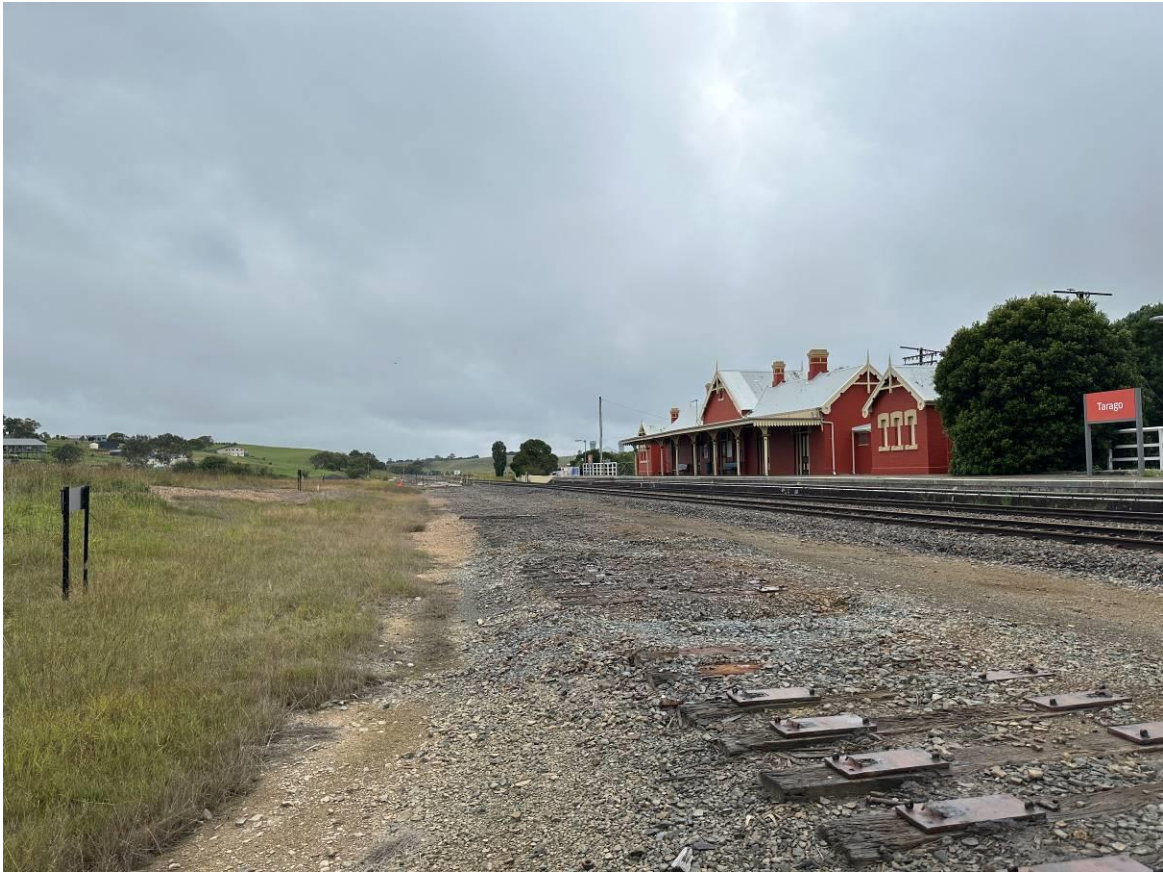
Section	Control	Inspection		Corrective Action
		Yes	No	
5.1	Is Exclusion Zone signage present as recommended on Figures 2a - 2e Appendix 1 to demarcate contamination in the rail formation and adjacent soils?	Yes ( <b>Photos 1, 10 and 18</b> )		
	Is Exclusion Zone signage undamaged?	Yes, exclusion zone signage appeared in good condition		
	Are sediment controls present in/adjacent each rail culvert?	Yes, rock checks and rock armour observed upgradient of each culvert. Coir sediment control logs west of former Woodlawn siding and along cess drain feeding the south and middle culverts. Silt fencing between middle and northern culvert.		
	If sediment is present what is the estimated depth of sediment?	Minor sediment build up on silt fencing present on site (approximately 5 cm).		
	Are sediment controls still functional?	Yes. Sediment controls in place with some minor damages. Refer to 'additional observations' section points 2 and 3 for comment'.

Photo 1: Picture of Tarago railway station platform facing north east. No airborne dust visible.

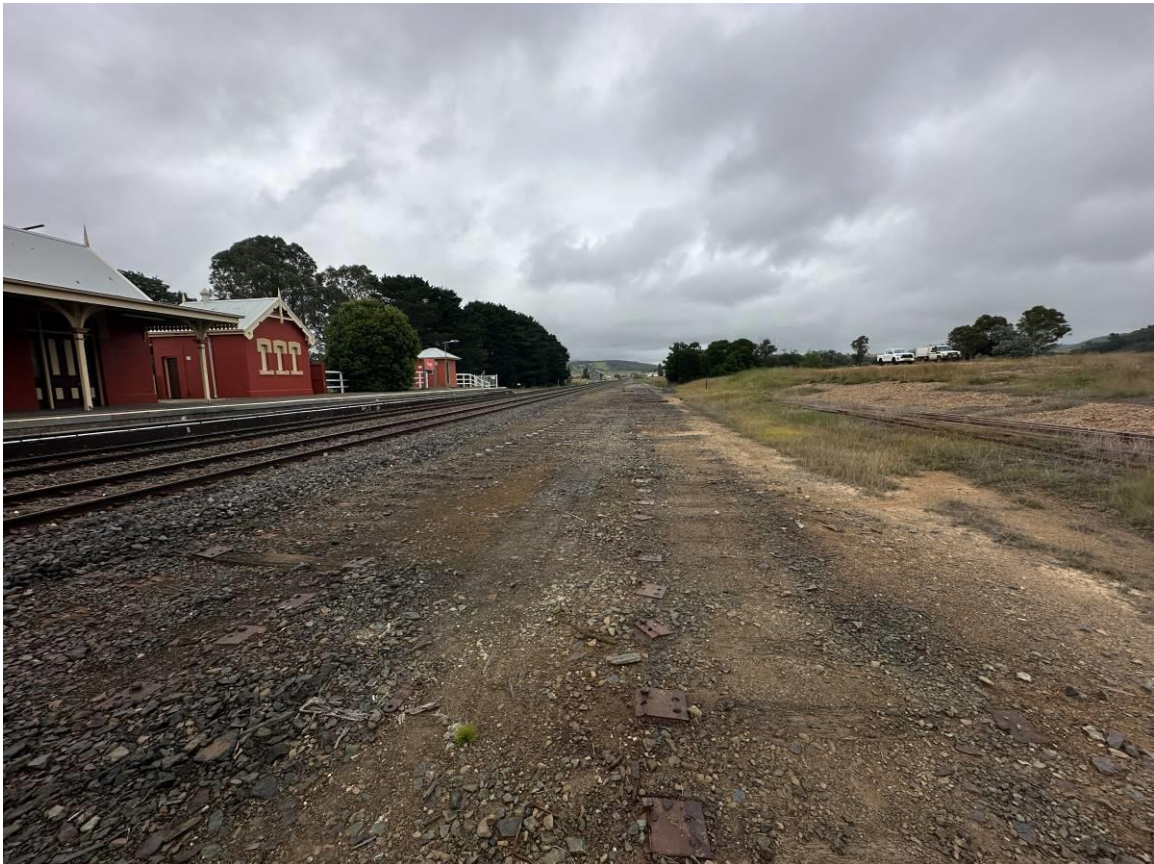
Photo 2: Picture of Tarago railway station platform and rail line facing south west. No airborne dust visible.

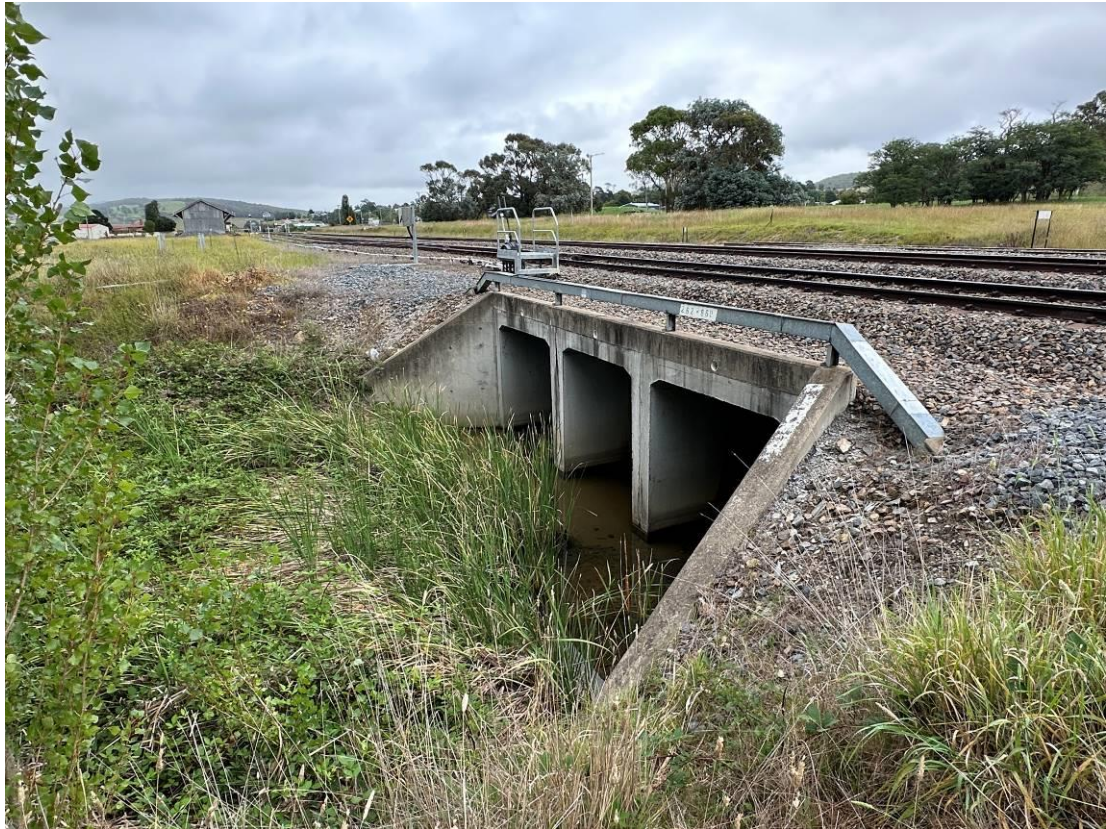
Surface water was observed discharging from the site at the southern and middle culvert ( <b>Photos 3 - 6</b> ). Surface water was observed between the middle and northern culvert pooled both onsite ( <b>Photo 14</b> ). No other flowing surface water was observed onsite during the inspection.		
<u>Is there evidence of excavation or other works non-compliant with the Action Plan?</u>		
No		
<u>Other observations?</u>		
<p>1. The previous monthly site inspection in January identified several new locations where the marker layer was exposed. During this inspection, the exposure locations appear to have been covered with concrete (<b>Photo 16</b>). No further damages to the concrete capping of the stockpile were observed during this inspection (<b>Photo 17</b>).</p> <p>2. The geofabric silt curtain (sediment fencing) located upgradient of middle trainline culvert (<b>Photo 15</b>) was noted to have large sediment build up. Ramboll recommends the removal of the build up to ensure the sediment fencing remains undamaged and an adequate control.</p> <p>3. Evidence of erosion has been noted upgradient of the southern most culvert in multiple previous site inspections and remains on site but in a stable condition (<b>Photo 10</b>). No evidence of sediment was found in water flowing offsite at southern culvert during this site inspection. Ramboll recommends replacing ground cover material (ballast) if further erosion occurs or sediment is visible in the downstream surface water of the southern culvert.</p>

**Photo 3: Southern culvert downgradient of railway line with surface water flowing offsite. Surface water is clear with slight brown tint and low to no turbidity.**

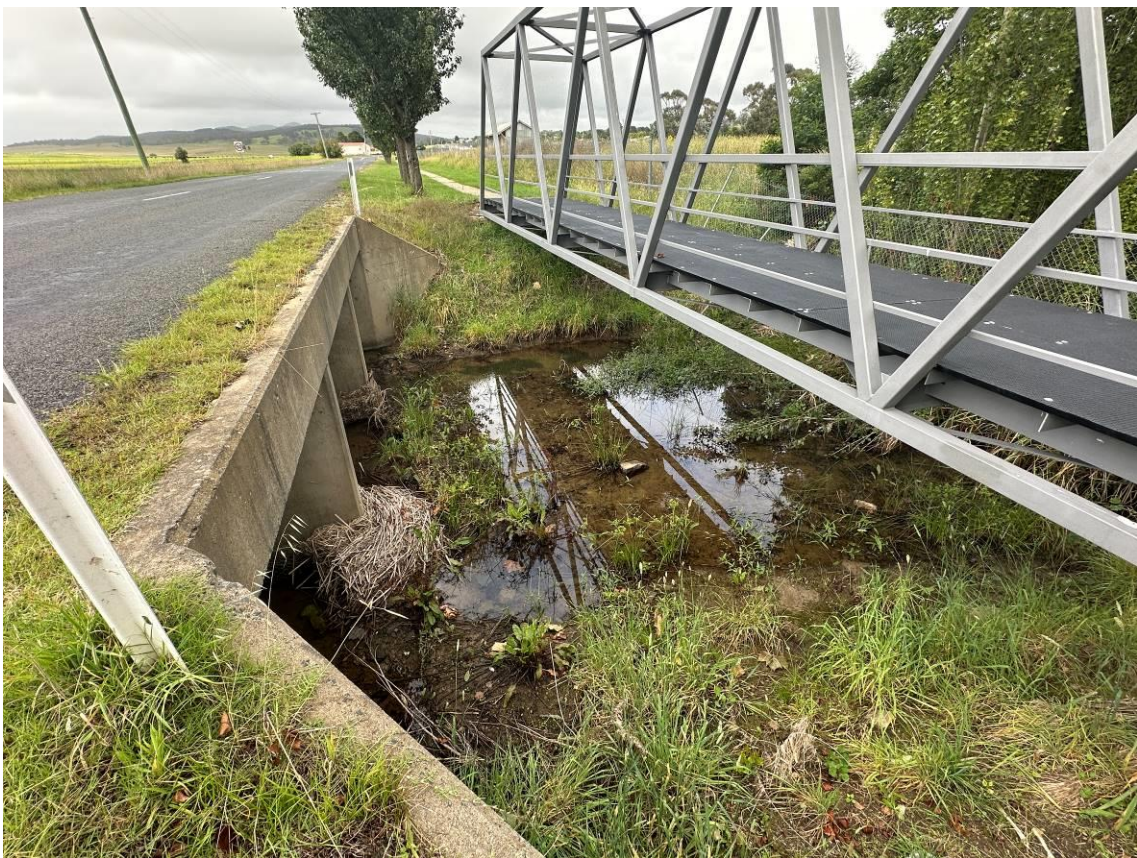
**Photo 4: Southern culvert downgradient of site fence line with surface water flowing offsite. Surface water is clear with a slight brown tint and low to no turbidity.**

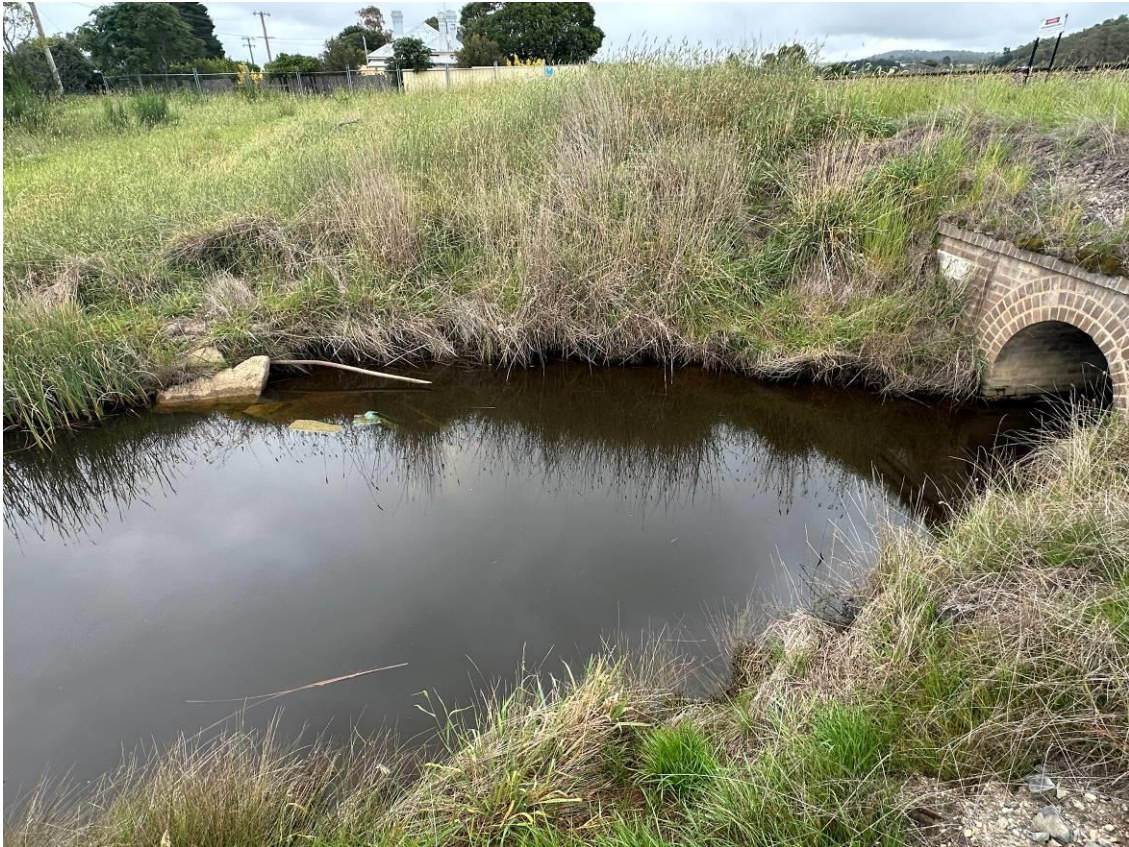
**Photo 5: Downgradient of middle culvert with pooled surface water. Surface water was dark red/brown with minor turbidity.**

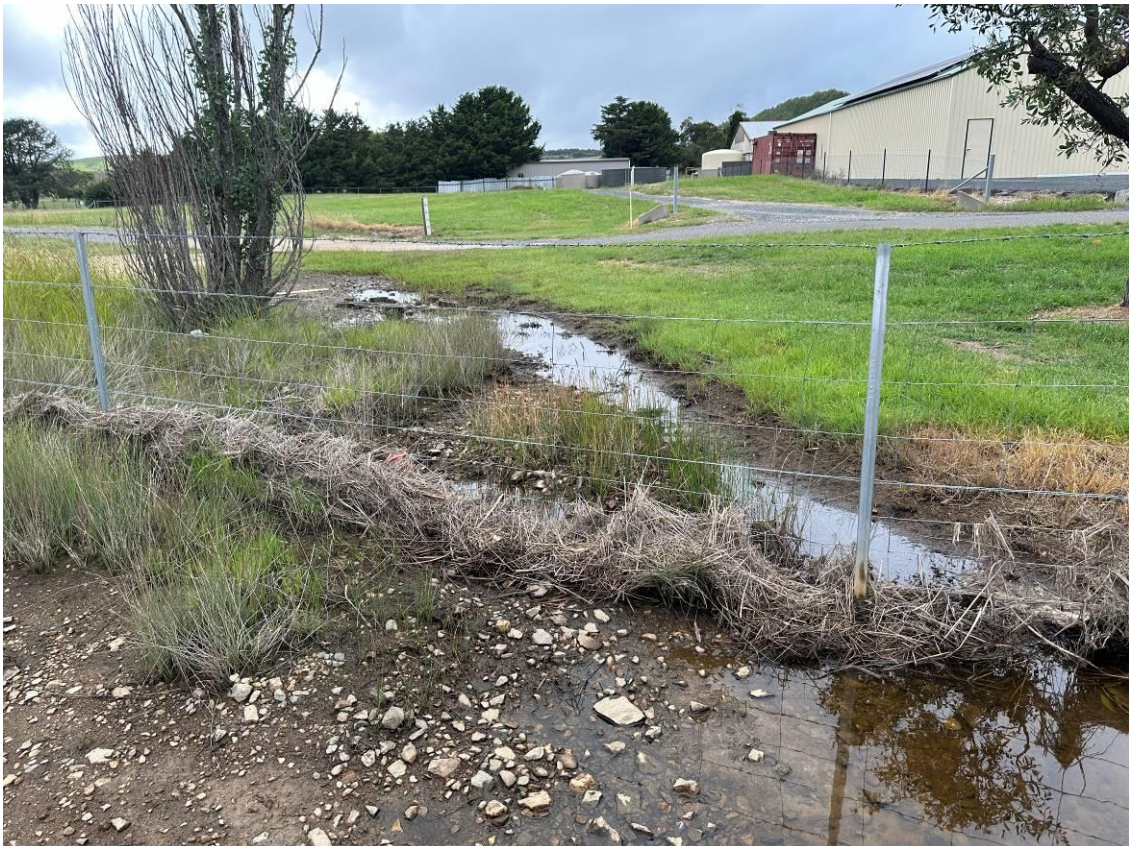
**Photo 6: Downgradient of middle culvert facing east with flowing surface water. Surface water across road causeway appeared clear with low turbidity and suspended solids.**

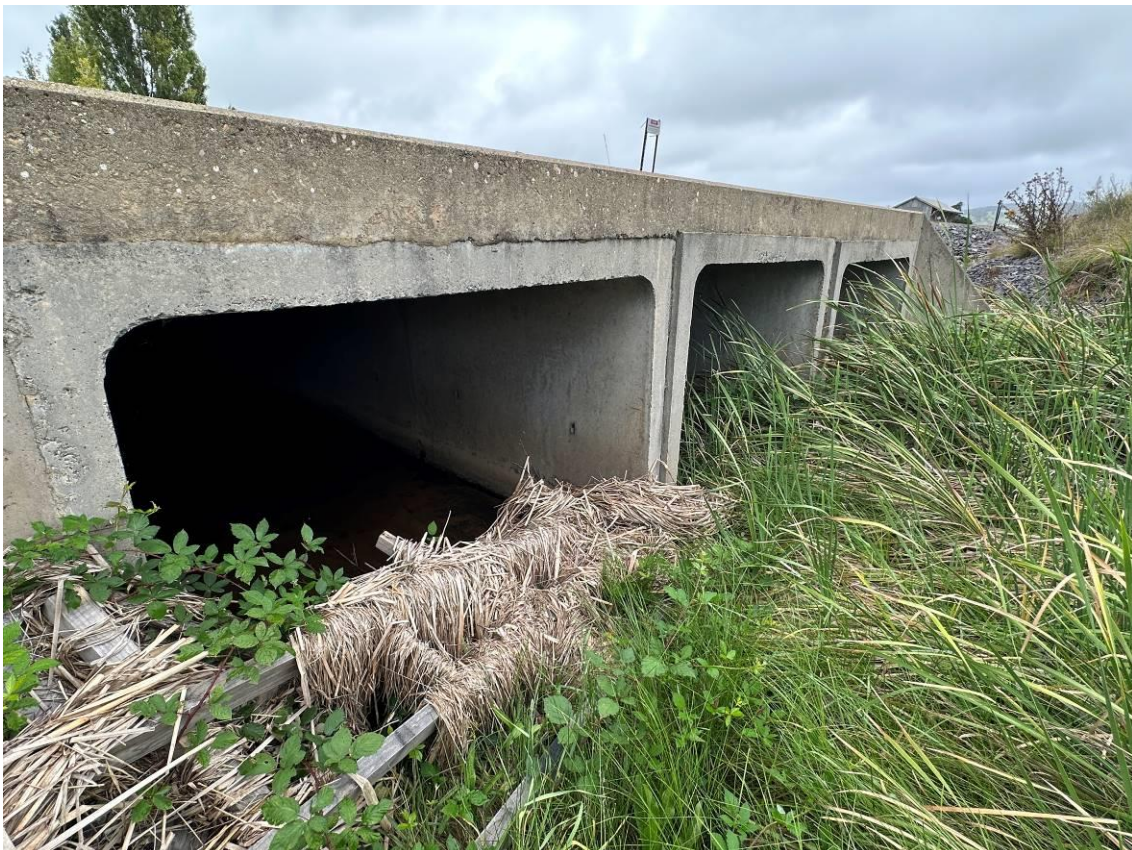
**Photo 8: Southernmost culvert upgradient of the railway line with flowing surface water. Evidence of previous high surface water flow (build-up of vegetation debris).**

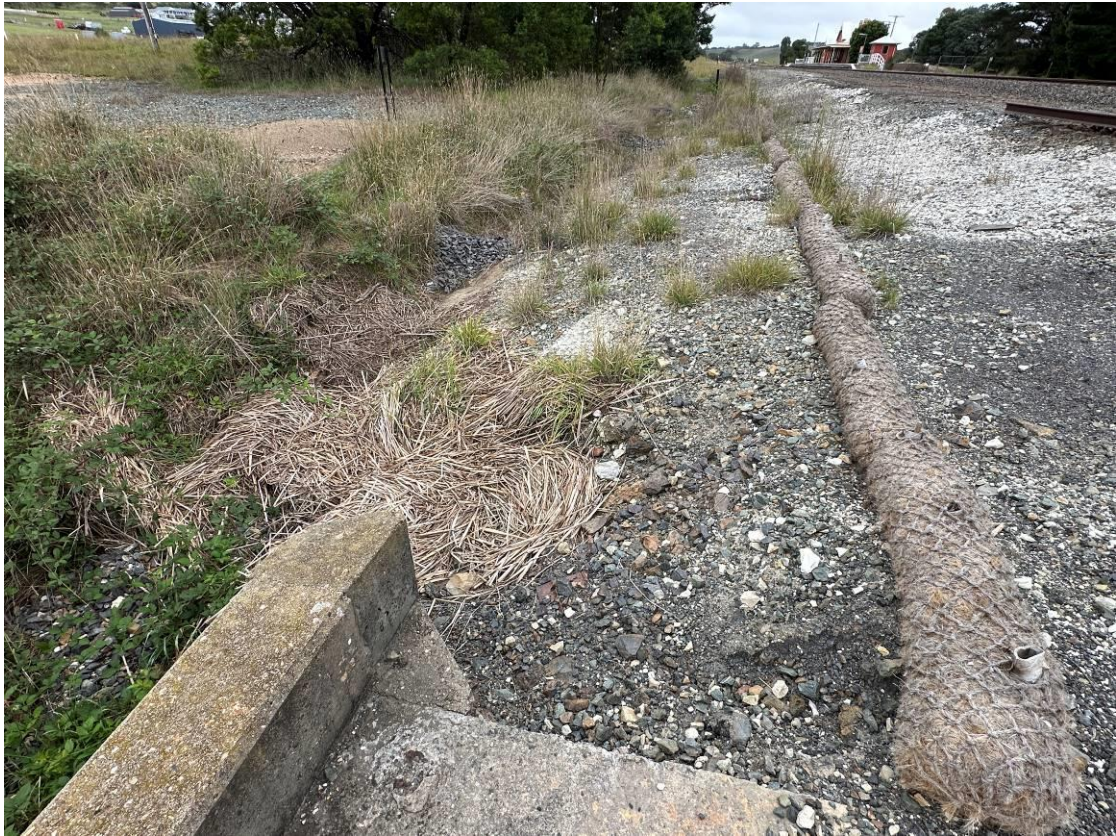
**Photo 9: Southernmost culvert upgradient of the railway line. Evidence of previous high surface water flow (build-up of vegetation debris). Sediment control coir logs in place and in good condition.**

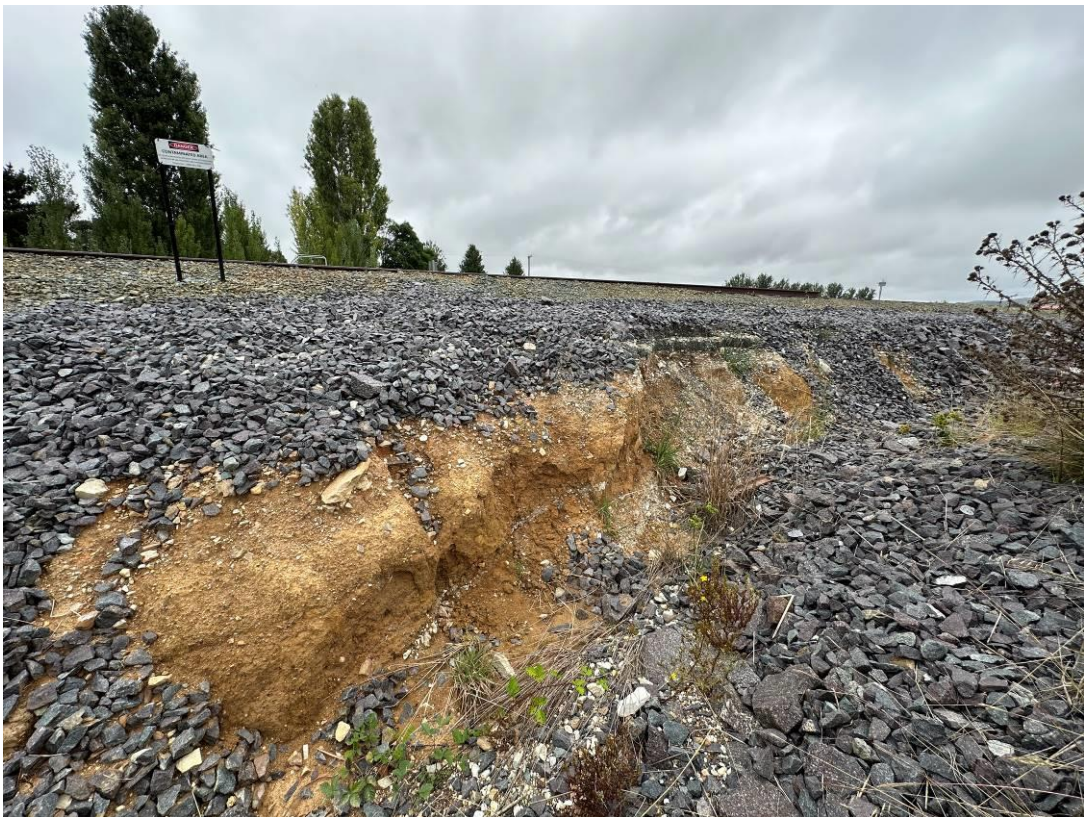
**Photo 10: Southernmost culvert upgradient of the railway line. Evidence of erosion due to lack of ground cover. Only minor changes since previous inspection.**

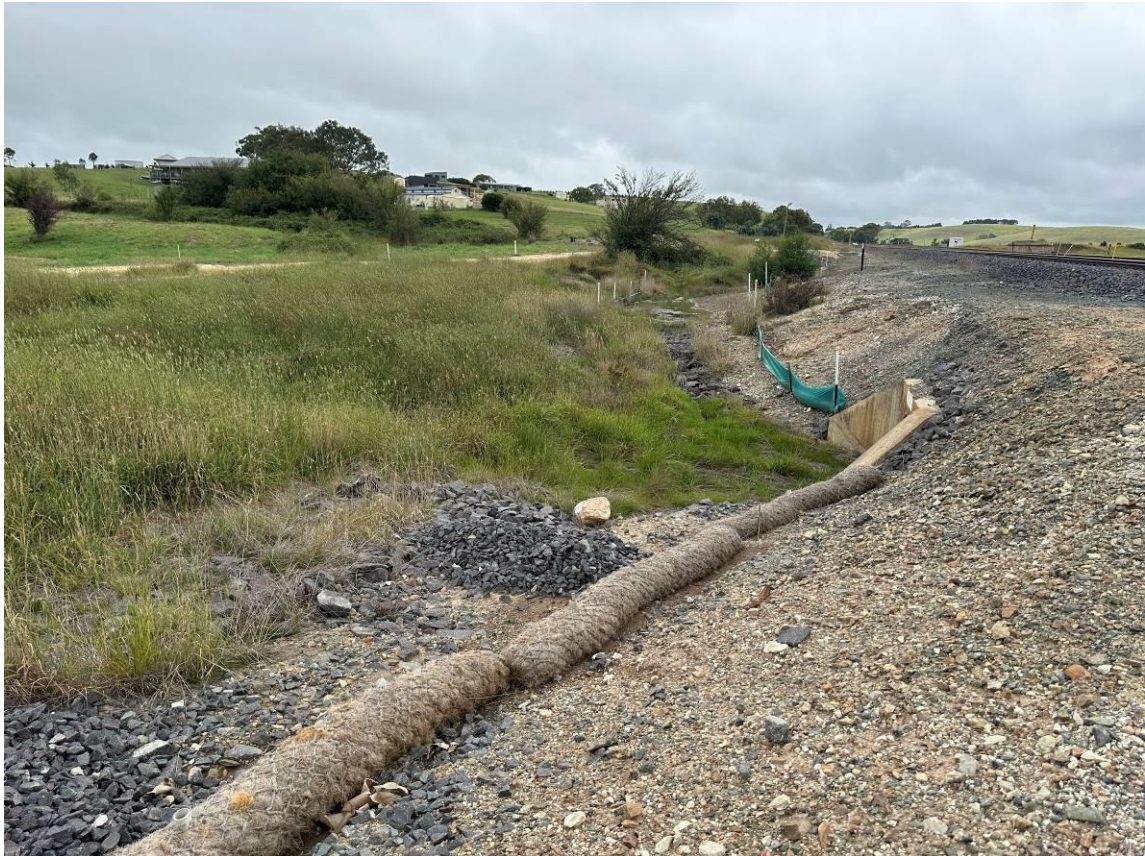
**Photo 11: Upgradient of middle culvert. Sediment controls in place (coir logs and rock armoury in good condition).**

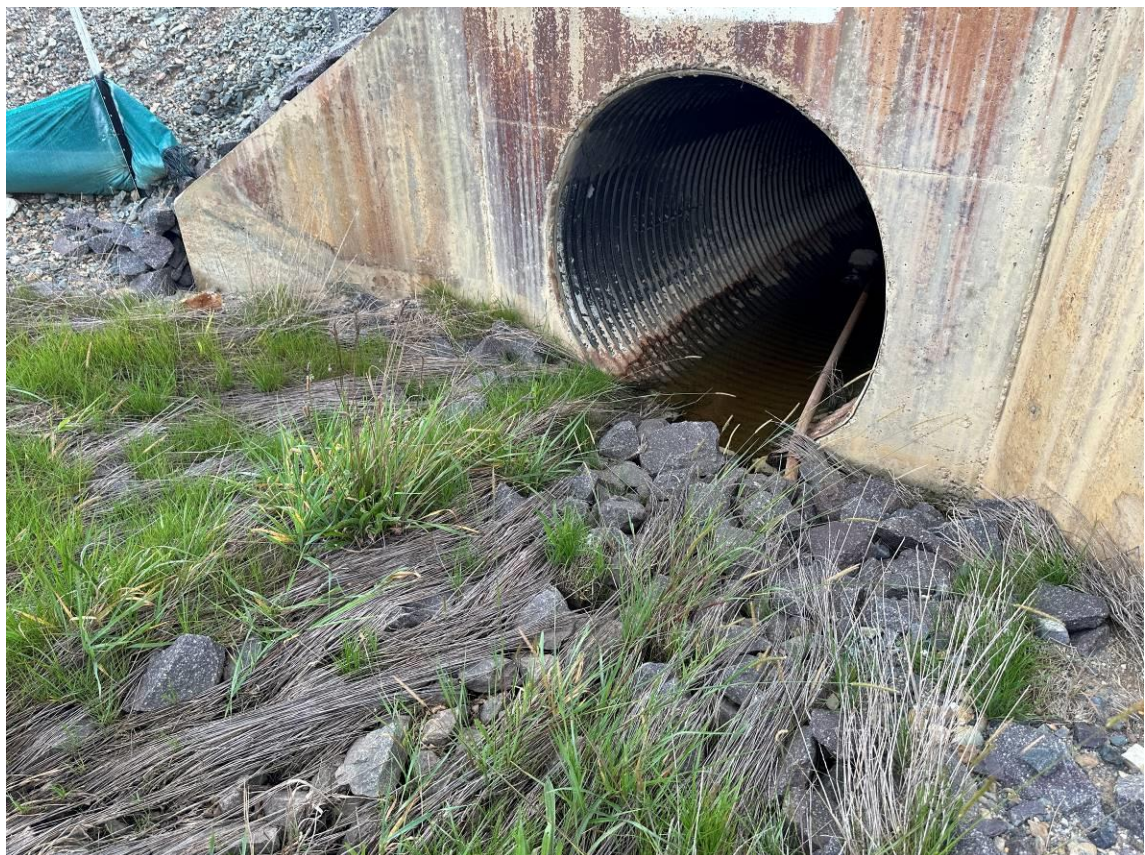
**Photo 12: Upgradient of middle culvert with slow flowing/pooled surface water. Surface water was clear with a dark red/brown tint and with no to low turbidity.**

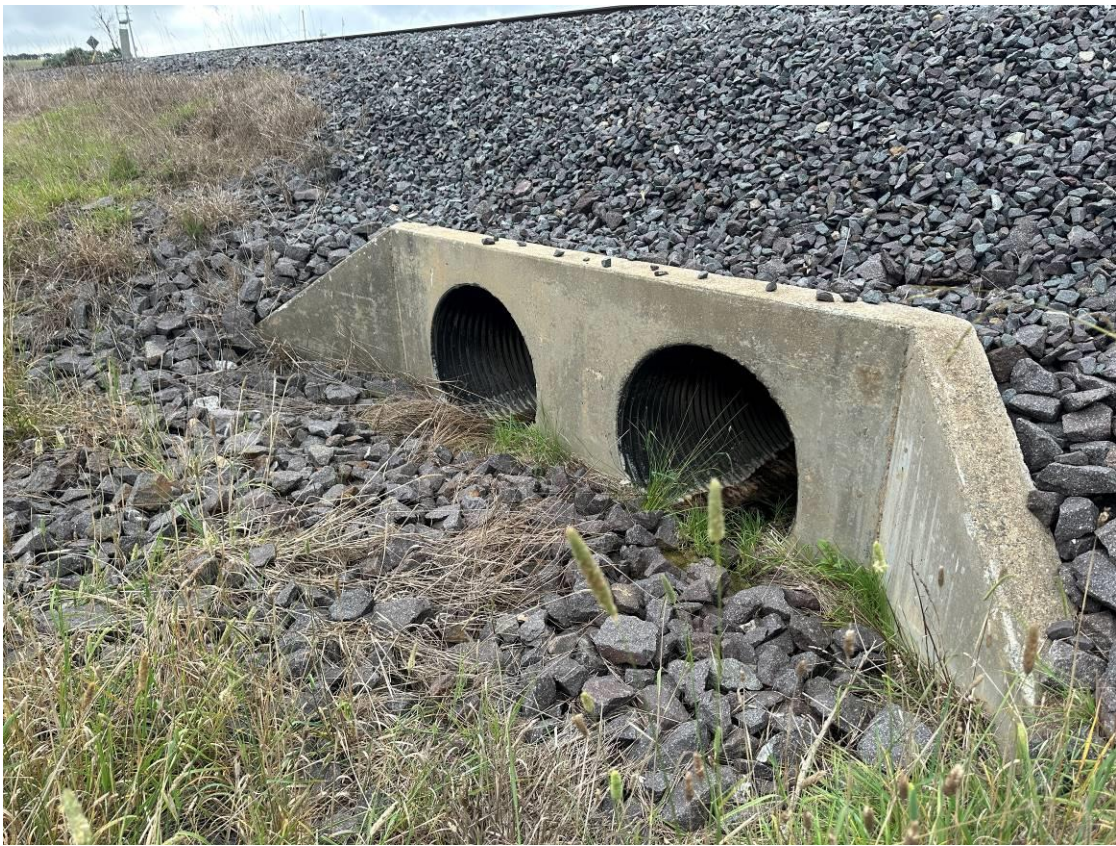
**Photo 13: Upgradient of northernmost culvert with no surface water. No sediment build up was noted on rock armoury.**

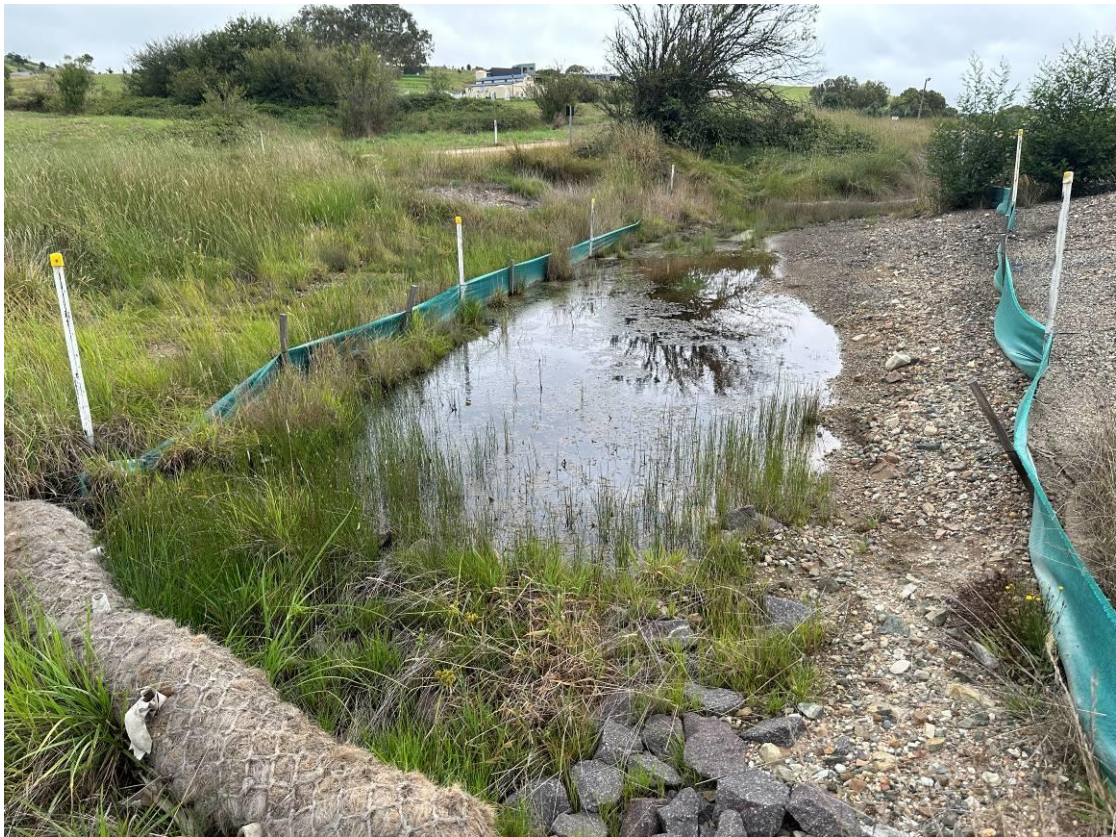
**Photo 14: Surface water pooled upgradient of railway line. Sediment controls (coir logs, silt fencing and rock armoury) in place and adequate. Surface water was clear with low to no suspended solids.**

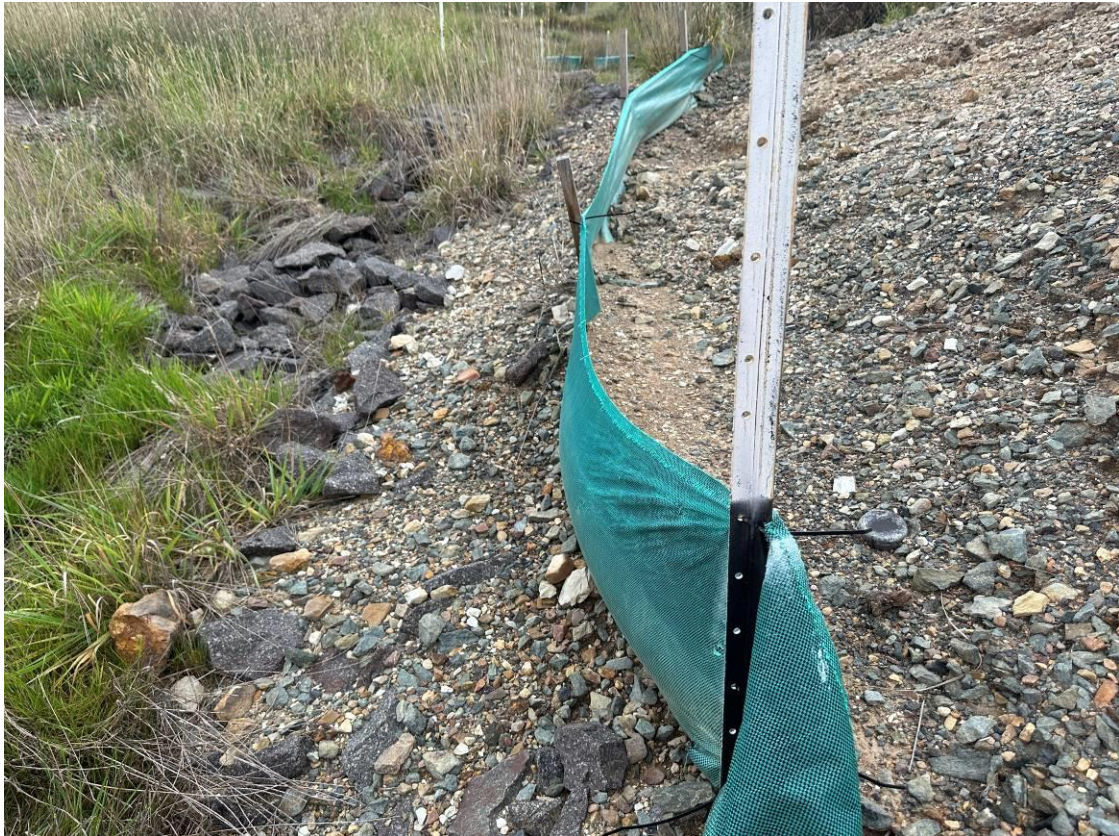
**Photo 15: Upgradient of railway line to the north of the middle culvert. Sediment fencing in place with large build-up of sediment.**

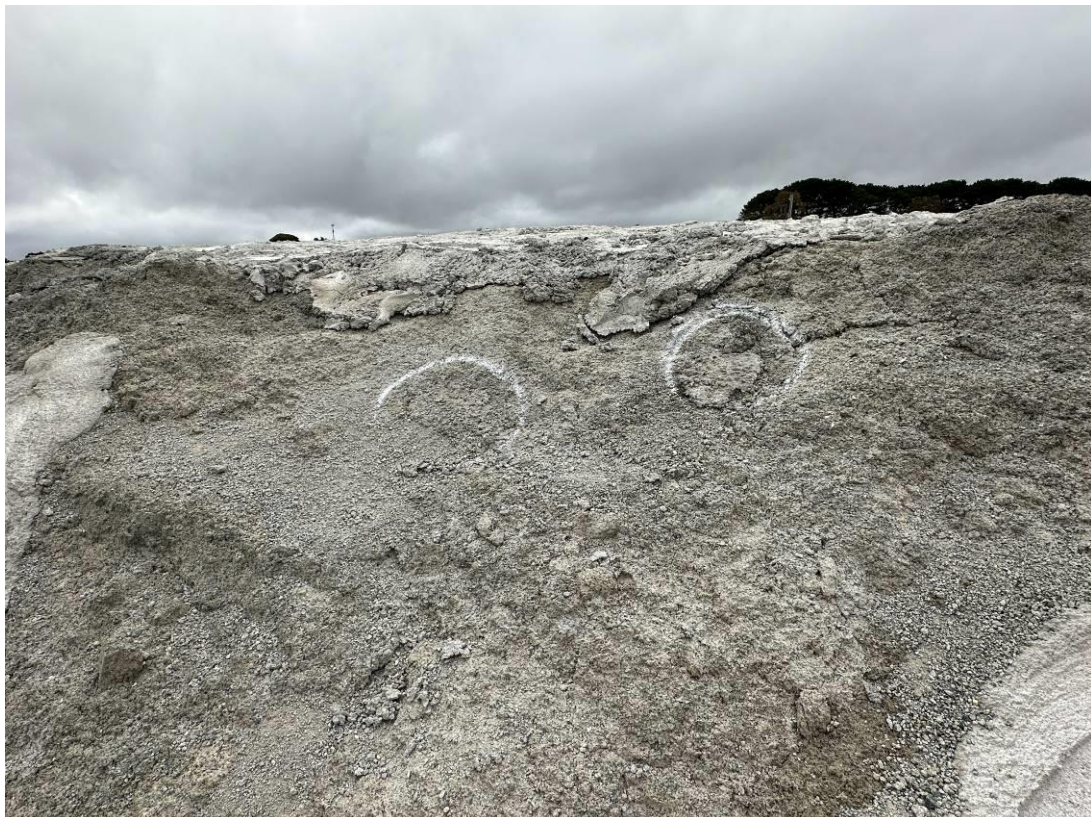
Is geofabric marker layer visible beneath capping of the existing stockpile? If so record in written form and through photographs and consolidate with this checklist. If marker layer is visible rectification work is required.	No. Several new exposed locations were identified during the previous January inspection. This inspection verified the locations have since been sealed. Refer to 'Other Observations' section for additional comments

**Photo 16: Exposed geofabric layer marker on stockpile (identified during the January inspection) has since been filled in with concrete.**

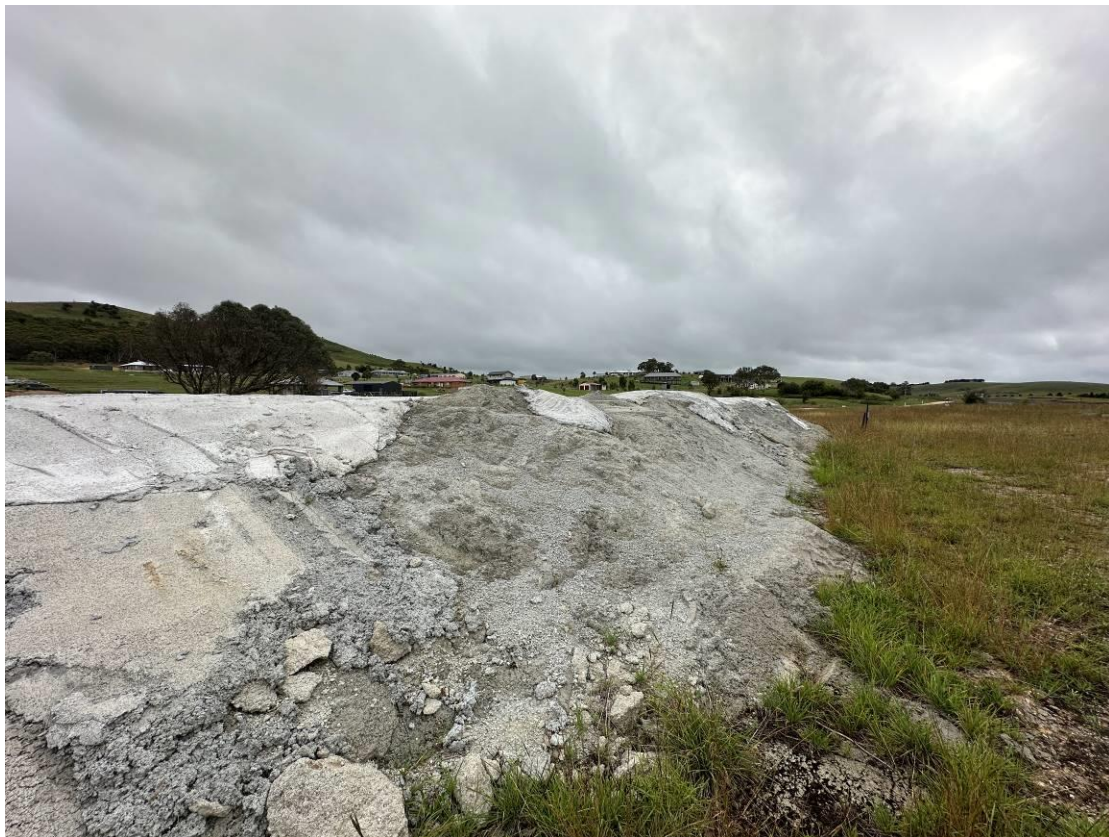
**Photo 17: Concrete capped stockpile. No new signs of exposure marker layer and erosion damage.**

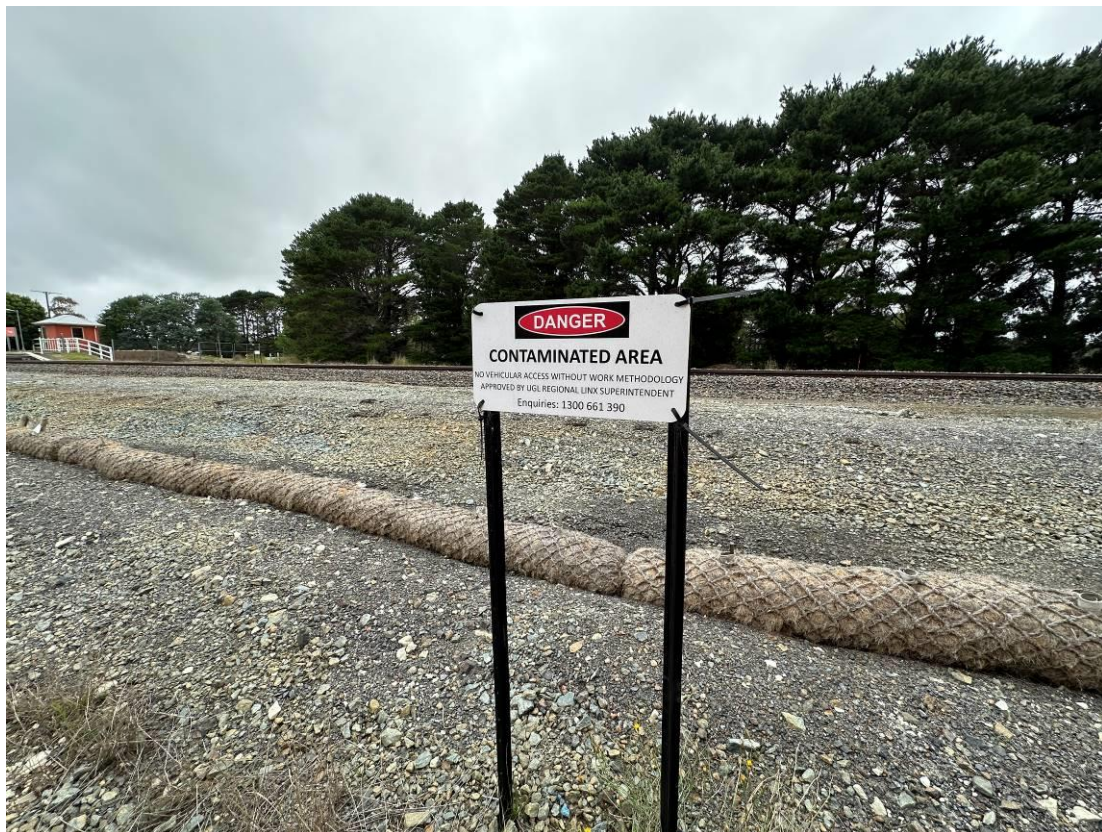
**Photo 18: Contaminated land signage in good conditions, placed at appropriate intervals along the site.**
