Condition Report

Balls Head Coal Loader

Waverton, NSW

Date of Issue: 5th March, 2018
Issue No: 5
Status: Final - Amended
Project No: 17204

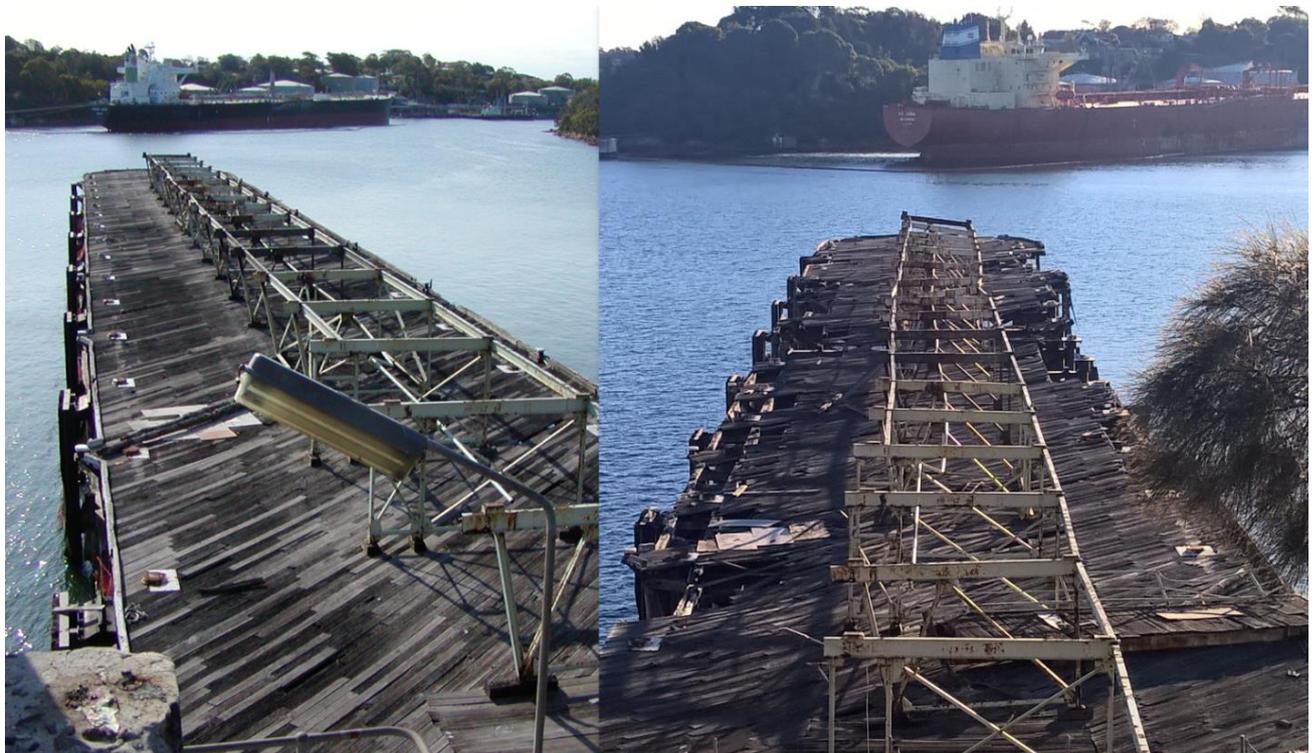
Figure 1: The Coal Loader Wharf in December 2006 (left) and 2017 (right).

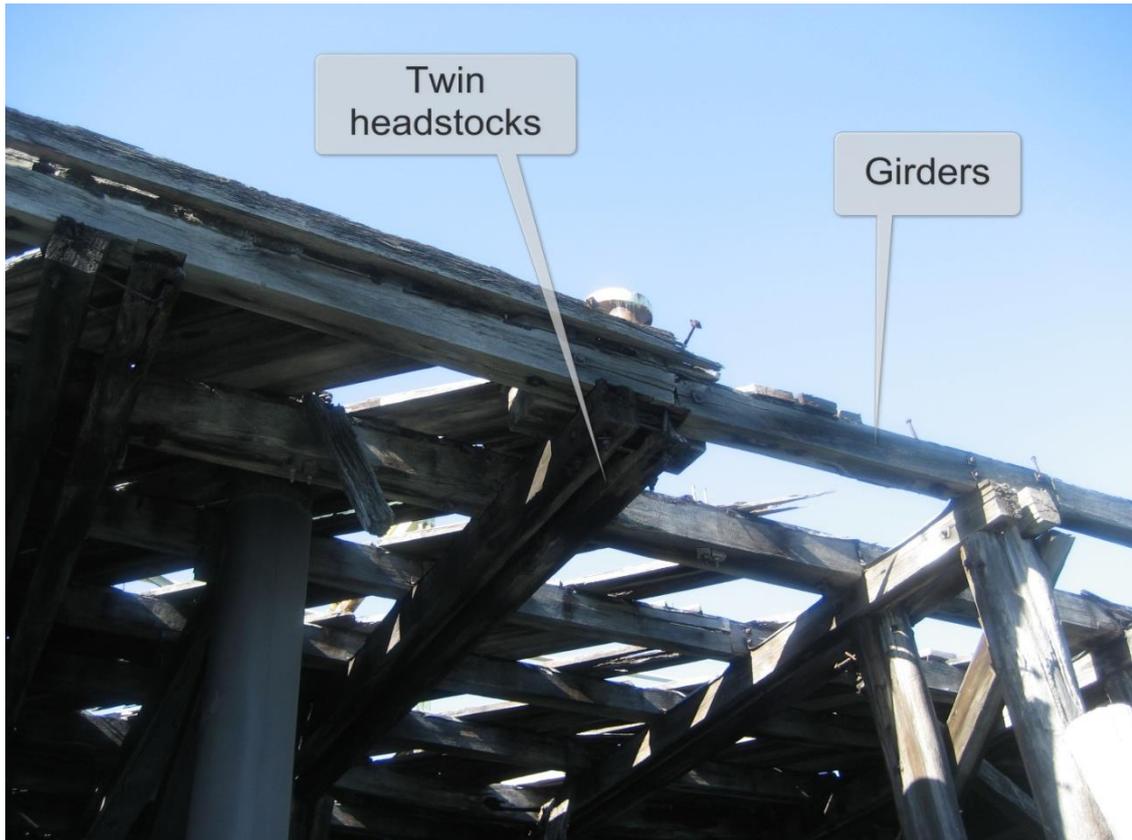
As most of the timber piles have failed or are structurally insufficient, in the majority of locations the headstocks can no longer support the girders. As such it is only the girders' ability to span between steel frames that supports the timber deck.

The deteriorated girders are not structurally sufficient over the increased span to safely support the self weight of the timber decking structure.

Figure 3: North side of Grid 11. Note that piles are missing from the headstocks in the middle and left of the photograph.

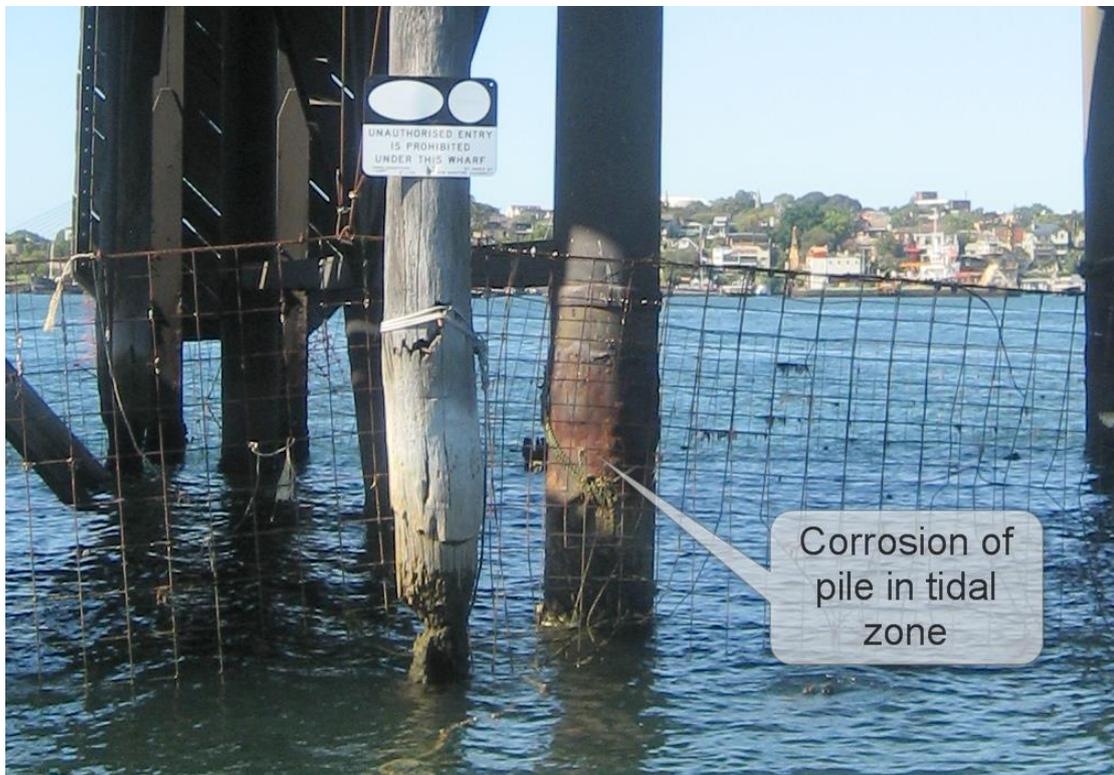
Figure 4: Example of pile corrosion in tidal zone. Photo taken December 2013.

The protective coating applied to the piles has failed in the tidal zone and as such the piles are corroding in this area. The loss of section due to corrosion is expected to increase over time.

- Repair of protective coating to piles in tidal zone, or;
- Replacement of protective coating in tidal zone;
- Localised repair of paintwork to bracing frames;
- Installation and/or replacement of sacrificial anodes to piles.

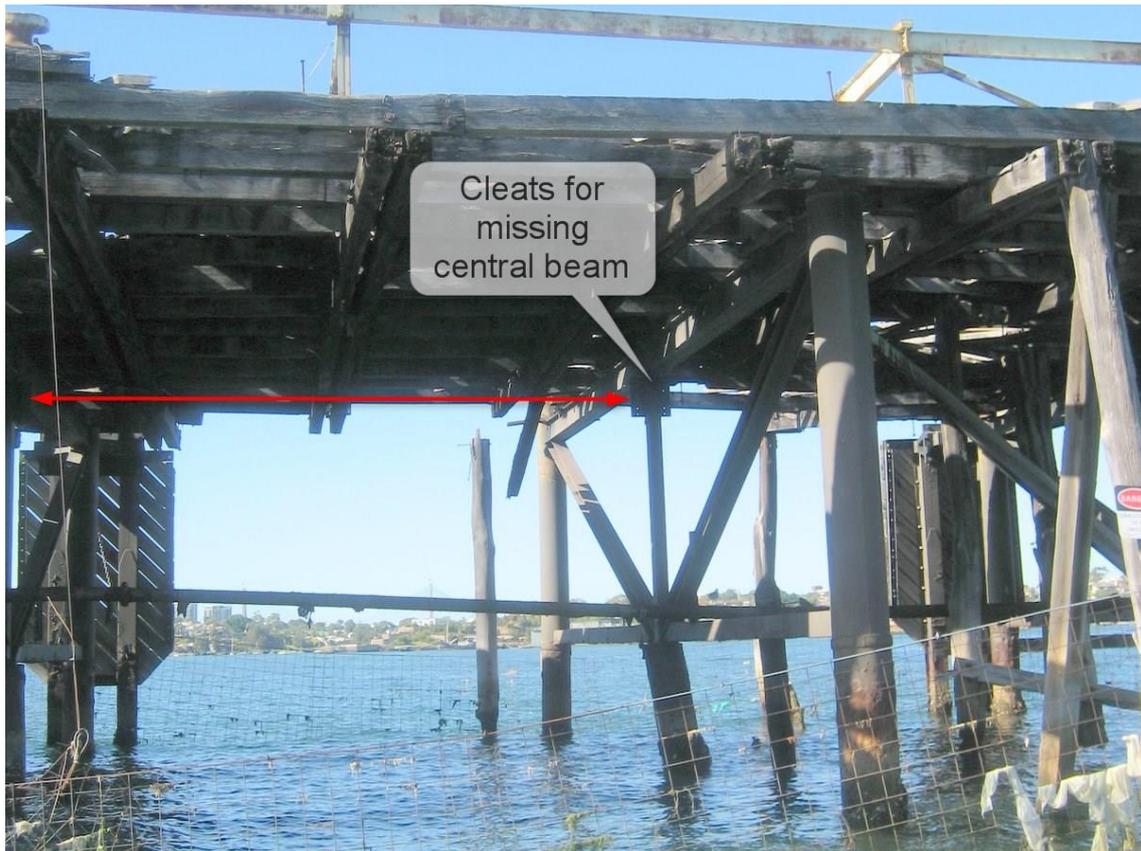
The original steelwork drawings show a large steel beam running longitudinally down the centreline of the wharf, connecting each of the steel bracing frames. This beam is missing from the shoreline to the frame between grids 39 and 40. There is no indication of damage or failure; therefore we have concluded that the beams have been removed. The remaining members appear to be in satisfactory condition.

We note that the removal of this beam has reduced the overall stability of the wharf in the longitudinal direction.

Figure 5: Typical steel bracing frame. Note majority of timber piles are missing, as is the central steel beam between the frames. Photo taken December 2013.

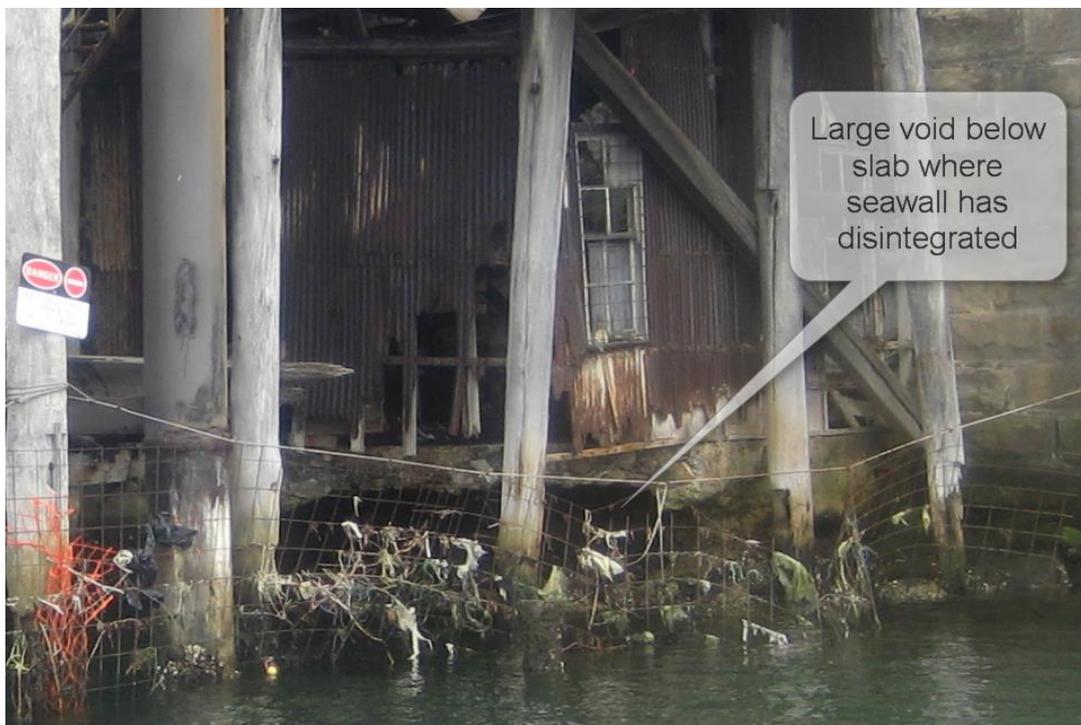
The pump house structure appears to be in very poor condition. The corrugated cladding is corroding and has disintegrated in a number of places. The corrosion appears to be much more significant on the south side, and at the base of the structure. This is likely to be due to the longer wave fetch from the south, leading to larger waves and more severe environmental exposure.

Figure 6: Photo taken December 2014 showing condition of southwest corner of pump house.

Based on the current condition of the pump house we consider that the pump house structure is likely to be fragile and may remain intact for 5 to 10 years. The southwest corner of the pump house is not expected to last beyond 5 years. In addition the slab supporting the southwest corner is disintegrating and is not expected to last beyond 5 years.

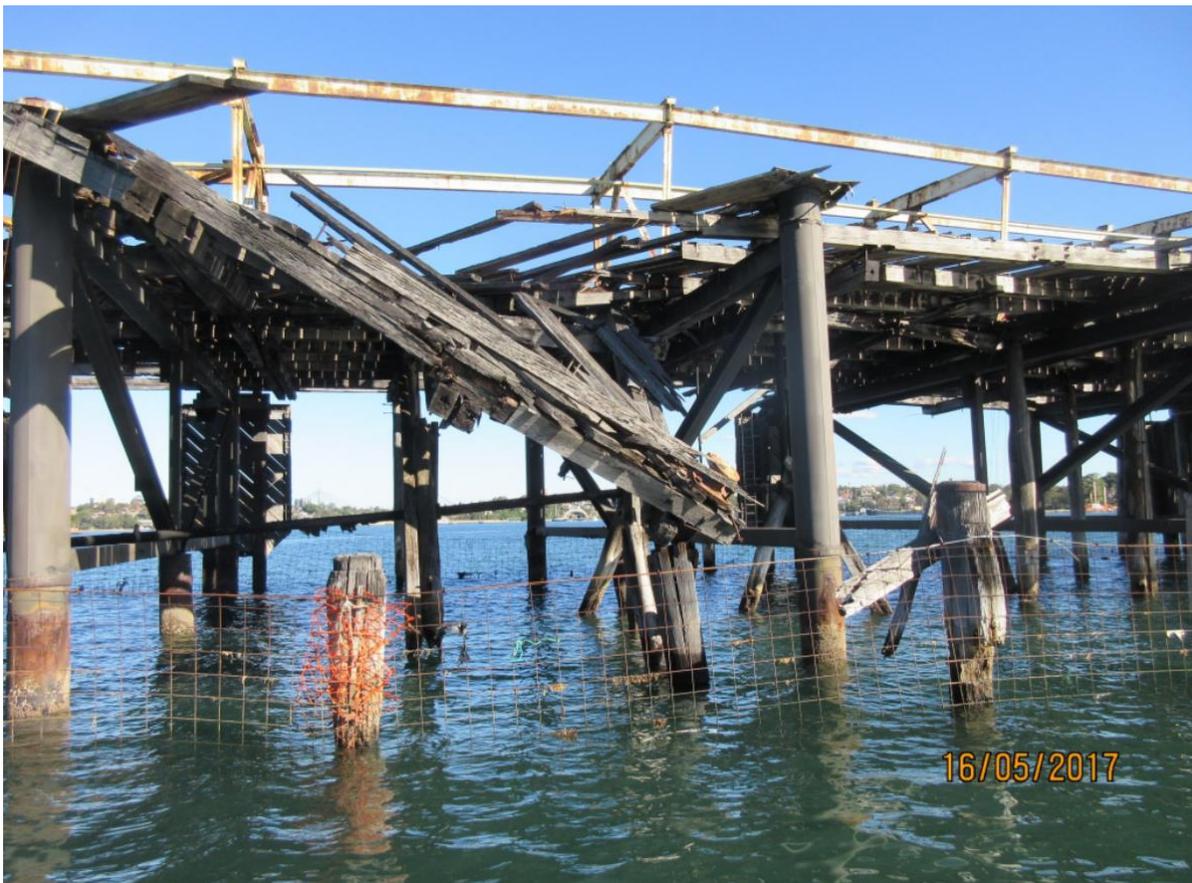
Persons accessing the deck of the Coal Loader Wharf may overestimate the condition of the deck and could cause a collapse, possibly resulting in serious injury. We note that the timber pile stumps remain submerged just below the low water level, and a fall into the water may impact a stump or other submerged debris.

Figure 7: Photo taken May 2017 showing a collapse of a deck area in progress.

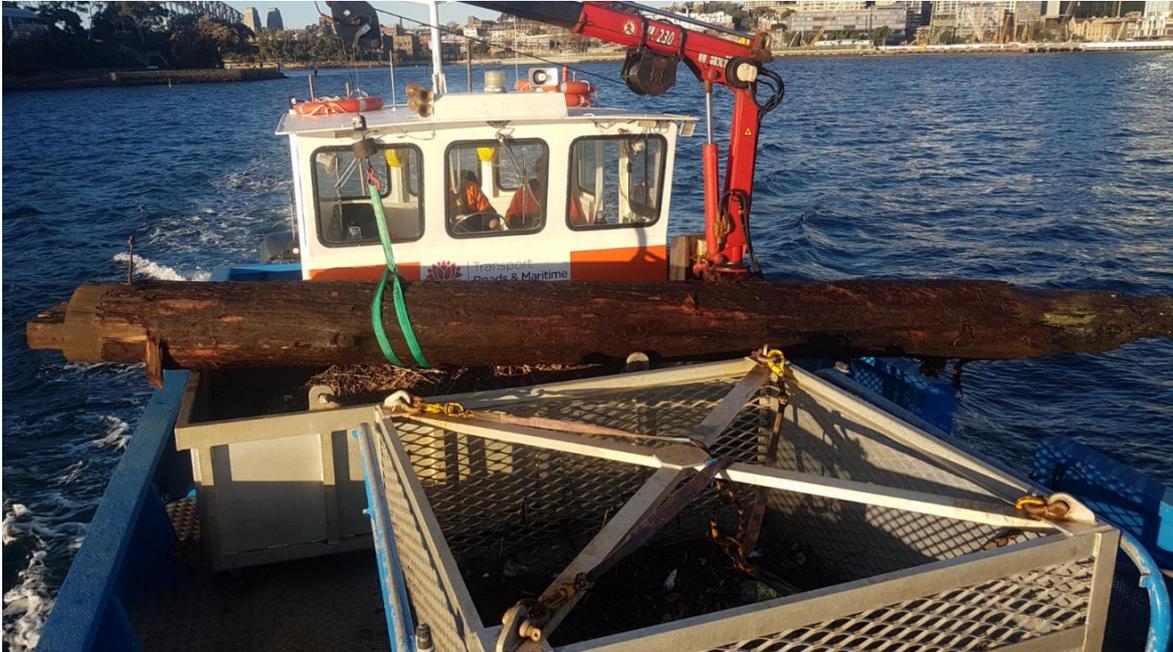
Failed timber elements have been found floating away from the structure for more than 20 years. Most of these elements in the past are likely to have been timber piles as only 30-40 pile heads remain. The remaining pile heads can still fall from the structure and may fall outside the steel mesh, particularly the remaining piles on the perimeter of the structure.

Figure 8: Photo taken July 2017 showing a floating pile head retrieved from outside structure.

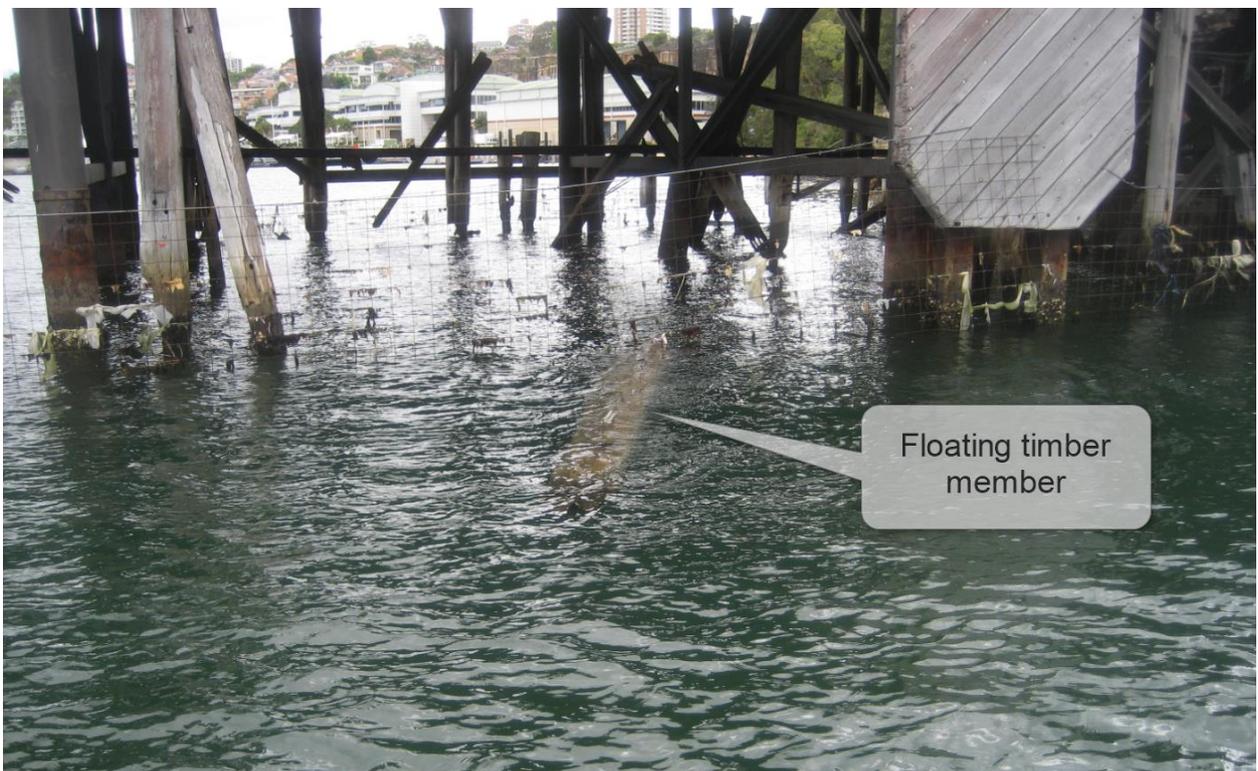
Figure 9: Photo taken October 2014 showing a large timber member found floating outside of containment mesh.

Large floating members pose a significant hazard to passing vessels due to the risk of collision and the resulting damage. As shown in Figure 9 even large members can be difficult to see as most of the member is submerged.

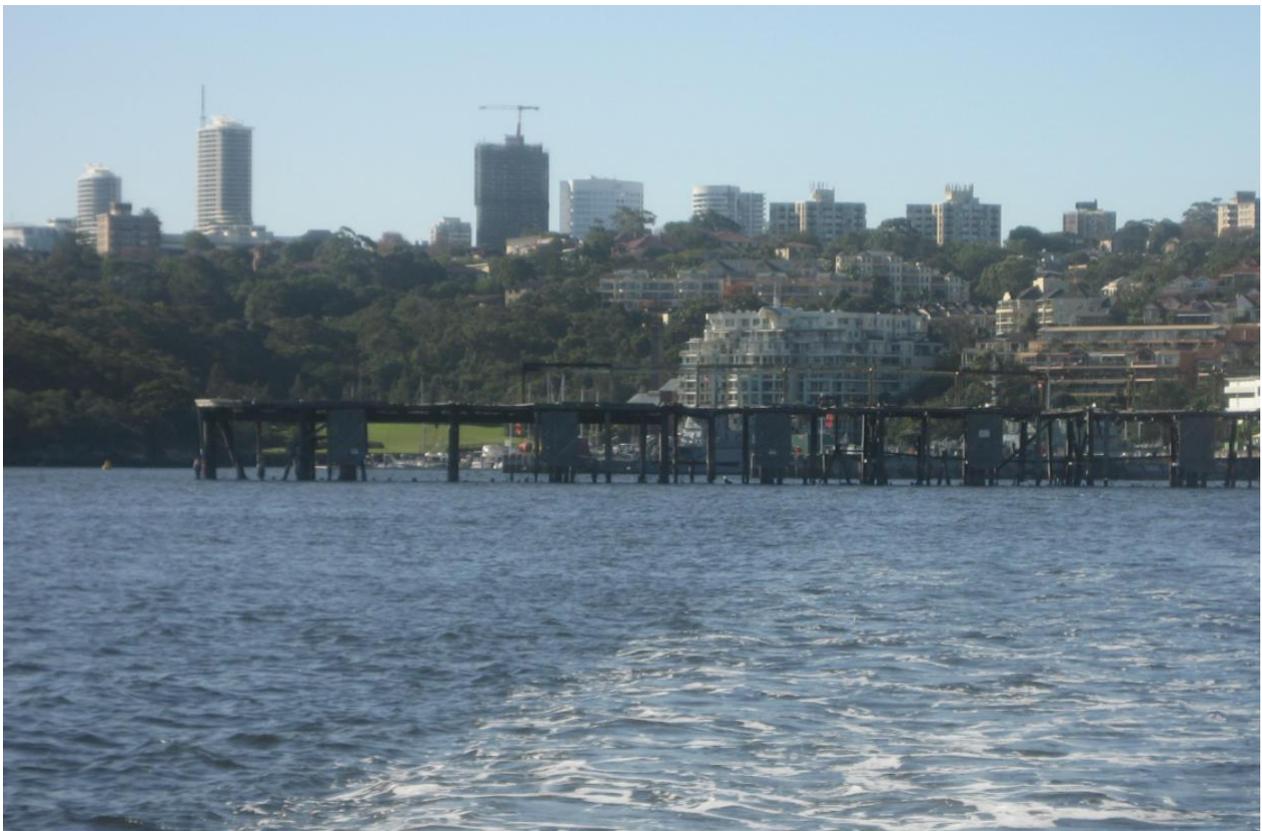
The removal of the deck is also likely to make the structure and spacing of frames appear "open" which could encourage vessels to pass between the frames, and persons to climb on the frames. If the submerged timber pile stumps have not been removed there is a significant risk of damage to a vessel.

Figure 10: Photo taken May 2015. Note "open" bays at west end due to loss of pile heads. Submerged pile stumps remain and are not visible at high tide.

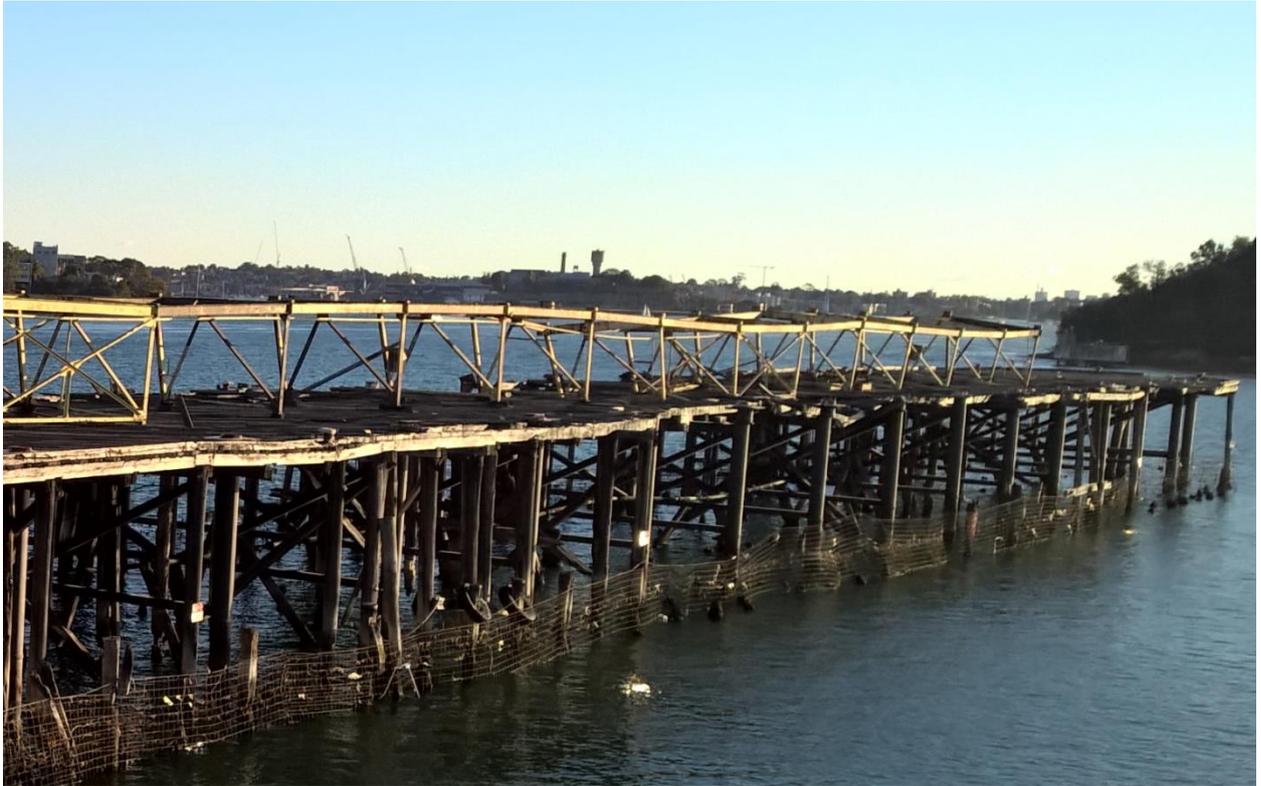
The steel conveyor frames above the deck are supported by the deck and are in poor condition. The frames are corroding in a number of locations and are likely to have suffered damage as a result of deterioration of the timber deck. Deterioration of the deck has resulted in deformations of the deck, which in turn has caused settlement of the conveyor frames and likely yielding or deformation of the connections between the portal frames and the connecting beams.

Figure 14: Photo taken July 2017. Note deformations of conveyor frames.

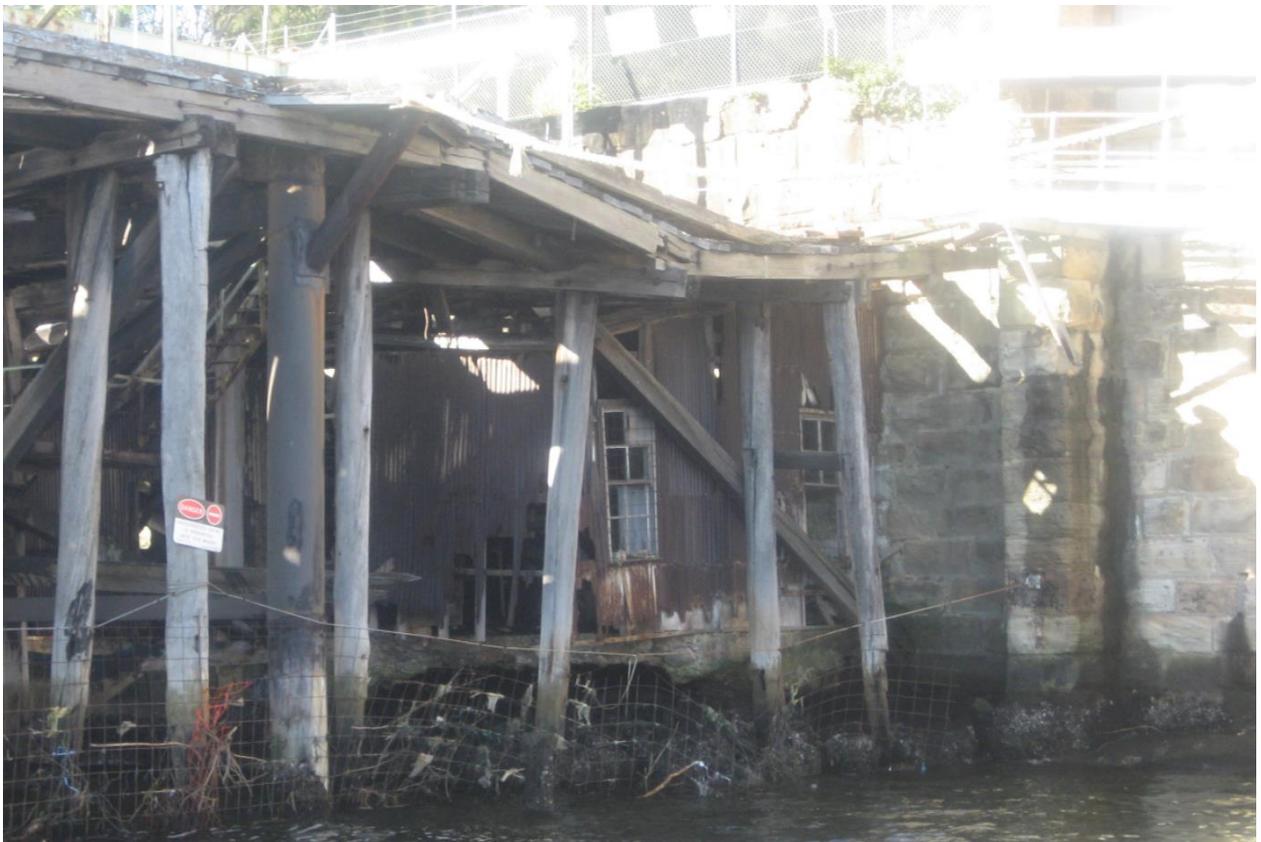
Figure 15: Photo of pump house taken in 2015. Note sag in deck structure above.

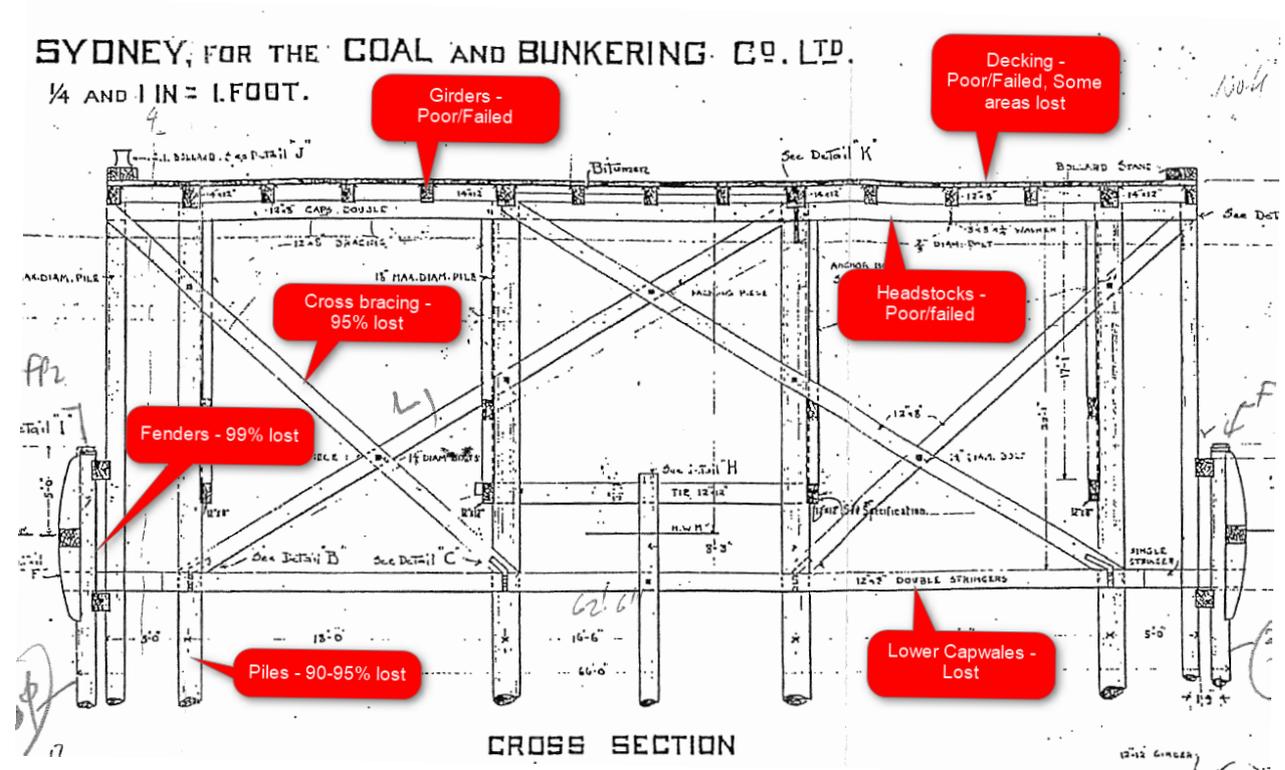
Figure 18: Cross section of original timber wharf structure with mark-up of condition and loss of elements, as of 2017.

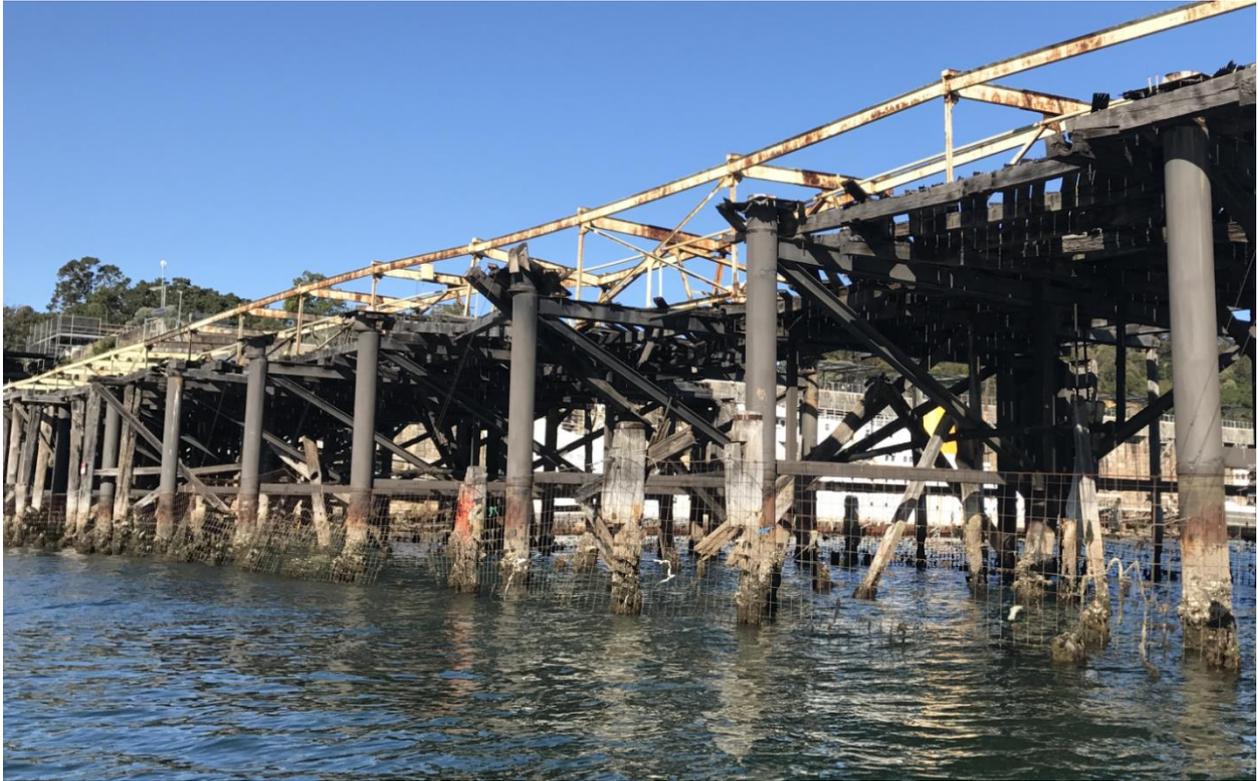
Figure 19: Photo taken July 2017 provided by RMS. Only one timber cross brace remains connected at left edge of photo. This length of the wharf originally utilised more than 70 timber cross-braces.

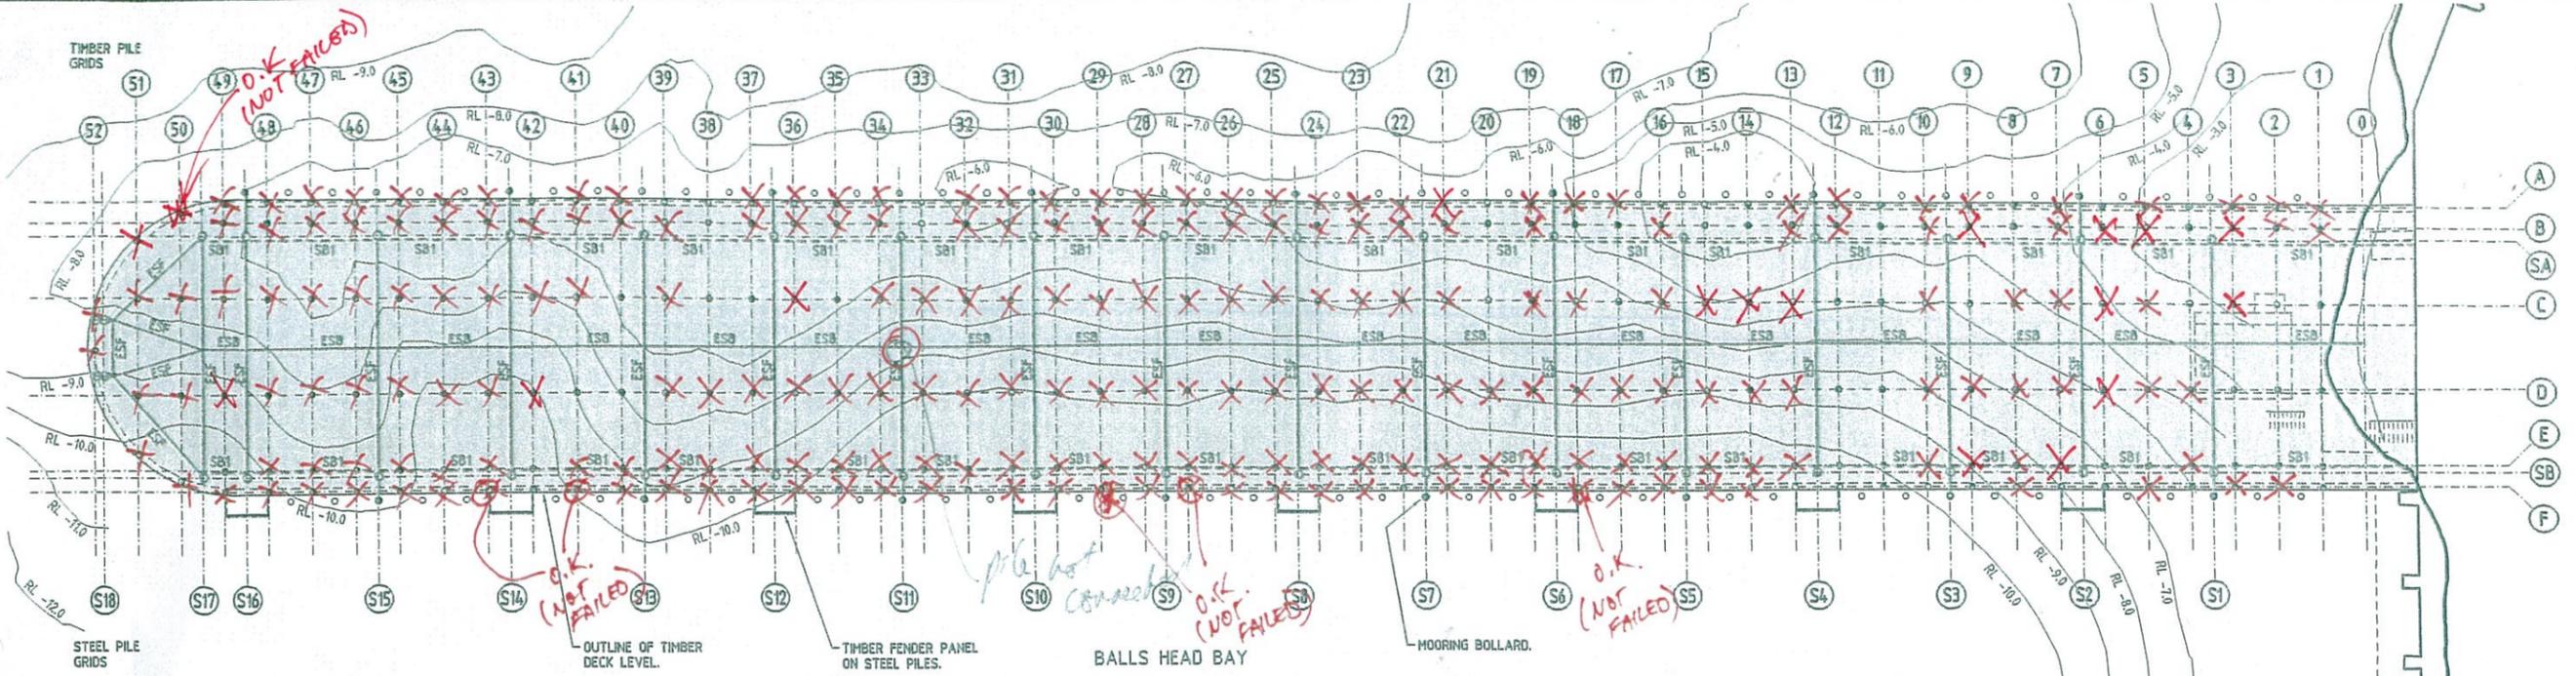
X - PILES MARKED AS SUCH WERE NOT PRESENT OR HAD SNAPPED AT TIME OF REVIEW. (2013)
