NEWCASTLE INNER CITY BYPASS: RANKIN PARK TO JESMOND
ENVIRONMENTAL REPRESENTATIVE MONTHLY REPORT
March 2021

Reporting Period: 1 to 31 March 2021

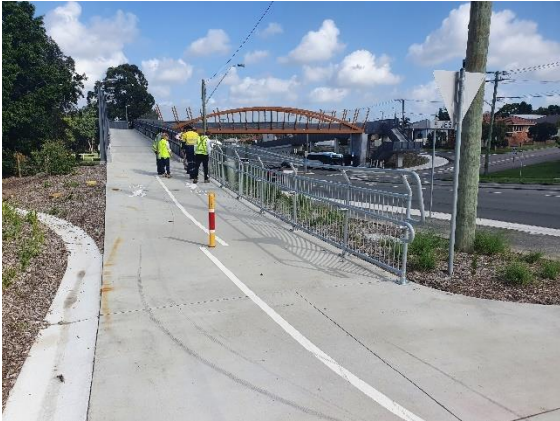
Image 1: SPB, Newcastle Road

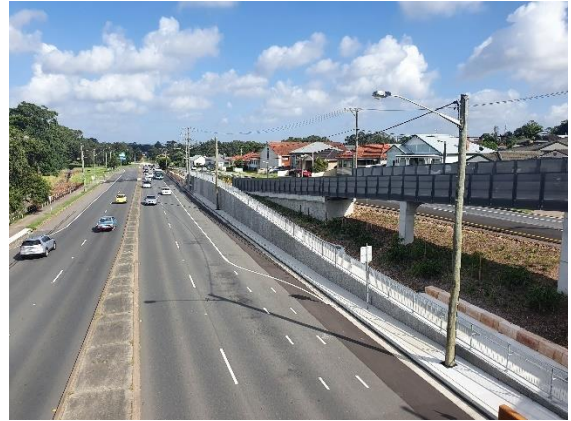
Image 2: On SPB looking west

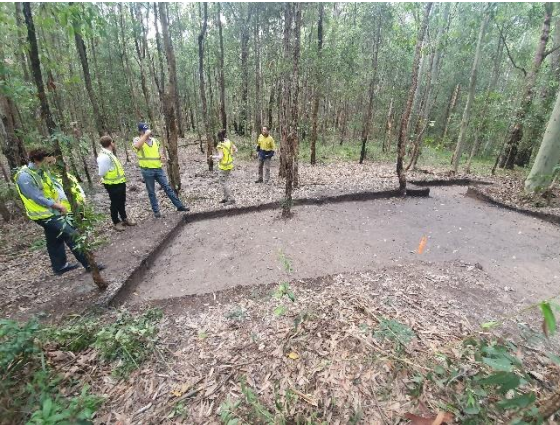
Image 3: Cultural Heritage Salvage

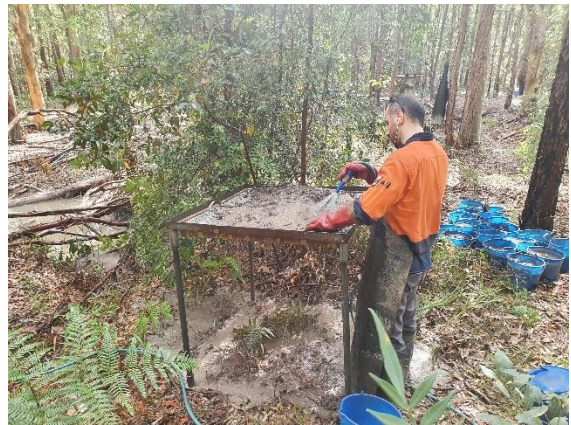
Image 4: Cultural Heritage Salvage

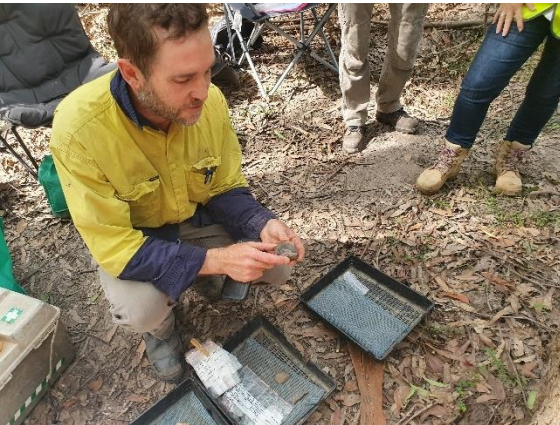
Image 5: Cultural Heritage Salvage

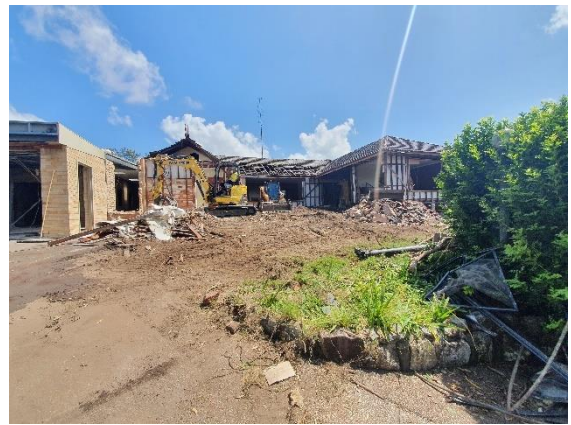
Image 6: Demolition
