# ARBORICULTURAL IMPACT ASSESSMENT REPORT

**SITE ADDRESS:** Prospect Highway Project (Seven Hills, NSW)  
**CLIENT:** SMEC Australia Pty Ltd  
**PREPARED BY:** ArborSkills Arboricultural Consultancy  
**DATE:** 11 December 2015

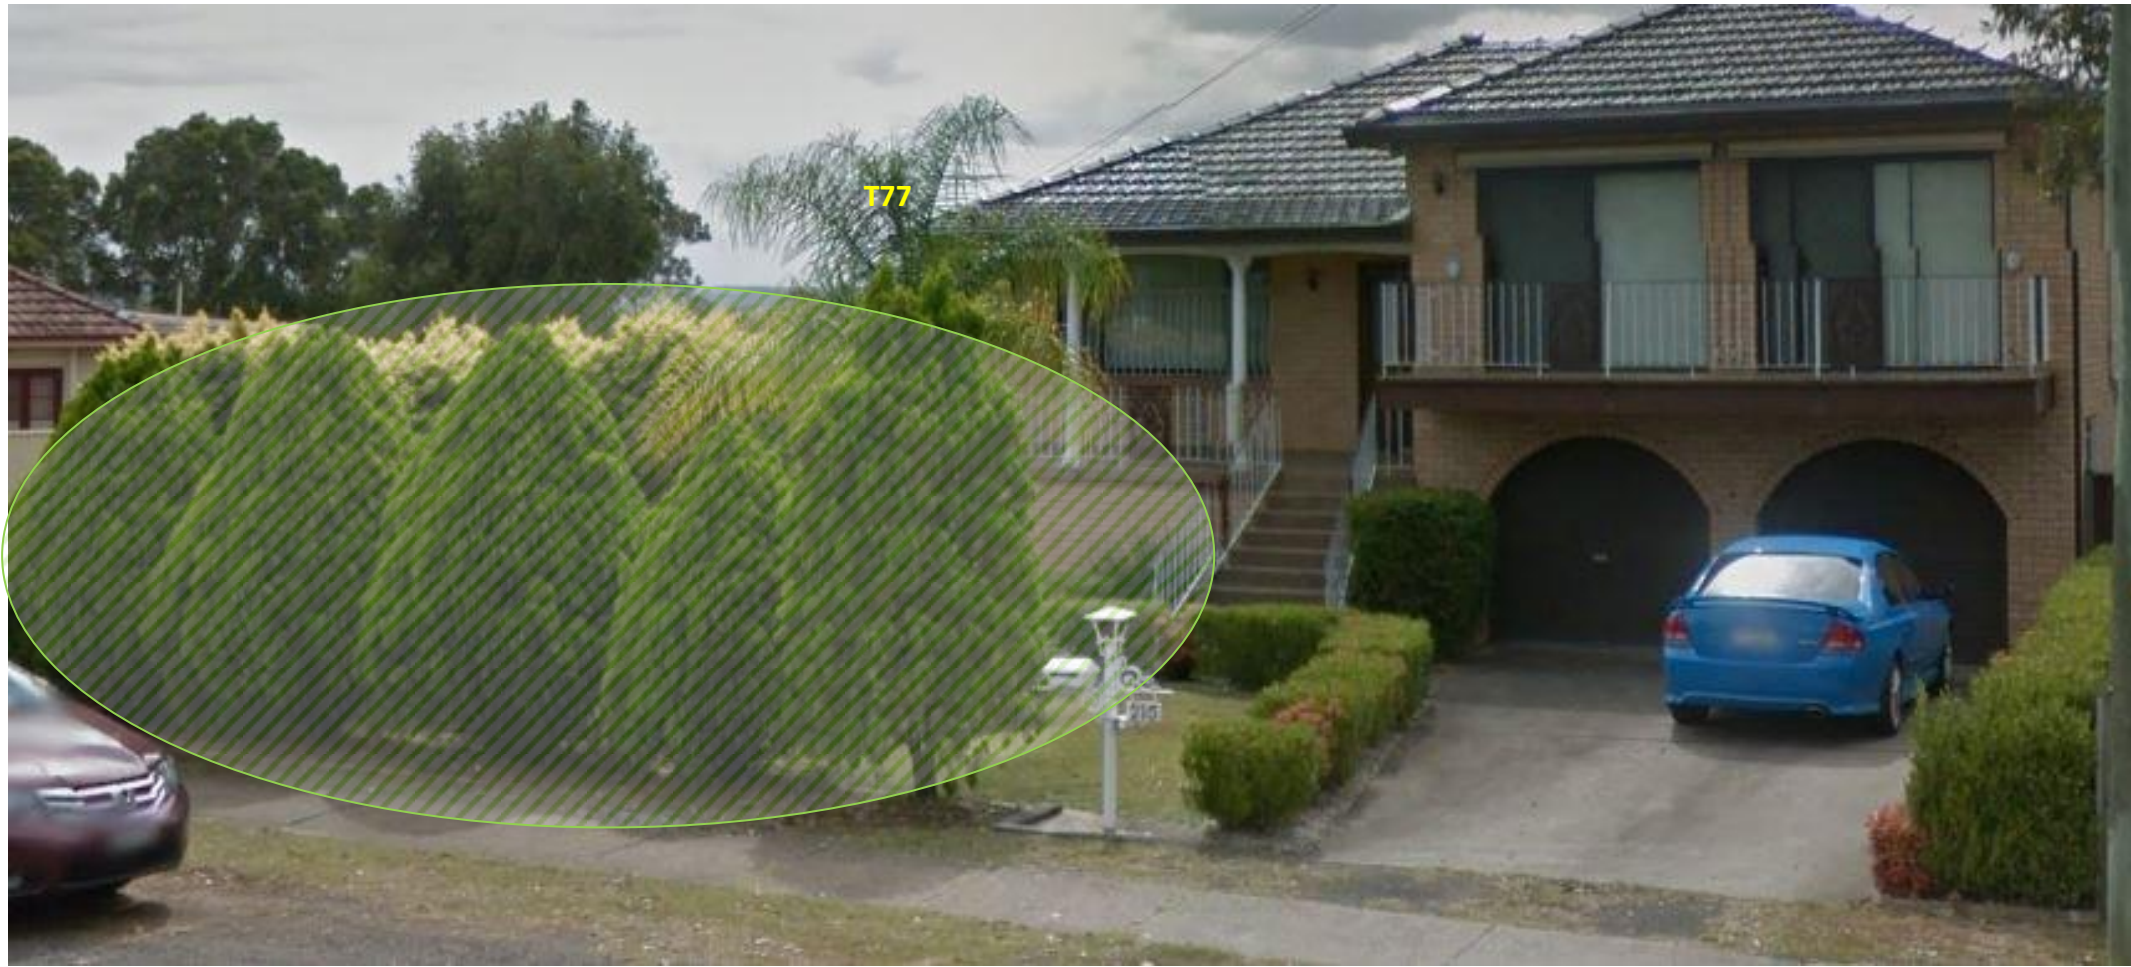
**Image 25:** 205 (left of frame) and 207 (right of frame) Blacktown Road.

One exception to this timeframe is a Canary Island Date Palm (*Phoenix canariensis*) located outside of No. 205 Blacktown Road. The dwelling on this property is in the style of a Federation bungalow. Palms of all species were fashionable plantings of this era however, examination of the 1943 aerial photograph shows that the dwelling existed but not the palm. This indicates that it is not a contemporary planting but one installed after 1943. Given that the species is relatively slow growing, it is suggested that the planting did not take place much after 1943 in order for the palm to be of the size that it is today. It is understood from the client that the owners of this property have expressed an emotional attachment to this palm. Further investigation would be required to ascertain the context of the expressed attachment.

Tree ID No.	Location	Common Name	Botanical Name
74	205 Blacktown Rd	Canary Island Date Palm	<i>Phoenix canariensis</i>
