# **RICHMOND BRIDGE AND APPROACHES CONGESTION STUDY**

## **STAGE 1    APPENDIX 2**

### **BRIDGE INSPECTION AND STRUCTURAL ASSESSMENT**

The Roads and Maritime Services (RMS) Project Development Manager (from Infrastructure Development) has made a request for a Level 3 inspection and load capacity assessment of the bridge over the Hawkesbury River at North Richmond (Bridge Number 429) in anticipation of future widening.

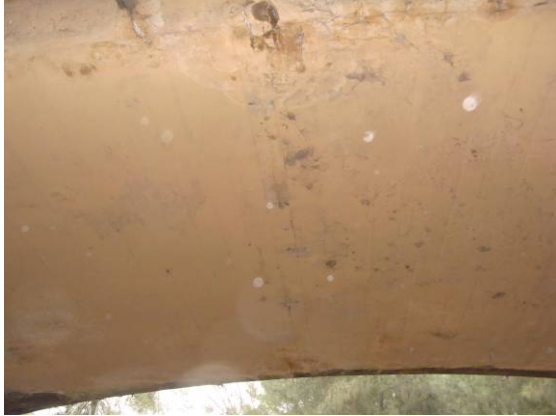
Some of the concrete arches have flexural cracking (transverse cracking) at the apex. Span 13 has the largest crack compared with all the other spans. Span 13 has been monitored since 2002, as per a previous L2 inspection report. There were crack observed in the telltales (crack monitoring glass) on span 13. New telltales were installed in October 2011 on span 13 to monitor these cracks. These cracks in span 13 might have been due to a minor movement in abutment B.

<b>Photo 19– (B-86) Span I3 cracking at concrete arch-</b>	<b>Photo 20 – (B-87) Span I3 telltale to crack in arch</b>

- *Monitor the telltales on span 13 in a regular basis, importantly during construction of any widening works.*
- *Repair concrete spall and monitor cracks annually in all the other spans.*

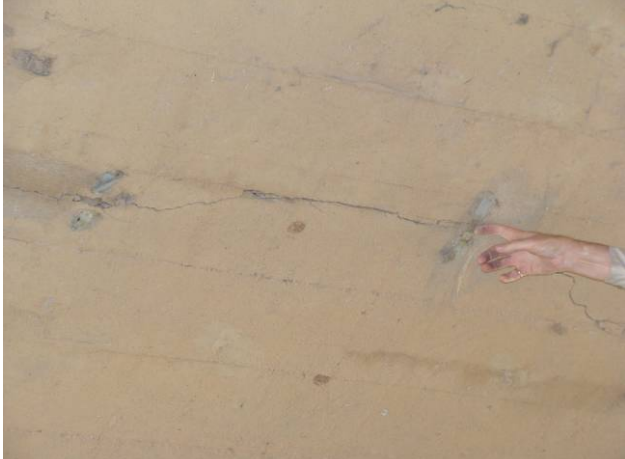
Concrete arches are in fair to good condition with transverse cracking at the apex. Span 13 was the worst of all the spans. The old 2002 crack monitoring regime was examined and found that glass had cracked in two locations and two had failed glue joints. Three new glass telltales were glued over the crack on 20/10/2011. These should be checked monthly to determine if the crack is getting wider.

<b>Photo 21 – (C-5)Span I3 - 3mm Crack</b>	<b>Photo 22 – (C-7) Span I3 - 3mm crack</b>

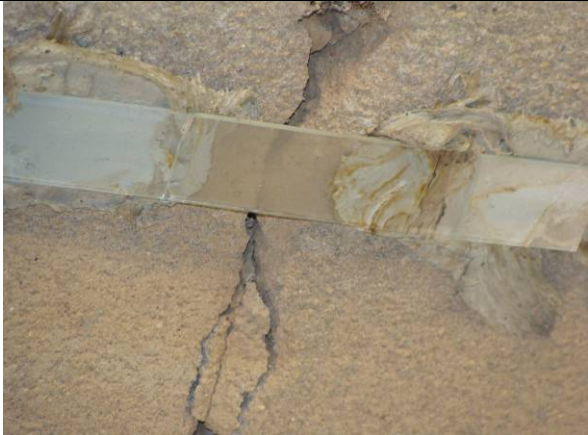
<b>Old Tell tale- cracked</b>	<b>Old Tell tale- cracked</b>
<b>Photo 23 – (C-8) Sp I3- 3mm Crack tell- tale cracked- closer views</b>	<b>Photo 24 – (C-10) Span I3- 3mm Crack- old tell-tale cracked</b>

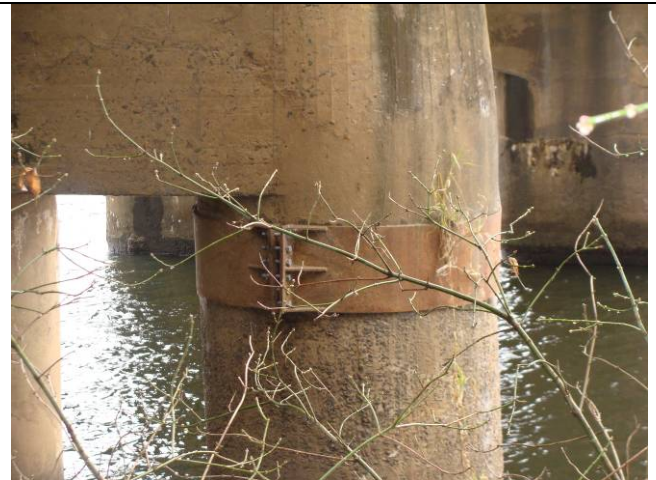
**Photo 32 – (B-39) Span 4 Pier4 Downstream column old strengthening**

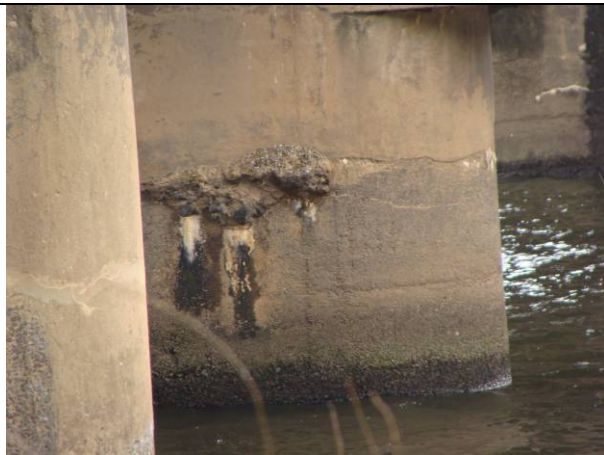
**Photo 33– (B-40)Span 5 Pier 5 & Pier 6 column2 - crack at pier construction joint**

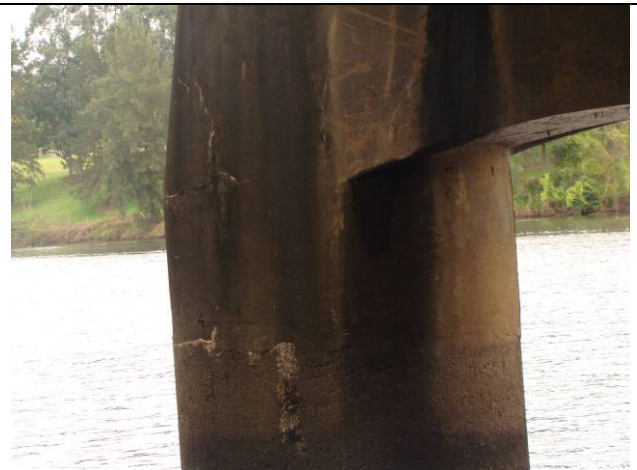
**Photo 34-(B-43)Span 4 Pier 4 column 1 Upstream crack at joint**

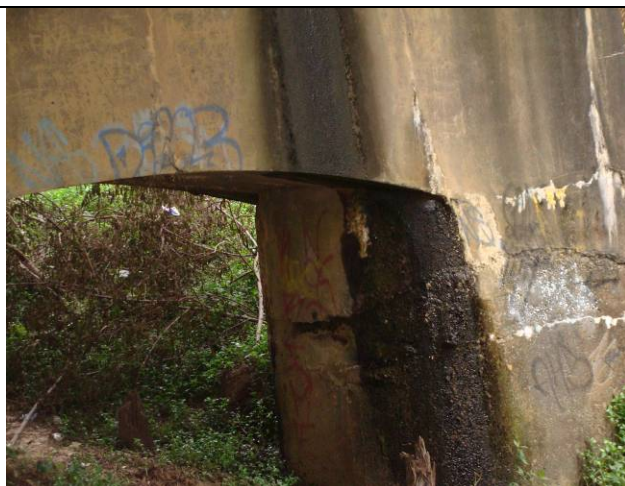
**Photo 35 – (B-49) span 3 pier 2 Upstream column 1 - similar crack**

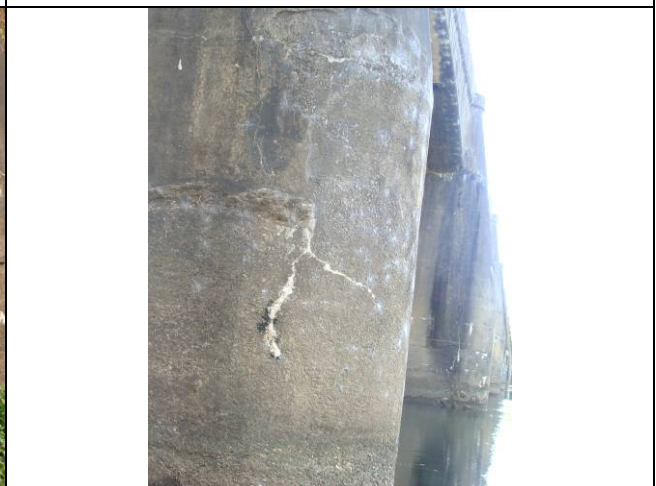
All of the pier headstocks have a crack at mid span. However, the depth of the headstock is 3.3m and the span of the headstock is 3.35m, which would suggest that a flexural crack is possibly not from live load. This may be due to minor movement of pier foundation over many years. It is not clear that the piers and headstocks have reinforcement, as per the drawings. In addition, all the piers and headstocks have random thermal cracks.

**Photo 36 – (C-24) Span 11-Pier 12-crack pattern similar in most piers**

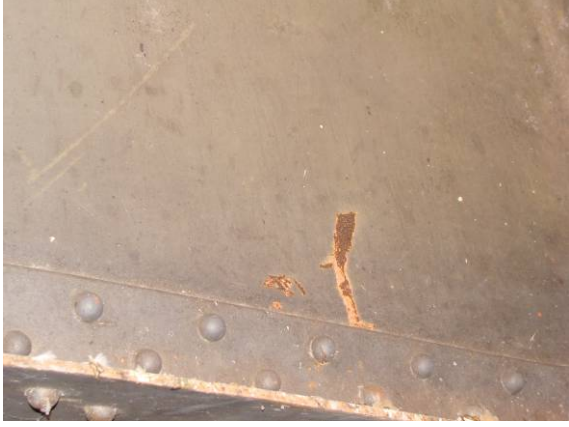
<p><b>Photo 53 – (A-8)Span I2- steel beam web -minor corrosion</b></p>	<p><b>Photo 54 – (A-5)Span I2 Pier I I SpanI Corrosion at hole in the stiffeners</b></p>

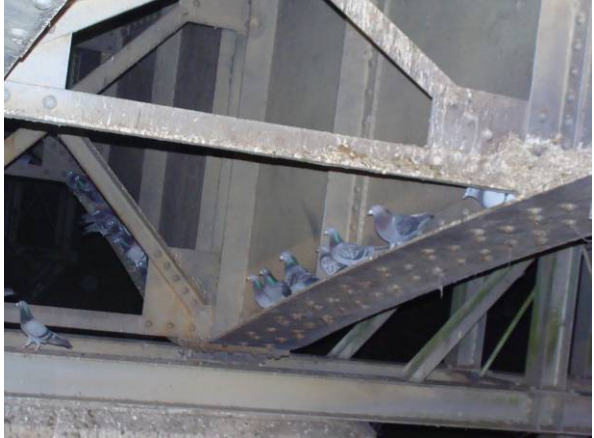
Minor paint removal was observed in various locations. There were few corroded rivets found. Bird droppings and a nest was found on some of the steel bracing and steel beam connections. This may lead to corrosion on these beams and bracings in the future.

<p><b>Photo 55 – (A-15) Widening adjacent Pier 12</b></p>	<p><b>Photo 56 – (A-16) P12 support –with birds</b></p>

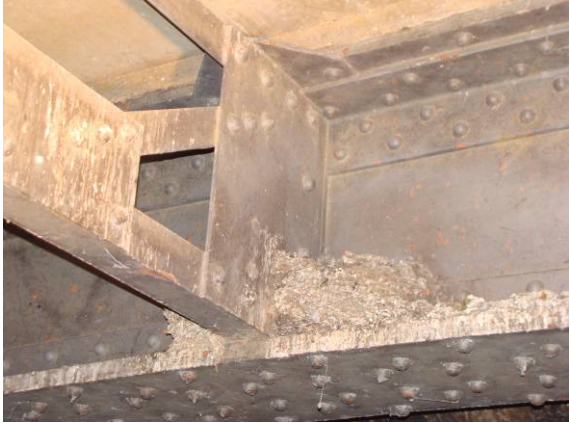
<p><b>Photo 57 – (A-18) steel arch –Bird dropping at bottom flange</b></p>	<p><b>Photo 58 – (A-55) Span 10- Down Stream debris stuck in the steel beam</b></p>

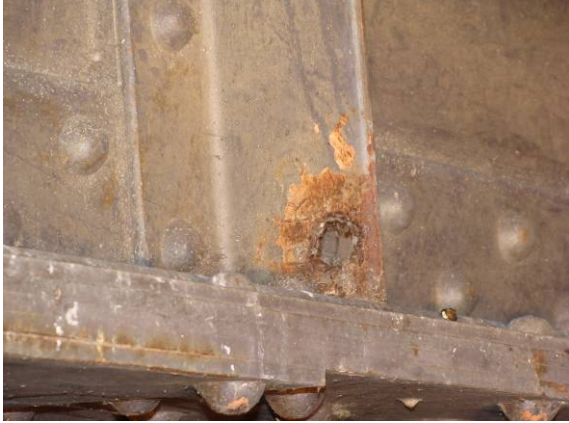
<p><b>Photo 59 – (A-77) Span 8 - hole at beam stiffener</b></p>	<p><b>Photo 60 – (A-78) Span 8 abrasion and corrosion at flange</b></p>

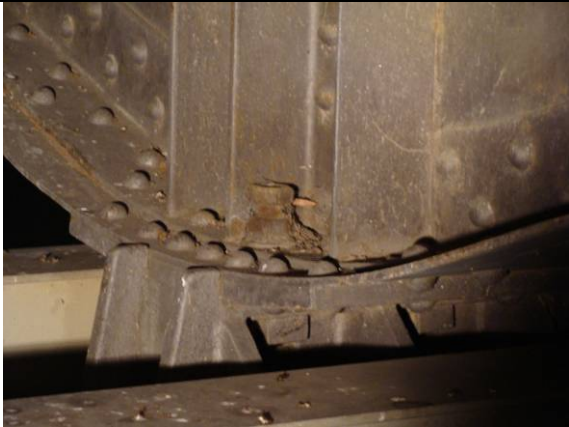
<p><b>Photo 61 – (A-87) Pier 6 Steel Beam corroded k nut and also loose.</b></p>

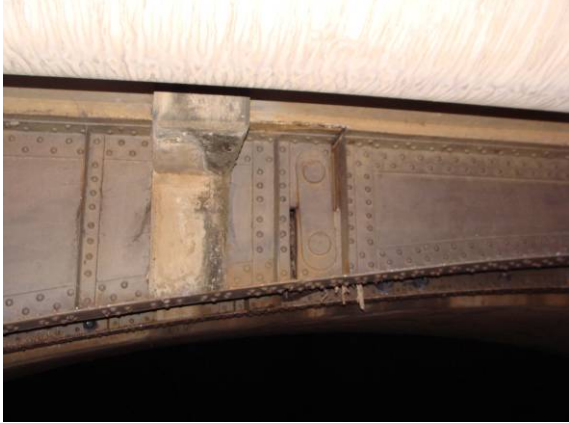
Movement at the span 9 steel beam step joint was observed. The expansion joint above the deck at span 9 was cracking. This may be due to this movement in the steel step joint.

<p><b>Photo 63 – (A-58) Span 9 Suspension joint- deck movement joint</b></p>

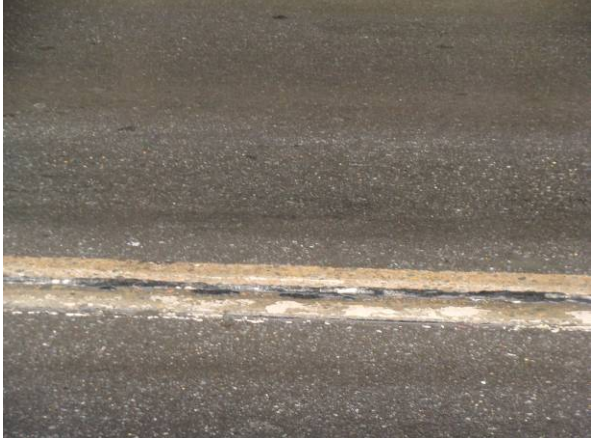
The roadway surface is generally without any necessary repairs. However the longitudinal joint currently along the centreline of the road does have a differential level that is not noticeable due to the painted centreline disguising. The roadway is cracking along the expansion joints,

- *Restore or repair the longitudinal joint*
- *Repair the roadway cracking along the expansion joints*

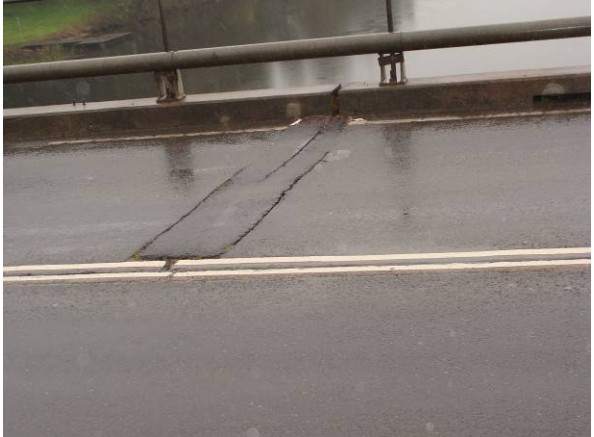
<p><b>Photo 69 – (B-10) Span 5 expansion joint</b></p>	<p><b>Photo 70 – (B-16) Span 9 expansion joint</b></p>

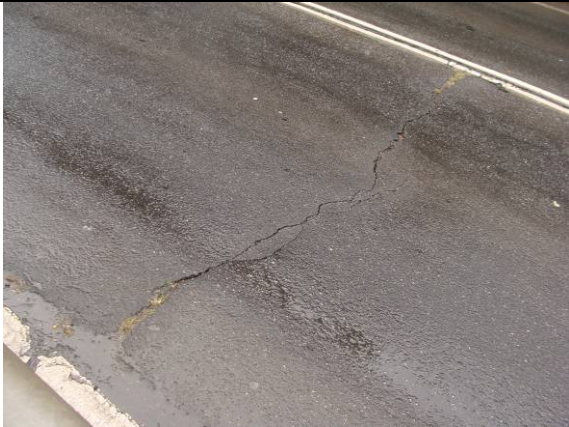
<p><b>Photo 73– (B-24) Span 9 crack at ac Upstream</b></p>

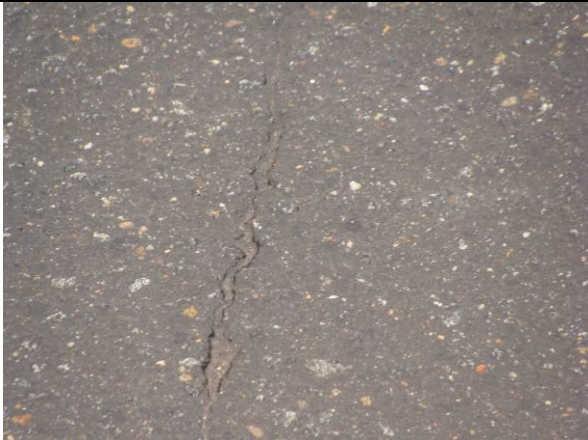
<p><b>Photo 74 – (B-15) Span 7 crack at ac Upstream</b></p>

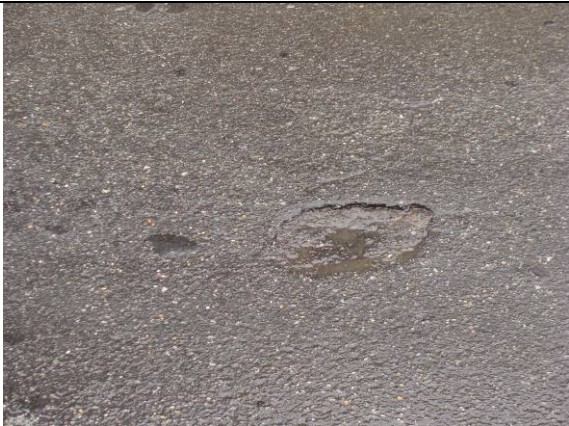
<p><b>Photo 75 – (B-26) Span 11 ac failure</b></p>

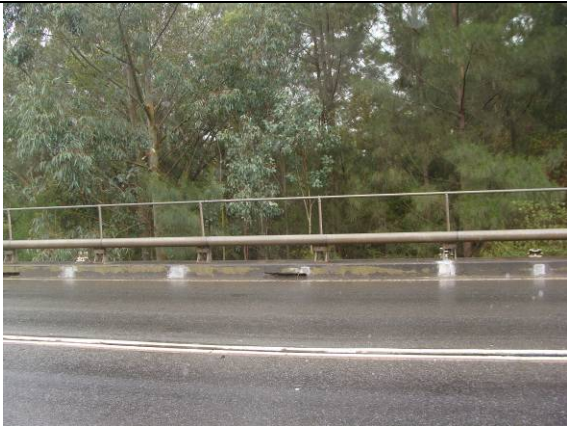
<p><b>Photo 76 – (B-7) DS kerb repair</b></p>

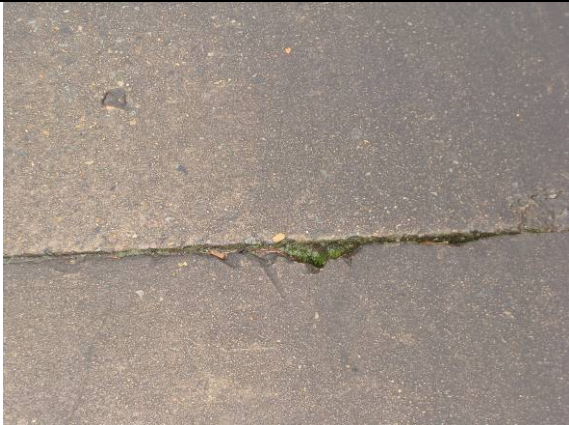
<p><b>Photo 77 – (B-9) Span 3 footpath minor trip hazard</b></p>

COMMENTS											
Footpath has no broken slabs however has one minor trip hazard in span 3. Photo B009
