ROADS AND MARITIME SERVICES

RICHMOND BRIDGE AND APPROACHES

ROAD SAFETY AUDIT

Report No F0006-AA005381-AAR-01 Richmond Bridge and approaches RSA Rev01

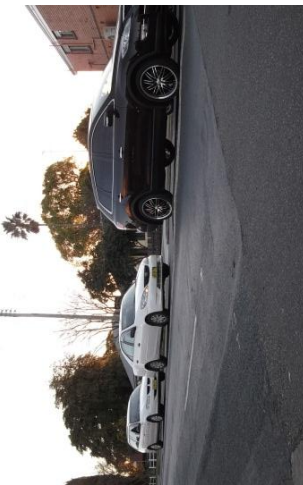
Item	Location	Safety findings	Risk rating	Photo
1	Bells Line of Road/ Grose Vale Road/ Terrace Street intersection – existing conditions.	On the Grose Vale Road (southern) approach to intersection, there is a high degree of pavement shoving creating a rough and variable surface. This may de-stabilise a vehicle or compromise the skid resistance available. This is also in an environment where there would be heavy braking demands due to the traffic signals and associated queues. It should be noted that during the site inspection, the audit team witnessed a rear-end crash in this approach.	Low

Figure 2 Variable pavement surface

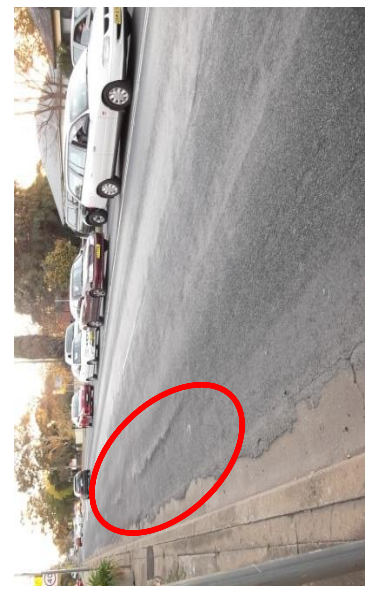
Figure 3 Pavement shoving

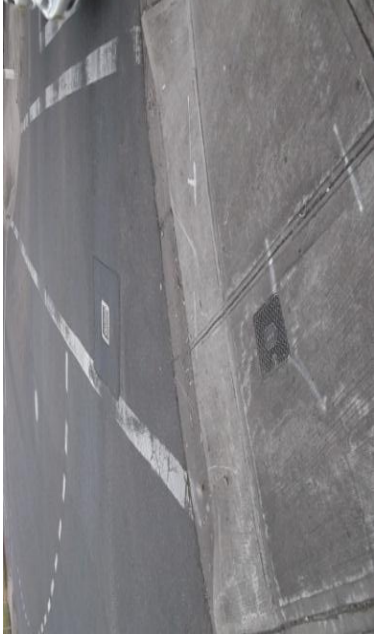
Item	Location	Safety findings	Risk rating	Photo
2	Bells Line of Road/ Grose Vale Road/ Terrace Street intersection – existing conditions.	<p>The pedestrian ramp directionality is poor for most of the crossings. The alignment of the ramp does not line up with the marked crossing. This could lead vision-impaired users into the control area of the intersection where they would be at increased risk of impact from vehicles.</p> <p>Furthermore, the poor condition of line marking could exacerbate this issue.</p>	Low

<p>Figure 4 Poor ramp directionality and pavement marking condition.</p>				
3	Bells Line of Road/ Grose Vale Road/ Terrace Street intersection – existing conditions.	<p>The designated parking on the eastern side of Grose Vale Road (southern) departure is too close to the intersection. This could lead to a number of safety risks including (i) increased rear-end crash risk associated with through vehicles and parked cars, (ii) increased side swipe and lane-change crash risk associated with through vehicles changing lanes, (iii) rear-end crash conflicts due to traffic flow turbulence.</p>	Med

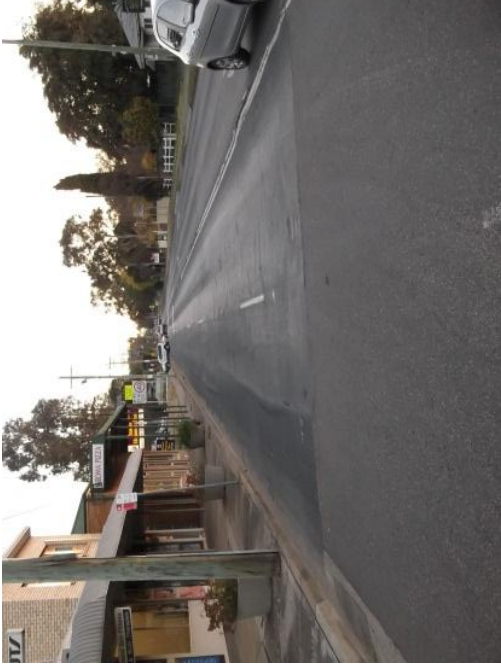
<p>Figure 5 Start of kerb side parking in Grose Vale Road departure.</p>

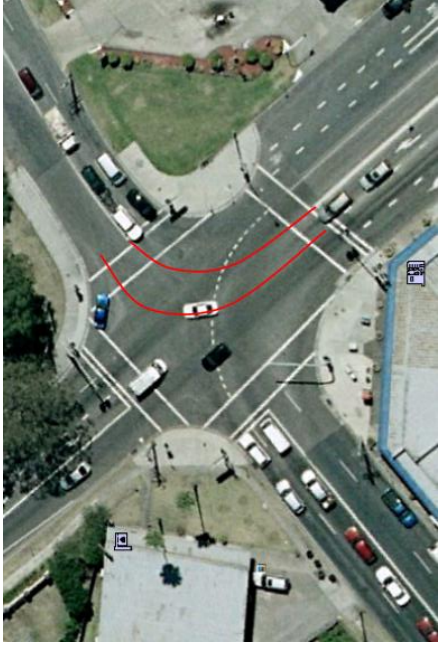
Item	Location	Safety findings	Risk rating	Photo
4	Bells Line of Road/ Grose Vale Road/ Terrace Street intersection – existing conditions.	<p>The increased setback of the hold line in the Bells Line of Road eastern approach has resulted in a non-uniform turn radius for right-turning traffic heading to Terrace Street. Right-turning drivers are required to adjust their steering angle mid-way through the turn. The tightening of the turn radius may lead to encroachment into the southbound traffic lanes in Terrace Street.</p> <p>This issue also inhibits the opposing right-turn (from Bells Line of Road into Grose Vale Road) from running in the same phase (ie. a diamond phase). Although this has more of a direct impact on traffic performance rather than road safety performance, the capacity issues in general are a major source of road safety risk due to queues (rear-end crash risks) and driver frustration leading to unsafe behaviours.</p>	Med

Figure 6 Likely swept path for right-turning vehicle from Bells Line of Road East to Terrace Street.

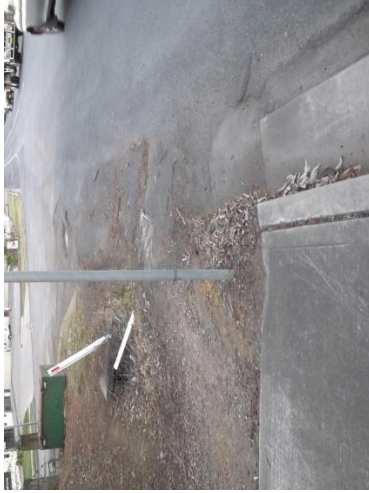
5	Terrace Street, departure from intersection with Bells Line of Road – existing conditions.	<p>The drainage facilities on the western side of this intersection departure are discontinuous with poor transition from one treatment to the other. The kerb and gutter stops abruptly with no inlet drain or kerb splay. Water then runs off to the un-formed shoulder area and into the mountain drain. The poor transition between these drainage facilities has resulted in water damage of the pavement, which has led to pavement depressions. This has further led to deposition of leaf and dirt materials which compromises ride quality and skid resistance.</p> <p>The poor surface conditions and discontinuity of the footpath may also increase the potential for pedestrian slips and trips.</p>	low

Figure 7 Poor transition between drainage facilities on Terrace Street departure.

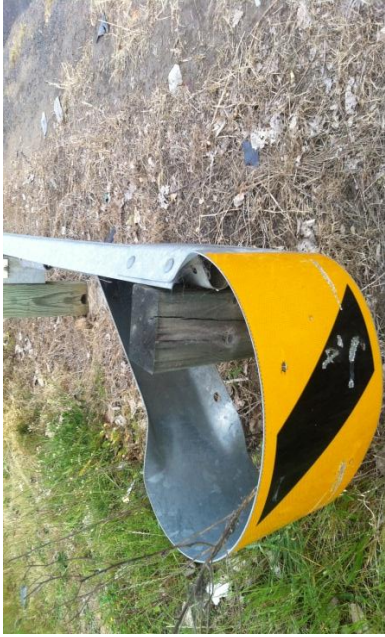
Item	Location	Safety findings	Risk rating	Photo
6	Old Kurrajong Road, at the intersection with Kurrajong Road – existing conditions.	The guardrails at this intersection lack diaphragm plates in the buffered end terminals. This would increase the spearing potential of the terminals.	Med

Figure 8 Buffered end terminal.

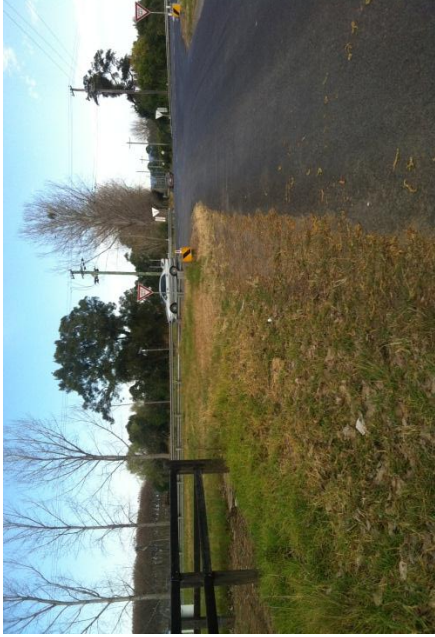
7	Old Kurrajong Road / Kurrajong Road intersection – existing conditions.	The intersection alignment is a major issue. Both Old Kurrajong Road approaches are staggered forcing vehicles to negotiate longer distances for right-turns and through movements on Old Kurrajong Road. For a road with high traffic volumes and poor gap availability, the extra duration required to complete these movements increases the crash exposure. The staggered alignment of the two side road approaches also means that opposing right-turns on Kurrajong Road cannot occur at the same time without a head-on crash conflict.	High

Figure 9 Old Kurrajong Road looking southbound towards the intersection with Kurrajong Road.

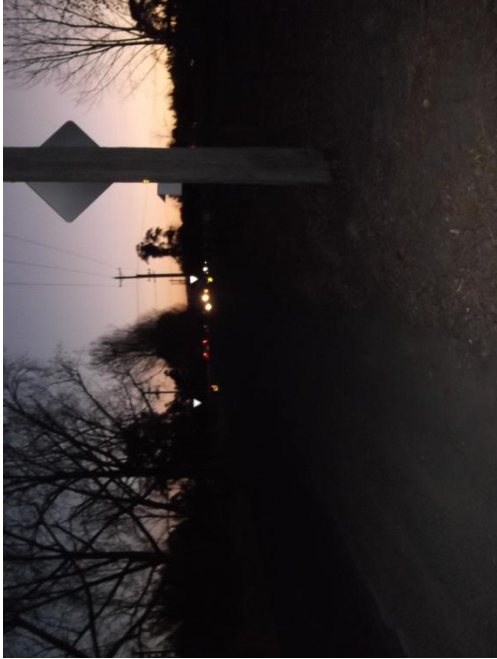
Item	Location	Safety findings	Risk rating	Photo
8	Old Kurrajong Road / Kurrajong Road intersection – existing conditions.	There is a lack of lighting at the intersection creating dangerous night time driving conditions. The lack of delineators also exacerbates this problem.	Med

Figure 10 Lack of lighting at Kurrajong Road/ Old Kurrajong Road intersection.

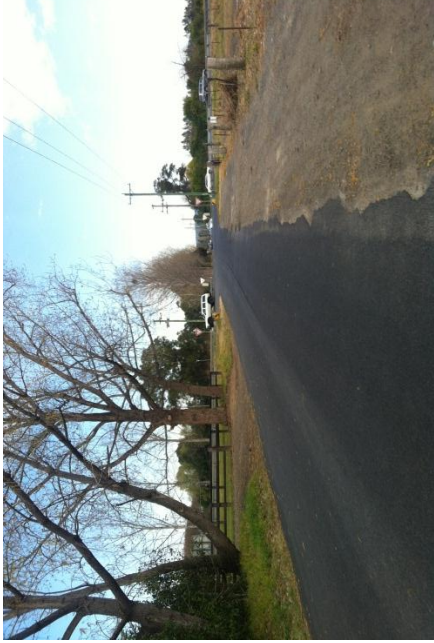
Item	Location	Safety findings	Risk rating	Photo
9	Old Kurrajong Road / Kurrajong Road intersection – existing conditions.	Old Kurrajong Road has poor pavement quality including loose gravel and a narrow sealed width (less than 5.5m). This may lead to loss of control of vehicles entering and egressing from the road. It may also lead to loss of control when braking in advance of the intersection hold lines and associated queues.	Low

Figure 11 Poor pavement quality in Old Kurrajong Road

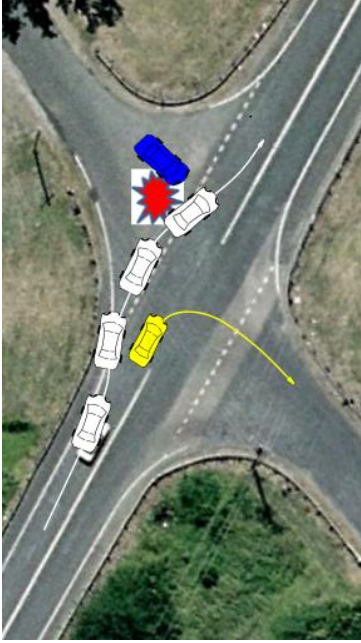
10	Old Kurrajong Road / Kurrajong Road intersection – existing conditions.	Vehicles turning right from Kurrajong Road West to Old Kurrajong Road South (yellow vehicle in diagram) block the eastbound through traffic on Kurrajong Road. As a result, many eastbound through vehicles (white vehicles in diagram) were observed to pass around the queued vehicle by using the space in the Old Kurrajong Road North intersection approach. This could increase the risk of collision with queued traffic in Old Kurrajong Road North (blue vehicle in diagram).	Med

Figure 12 Crash conflict due to the lack of turning facilities at Kurrajong Road/Old Kurrajong Road intersection.

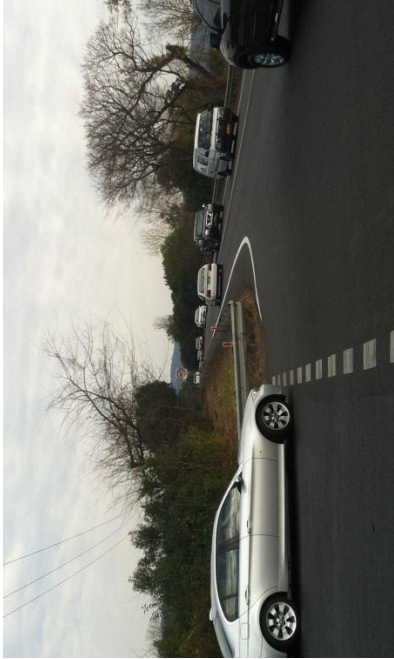
Item	Location	Safety findings	Risk rating	Photo
11	Kurralong Road/ Old Kurralong Road intersection – existing conditions.	<p>The entering sight distance from Old Kurralong Road South to Kurralong Road west is obscured by road side vegetation. This creates issues when turning right from Old Kurralong Road West. This traffic may need to advance further beyond the hold line in this approach to establish a good sight line. This could increase crash risk with westbound through vehicles on Kurralong Road.</p> <p>The lack of clear sight line from this approach to the west increases the “follow up” (t₁) time which may affect the capacity of this approach. That is, without a clear sight line, vehicles queued behind a lead vehicle are unable to take advantage of large gaps in the eastbound traffic stream. Rather they would each need to progress to the hold line and check for separate five second gaps.</p> <p>As observed by the audit team, the long delays due to the above issue, have resulted in poor gap acceptance behaviour due to driver frustration. The increased start-stop pattern in the Old Kurralong Road South approach (due to the lack of follow up sight distance) also increases the rear-end crash risk in this approach.</p>	Low

Figure 13 Poor entering sight distance from Old Kurralong Road South to Kurralong Road West.

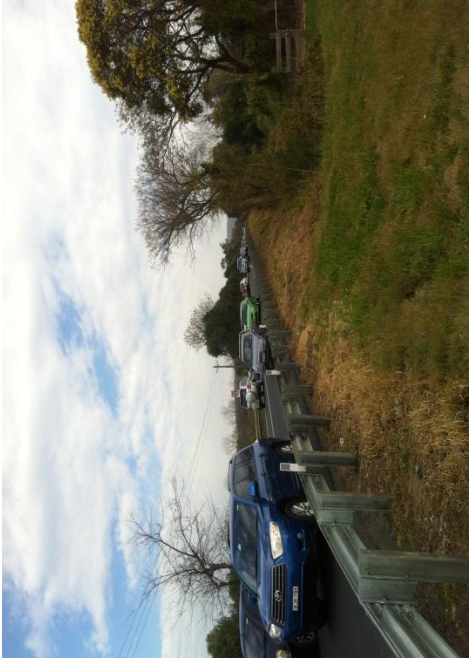
Item	Location	Safety findings	Risk rating	Photo
12	Kurralong Road/ Old Kurralong Road intersection – existing layout.	<p>The constant traffic flow along Kurralong Road during peak traffic periods does not provide sufficient gaps to allow vehicles to turn right into and left/right out of the two Old Kurralong Road approaches. The lack of gaps is due to the lack of metering points in the up and downstream road network. The audit team observed delays of up to two minutes which may force the lower priority traffic to take unsafe gaps.</p> <p>The audit team noted a number of symptoms of unsafe gap acceptance such as hard acceleration from rest, drivers creeping out into the main road travel lanes, drivers stalling beyond the hold line, and main line traffic “borking” and braking hard in response to unexpected egressing vehicles.</p>	High	See Figure 13 and Figure 14.

<p>Figure 14 High traffic volumes on Kurralong Road.</p>

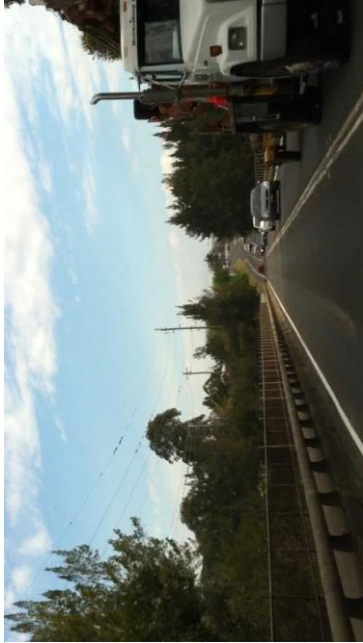
13	Richmond Bridge – existing conditions.	<p>The bridge barriers are not crashworthy and are not capable of containing and re-directing errant vehicles. Any errant vehicles may be at risk of breaching the system or alternatively experiencing poor ridedown performance compared with the approved barrier systems.</p>	Med

<p>Figure 15 – Substandard bridge barriers.</p>

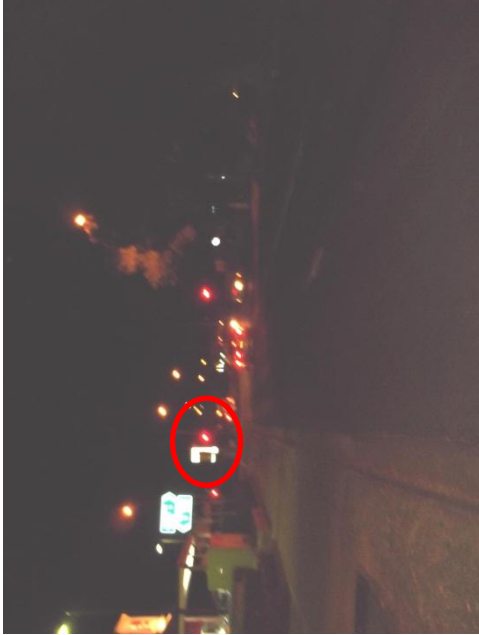
Item	Location	Safety findings	Risk rating	Photo
14	Kurralong Road/ Bosworth Street/ March Street intersection – existing conditions.	The speed limit sign in the Bosworth Street (northern) intersection approach obscure visibility to the primary signal lanterns. Approaching drivers may not be aware of the prevailing signal phase.	High

Figure 16 Obscured traffic signals.

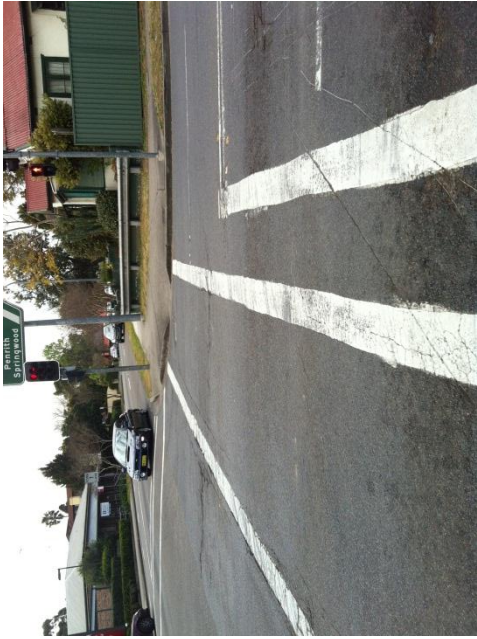
Item	Location	Safety findings	Risk rating	Photo
15	Kurrajong Road/ Bosworth Street/ March Street intersection – existing conditions.	There are numerous pavement failures at this intersection including polishing and cracking. These may lead to loss-of-control and rear-end crashes, especially since this is a high braking environment.	Low

Figure 17 Example of Bosworth Street / Kurrajong Road/
March Street pavement issues.

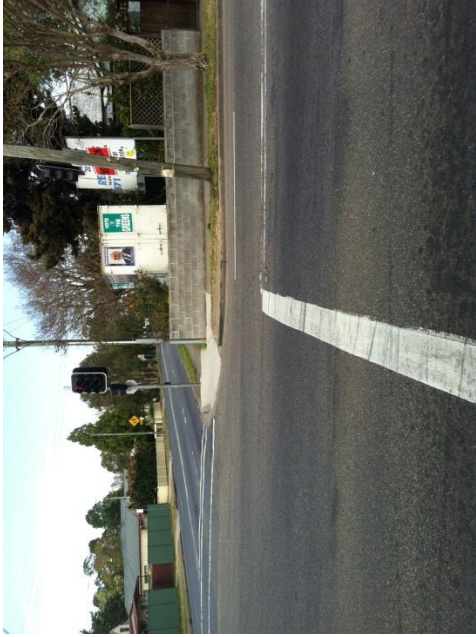
Item	Location	Safety findings	Risk rating	Photo
18	Kurralong Road/ Bosworth Street/ March Street intersection – existing conditions.	The western approach to the intersection does not have a marked foot crossing. This may lead to pedestrians jaywalking across this approach rather than walking the more circuitous route via the other three crossings. This could increase the risk of pedestrian crashes.	High

Figure 19 No pedestrian crossing on Kurralong Road western intersection approach.

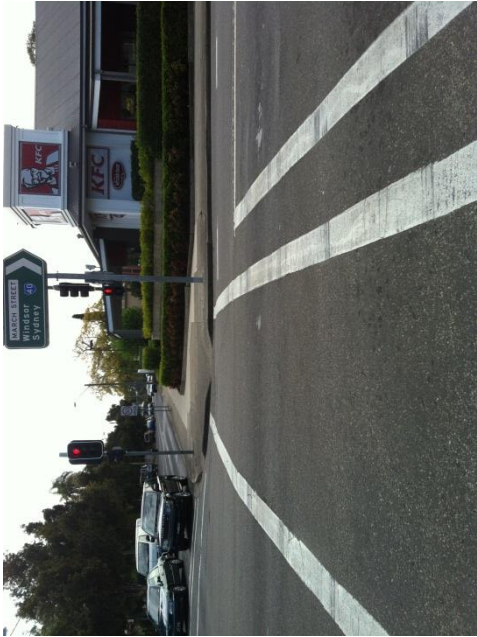
Item	Location	Safety findings	Risk rating	Photo
19	Kurralong Road/ Bosworth Street/ March Street intersection – existing conditions.	There is a pronounced road crown in the March Street approach. This may act as a pedestrian trip hazard.	Low

Figure 20 - Pronounced crown in the road.

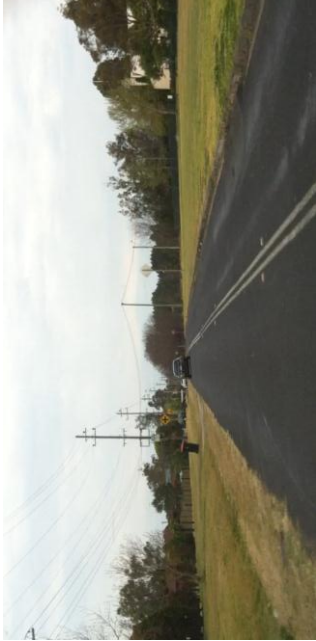
Item	Location	Safety findings	Risk rating	Photo
21	Innals Lane - existing conditions.	This road contains several pavement deficiencies including shoving, depressions and polishing which may increase the loss of control crash potential. This road also contains reverse curves on a downhill grade which may further exacerbate the loss of control and run off road crash risk. Additionally the road has unsealed shoulders, poor edge conditions and a lack of run off road areas.	Med

<p>Figure 22 Innals Lane pavement issues – note polishing in right-hand lane.</p>				
22	Innals Lane- existing conditions.	Utility poles are located within the clear zone which can present a potential crash hazard for errant vehicles.	Med	
23	Innals Lane - existing conditions.	Innals Lane runs through a flood plain which has resulted in a fill embankment on either side of the road. Although delineators are present to mitigate this risk, these do not provide sufficient safeguards against errant vehicles that may run off road.	Med

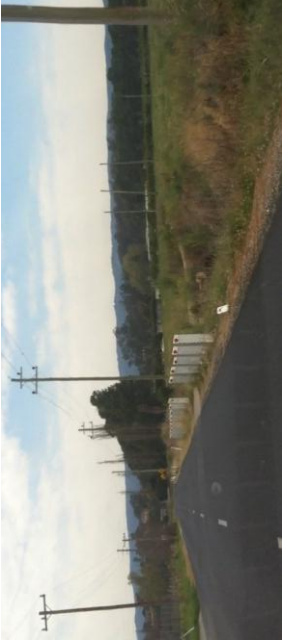
<p>Figure 23 Fill embankment and drop off.</p>

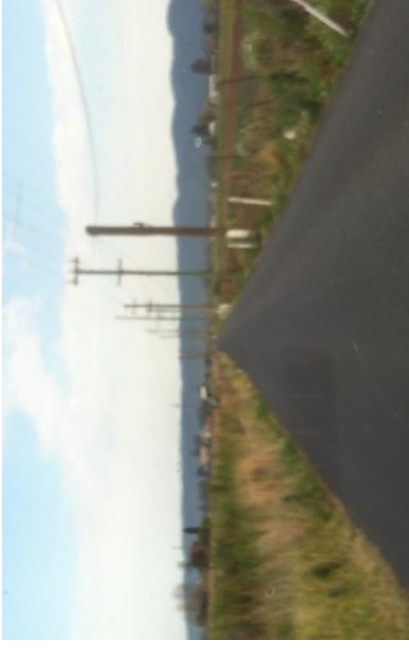
Item	Location	Safety findings	Risk rating	Photo
24	Yarramundi Lane - existing conditions.	There is a lack of line marking and night-time delineation throughout the entire length of Yarramundi Lane. This would lead to very poor visibility of the road ahead.	Med

<p>Figure 24 Yarramundi Lane.</p> <p>As seen in Figure 24 there are no streetlights and a general lack of delineation.</p>
25	Yarramundi Lane - existing conditions.	There is a lack of lighting and night-time delineation on this route which provides insufficient guidance to road users. Furthermore, there is limited the sight distance and little warning provided regarding vehicles egressing (and possibly reversing) from driveways.	Low	Refer to Figure 24.
26	Yarramundi lane - existing conditions.	There are utility poles located within the clear zone which can present a potential crash hazard for errant vehicles. There is also a length of barbed wire fence in the clear zone presenting a crash hazard for errant vehicles.	Low	Refer to Figure 24.

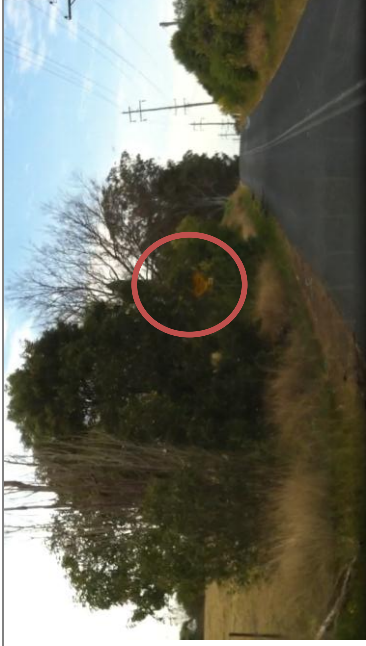
Item	Location	Safety findings	Risk rating	Photo
27	Crowleys Lane – existing conditions.	A speed limit and warning sign are obstructed on this route, when travelling northbound	Low

Figure 25 Obstructed warning sign.				
28	Crowleys lane – existing conditions.	<p>There are a number of pavement deficiencies along this route including a narrow sealed width with no sealed shoulders. The pavement also contains depressions, shoving and poor edge quality. This may result in an increase in the loss of control crash potential.</p> <p>It should be noted that the road side vegetation is dense and presents a run off road crash hazard.</p>	Low

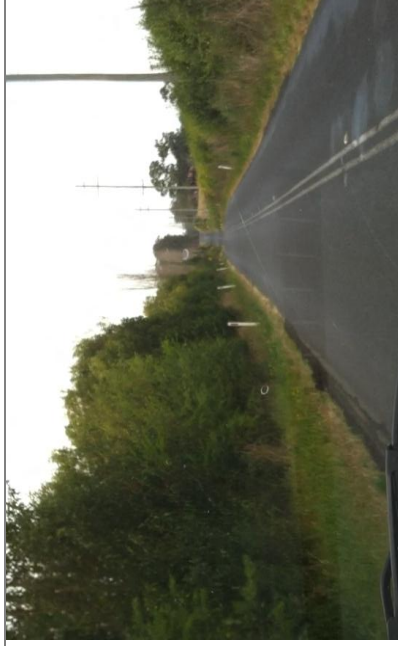
Figure 26 Pavement deficiencies.				
29	Crowleys Lane – existing conditions.	<p>There is a lack of lighting and night-time delineation on this route which provides insufficient guidance to road users. Furthermore, there is limited sight distance and little warning provided regarding vehicles egressing (and possibly reversing) from driveways.</p>	Low	Refer to Figure 26.

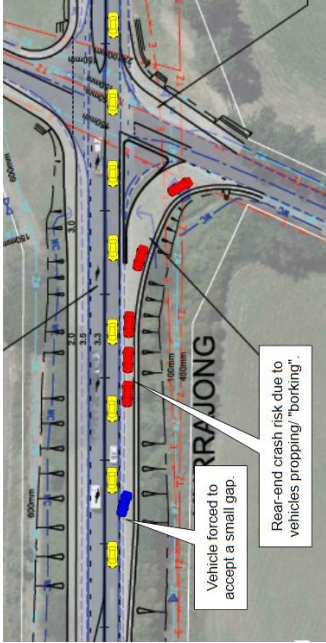
Item	Location	Safety findings	Risk rating	Photo
32	Kurradjong Road/ Old Kurradjong Road intersection – preliminary design SK1109-4	<p>The proposed acceleration lane on Kurradjong Road for left-turning vehicles from Old Kurradjong Road South will improve the ability of cars to enter Kurradjong road in heavy traffic conditions (ie. reduced gap acceptance requirement from 5 seconds to 3 seconds). However this may lead to new crash risks as described below.</p> <p>Due to the high and constant westbound traffic volumes on Kurradjong Road (particularly during the PM peak) there may still be difficulty in finding acceptable gaps for side road traffic to enter. If a vehicle in the acceleration lane is unable to find a gap, they may either:</p> <ul style="list-style-type: none"> ▪ Attempt to merge via a substandard gap which increases side swipe, lane changing and rear end crash risk (blue vehicle), or ▪ “Bork” or brake hard and be at risk of rear-end crashes from following vehicles in the acceleration lane (red vehicles). <p>The audit team acknowledges that this crash risk would involve low-angled impacts with small differences in relative velocity between the entering traffic and the main line traffic. As such, the potential crash severity would be controlled in this manner. By contrast, the “do nothing” approach would retain the potential for higher angled crashes with higher speed differentials which are potentially more severe.</p>	Med

<p>Figure 27 Likely safety risks with acceleration lane.</p>				
33	Old Kurradjong Road / Kurradjong Road intersection – preliminary design SK1109-4	<p>Under the preliminary design the hold line on Old Kurradjong Road North is being moved back to accommodate the proposed intersection widening works. Drivers at the new hold line would have reduced entering sight distance due to the presence of trees and vegetation on the northern side of Kurradjong Road.</p> <p>This could result in drivers creeping forwards to establish a better sightline. This could in turn result in increased crash risk with vehicles on Kurradjong Road.</p>	Med

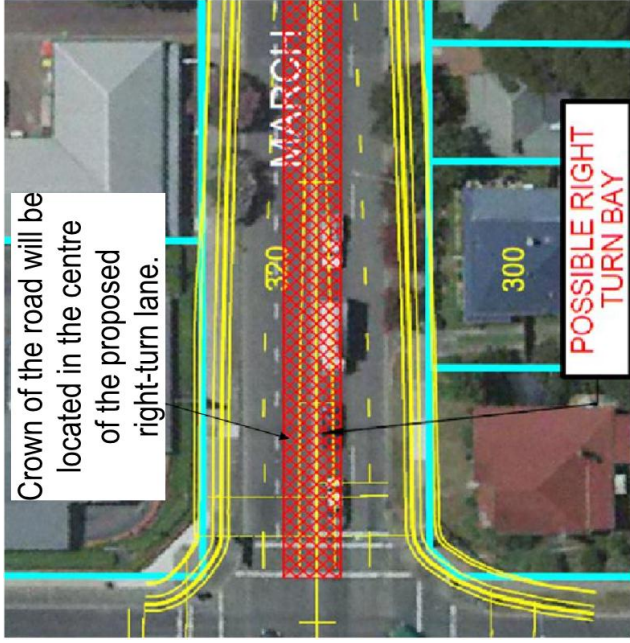
Item	Location	Safety findings	Risk rating	Photo
35	Kurralong Road/ Bosworth Street/ March Street intersection – Preliminary design SK30011177- 120820-Bosworth- Int-Plan	<p>The March Street (eastern) approach to the intersection has a pronounced road crown with steep crossfalls either side. The proposed intersection widening works in March Street may lead to the right-turn lane straddling the crown (if the crown is not relocated). This could result in variable and awkward level transitions for vehicles turning right.</p> <p>This could also result in vehicles “bottoming out” or scraping of the undercarriage.</p>	Low

Figure 28	Possible grading issue Kurralong Road and March Street.			
36	Kurralong Road/ Bosworth Street/ March Street intersection – Preliminary design SK30011177- 120820-Bosworth- Int-Plan	<p>The proposed widening works on the northern sides of Kurralong Road and March Street appear to clash with the property lines. This may lead to fences and walls associated with properties being at a significantly reduced offset from the road, and hence a higher risk road side hazard. Furthermore, there are a number of driveways that would have an abrupt level transition to the new road boundary.</p>	Low
