## Graphitisation Investigation

### Windsor Bridge

<b>Prepared for:</b> Roads & Traffic Authority NSW 110 George St Parramatta NSW 2150		<b>Contact:</b> Peter Ton <b>Phone:</b> (02) 8837 0843 <b>Mob:</b> (0407) 295 624
<b>Date:</b> July 13 <sup>th</sup> , 2011	<b>Job Number:</b> 2739	<b>Report Number:</b> C11231 <b>Rev:</b> Original

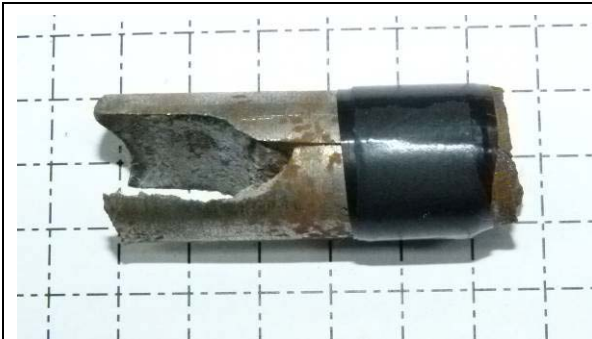
Core sampling into one of the seams (Pier 5 Downstream, mid-water level) revealed there to be an internal flange, with a bolt hole intersected by the core as indicated by the concave shape at its end. This confirms the castings are joined by internally bolted flanges.

Core from seam between sections as retrieved by divers - length > 50mm, with cast-in rebate for gasket (two halves taped together)

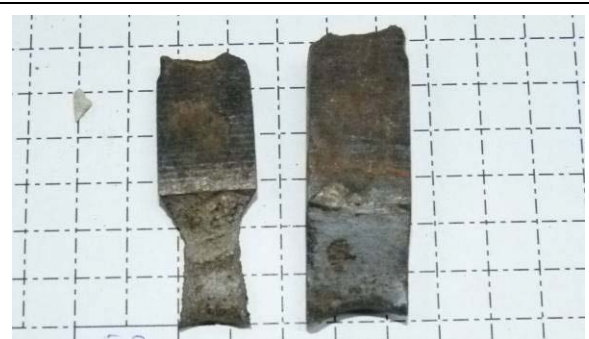
Inner ends of the two halves of the core were a concave shape, indicating the core intersected a bolt hole

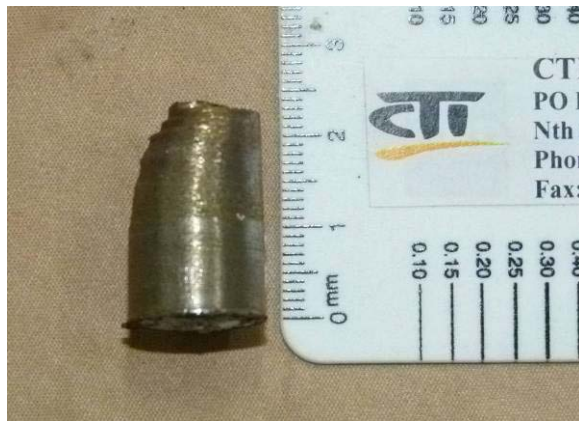
5D NE aspect, above water; no graphitisation

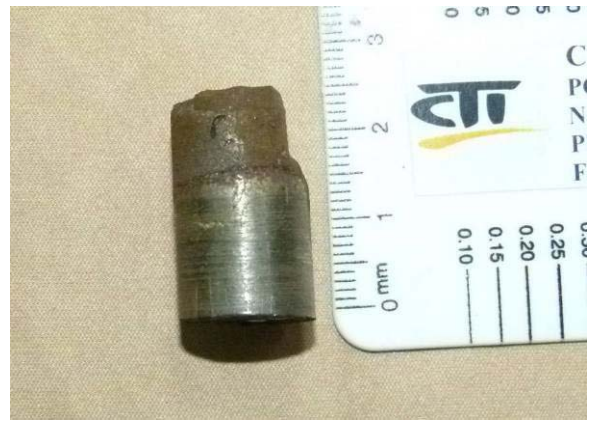
5U NE aspect, upper quarter of immersed casting, showing 9-10mm of graphitisation and 14-15mm remaining cast iron

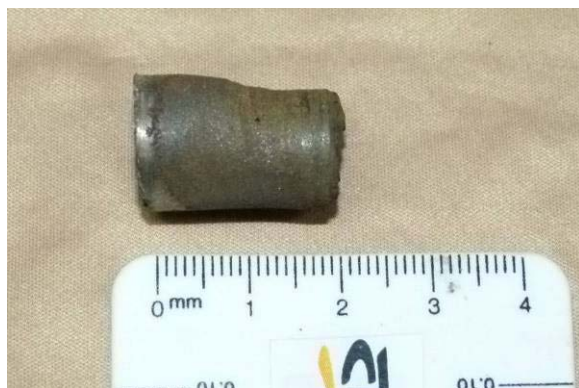
5U SW aspect, upper quarter of immersed casting, showing up to 18 mm of graphitisation and as little as 2mm remaining cast iron

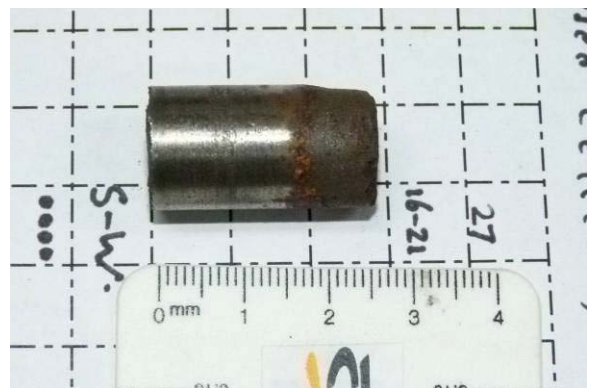
5U SW aspect, lower quarter of immersed casting, showing up to 11 mm of graphitisation and as little as 16mm remaining cast iron

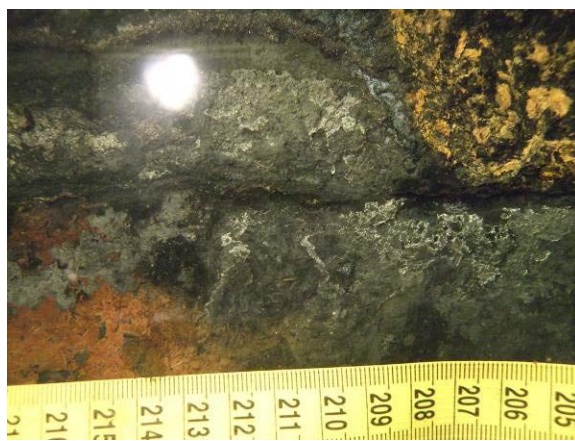
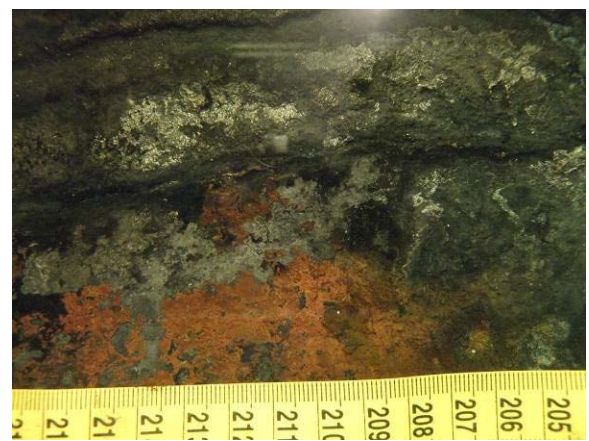
The Upstream Column of Pier 5 (5U) had a full circumferential crack, approximately 200mm above the seam at the top of first fully immersed section. This placed the crack just below the collar for the bracing, and it probably coincides with the beginning of the internal thickening of the casting to create the flange. The crack was at its widest on the downstream (6 o'clock) side of the pier, where it was estimated to be in excess of 1 mm.

Circumferential crack on column 5U

Horizontal cracking is present in three of the columns, including both columns in pier 5. They occur at quite shallow depths, and may be related to the location of the bracing collars just above where they occur.

It appears that the cracks are not new and have been present for quite some time, at least a few decades and possibly longer.

Nevertheless such cracks would be expected to have a serious impact on the overall serviceability of the bridge, and a detailed structural analysis should be carried out to determine their probable impact on the bridge's capacity.

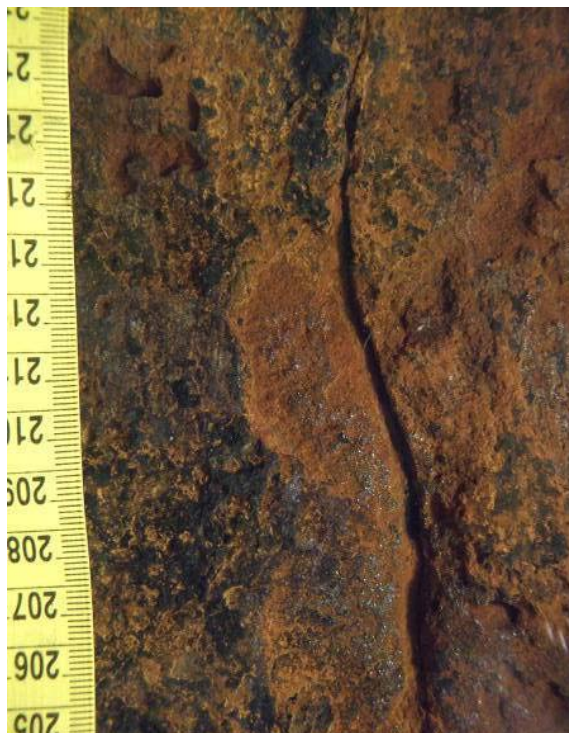
There was also a vertical crack on the column, starting at the same seam (at 6 o'clock, east or downstream) and extending approximately 100 mm upwards. Its width was measured to be up to 2 mm wide at its base, tapering upwards.

Vertical crack on column 5U on downstream side, estimated to be > 2 mm wide at its base

There is also a short vertical crack on the upstream column of pier 5.

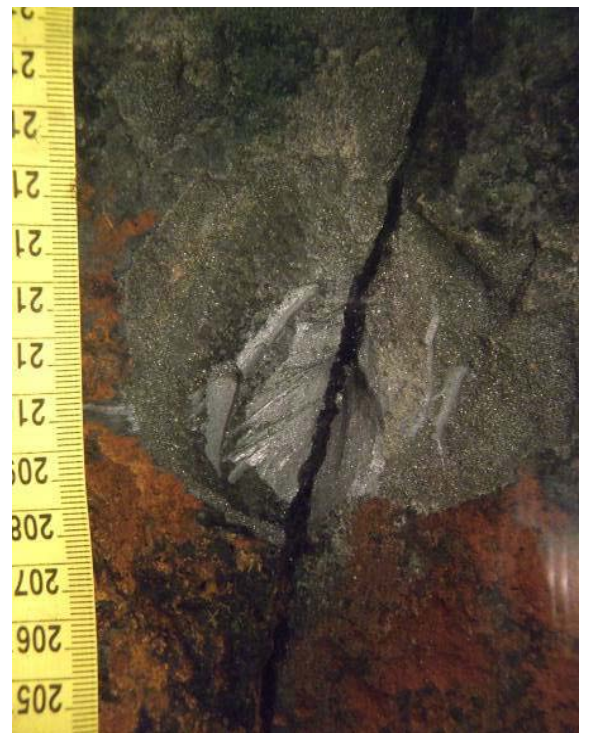
Cleaning and excavating graphite layer shows crack to extend beyond the outer graphite layer

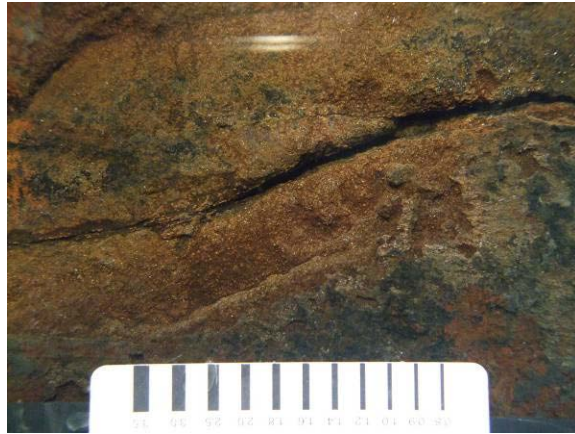
The Downstream column of Pier 5 (5D) also had a full circumferential crack but in this case, the crack was approximately 200mm below the seam at the top of the first fully immersed casting. The crack was cored using a 50mm diameter bit, and confirmed the crack to be full depth. Graphitisation had followed the line of the crack for some distance, indicating the crack to be of some age.

5D crack, at its widest on East, downstream side (6 o'clock)

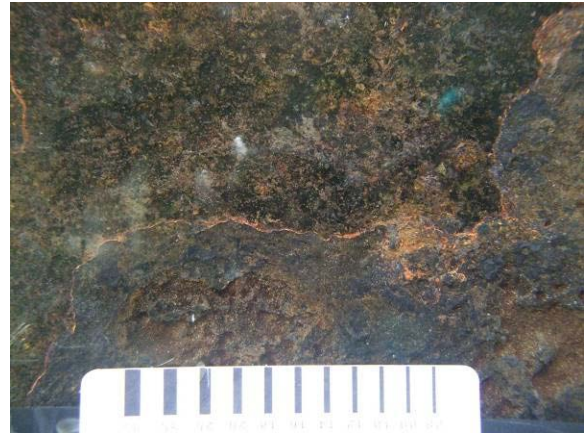
5D crack, narrow on West, upstream side (12 o'clock)

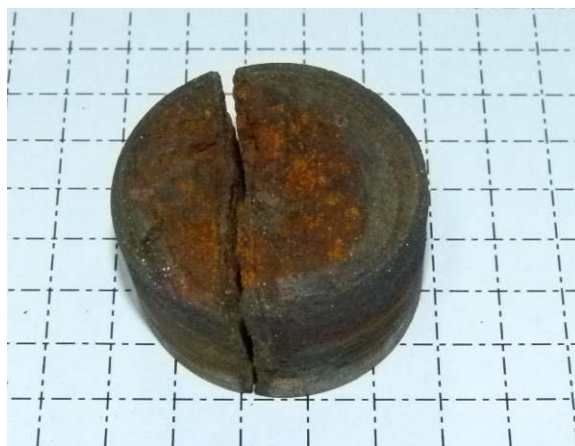
Core (50mm diameter) through crack on 5D showing it to extend full depth through the casting

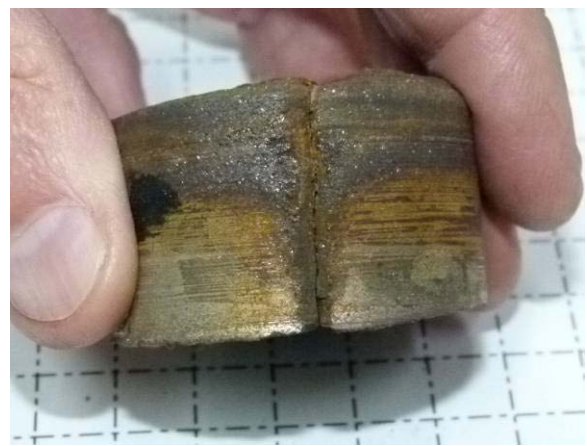
Graphitisation follows line of crack indicating crack to be of reasonable age

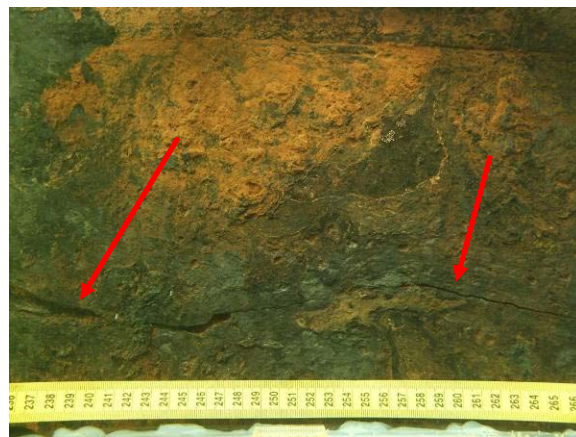
The third circumferential crack was on the downstream column of pier 6 (6D), also situated below the first immersed seam, and extended for three quarters of the circumference, from 12 o'clock to 9 o'clock.

Crack on 6D some 200mm below seam, with occasional frayed edges

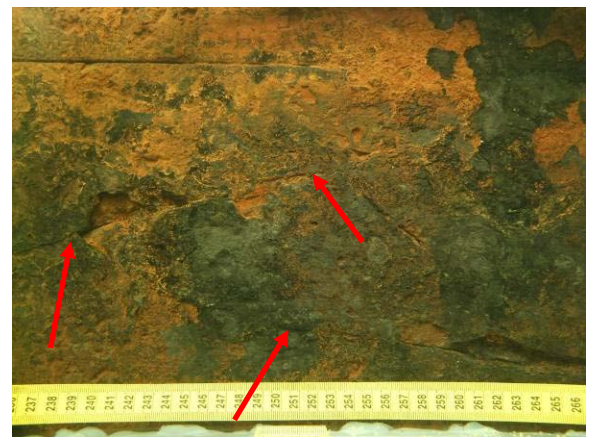
This crack was more complex, bifurcating at approximately 6 o'clock and developing parallel cracks for some distance. This suggests significant damage to the upper casing including the internal flange.

Crack bifurcates, indicating top of casting is essentially broken

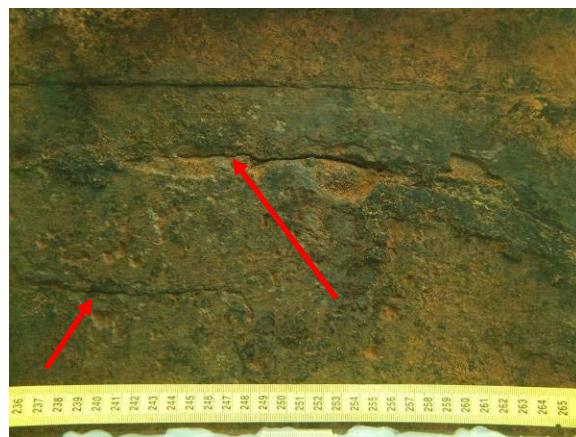
Twin cracks running parallel to each other

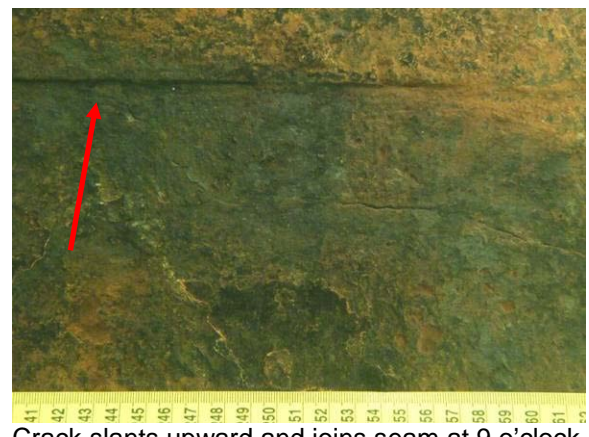
At its southern end (9 o'clock), the crack slanted upwards and joined the seam.

Crack slants upward and joins seam at 9 o'clock (south aspect)

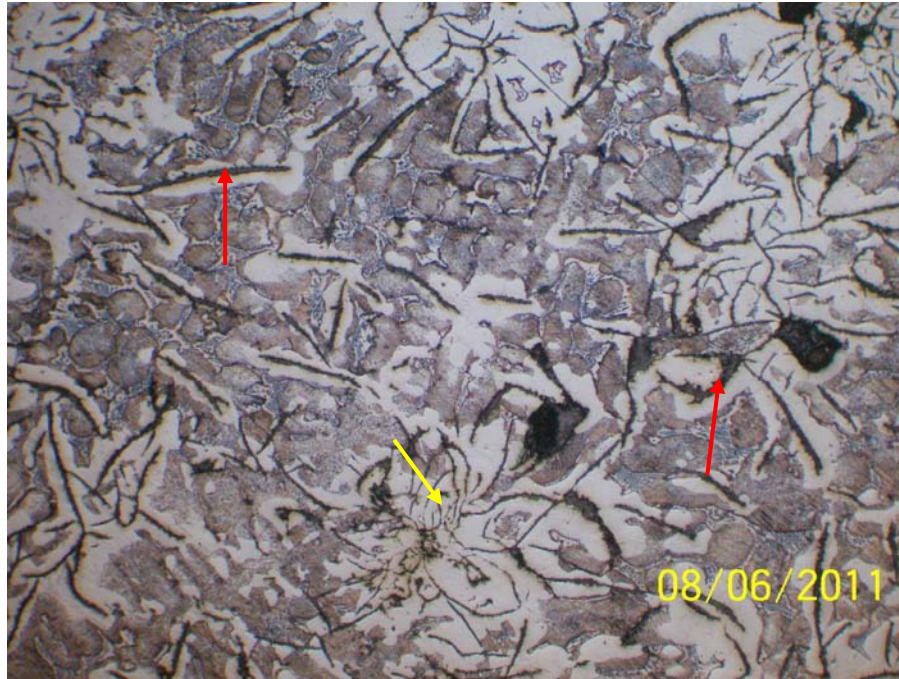
**Figure 2** Core Sample CTI 38888 (etched) showing coarse graphite flakes (red arrow) and "rosettes" of medium and finer carbon flakes (yellow arrow) in a ferritic/pearlitic matrix. Magnification -X120; Etchant - 3% Nital.

The core sample from column 5D at sea-bed level was of grey cast iron as indicated by the presence of flake graphite. The size of the graphite flakes and the high level of phosphide eutectoid in the sample indicate the cast iron pier was relatively old and the tensile strength would be relatively low compared to modern day grey or SG iron.

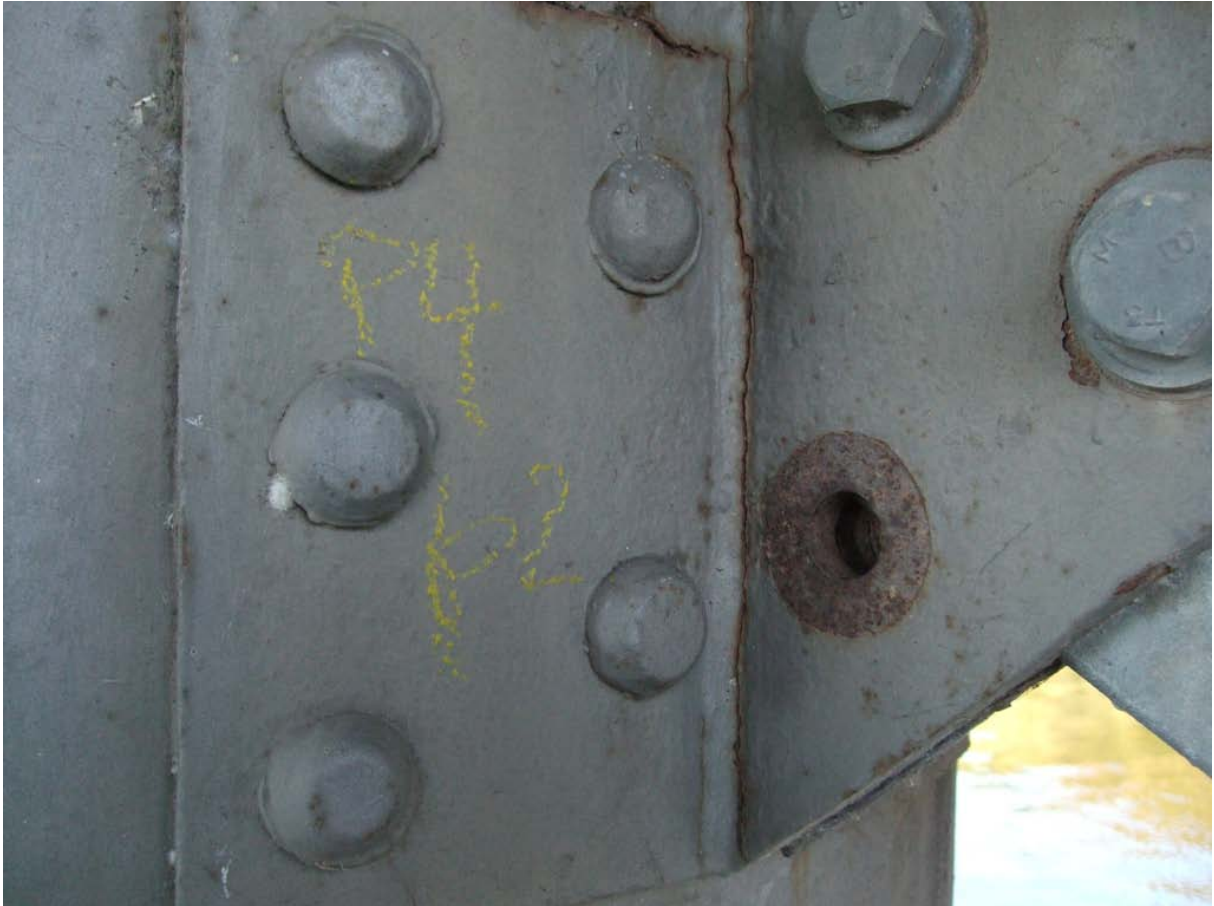
Although the scope of the investigation was limited to the underwater sections of the piers, it was noticed that on Pier 4, there are vertical cracks in the brackets securing the upper end of the diagonal bracing to the piles. Cracks are present in this bracket on both upstream and downstream columns.

The photograph below illustrates one of these cracks, on the downstream column of Pier 4. Note also that there is one bolt missing from this detail.
