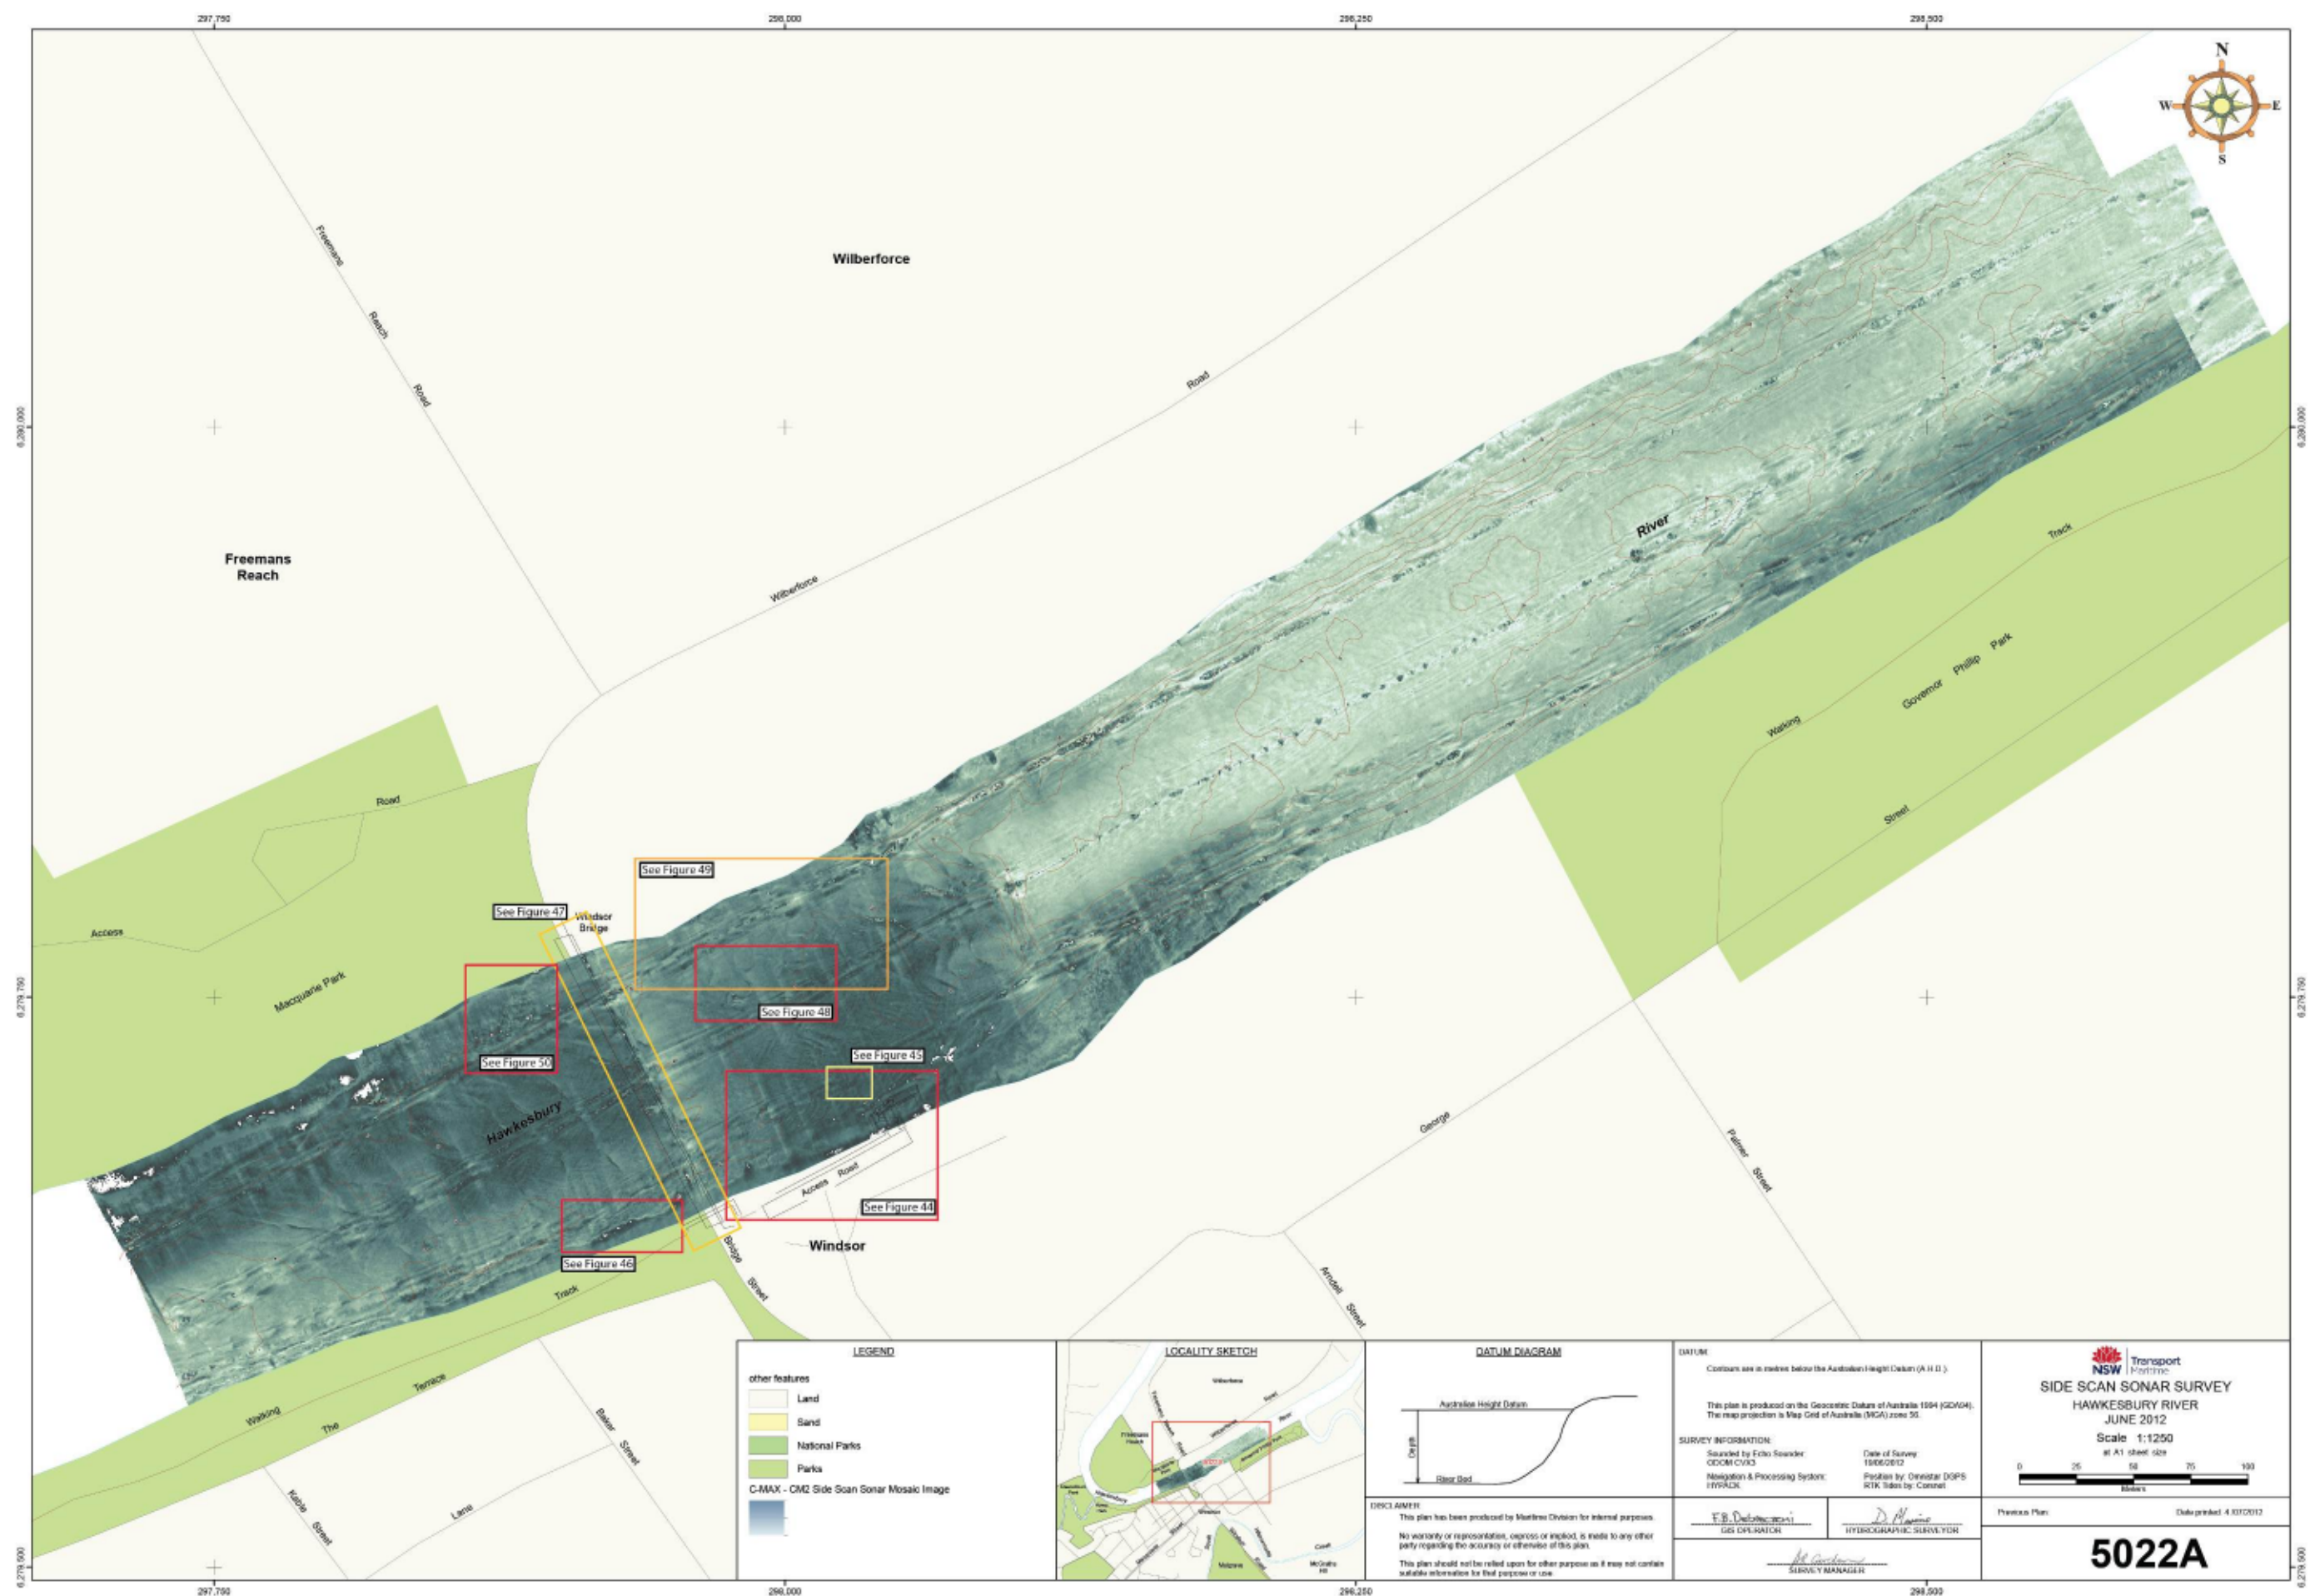
Figure 43: Side Scan Sonar results (Source: RMS Hydrographical department in June 2012).

Several known and potential cultural anomalies have been identified in the SSS data. On the southern side of the river, the location of the known ballast wharf can be seen. This site was identified during the archaeological survey in 2008-9. The dark features located on the western side of the known location of the former wharf are unknown; however recent flooding events on the river may have deposited debris in the area, including tree branches or similar.

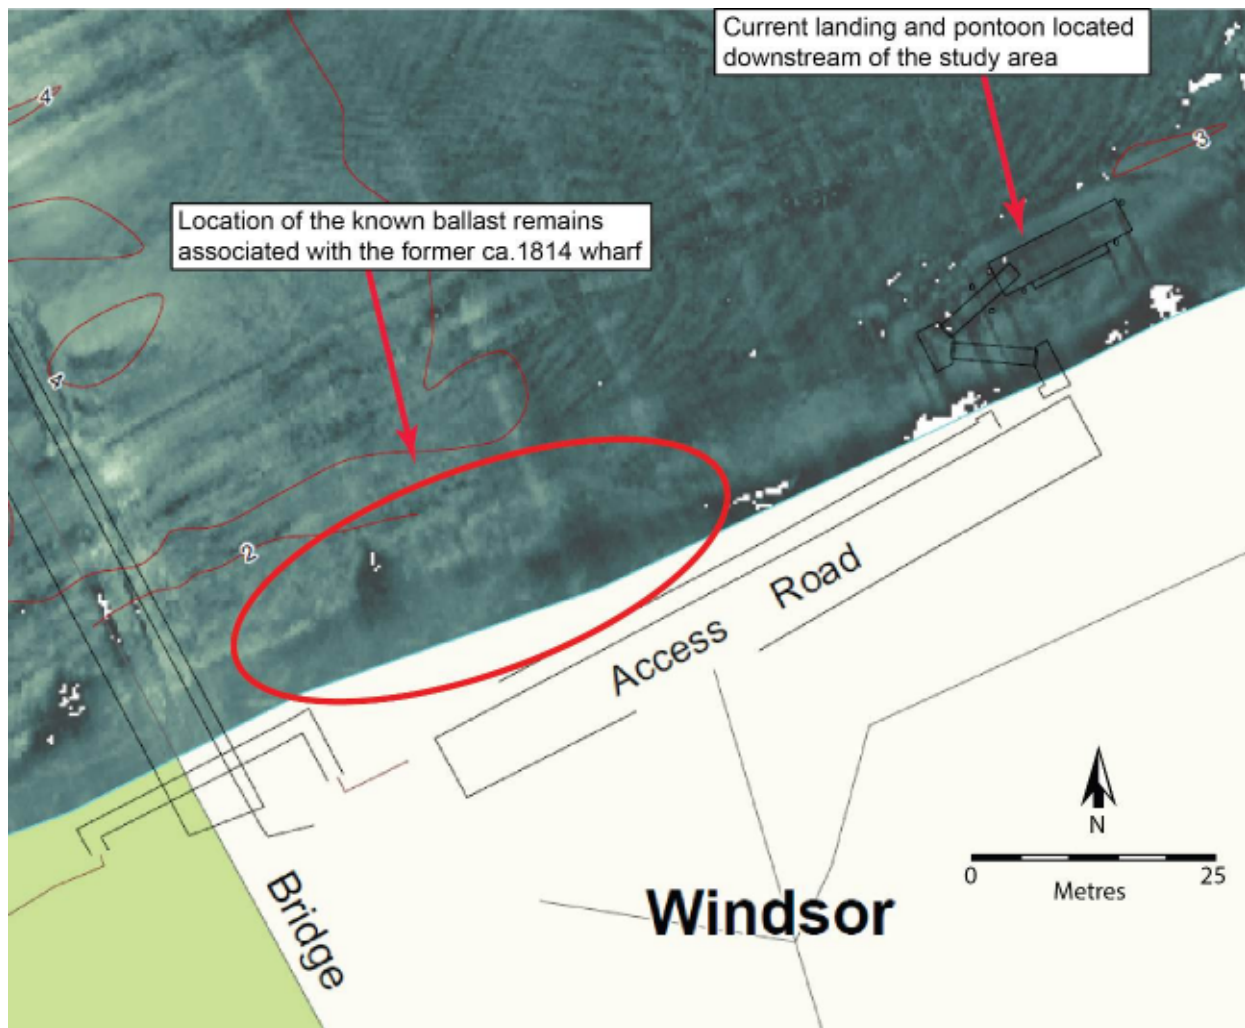
Current standing piles associated with the current landing and pontoon location to the east of the bridge can clearly be seen by the dark “shadow” that is created (Figure 44 and Figure 45). These appear as long shadows due to the height of the pile above the riverbed.

Figure 44: Remains of the known location of the former ca.1814 wharf and current pontoon wharf on the southern bank of the Hawkesbury River.

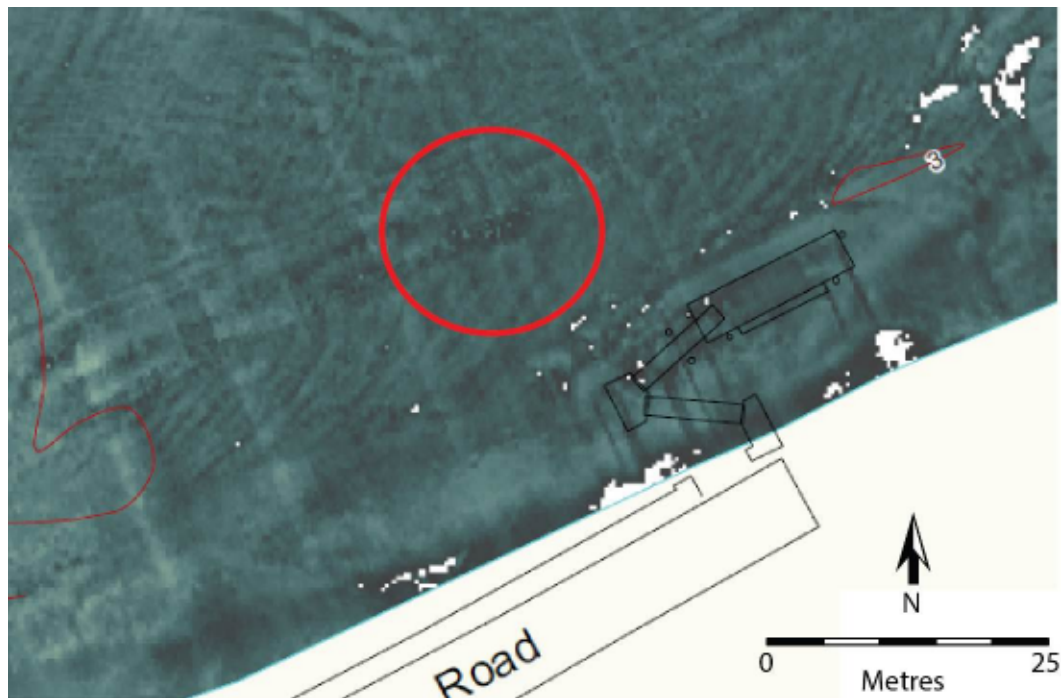
Also located within this area to the northwest of the current pontoon wharf is an anomaly that is similar to an exposed ballast mound. The concentration of rock in this area cannot be described from the general geomorphology of the sediments that are present on the site, and may be an introduced feature (Figure 45).

Figure 45: Anomaly located to the northwest of the current pontoon wharf in the vicinity of the former ca.1814 wharf.

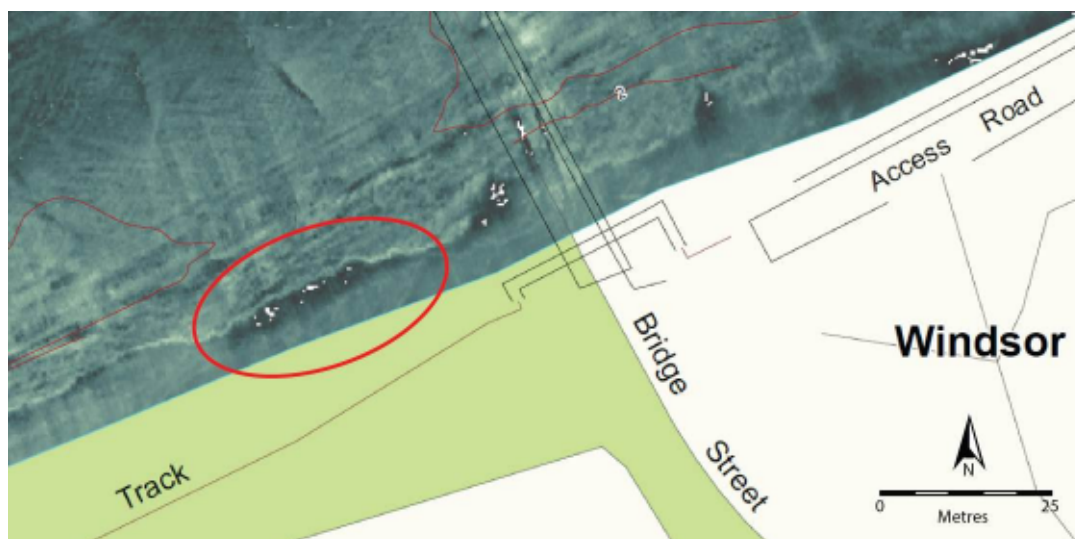
Approximately 30 m upstream of the current bridge a large almost linear anomaly can be seen. This feature is in the location of the former post 1835 punt crossing, however, it is difficult to determine from the anomaly if this is a natural or cultural feature (Figure 46).

Figure 46: Anomaly located on the southern bank of the Hawkesbury River upstream of the current bridge. This anomaly is in the general location of the southern landing of the post ca.1835 punt crossing.

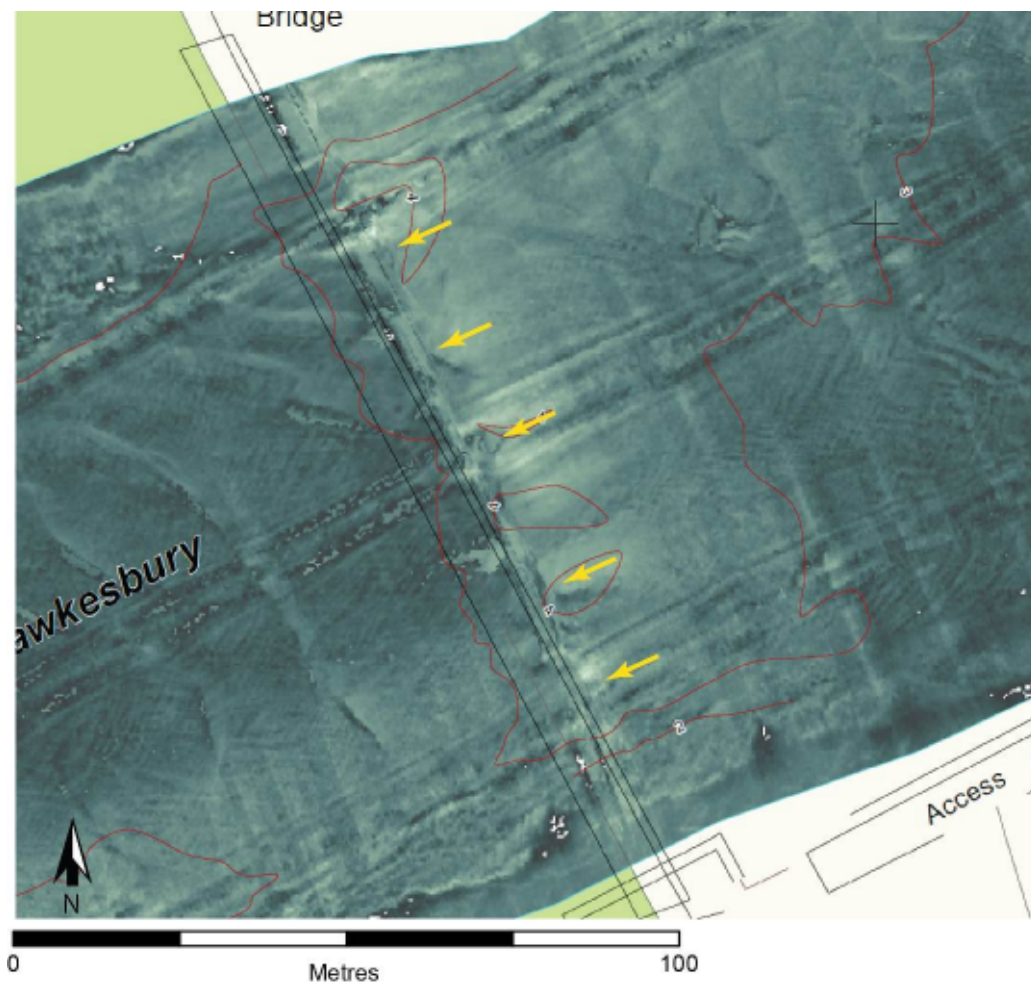
In the midsection of the river, localised scouring and deposition can be seen immediately along the downstream, eastern, side of the current bridge (Figure 47)

Figure 47: Deposition within the river immediately downstream of the current bridge (*yellow arrows*). These are likely to be deposition caused by the location of the piers of the current bridge.

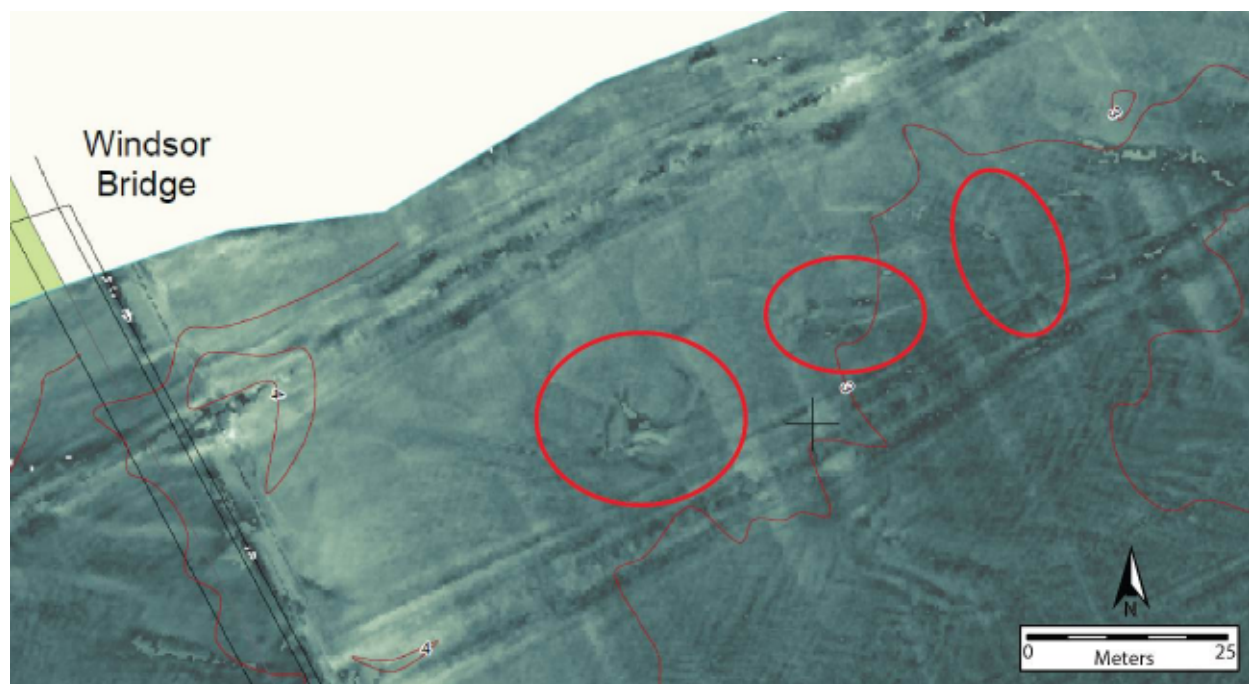
Three anomalies are present on the downstream side of the bridge closer to the northern side of the river. Two of these anomalies are close to each other with the third located further to the east. These may be associated with floating debris deposited in the river since the last flood event. This cannot be determined accurately from the images in the survey results; however, it is possible these anomalies may be close to the location of one of the in-water piers (Figure 48).

Figure 48: Three potential anomalies present close to the northern bank downstream of the current bridge.

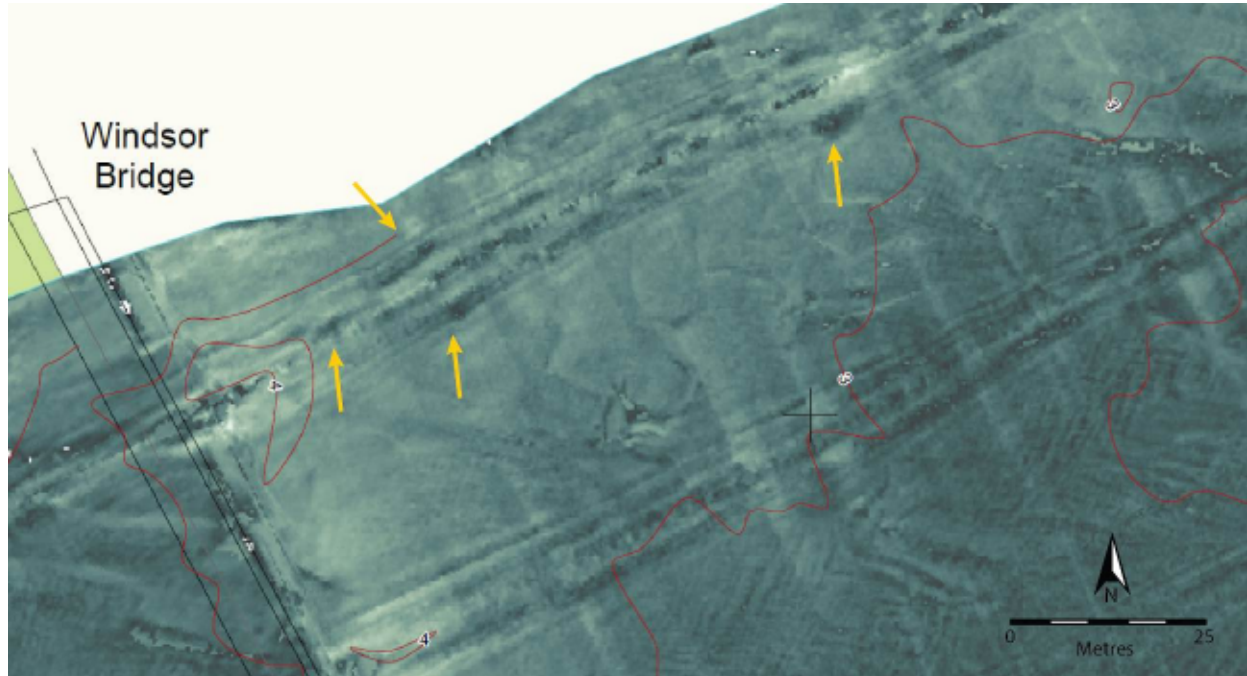
Closer to the northern bank of the river there are several potential anomalies approximately 30 m from the downstream side of the current bridge. They are spread over approximately 50 m. Being close to the bank these anomalies may be associated with trees or other recent debris, however, this area was once used for mooring of smaller boats after the completion of the first bridge crossing. Cultural material in this area may relate to former moorings. Approximately 100 m further downstream the series of features observed are most likely associated with trees growing on the river bank (Figure 49).

Figure 49: Anomalies located close to the northern bank of the river downstream from the current bridge.

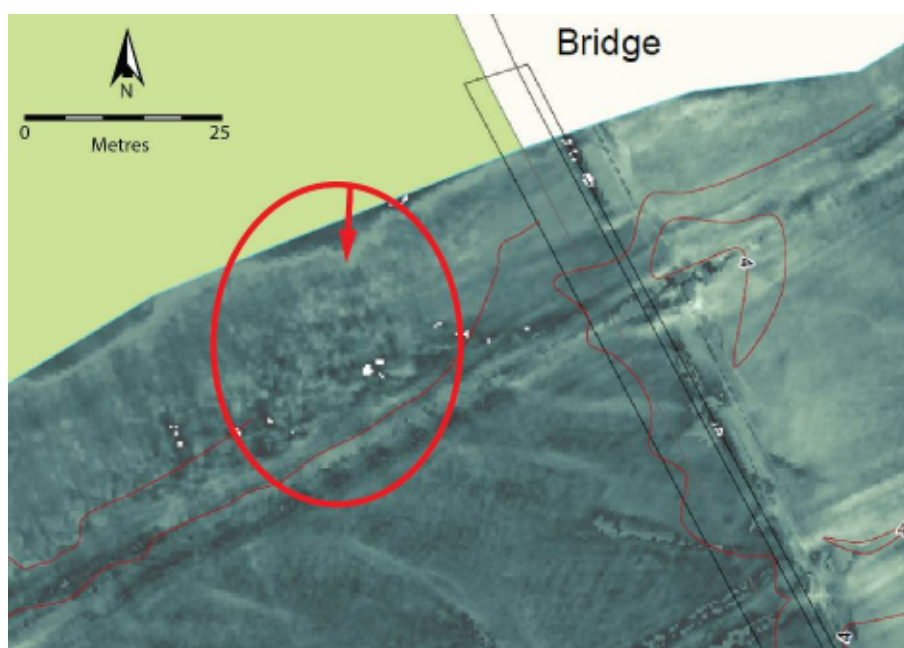
Thirty metres upstream of the current northern side of the bridge localised scouring can be seen. This is likely from a stormwater outlet or similar concentrated runoff that is entering the river in this location (Figure 50).

Figure 50: Localised scouring caused by a stormwater drain or similar in this area.
