## **Roads and Maritime Services**

14.2166.0502-0016

### **Windsor Bridge Rehabilitation Design of Viewing Platform Condition Assessment and Rehabilitation Options**

December 2019

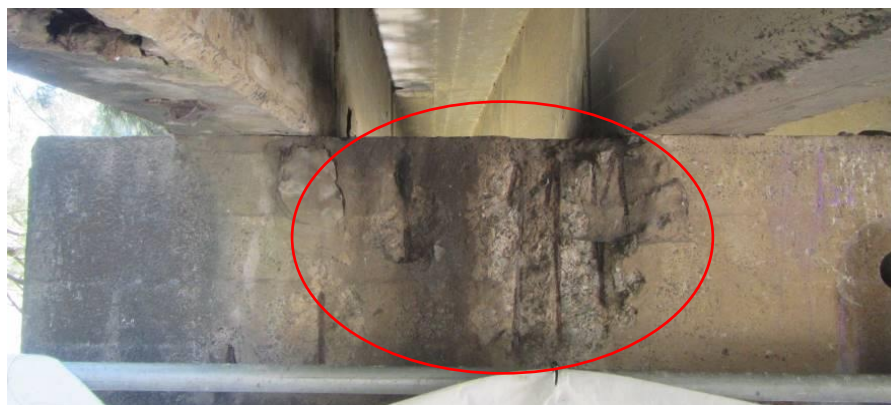
Headstock 1 appears to be in a fair to poor condition (Figure 7), with:

- Large areas of spalling, including an area approx. 600 x 600 mm on the South face, West side
- Two areas of spalling (150 x 150 mm on East side and 400 x 400 mm on West side approximately) on the North face.

**Figure 7: Area of spalling on Headstock 1 south face, west side**

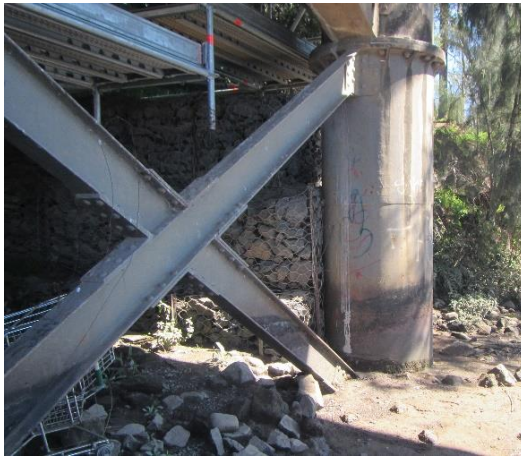
Numerous incidences of localised coating failure and corrosion were observed on the cast iron piers and braces. Refer Figures 8-9.

**Figure 8: Span 1 cast iron piers and cross beams**

- For steel (cast iron) piles above water/mud, apply a suitable coating.
  - For the concrete elements, repair all cracked/spalled/delaminated concrete. Cracks >0.3 mm shall be repaired using crack injection.

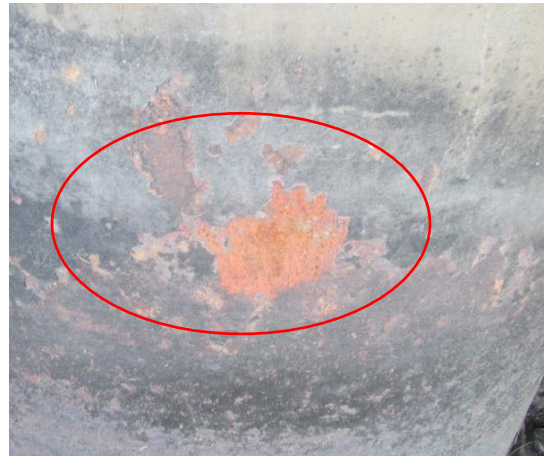
**Figure 9: Localised corrosion on pier**

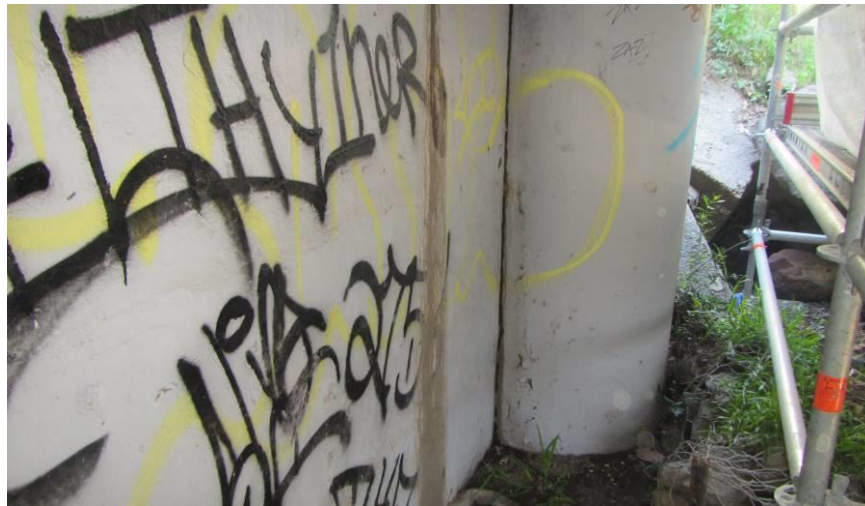
- Extensive graffiti was noted
- No delamination was observed on the abutment wall.

**Figure 10: Extensive graffiti noted on south abutment wall**

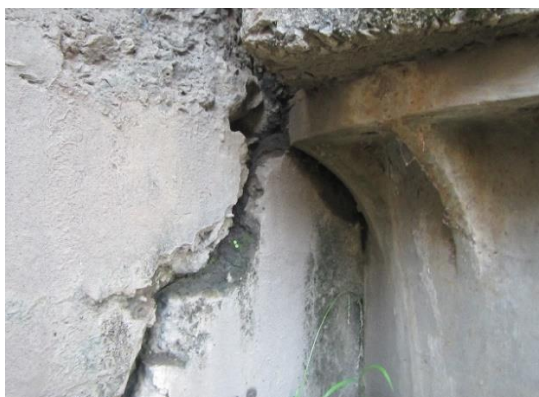
- Area of delamination on the eastern wing wall, approximately 500 x 500 mm
- Large vertical crack on the eastern wall, approximately 1500 mm high and 5 mm width. Refer Figures 11-12.
- Area of delamination on the western wing wall, approximately 1200 mm x 200 mm
- Large horizontal crack on the western wing wall, approximately 1200 mm high and 3 mm width
- The concrete itself was noted to be quite soft (i.e. fairly low-strength).
- Based on the visual observation, it appears that the larger cracks on the wing wall are not live cracks. Until conversion of Span 1 to a viewing platform it is recommended that crack movement be monitored for safety purposes. Prior to conversion of viewing platform normal crack repair will be required as mass concrete and new retaining wall is proposed in front of the existing wing wall as per Jacobs design drawings DG-1050 and DG-1051.

**Figure 11: East wing wall vertical cracking, upper**

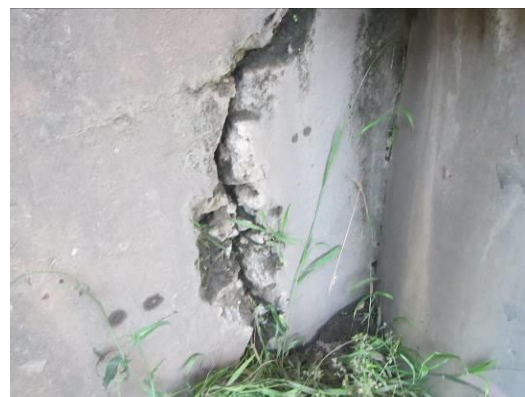
**Figure 12: East wind wall vertical cracking, lower**

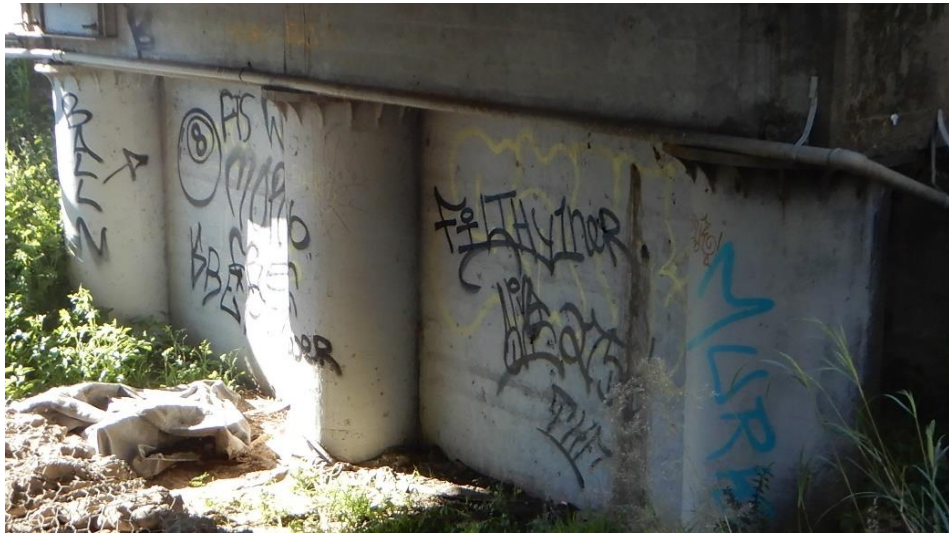
No notable visual defects or delamination was observed on the three piers integrated into the abutment wall.

**Figure 13: Abutment piers, general condition**

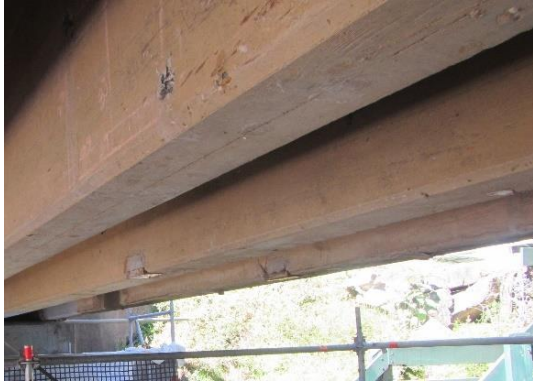
- Numerous past repair concrete patches, many of which are now detached
- Outer girders 1 and 7 are noted to be in significantly worse condition than interior girders 2 to 6 (refer Figure 14 and Figure 15 below); interior girders are in generally fair condition however outer girders are in quite poor condition
- Areas of localised spalling, predominantly on outermost girders (Girder 1 and Girder 7), although an area of spalling is also present on Girder 3. The defect areas generally average approximately 200 mm diameter. A larger area of spalling (approx. 600 mm x 300 mm) is present on Girder 7.
- Wet surface with moss growth apparent on Girder 1 (westernmost girder)
- Cracking of approximately 1 mm width was noted on Girders 3 and 6

**Figure 14: Typical interior girder condition (G2-G6)**

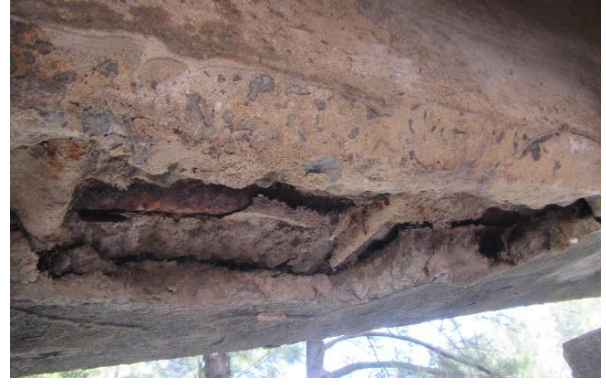
**Figure 15: Spalling on Girder 1**

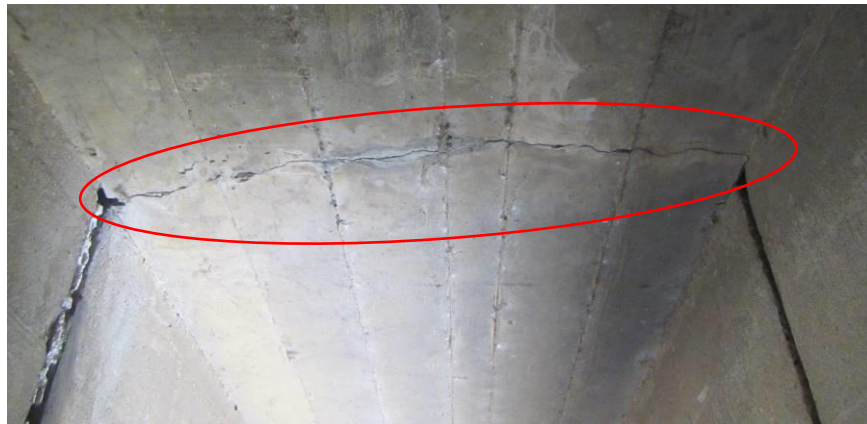
- Two areas of localised spalling between Girders 5 and 6, each approximately 200 mm in diameter
- Cracking noted between each girder above piers, coincident with joints between Span 1 and Span 2 girders. Note that the deck soffit appears to have been continuously cast.

**Figure 16: Crack in deck soffit between Span 1 and Span 2**

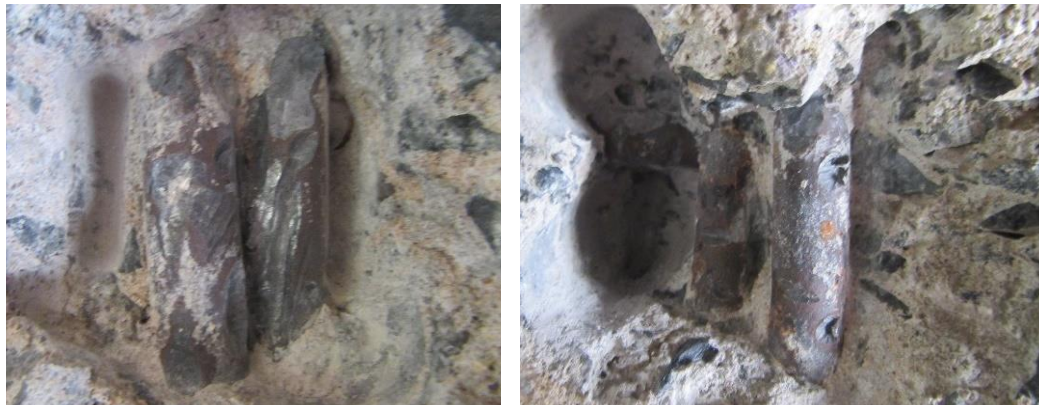
Most of the exposed reinforcement was found to have sustained minor surface corrosion.

**Figure 18: General condition of reinforcement in breakouts**

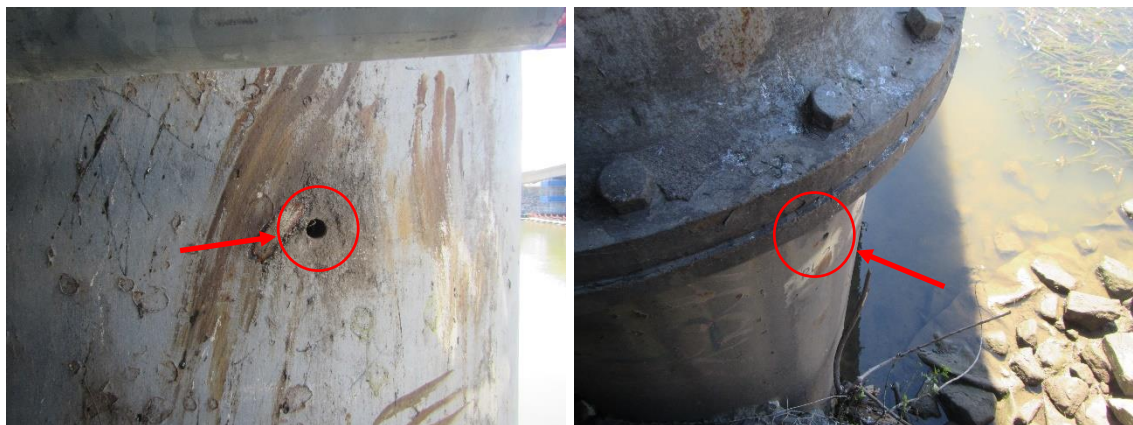
The top core location was noted on the Pier 1 upper castings by GHD inspectors, which were re-measured. These core locations indicated a wall thickness of approximately 35 mm of the upper pier half, corresponding to measurements obtained by CTI in 2005. On this basis, the upper pier segment appears not to display any significant section loss at the measured location.

**Figure 19: Pier 1 East Column core hole in the upper section (Left) and the lower section (Right) from the past investigation**

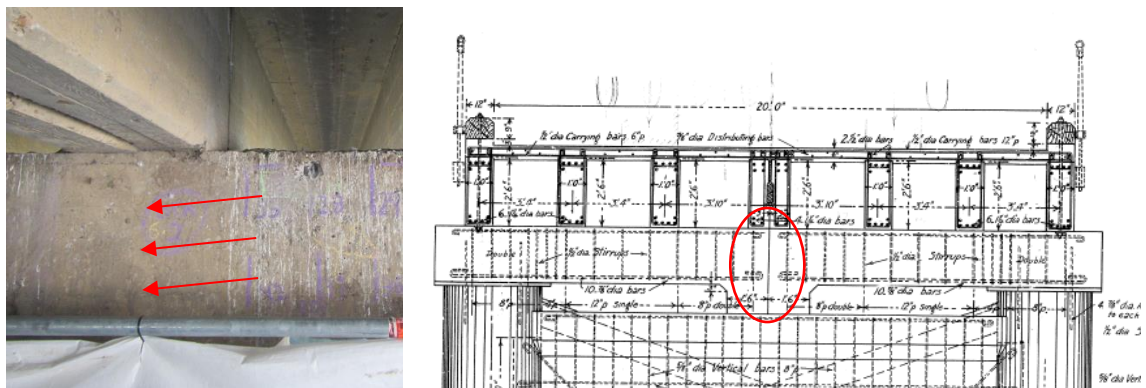
One of the existing drawing showed a joint in Pier 1 headstock. During the site investigation, this joint was observed in the headstock. The reinforcement electrical continuity test results supported this observation.

**Figure 20: The joint in Pier 1 headstock directly under Girders 4A & 4B (Left) and in the drawing (Right)**

The headstocks (both abutment and Pier 1) appeared to have constructed in two halves. The existing drawing suggests that the reinforcement in headstocks are connected within the each half of the elements, but not across the halves. GHD’s electrical continuity test results also support this drawing information. If electrochemical repair is used, such discontinuity issue can be addressed by having separate reinforcement connections in the two halves
