Safety Investigation Report

Electric Shock Occurrence

Intersection of Ultimo Road and George Streets Sydney

Prepared for The Secretary
Transport for NSW
2 August 2018

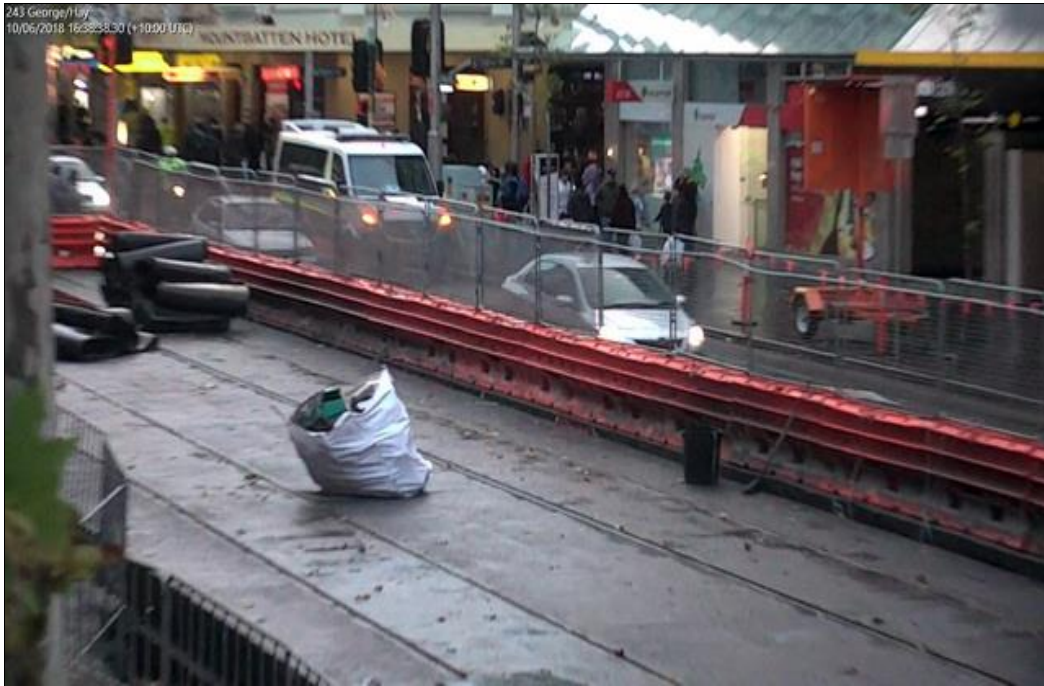
Image 1: Ultimo Road Looking South West - 10 June 2018

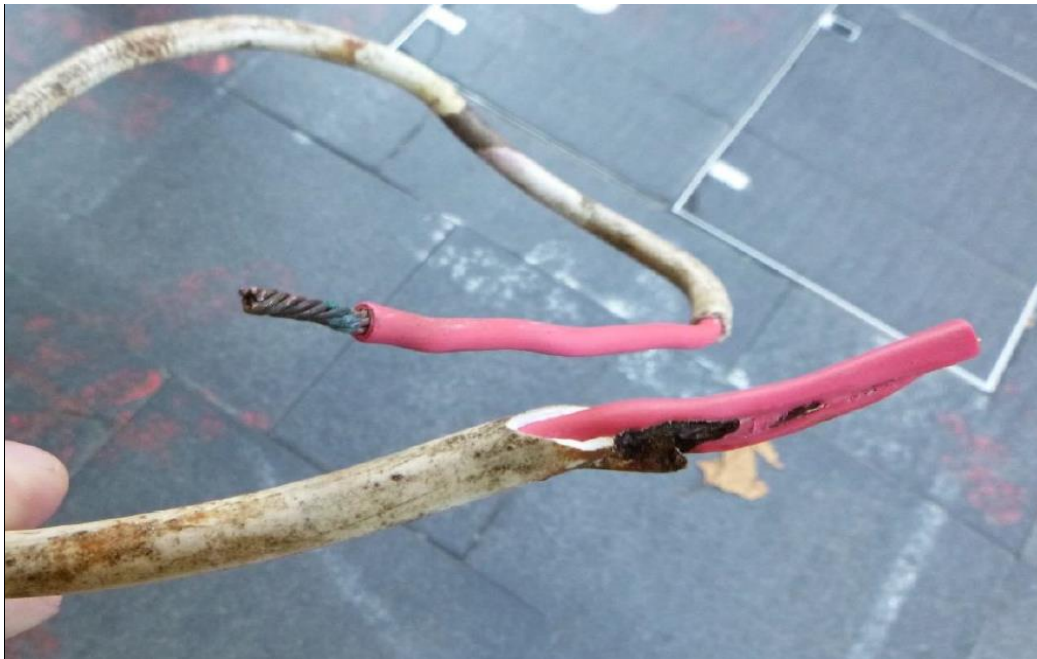
Image 2: Damaged Cable TCS 1837

In the wake of the incident, it was reported that a cable had been found tucked up between the pit wall and the lid. Following the incident this cable was removed and re-terminated in the fuse box.

The damaged section of cable is most likely the cause of current flow in a circuit other than design.

- A bare area on the cable of approximately 1cm² has been in contact with the metal pit frame. There is no evidence of burning or heating on the pit frame, however the cable insulation shows signs of heating having melted the insulation, and there are brown heat marks on the outer insulation near the damaged section

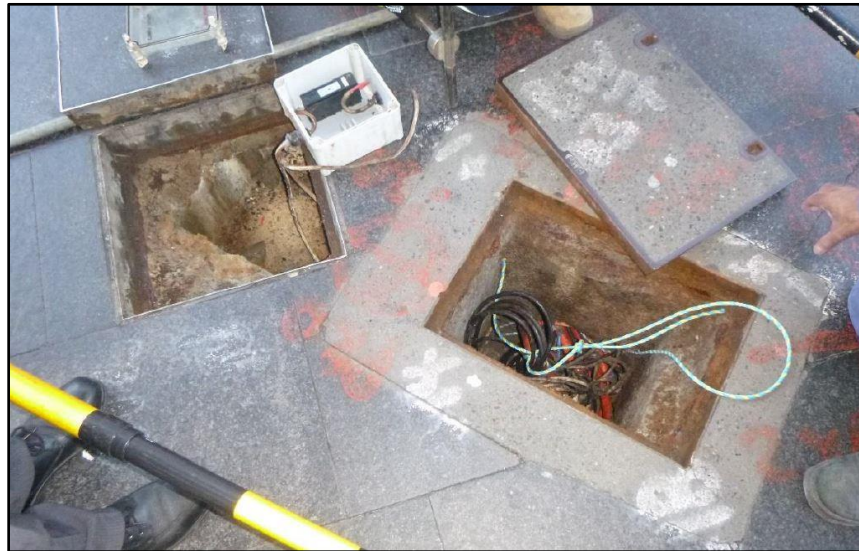
- The pit cover weighs in excess of 15Kg owing to the granite flagstone material specified by the City of Sydney Streetscape requirements¹⁰
- The pit design utilises tapered sides which make removal and replacement difficult as well as creating a 'pinch point' should fingers or cables become trapped
- The pit has no markings to indicate contents, ownership or potential hazards

Image 3: TCS 1837 and adjacent (larger) pit

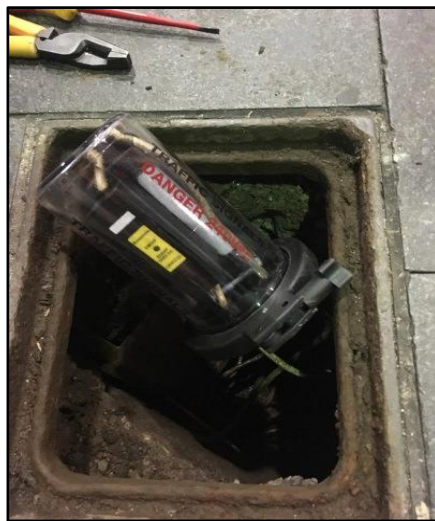
Image 4: Contemporary Fuse Holder

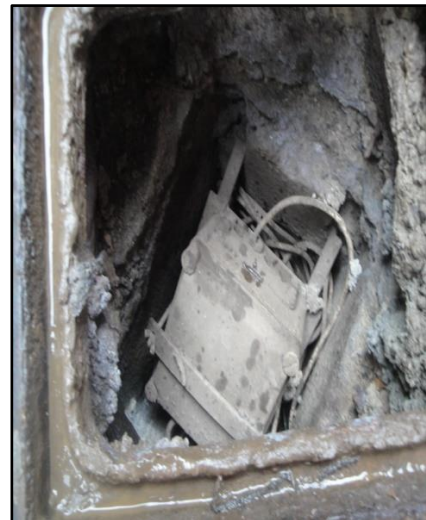
Image 5: Current TCS Fuse Holder

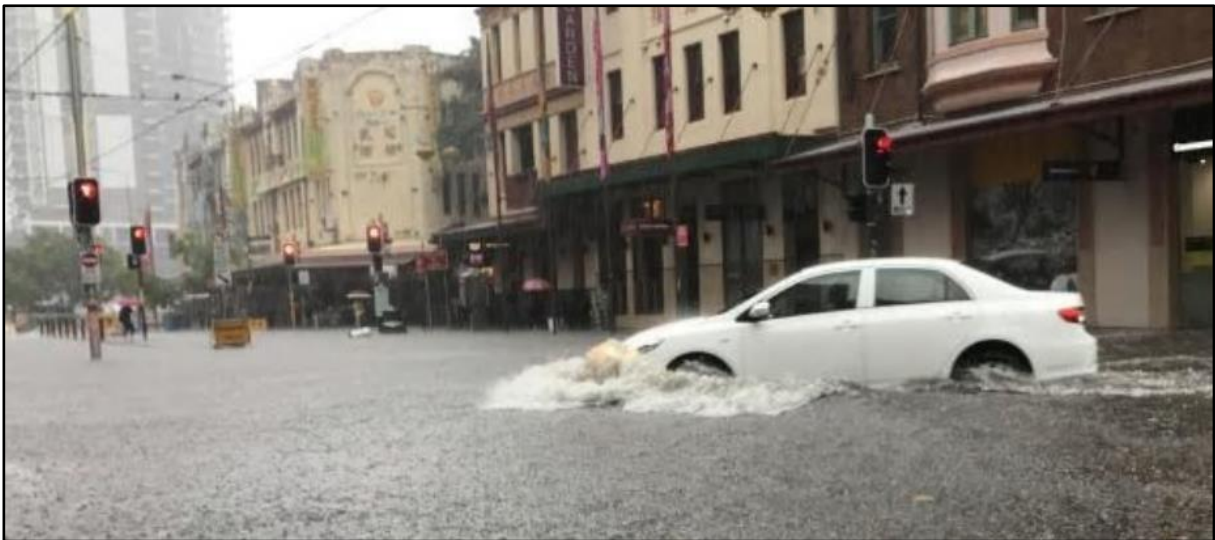
The intersection of George Street and Ultimo Road in particular is routinely affected by seasonal flooding. In spite of instances of water depth to 1.5 metres, predictable impacts on road and pedestrian traffic are usually short lived, however the impact beneath the roads and footpaths can be longer lasting and detrimental to safety critical installations owing to a lack of effective drainage and exposure to sunlight to support the evaporation of moisture. This factor alone provides a major impetus for reliable and maintainable weatherproof componentry to deliver the integrity necessary for a major city.

Image 6: Campbell Street Haymarket. February 2017

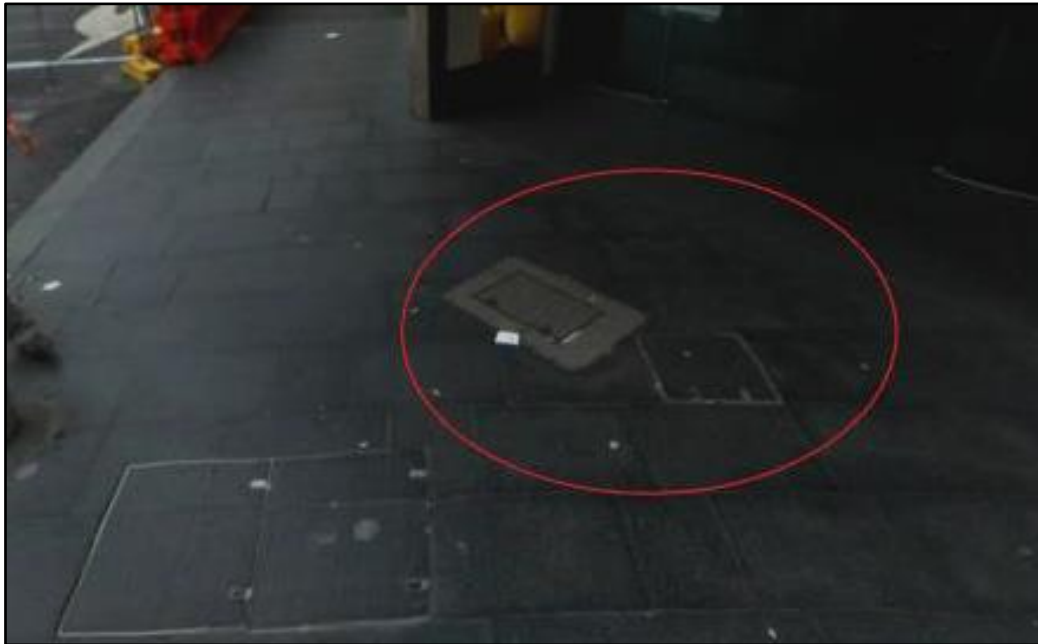
The state of this equipment was consistent with a number of other pits, within and outside of the light rail corridor, sampled by SafeWork NSW and RMS officers on 27 June 2018.

Image 7: Pit layout - TCS 1837 to the right

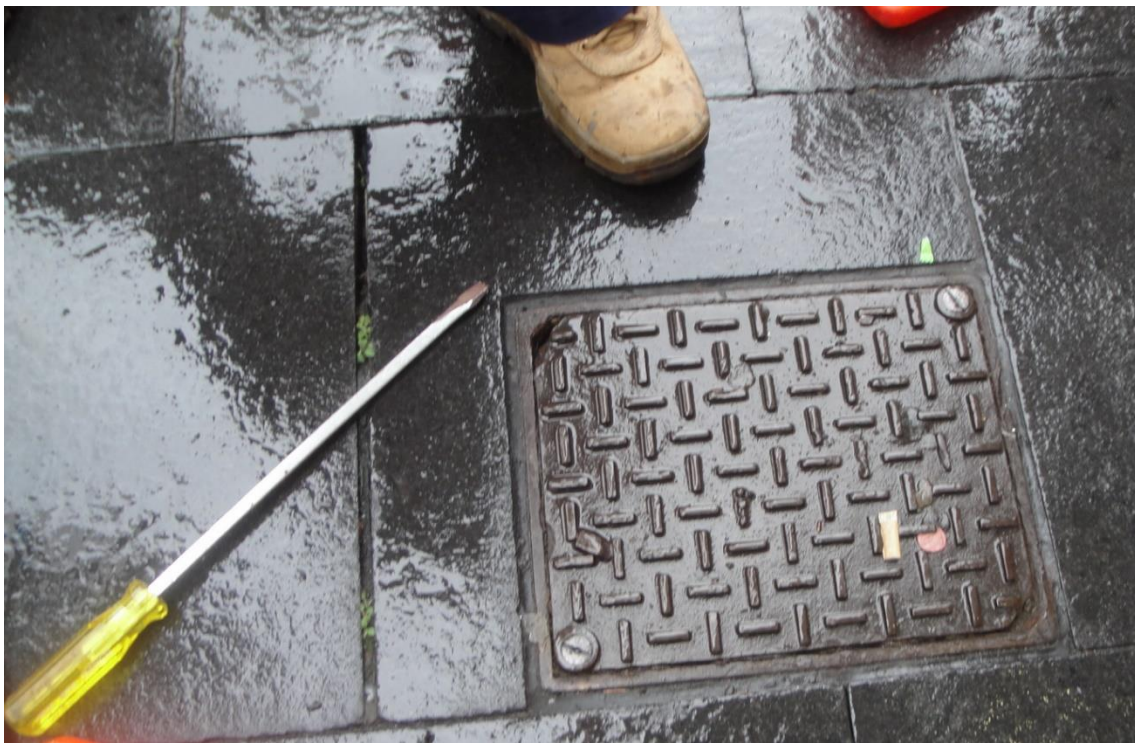
In the case of the historically earlier, and less substantial metal pit lids, many of these can be easily opened with a simple screwdriver. During the CBD pit sampling exercise, several pit lids were noted to have defective or missing screw down retainers.

Image 11: Metal Pit Lid
