Tarago rail yards lead contamination

Information pack
April 2020

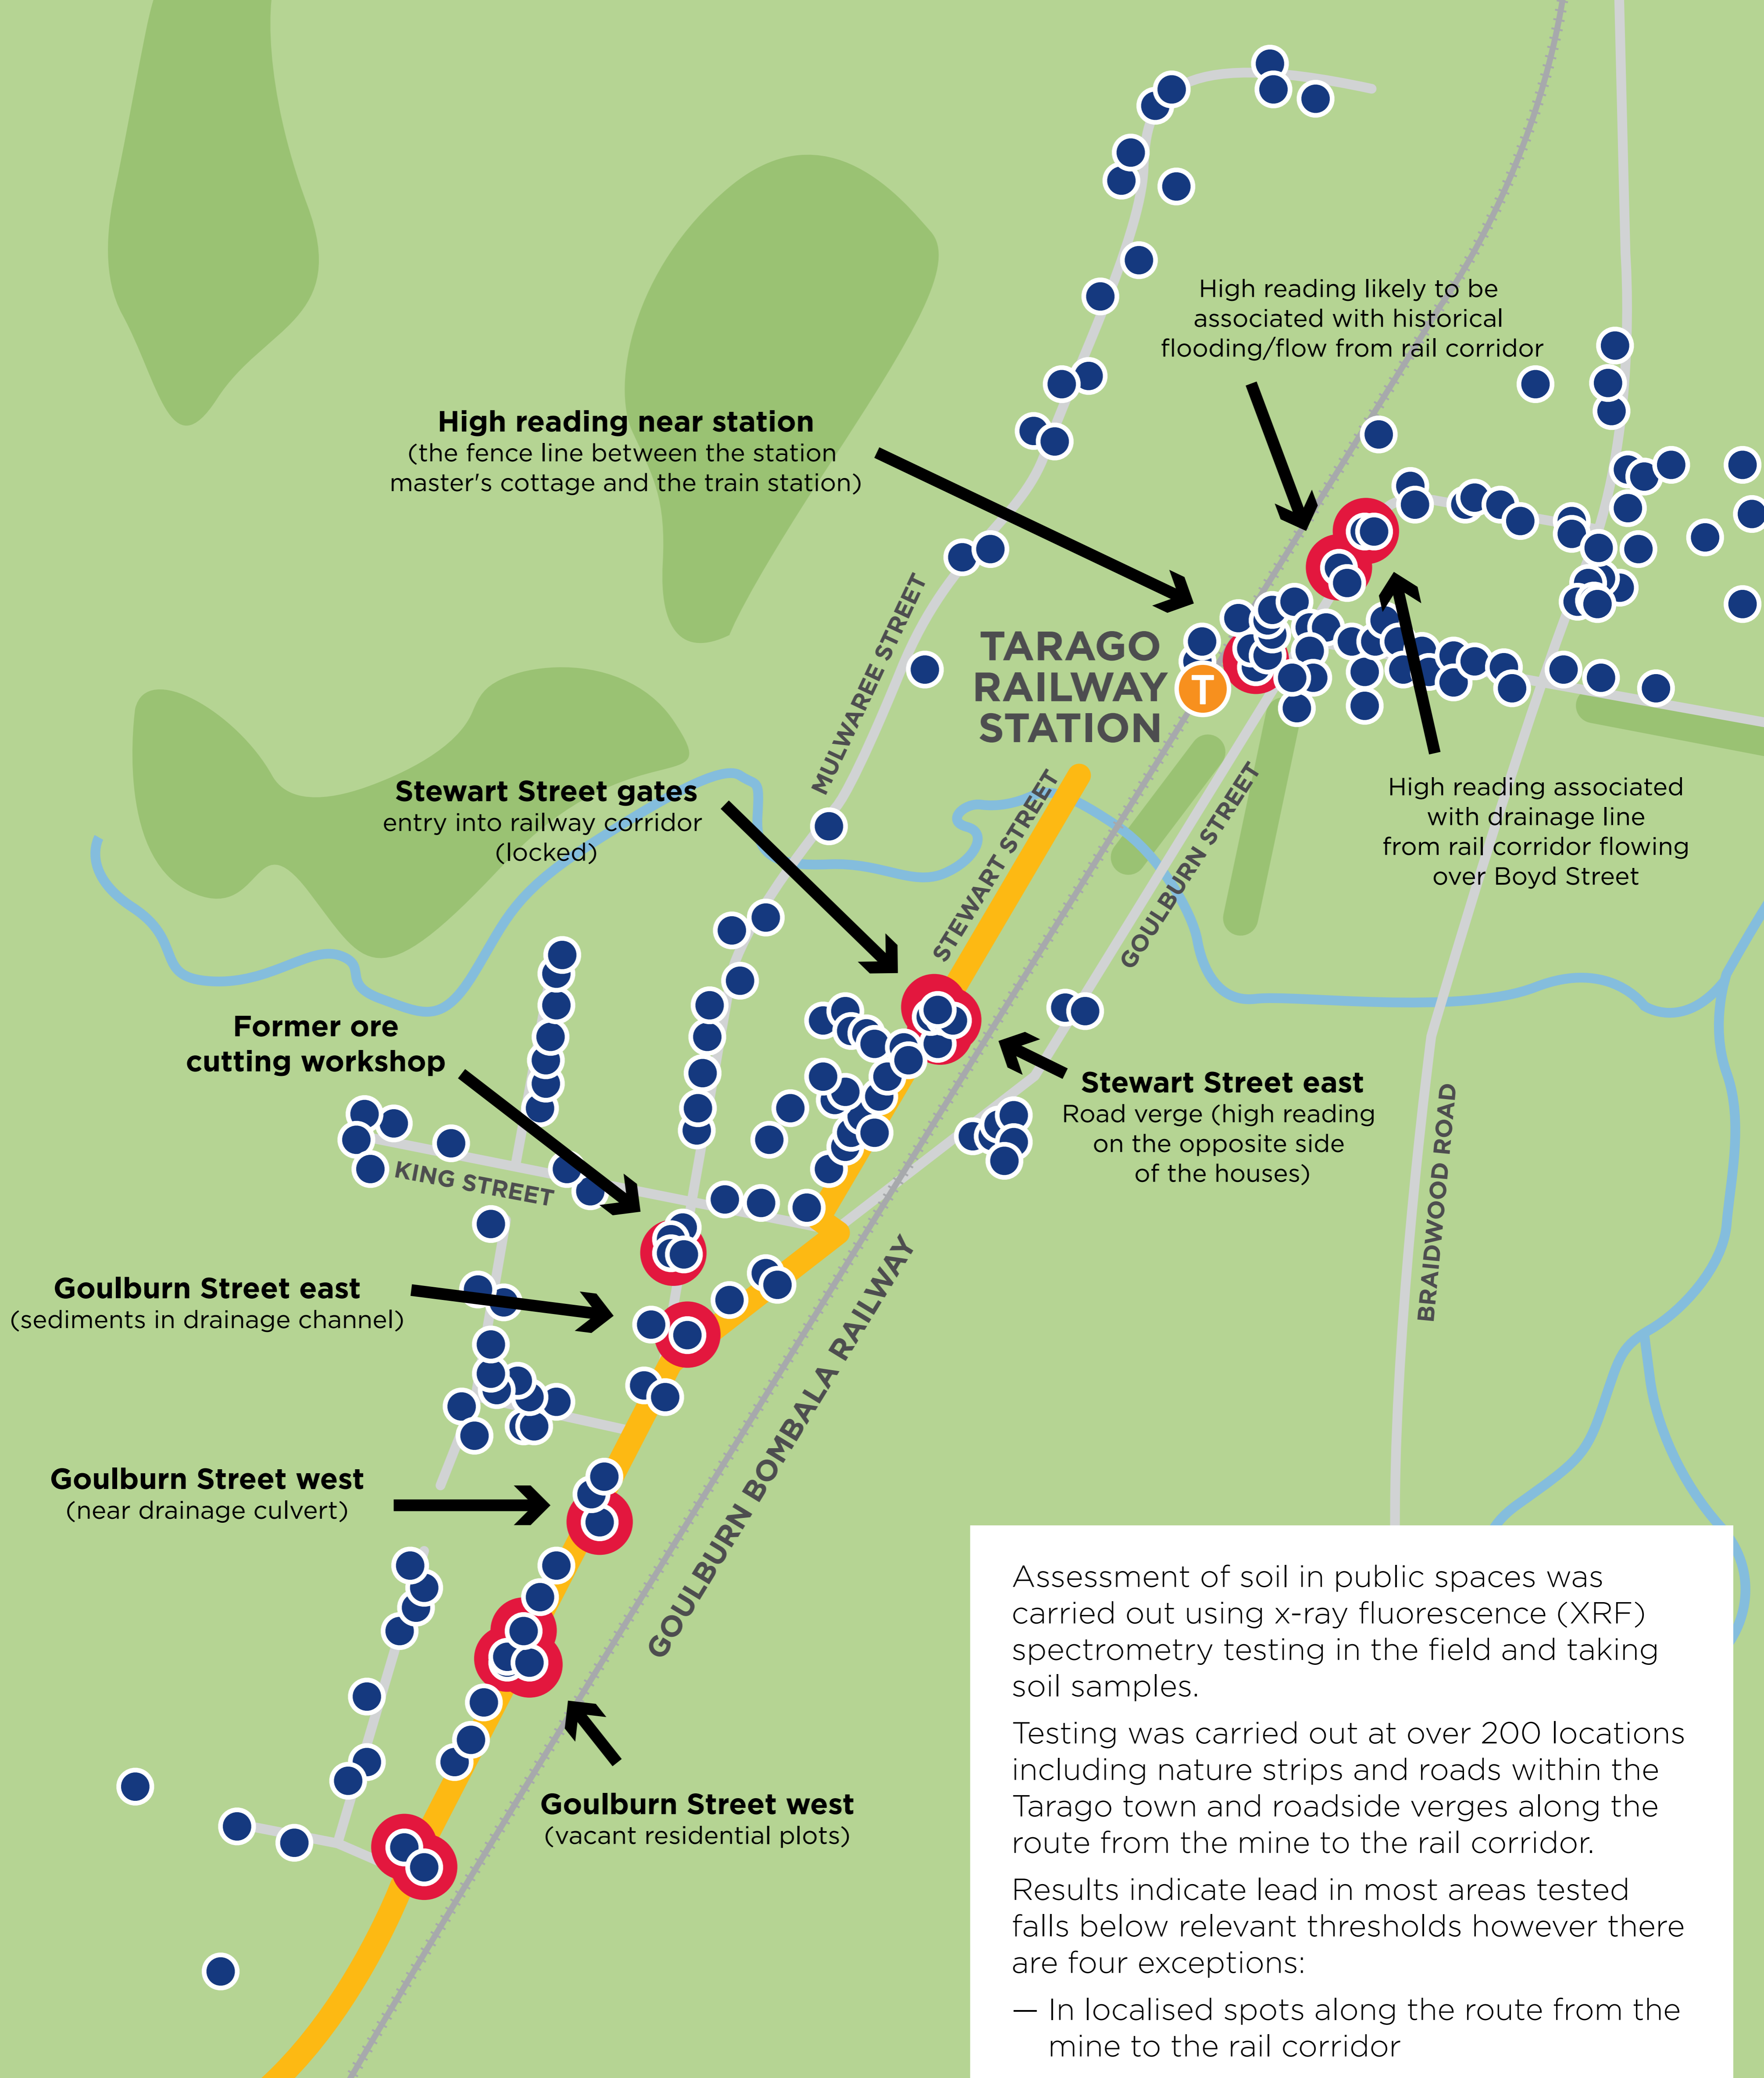
Assessment of soil in public spaces was carried out using x-ray fluorescence (XRF) spectrometry testing in the field and taking soil samples.

Testing was carried out at over 200 locations including nature strips and roads within the Tarago town and roadside verges along the route from the mine to the rail corridor.

Results indicate lead in most areas tested falls below relevant thresholds however there are four exceptions:

- In localised spots along the route from the mine to the rail corridor
- Around an old workshop on Mulwaree Street
- South of the station masters cottage within the rail corridor
- On an overland flow path from the rail corridor across Boyd Street.

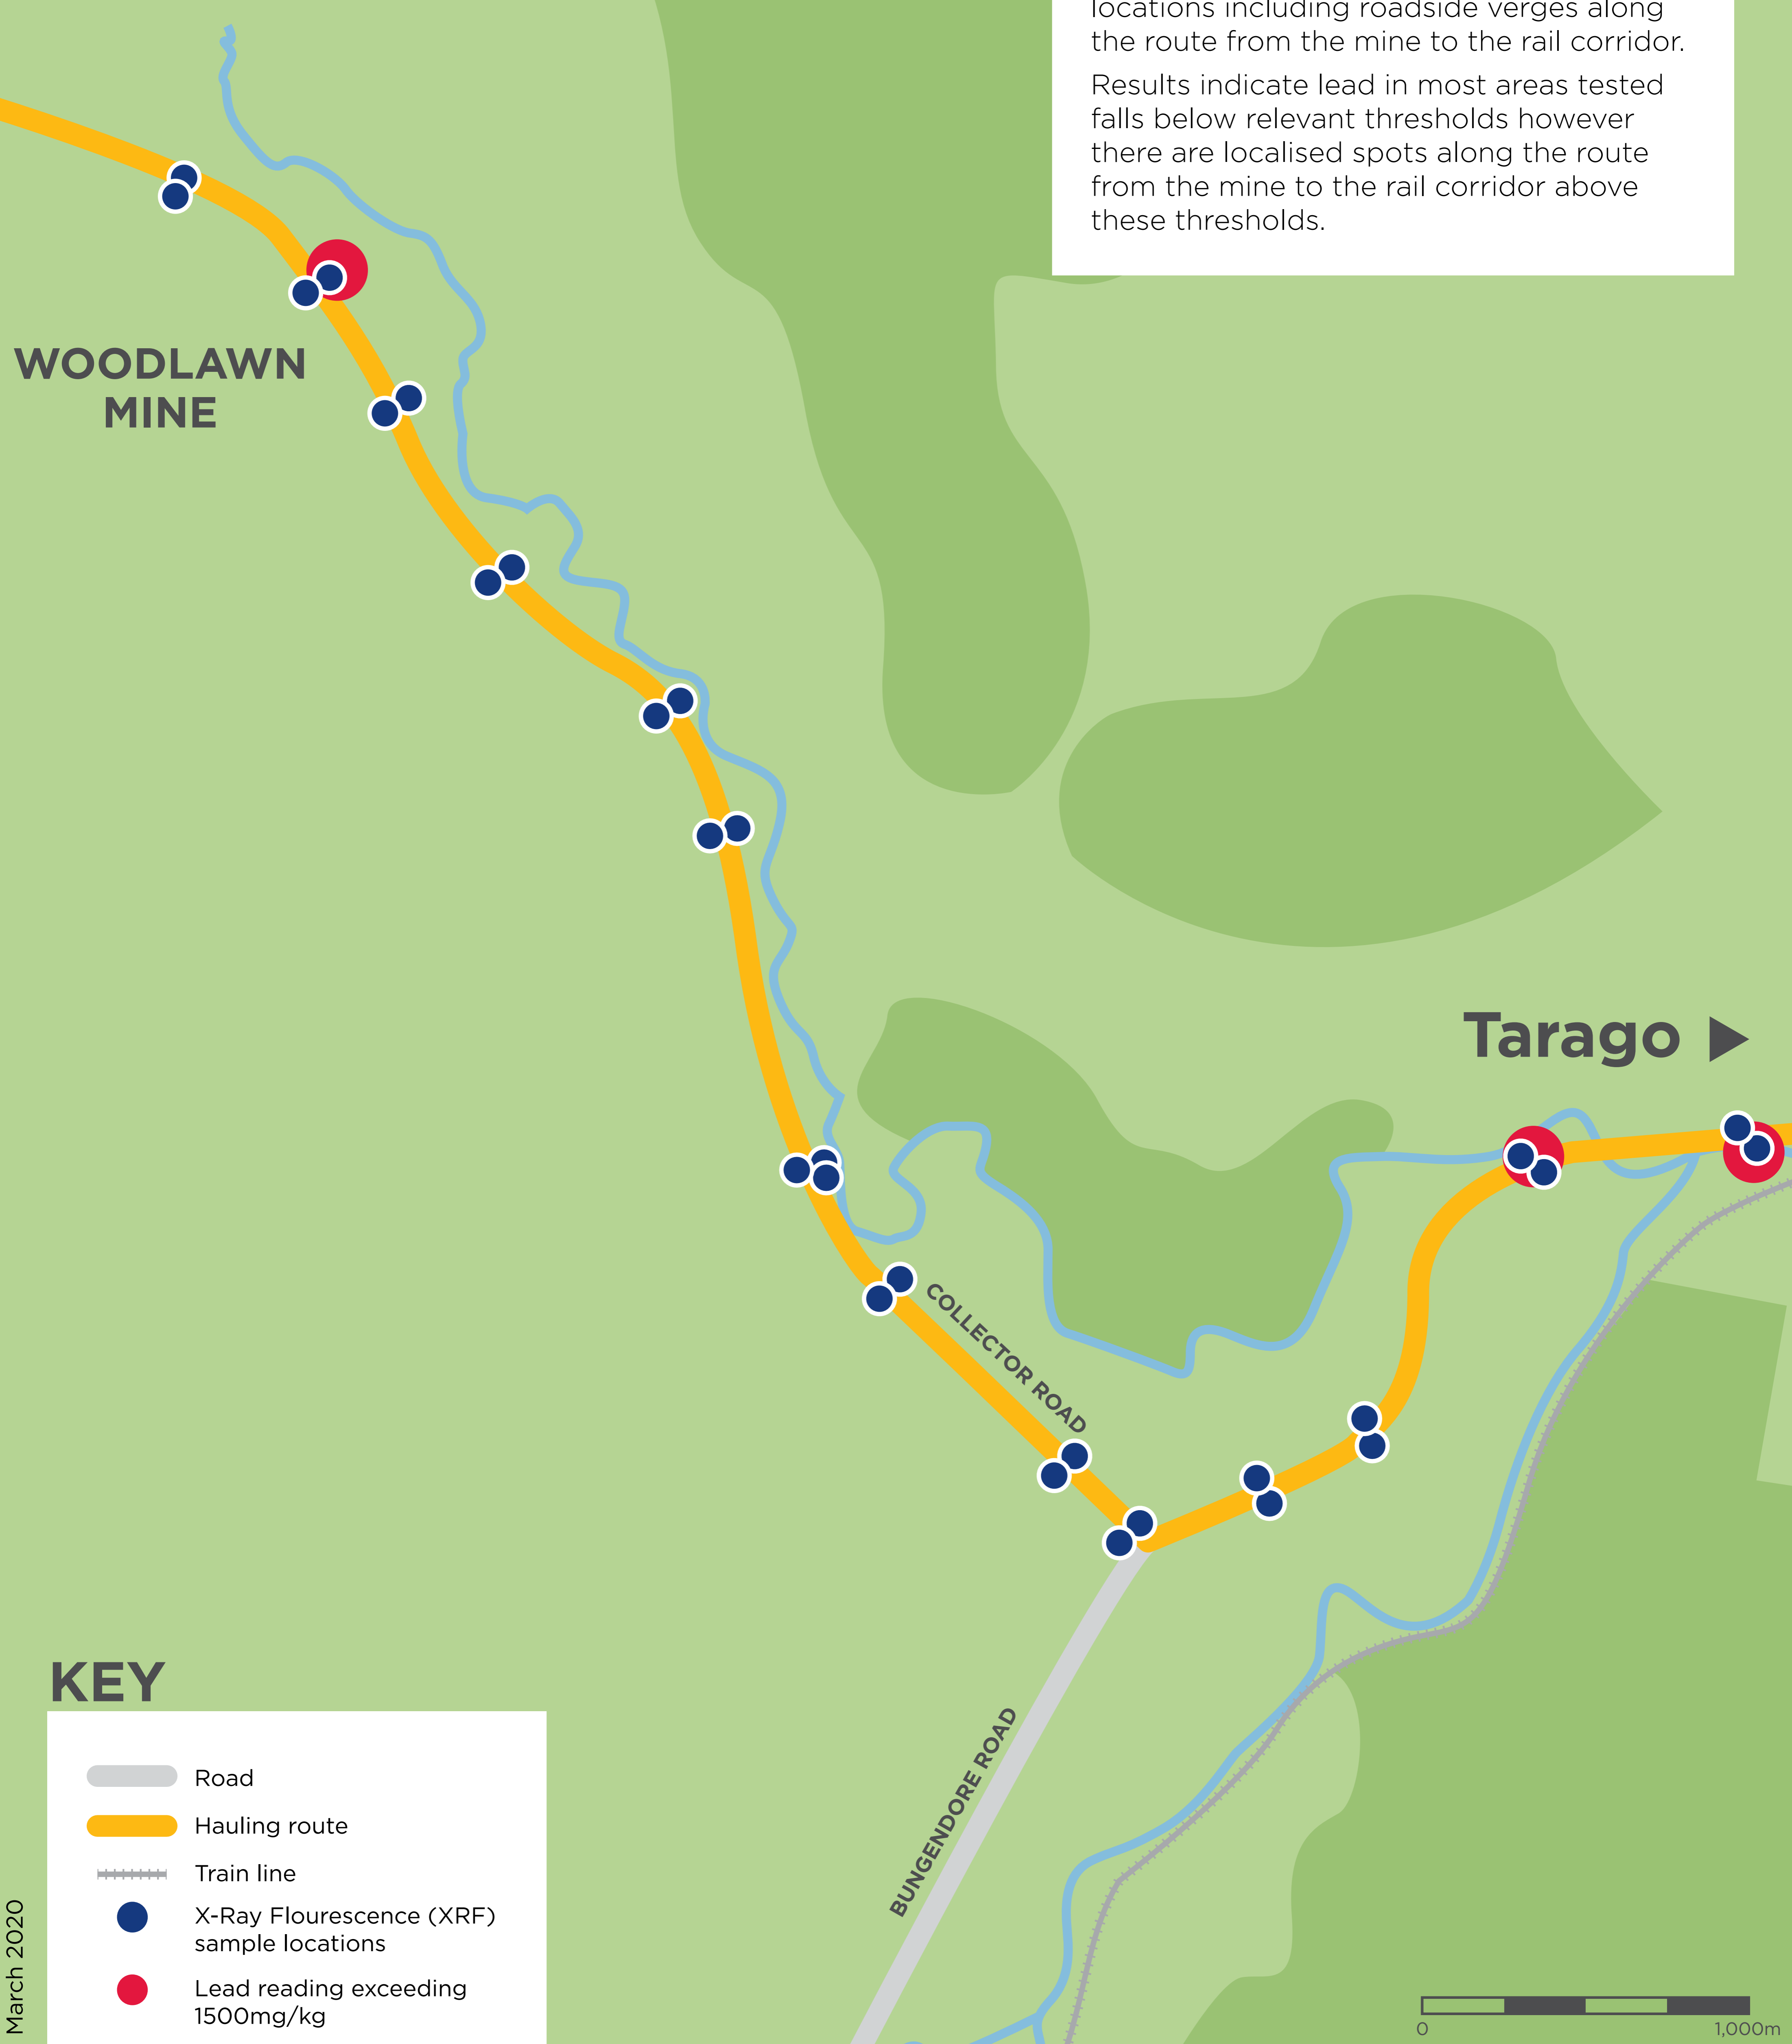
Assessment of soil in public spaces was carried out using x-ray fluorescence (XRF) spectrometry testing in the field and taking soil samples.

Testing was carried out at over 200 locations including roadside verges along the route from the mine to the rail corridor.

Results indicate lead in most areas tested falls below relevant thresholds however there are localised spots along the route from the mine to the rail corridor above these thresholds.

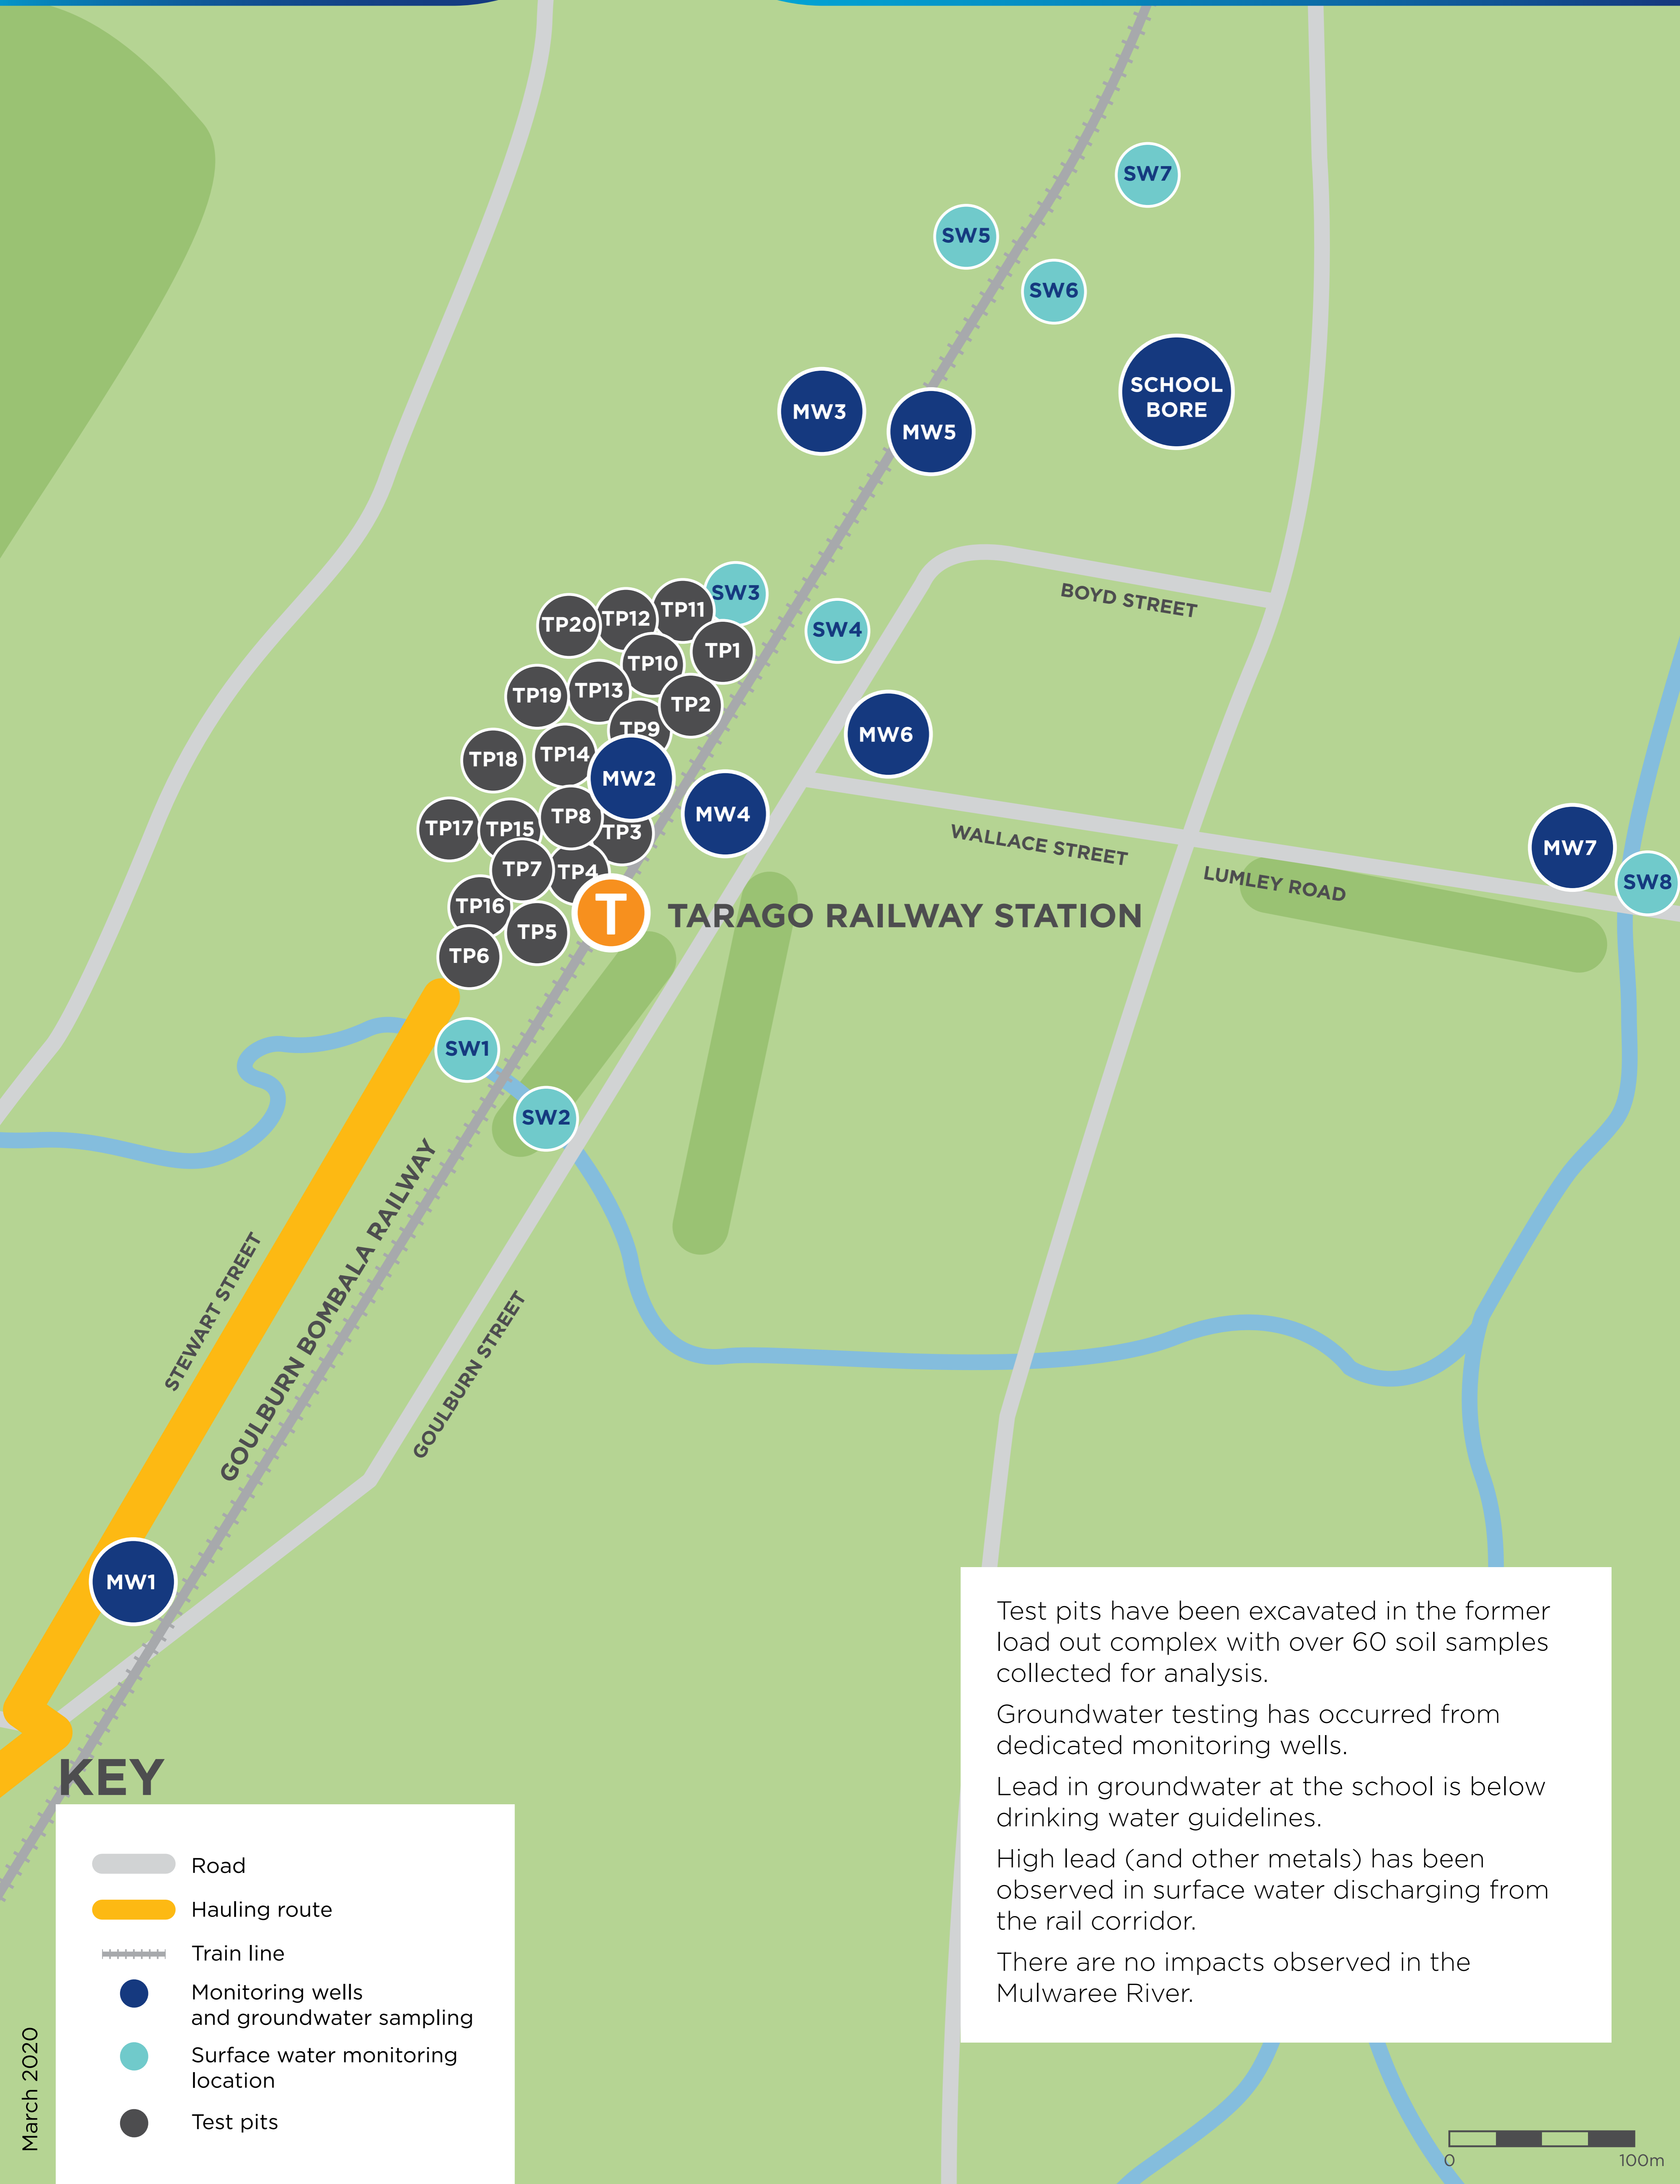
Test pits have been excavated in the former load out complex with over 60 soil samples collected for analysis.

Groundwater testing has occurred from dedicated monitoring wells.

Lead in groundwater at the school is below drinking water guidelines.

High lead (and other metals) has been observed in surface water discharging from the rail corridor.

There are no impacts observed in the Mulwaree River.
