Tarago Station
C/-
Tarago Railway Station, Goulburn Street
Tarago NSW 2580

Tarago Railway Station, Goulburn Street, Tarago NSW Internal Dust Removal Report

Date 12/10/2020

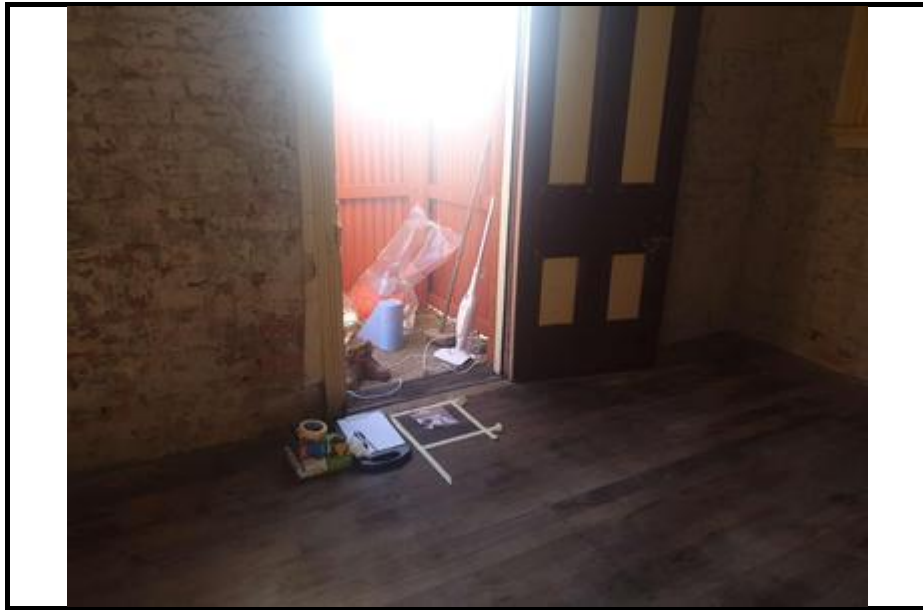
Photo 1: Floor dust swab sampling at location DSWAB_VALA(TS).

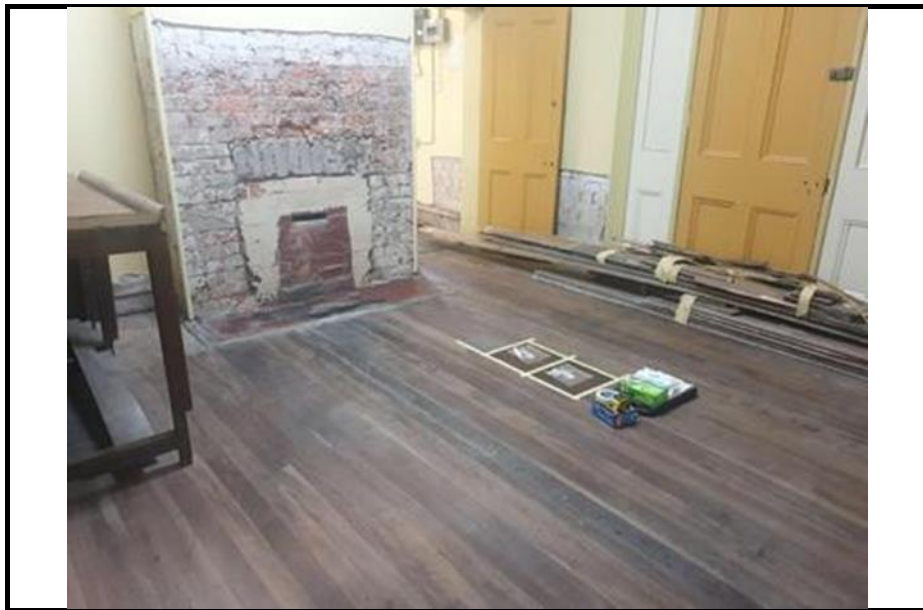
Photo 2: Floor dust swab sampling at location DSWAB_VALB(TS) with duplicate sample DSWAB_DUP2.

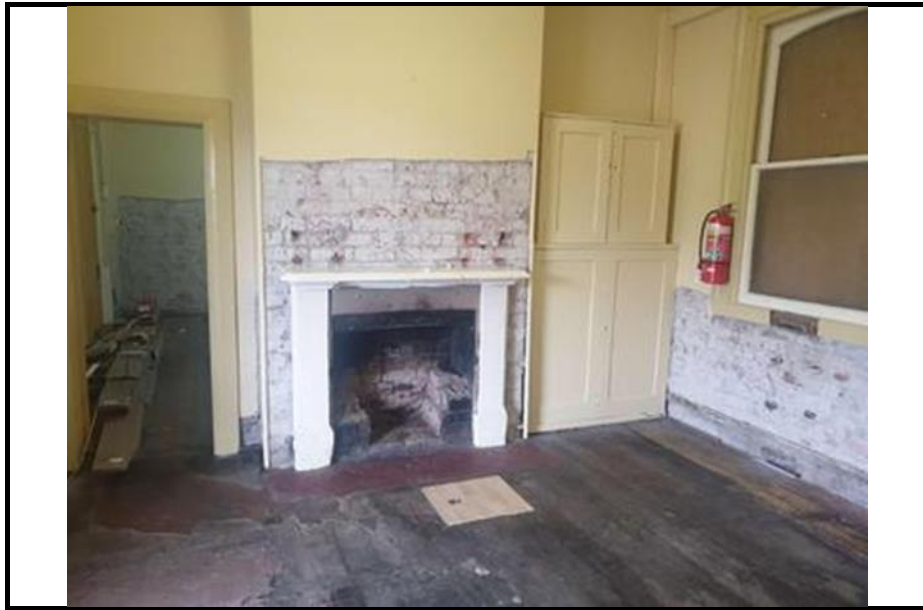
Photo 3: Shelf (fireplace mantle) dust swab sampling at location DSWAB_VALC(TS).

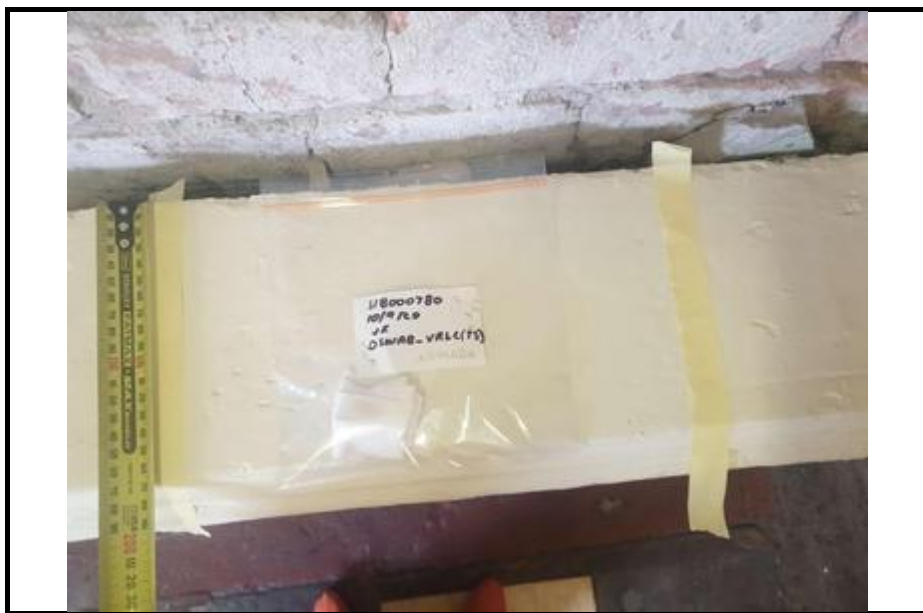
Photo 4: Shelf (fireplace mantle) dust swab sampling at location DSWAB_VALC(TS).

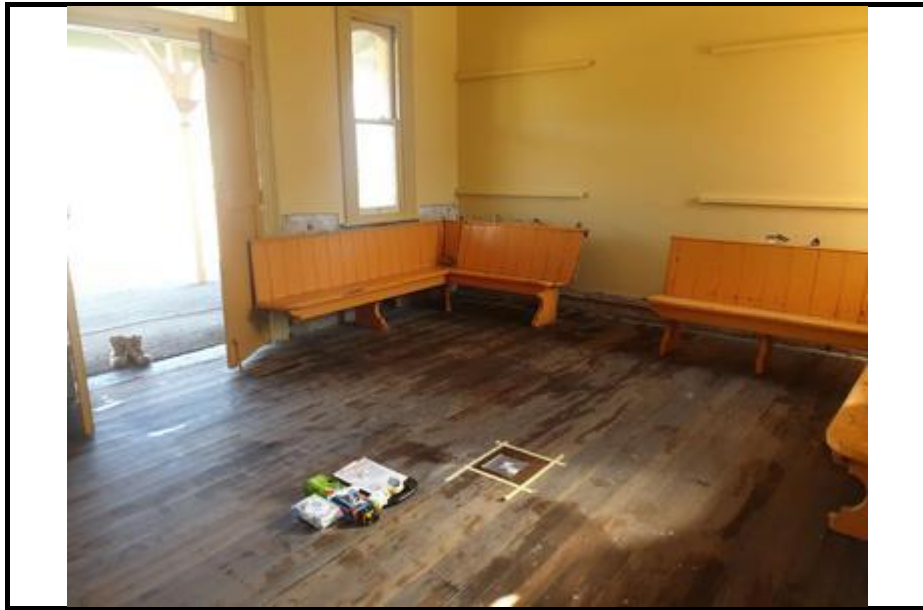
Photo 5: Floor dust swab sampling at location DSWAB_VALD(TS).

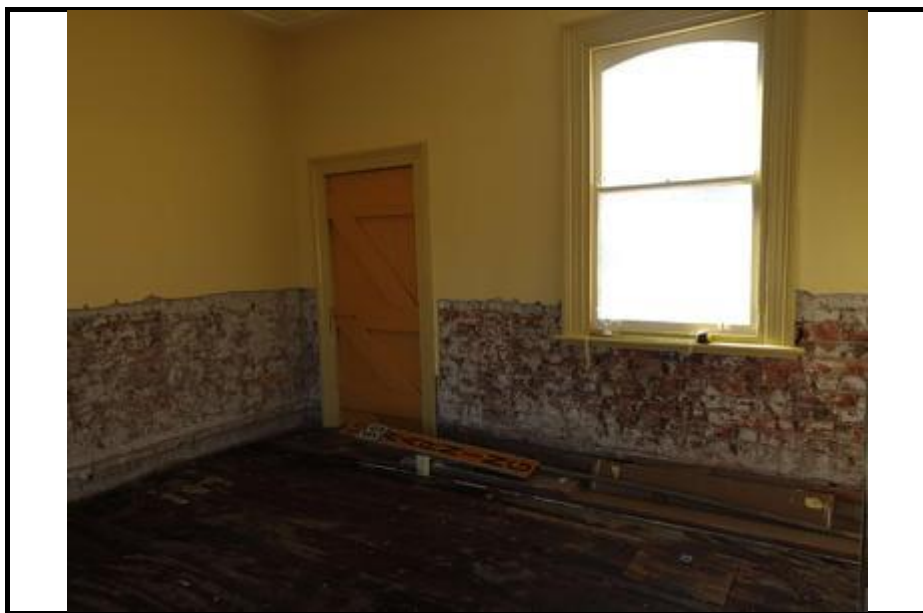
Photo 6: Windowsill dust swab sampling at location DSWAB_VALE(TS).

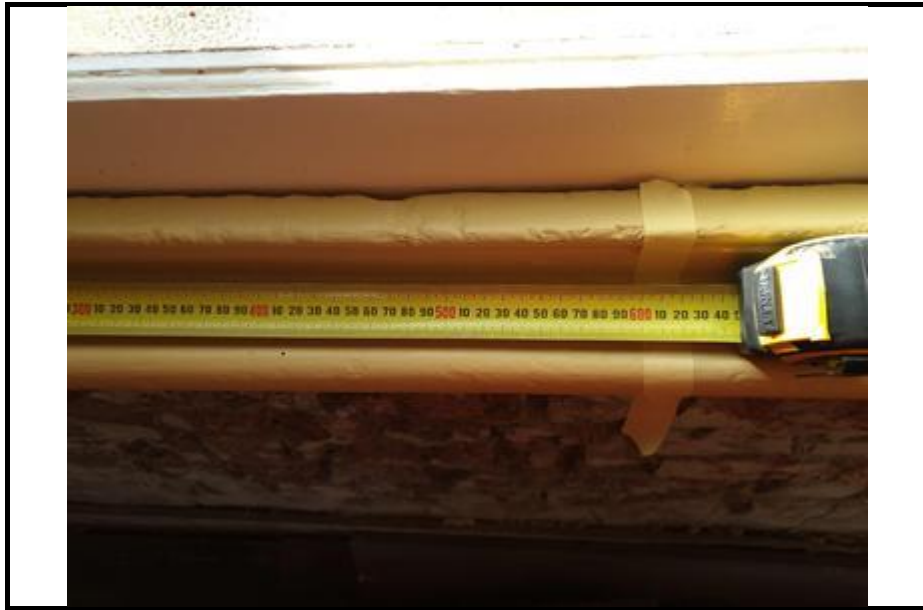
Photo 7: Windowsill dust swab sampling at location DSWAB_VALE(TS).

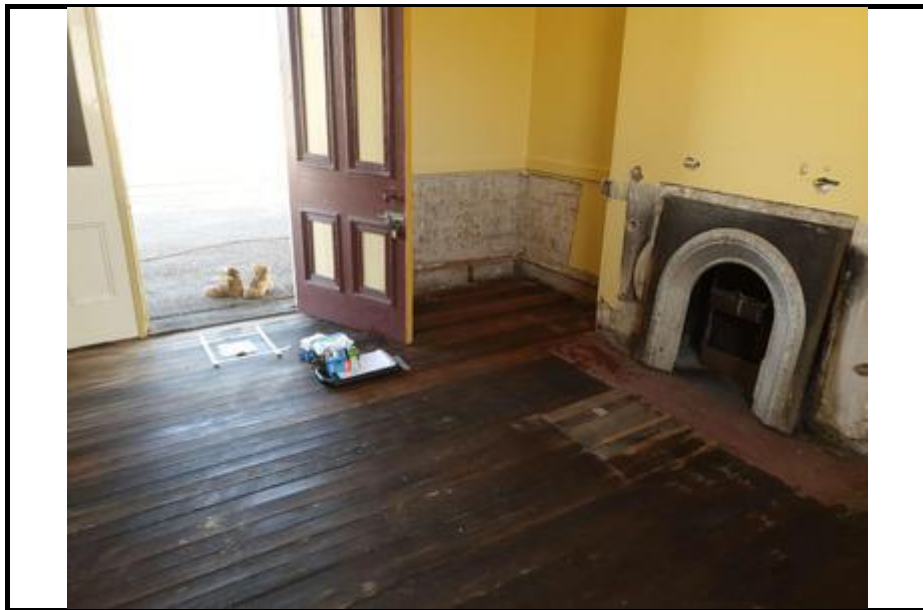
Photo 8: Floor dust swab sampling at location DSWAB_VALF(TS).

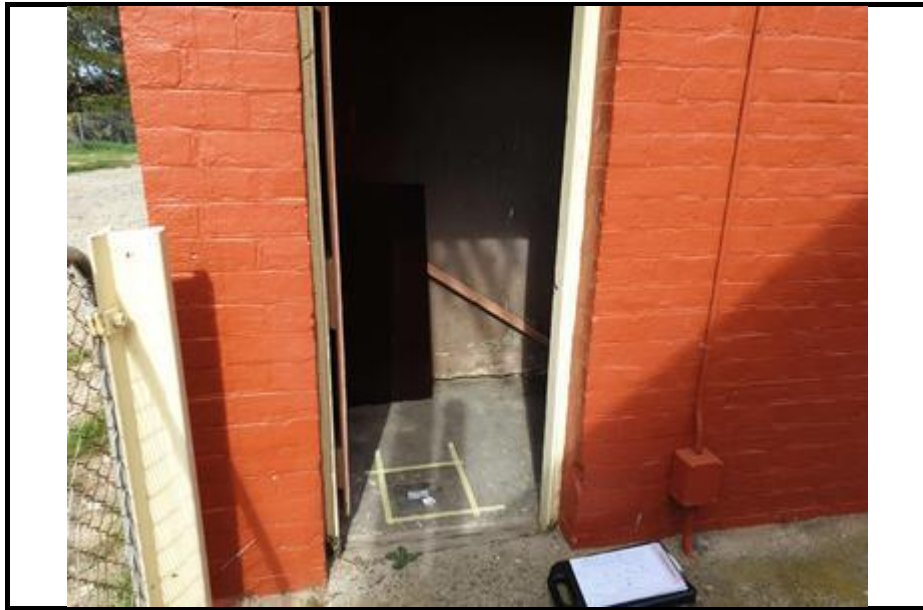
Photo 9: Floor dust swab sampling at location DSAB_VALG(TS).

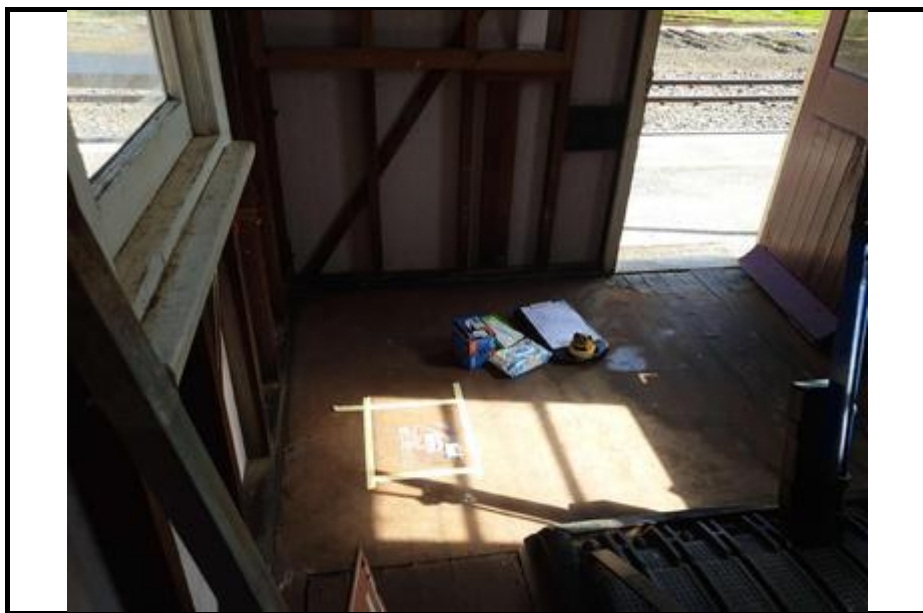
Photo 10: Floor dust swab sampling at location DSAB_VALH(TS).
