Routine Site Inspection Form

Title:	Bungendore Rail Corridor & Woolshed Siding Inspection	Approved: SM	Project-Nr.: 318001704	Date: April 2023
Site:	Bungendore, NSW			
Client:	UGL Regional Linx

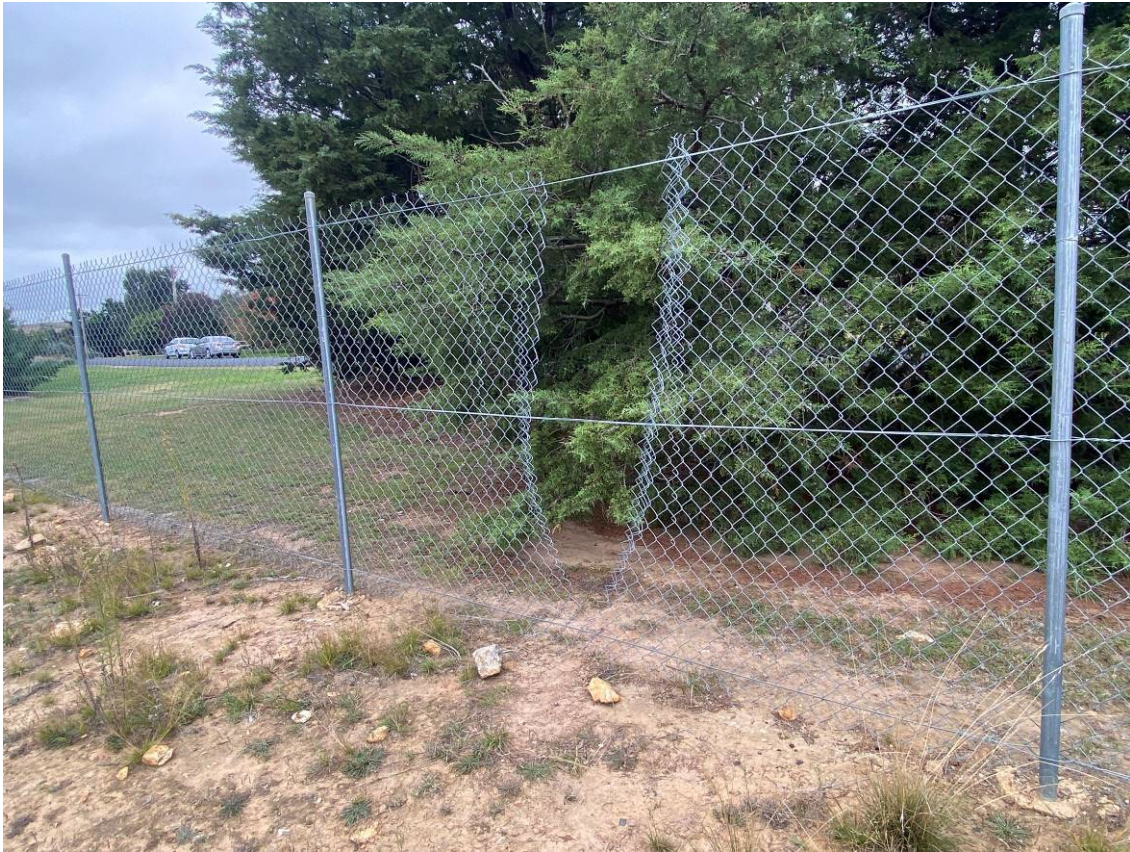
Yes	No	Comments/Observations
Is Site fencing secure and intact?		No	Break in fencing appearing to be deliberately cut (Photo 1)
Is there any evidence of trespassing since last inspection?	Yes		Fencing cut (Photo 1), therefore assumed trespassing entry to site from public
Is any surface water discharging from site? if yes, describe water quality	Yes		Yes, slow surface water flowing through site under culvert near rail crossing (Photos 5 - 6) off from site. Pooled water at two other culverts (Photo 3 - 4) and remaining culvert was dry (Photo 2) (Circle One) clear/cloudy/turbid/sediment laden
Are appropriate erosion and sediment controls in place and effective?	Yes		Appropriate ground cover of vegetation and rocks in areas where lead contamination identified. Evidence of erosion in some places (Photos 9 - 10), but unlikely to mobilise contaminated sediment which would present a risk to the receiving environment.

Photo 1: Deliberately cut fencing on site opposite train station and facing Powell Street. UGL representative on site notified, expected to be repaired same day.

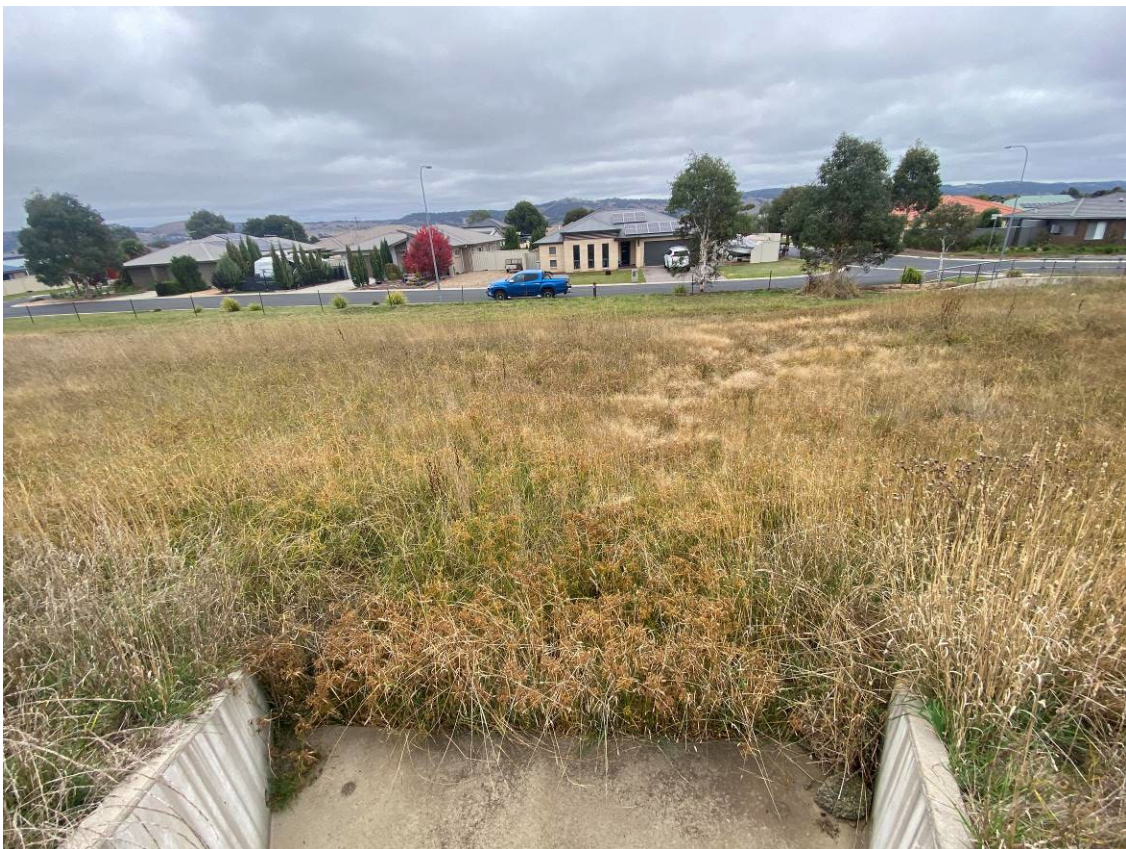
Photo 2: Downgradient of first culvert encountered on site from the south, facing Murray Grey Place. No discharge of surface water off site.

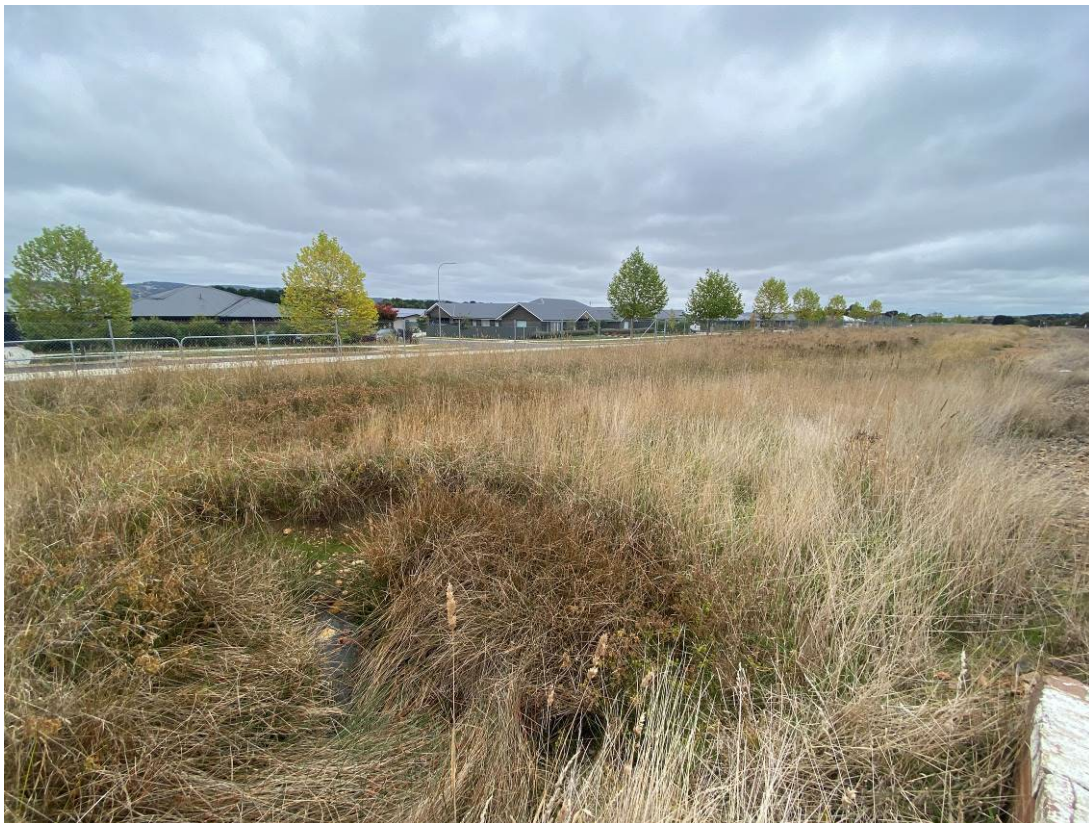
Photo 3: Downgradient of second culvert encountered on site from the south, facing Majara Street, near Finch Street intersection. No discharge of surface water off site. Some pooled water, clear and no turbidity.

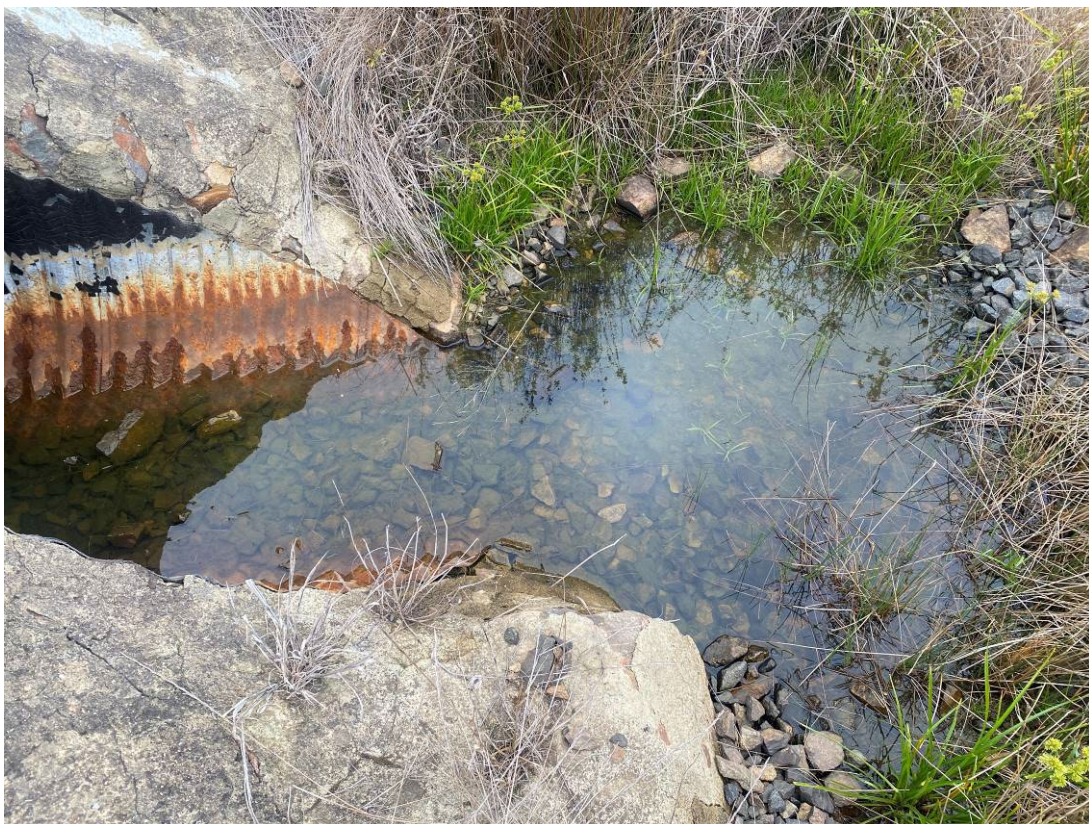
Photo 4: Downgradient of third culvert encountered on site from the south, discharges towards Majara Street, near King St intersection. Water pooled with no discharge of surface water off site. Clear and no turbidity.

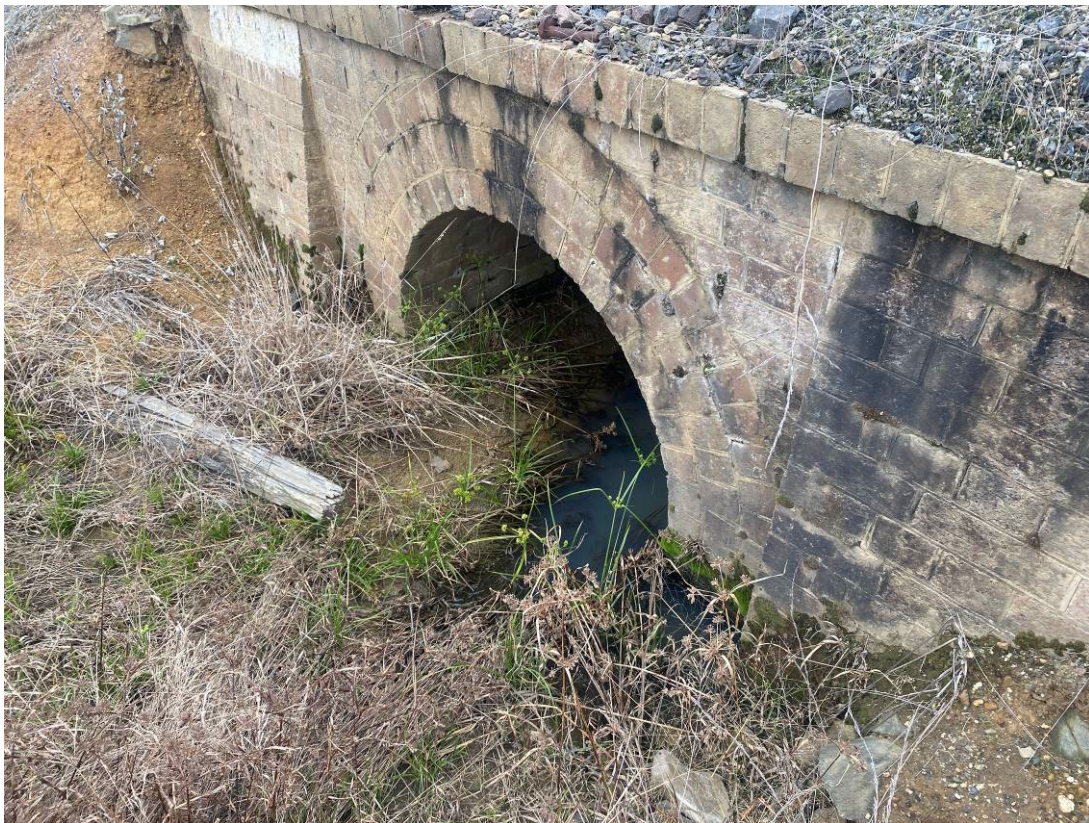
Photo 5: Upgradient of fourth culvert encountered on site from the south, near rail crossing on Malbon Street. Water slowly discharging through site. Moderate turbidity.

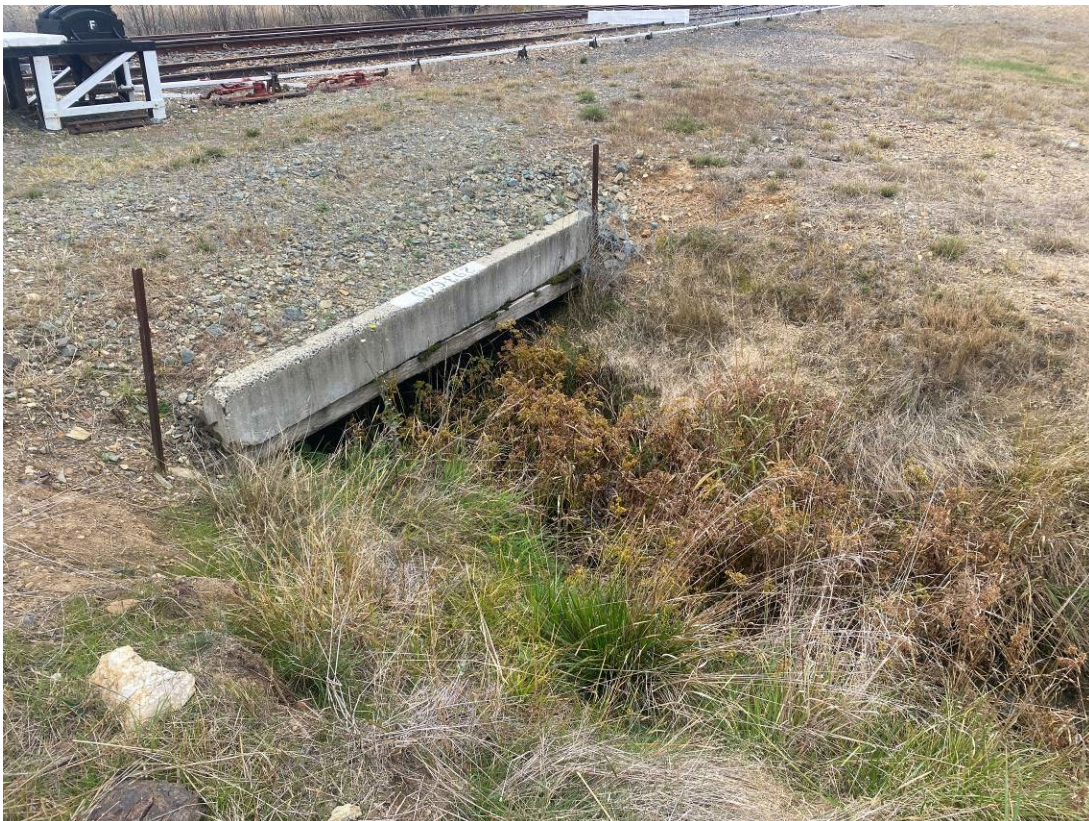
Photo 6: Downgradient of fourth culvert encountered on site from the south, near rail crossing on Malbon Street. Water slowly discharging through site. Clear and no turbidity after passing through weeds and reeds that act as natural sediment filters.

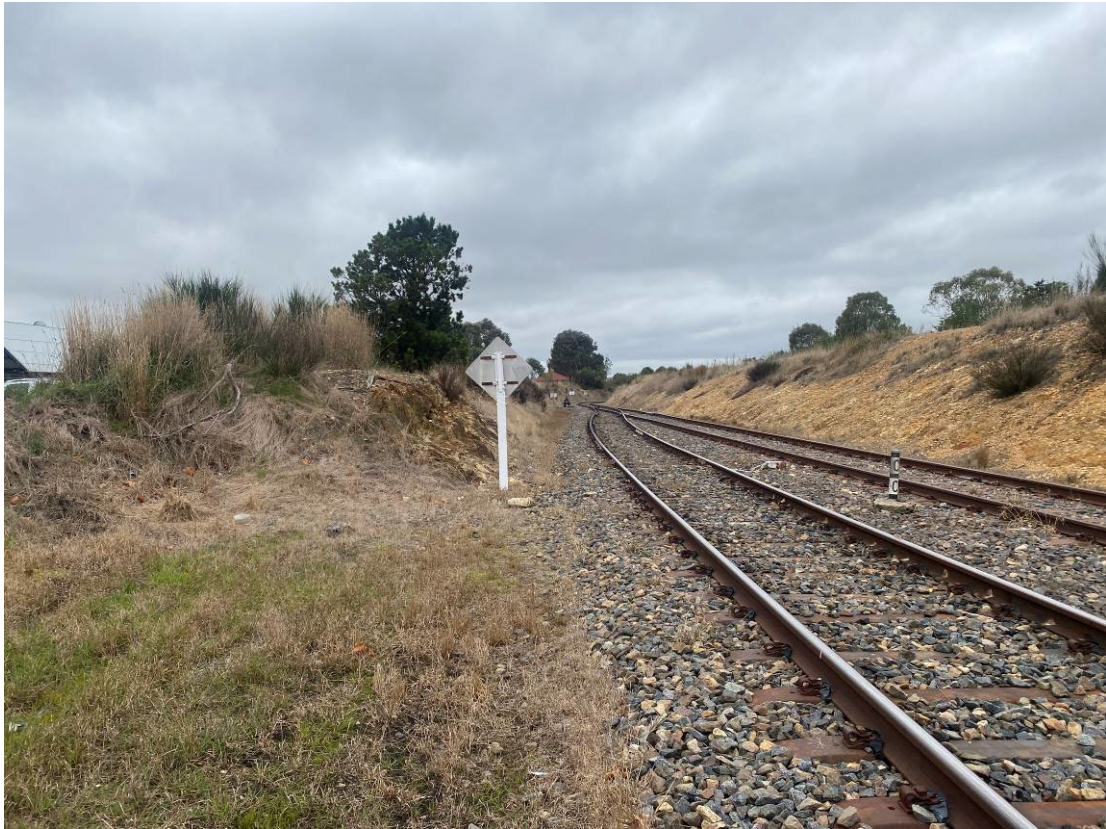
Photo 7: Picture of railway line facing north towards Turallo Creek. No airborne dust visible in air.

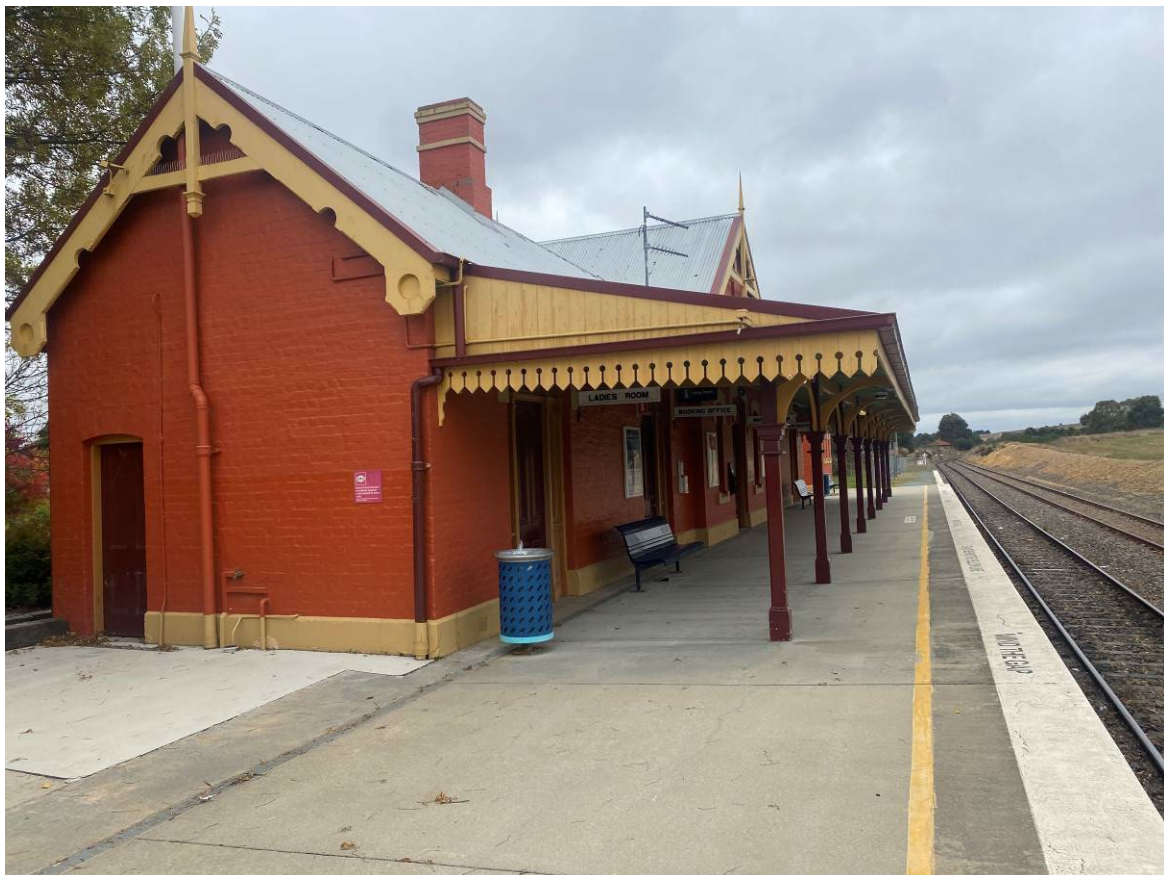
Photo 8: Picture of railway station facing north towards Turallo Creek. No airborne dust visible in air or on surface at station.

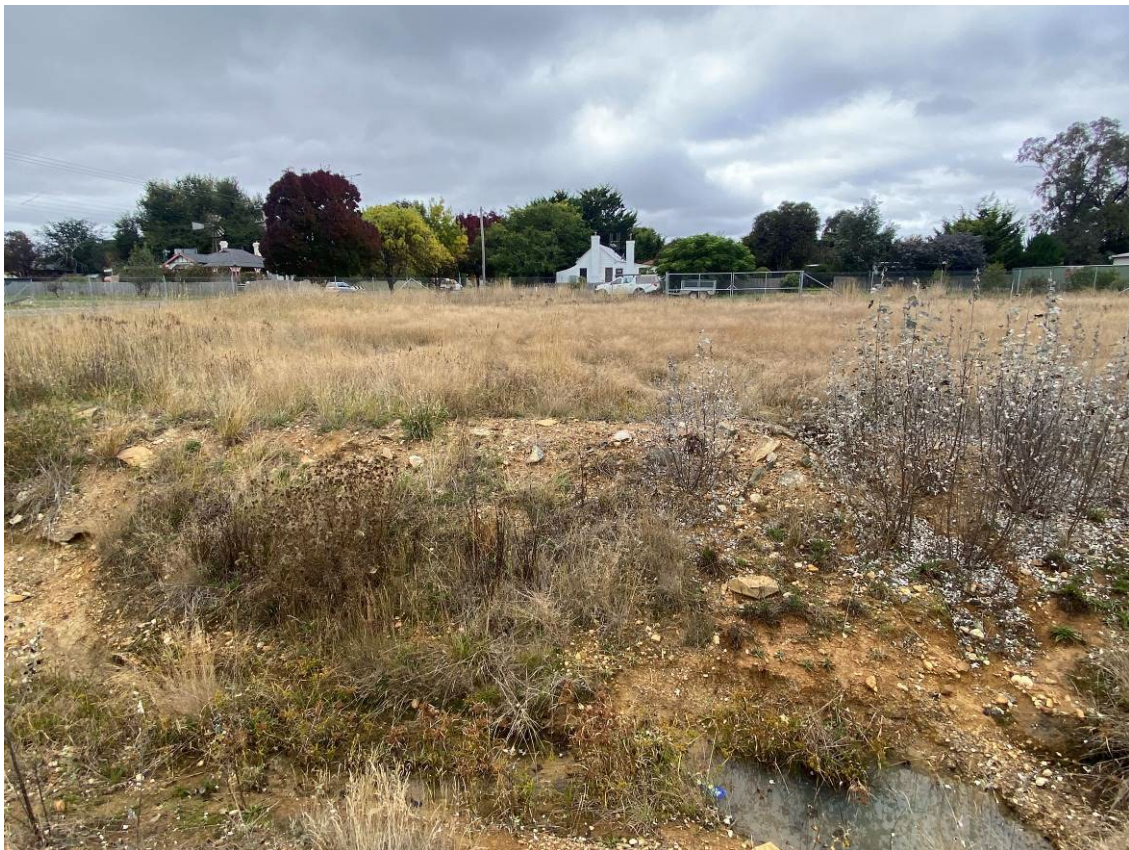
Photo 9: Evidence of erosion upgradient of train line facing east towards Powell Street. Some pooled water on site with sediment however not migrating.

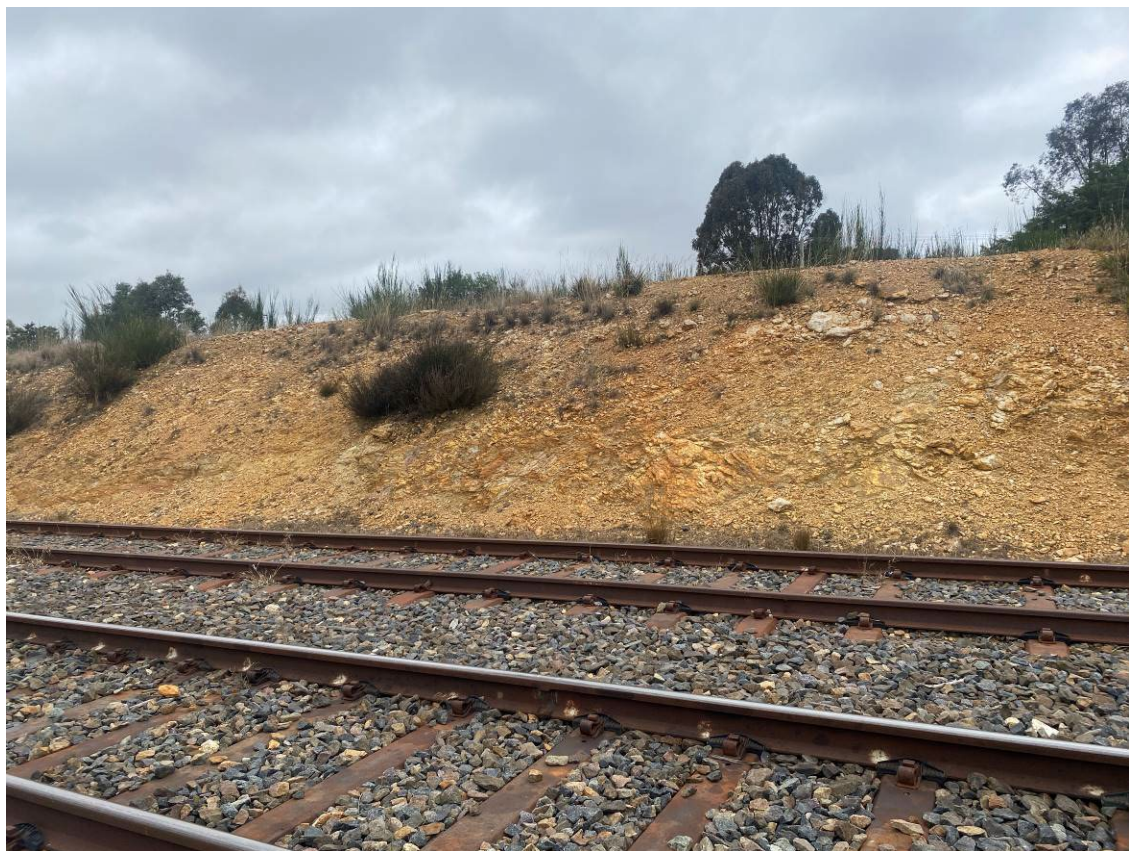
Photo 10: Evidence of erosion upgradient of train line facing east towards Powell Street. And opposite Station Master Cottage.
