Captains Flat EMP Inspection Checklist

| Title: | Captain’s Flat Rail Corridor Inspection | Approved: SM | Project-Nr.: 318001704 | Date: April 2023 |
| Site: | Captains Flat, NSW | | | |
| Client: UGL Regional Linx | | | | |

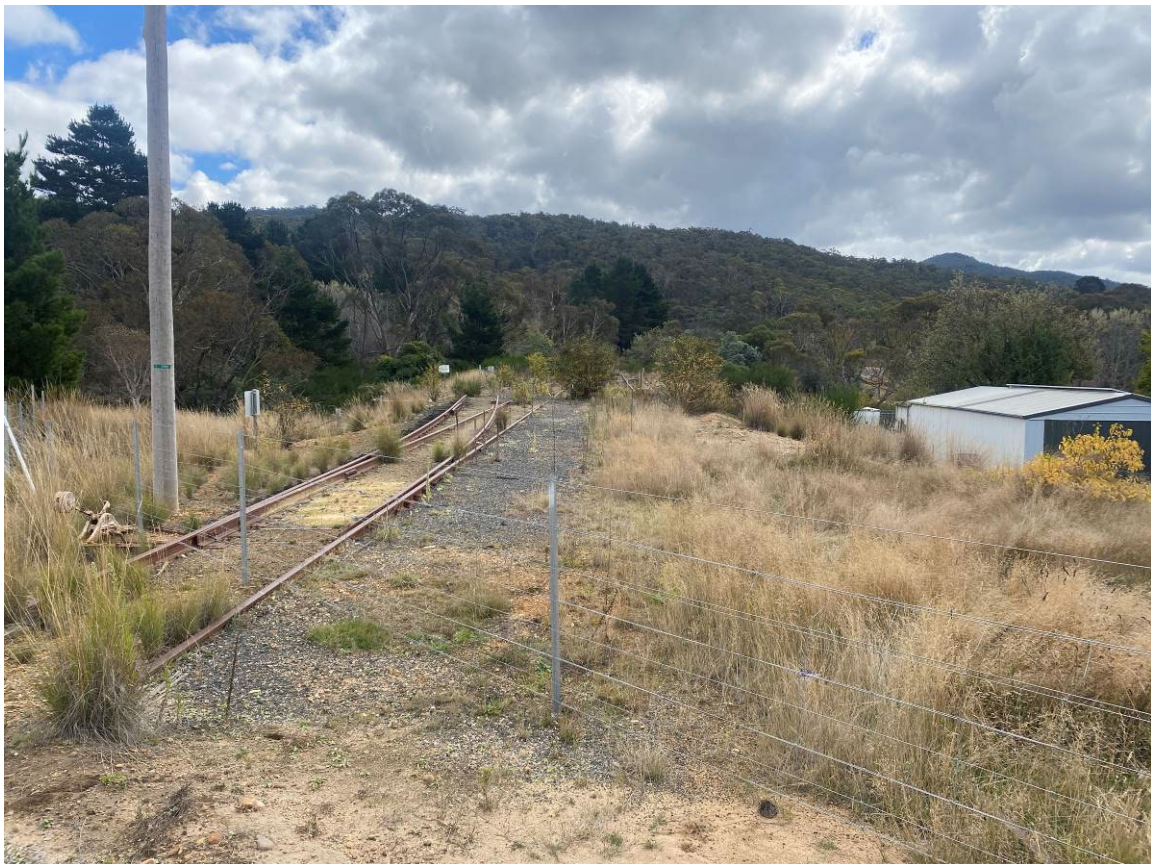
| Captains Flat EMP Inspection Checklist | | | | | |
|--|--|---|---|---|---|
| NA | Is airborne dust from site evident? | | No | No airborne dust was visible (Photo 1 - 2) | |

Photo 1: Trainlines behind fence facing north west. Station Masters Cottage on left of photo. No airborne dust was visible on site.

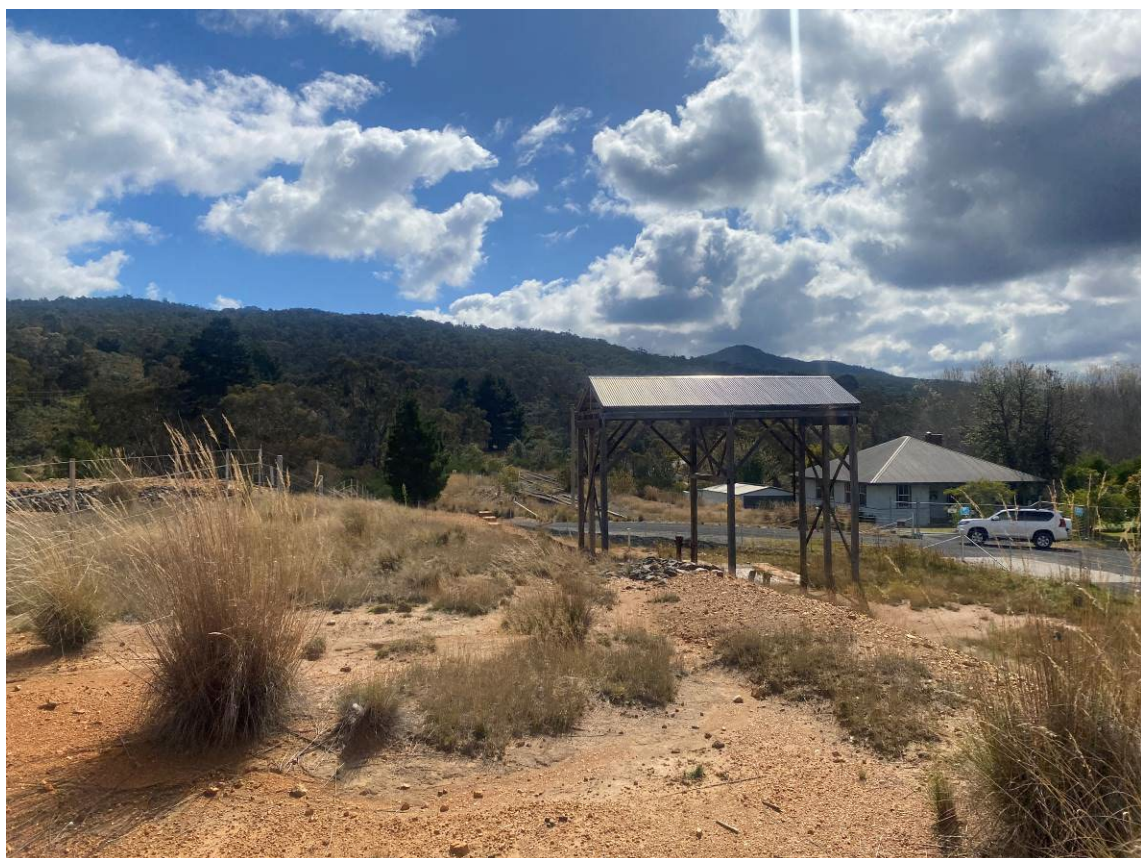
Photo 2: Former Loadout Facility and Weigh Bridge. No airborne dust was visible on site.

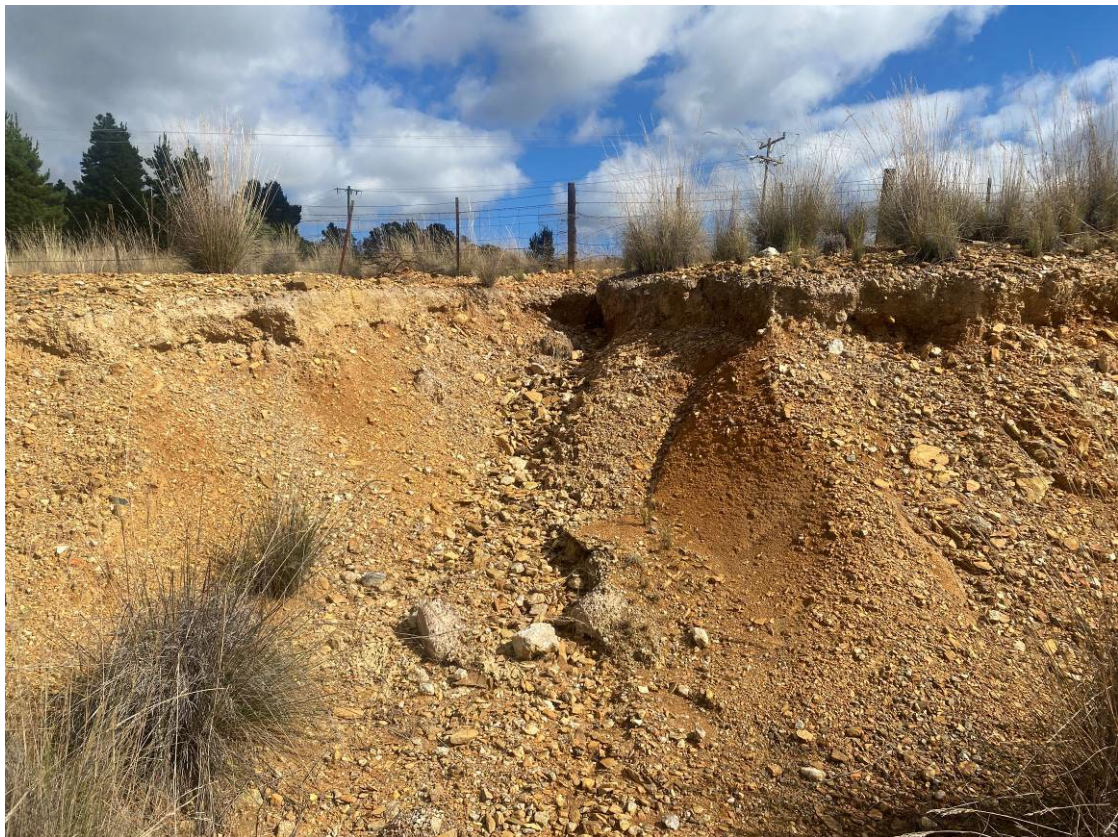
| Captains Flat EMP Inspection Checklist | | | | | |
|--|--|---|---|---|---|
| | Is sediment run-off evident? | | No | Evidence of erosion in some areas (Photos 3 - 4), but this is unlikely to mobilise contaminated sediment which would present a risk to the receiving environment. | |

Photo 3: Evidence of erosion of soils on site. No evidence of current surface water runoff into Coppers Creek.

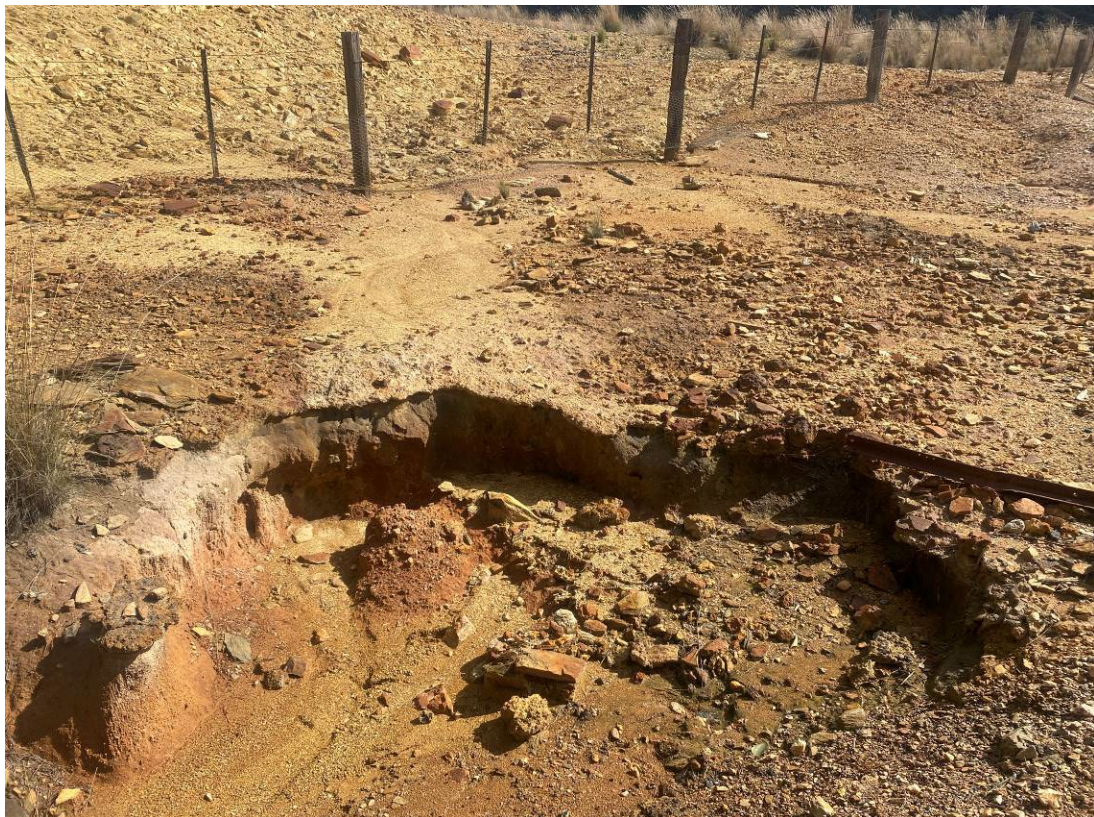
Photo 4: Evidence of erosion of soils on site. No evidence of current surface water runoff into Coppers Creek.

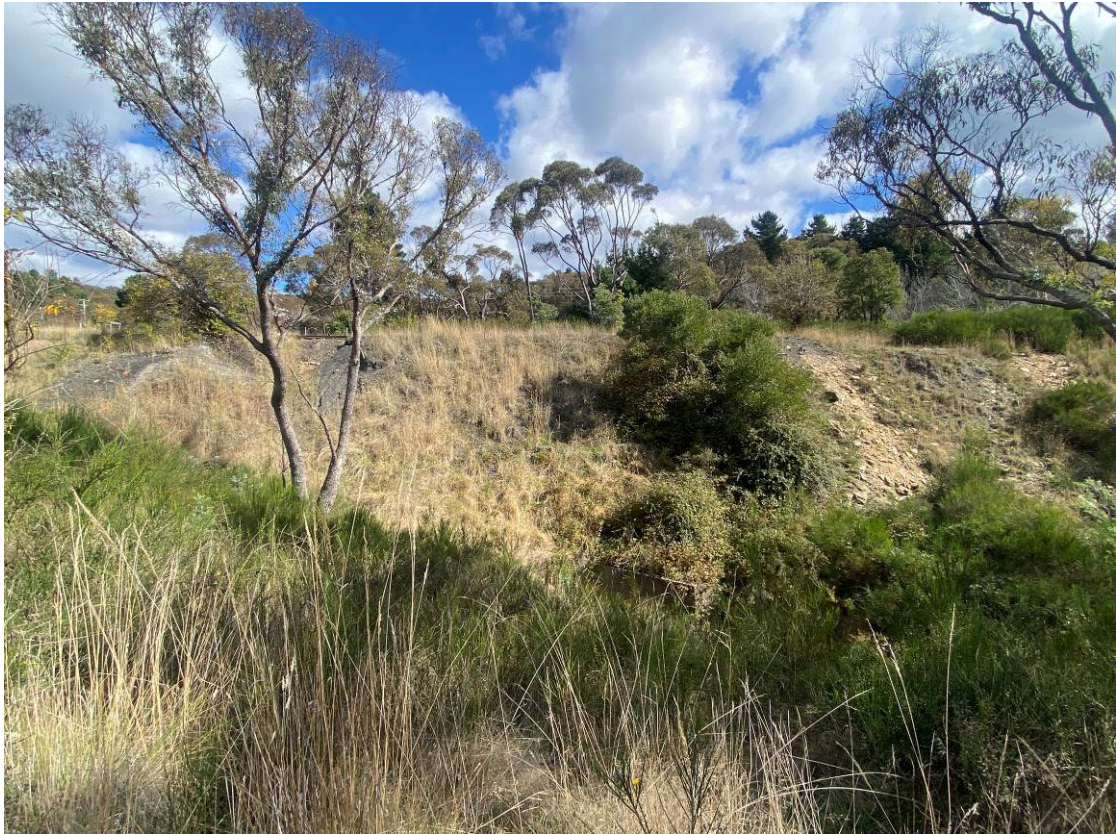
| Captains Flat EMP Inspection Checklist | | | | | |
|--|--|---|---|---|---|
| | Is surface water discharging from site? | | No | No surface water was running off site into Coppers Creek (Photo 5), and no surface water on site contributing to a small unnamed creek which flows through the south east corner of site (Photo 6). | |

Photo 5: Photo taken from Miners Road near Captains Flat Road intersection showing southern boundary of site. No evidence of current surface water runoff into Coppers Creek.

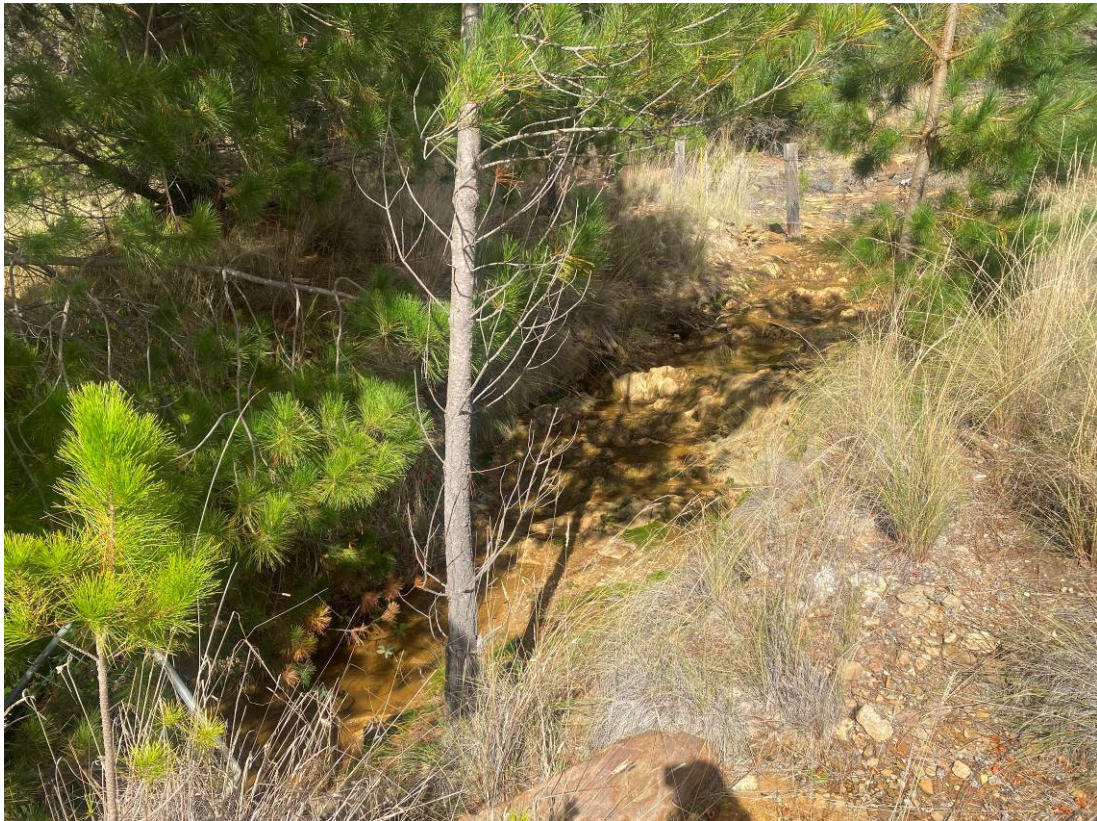
Photo 6: Small unnamed Creek flowing very slowly through south east of site. No additional surface water from site contributing and no evidence of sediment run off from site.

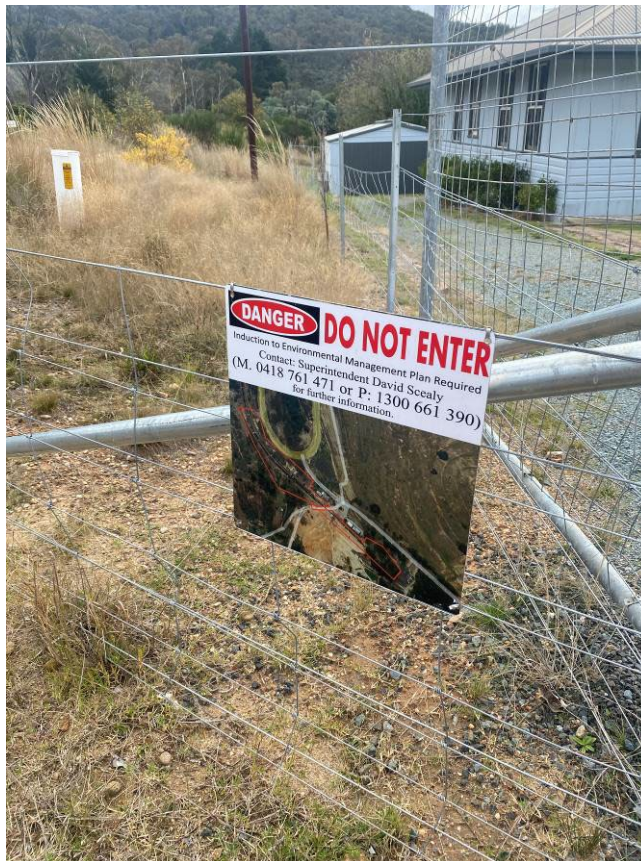
| Captains Flat EMP Inspection Checklist | | | | | |
|--|--|---|---|---|---|
| 3.3 | Is signage in place adjacent the Copper Creek Road crossing and at other readily accessible areas? | Yes | | Multiple signposts along fences where site is accessible from the roadside (Photos 7 - 8). | |
| | Is fencing in place to prevent access via the Coppers Creek Road crossing? | Yes | | Fencing is placed to restrict access to site from Coppers Creek Road crossing (Photo 7). | |
| | Exclusion Zone fencing and signage undamaged? | Yes | | All fencing and signage was in good condition (Photos 7 - 8). | |

Photo 7: Exclusion zone signage placed periodically along contamination areas which are adjacent to Coppers Creek Road. Fencing in place to demark site.

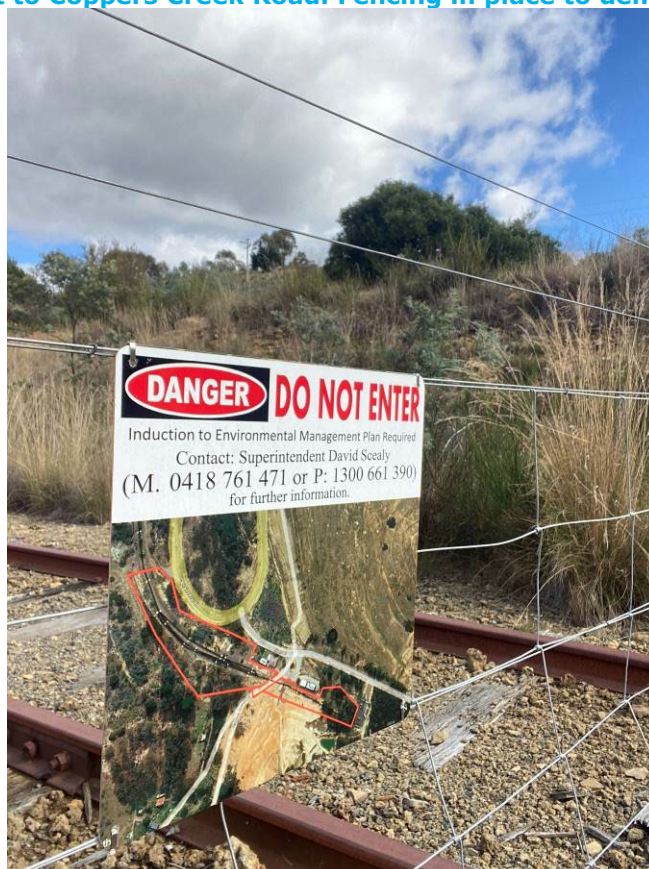
Photo 8: Exclusion zone signage placed at north east boundary of the site with appropriate fencing.

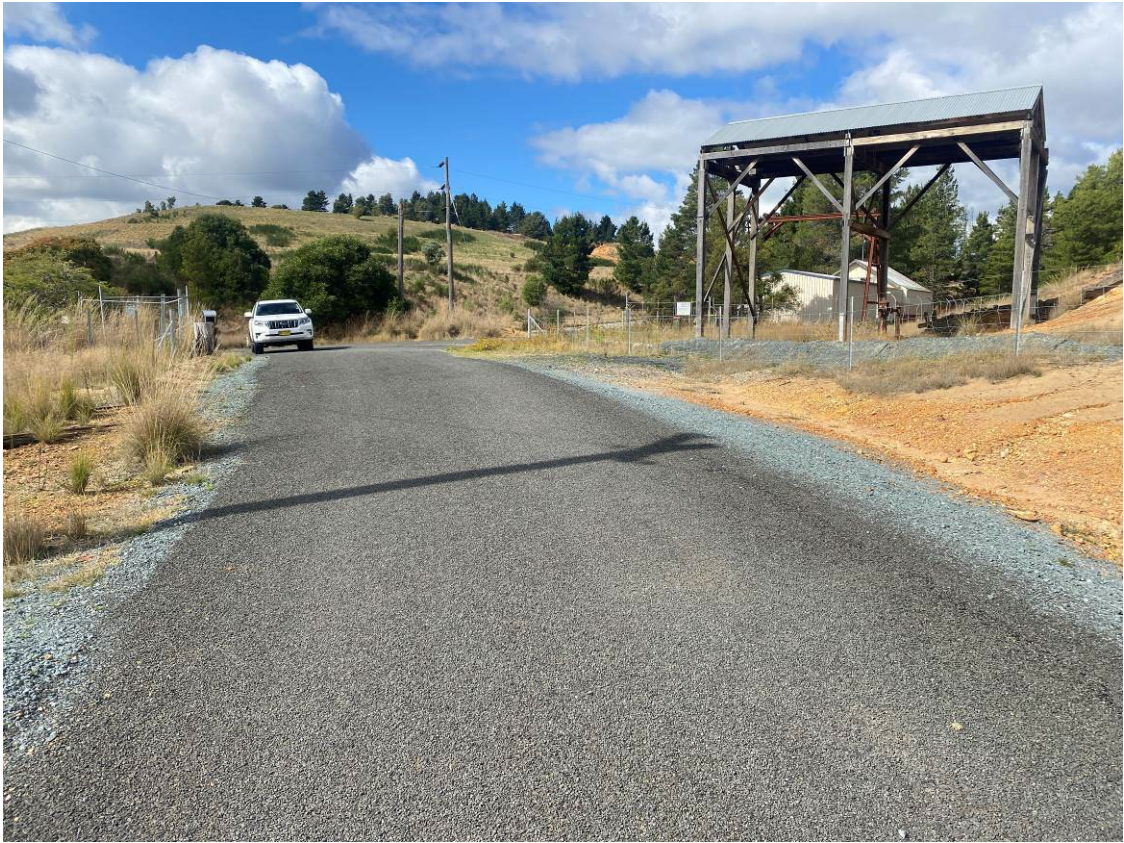
| Captains Flat EMP Inspection Checklist | | | | | |
|--|--|---|---|---|---|
| | Is capping over Coppers Creek Road preventing inadvertent access to site materials? | Yes | | Copper Creek Road Crossing is a tarred road preventing access to soil underneath (Photo 9). | |

Photo 9: Tarred road over Copper Creek Road crossing, preventing inadvertent access to site materials underneath.

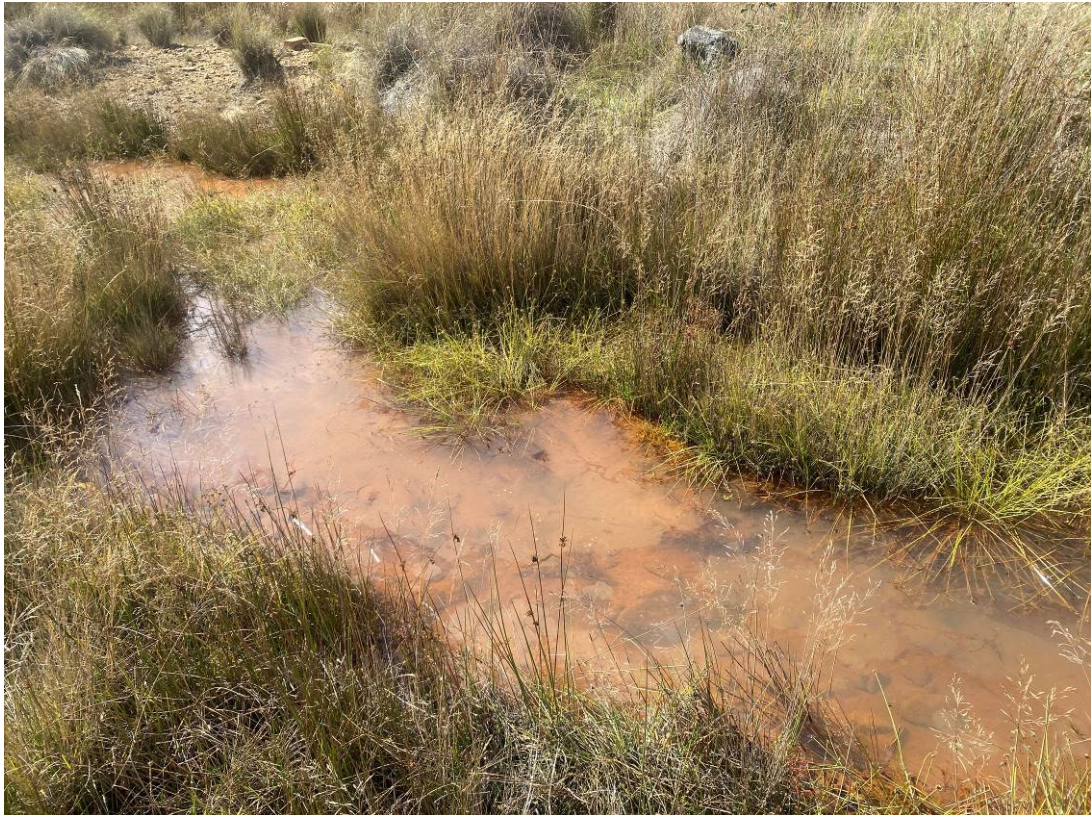
An unnamed tributary off site and down gradient from Captains Flat State Emergency Service shows cloudy surface water with minor sediment present. This is not expected to be mobilised contaminated sediment from site (**Photo 10**).

Photo 10: Unnamed tributary off site and down gradient from Captains Flat State Emergency Service, showing cloudy surface water with minor sediment. This is not expected to be mobilised contaminated sediment from site.

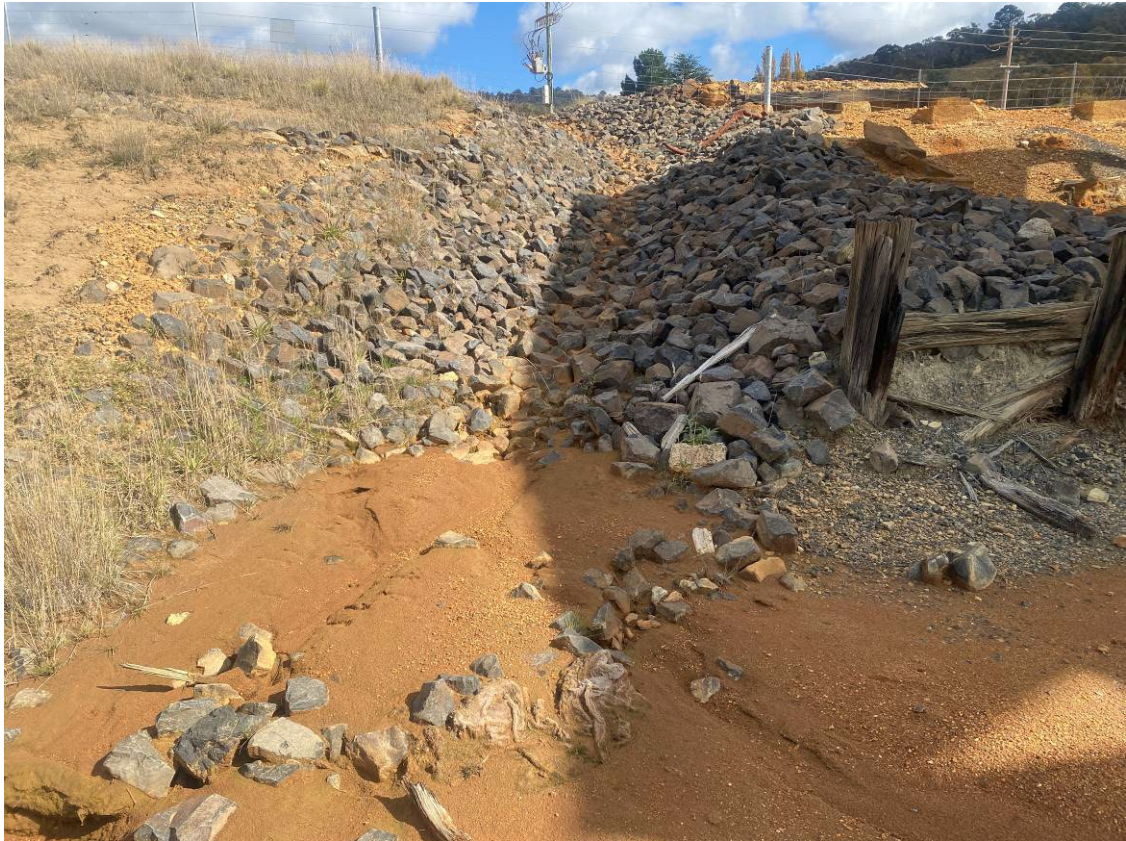
Some sediment trapped in rocks on site from upgradient of site. Source of sediment appears to be upgradient of site and not expected to be mobilised contaminated sediment from site (**Photo 11**).

Photo 11: Some sediment trapped in rocks on site from upgradient of site. Source of sediment appears to be upgradient of site and not expected to be mobilised contaminated sediment from site.
