# Sydney Ferry Fleet Engineering Assessment

Transport for NSW (TfNSW)

**Report No.:** 2023-9359, Rev. 2

**Date:** 2023-06-09

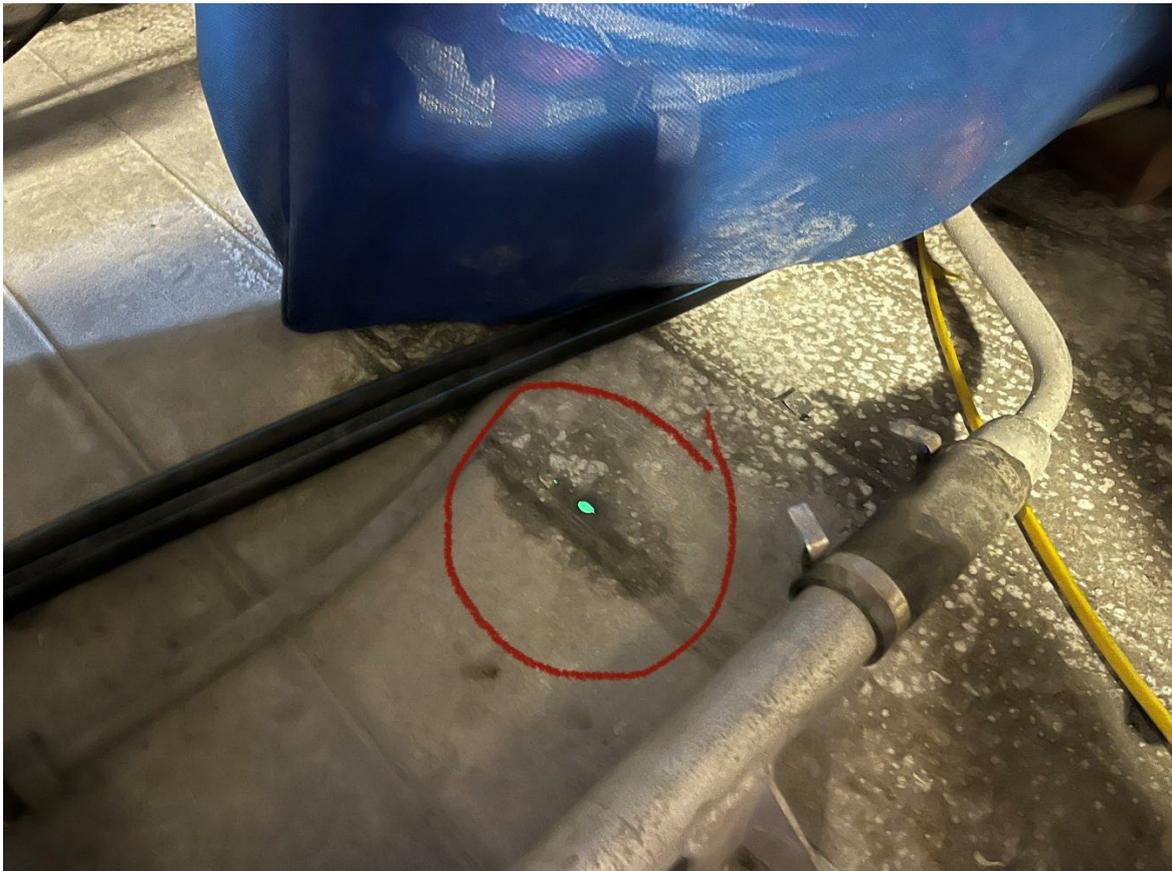
If these are not addressed the residual or design life of the vessel may be affected. This is not considering any regulatory compliance issues that this defect may present.

**Photo 11.1** – Pits (circled) which has corroded through the main deck of *Marlene Matthews*. Note the build-up salt in the vicinity.

- Rectify pitting corrosion on the main deck (below the wheelhouse) on RiverCat *Marlene Matthews*.
- Upgrade the interior fit-out onboard *Alexander* to be in line with the other First Fleet vessels.

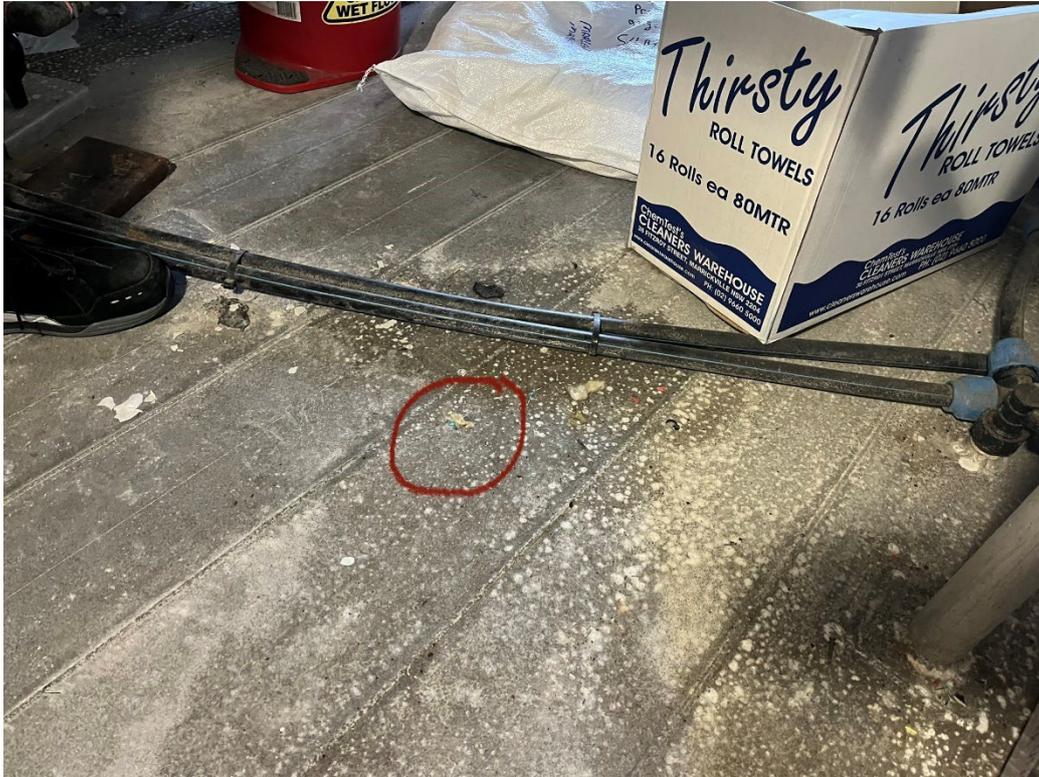
**Photo 11.2** – Pits (circled) which has corroded through the main deck of *Marlene Matthews*. Note the build-up salt in the vicinity.

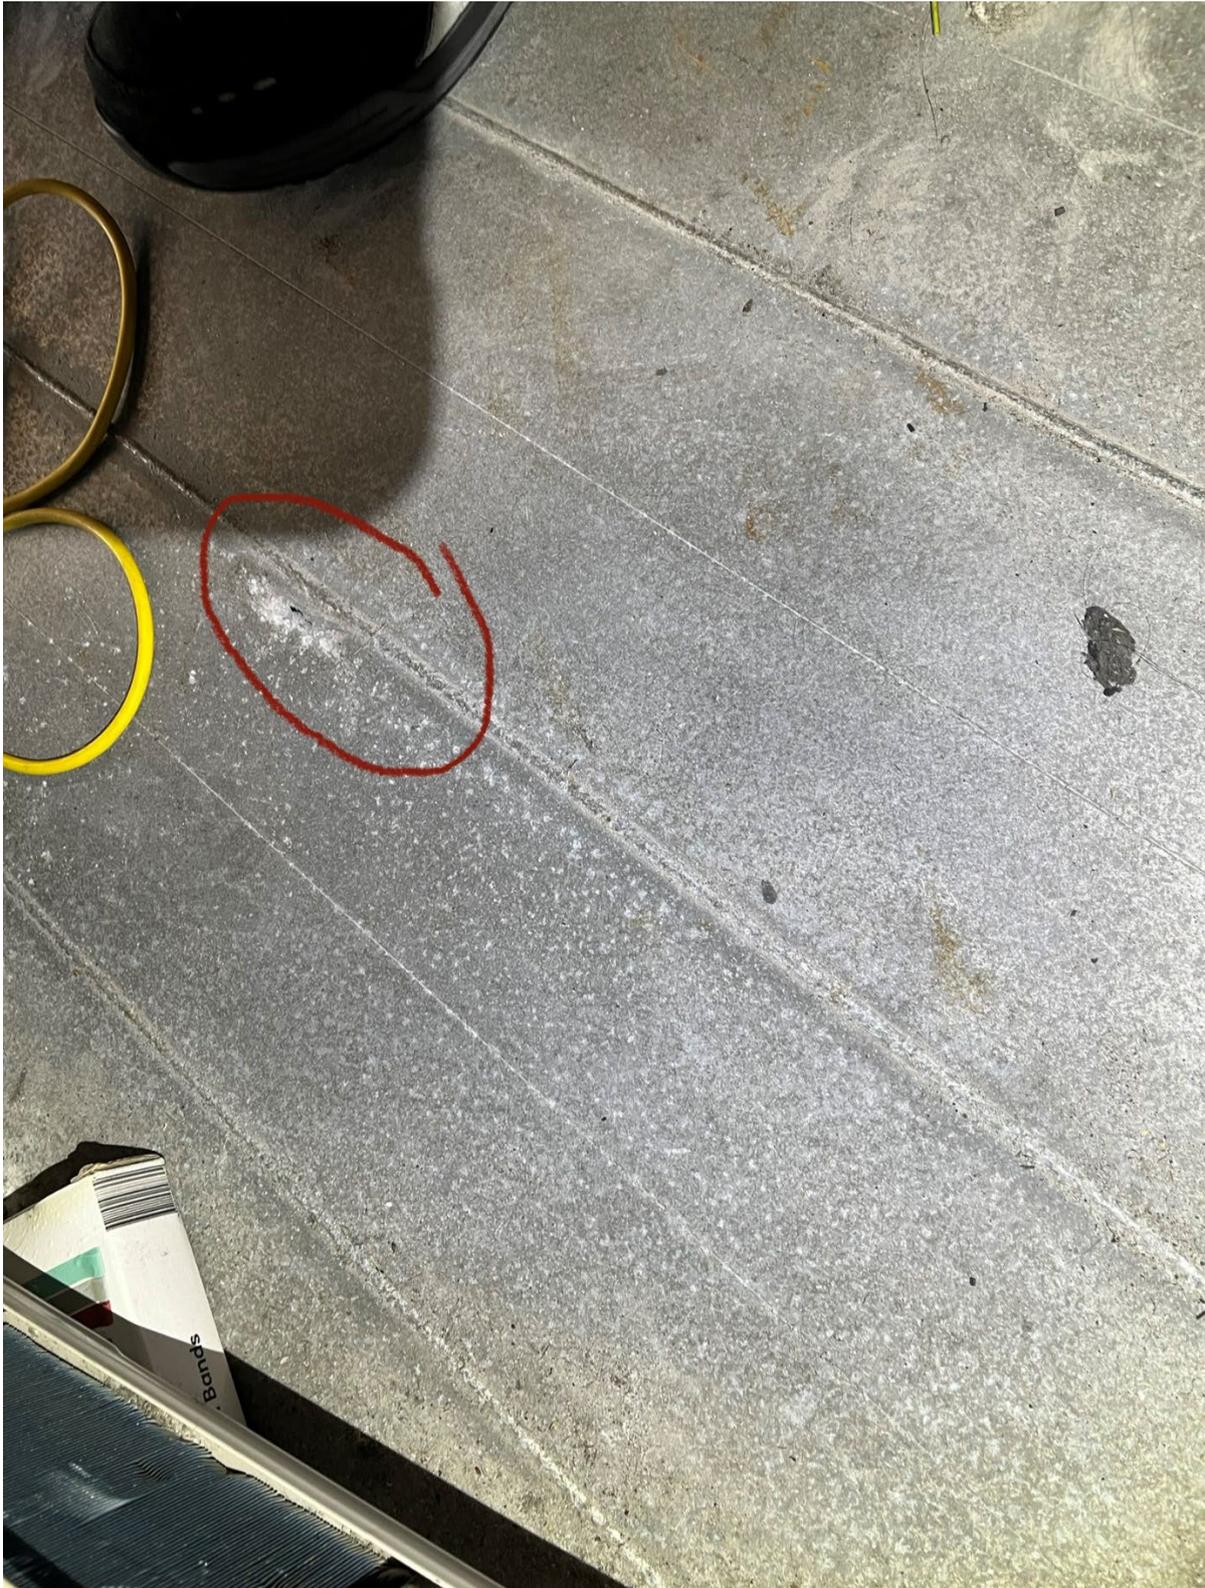
**Photo 11.3** – Pits (circled) which has corroded through the main deck of *Marlene Matthews* and has caused a crack-like defect in the plate

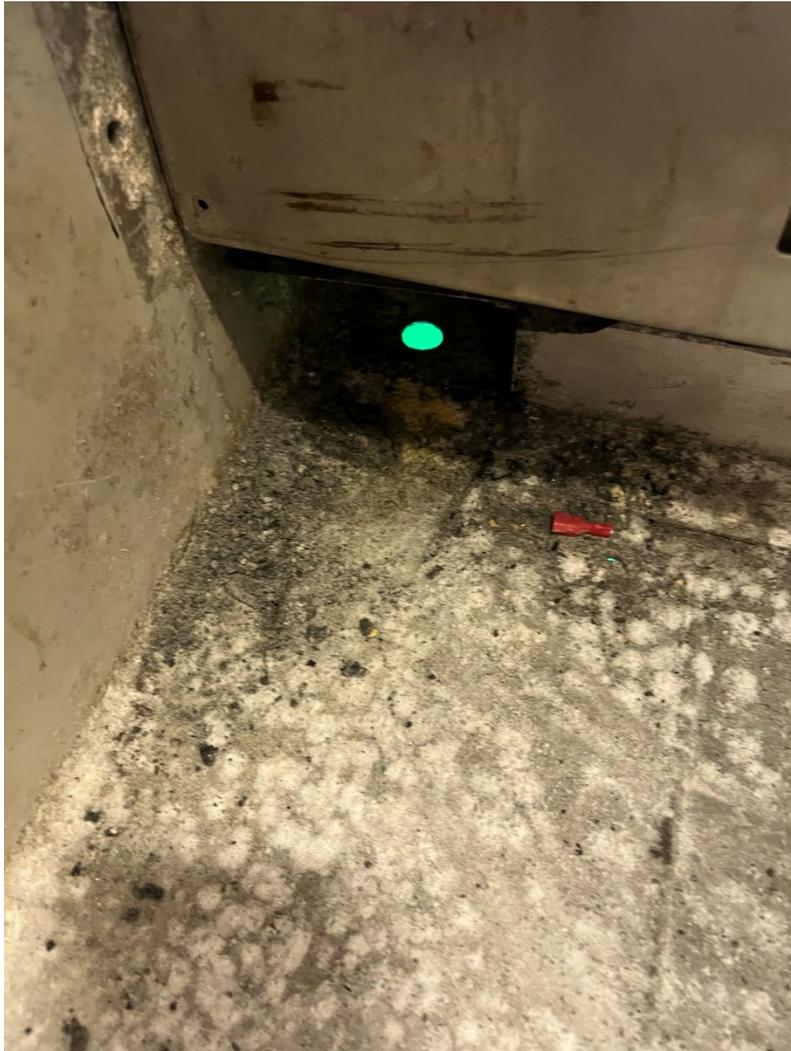
**Photo 11.4** – Pit which has corroded through the main deck of *Marlene Matthews*. Note the build-up salt in the vicinity.

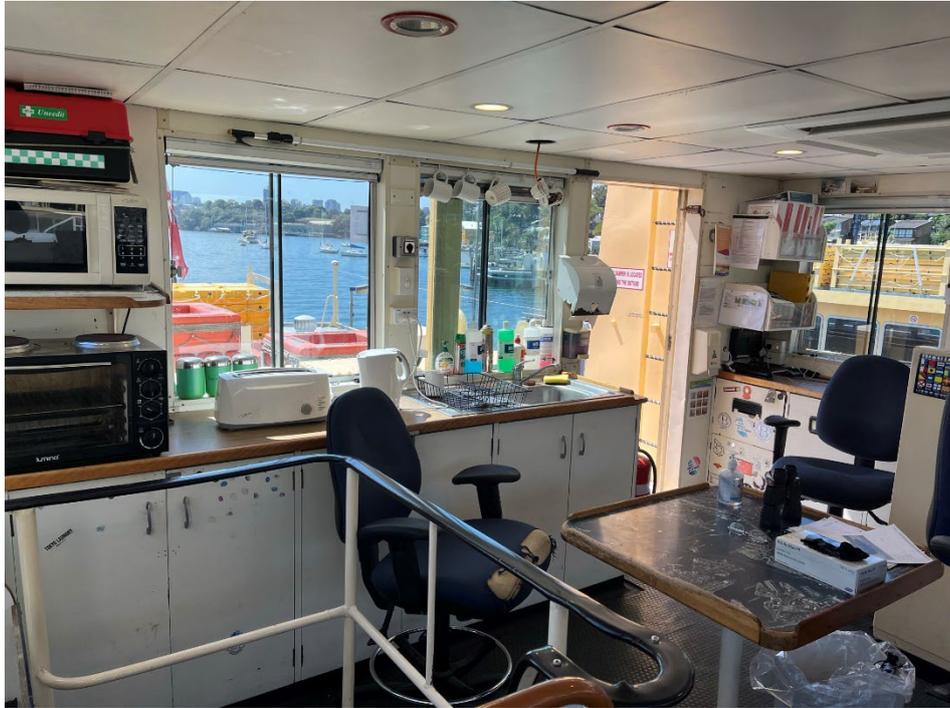
Photo 11.5 – Condition of bridge fit-out

It is recommended that the interior fit-out onboard *Alexander* is upgraded to be in line with the other First Fleet vessels.

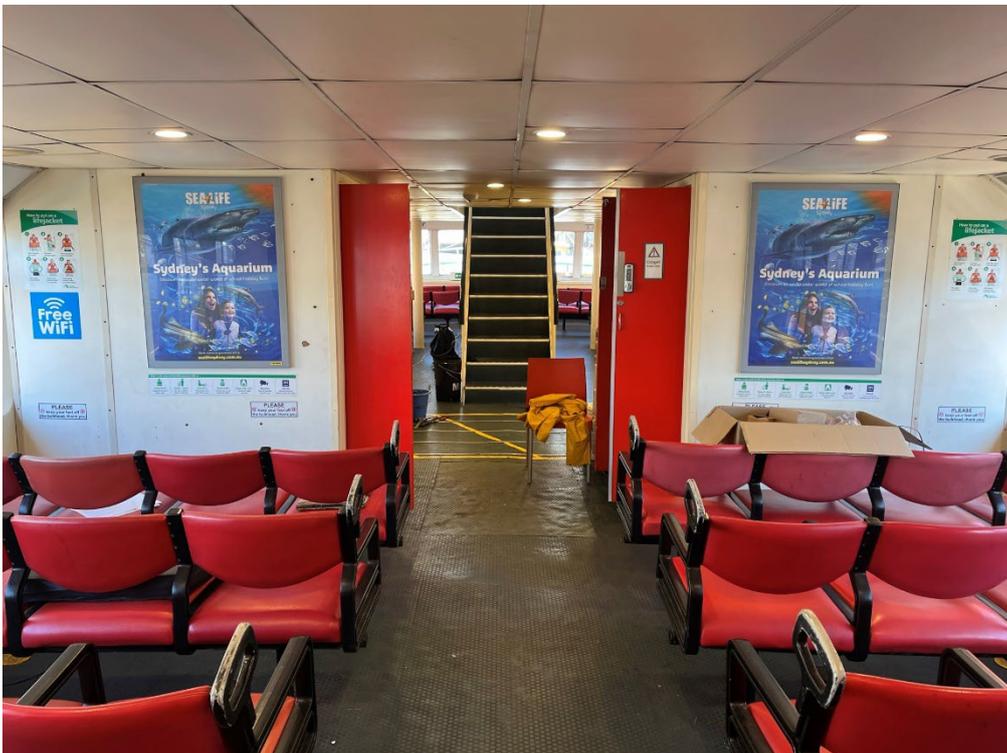
Photo 11.6 – Condition of passenger area fit-out

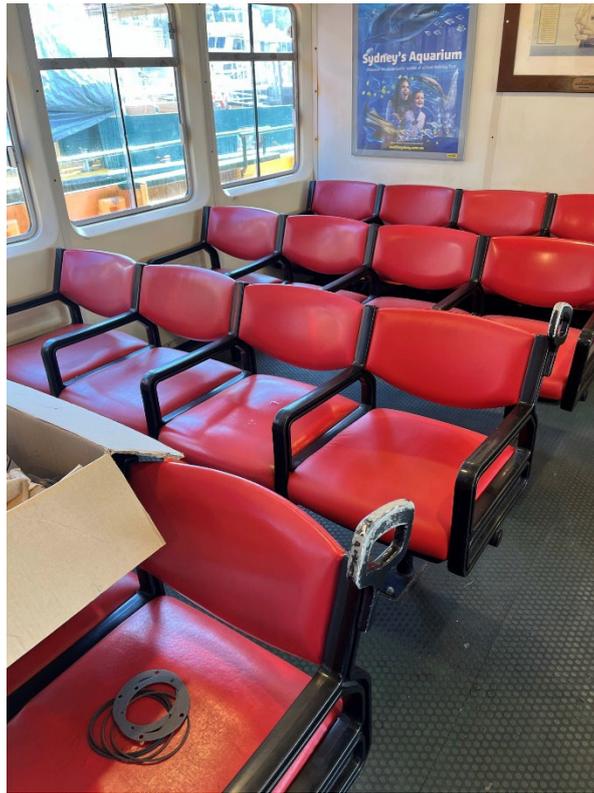
**Photo 11.7** – Condition of passenger area fit-out

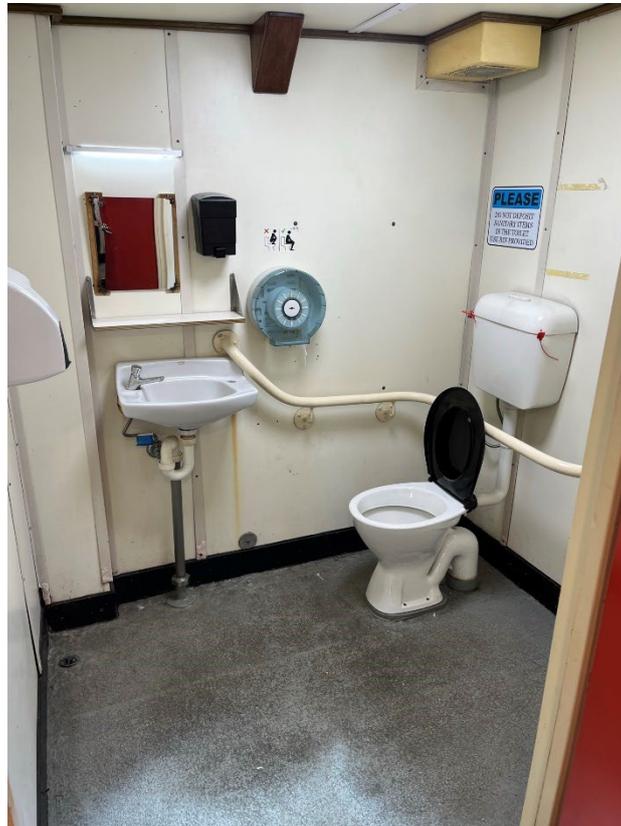
**Photo 11.8** – Condition of passenger toilet fit-out
