Tarago Action Plan Routine Inspection Checklist

Title: Tarago Rail Yard Inspection	Approved: SM	Project-Nr.: 318001704	Date: March 2023
Site: Tarago, NSW			
Client: UGL Regional Linx

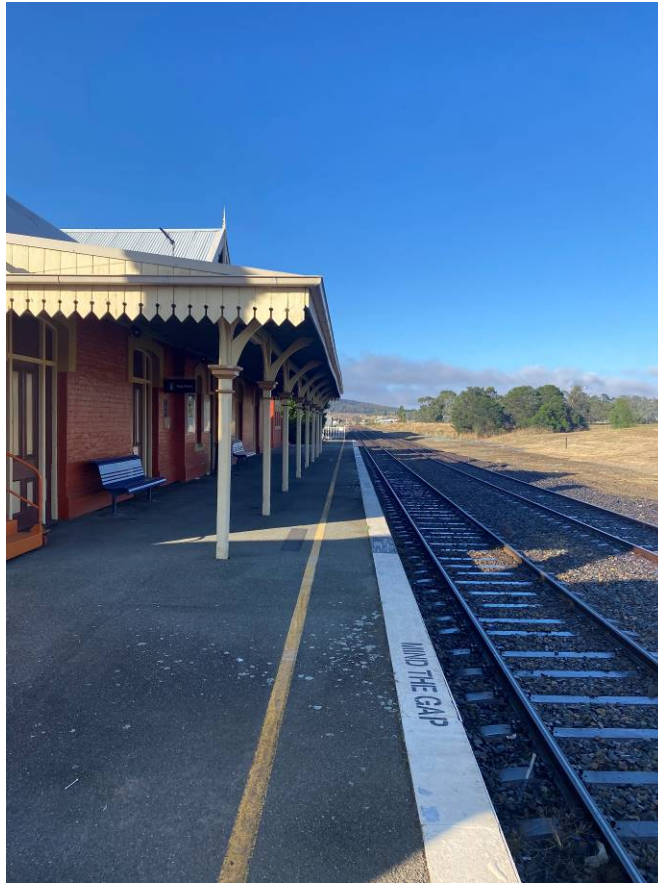
Photo 1: Picture of railway station facing south west. No airborne dust visible in air or on surfaces.

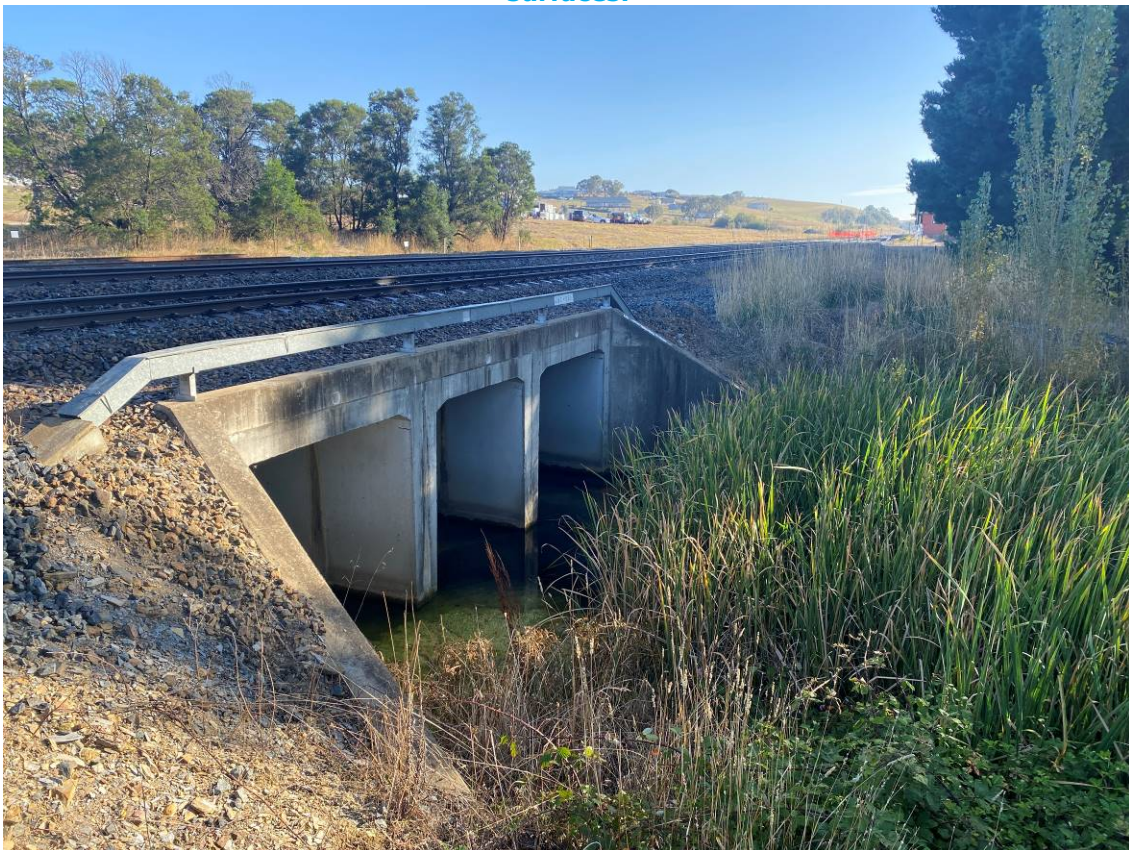
Photo 2: Immediately downgradient of southernmost culvert showing pooled water, not flowing off site. High reeds and vegetation adding natural filters for sediment.

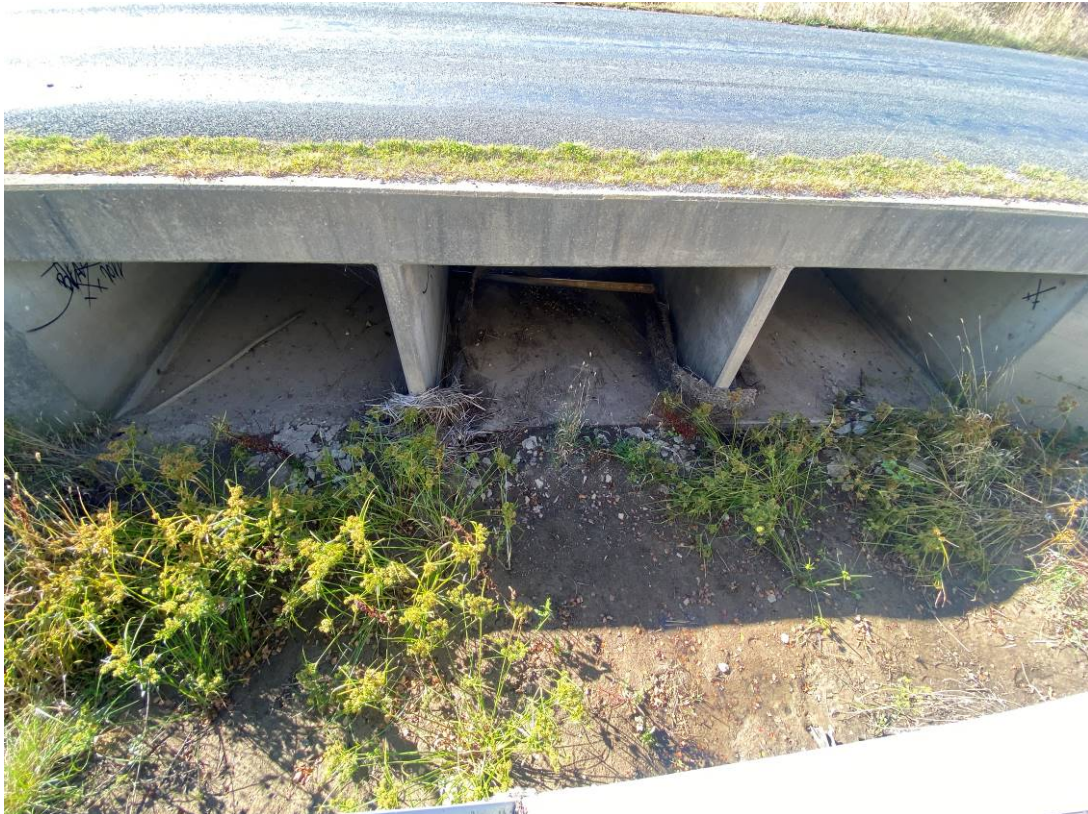
Photo 3: Culvert under Golburn street, downgradient of southernmost culvert on site, showing no evidence of surface water run off on site and no evidence of sediment from previous surface water on site.

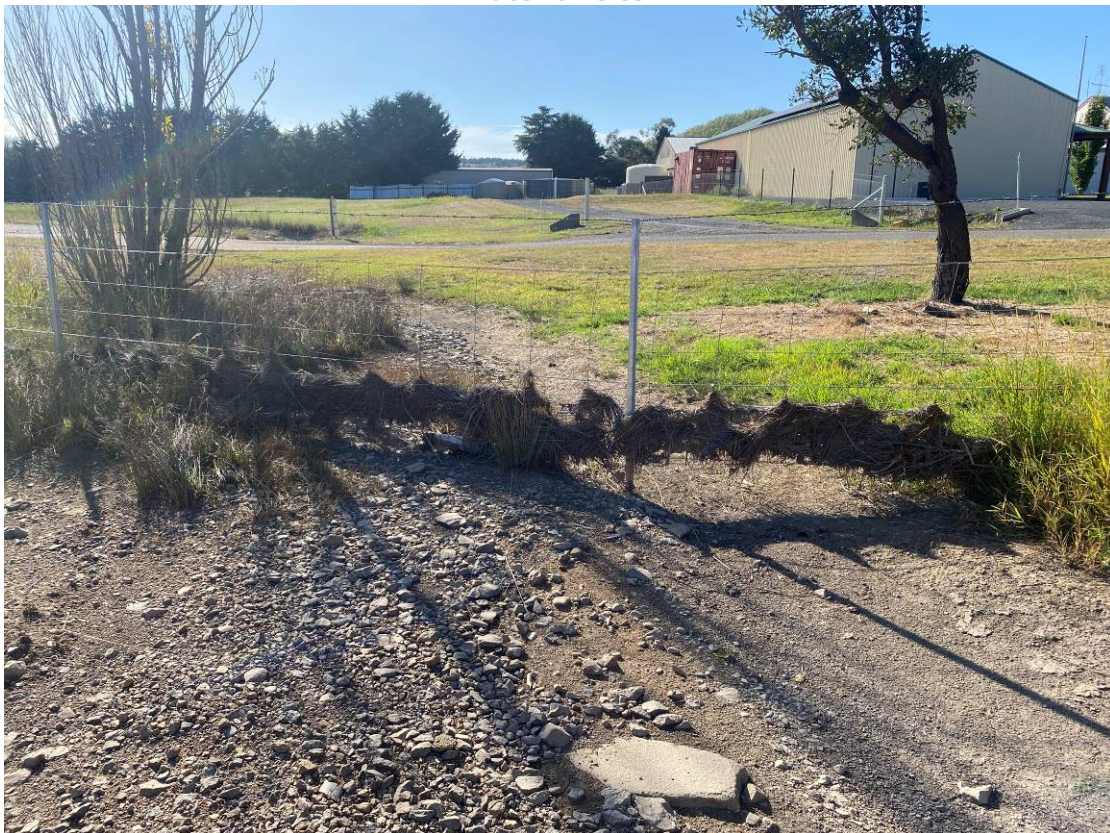
Photo 4: Downgradient of middle culvert showing no evidence of surface water run off on site and no evidence of sediment from previous surface water on site.

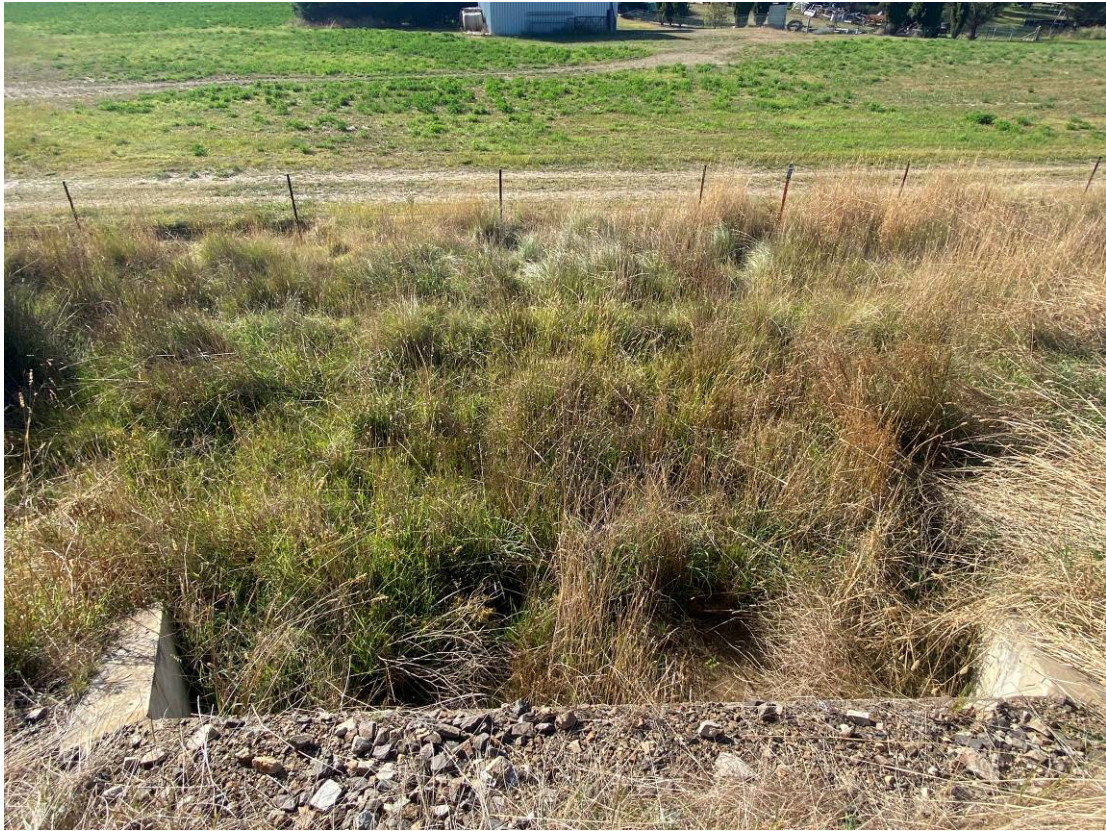
Photo 5: Downgradient of northernmost culvert showing no evidence of surface water run off on site and no evidence of sediment from previous surface water on site.

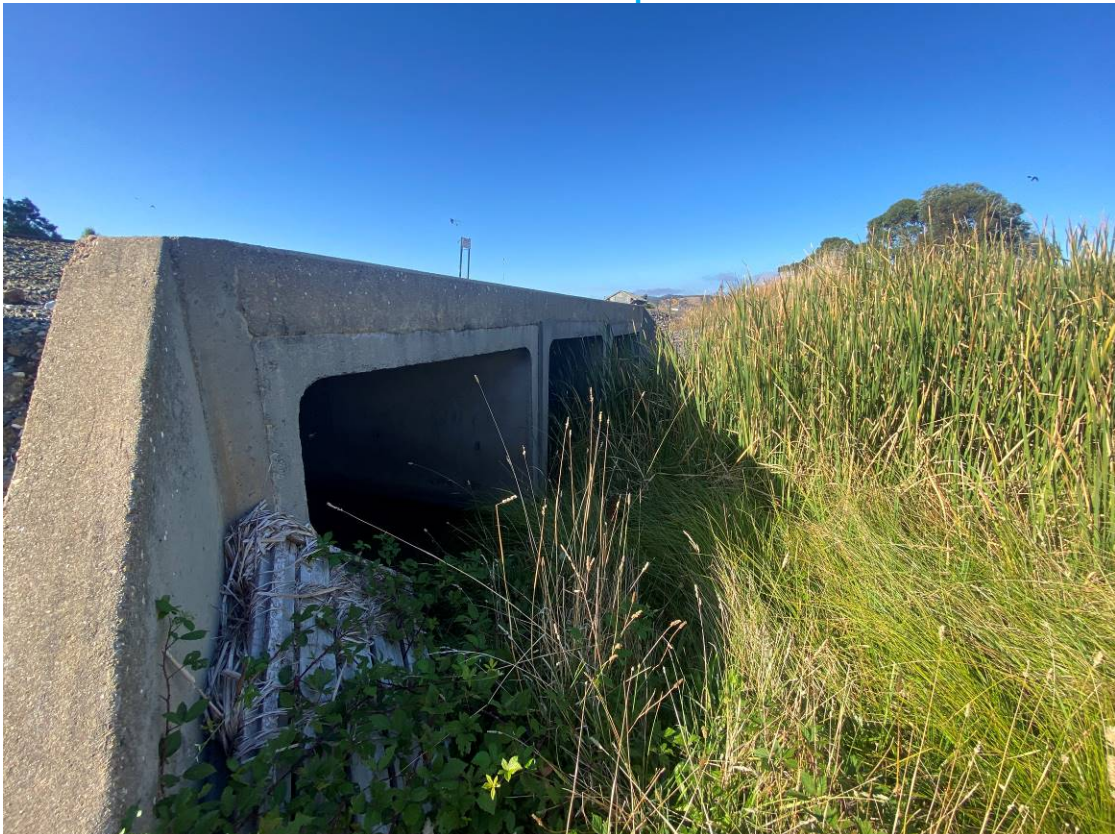
Photo 6: Upgradient of southernmost culvert showing no evidence of surface water run off on site and no evidence of sediment from previous surface water on site.

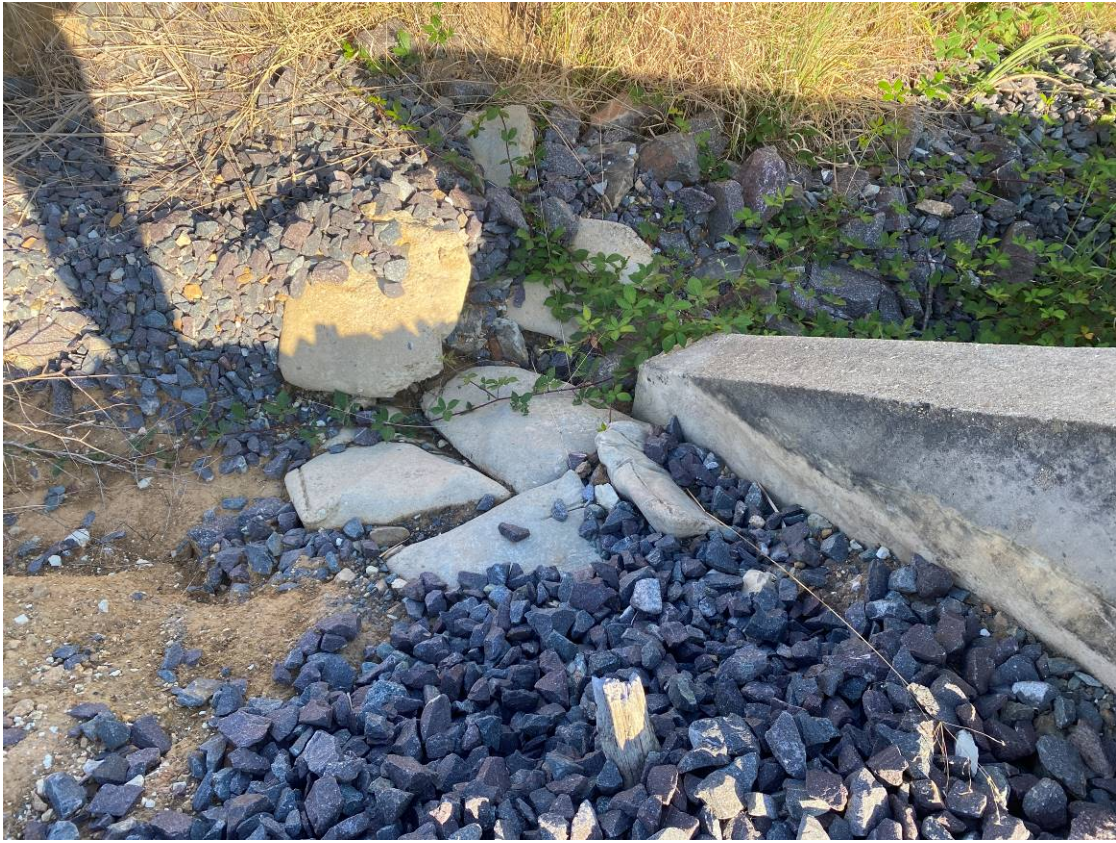
Photo 7: Upgradient of southernmost culvert showing rock armour used as control measures for sediment control.

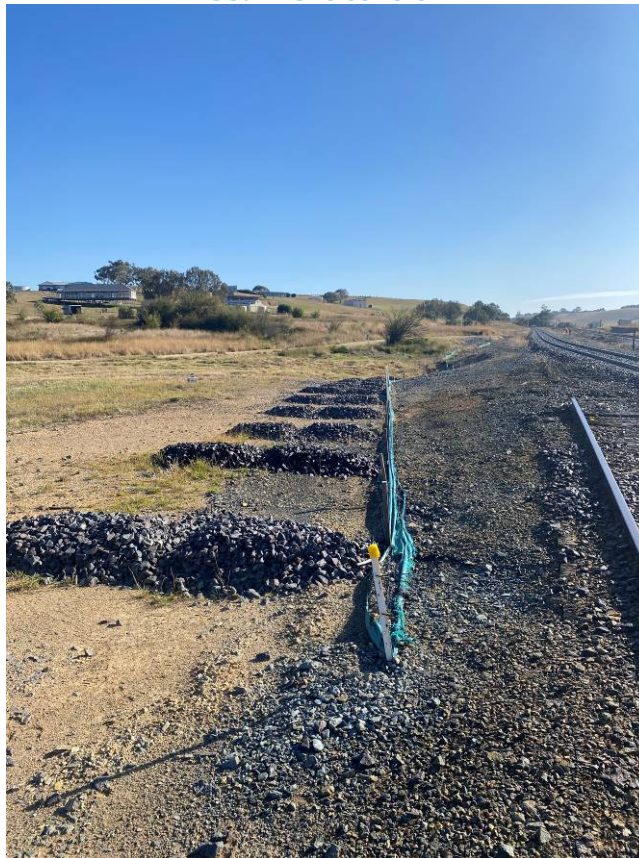
Photo 8: Rock checks and silt fences running alongside former Woodlawn siding towards the middle culvert. No sediment build up on rock checks or fencing.

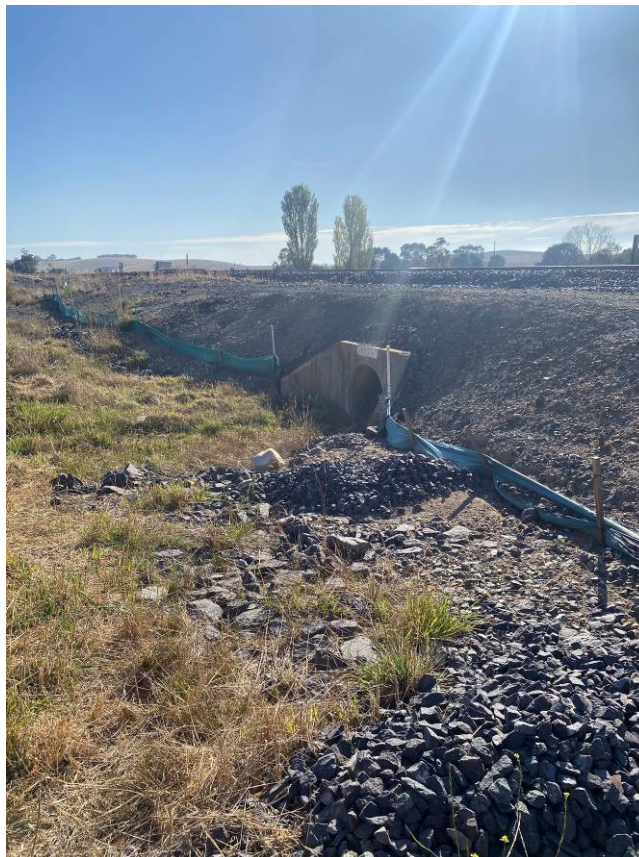
Photo 9: Upgradient of middle culvert, showing sediment control measures of rock checks and silt fencing.

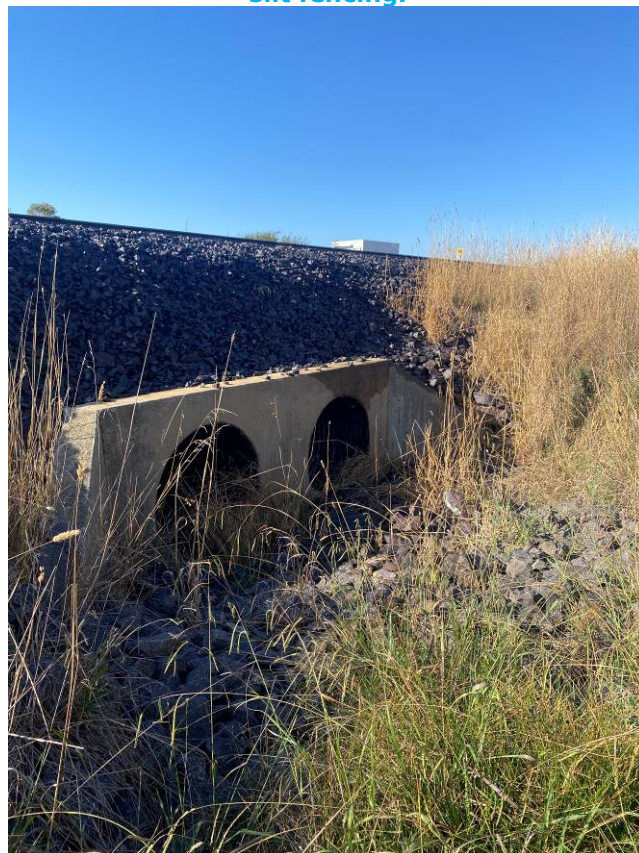
Photo 10: Upgradient of northernmost culvert, showing sediment control measures of rock armour.

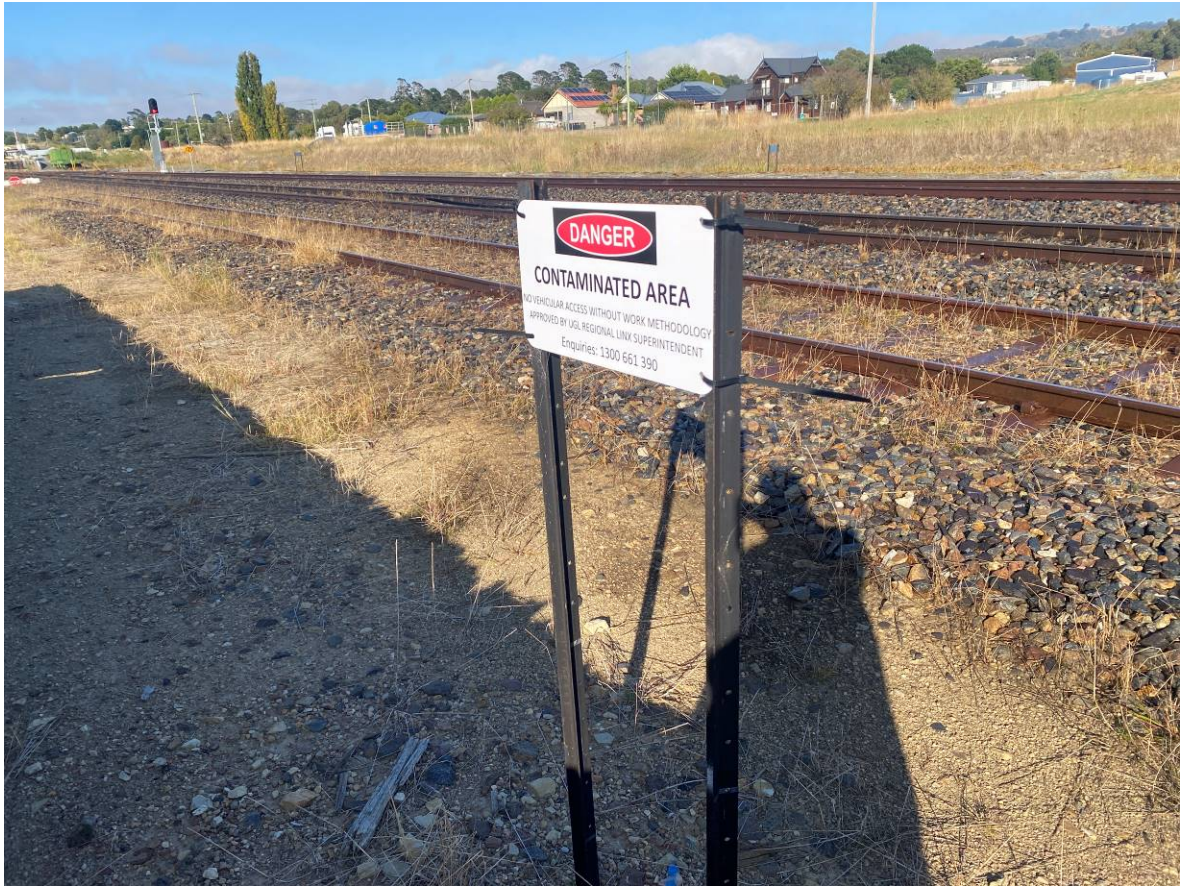
Photo 11: Exclusion zone signing placed periodically along contamination areas. Reverse side of more signing can be seen on opposite side of railway track.

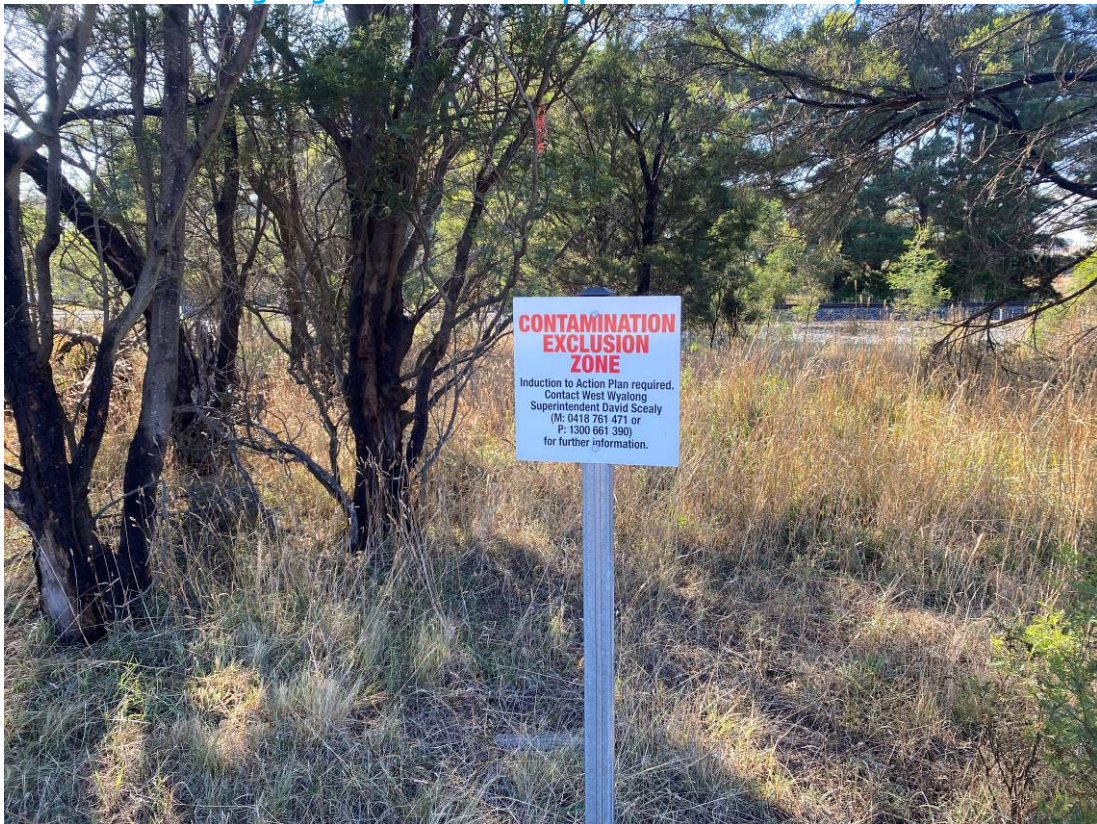
Photo 12: Additional exclusion zone signing placed periodically along contamination areas.

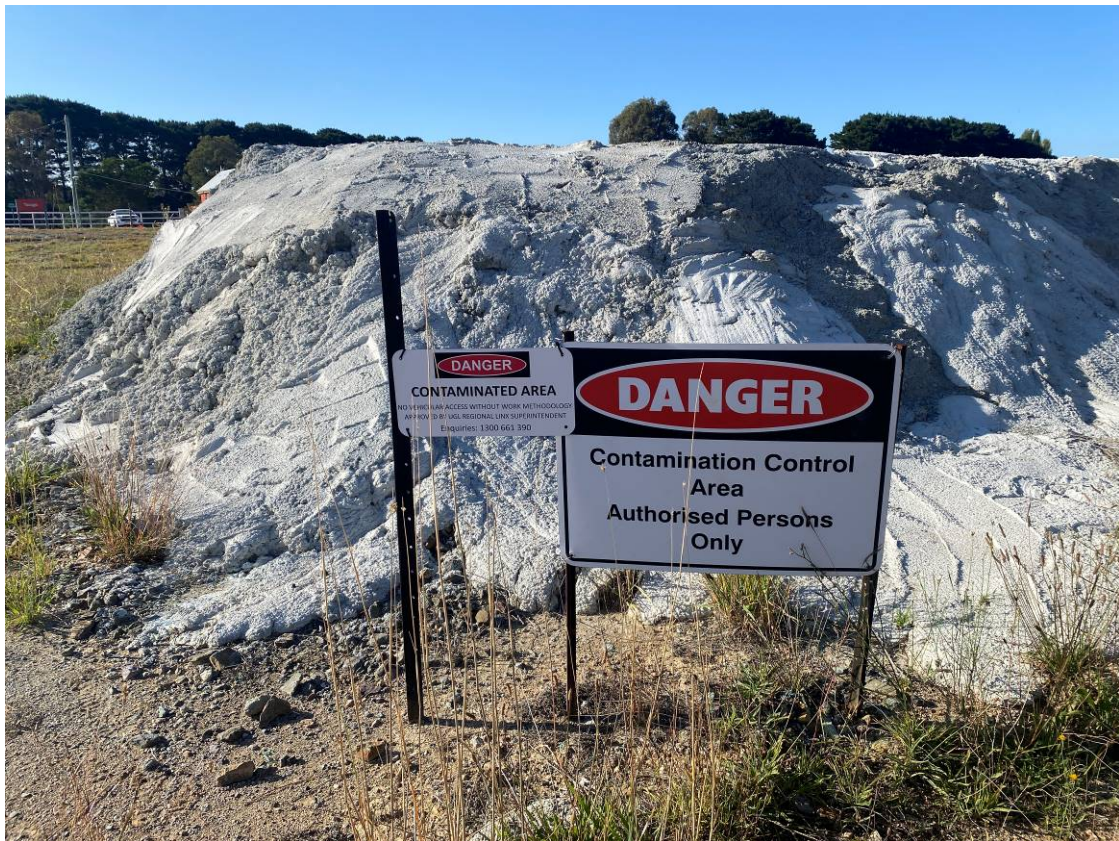
Photo 13: Additional Exclusion zone signing demarcating the capped stockpile of contaminated material.

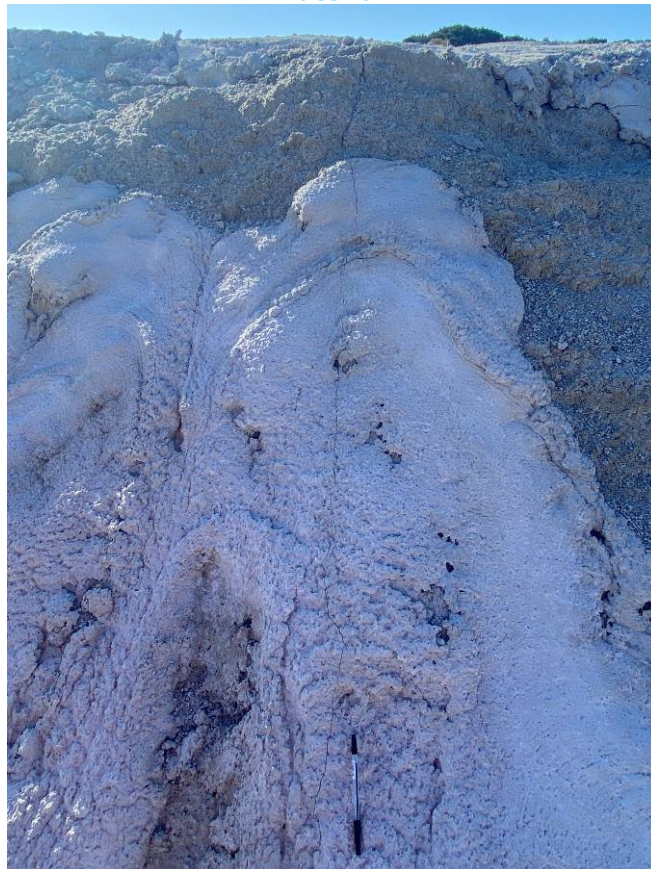
s	Control	Inspection		Corrective Action
		Yes	No	
5.1	Is Exclusion Zone signage present as recommended on Figures 2a - 2e Appendix 1 to demarcate contamination in the rail formation and adjacent soils?	Yes (Photos 11 - 13)		
	Is Exclusion Zone signage undamaged?	Yes, signage was in good condition (Photos 11 - 13)		
	Are sediment controls present in/adjacent each rail culvert?	Yes, rock checks and rock armour observed upgradient of each culvert (Photos 6 - 10), silt fencing west of former woodlawn siding and along cess drain feeding the southern culvert.		
	If sediment is present what is the estimated depth of sediment?	n/a sediment was not present		
	Are sediment controls still functional?	Yes		
	Is the existing stockpile covered securely to prevent surface water infiltration?	Yes		
	Are cracks present in the capping of the existing stockpile? If so record the width and length of cracks in written form and through photographs and consolidate with this checklist.	Yes, minor hairline crack (1-2mm x 2m) is present on the stockpile (observed during an inspection 31/01/2023) remain stable and not does allow for water infiltration (Photo 14)

Photo 14 Hairline cracking in stabilised sand applied to the stockpile for capping. Pen used for sizing reference.

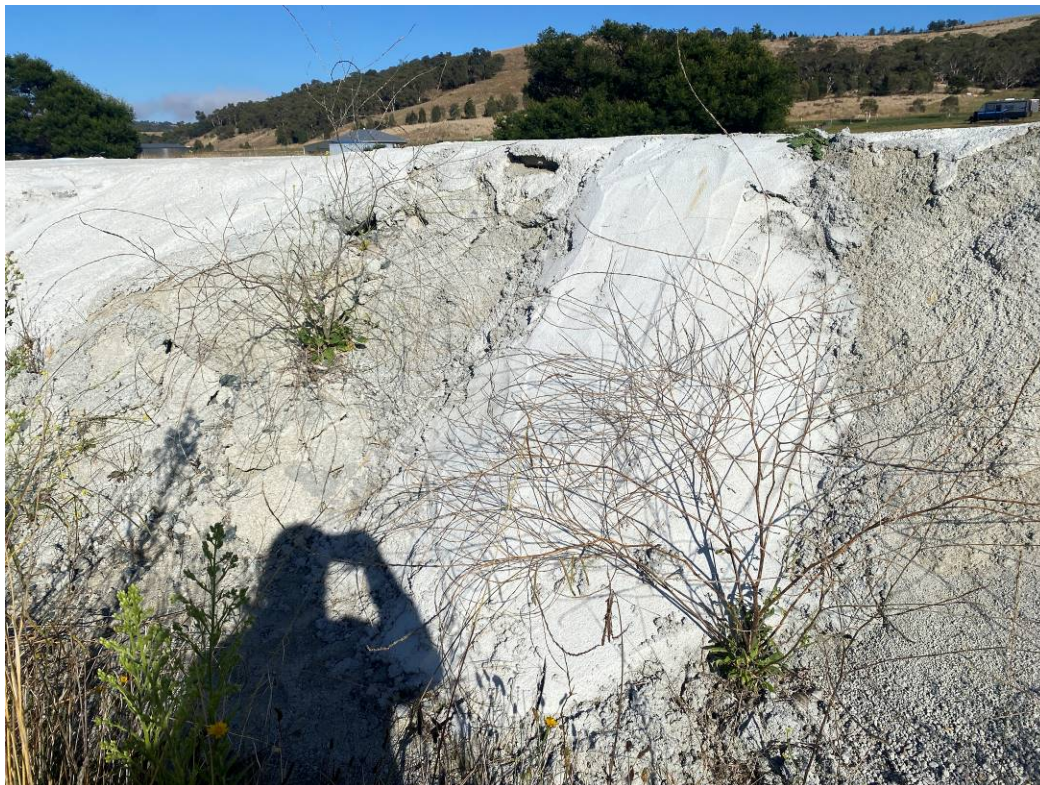
Are there signs of erosion or sediment run-off on or relating to the existing stockpile? If so record in written form and through photographs and consolidate with this checklist.	No, area surrounding the stockpile was clear of sediment		
	Are there signs of vegetation on the existing stockpile? If so record in written form and through photographs and consolidate with this checklist.	Yes, weeds growing out of the side of the stockpile (Photo 15)		
	Is geofabric marker layer visible beneath capping of the existing stockpile? If so record in written form and through photographs and consolidate with this checklist. If marker layer is visible rectification work is required.	No geofabric marker layer visible, however hairline cracking and weeds observed, consider weed removal

Photo 15: Vegetation (weeds) growing out of stockpile capping. No marker layer visible.

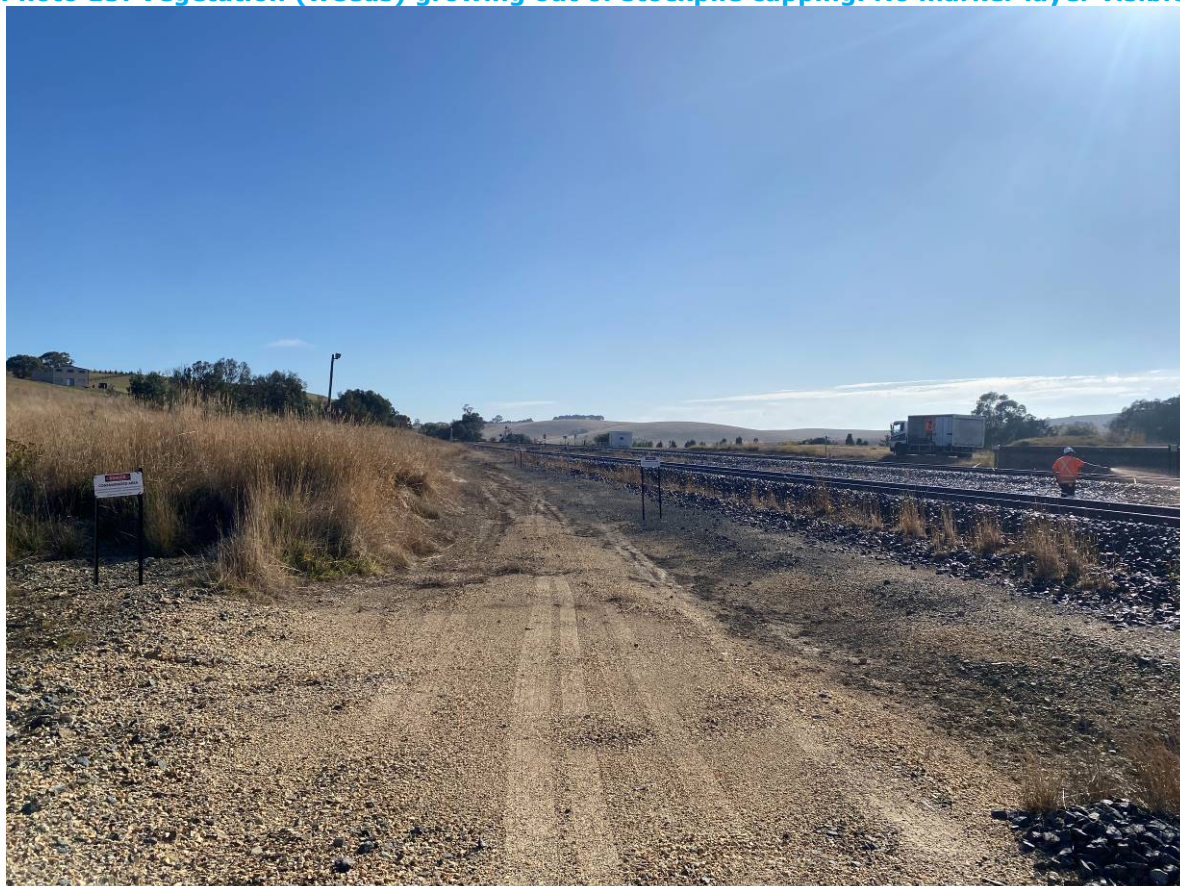
Photo 16: Polymer Sealant application in progress. Sprayed through hose by contractors onto railways and surrounding areas.

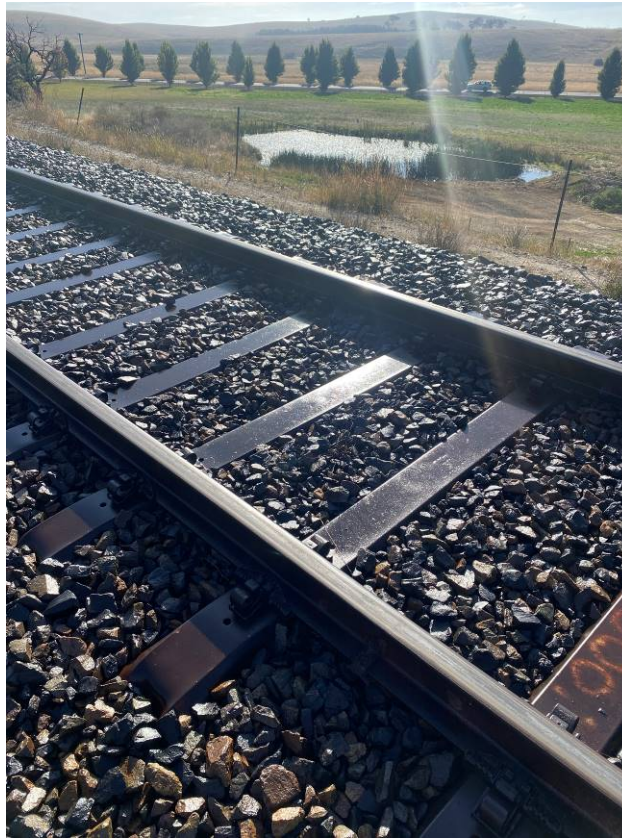
Photo 17: Polymer Sealant application on railway tracks. Translucent layer which oily sheen can be seen on rail sleepers.

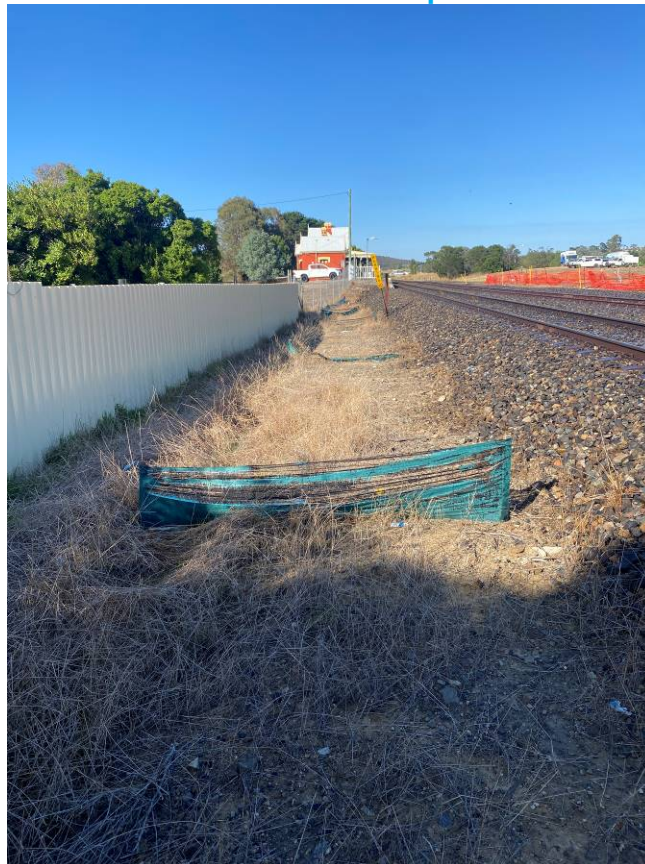
Photo 18: Damaged redundant silt fencing adjacent to the boundary of the Station Masters Cottage. Removal is recommended.

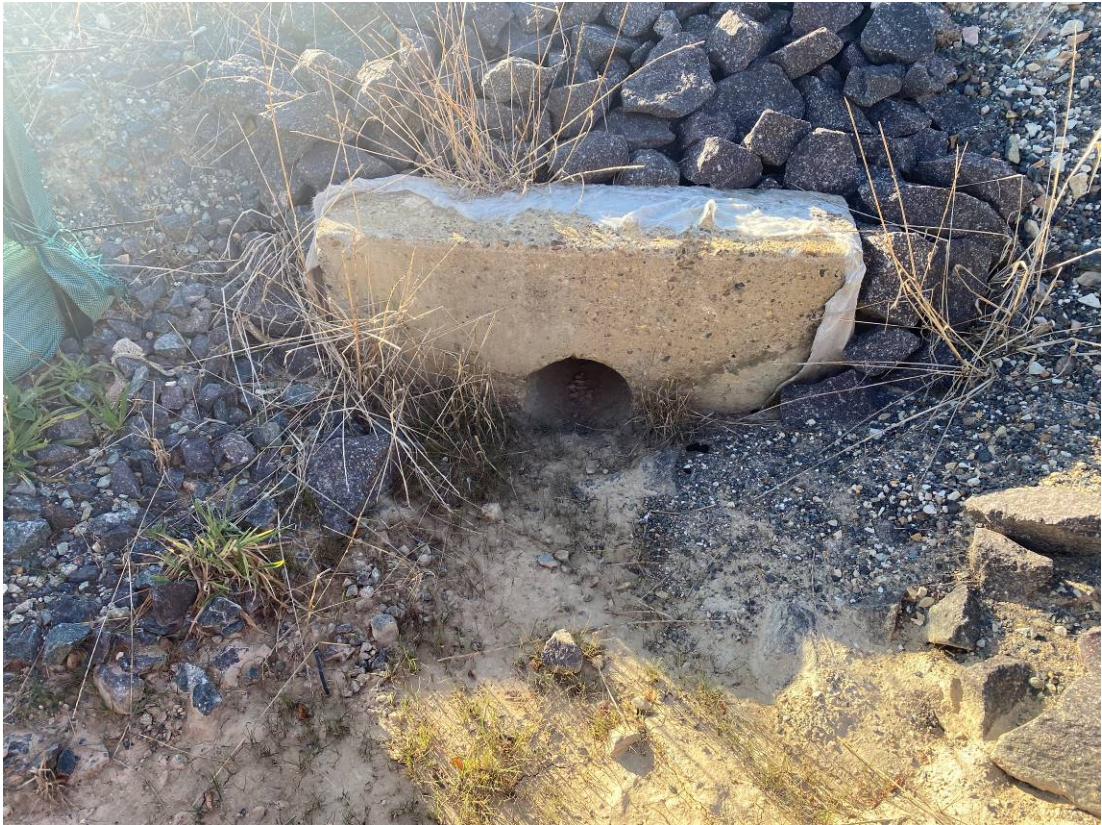
Photo 19: Outlet of drain from centre of railroad tracks showing minor signs of sediment. Water would flow through drain pipe to upgradient of the railway culverts and then through sediment controls in place at the culverts.

No		
Other observations?		
<p>As per suggestions in the Environmental Management Plan, Polymer sealant application was underway during visiting site (Photo 16 - 17).</p> <p>No sediment loading was observable in rock checks and armoury, and all locations were in good condition. Silt fences were all in good condition with the exception of a redundant fencing on the southern boarder of the site next to the Station Masters Cottage (Photo 18). Ramboll recommends this silt fencing could be removed.</p> <p>Drain inlet between the main and loop lines showed slight evidence of sediment build up (Photo 19-20). Although this drain does not directly discharge off site, Ramboll recommends a filter (geofabric or similar) placed over or the drain inlet or silt fencing around the drain inlet would reduce sediment mobility.</p>

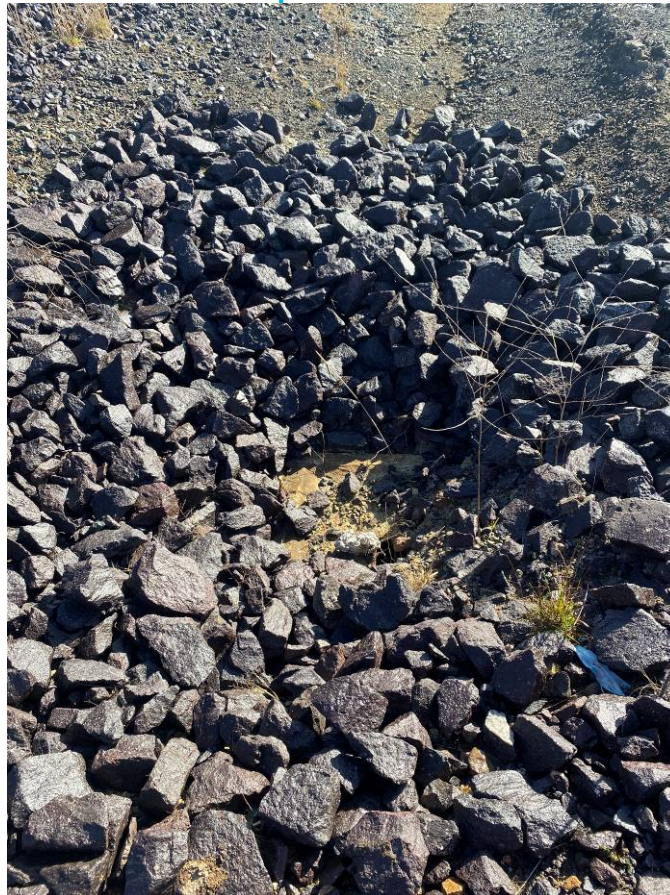
Photo 20: Inlet of drain from centre of railroad tracks showing minor signs of sediment.
