Tarago Action Plan Routine Inspection Checklist

Title: Tarago Rail Yard Inspection	Approved: SM	Project-Nr.: 318001704	Date: April 2023
Site: Tarago, NSW			
Client: UGL Regional Linx

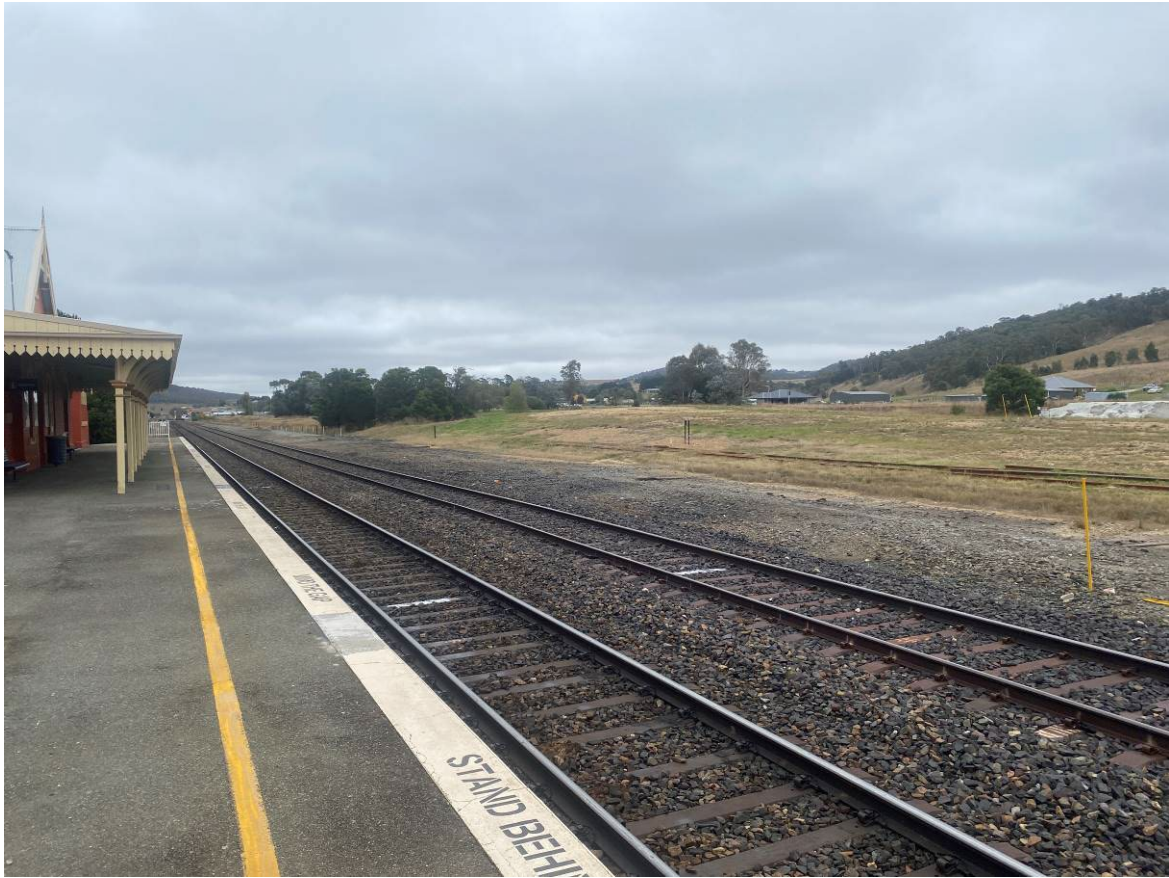
Photo 1: Picture of railway station facing south west. No airborne dust visible in air or on surfaces.

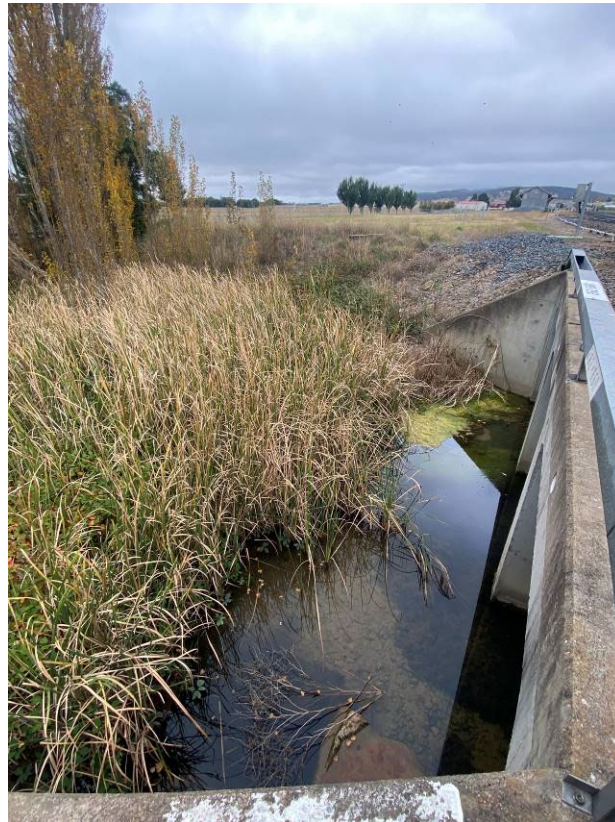
Photo 2: Immediately downgradient of southernmost culvert. Very slow surface water run off from site. Water was clear with no turbidity and no visible sediment. High reeds and vegetation adding natural filters for sediment.

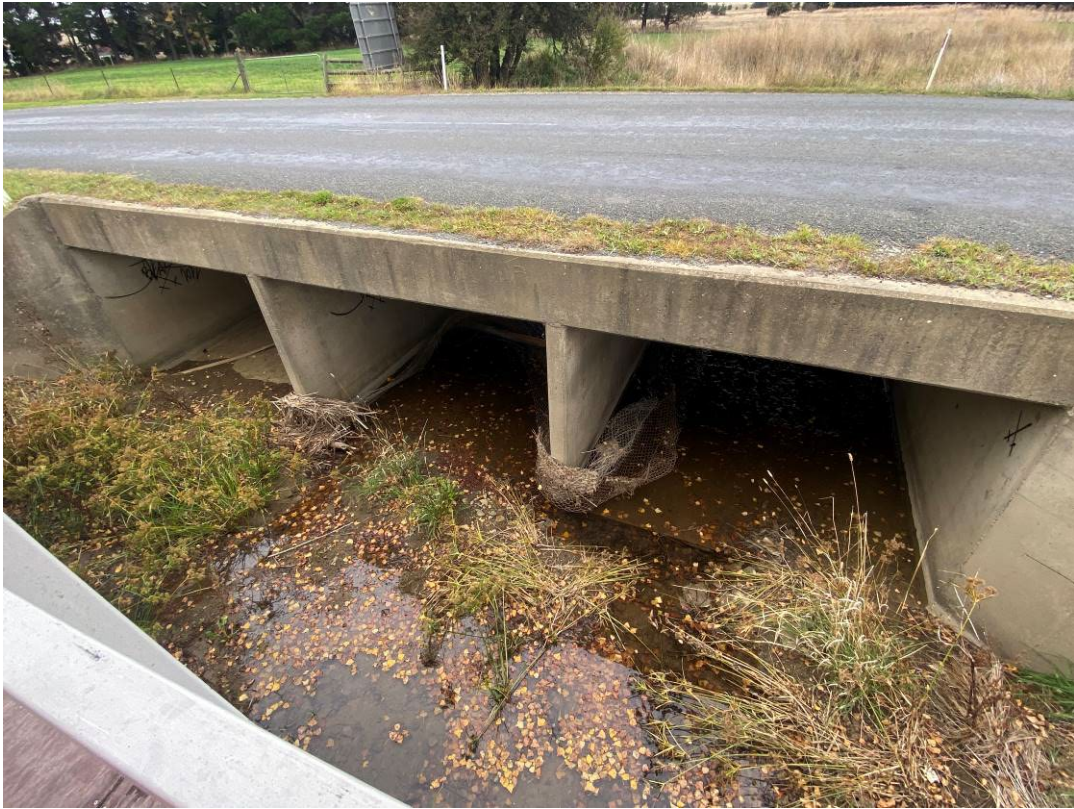
Photo 3: Inlet of culvert under Golburn street, downgradient of southernmost culvert on site, showing evidence of minor surface water run off on site. Water is clear with no observable sediment.

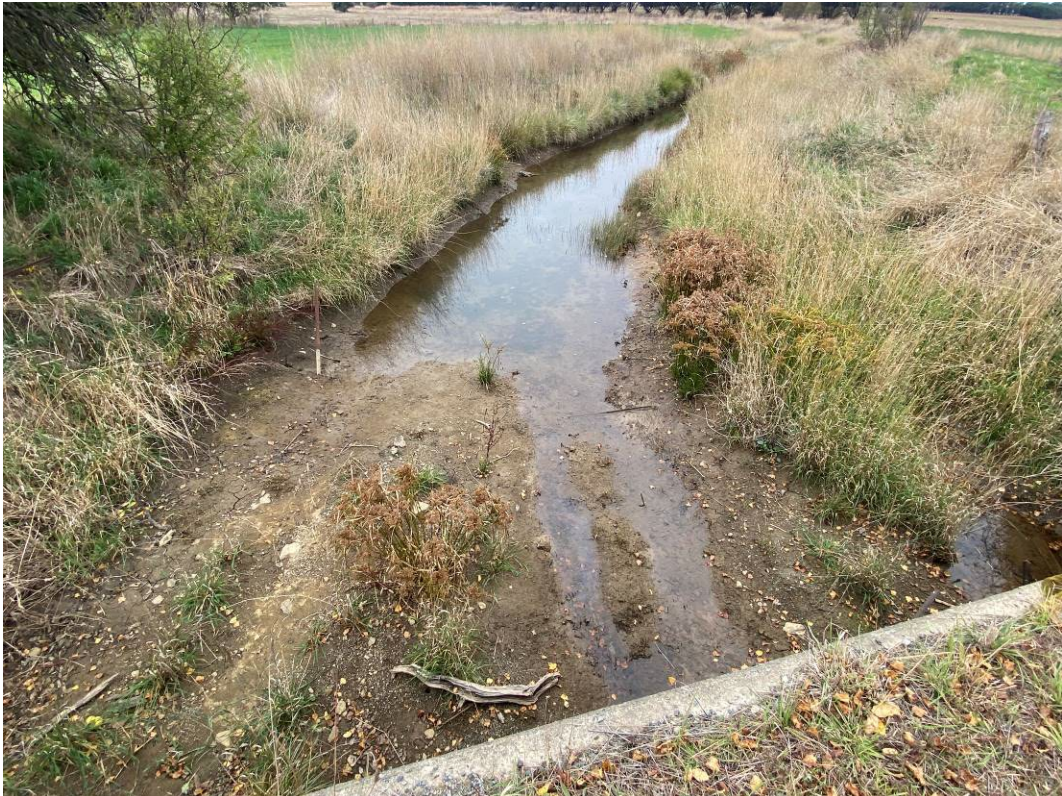
Photo 4: Outlet of culvert under Golburn street, downgradient of southernmost culvert on site, showing evidence of minor surface water run off on site. Water remains clear with no observable sediment.

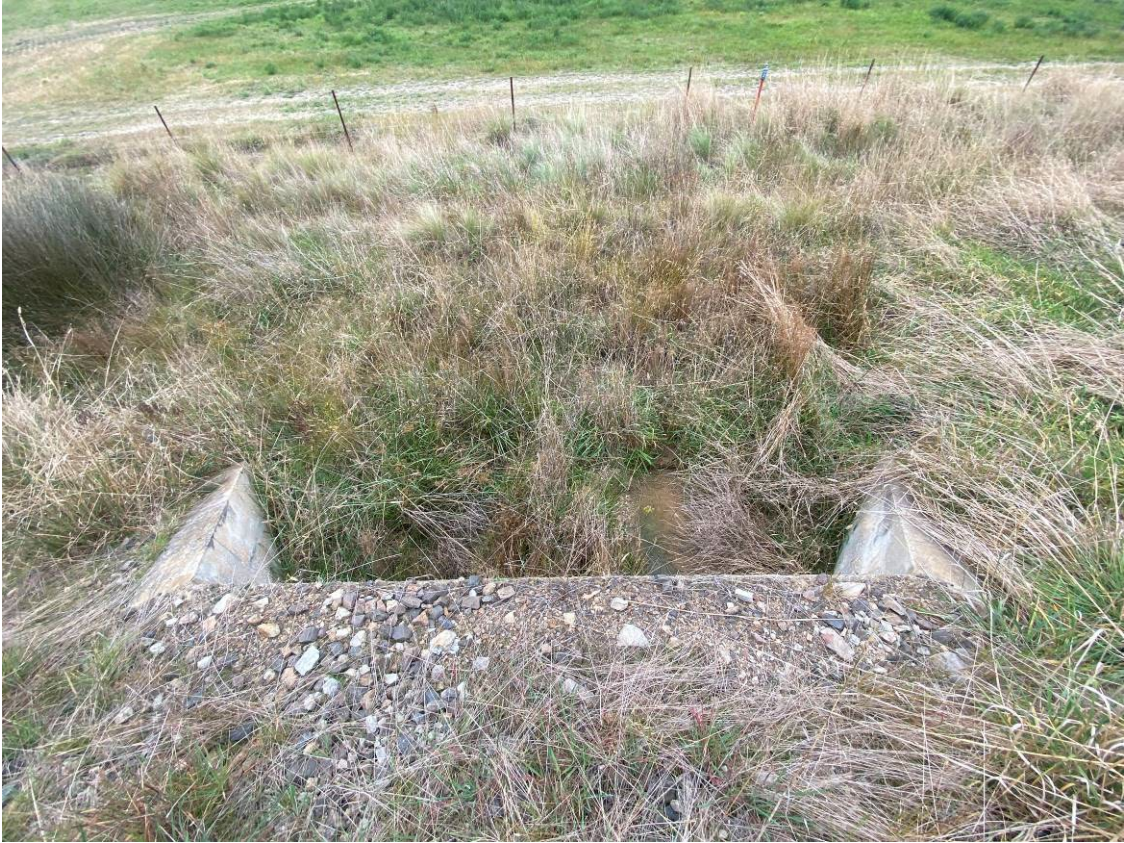
Photo 5: Downgradient of northernmost culvert facing private property, showing no evidence of surface water run off on site and no evidence of sediment from previous surface water on site.

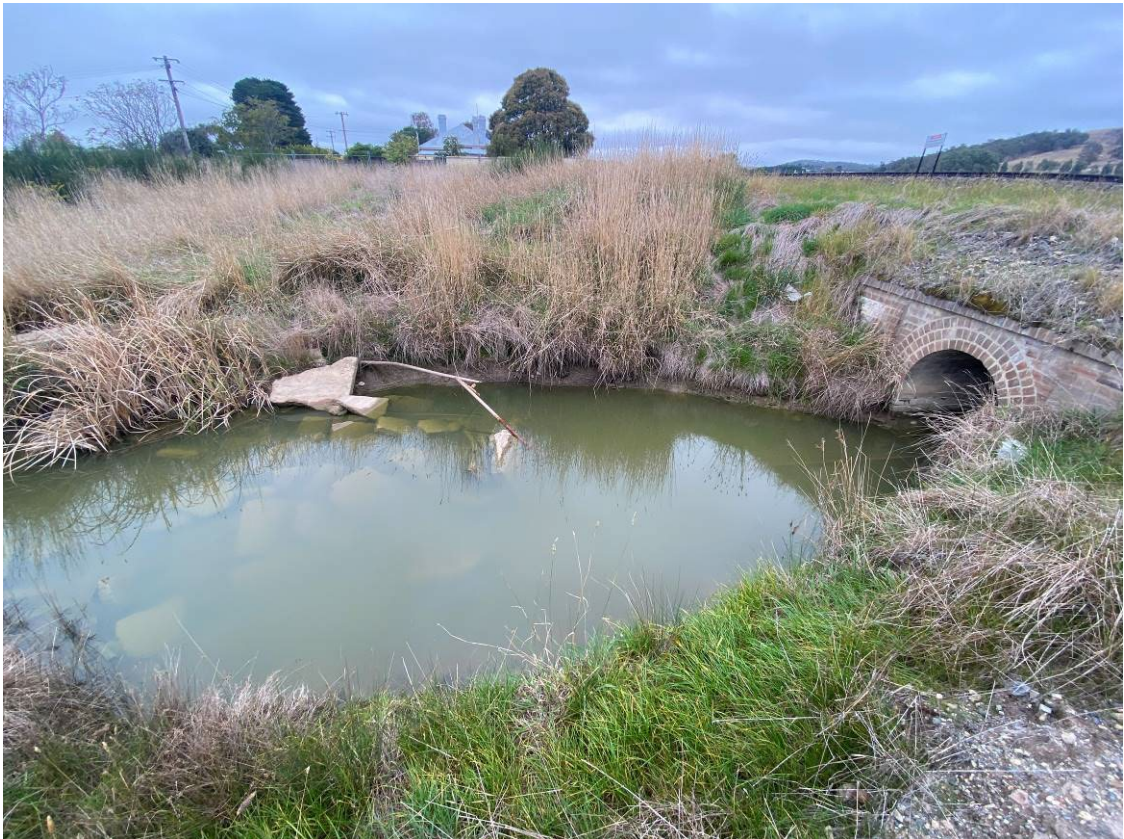
Photo 6: Downgradient of middle culvert. Pooled water but no evidence of current surface water run off on site. Minor sediment run off visible in pooled water on site.

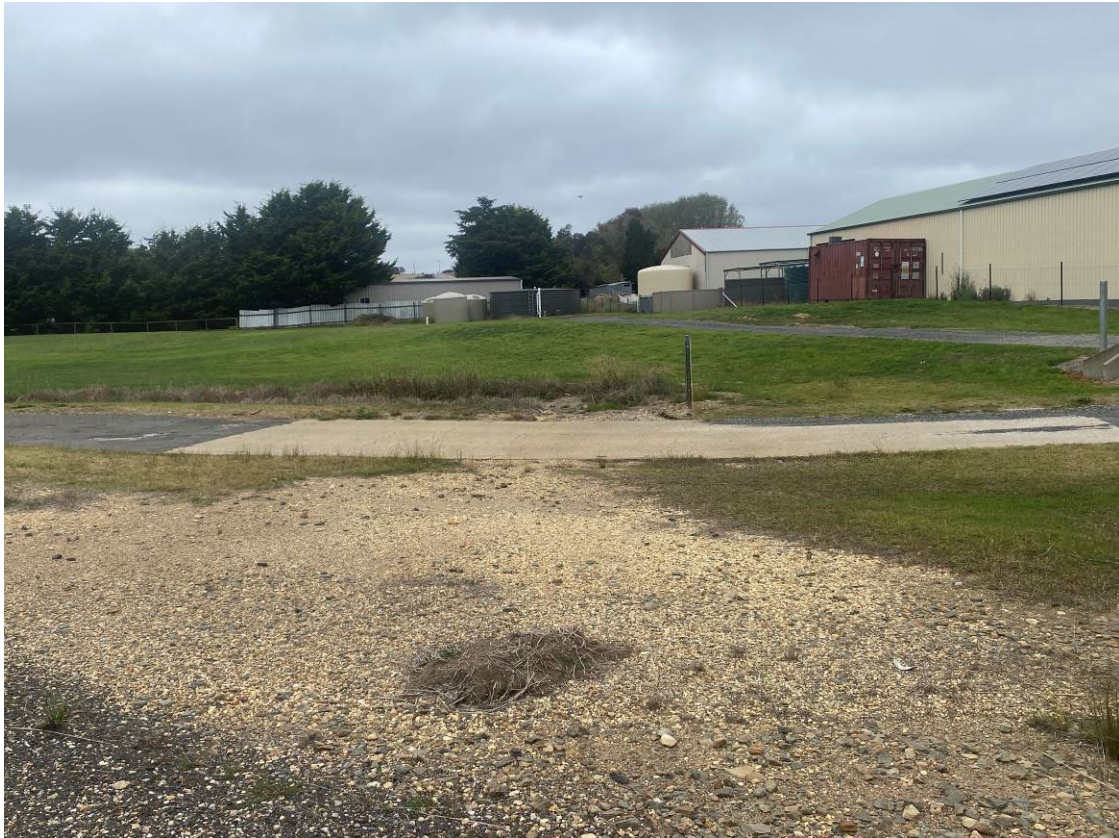
Photo 7: Causeway downgradient of middle culvert showing no evidence of current surface water run off on site. No visible sediment on road or vegetation nearby.

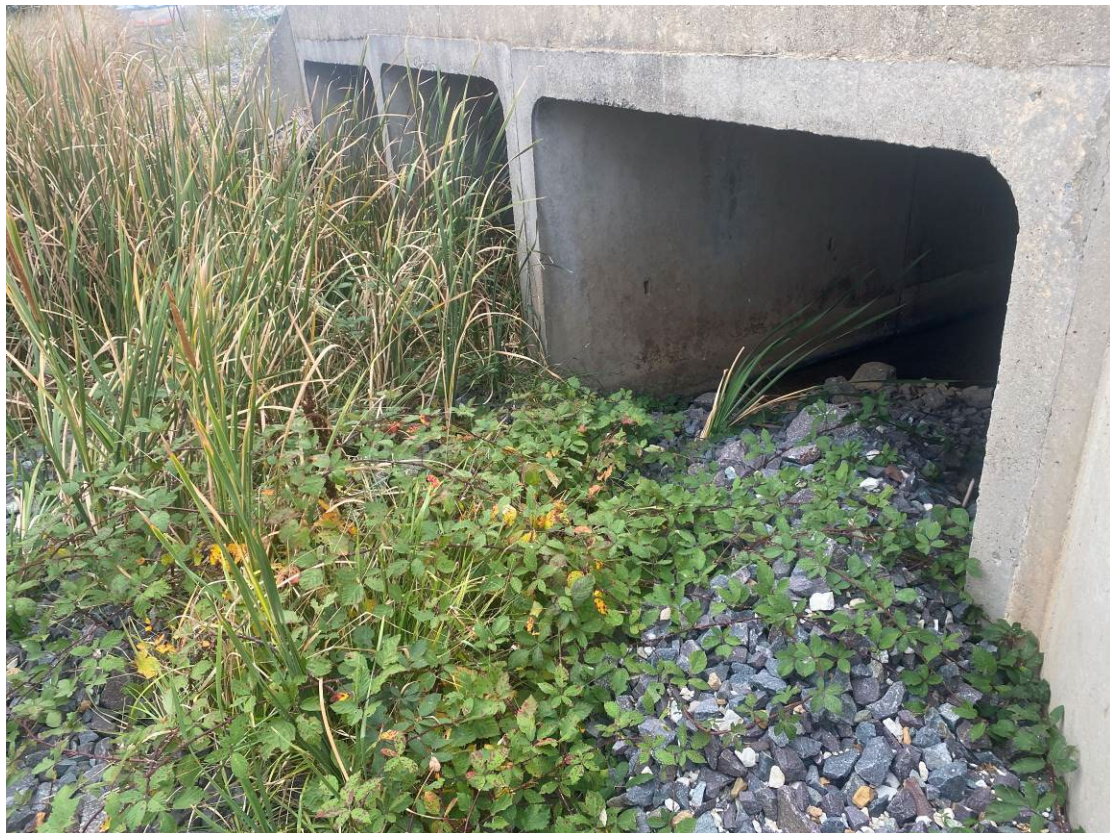
Photo 8: Upgradient of southernmost culvert showing evidence of minor surface water run off on site. No visible sediment observed beyond rock armoury.

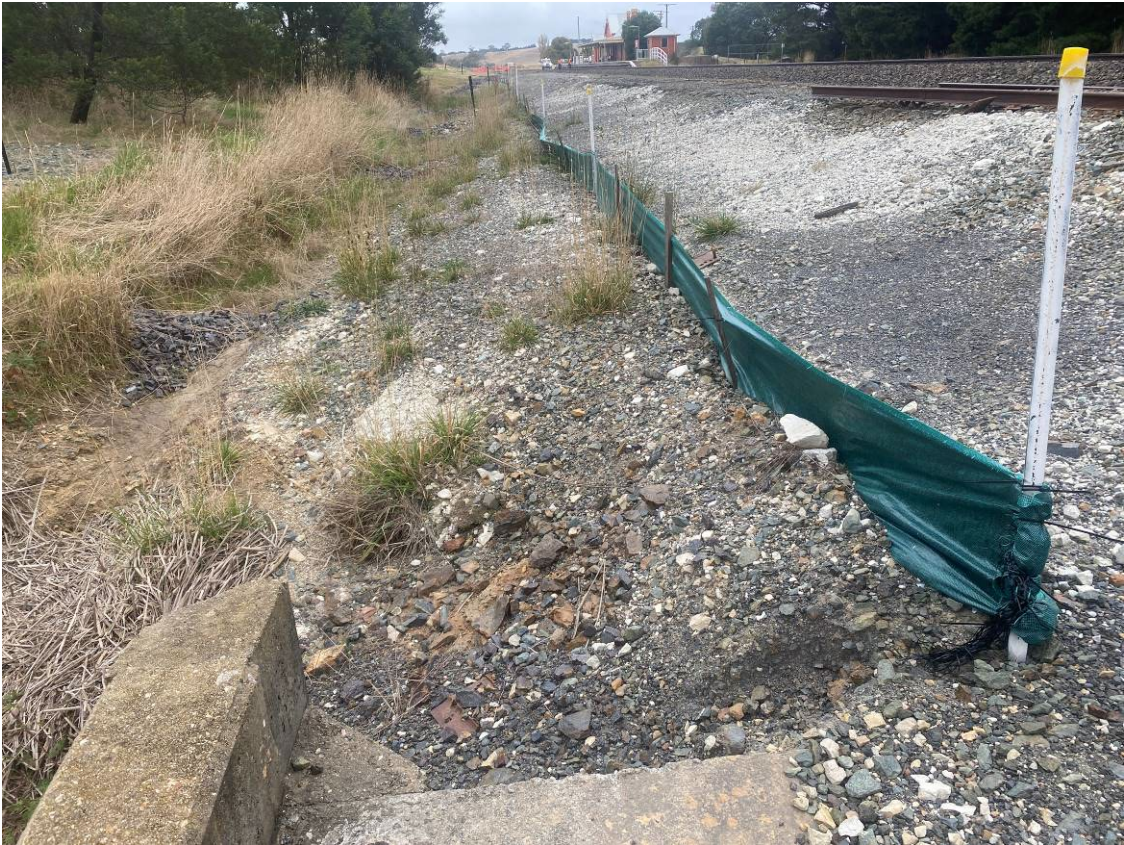
Photo 9: Upgradient of southernmost culvert showing silt fencing used as control measures for sediment control.

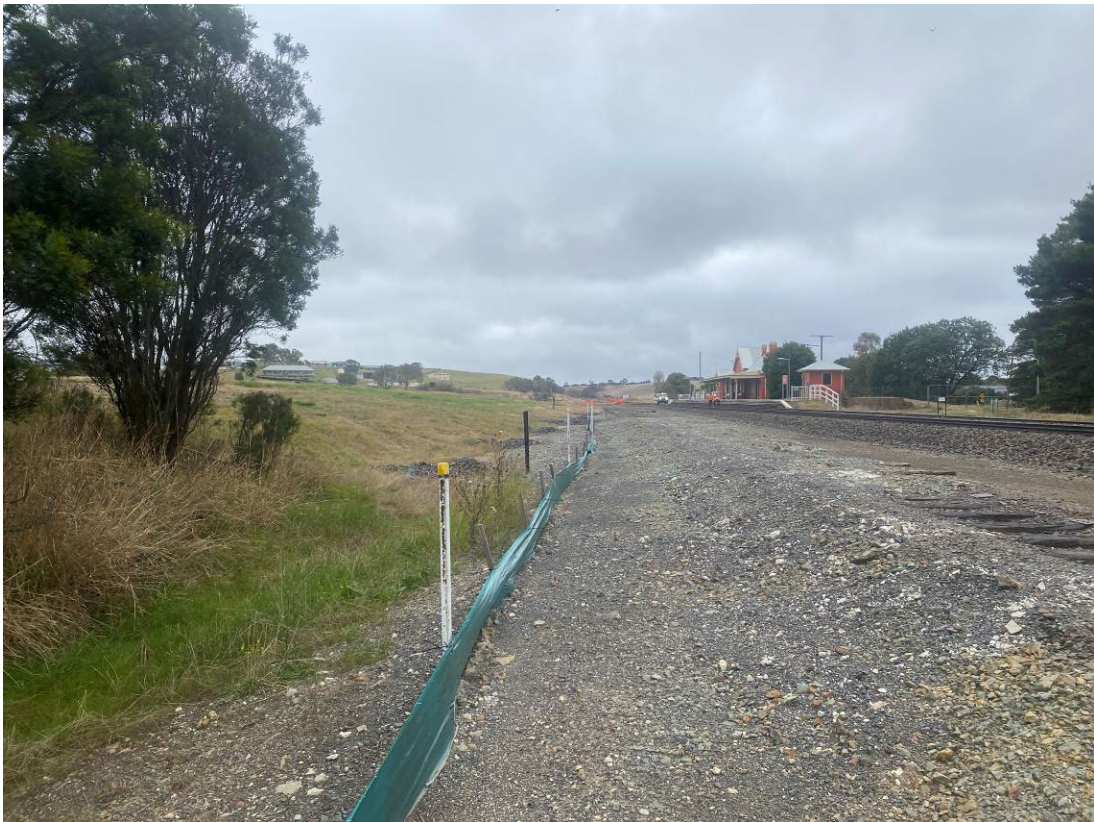
Photo 10: Rock checks and silt fences running alongside former Woodlawn siding towards the middle culvert. Moderate sediment build up on rock checks or fencing.

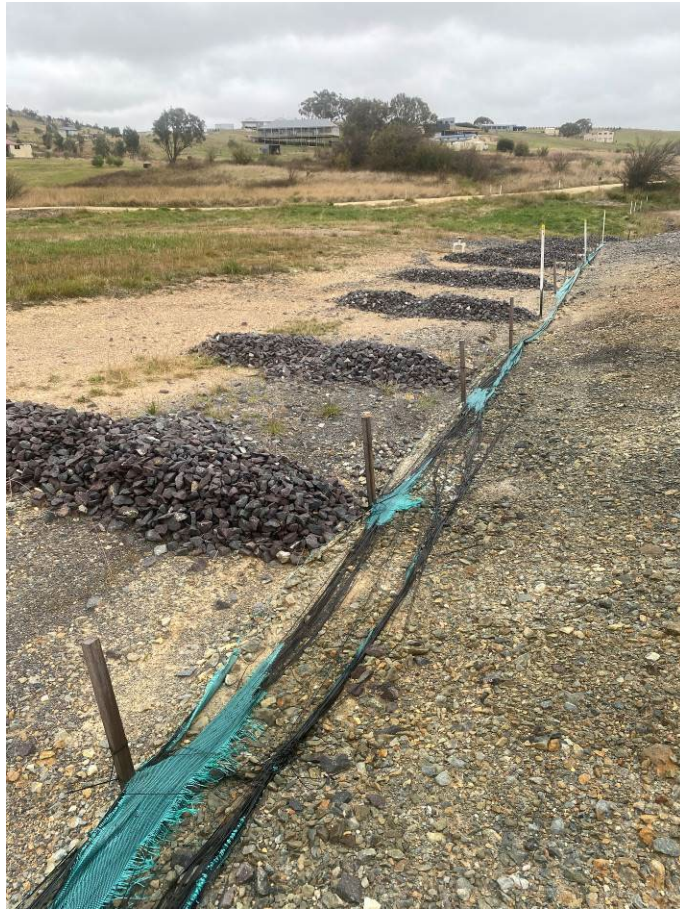
Control		Yes	No	Corrective Action
5.1	Is Exclusion Zone signage present as recommended on Figures 2a - 2e Appendix 1 to demarcate contamination in the rail formation and adjacent soils?	Yes (Photos 17 - 18)		
	Is Exclusion Zone signage undamaged?	Yes, signage was in good condition (Photos 17 - 18)		
	Are sediment controls present in/adjacent each rail culvert?	Yes, rock checks and rock armour observed upgradient of each culvert (Photos 8, 11, 12, 16). Silt fencing west of former woodlawn siding and along cess drain feeding the south and middle culverts (Photos 9 - 10, 14).		
	If sediment is present what is the estimated depth of sediment?	Minor sediment present in pooled water on site (Photo 6) (~3mm), sediment present on silt fencing and rock checks (~2cm) (Photos 27 - 30)		
	Are sediment controls still functional?	Yes, with the exception of silt fencing located south west of middle culvert (Photo 11). Refer to 'Other Observations' for recommendations.

Photo 11: Rock checks and silt fences running alongside former Woodlawn siding towards the middle culvert. Major damage to silt fencing remaining on southern side. No evidence of sediment build-up in rock armoury.

Ramboll notes that the major damage to the silt fencing uphill of the rail line (western side) and to the south of the middle culvert remains (**Photo 11**). Ramboll recommends this silt fencing be replaced as soon as possible.

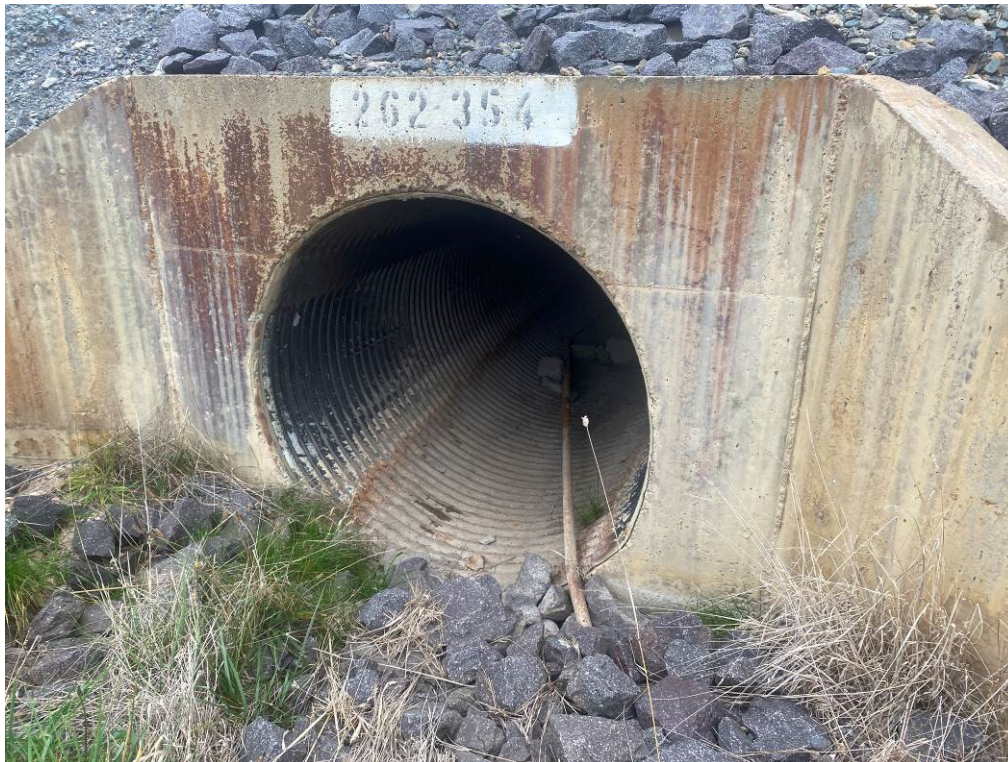
Photo 12: Upgradient of middle culvert showing minor signs of sediment in rock checks but no surface water discharge from site.

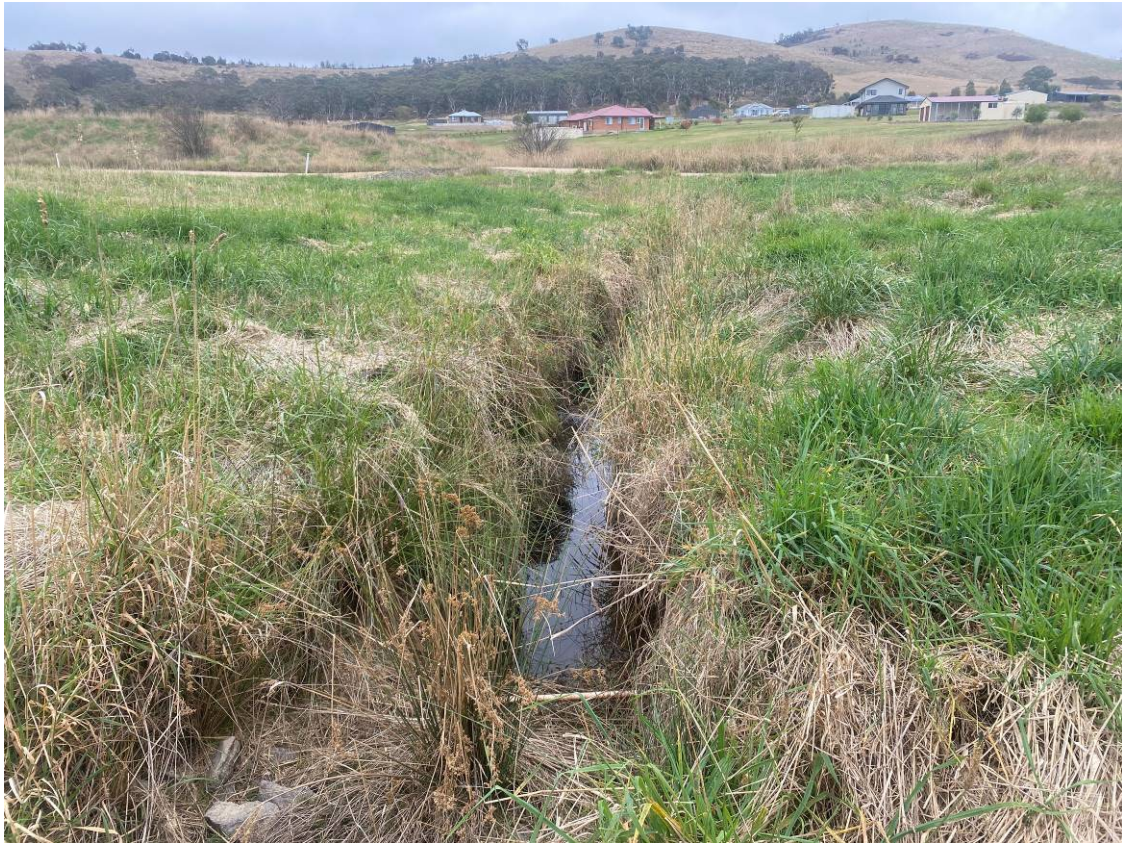
Photo 13: Upgradient of middle culvert facing west, showing pooling on site in Mulwaree River tributary. Water is clear with no signs of turbidity and sediment.

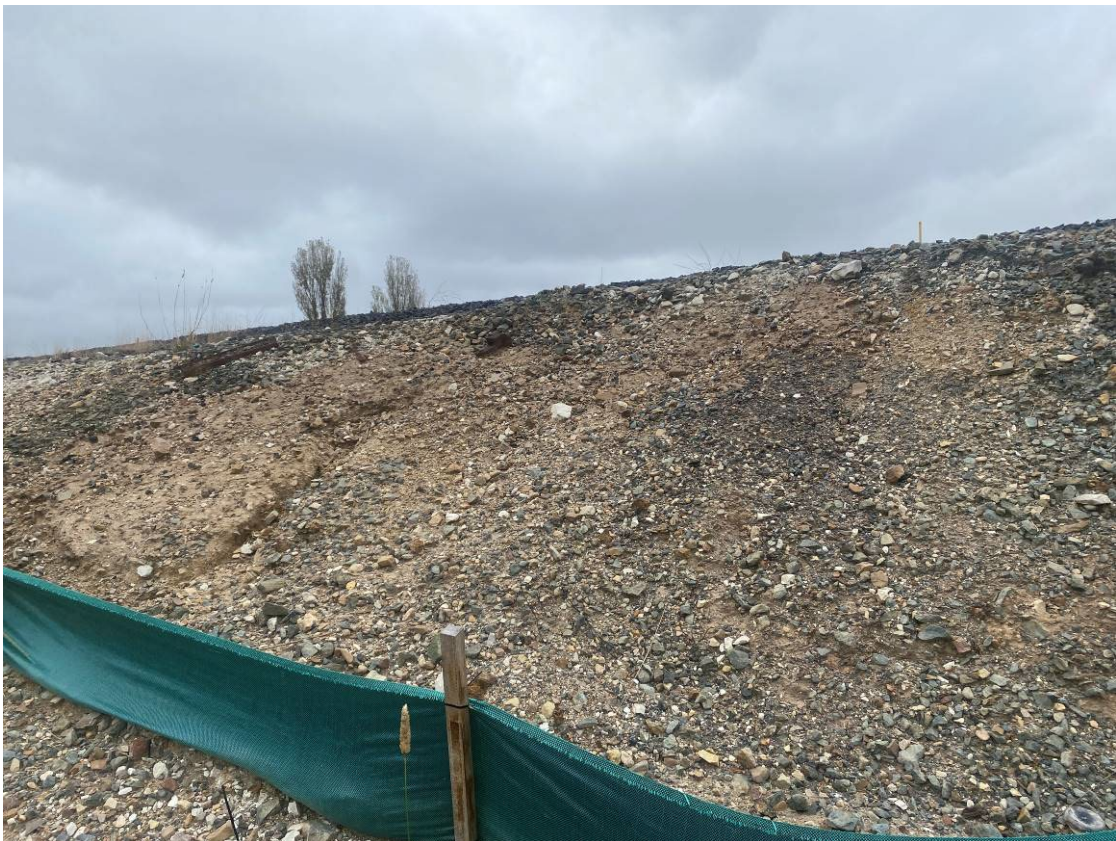
Photo 14: Silt fencing north of the middle culvert. Some erosion evidence of soil and build up of sediment on silt fencing.

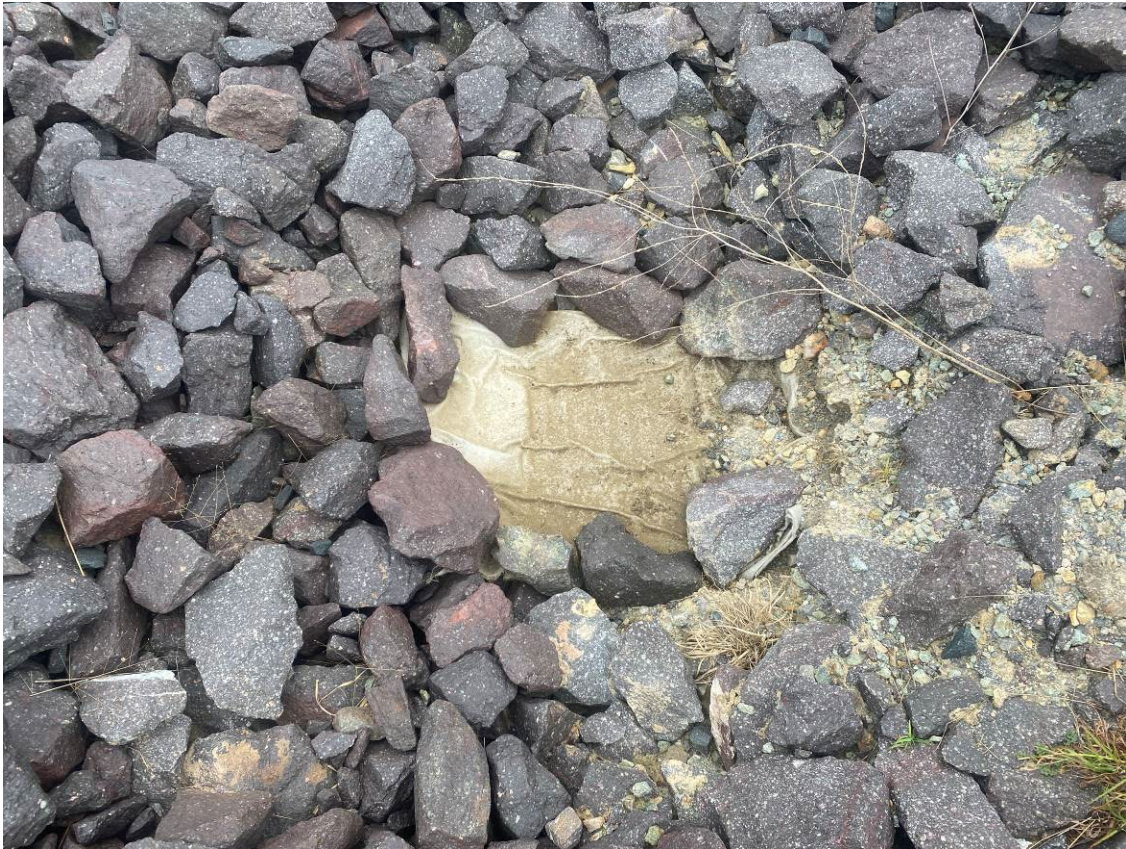
Photo 15: Geofabric filter over drain inlet between the main and loop lines as per recommendations from Inspection Checklist dated 15-Mar-23. Evidence of sediment capture.

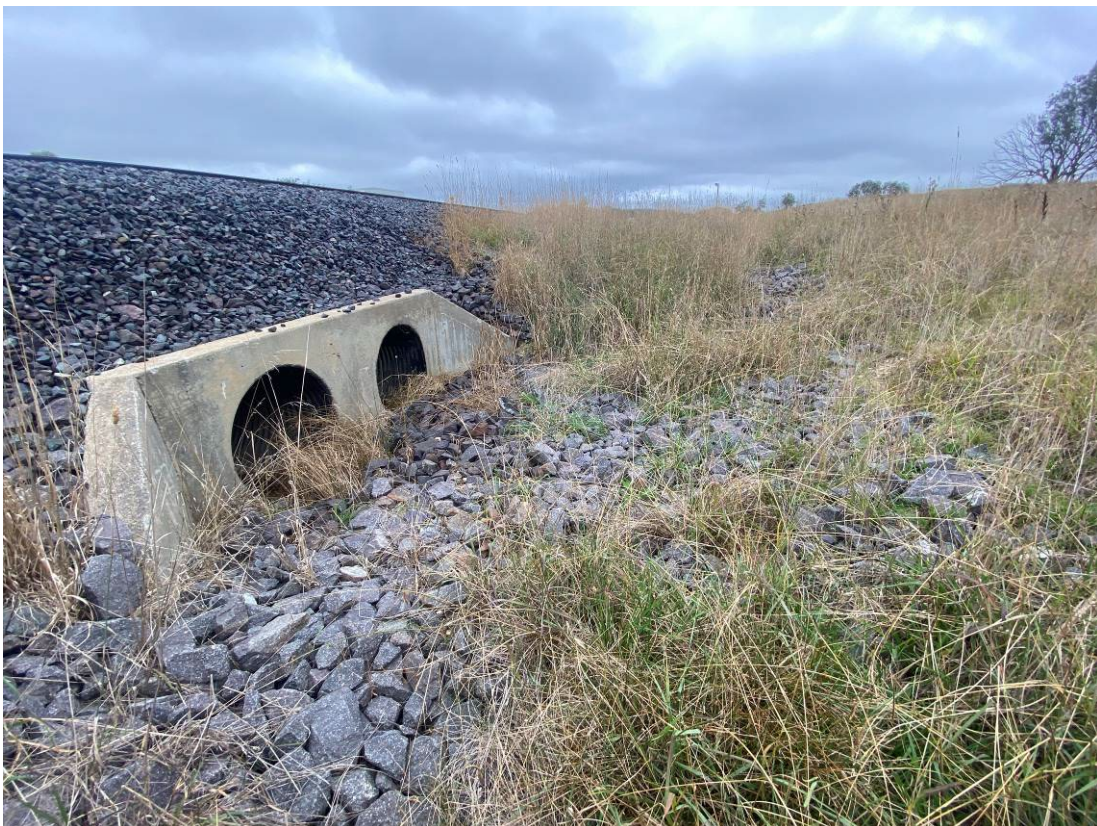
Photo 16: Upgradient of northernmost culvert, showing sediment control measures of rock armoury

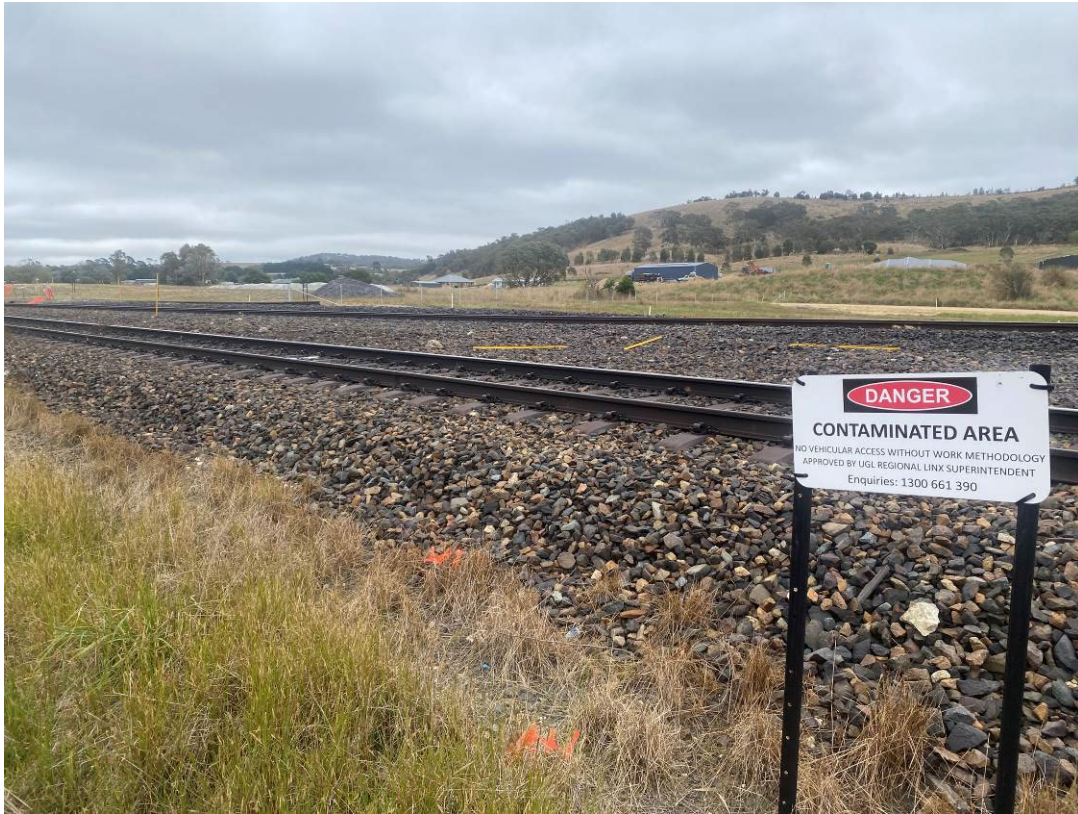
Photo 17: Exclusion zone signing placed periodically along contamination areas. Reverse side of more signing can be seen on opposite side of railway track.

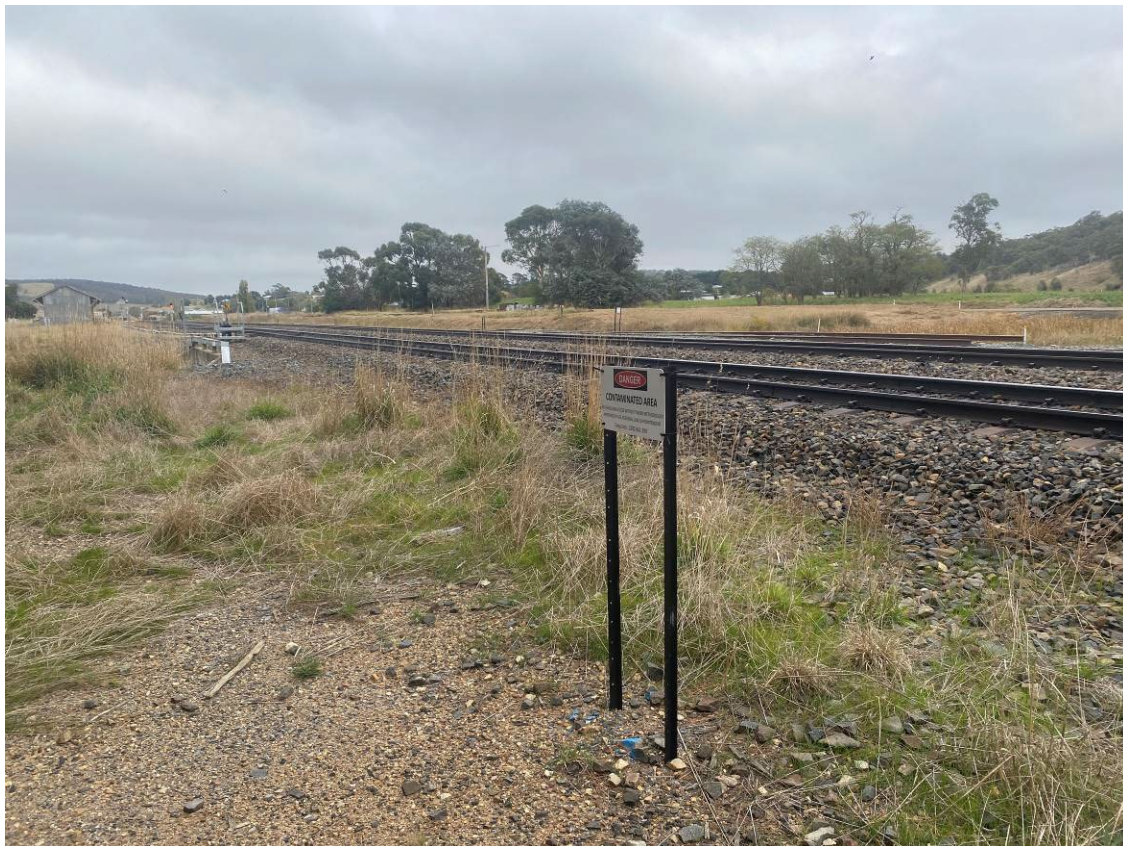
Photo 18: Additional exclusion zone signing placed periodically along contamination areas. Reverse side of more signing can be seen on opposite side of railway track.

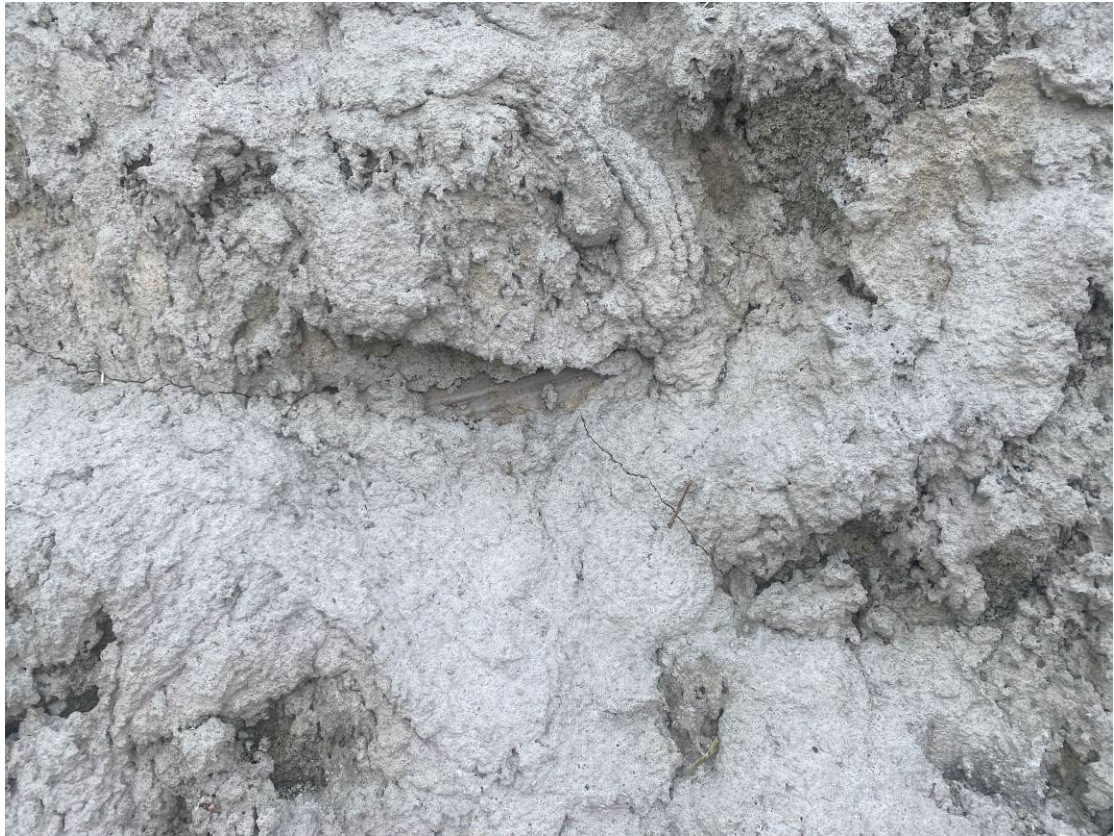
Is geofabric marker layer visible beneath capping of the existing stockpile? If so record in written form and through photographs and consolidate with this checklist. If marker layer is visible rectification work is required.	Yes, geofabric marker layer visible in three locations on west of stockpile. Location and size detailed in Photos 19 - 21 , refer to 'Other Observations' section for recommendations.

Photo 19 Hairline cracking in stabilised sand applied to the stockpile for capping. Geofabric marker layer visible. UGL on site representative was notified and marked this with spray paint. Approximately 10cm x 2cm.

Minor marker layer exposure was noted in three places on the western side of the stockpile (**Photos 19 - 21**). Ramboll recommends repairing these by patching with sand and cement mixture. UGL representative on site was notified of location and marked these with spray paint.

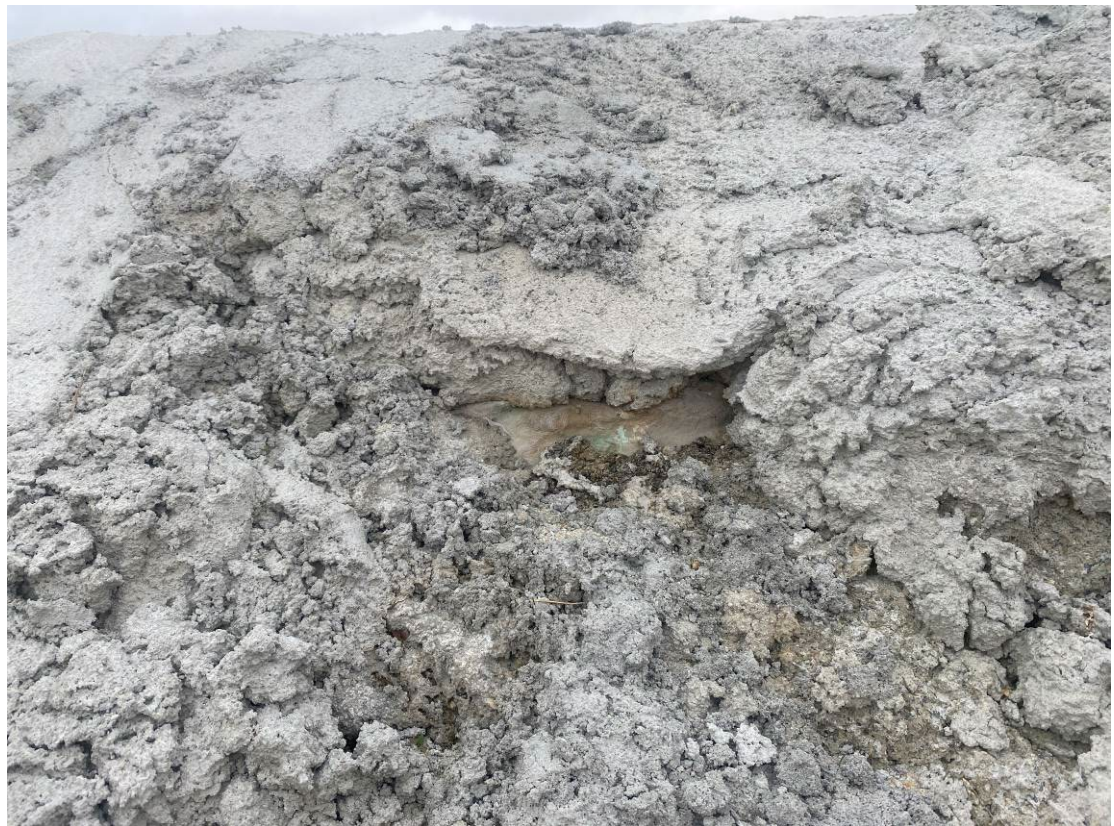
Photo 20. Geofabric marker layer visible in stockpile capping UGL on site representative was notified and marked this with spray paint. Approximately 10cm x 2cm.

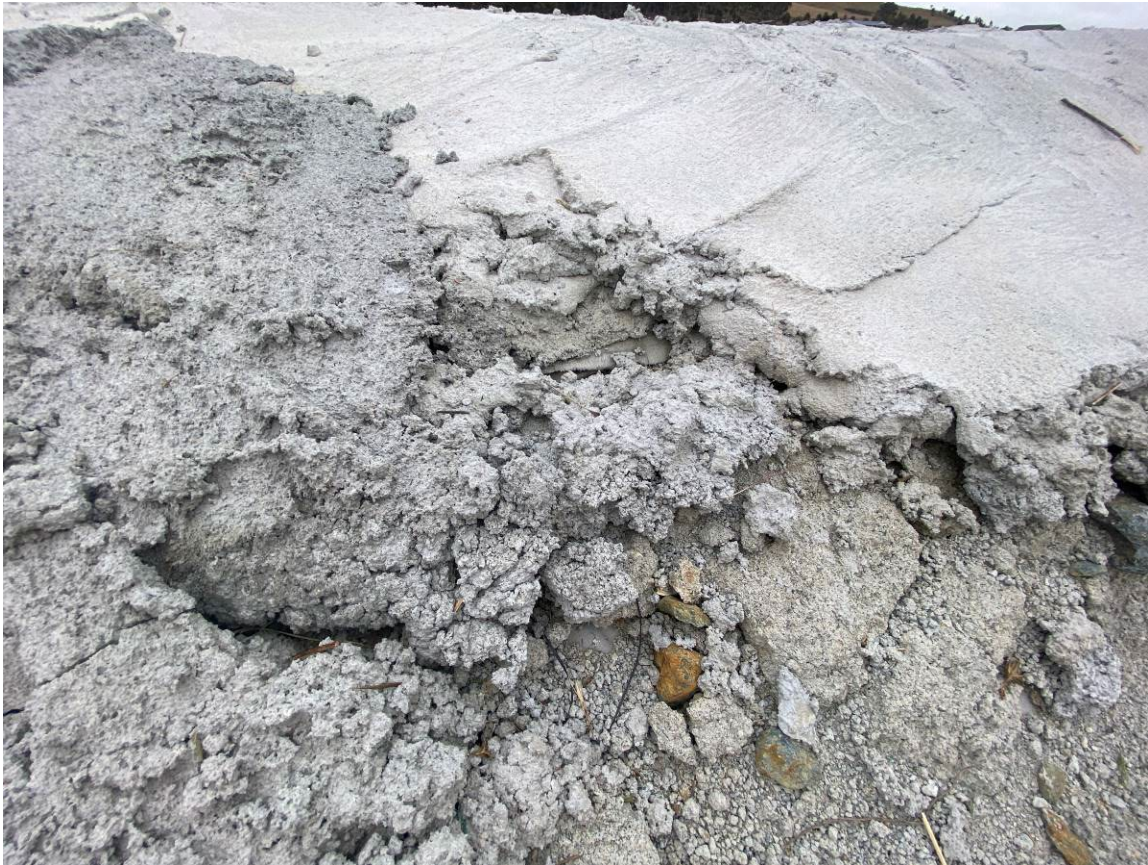
Photo 21. Geofabric marker layer visible in stockpile capping UGL on site representative was notified and marked this with spray paint. Approximately 8cm x 1.5cm.

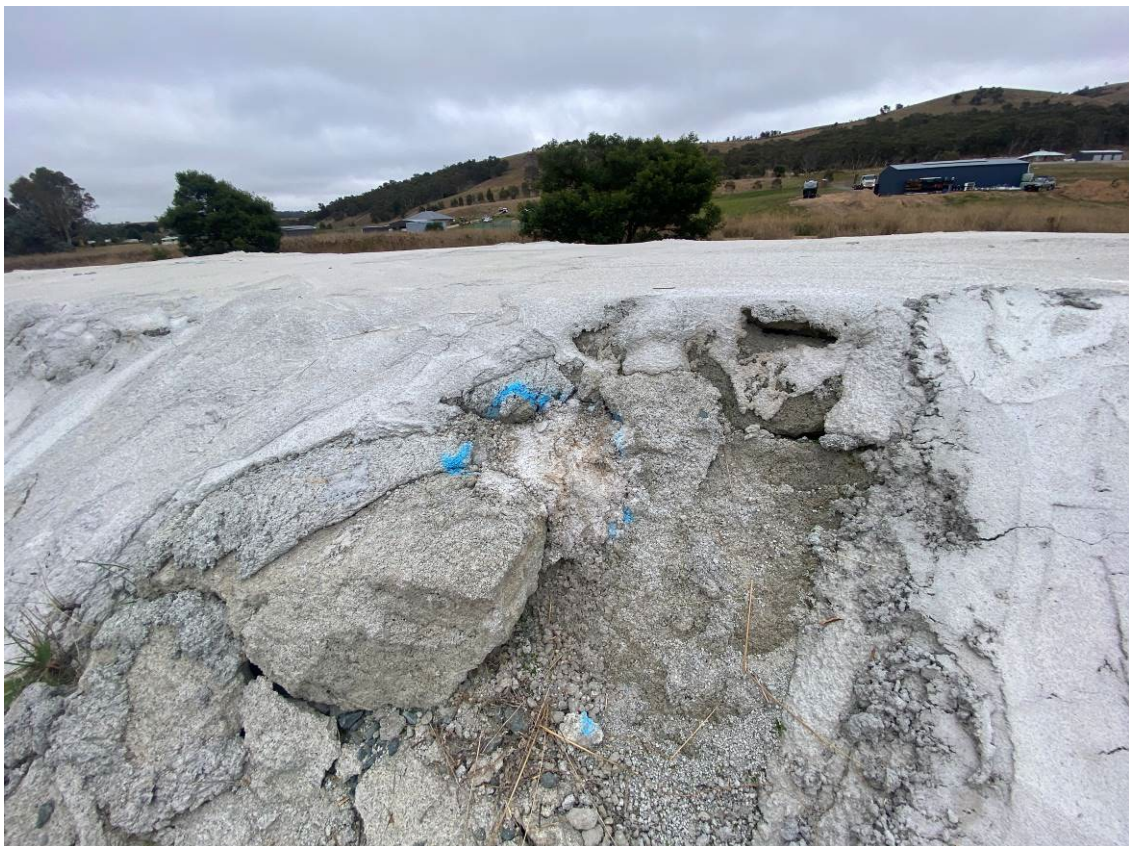
Photo 22. Geofabric marker layer previously visible has been patched as per recommendations from Inspection Checklist dated 28-Mar-23.

As per recommendation from the March Inspection Checklist (dated 15-Mar-23), vegetation maintenance on the stockpile was conducted (**Photo 24**). Additionally as per recommendation from the previous Inspection Checklist (dated 28-Mar-23), minor marker layer exposure noted in two places on the eastern side of the stockpile has been patched (**Photos 22 - 23**).

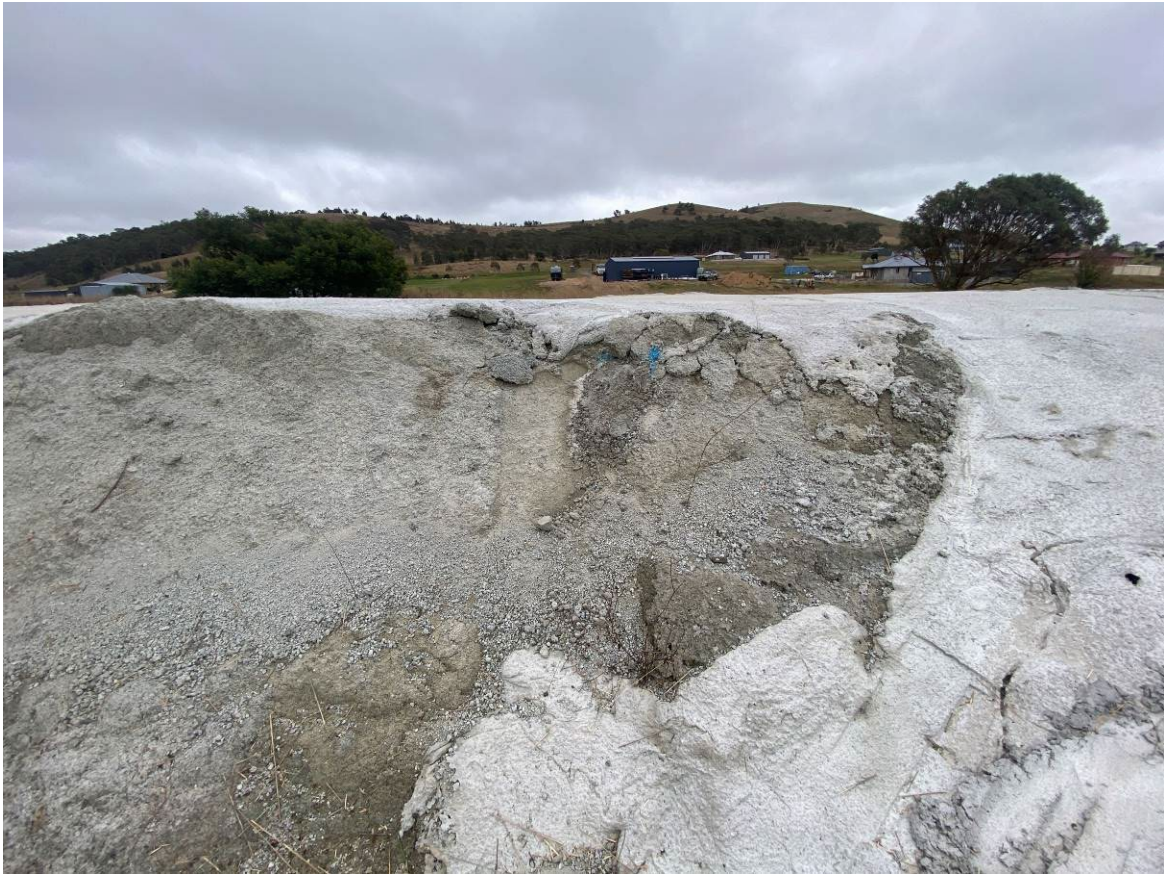
Photo 23. Geofabric marker layer previously visible has been patched as per recommendations from Inspection Checklist dated 28-Mar-23.
