Tarago Action Plan Routine Inspection Checklist

Title: Tarago Rail Yard Inspection	Approved: SM	Project-Nr.: 318001704	Date: April 2023
Site: Tarago, NSW			
Client: UGL Regional Linx

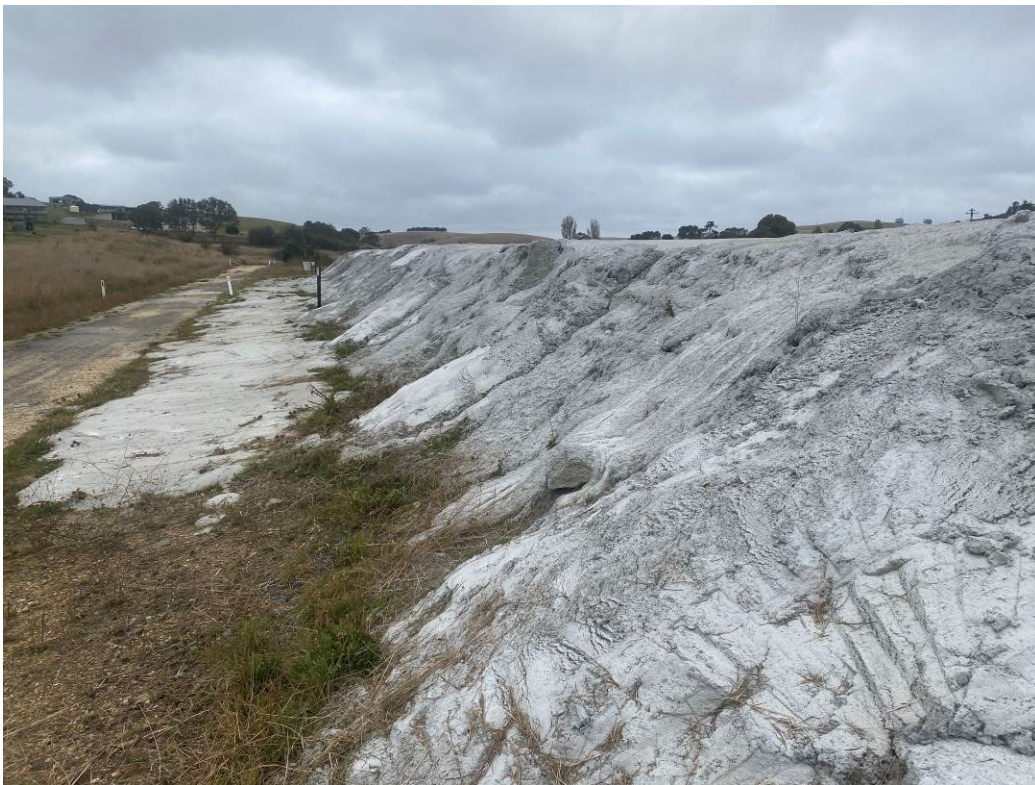
Photo 24. Vegetation maintenance nearby the stockpile had been undertaken. Overgrown weeds and grass cleared from capping and surrounding base.

As per recommendation from the March Inspection Checklist (dated 15-Mar-23), vegetation maintenance on the stockpile was conducted (**Photo 24**). Additionally as per recommendation from the previous Inspection Checklist (dated 28-Mar-23), minor marker layer exposure noted in two places on the eastern side of the stockpile has been patched (**Photos 22 - 23**).

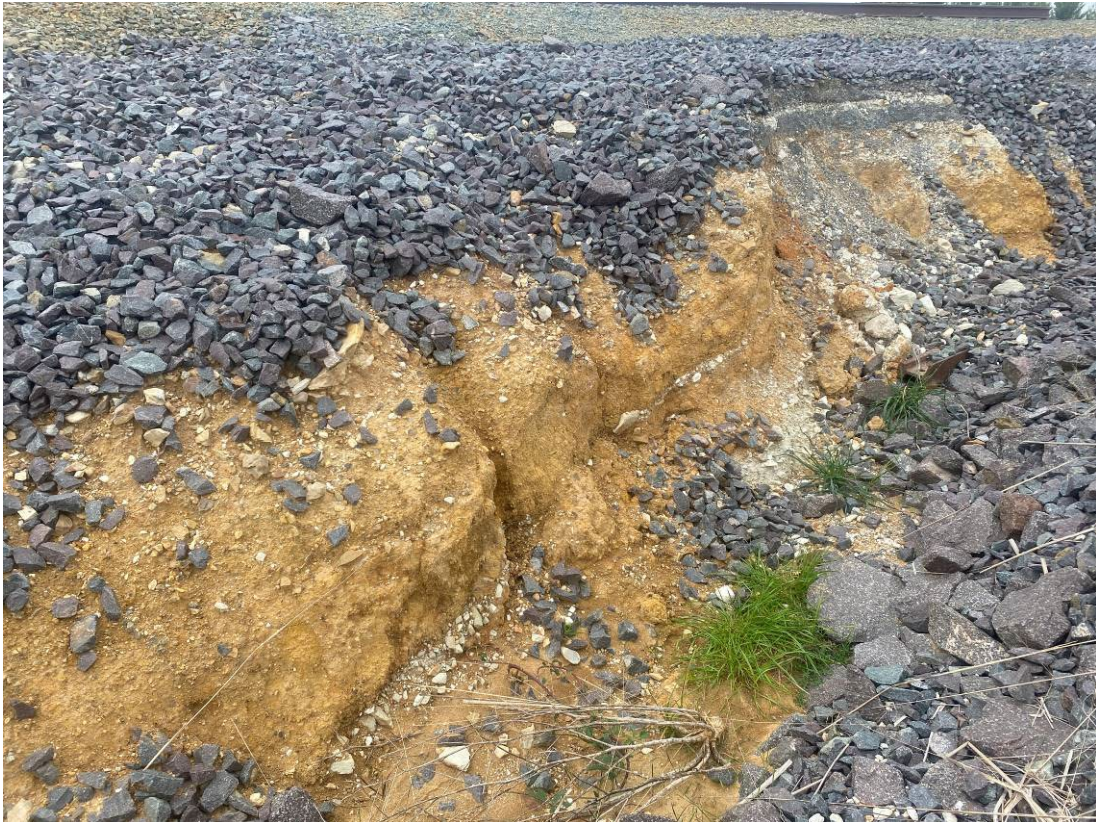
Photo 25. Visible evidence of erosion created by loss of ground cover (ballast material on top) upgradient of southernmost culvert. No visible evidence of sediment in water downstream of culvert despite erosion evidence.

Evidence of erosion was noted upgradient of the southern most culvert (**Photo 25 - 26**) however no evidence of sediment was found in water flowing offsite at southern culvert. Ramboll recommends replacing ground cover material (ballast) if further erosion occurs or sediment is visible in the downstream surface water of the southern culvert.

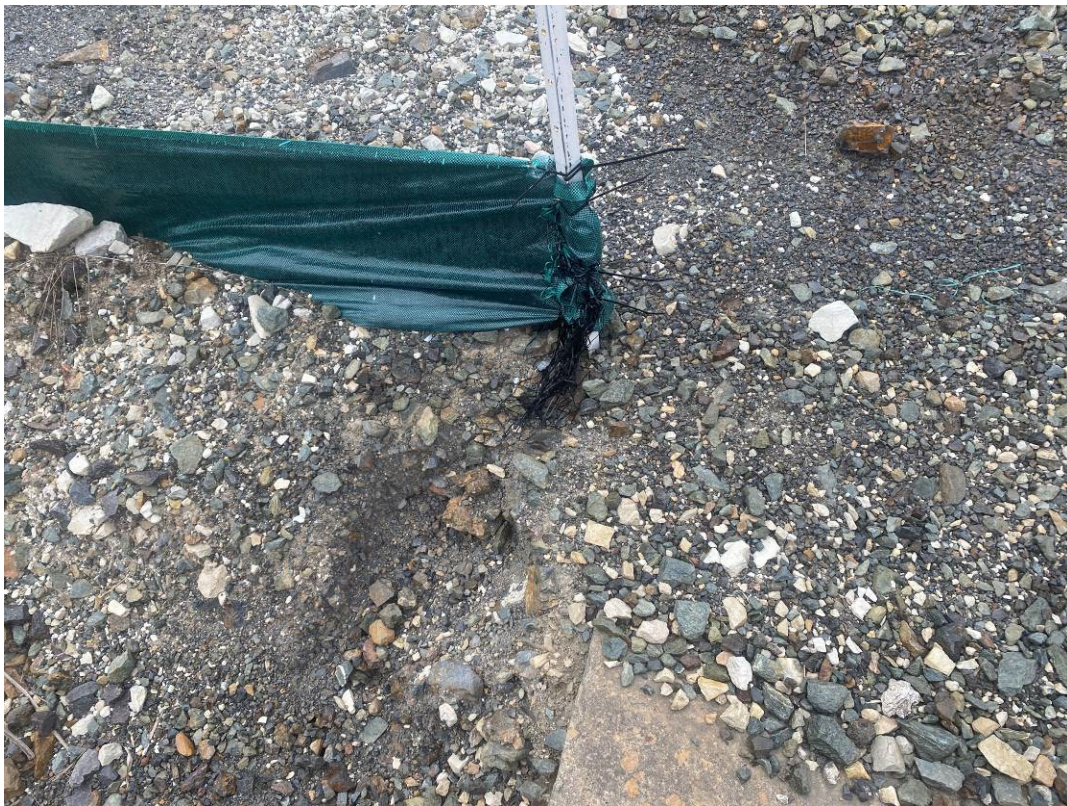
Photo 26. Visible evidence of erosion due to silt fencing diverting water. No visible evidence of sediment in water downstream of culvert despite erosion evidence. Ramboll recommends removal of silt above fencing to allow better water flow.

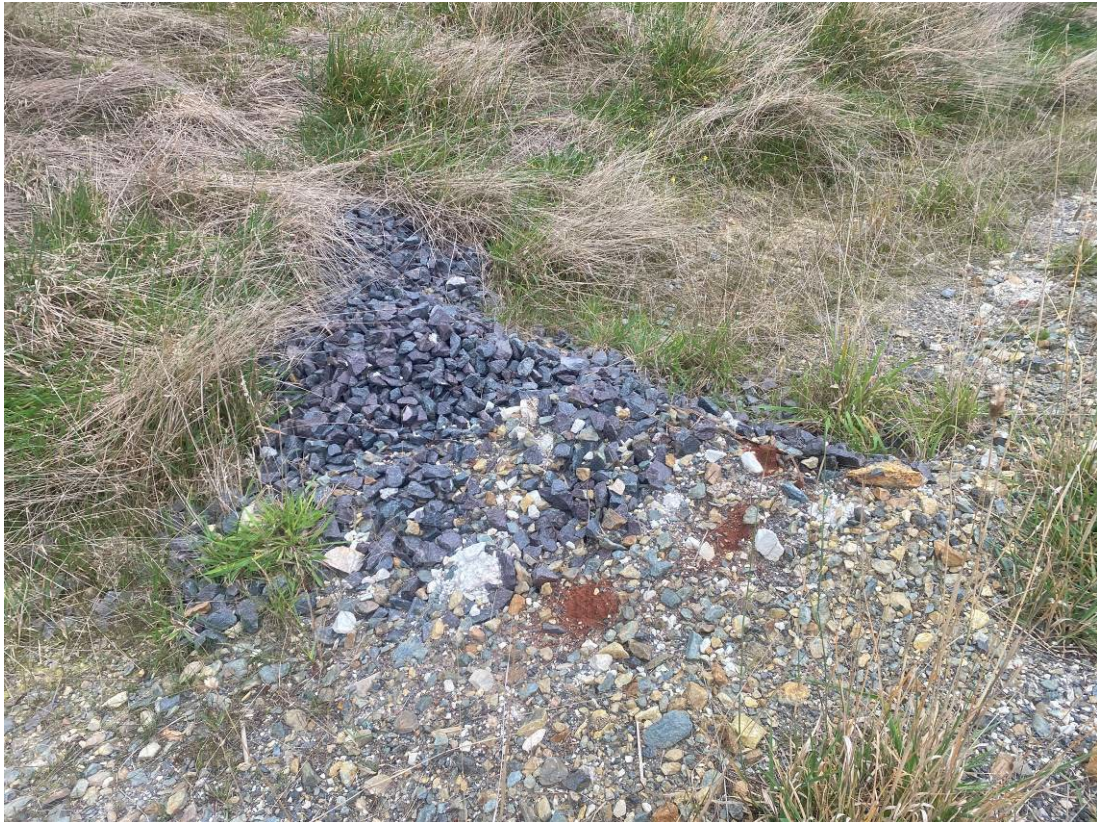
Photo 27. Build-up of sediment in rock armoury. Ramboll recommends replacing new rock armoury.

Evidence of build up of sediment in some rock armoury and silt fences upgradient of southern and middle culverts (**Photos 27 - 30**). Ramboll recommends removing silt build up on fences using a shovel and replacing rocks with sediment build up in rock armouries.

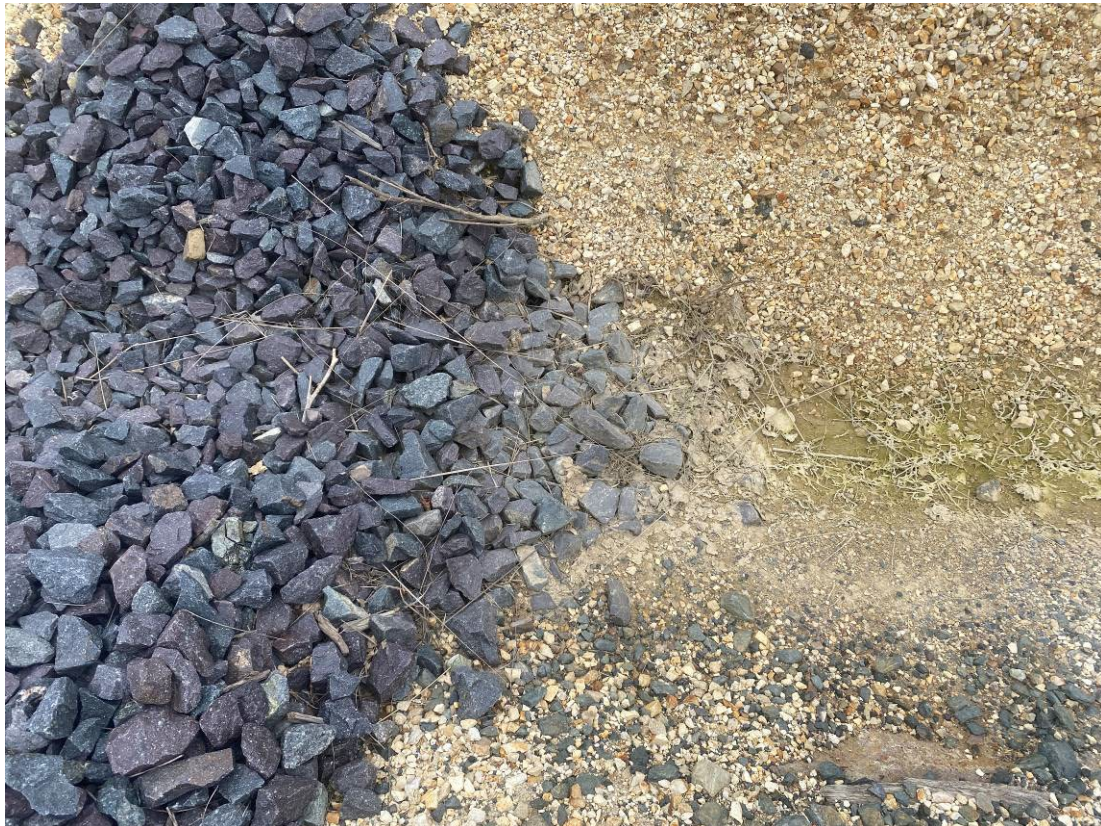
Photo 28. Build-up of sediment in rock armoury. Ramboll recommends adding additional rocks to armoury.

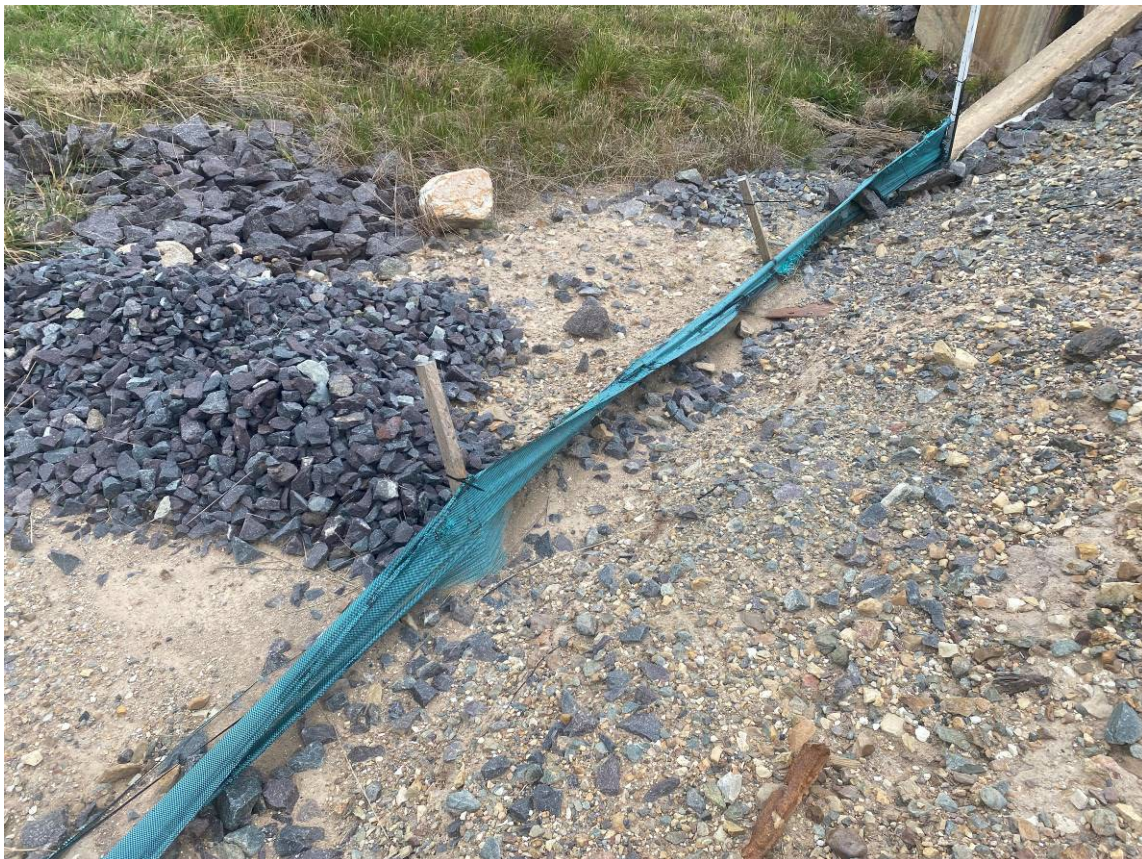
Photo 29. Build-up of sediment in silt fencing armoury. Ramboll recommends removing silt above fencing using a shovel.

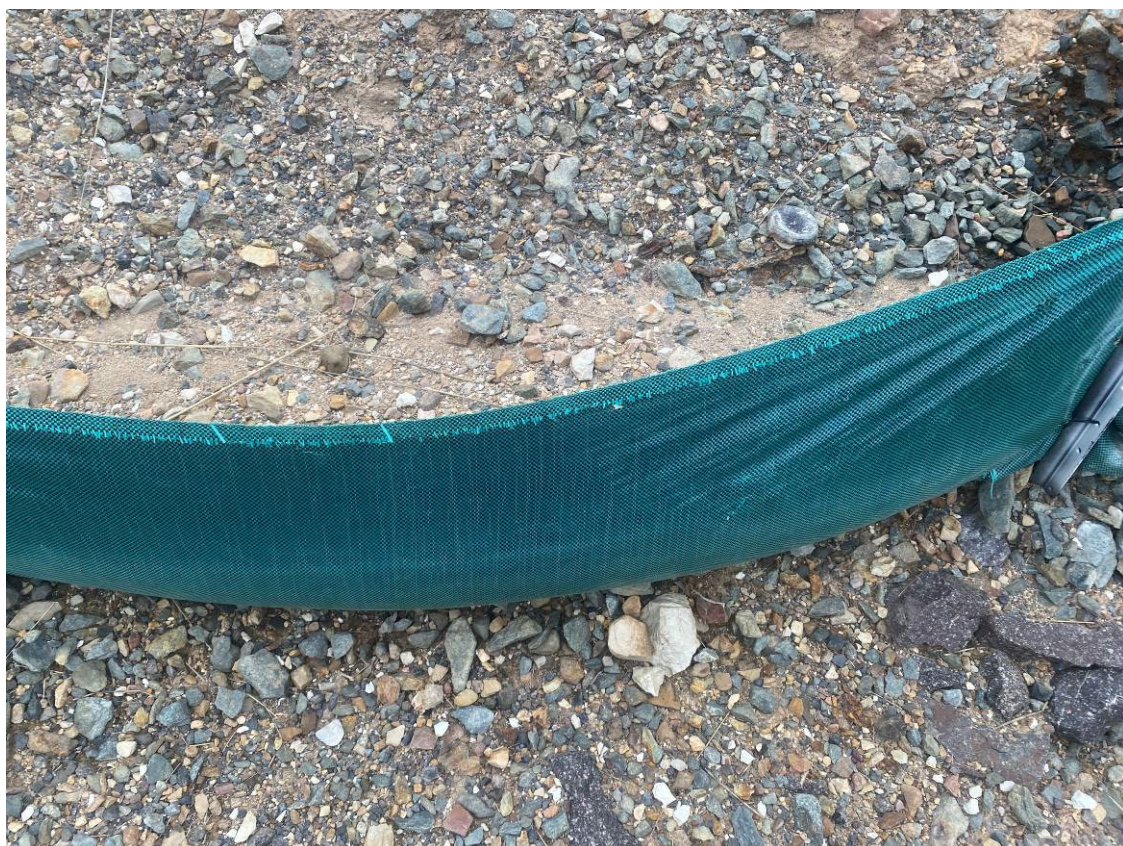
Photo 30. Build-up of sediment in silt fencing armoury. Ramboll recommends removing silt above fencing using a shovel.
