Tarago Action Plan Routine Inspection Checklist

Title: Tarago Rail Yard Inspection	Approved: SM	Project-Nr.: 318001704	Date: 30 March 2023
Site: Tarago, NSW			
Client: UGL Regional Linx

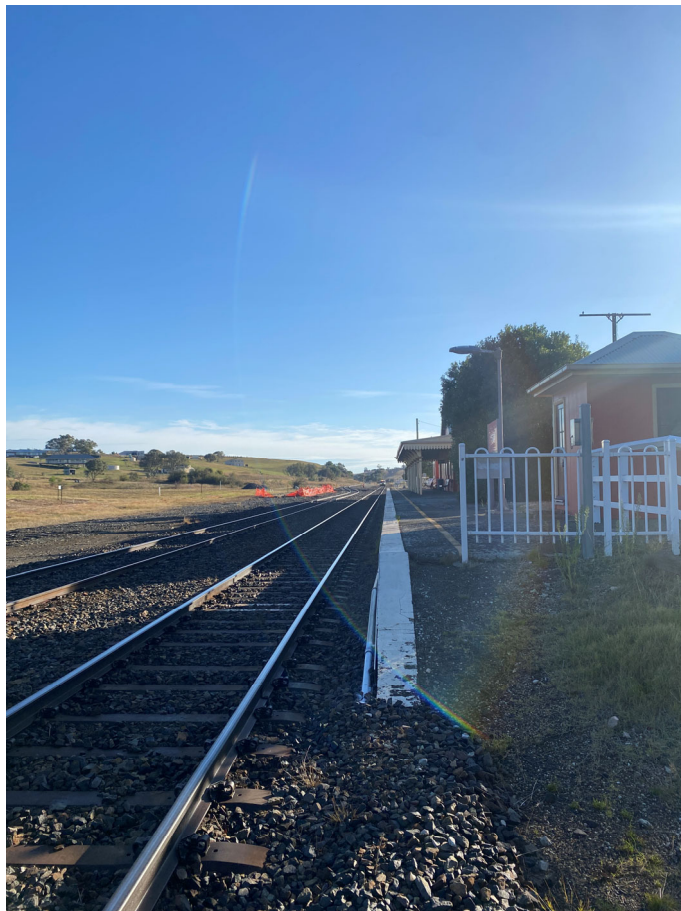
Photo 1: Picture of railway station facing north. No airborne dust visible in air or on surfaces at station.

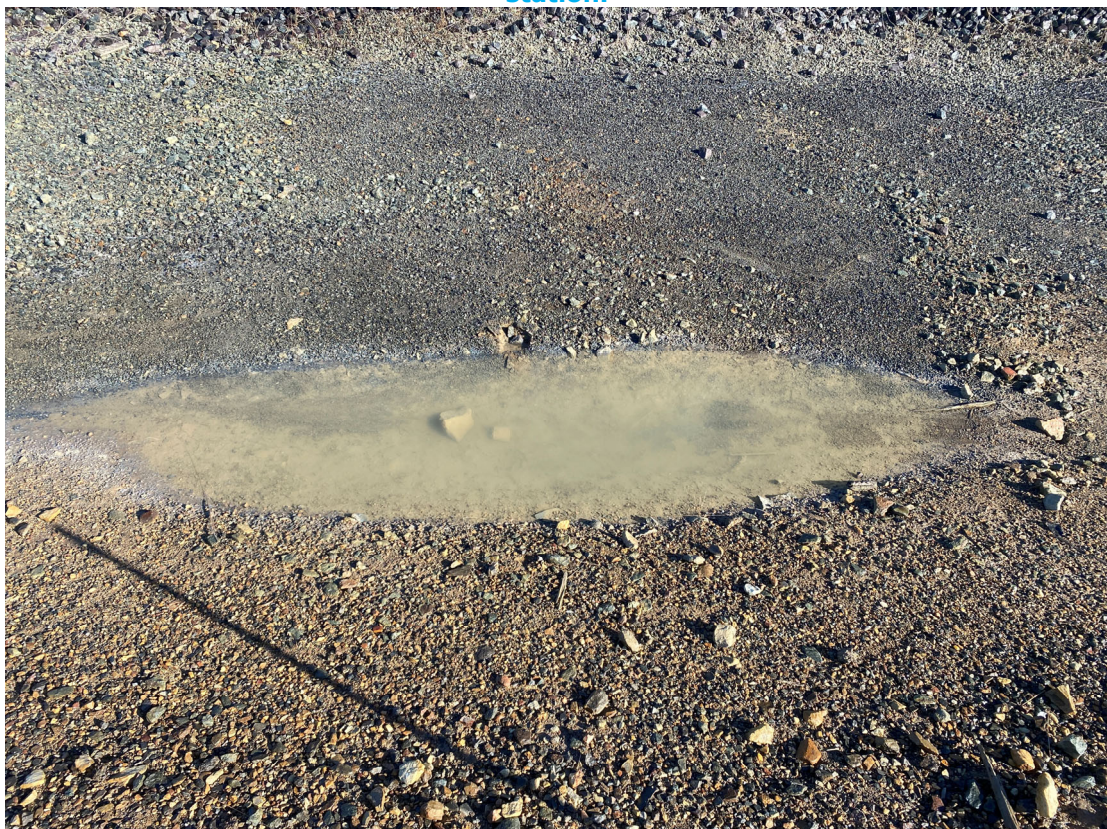
Photo 2: Minor sediment in pooled water between rail tracks. Not flowing off site and located prior to sediment controls such as rock checks and armoury. Not considered to be of concern.

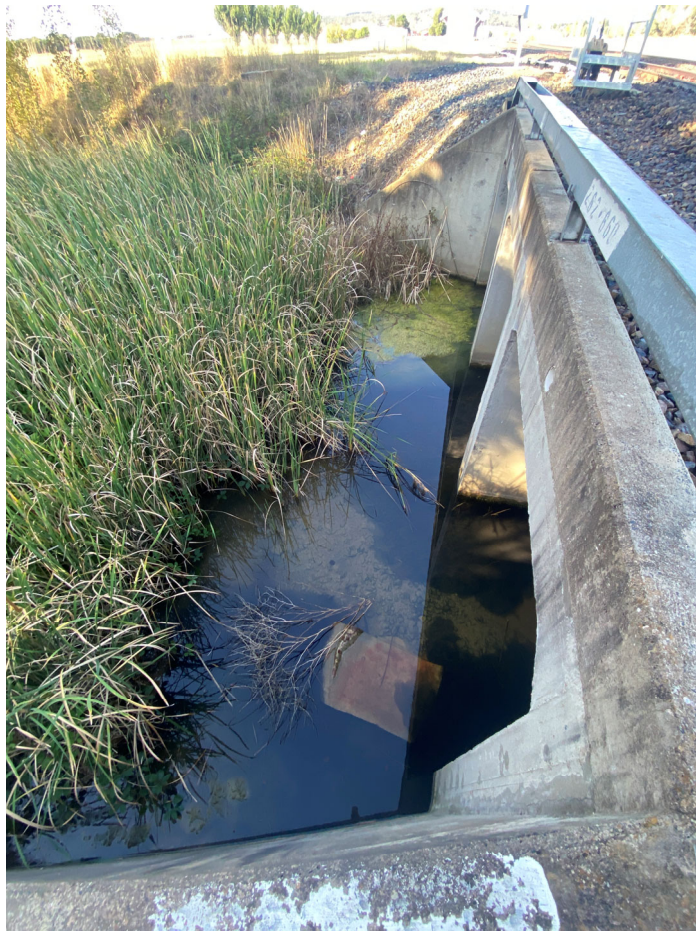
Photo 3: Downgradient of southern culvert showing very slow surface water run off from site. Water was clear with no turbidity and no visible sediment. Algal blooms seen in photo.

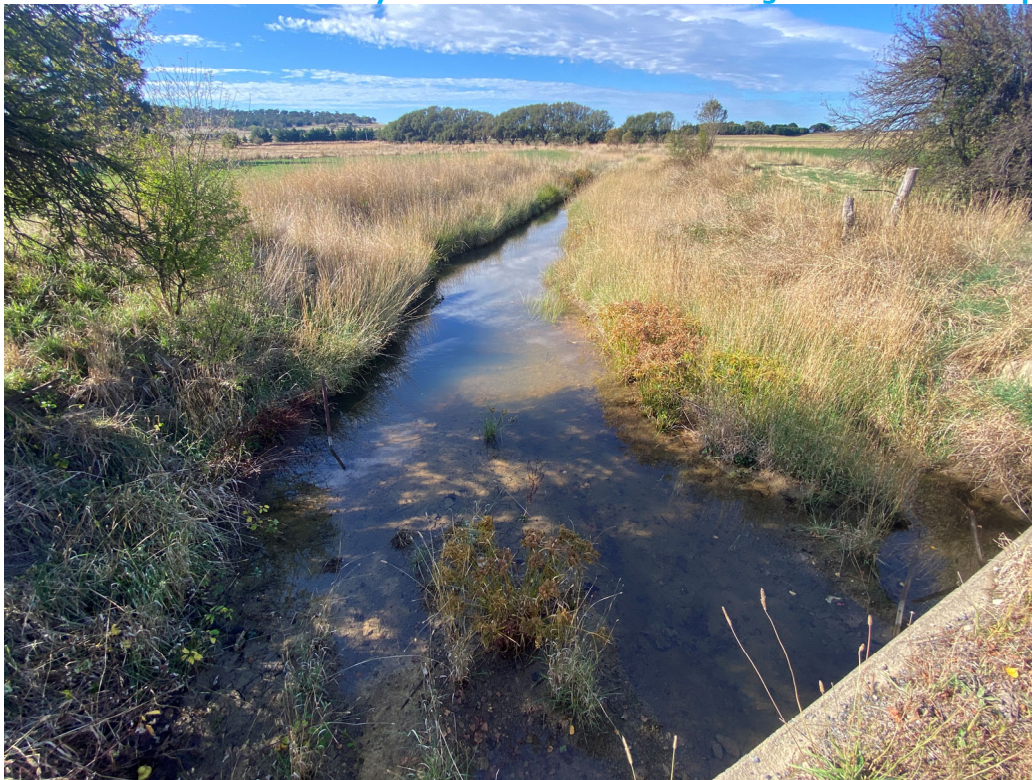
Photo 4: Culvert outlet under Golburn street, downgradient of southernmost culvert on site, showing surface water run off on site. Water clear with no visible evidence of sediment.

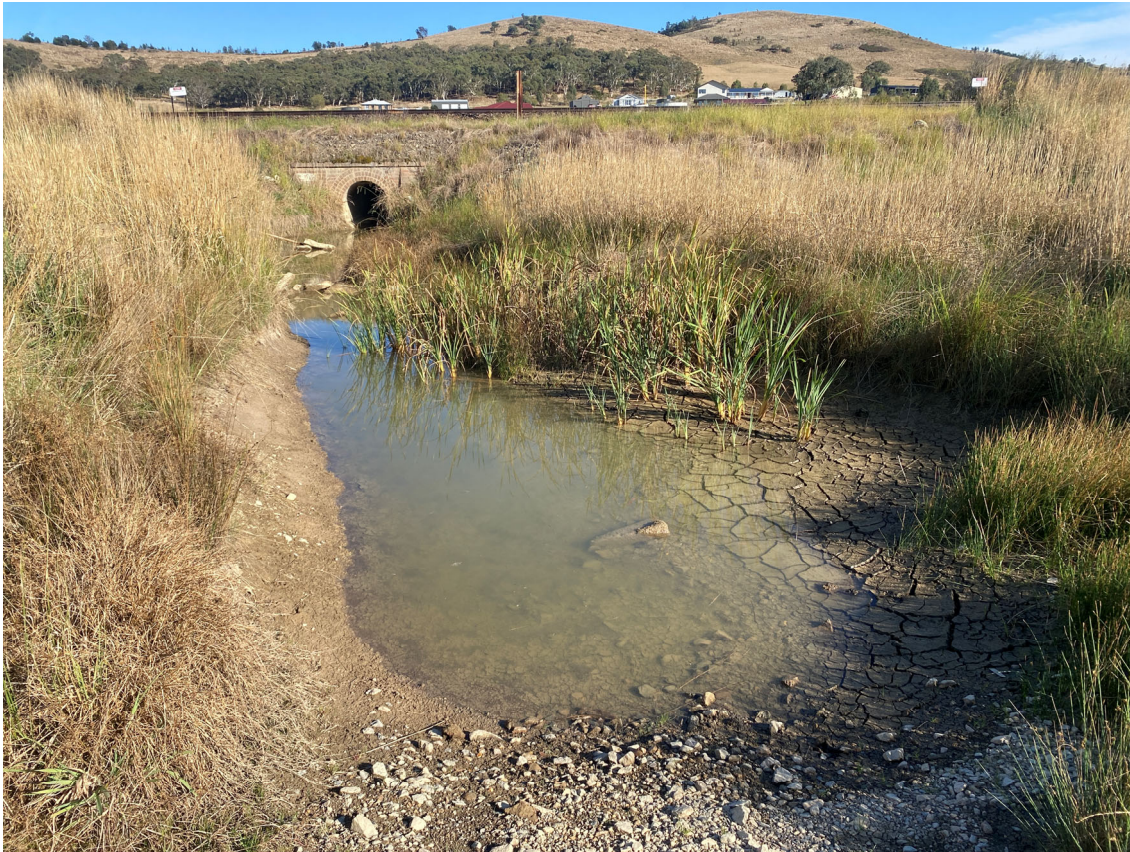
Photo 5: Downgradient of middle culvert. Pooled water but no evidence of current surface water run off on site. No sediment in water, slightly opaque from algae but low turbidity.

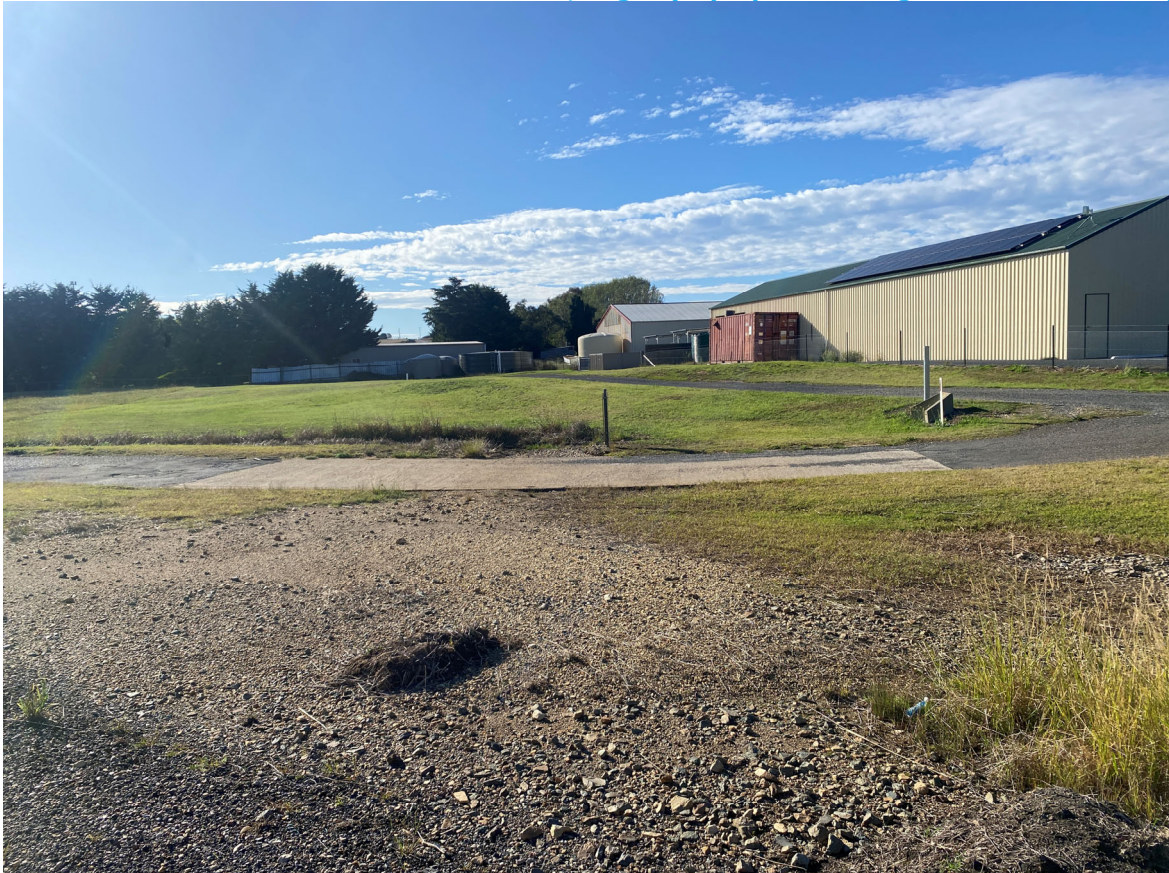
Photo 6: Causeway downgradient of middle culvert showing no evidence of current surface water run off on site. No visible sediment on road or vegetation nearby.

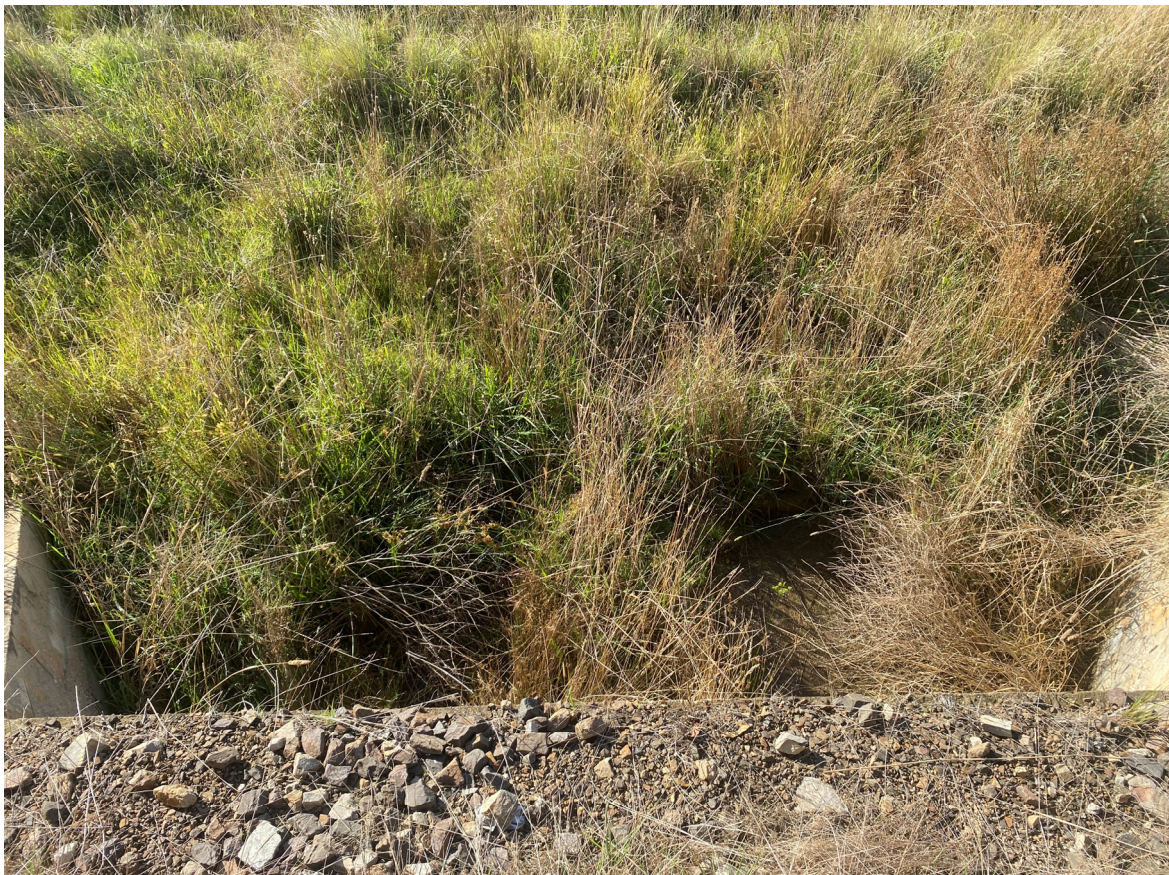
Photo 7: Downgradient of northernmost culvert facing private property, showing no evidence of surface water run off on site and no evidence of sediment from previous surface water on site.

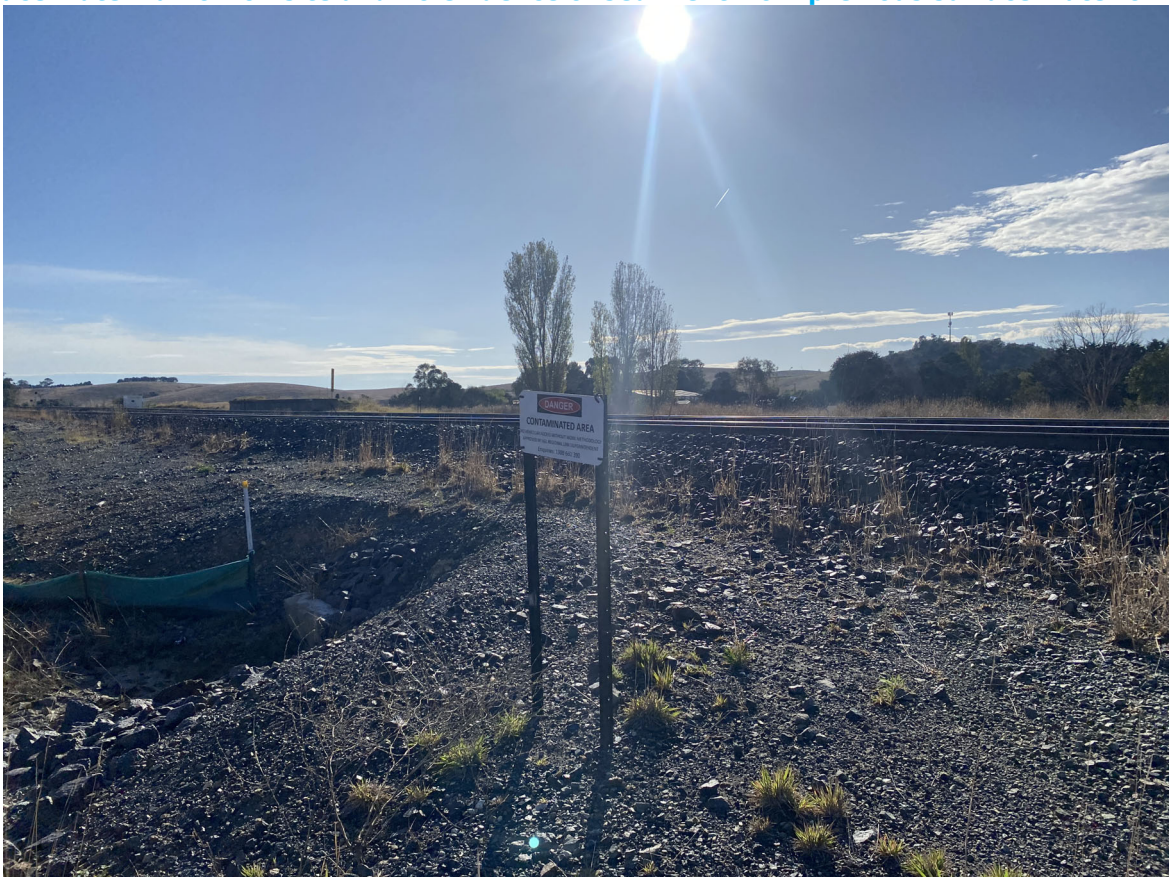
Photo 8: Exclusion zone signing placed periodically along contamination areas.

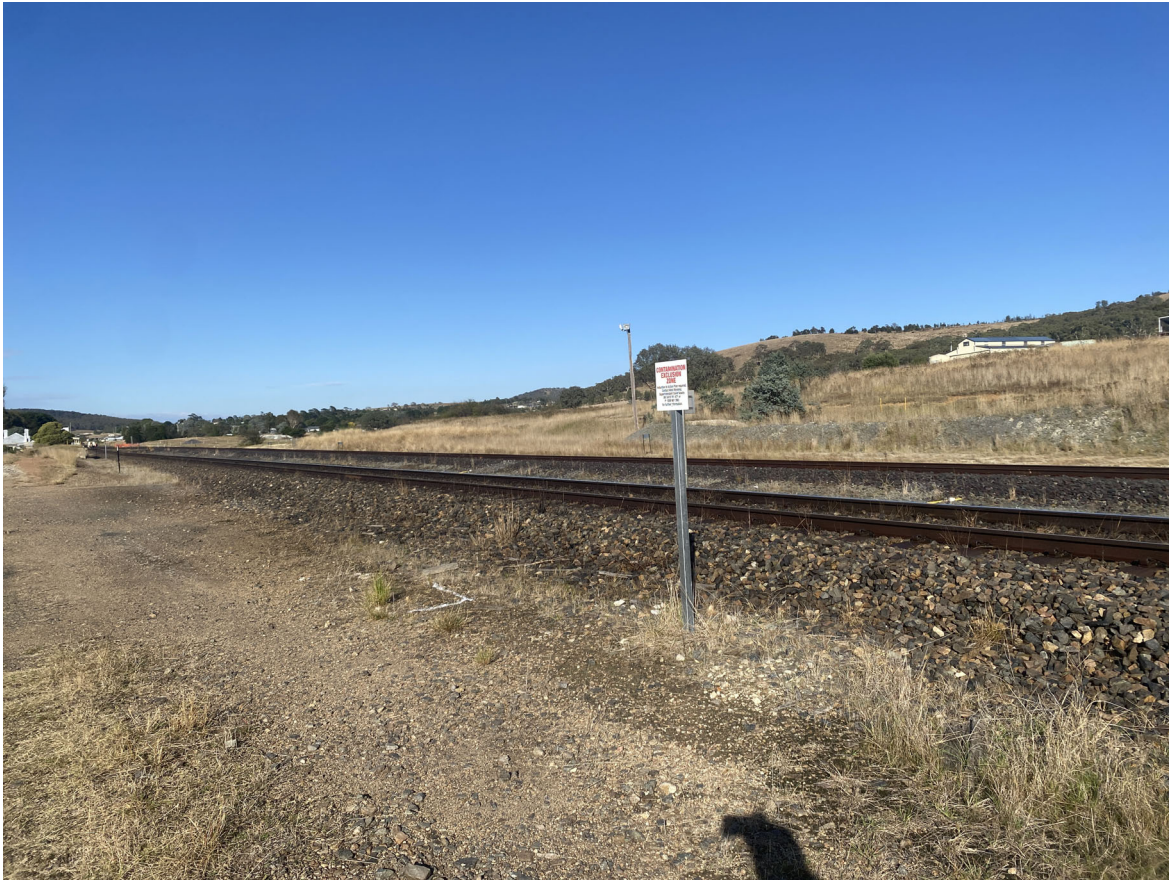
Photo 9: Additional exclusion zone signage placed periodically along contamination areas.

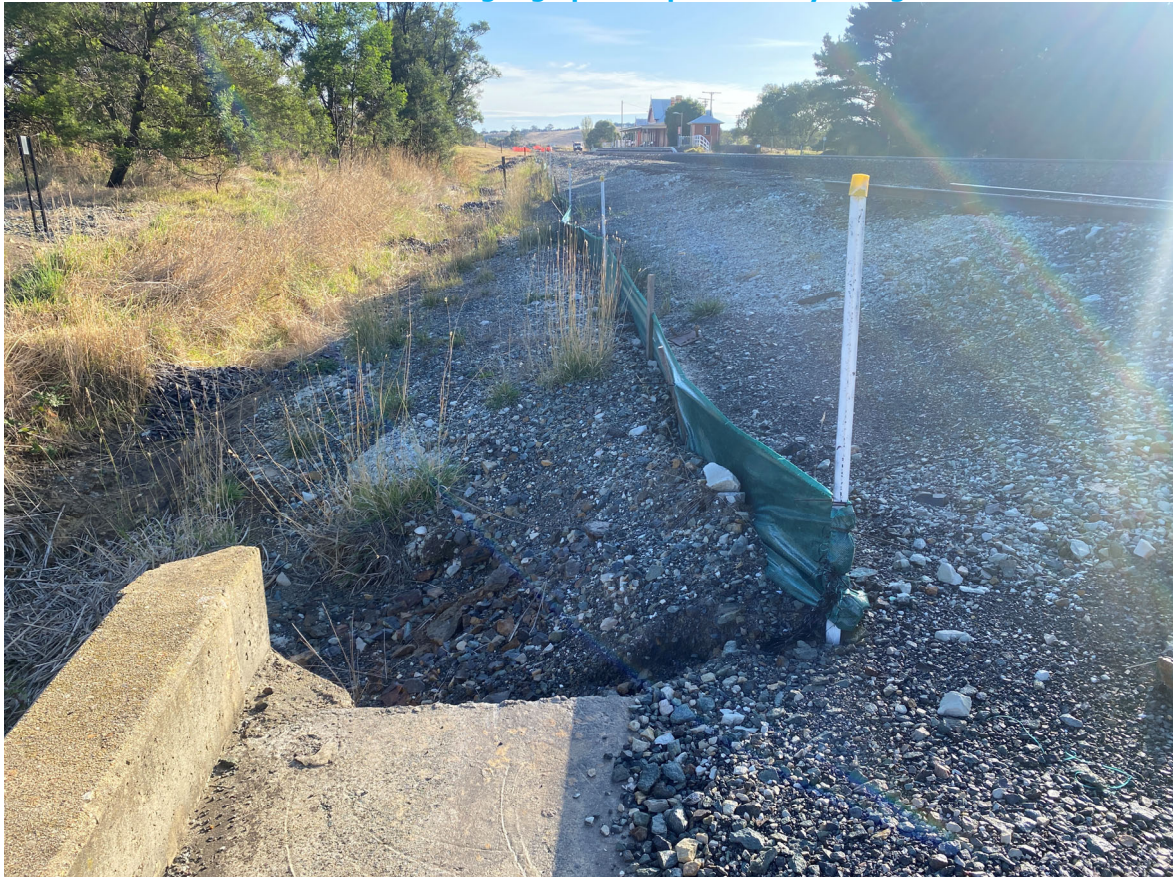
Photo 10: Upgradient of southernmost culvert showing rock armour within drainage line and silt fencing used as control measures for sediment control.

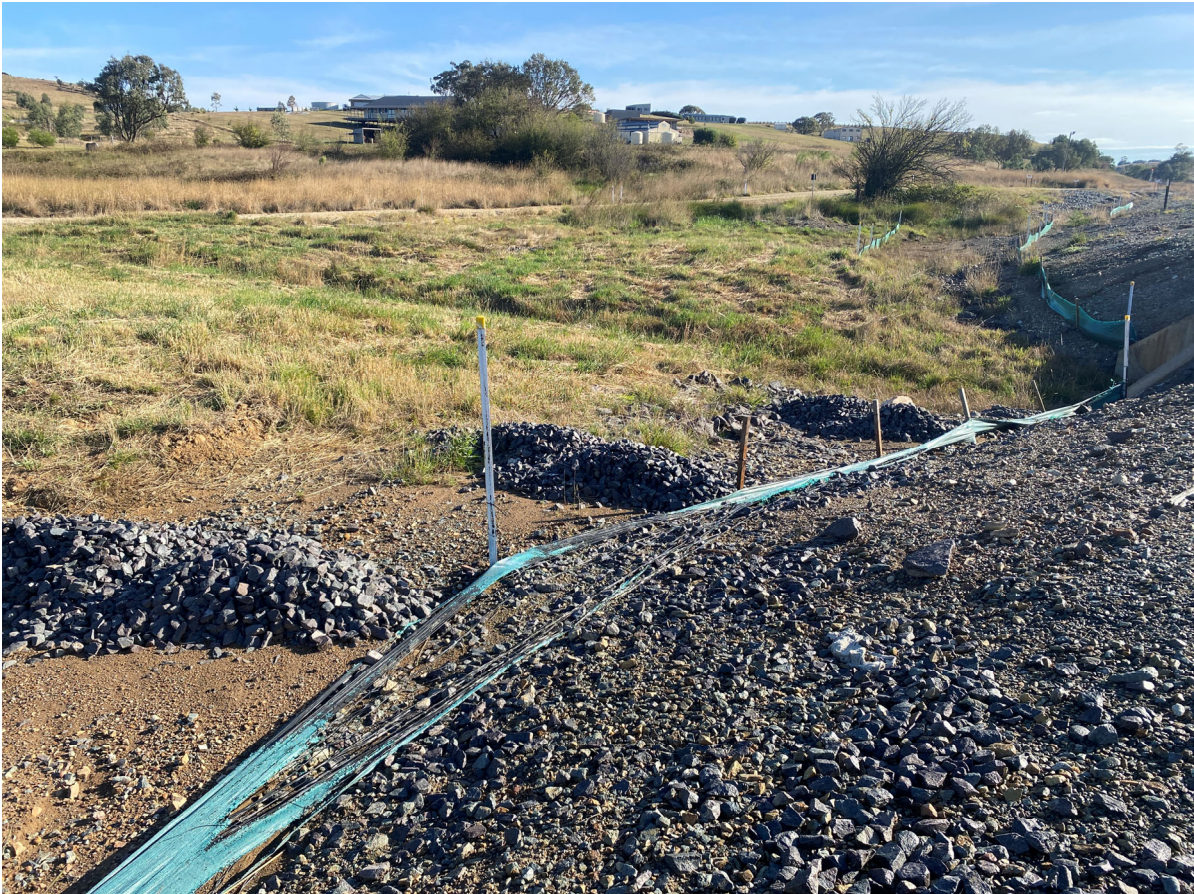
s	Control	Inspection		Corrective Action
		Yes	No	
5.1	Is Exclusion Zone signage present as recommended on Figures 2a - 2e Appendix 1 to demarcate contamination in the rail formation and adjacent soils?	Yes (Photos 8-9)		
	Is Exclusion Zone signage undamaged?	Yes, signage was in good condition (Photos 8-9)		
	Are sediment controls present in/adjacent each rail culvert?	Yes, rock checks and rock armour observed upgradient of each culvert, silt fencing west of former woodlawn siding and along cess drain feeding the south and middle culverts (Photos 10-12).		
	If sediment is present what is the estimated depth of sediment?	Minor sediment present in pooled water on site (Photo 2) (<1mm), sediment present on silt fencing (~1cm) (Photo 13)		
	Are sediment controls still functional?	Yes, with the exception of silt fencing located south west of middle culvert (Photo 11). Refer to 'Other Observations' for recommendations.

Photo 11: Rock checks and silt fences running towards the middle culvert. Major damage to silt fencing on southern side. No evidence of sediment build-up in rock armoury.

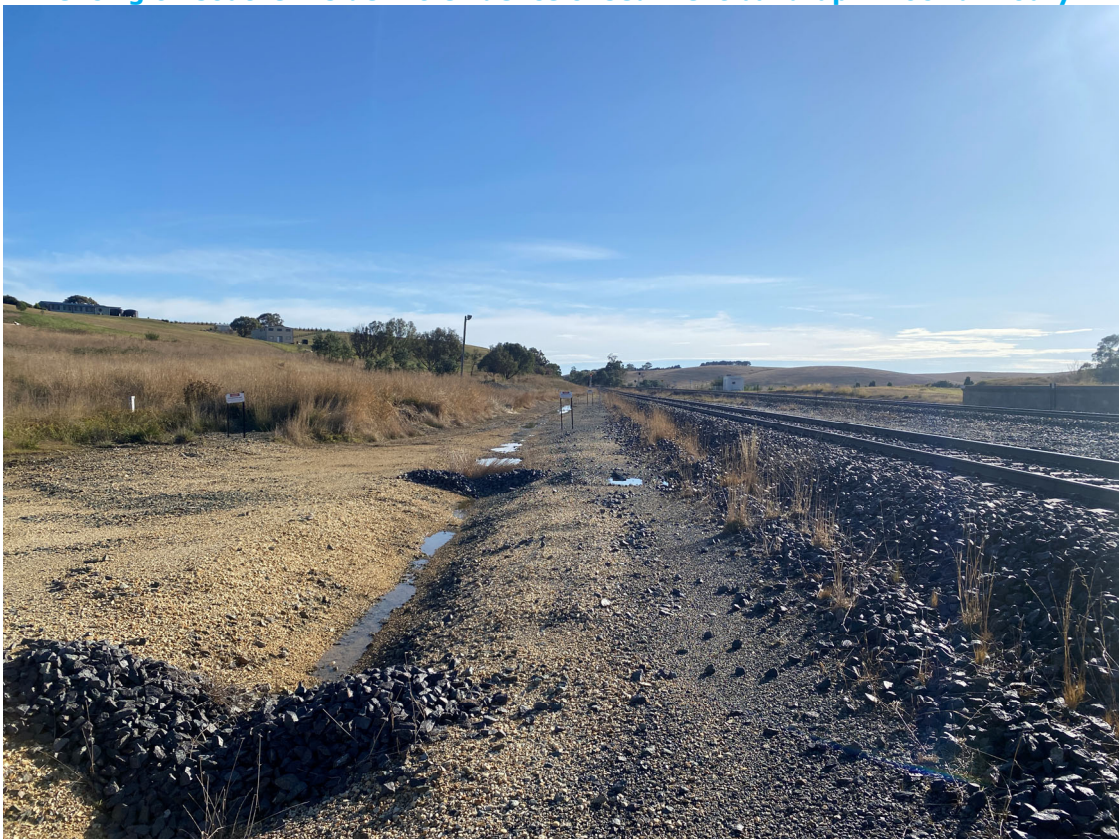
Photo 12: Pooled water with no sediment and sediment control measures of rock armoury within drainage trench towards northernmost culvert.

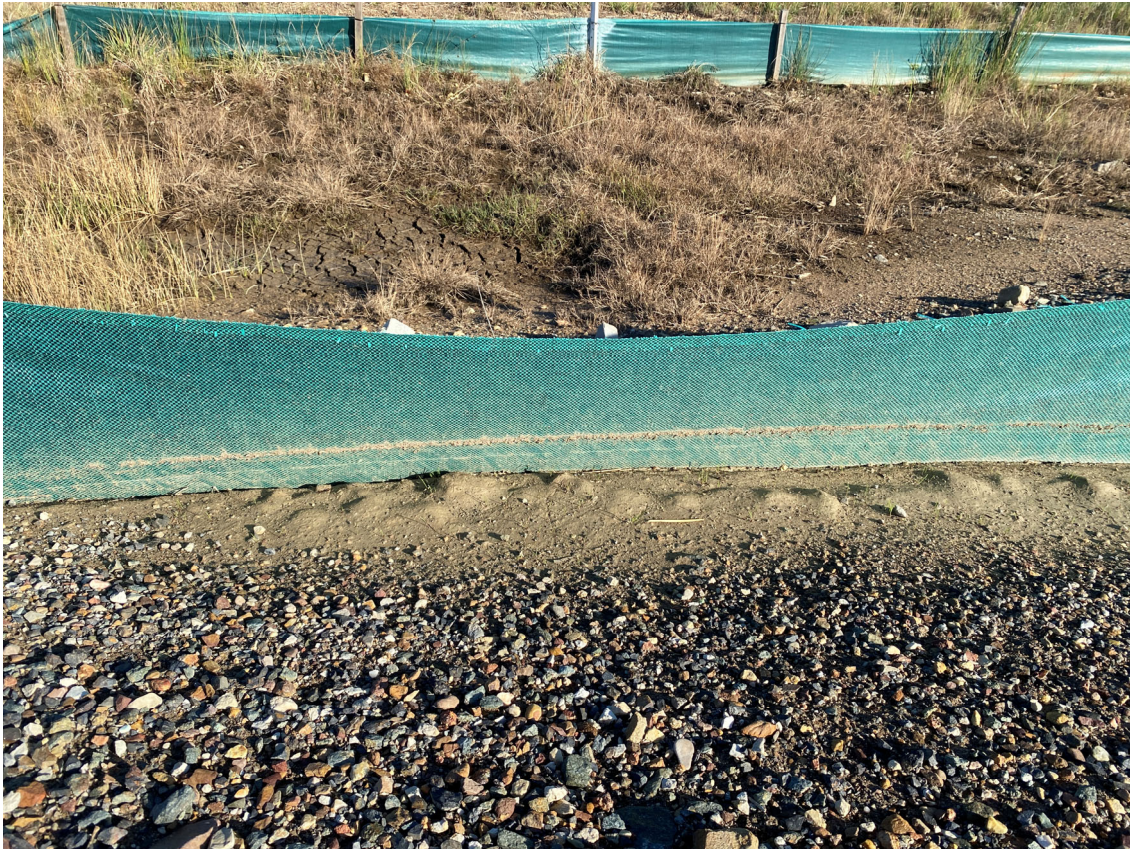
Photo 13: Sediment build up captured by silt fencing upgradient of middle culvert prior to drainage trench. Approximately 1cm build up.

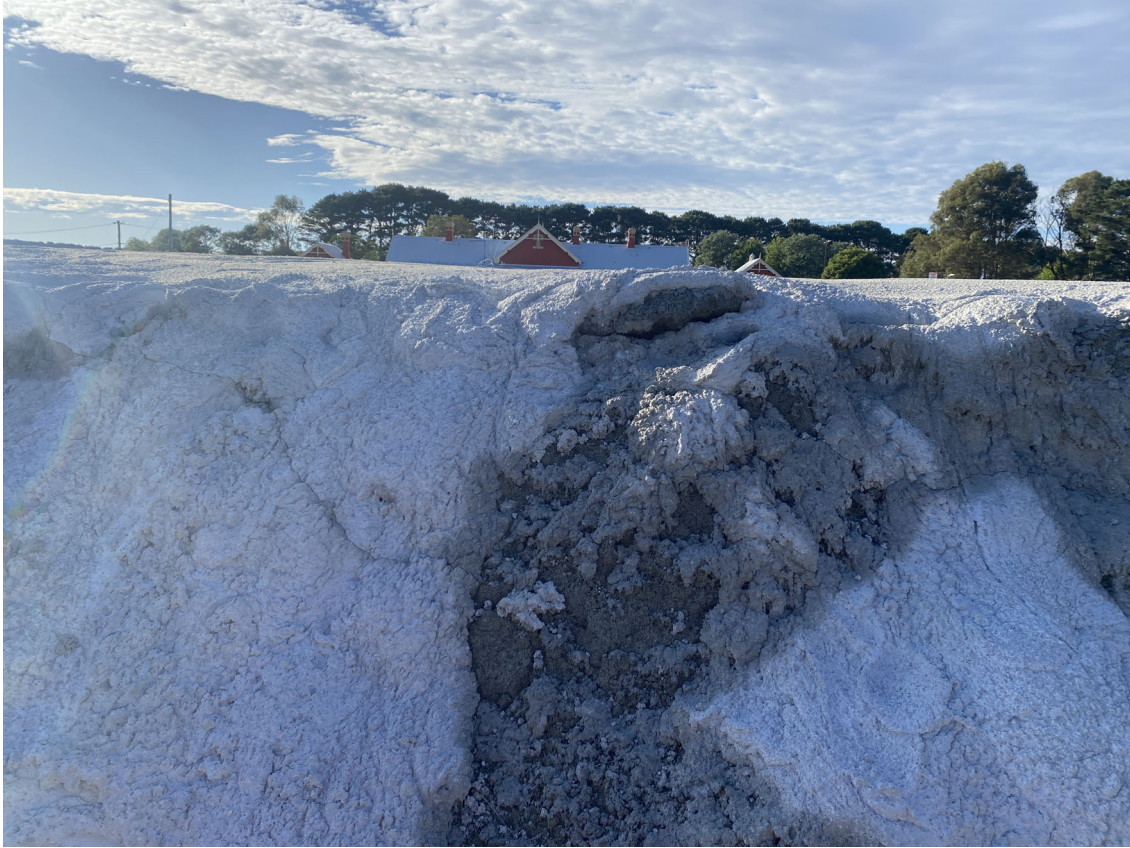
Photo 14: Minor hairline cracking on stabilised sand applied to the stockpile for capping running left to right on photo. Approximately 1-2mm x 3m.

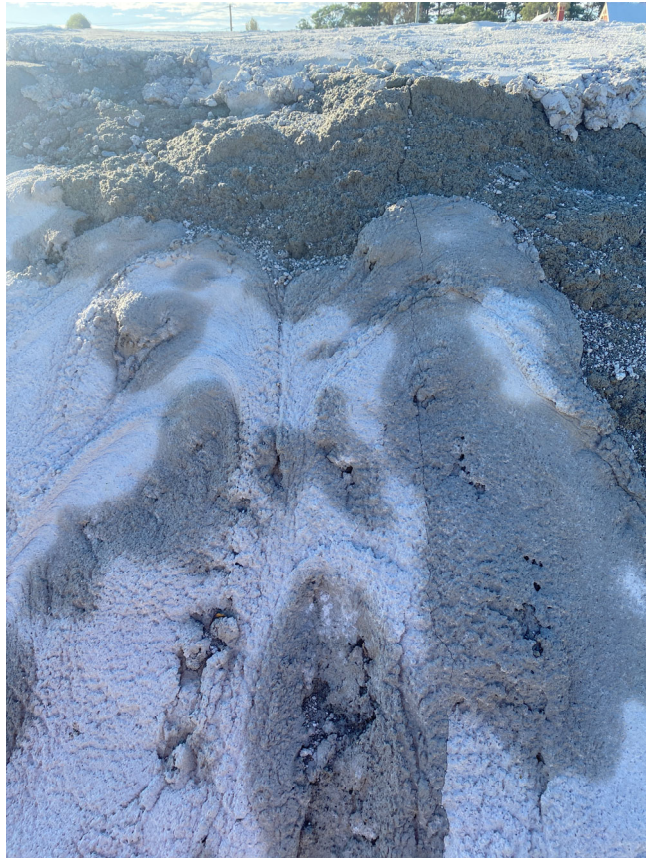
Photo 15: Minor hairline cracking in stabilised sand applied to the stockpile for capping. Approximately 1-2mm x 2m in size. Stable and not expected to allow for water infiltration.

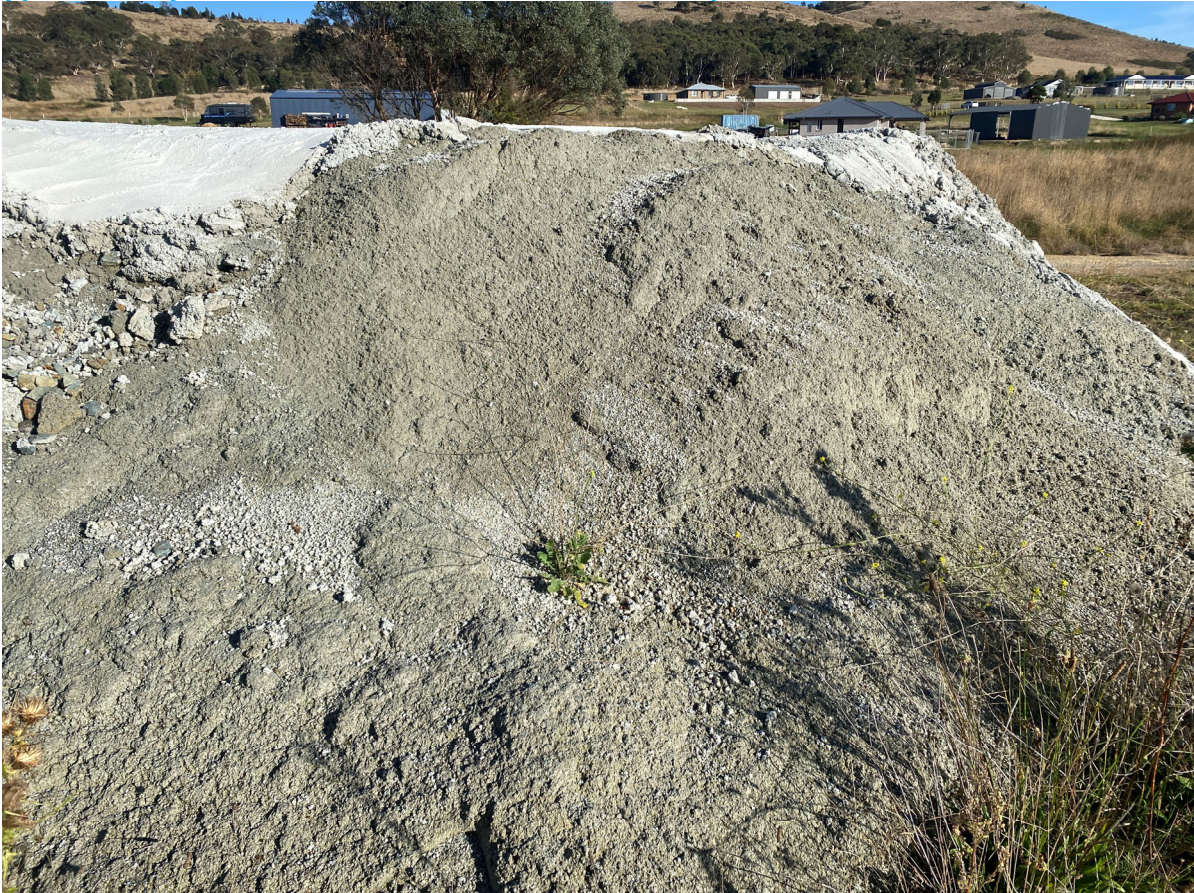
Is the existing stockpile covered securely to prevent surface water infiltration?	Yes, the existing stockpile is covered securely.		
	Are cracks present in the capping of the existing stockpile? If so record the width and length of cracks in written form and through photographs and consolidate with this checklist.	Yes, minor hairline cracking is present on the stockpile (observed during an inspection 15/03/23), these remain stable and are not expected to adversely affect cap competency in current condition. Further details and size provided in Photo 14-15 .		
	Are there signs of erosion or sediment run-off on or relating to the existing stockpile? If so record in written form and through photographs and consolidate with this checklist.	No. No erosion of, or sediment from the stockpile was observed.		
	Are there signs of vegetation on the existing stockpile? If so record in written form and through photographs and consolidate with this checklist.	Yes, minor weeds growing out of the side of the stockpile in multiple places (Photos 16-17). These are not expected to allow for water infiltration.

Photo 16: Minor vegetation (weeds) growing out of stockpile capping. No marker layer visible.

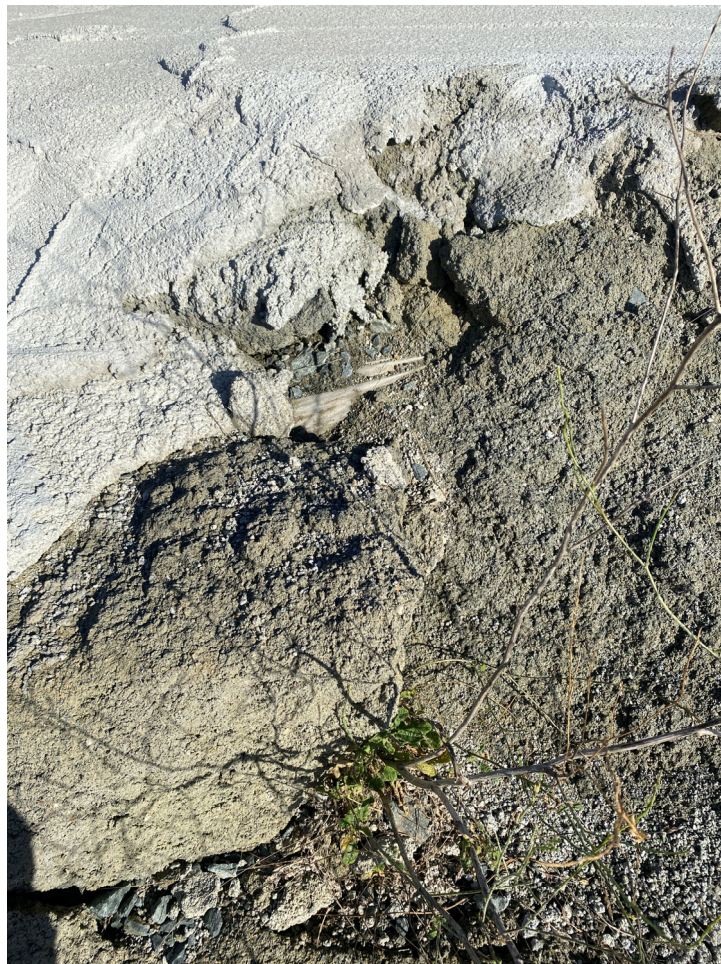
Is geofabric marker layer visible beneath capping of the existing stockpile? If so record in written form and through photographs and consolidate with this checklist. If marker layer is visible rectification work is required.	Yes, geofabric marker layer visible in two locations on east of stockpile. Location and size detailed in Photos 17-18 , refer to 'Other Observations' section for recommendations. Weeds observed nearby to marker layer exposure, consider weed removal.

Photo 17: Stockpile marker layer exposure nearby minor vegetation growing out of capping. Approximately 10cm x 5cm. Ramboll recommends patching using sand and cement mixture.

Is there evidence of excavation or other works non-compliant with the Action Plan?		
No		
Other observations?		
<p>As per recommendation from previous Inspection Checklist (dated 15-Mar-23), UGL staff were on site to remove the redundant fencing on the eastern site boundary next to the Station Masters Cottage (Photo 19) and to place a geofabric filter around the drain inlet between the main and loop lines (Photo 20). It is understood that wet weather has prohibited maintenance of vegetation on the stockpile.</p> <p>No sediment loading was observable in rock checks and armour. All locations with rock checks and armour remained in good condition.</p> <p>Silt fences were all in good condition with the exception of major damage to the silt fencing uphill of the rail line (western side) and to the south of the middle culvert (Photo 11). This damage was not present at time of last inspection on 15/03/2023. Ramboll recommends this silt fencing be replaced as soon as possible.</p> <p>Minor marker layer exposure was noted in two places on the eastern side of the stockpile (Photos 17-18). Ramboll recommends repairing these by patching with sand and cement mixture.</p>

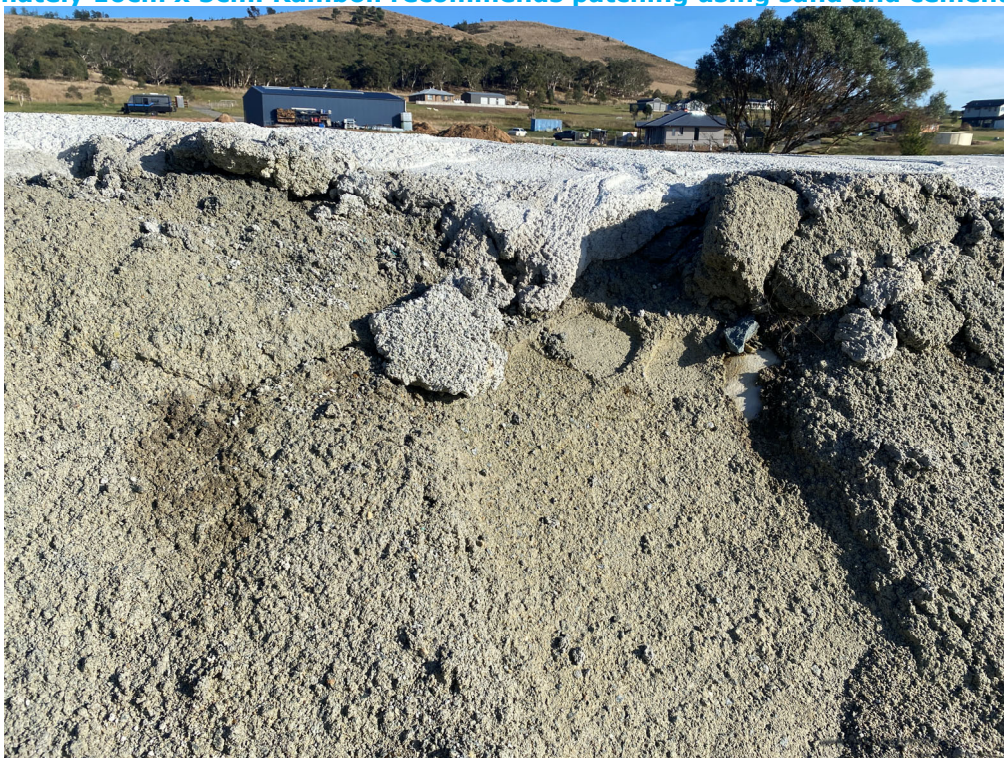
Photo 18: Stockpile marker layer exposure in capping (middle right in photo). Approximately 2cm x 3cm. Ramboll recommends patching using sand and cement mixture.

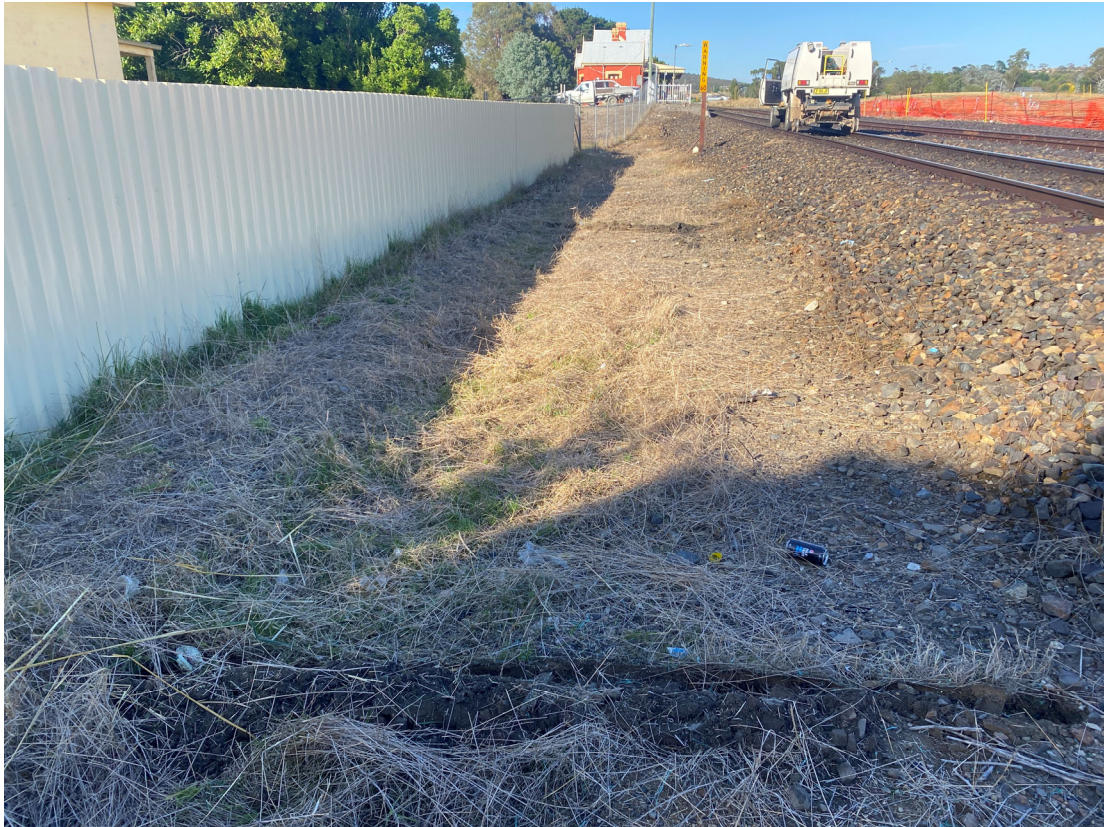
Photo 19: UGL on site. Removed damaged redundant silt fencing adjacent to the boundary of the Station Masters Cottage as per recommendations from Inspection Checklist dated 15-Mar-23.

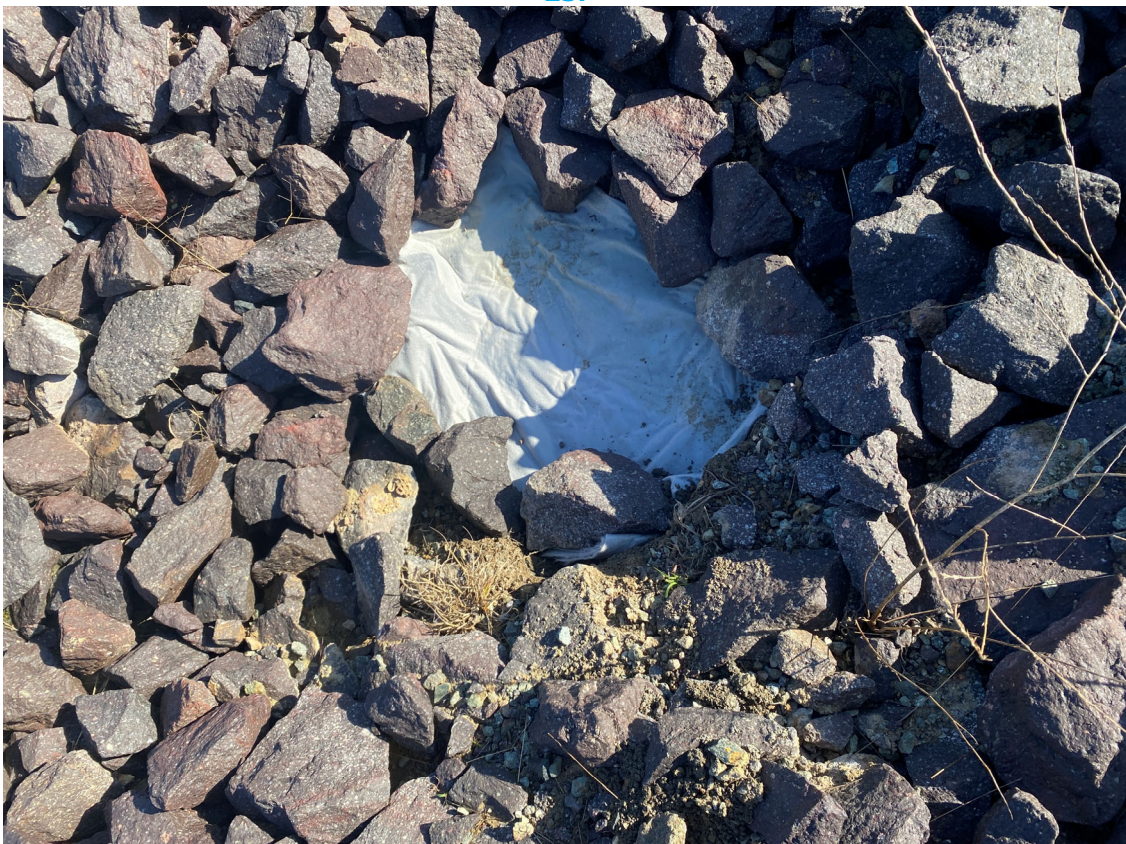
Photo 20: UGL on site. Placed geofabric filter over drain inlet between the main and loop lines as per recommendations from Inspection Checklist dated 15-Mar-23.
