# Tarago Action Plan Routine Inspection Checklist

<b>Title:</b> Tarago Rail Yard Inspection	<b>Approved:</b> SM	<b>Project-Nr.:</b> 318001704	<b>Date:</b> July 2023
<b>Site:</b> Tarago, NSW			
<b>Client:</b> UGL Regional Linx

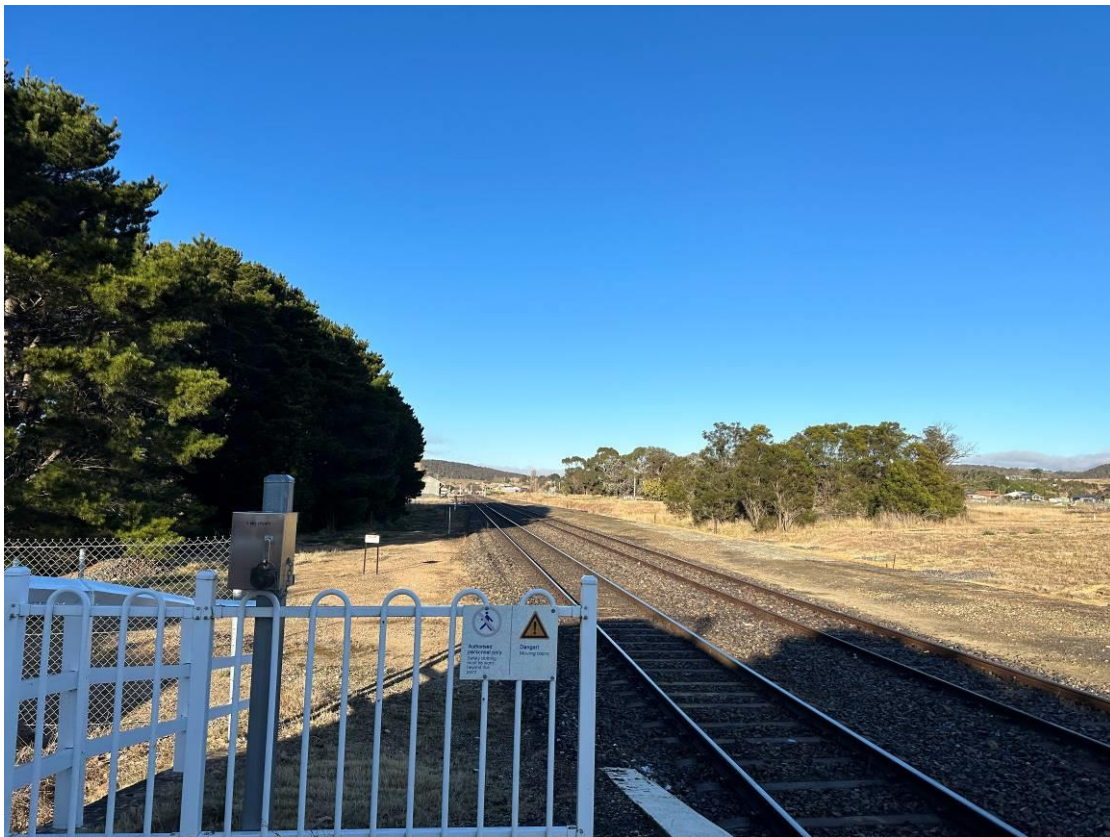
**Photo 1: Picture at southern end of railway station facing south west. No airborne dust visible in air or on surfaces.**

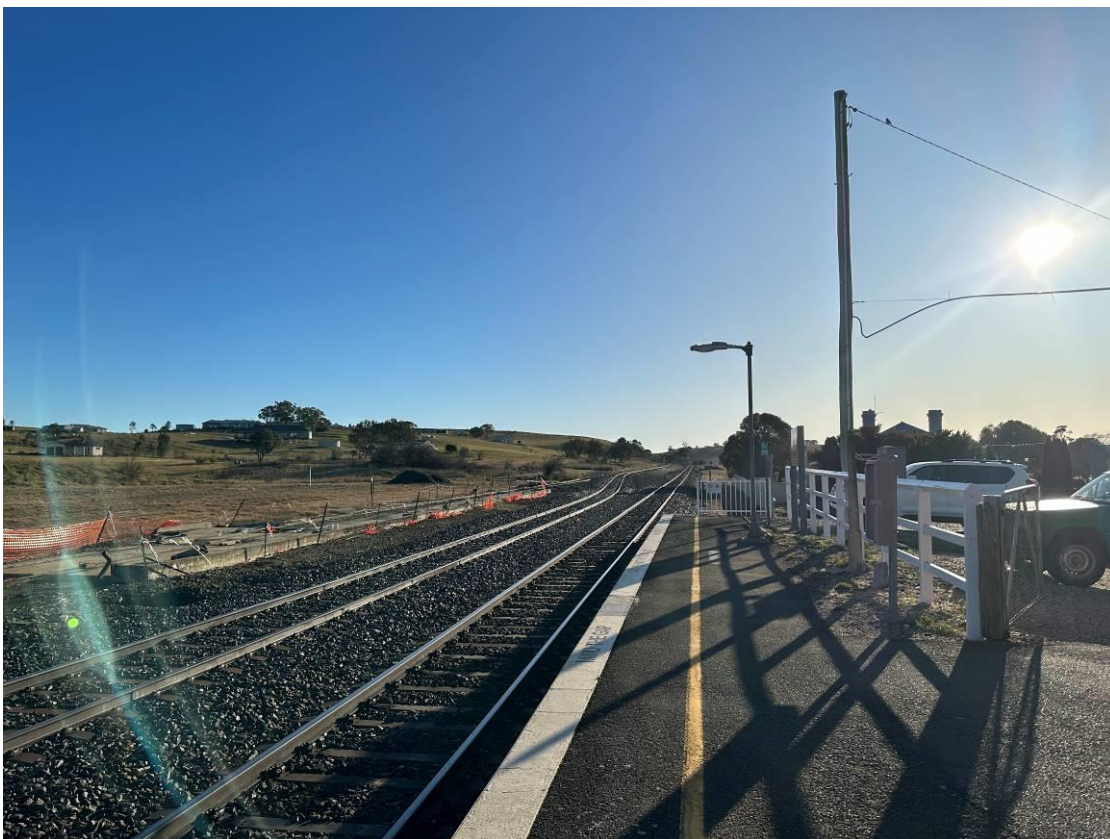
**Photo 2: Picture at northern end of railway station facing north west. No airborne dust visible in air or on surfaces.**

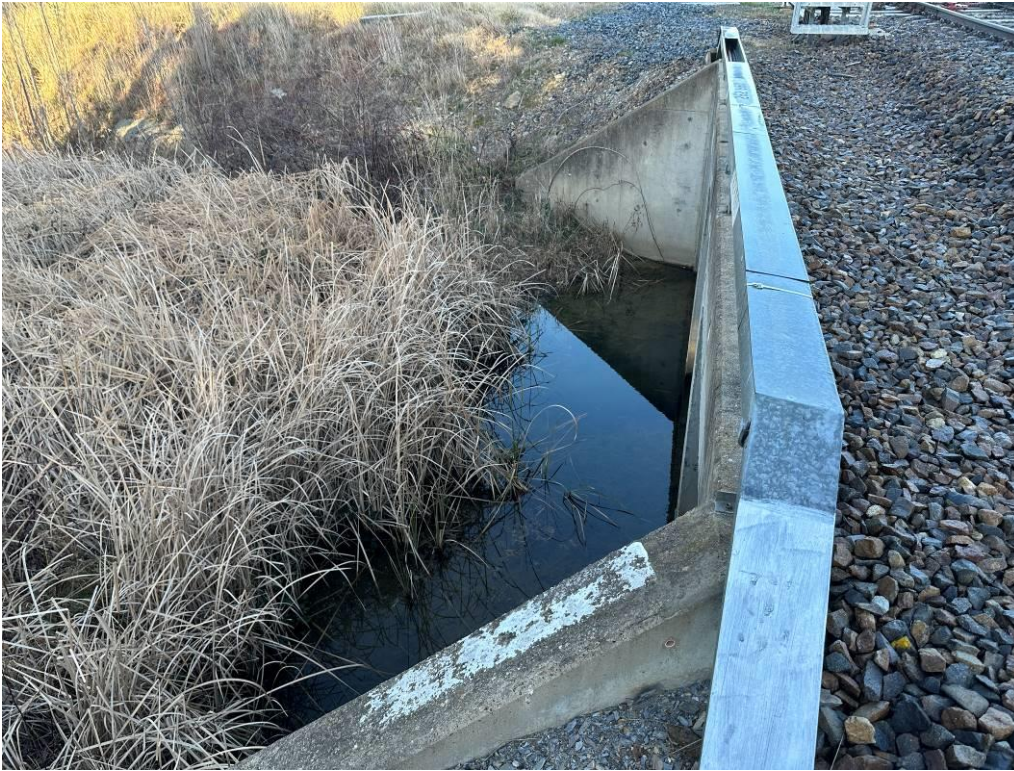
Is surface water discharging from site?		
Yes. Surface water discharging at a slow rate from the southern culvert ( <b>Photo 3</b> ). Some pooled water observed on site and immediately downstream of middle culvert but not discharging off site ( <b>Photos 4 - 6</b> ). No surface water at northern culvert ( <b>Photos 7 - 8</b> ).		
Is there evidence of excavation or other works non-compliant with the Action Plan?		
No		
Other observations?		
<p>Regarding the stockpile, four new marker layer exposure locations were identified (<b>Photos 19 - 21</b>), Ramboll recommends repairing these by patching with sand and cement mixture.</p> <p>Evidence of erosion was noted upgradient of the southern most culvert in previous site inspection and remains on site but stable (<b>Photo 9</b>). However, no evidence of sediment was found in water flowing offsite at southern culvert. Ramboll recommends replacing ground cover material (ballast) if further erosion occurs or sediment is visible in the downstream surface water of the southern culvert.</p> <p>Evidence of build up of sediment in some silt fences upgradient of middle culverts was noted in the previous report. It was recommended to remove silt build up on fences. Fencing appears to have been cleared of sediment (<b>Photo 14</b>).</p>

**Photo 3: Southern most culvert downgradient of rail line, showing evidence of surface water run off on site. Water is clear, no turbidity, with no observable sediment, long grass and some algae present.**

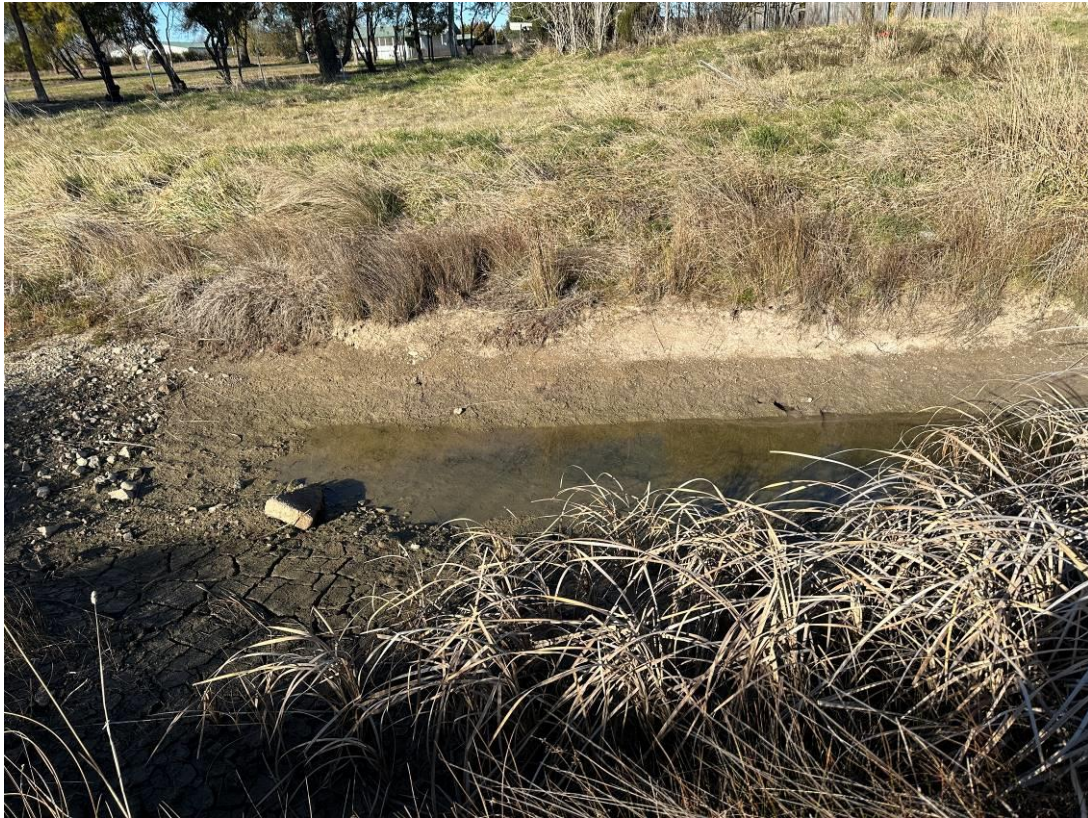
**Photo 5: Downgradient of middle culvert. Dry beyond the pooled water and no evidence of current surface water run off on site.**

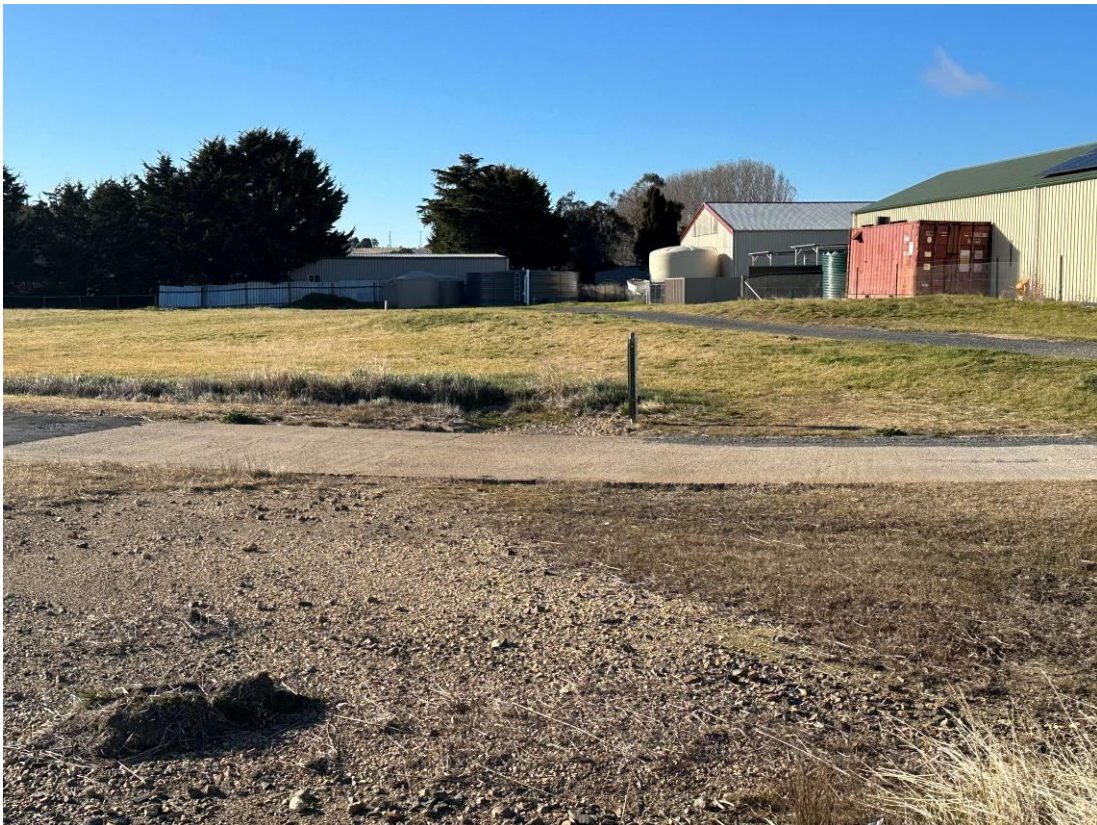
**Photo 6: Causeway downgradient of middle culvert showing no evidence of current surface water run off on site. No visible sediment on road or vegetation nearby from sediment water was running off site in between inspections.**

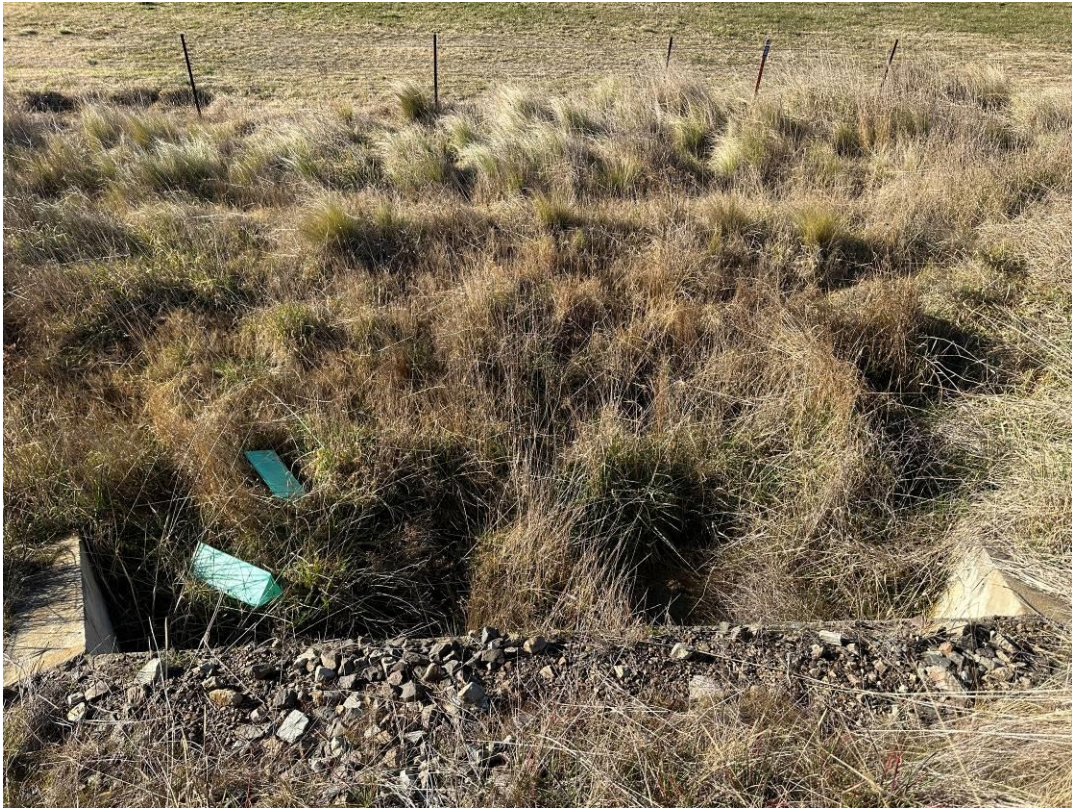
**Photo 7: Downgradient of northernmost culvert showing evidence of no surface water runoff from site to neighbouring property.**

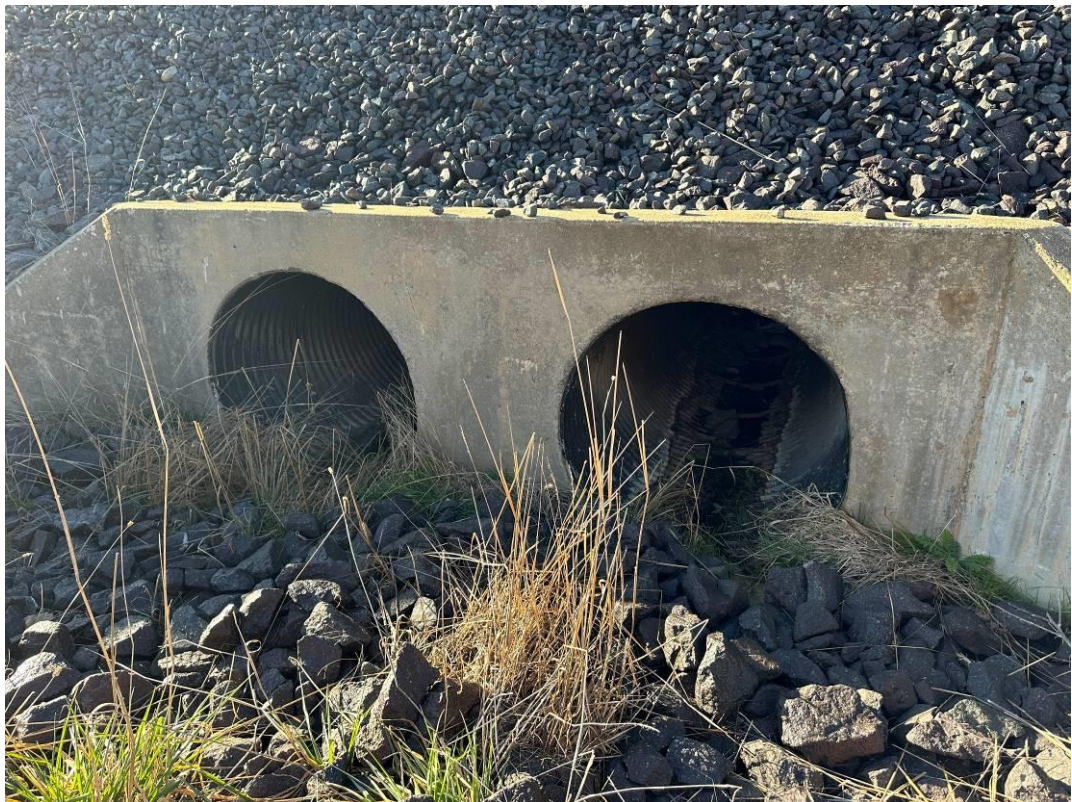
**Photo 8: Upgradient of northernmost culvert showing evidence of no surface water surrounding.**

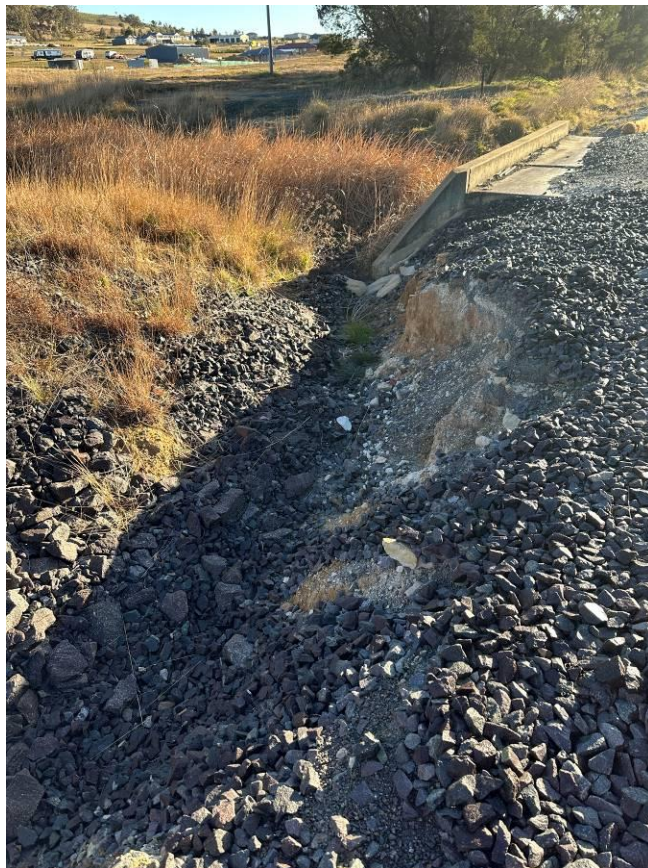
**Photo 9: Visible evidence of erosion due to loss of ground cover (ballast material) upgradient of southernmost culvert. Remaining stable and no major further erosion since last inspection. Facing north.**

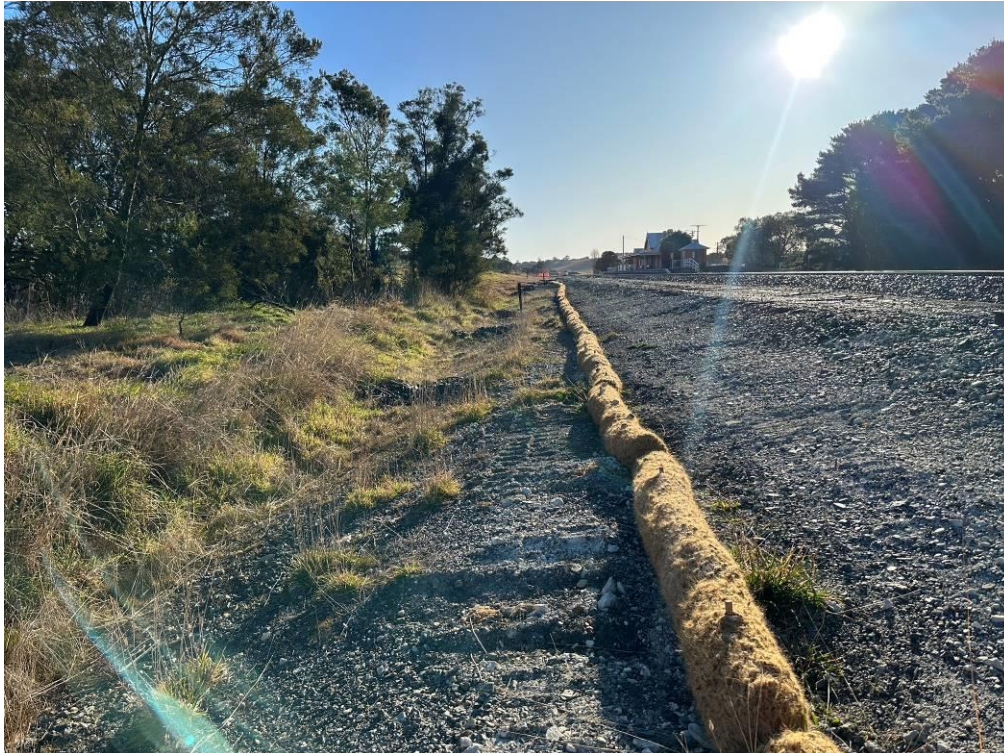
**Photo 10: Upgradient of southernmost culvert showing previous silt fencing replaced by Coir sediment control logs, used as control measures for sediment control. Facing north.**

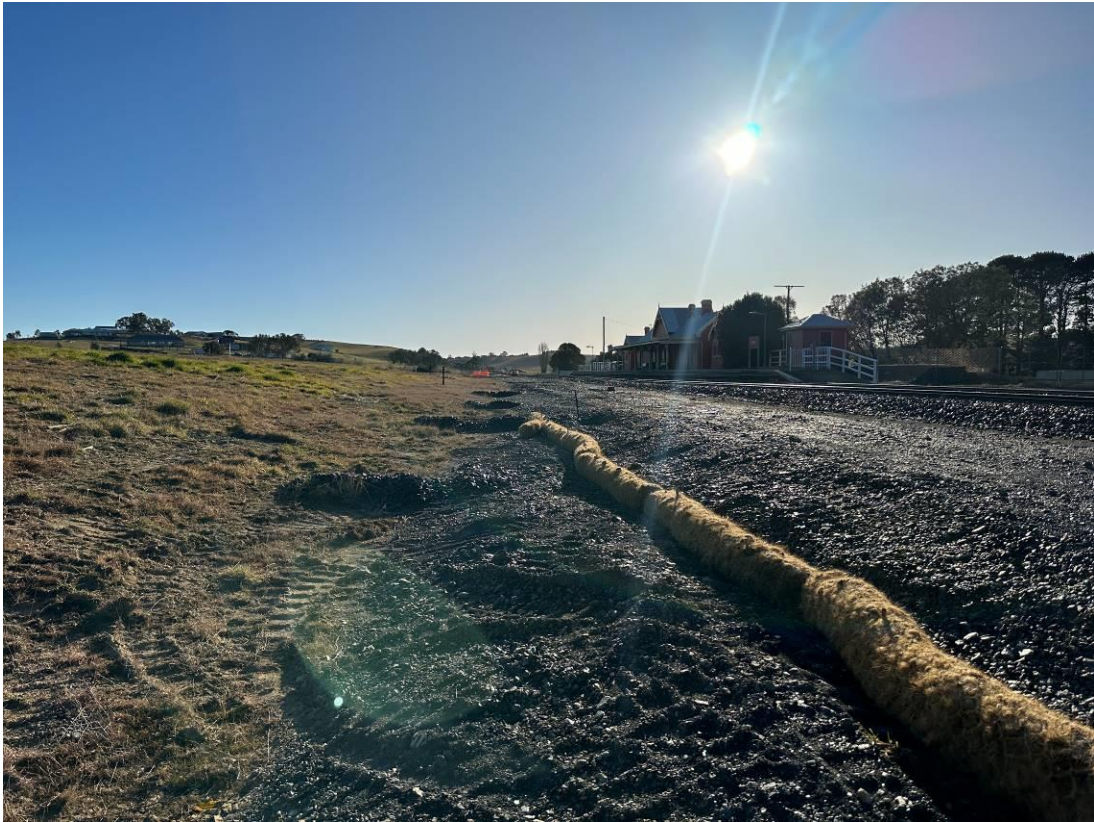
**Photo 11: Rock checks running along former Woodlawn siding and between southern and middle culverts. Silt fencing replaced by Coir sediment control logs.**

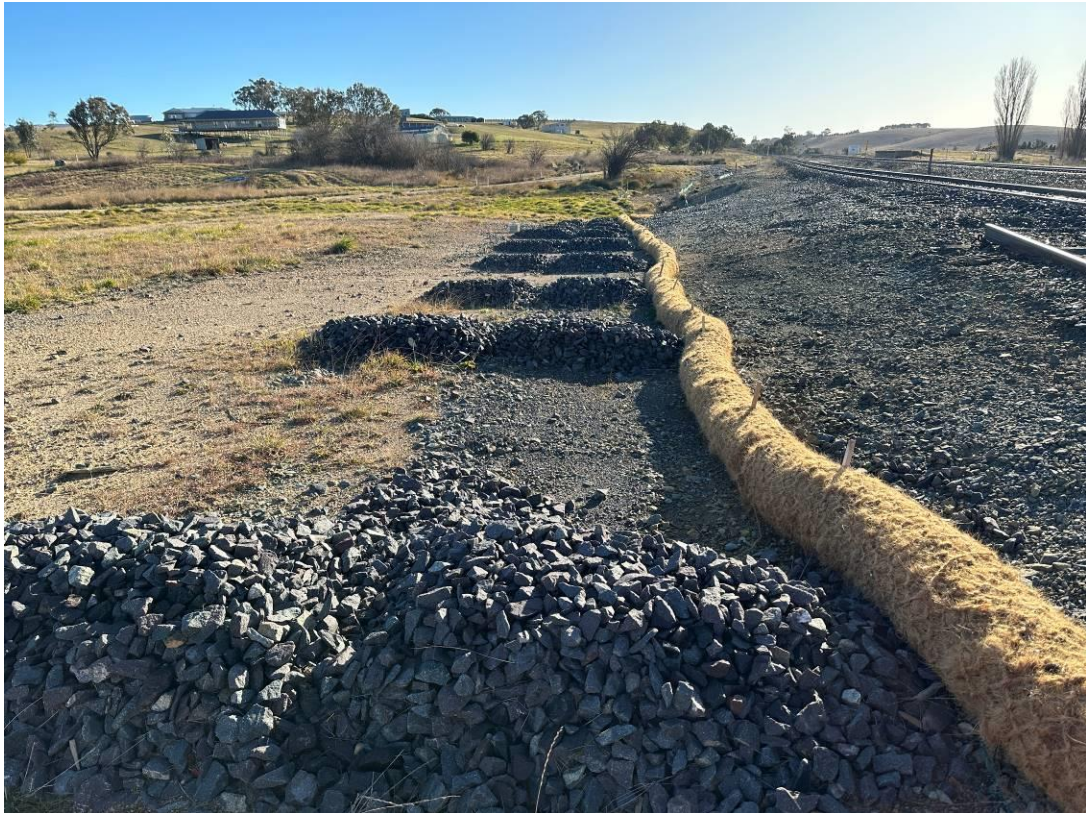
**Photo 12: Rock checks running alongside former Woodlawn siding towards the middle culvert. Previous silt fencing with major damage replaced by Coir sediment control logs as recommended in previous inspections. No evidence of sediment build-up in rock armoury.**

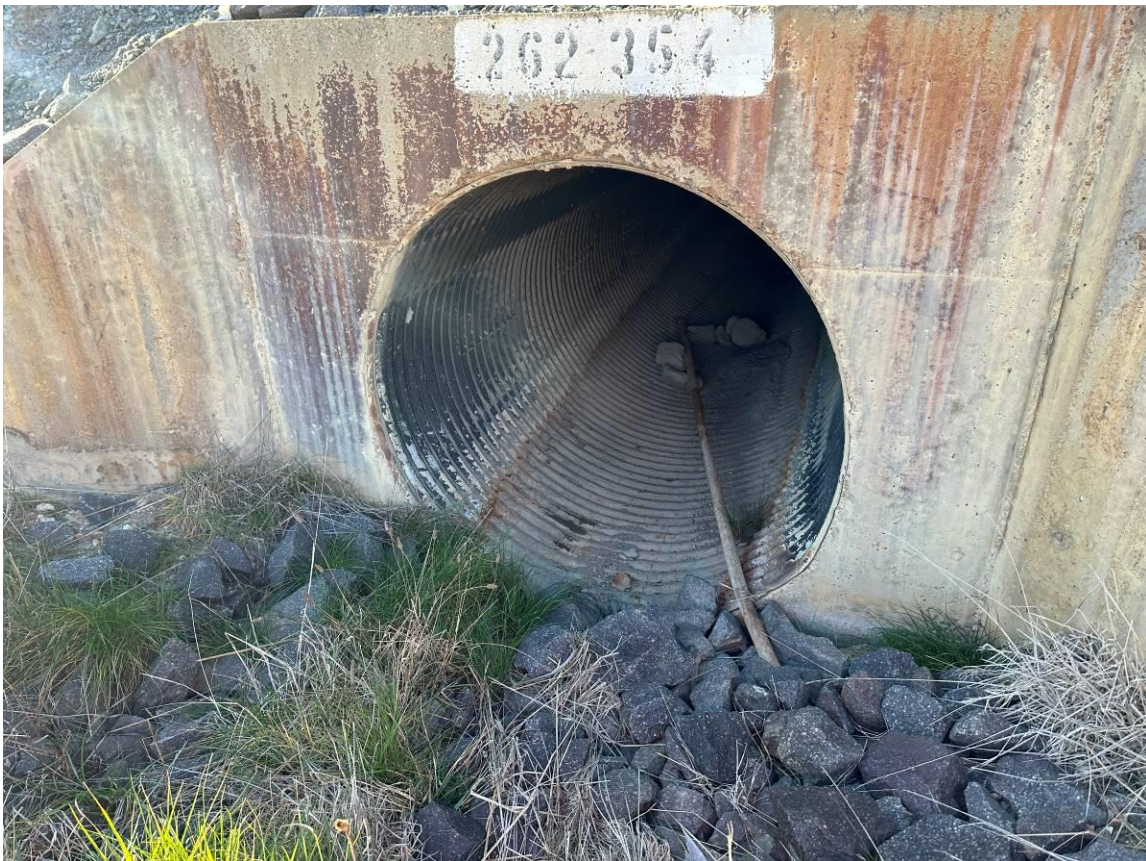
**Photo 13: Middle culvert showing no flowing or pooled water. No evidence of sediment build-up in culvert.**

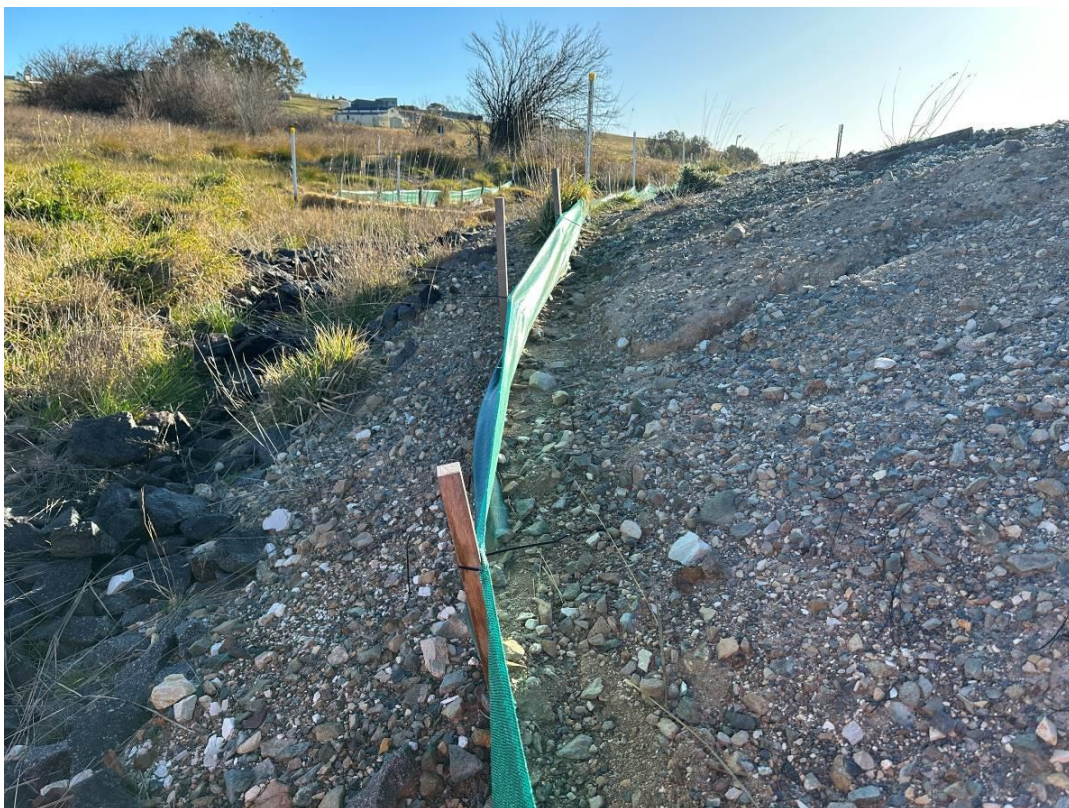
**Photo 14: Upgradient of trainline culvert facing north, showing minimal pooling on site near rock checks. Silt fencing appears to have been recently cleared and no sediment was visible.**

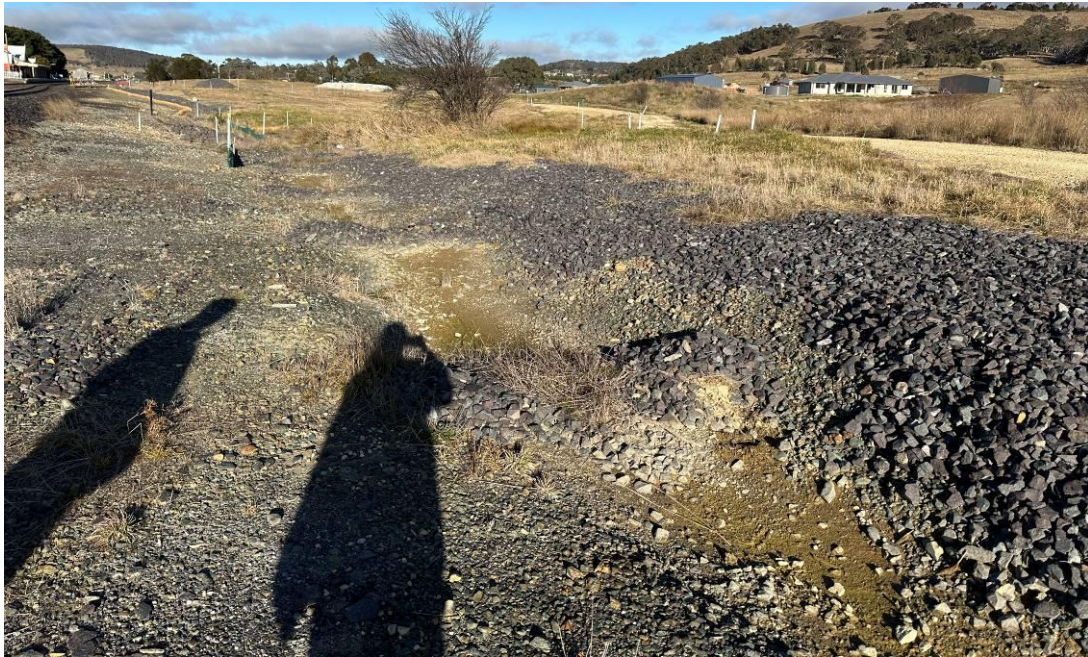
**Photo 15: Rock armour upgradient of trainline running from the middle to the north culvert. Some sediment visible on rock armour. Facing South West.**

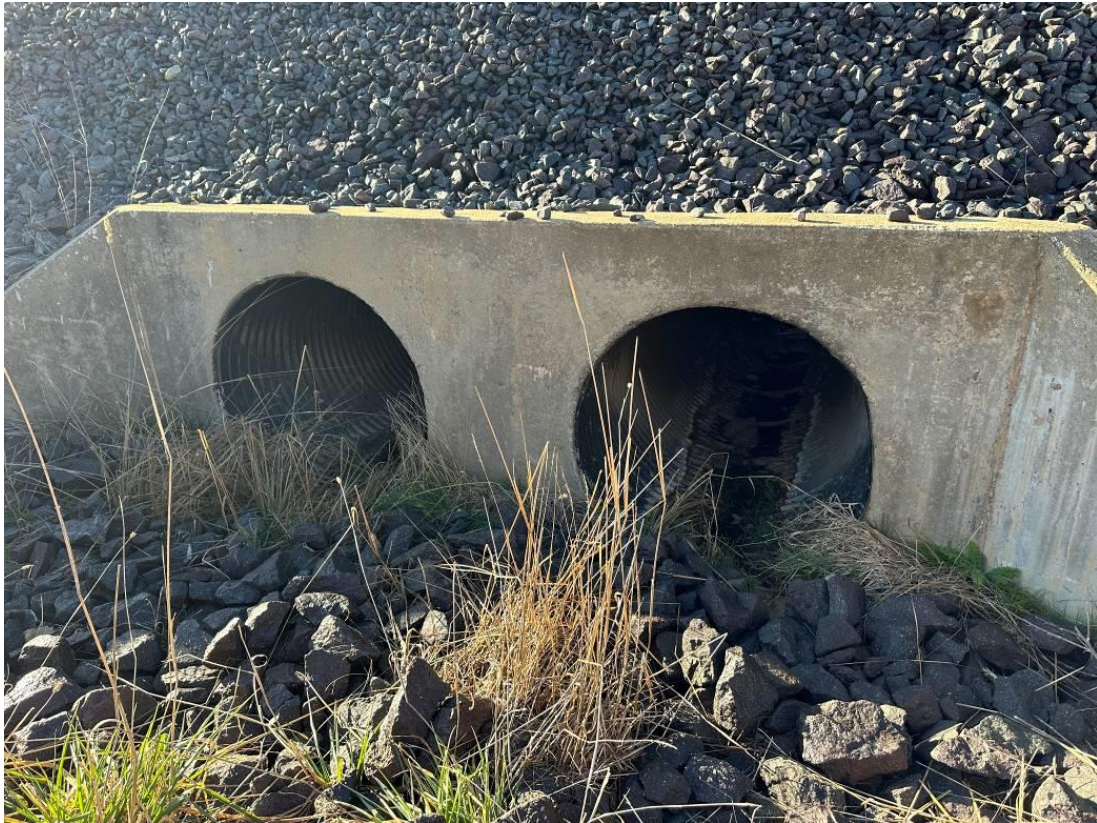
**Photo 16: Upgradient of northernmost culvert. No evidence of surface water run off on site. No evidence of sediment buildup on rocks. Rock armour and natural vegetation allow for sediment control in surface water.**

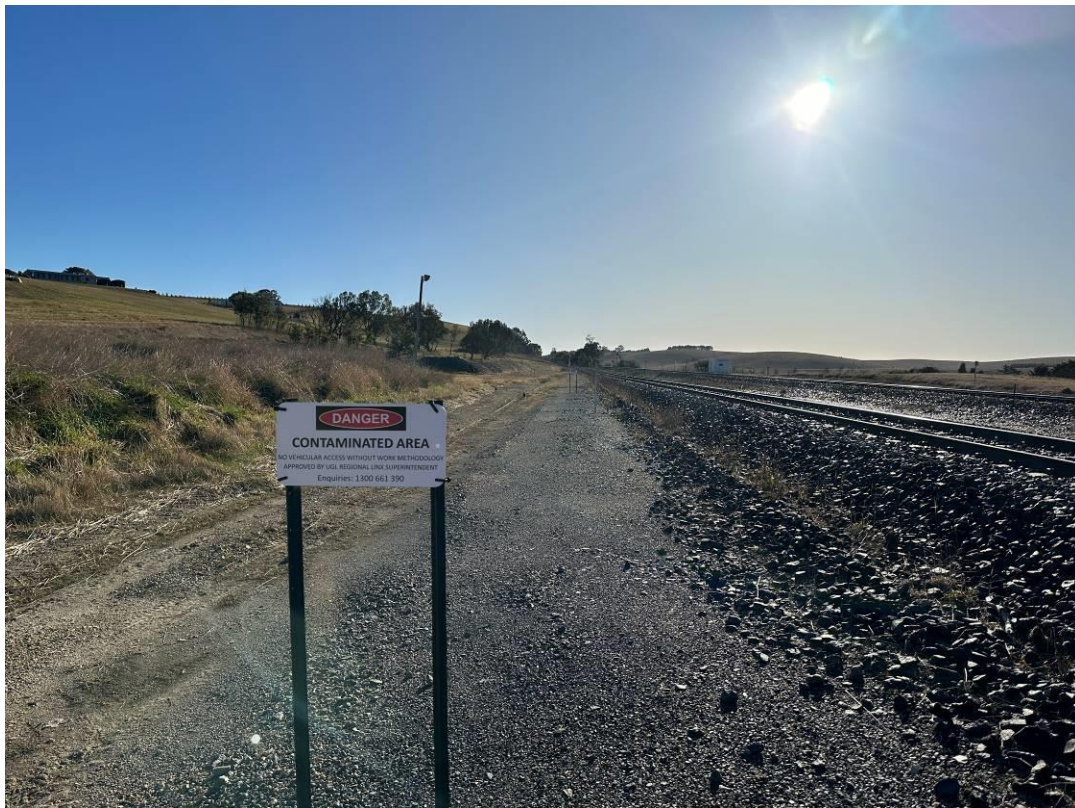
Photo 17: Exclusion zone signing placed periodically along contamination areas. Undamaged and in good condition.

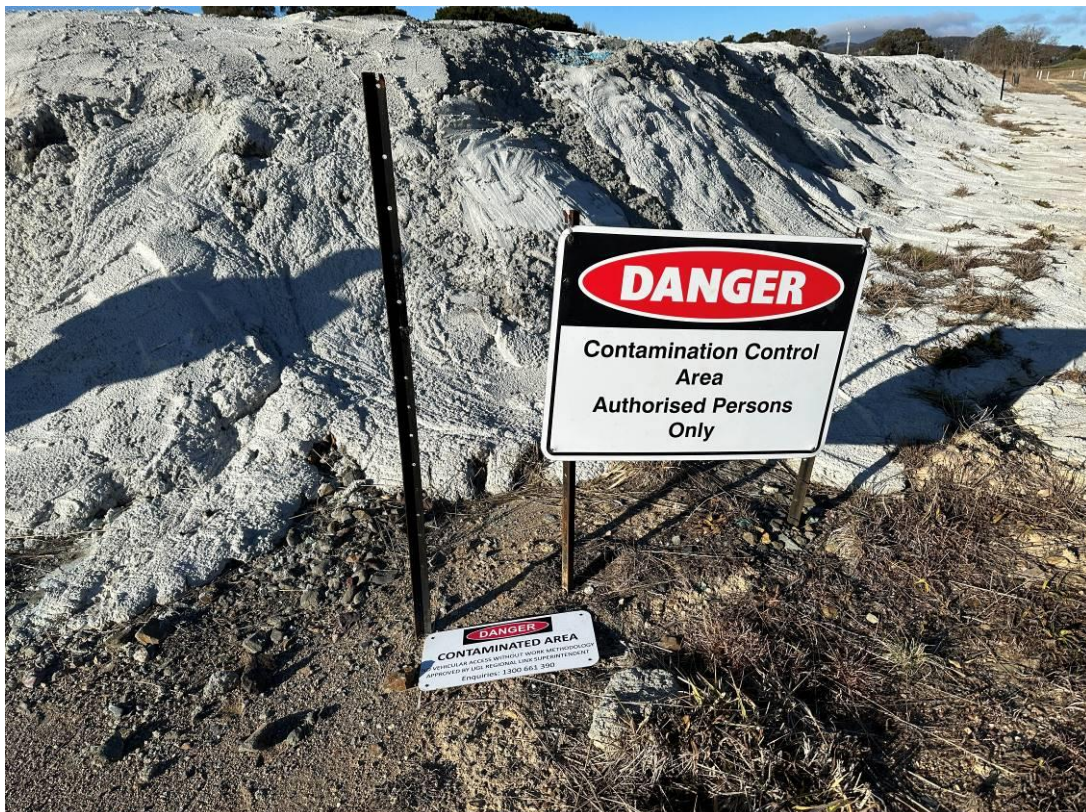
Photo 18: Damaged exclusion zone signage. UGL staff assisting on site reported it was fixed on the same day as site visit (19/07/2023).

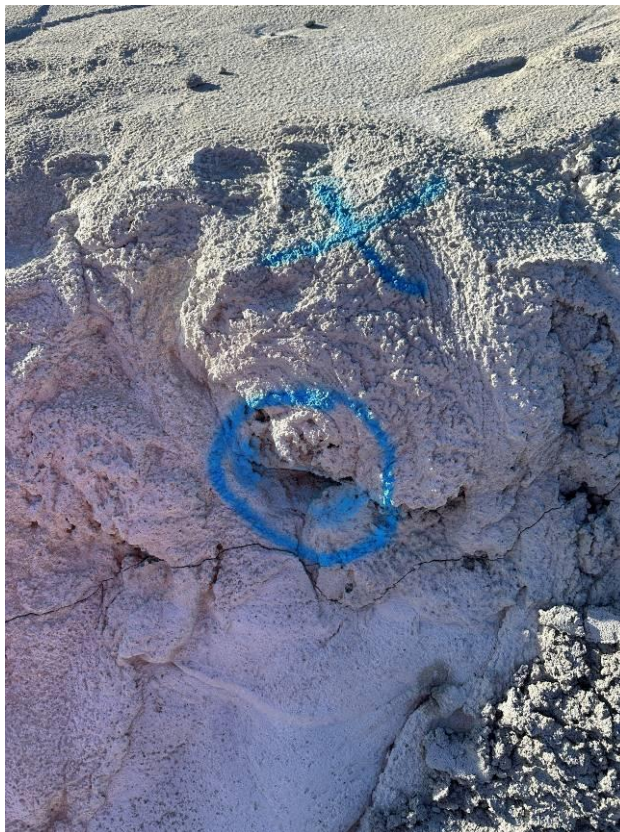
Is geofabric marker layer visible beneath capping of the existing stockpile? If so record in written form and through photographs and consolidate with this checklist. If marker layer is visible rectification work is required.	Yes, geofabric marker layer visible in four locations on the western side of the stockpile. Location and size detailed in <b>Photos 19 - 21</b> , refer to 'Other Observations' section for recommendations.

**Photo 19: New Geofabric marker layer visible in stockpile capping, on western side, marked with blue paint. Approximately 4cm x 3cm.**

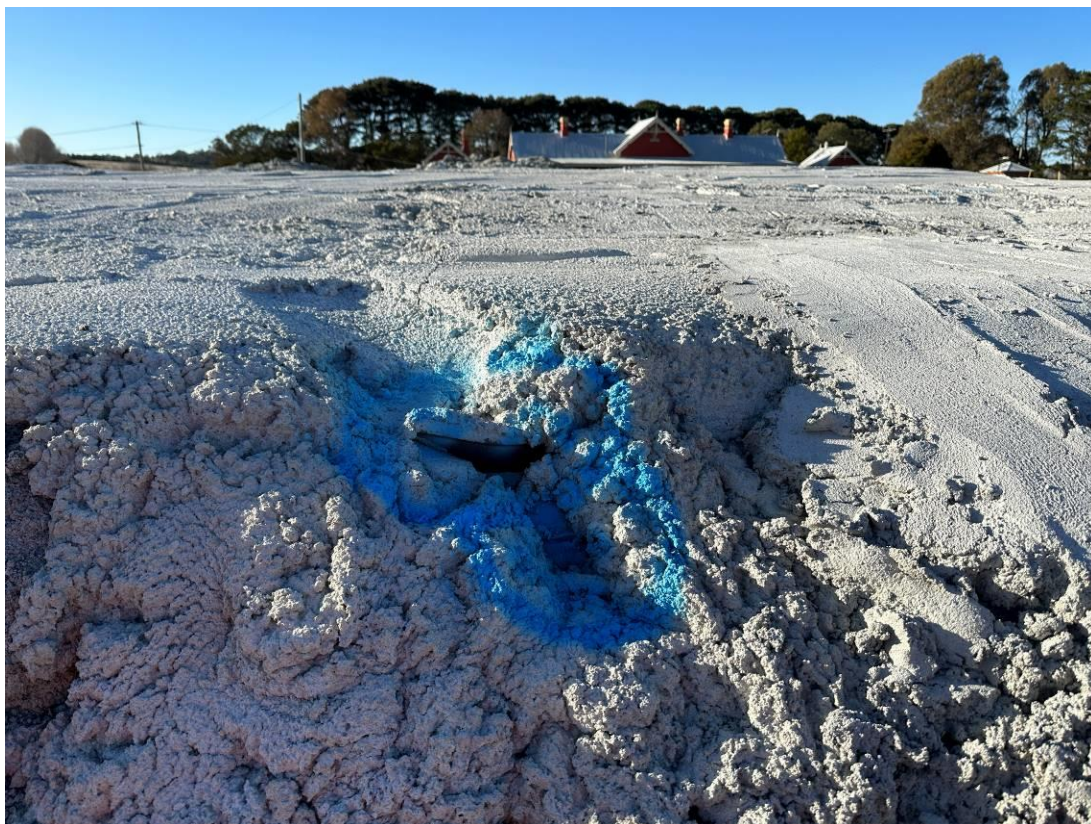
**Photo 20. New Geofabric marker layer visible in stockpile capping, on western side, marked with blue paint. Approximately 4cm x 5cm.**

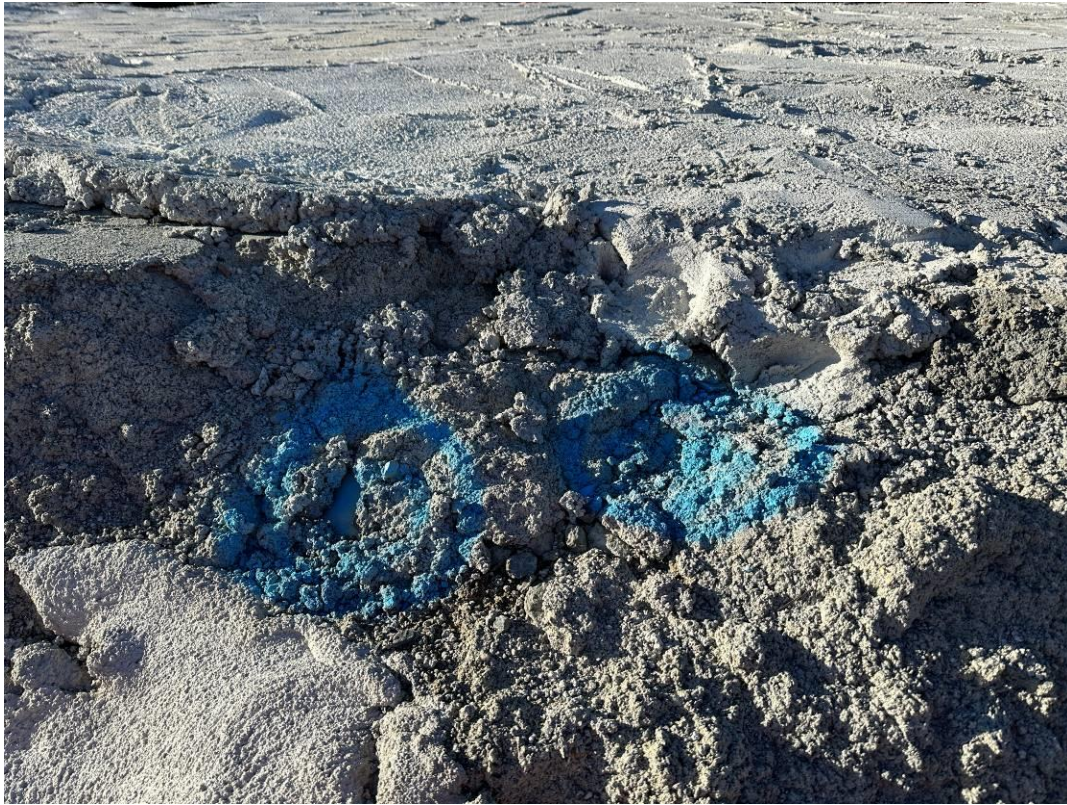
**Photo 21. Two new Geofabric marker layer visible in stockpile capping, on western side, marked with blue paint. Approximately 3cm x 5cm (left) and 3cm x 2cm (right).**
