## Tarago Action Plan Routine Inspection Checklist

Date: 10/02/2023	UGL RL Environmental Representative completing inspection <sup>1</sup> : [REDACTED]
Start time: 08:20	
Finish time: 08:20	
Weather Fine	<a href="#">BoM</a>
Date and volume of maximum rainfall in a 24hr period since last inspection?	
Date: 9/02/2033	
Max volume (mm) in 24hr period: 11mm	
<b>General Site Observations</b>	
Is airborne dust from site evident?	No
Is sediment run-off evident that is not captured by sediment controls?	No
Is surface water discharging from site?	No
Is there evidence of excavation or other works non-compliant with the Action	No
Other observations?	
Cracks observed in the stockpile (sections: 3-4 & 4-5) during an inspection 31/1/2023 remain stable and do not appear to have developed further in length or width.	
Sediment movement and depth appears stable with no significant increases across the site.

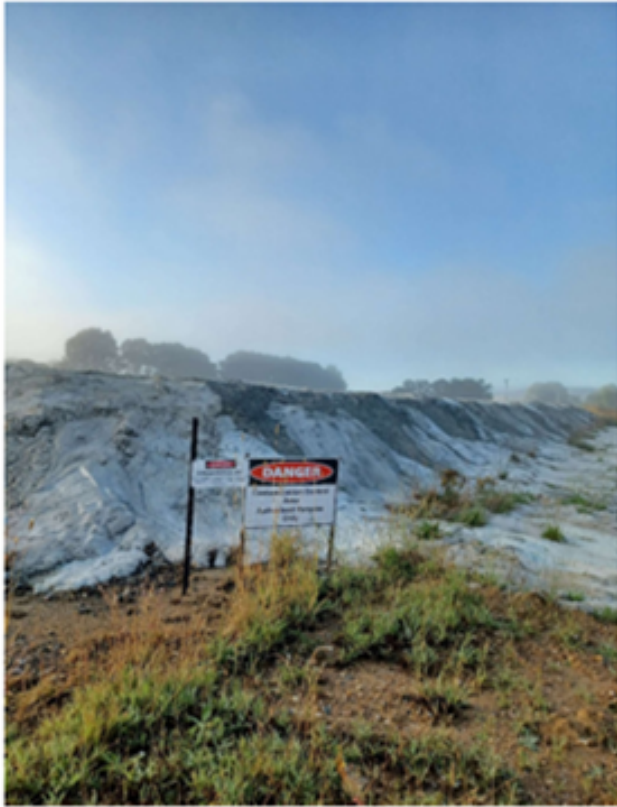
**North West Corner Of Contaminated Stockpile**

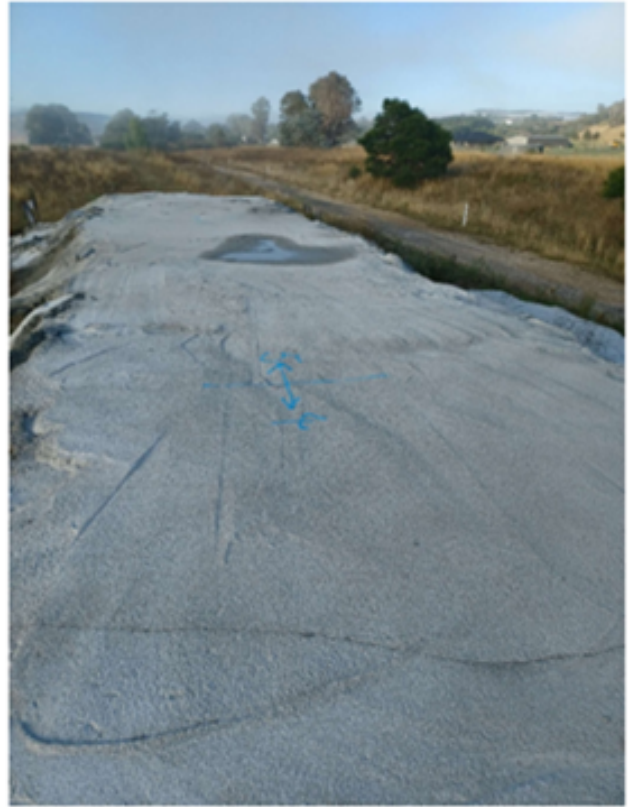
Plan Ref	Control	Inspection		Corrective Action
		Yes	No	
5.1	Is Exclusion Zone signage present as recommended on Figures 2a - 2e Appendix 1 to demarcate contamination in the rail formation and adjacent soils?	Yes		
	Is Exclusion Zone signage undamaged?	Yes		
	Are sediment controls present in/adjacent each rail culvert?	Yes		
	If sediment is present what is the estimated depth of sediment?	5-10mm		
	Are sediment controls still functional?	Yes		
	Is the existing stockpile covered securely to prevent surface water infiltration?	Yes		
	Are cracks present in the capping of the existing stockpile? If so record the width and length of cracks in written form and through photographs and consolidate with this checklist.	Yes - cracks observed in the stockpile during an inspection 31/01/2023 remain stable and do not appear to have developed further in length or width, (approximately the width of the stockpile and 1mm wide)

**Minor Cracking In Section 4 Of Contaminated Stockpile**

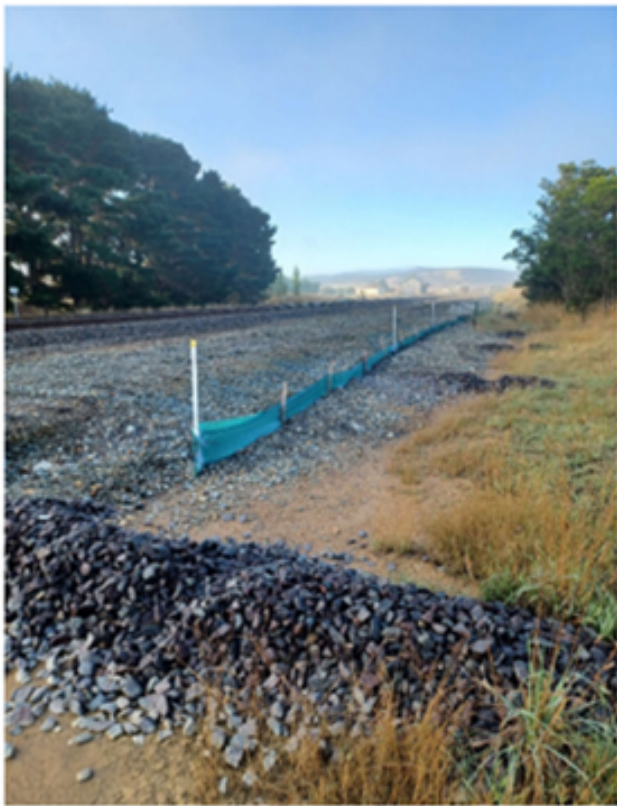
**West Side Cess Drain South End Of Yard With Sediment Controls**

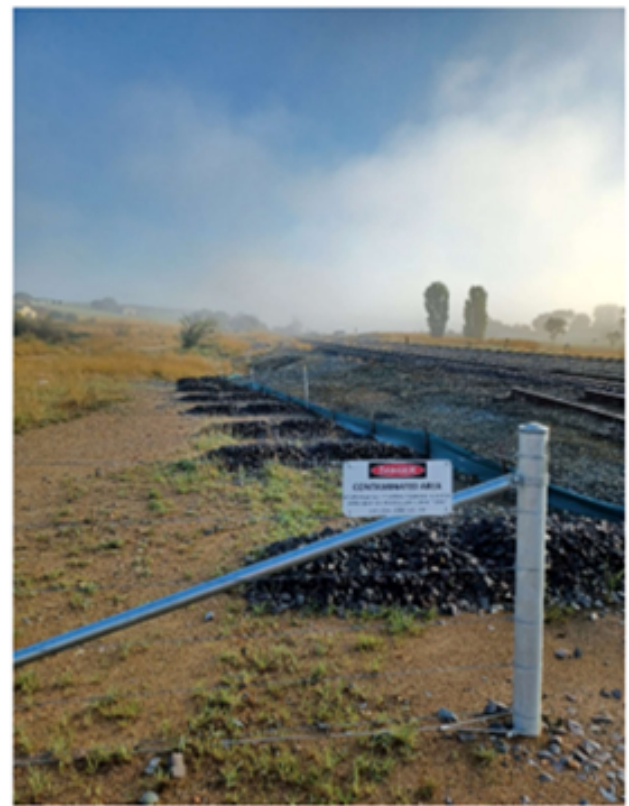
**West Side Cess Drain North End Of Yard With Sediment Controls**
