Tarago Action Plan Routine Inspection Checklist

Date: 25/01/2023	UGL RL Environmental Representative completing inspection ¹ : [REDACTED]
Start time: 07:17	
Finish time: 09:00	
Weather: Showers	
BoM	
Date and volume of maximum rainfall in a 24hr period since last inspection?	
Date: 22/01/2023	
Max volume (mm) in 24hr period: 11.2mm	
General Site Observations	
Is airborne dust from site evident?	No
Is sediment run-off evident that is not captured by sediment controls?	No
Is surface water discharging from site?	No
Is there evidence of excavation or other works non-compliant with the Action Plan?	No
Other observations?	
Cracks observed in the stockpile during an inspection 17/1/2023 remain stable and do not appear to have developed further in length or width.	
Sediment movement and depth appears stable with no significant increases across the site.

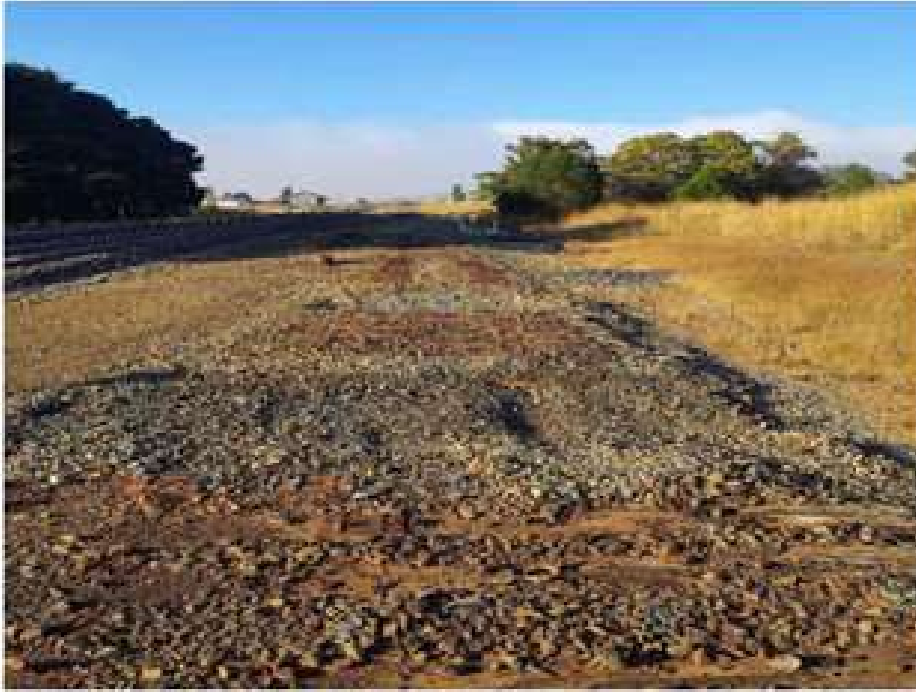
West side cess drain south end of yard with sediment controls

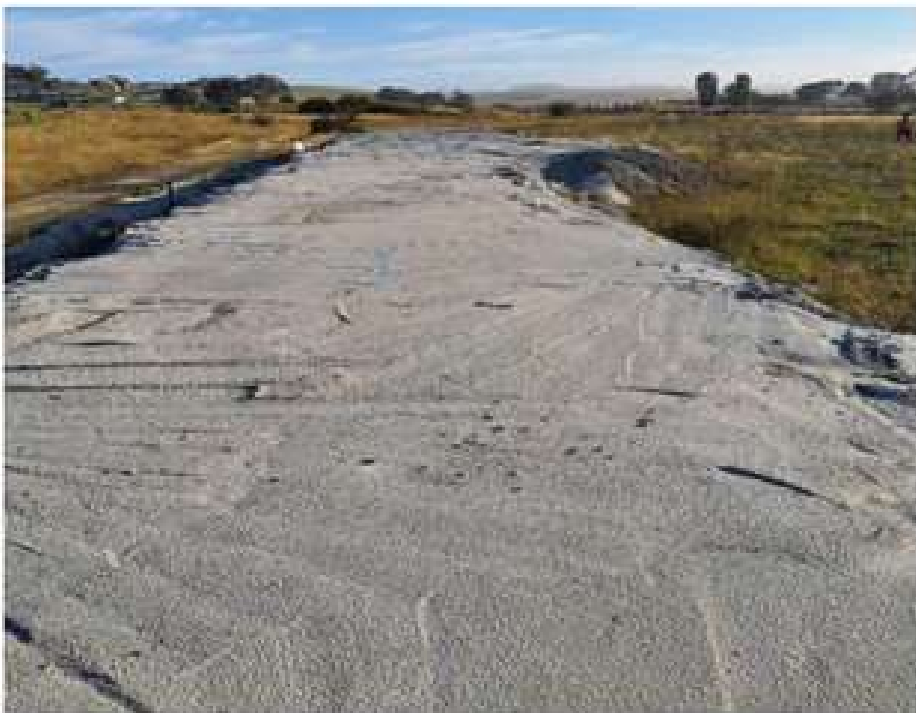
Top of stockpile looking in northerly direction

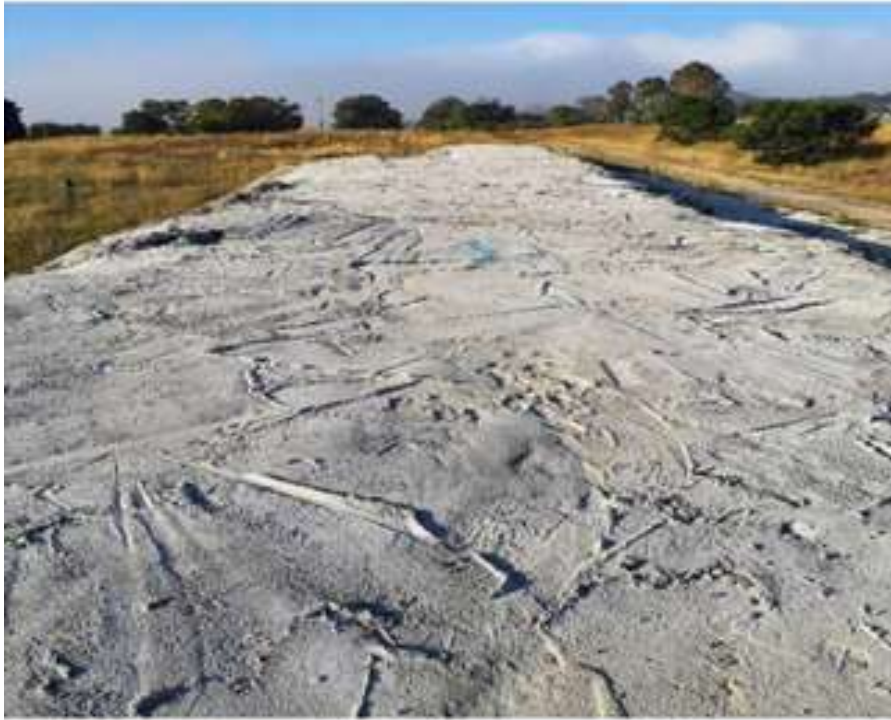
Top of stockpile looking in southerly direction

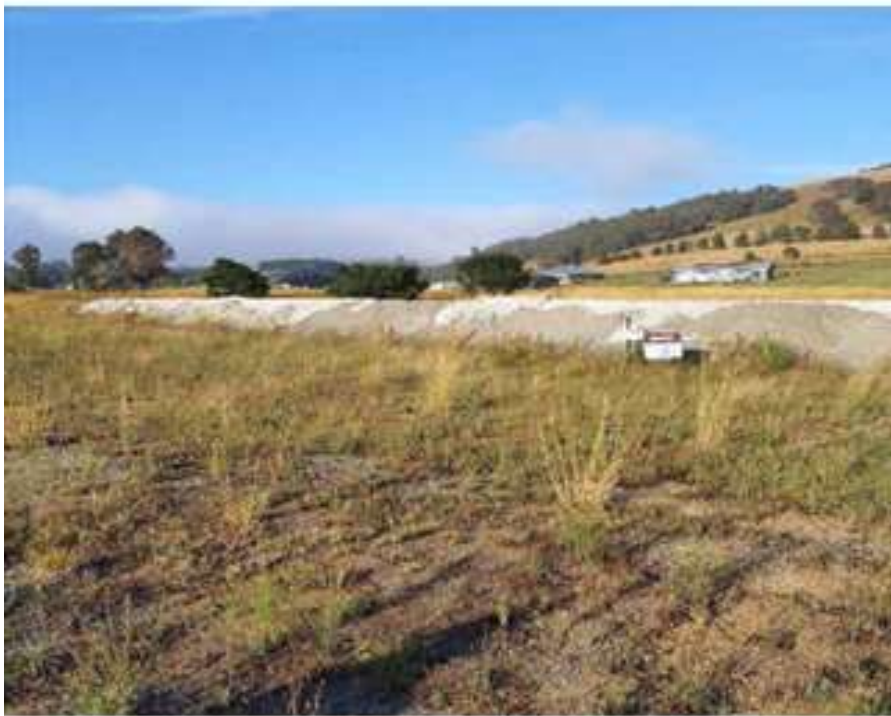
Eastern face of stockpile with signage in place
