Tarago Action Plan Routine Inspection Checklist

Date: 30/01/2023	UGL RL Environmental Representative completing inspection ¹ : [REDACTED]
Start time: 08:00	
Finish time: 09:00	
Weather Showers	
BoM	
Date and volume of maximum rainfall in a 24hr period since last inspection?	
Date: 30/01/2023	
Max volume (mm) in 24hr period: 11.2mm	
General Site Observations	
Is airborne dust from site evident?	No
Is sediment run-off evident that is not captured by sediment controls?	No
Is surface water discharging from site?	No
Is there evidence of excavation or other works non-compliant with the Action Plan?	No
Other observations?	
Cracks observed in the stockpile during an inspection 25/1/2023 remain stable and do not appear to have developed further in length or width.	
Sediment movement and depth appears stable with no significant increases across the site.

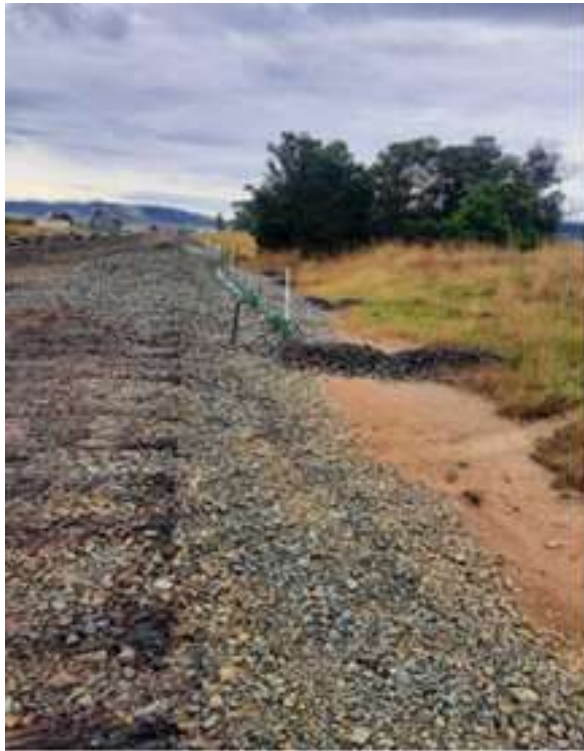
West side cess drain south end of yard with sediment controls

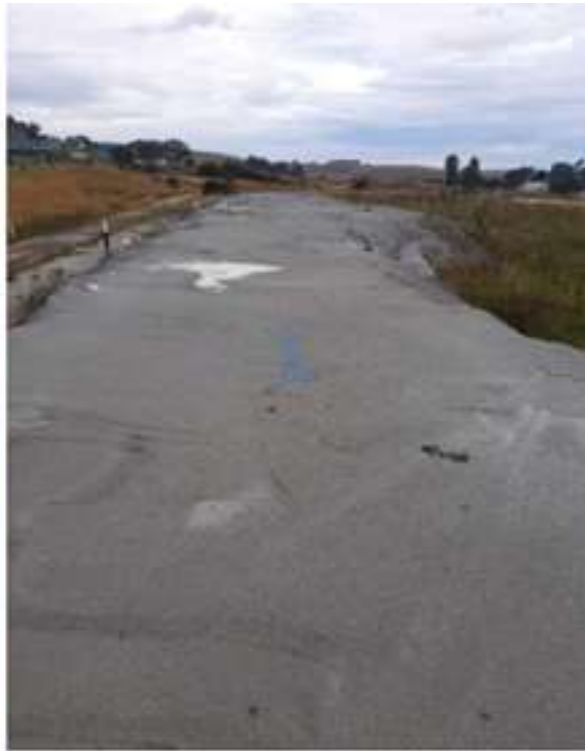
Top of stockpile looking in northerly direction

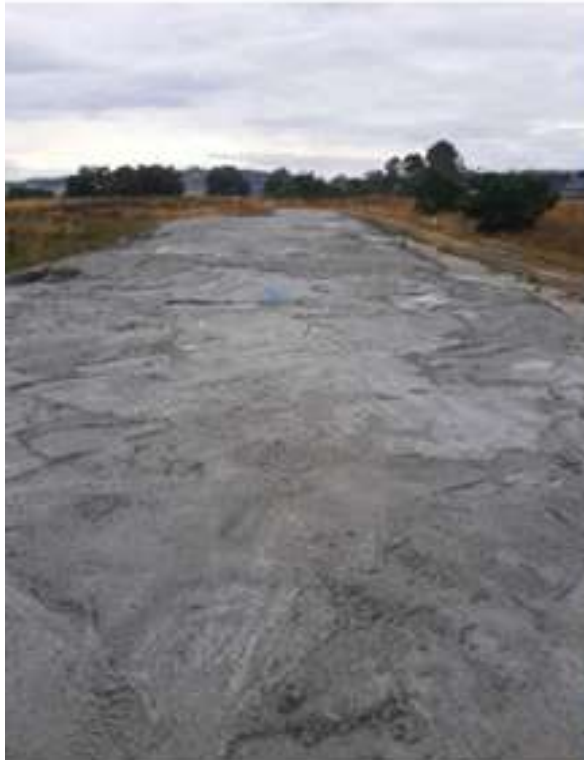
Top of stockpile looking in southerly direction

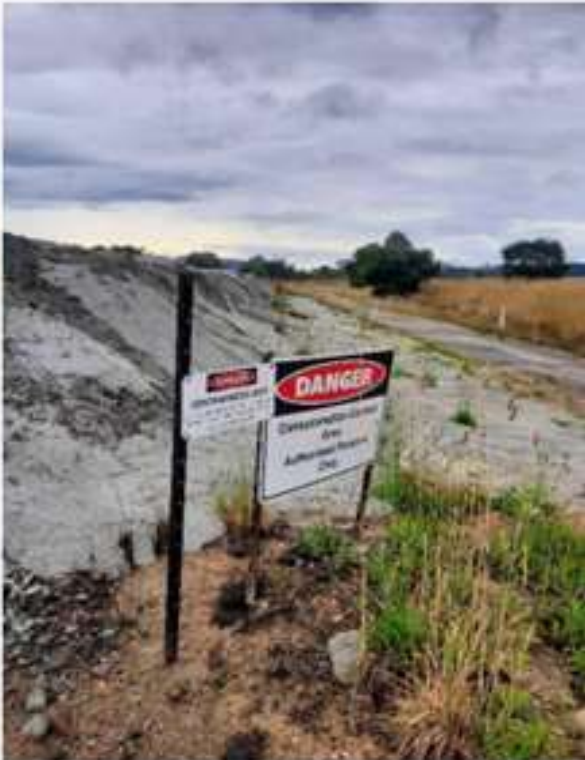
Example of signage adjacent to stockpile

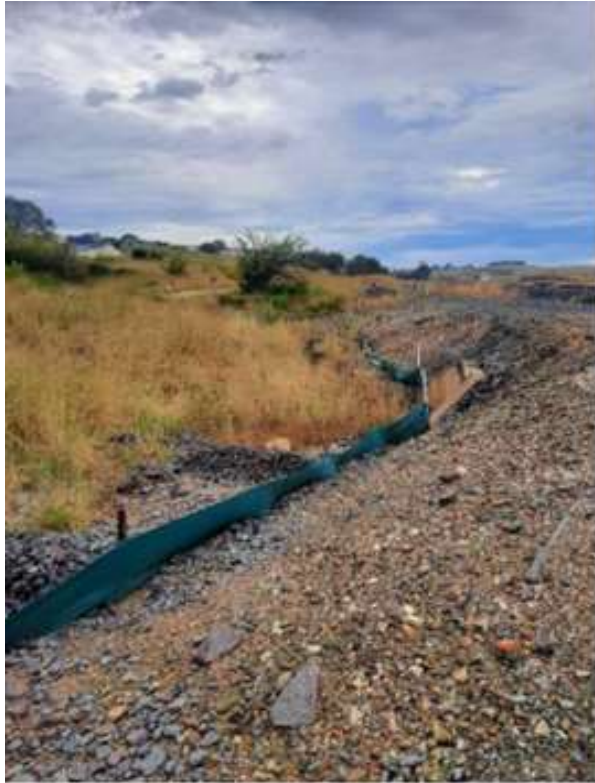
West side culvert north end of yard with sediment controls

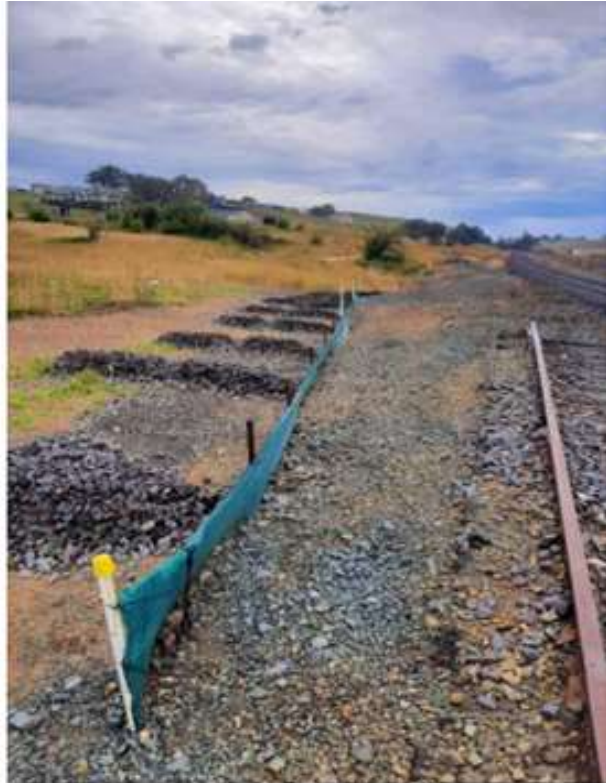
West Side cess drain north end of yard with sediment controls
