Tarago Action Plan Routine Inspection Checklist

Date: 31/01/2023	UGL RL Environmental Representative completing inspection ¹ : [REDACTED]
Start time: 08:15	
Finish time: 09:15	
Weather Overcast	
	BoM
Date and volume of maximum rainfall in a 24hr period since last inspection?	
Date: 30/01/2023	
Max volume (mm) in 24hr period: 17mm	
General Site Observations	
Is airborne dust from site evident?	No
Is sediment run-off evident that is not captured by sediment controls?	No
Is surface water discharging from site?	No
Is there evidence of excavation or other works non-compliant with the Action	No
Other observations?	
Cracks observed in the stockpile (sections: 3-4 & 4-5) during an inspection 30/1/2023 remain stable and do not appear to have developed further in length or width.	
Sediment movement and depth appears stable with no significant increases across the site.

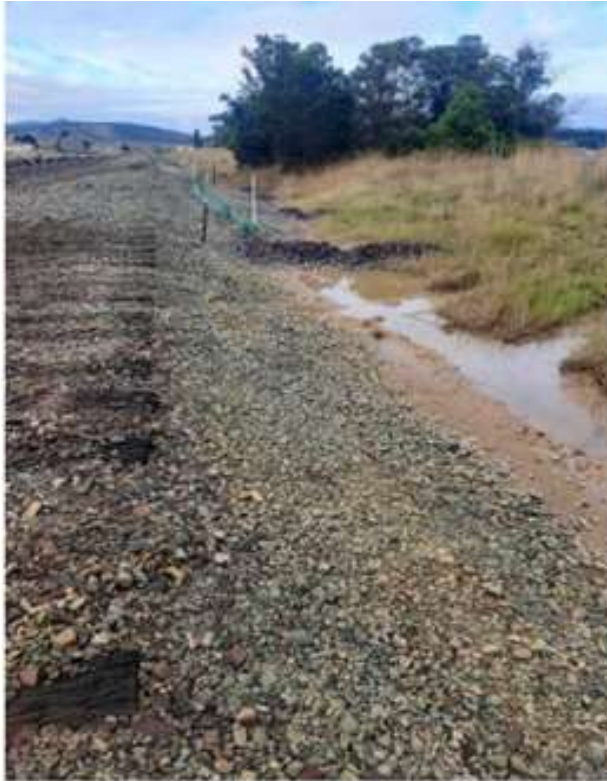
West side cess drain with sediment controls

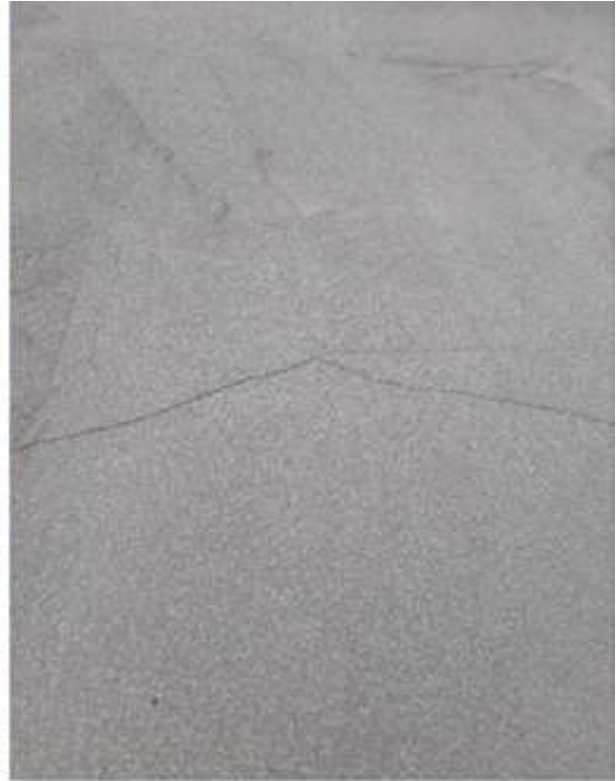
Plan Ref	Control	Inspection		Corrective Action
		Yes	No	
5.1	Is Exclusion Zone signage present as recommended on Figures 2a - 2e Appendix 1 to demarcate contamination in the rail formation and adjacent soils?	Yes		
	Is Exclusion Zone signage undamaged?	Yes		
	Are sediment controls present in/adjacent each rail culvert?	Yes		
	If sediment is present what is the estimated depth of sediment?	5-10mm		
	Are sediment controls still functional?	Yes		
	Is the existing stockpile covered securely to prevent surface water infiltration?	Yes		
	Are cracks present in the capping of the existing stockpile? If so record the width and length of cracks in written form and through photographs and consolidate with this checklist.	Yes - cracks observed in the stockpile during an inspection 30/01/2023 remain stable and do not appear to have developed further in length or width, (approximately the width of the stockpile and 1mm wide)

Example of hair line cracks in stockpile capping
