Tarago Action Plan Routine Inspection Checklist

Date: <i>13.01.23</i>	JHR Representative completing inspection:
Start time: <i>1200</i>	<i>[Redacted]</i>
Finish time: <i>1345</i>	<i>[Redacted]</i>

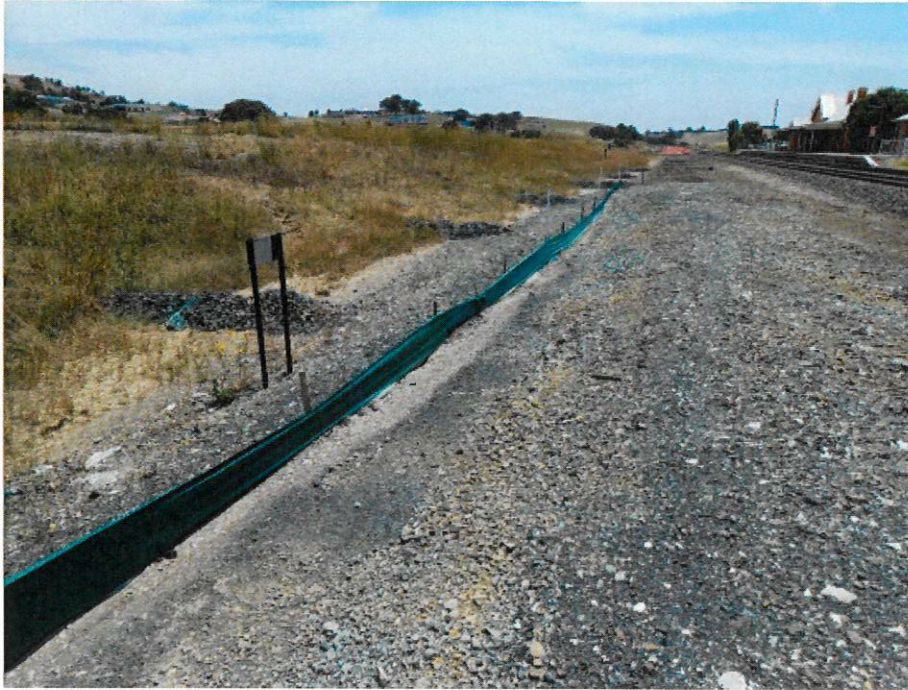
Figure 1: Sediment controls, west of railway line looking North.

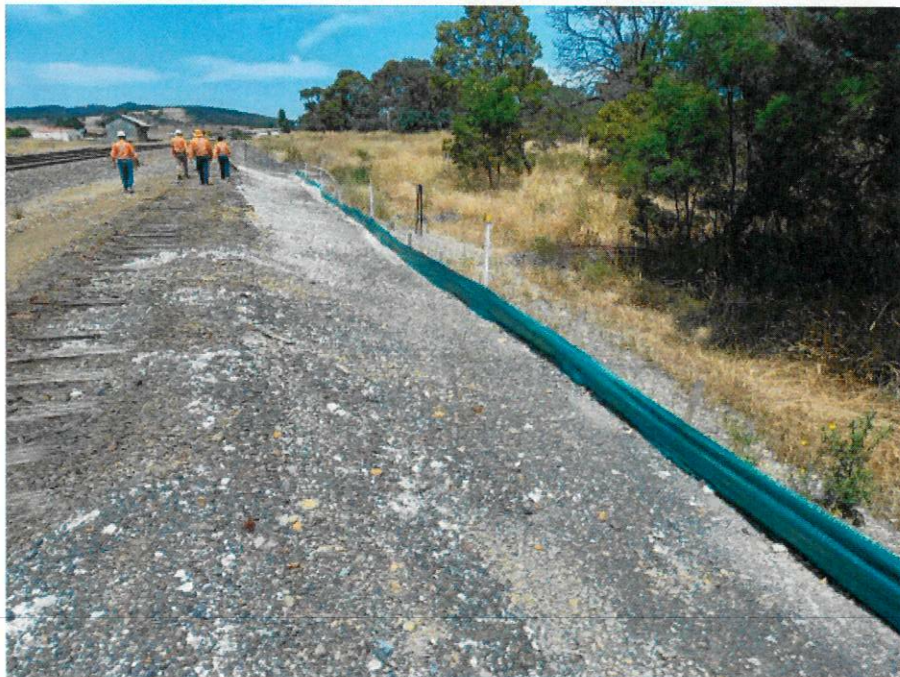
Figure 2: Sediment controls, west of railway line looking South towards Goulburn Street level crossing.

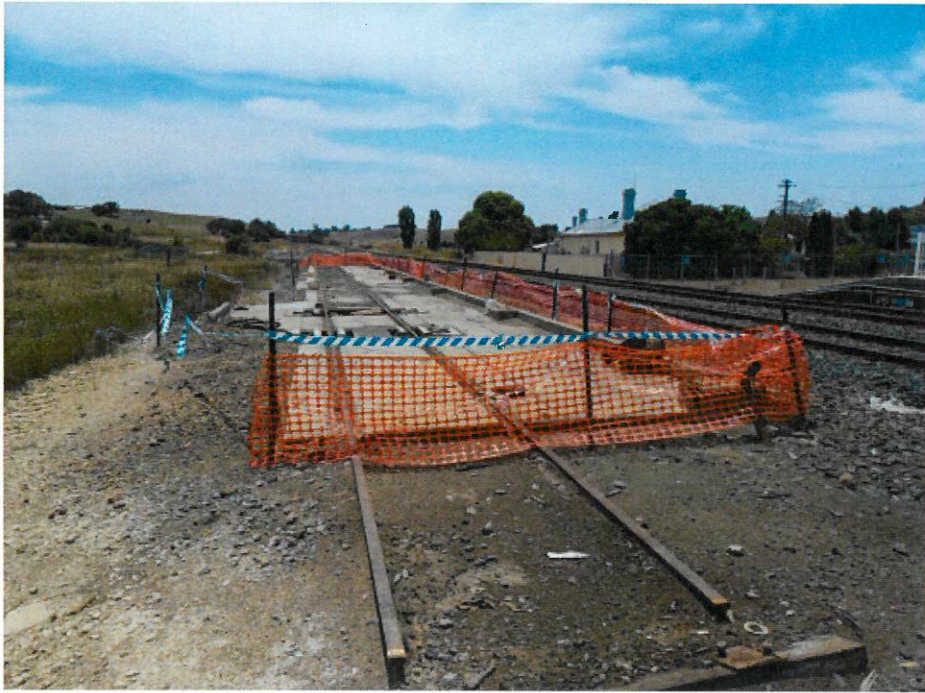
Figure 3: Demarcation fencing around old concrete loading dock and pit, looking north.

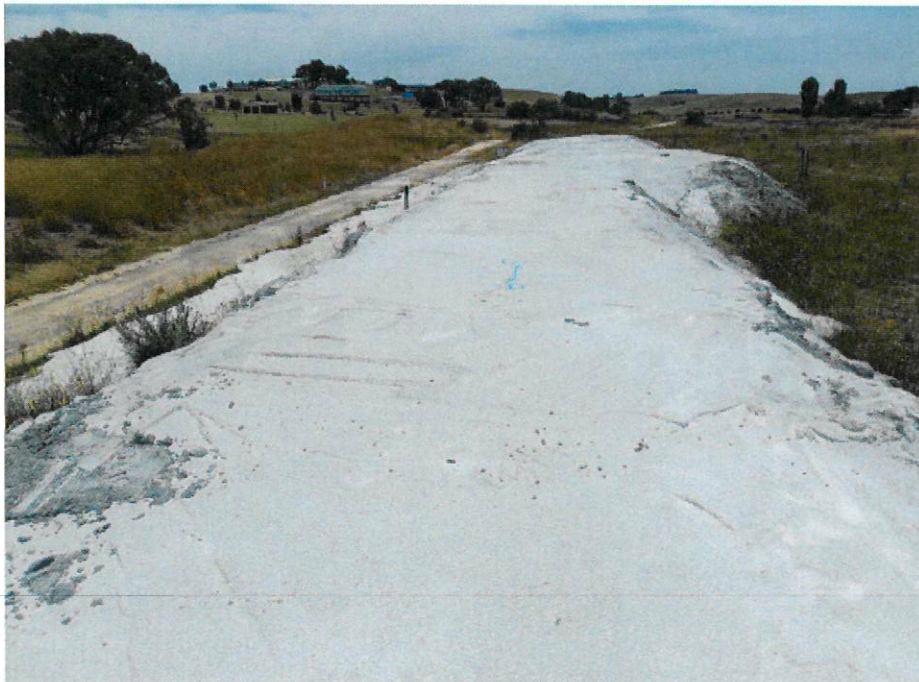
Figure 4: Stabilised sand encased stockpile, west of railway line looking North.

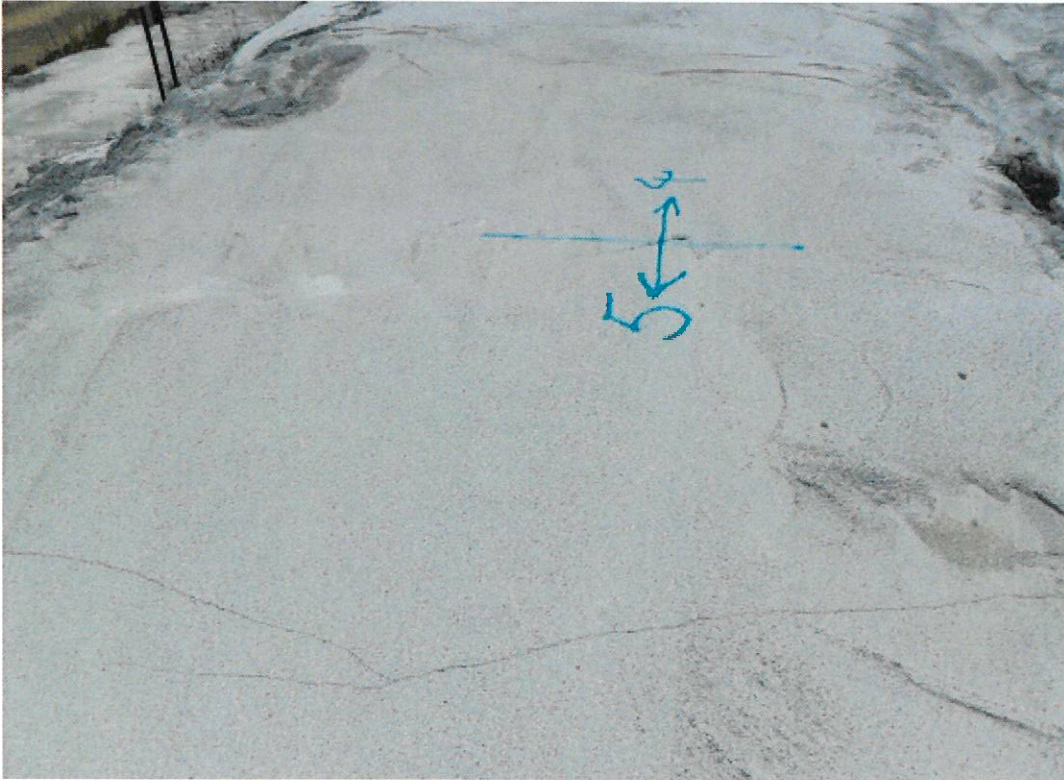
*	Are cracks present in the capping of the existing stockpile? If so record the width and length of cracks in written form and through photographs and consolidate with this checklist.	Approx 4 noticeable cracks, less than 1mm in width, but run full width of stockpile. Depth unknown.		
	Are there signs of erosion or sediment run-off on or relating to the existing stockpile? If so record in written form and through photographs and consolidate with this checklist.	No		
	Are there signs of vegetation on the existing stockpile? If so record in written form and through photographs and consolidate with this checklist.	No		
	Is geofabric marker layer visible beneath capping of the existing stockpile? If so record in written form and through photographs and consolidate with this checklist. If marker layer is visible rectification work is required.	No

Figure 5: Stockpile Zone 5 – foreground of image gives an example of approximately 1mm cracking in stabilised sand cement cover. Future monitoring will focus on lateral cracking, width, and depth.

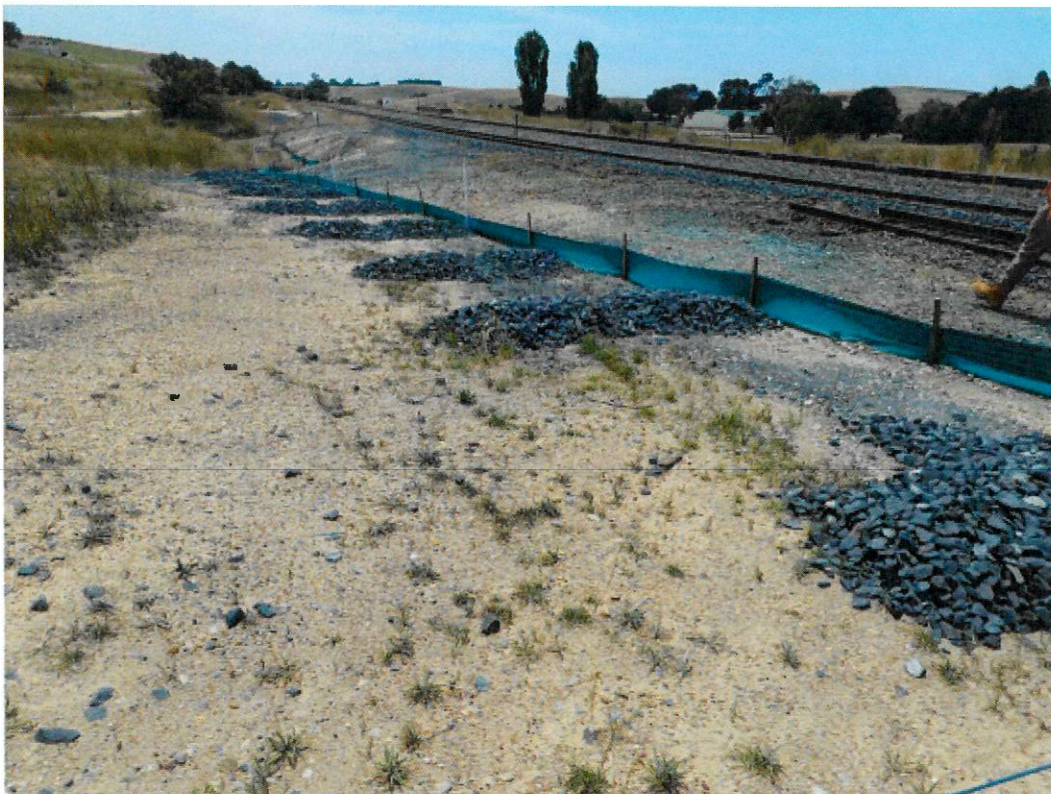
Figure 6: Erosion and Sediment Controls (sediment fence and rock checks) positioned west of the railway line looking north.

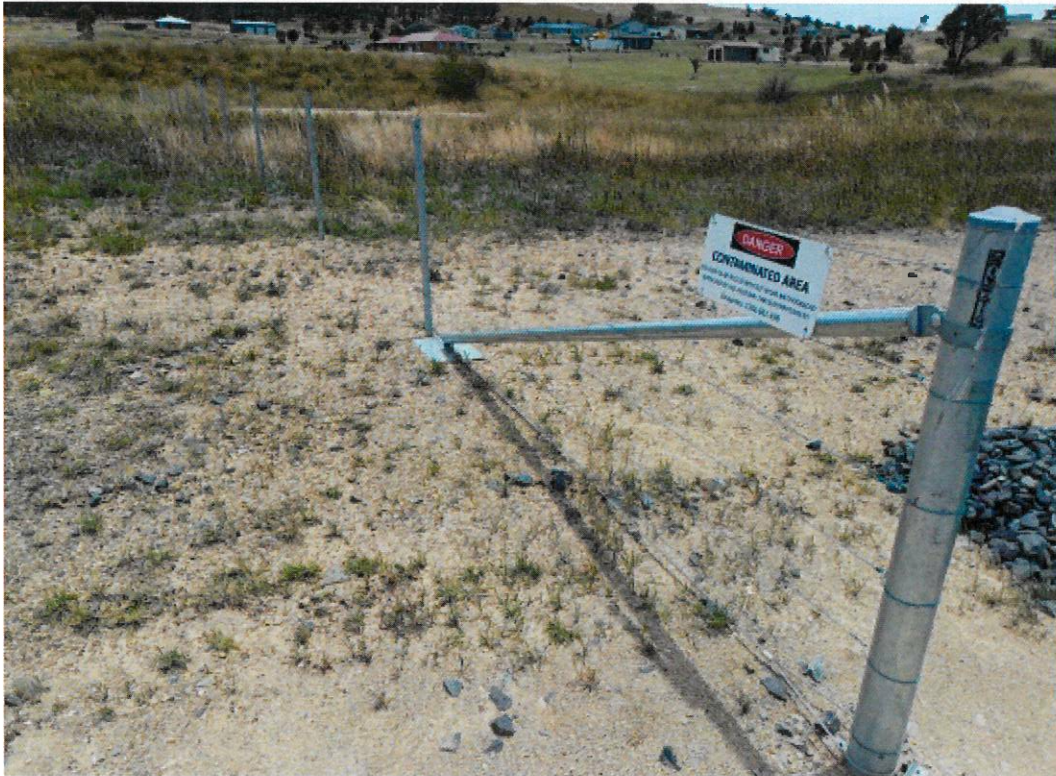
Figure 7: Exclusion fencing and signage, perpendicular to railway line looking west to Mulwaree Street subdivision.

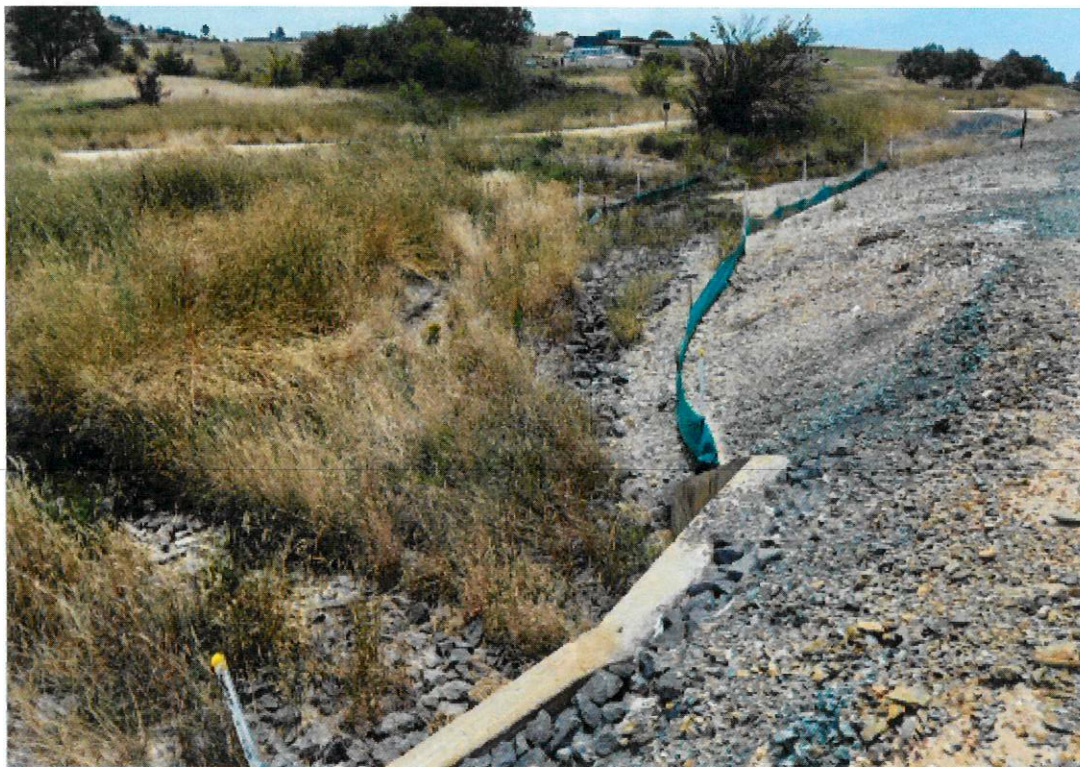
Figure 8: Sediment fences protecting site drainage, installed west of the railway line looking north (approximately opposite Boyd Street)

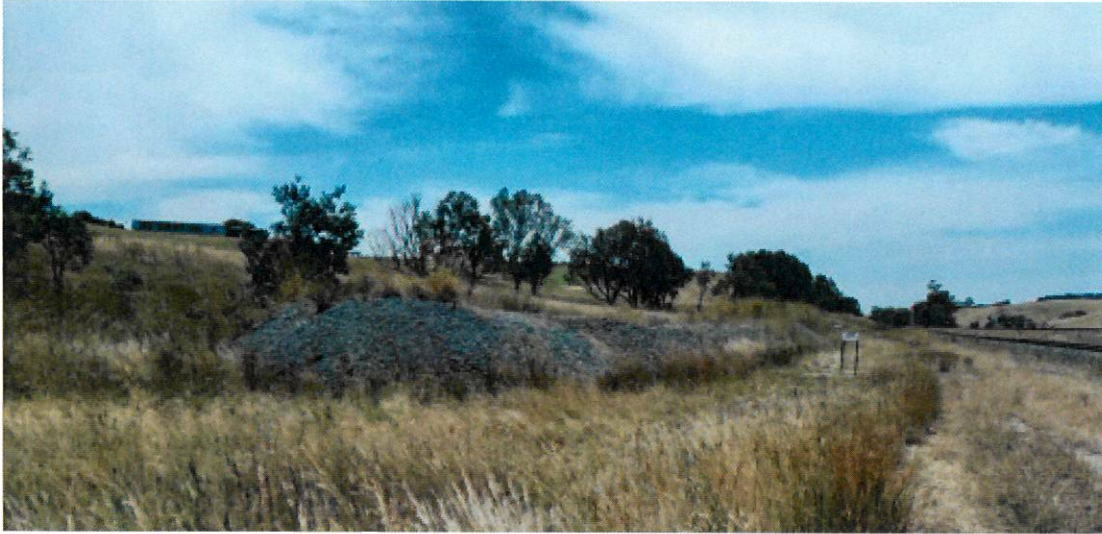
- *Additional stockpile at the northern end of Tarago Yard, west of the rail line was inspected using a drone and there was evidence of environmental controls (sed fencing) in place. The stockpile is not new and has been identified in previous site inspections with EPA and Ramboll. Photos attached.*
- *Cement covered stockpile notes: **
Plan reference 5.1 - stockpile cracking most likely due to thermal expansion. No lateral cracking present. Future monitoring will focus on identification of lateral cracking, widening of cracks and observed depth.

Figure 9: Non contaminated ballast material stockpile, located west of the railway line, northern end of the site.

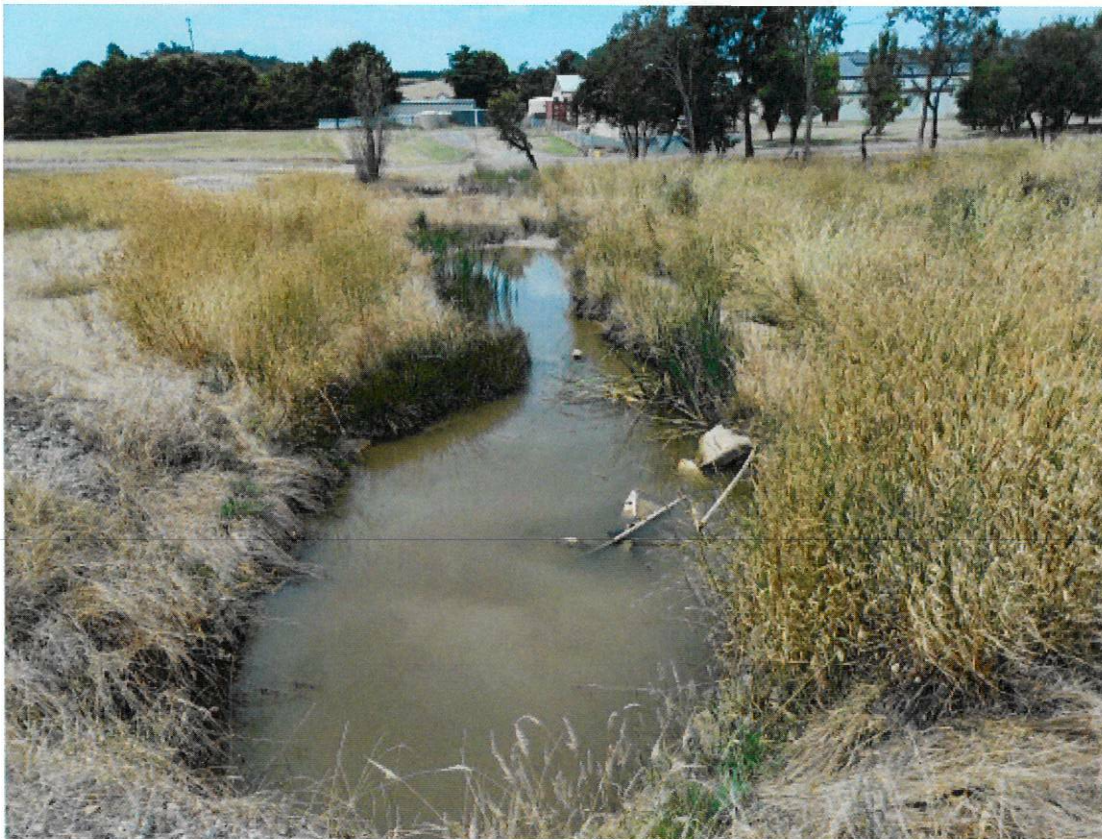
Figure 10: Stagnant site water, located on the east side of the railway line, opposite Boyd Street.
