Tarago Action Plan Routine Inspection Checklist

Title: Tarago Rail Yard Inspection	Approved:	Project-Nr.: 318001704	Date: August 2023
Site: Tarago, NSW			
Client: UGL Regional Linx

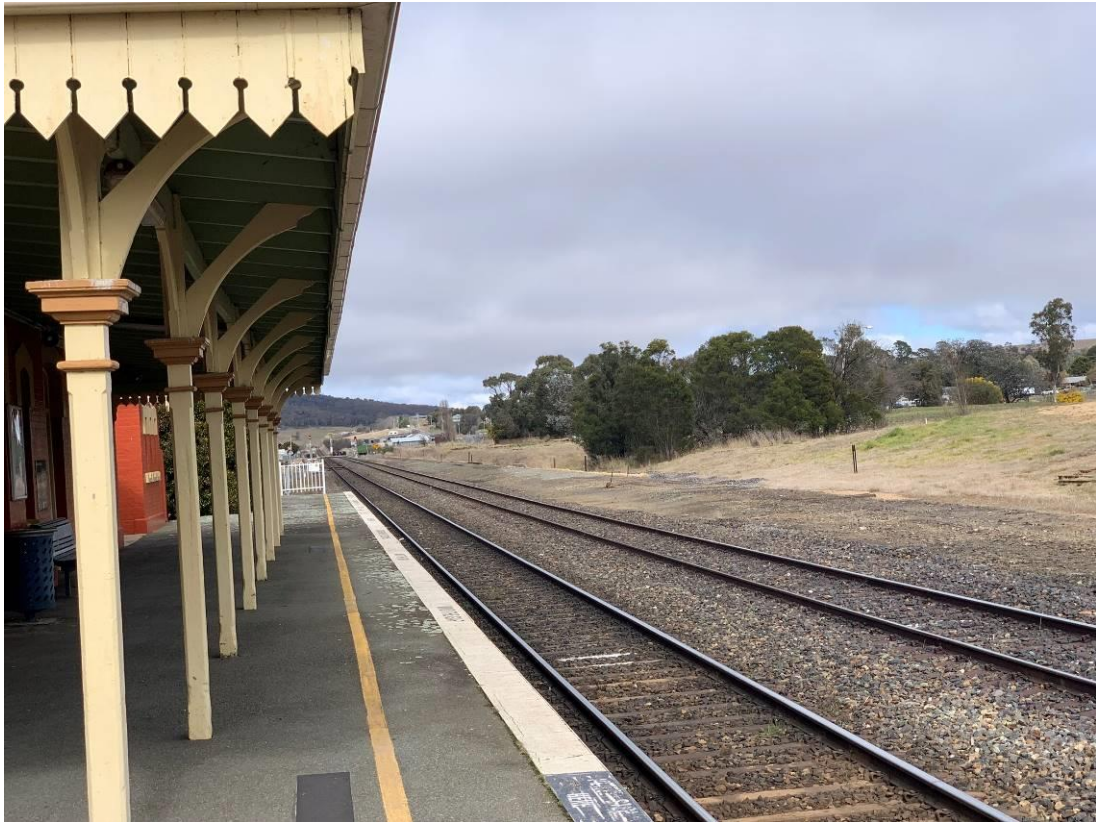
Photo 1: Picture at north-east end of railway station facing south-west. No airborne dust visible.

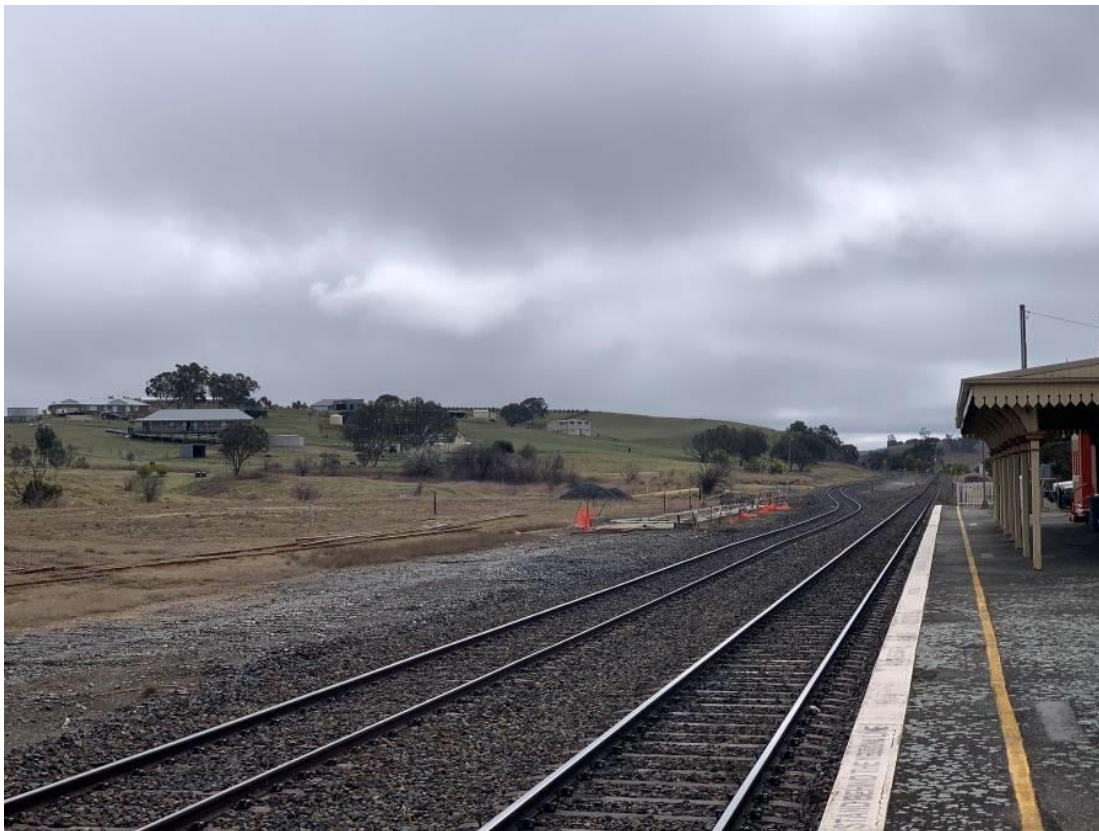
Photo 2: Picture at south-western end of railway station facing north-east. No airborne dust visible.

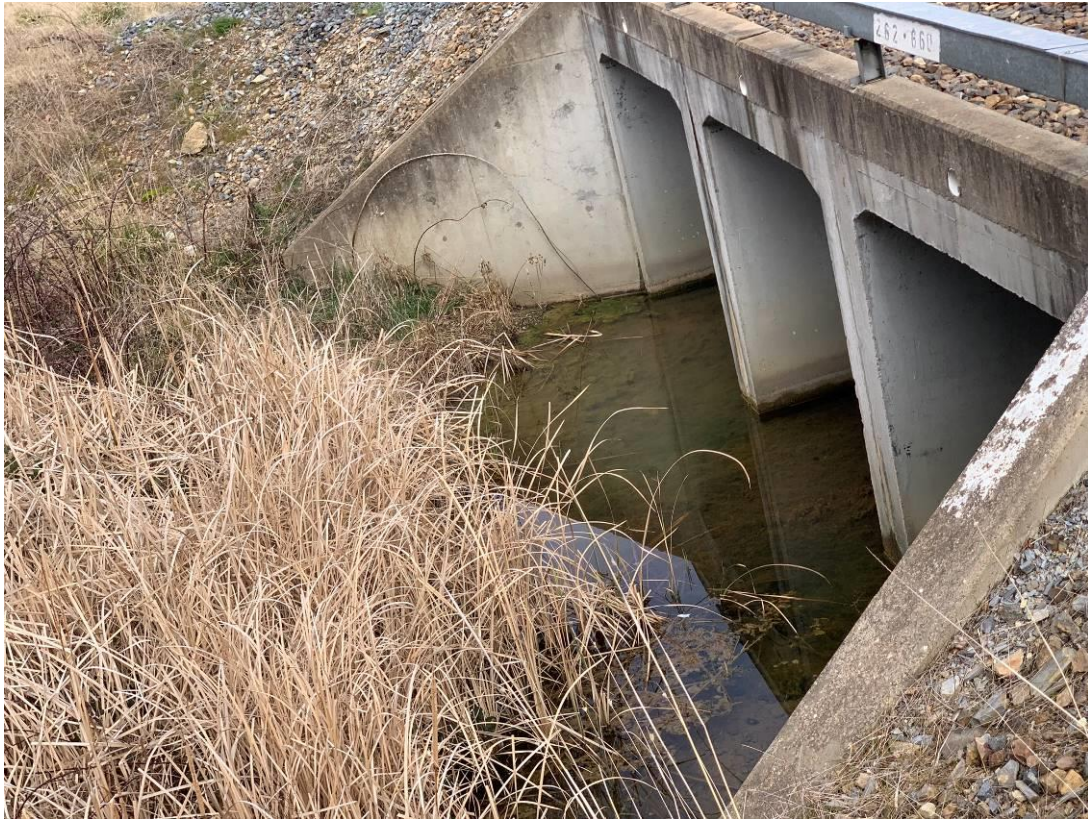
<u>Is surface water discharging from site?</u>		
Yes. Surface water was discharging at a slow rate from the southern culvert through a thick layer of grass (Photo 3). A large pool of water was observed on site and immediately downstream of middle culvert but not discharging off site (Photos 4 - 6). There was no surface water discharging at the northern culvert (Photos 7 - 8).		
<u>Is there evidence of excavation or other works non-compliant with the Action Plan?</u>		
No		
<u>Other observations?</u>		
<p>Regarding the stockpile, the previous site inspection (19/07/23) identified four new locations where the marker layer was exposed, with Ramboll providing the recommendation for them to be repaired. On this inspection the four exposure locations appear to have been rectified as they have now been covered with concrete (Photos 19 - 21). These repairs satisfy the recommended actions previously provided and no further action is needed.</p> <p>Evidence of erosion has been noted upgradient of the southern most culvert in multiple previous site inspections and remains on site but in a stable condition (Photo 9). No evidence of sediment was found in water flowing offsite at southern culvert. Ramboll recommends replacing ground cover material (ballast) if further erosion occurs or sediment is visible in the downstream surface water of the southern culvert.</p> <p>Pooled water was observed more frequently onsite during this inspection compared to the previous inspection (19/07/23). The majority of pooled water was located in the northern half of the site, and mostly parallel to the rail tracks (Photo 22-24). The pooled water appeared clear and there was no evidence of run-off from site. No action is required.</p>

Photo 3: Southern most culvert downgradient of rail line, with slow moving surface water travelling off-site. Water is clear, low turbidity, minimal observable sediment, long grass and some algae present.

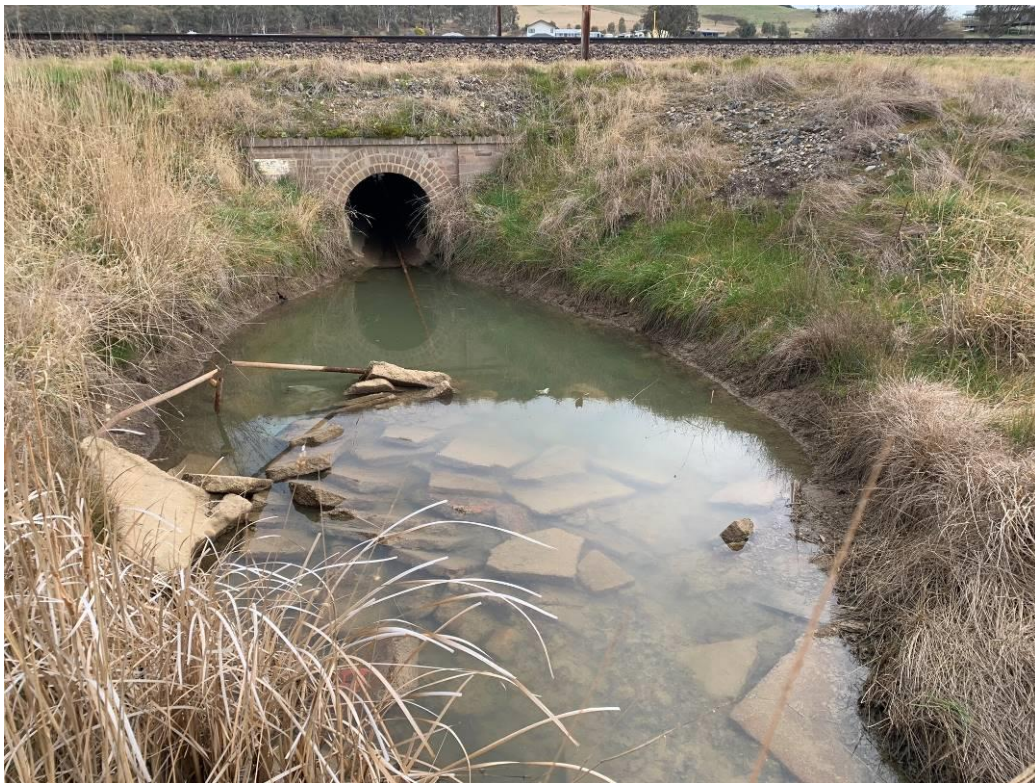
Photo 4: Downgradient of middle culvert showing mostly clear water on site. Majority of sediment has settled to the bottom of the water body. No surface water running off site at middle culvert.

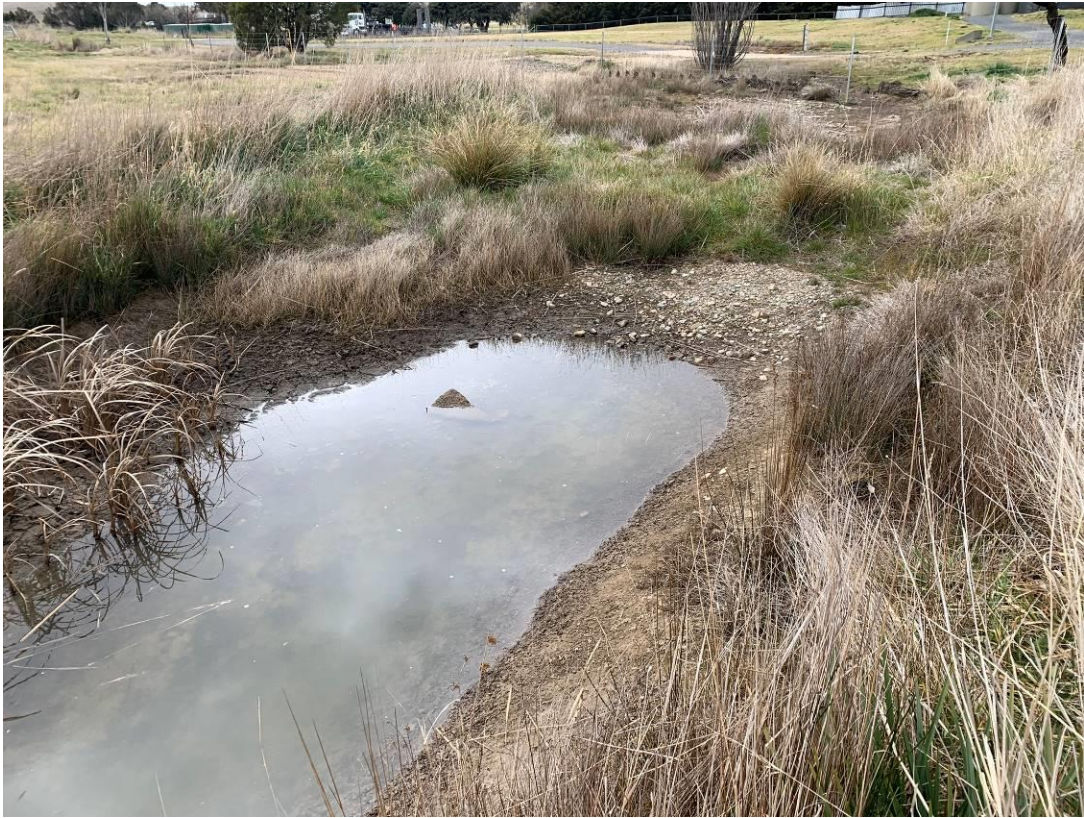
Photo 5: Downgradient of middle culvert. Dry beyond the pooled water and no evidence of current surface water run off on site.

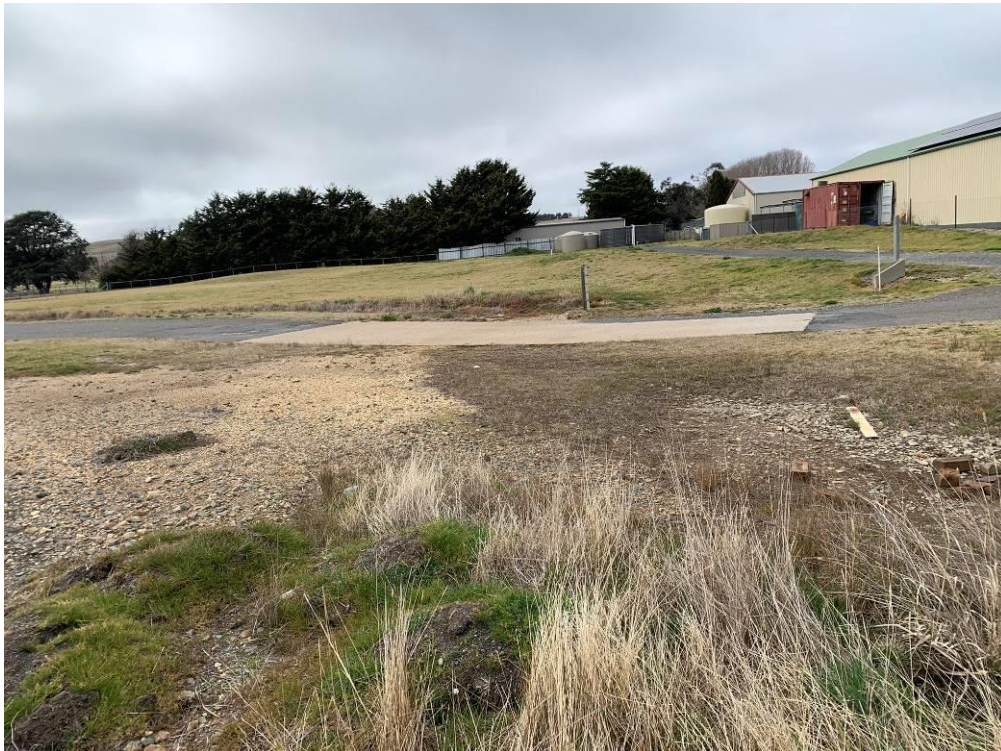
Photo 6: Causeway downgradient of middle culvert showing no evidence of current surface water moving off site. No visible sediment on road or vegetation nearby from sediment water was running off site in between inspections.

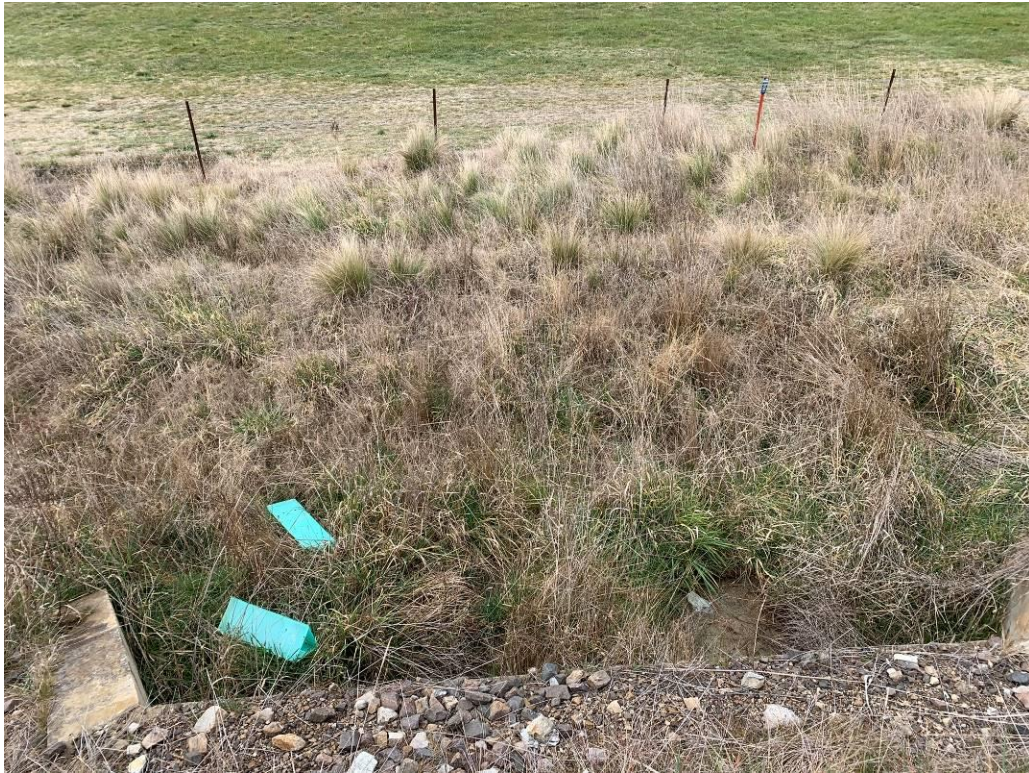
Photo 7: Downgradient of northernmost culvert showing evidence of no surface water runoff from site to neighbouring property.

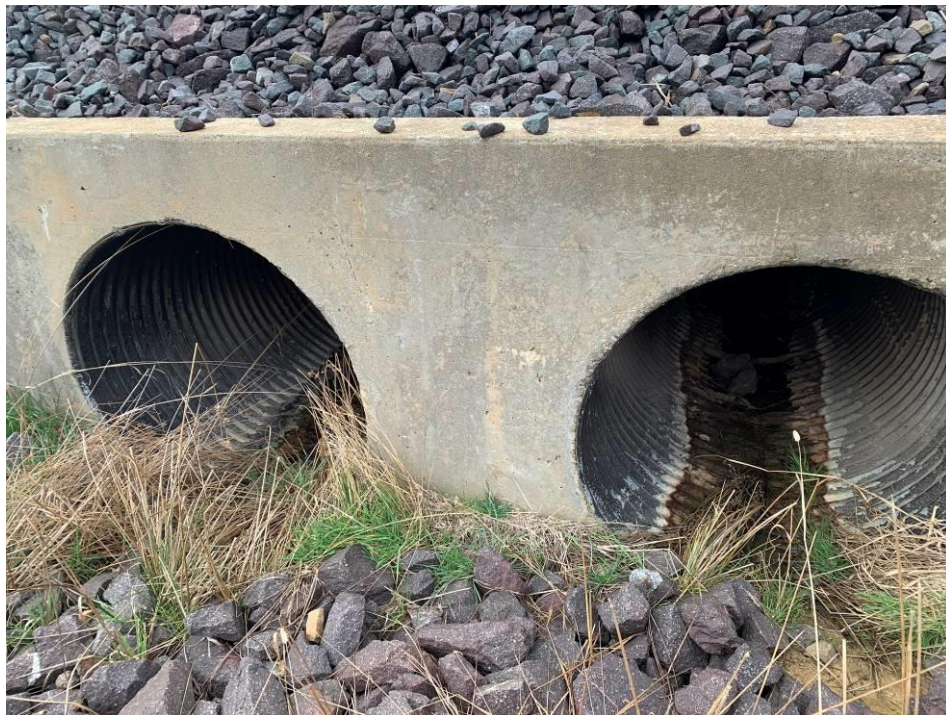
Photo 8: Upgradient of northernmost culvert showing evidence of no surface water surrounding.

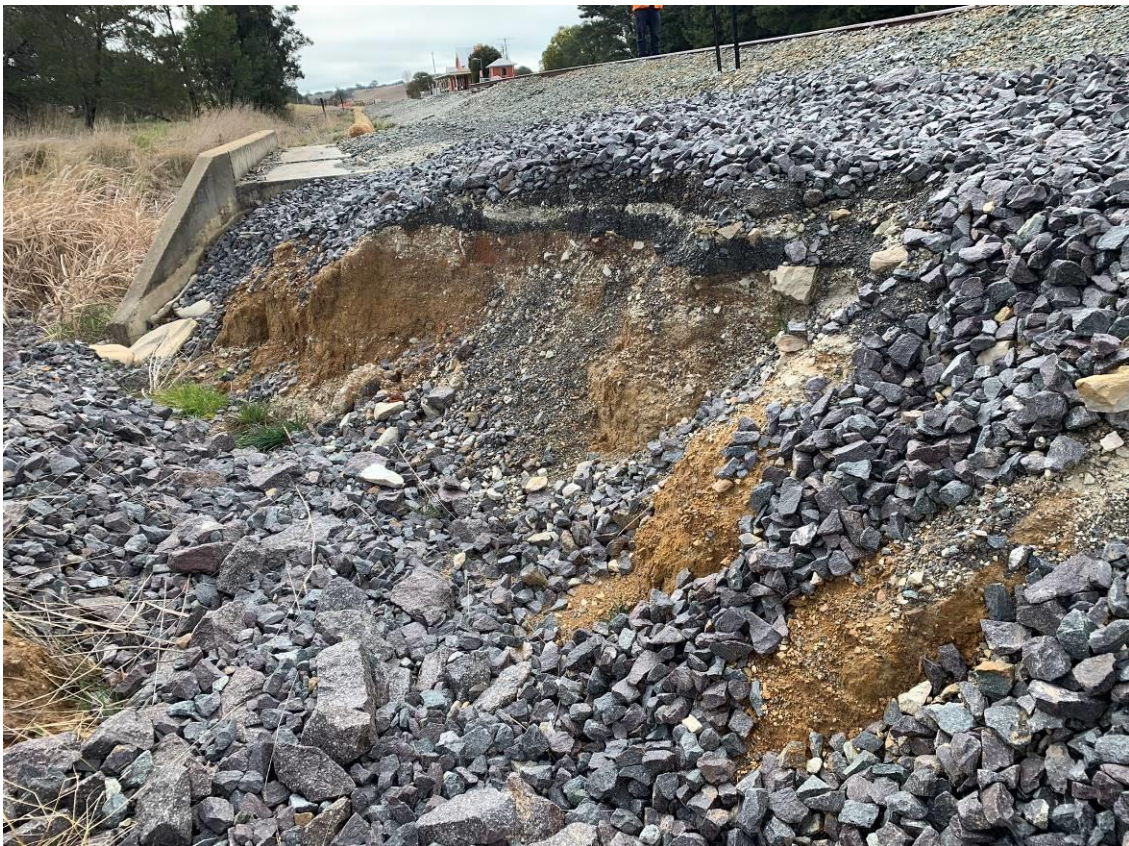
Photo 9: Visible evidence of erosion due to loss of ground cover (ballast material) upgradient of southernmost culvert. Remaining stable and no major further erosion since last inspection. Facing north-east.

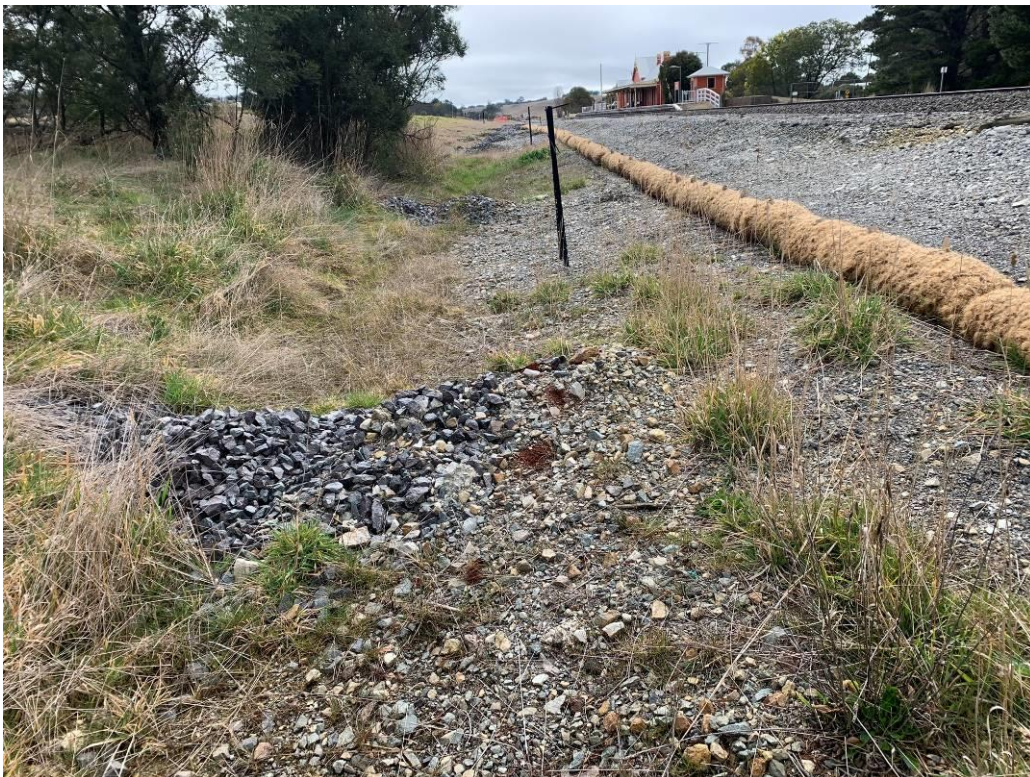
Photo 10: Upgradient of southernmost culvert showing previous silt fencing replaced by Coir sediment control logs, used as control measures for sediment control. Facing north-east.

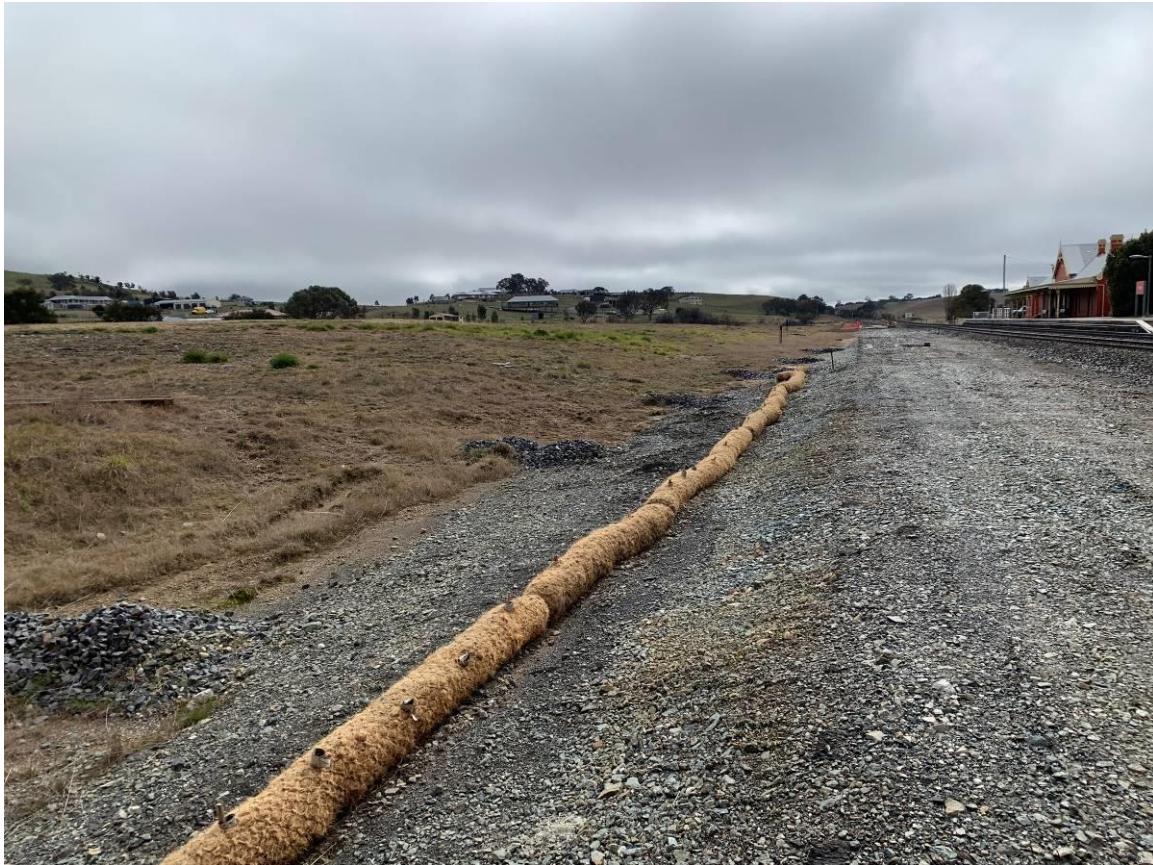
Photo 11: Rock checks running along former Woodlawn siding and between southern and middle culverts. Silt fencing replaced by Coir sediment control logs.

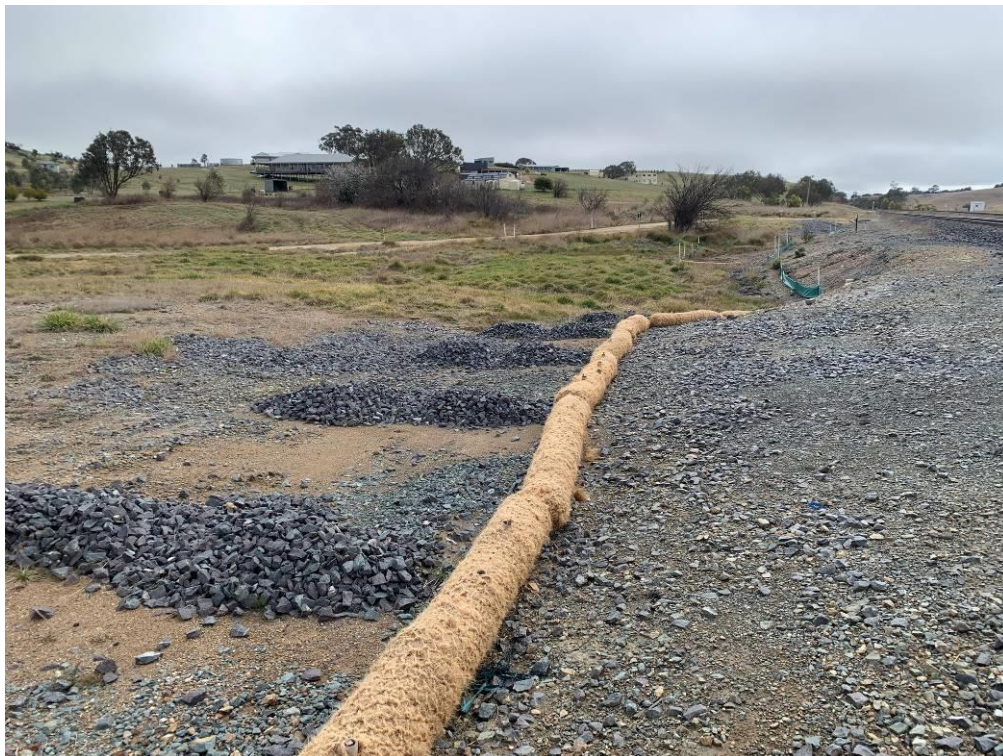
Photo 12: Rock checks running alongside former Woodlawn siding towards the middle culvert. Previous silt fencing with major damage replaced by Coir sediment control logs as recommended in previous inspections. No evidence of sediment build-up in rock armoury.

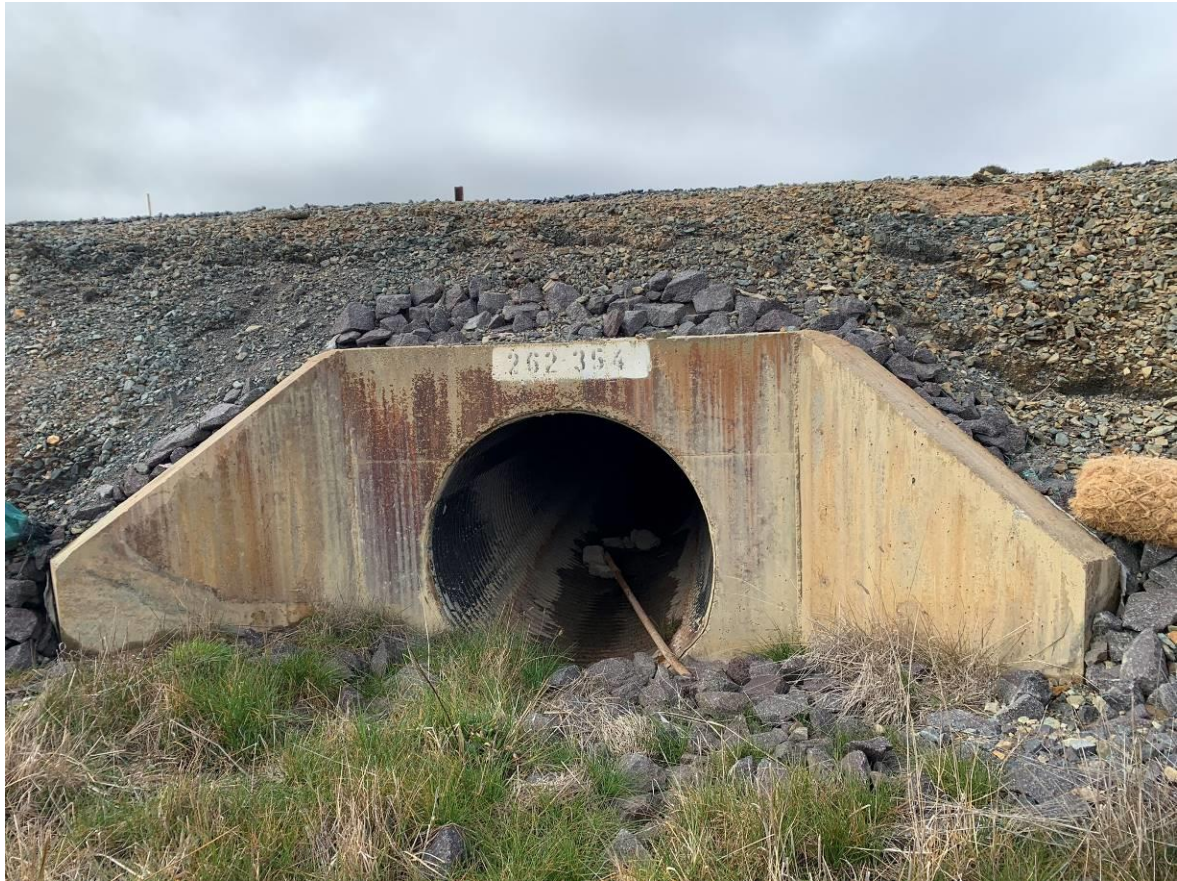
Photo 13: Middle culvert showing no flowing or pooled water. No evidence of sediment build-up in culvert.

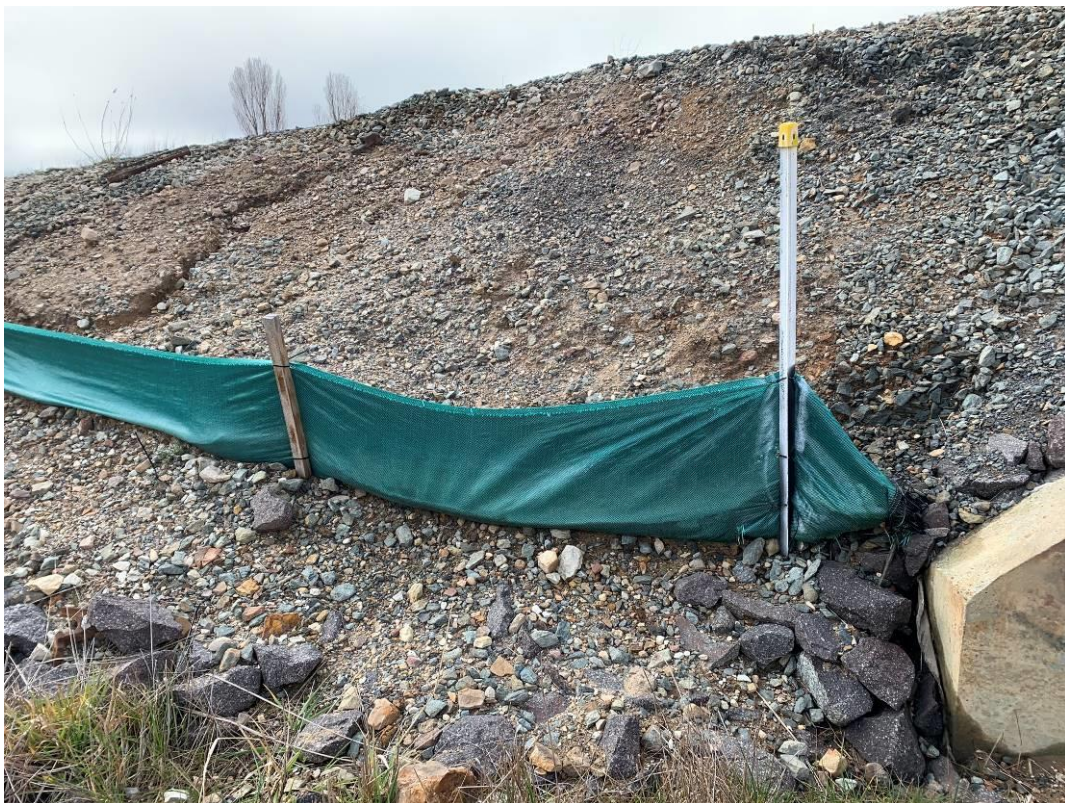
Photo 14: Upgradient of middle trainline culvert facing east. Silt fencing is clear with no sediment visible.

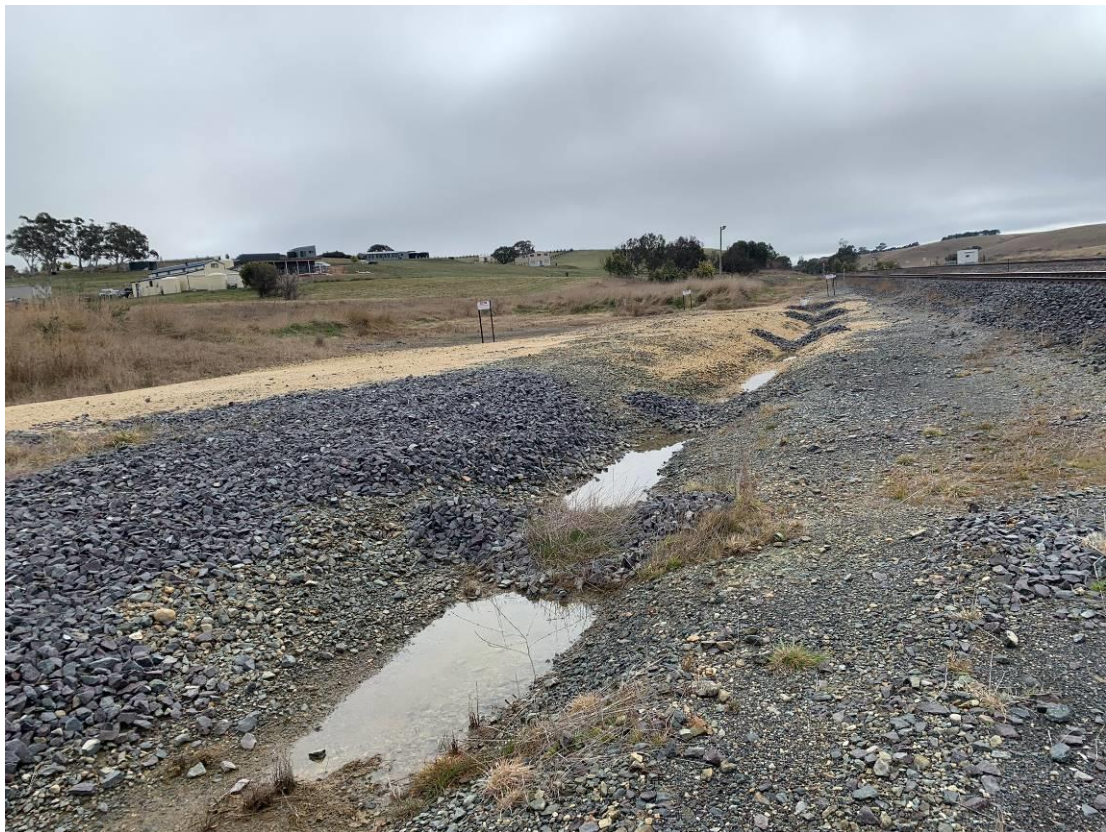
Photo 15: Rock armour upgradient of trainline running from the middle to the north culvert. Some sediment visible on rock armour. Pooled water in rock armoury visible. Water is clear and not running off-site. Facing north-east.

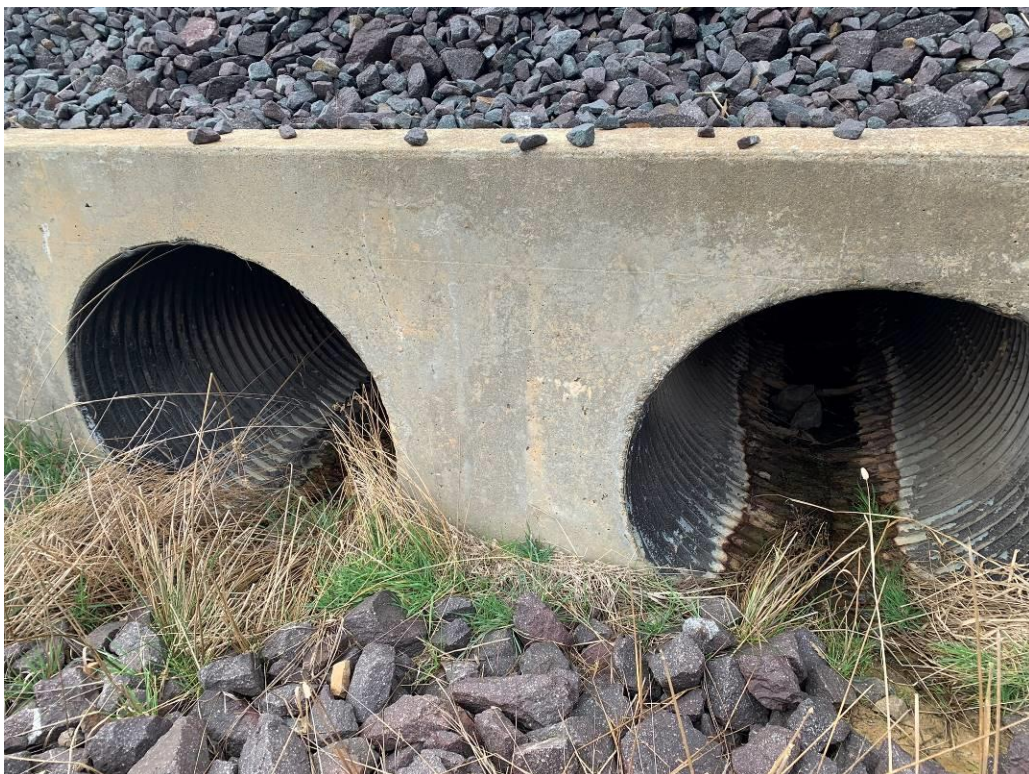
Photo 16: Upgradient of northernmost culvert. No evidence of surface water run off on site. No evidence of sediment buildup on rocks. Rock armor and natural vegetation allow for sediment control in surface water.

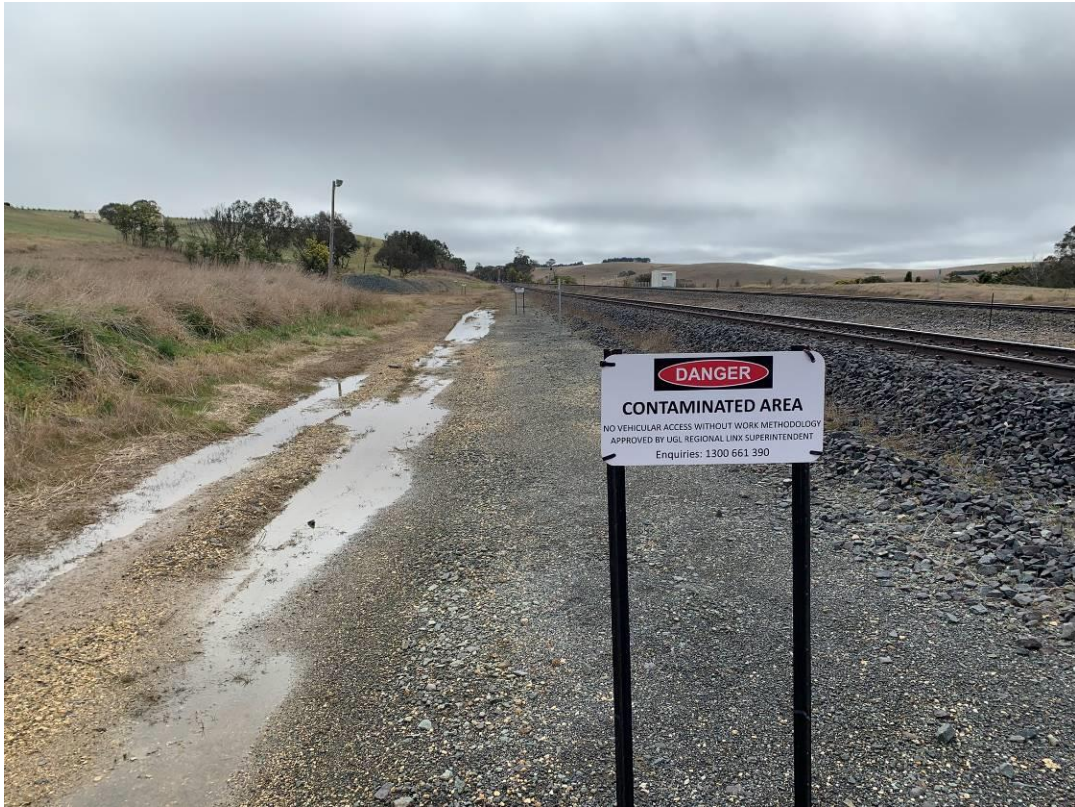
Photo 17: Exclusion zone signing placed periodically along contamination areas. Undamaged and in good condition. Facing North-East

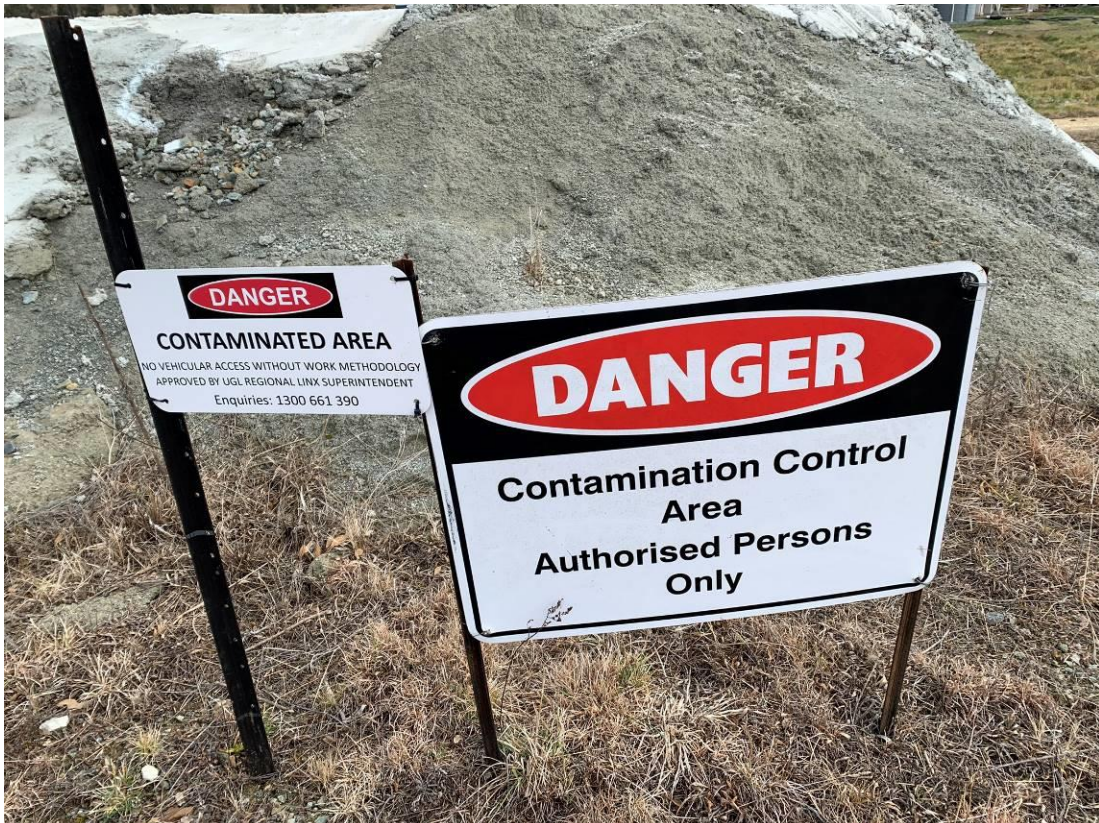
Photo 18: Repaired exclusion zone signage in good condition. This signage was reported as damaged on the last inspection visit (19/07/2023).

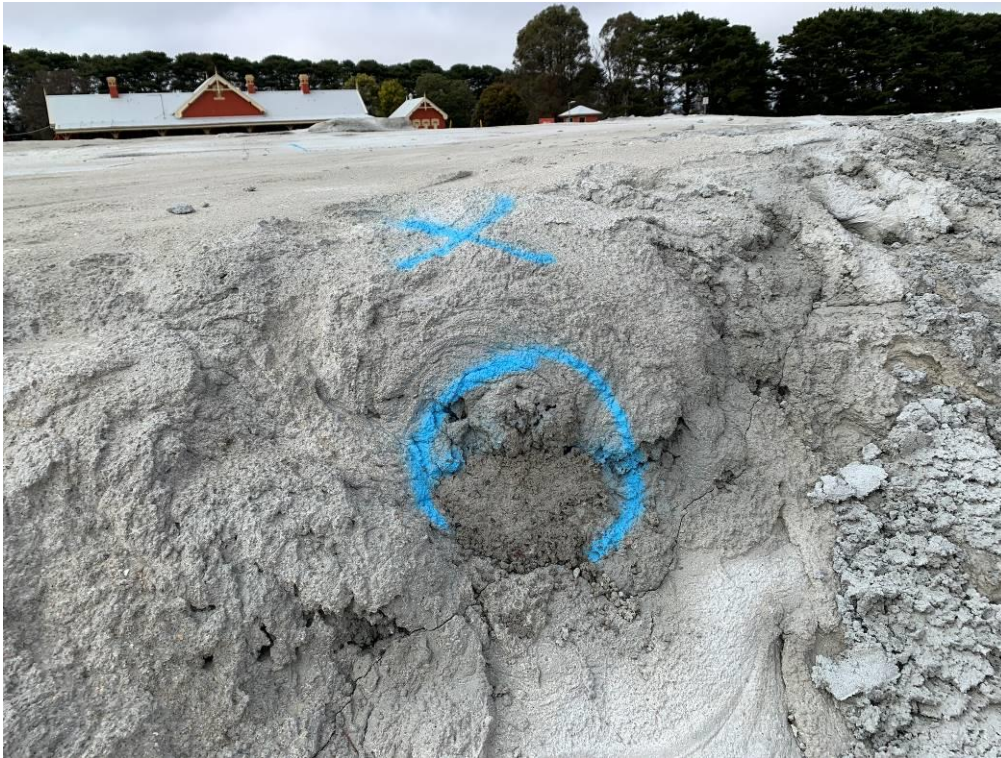
Photo 19: Exposed geofabric layer marker on main stockpile which was identified during the previous inspection (19/07/23), that has since been filled in with concrete.

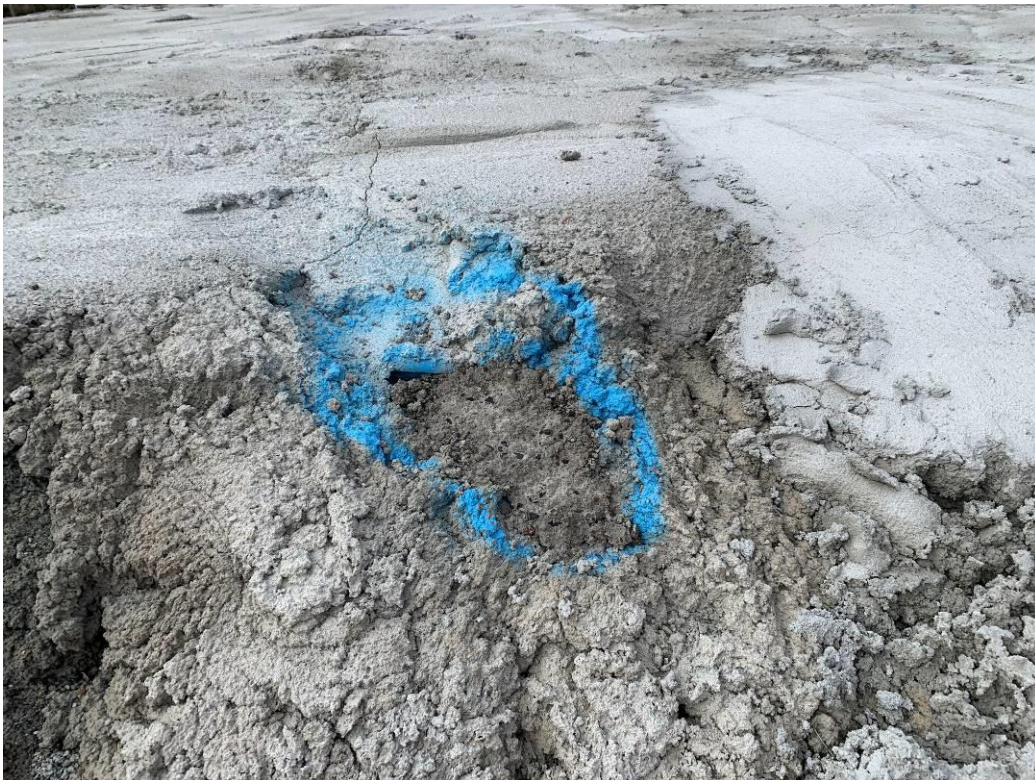
Photo 20. Exposed geofabric layer marker on main stockpile which was identified during the previous inspection (19/07/23), that has since been filled in with concrete.

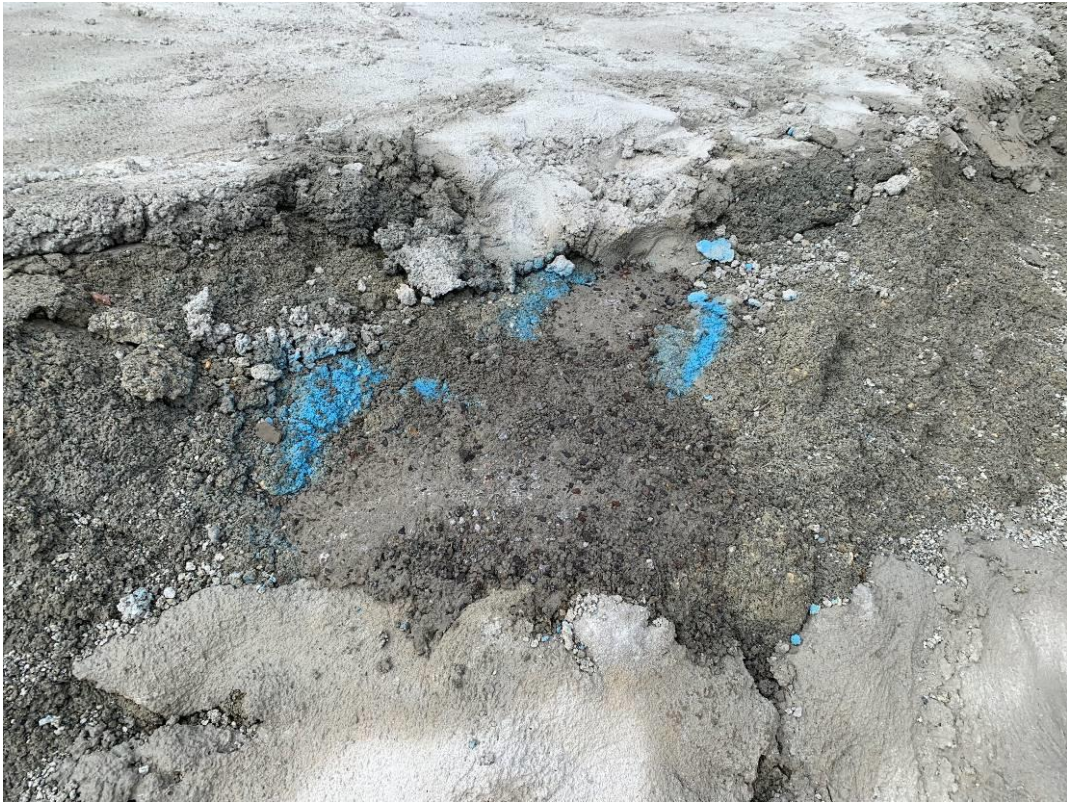
Photo 21. Two exposed geofabric layer markers on the main stockpile which were identified during the previous inspection (19/07/23), that have since been filled in with concrete.

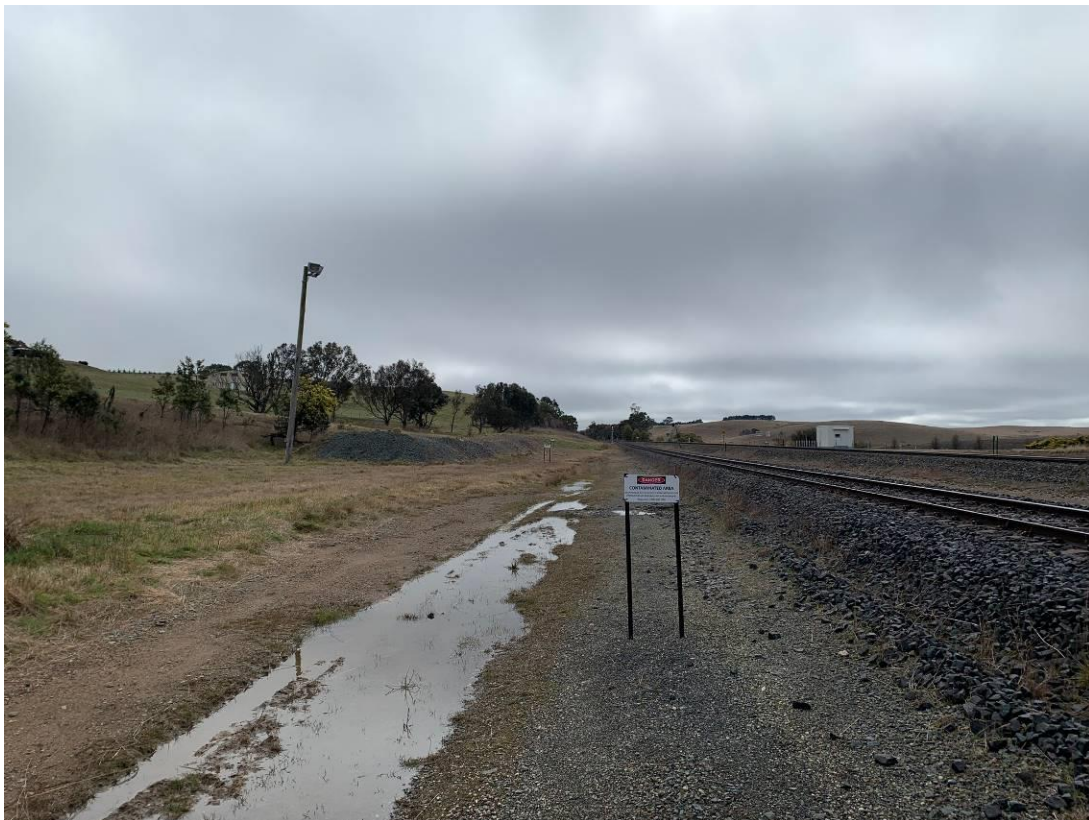
Photo 22. Pooled water along the north-western most railway tracks on the northern half of the site. Water is clear and not flowing. Facing North-East.

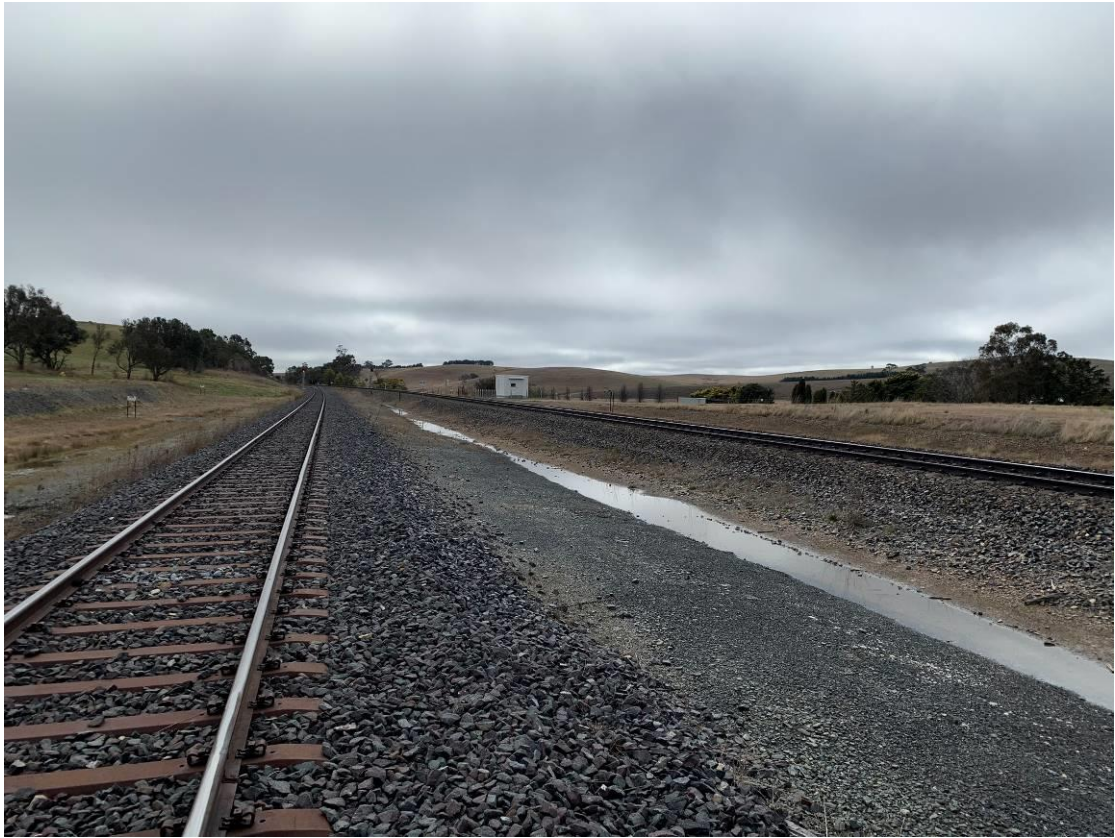
Photo 23. Pooled water between the railway tracks on the northern half of the site. Water is clear and not flowing. Facing North-East.

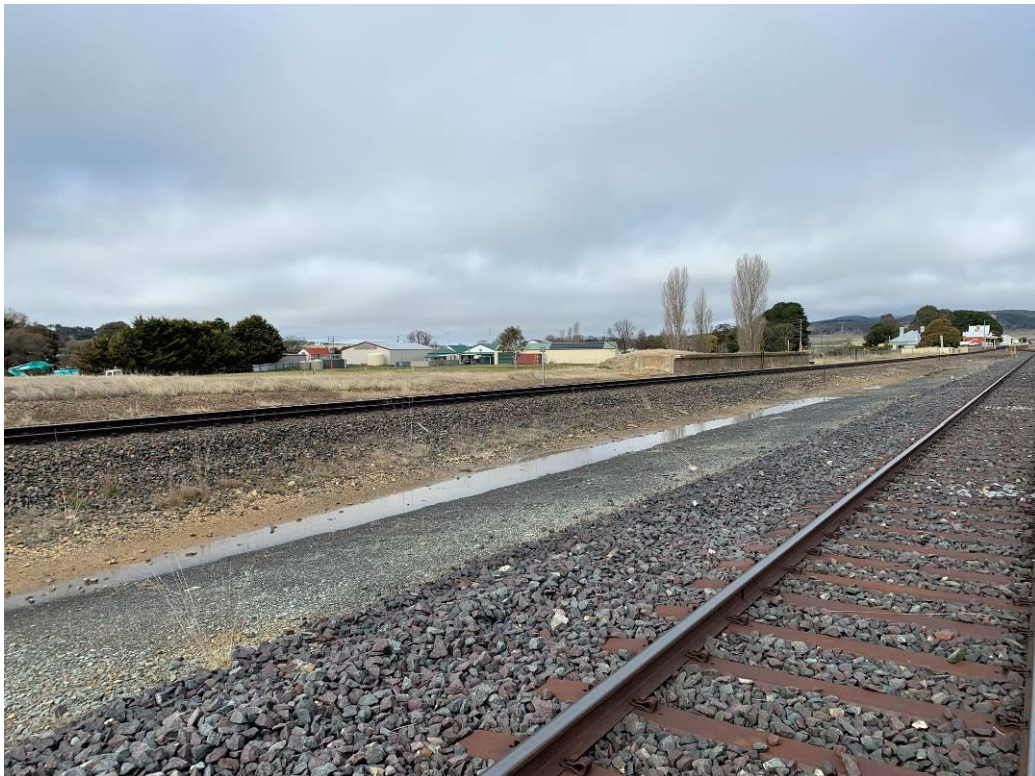
Photo 24. Pooled water between the railway tracks on the northern half of the site. Water is clear and not flowing. Facing South.
