Tarago Action Plan Routine Inspection Checklist

Title: Tarago Rail Yard Inspection	Approved: SM	Project-Nr.: 318001704	Date: June 2023
Site: Tarago, NSW			
Client: UGL Regional Linx

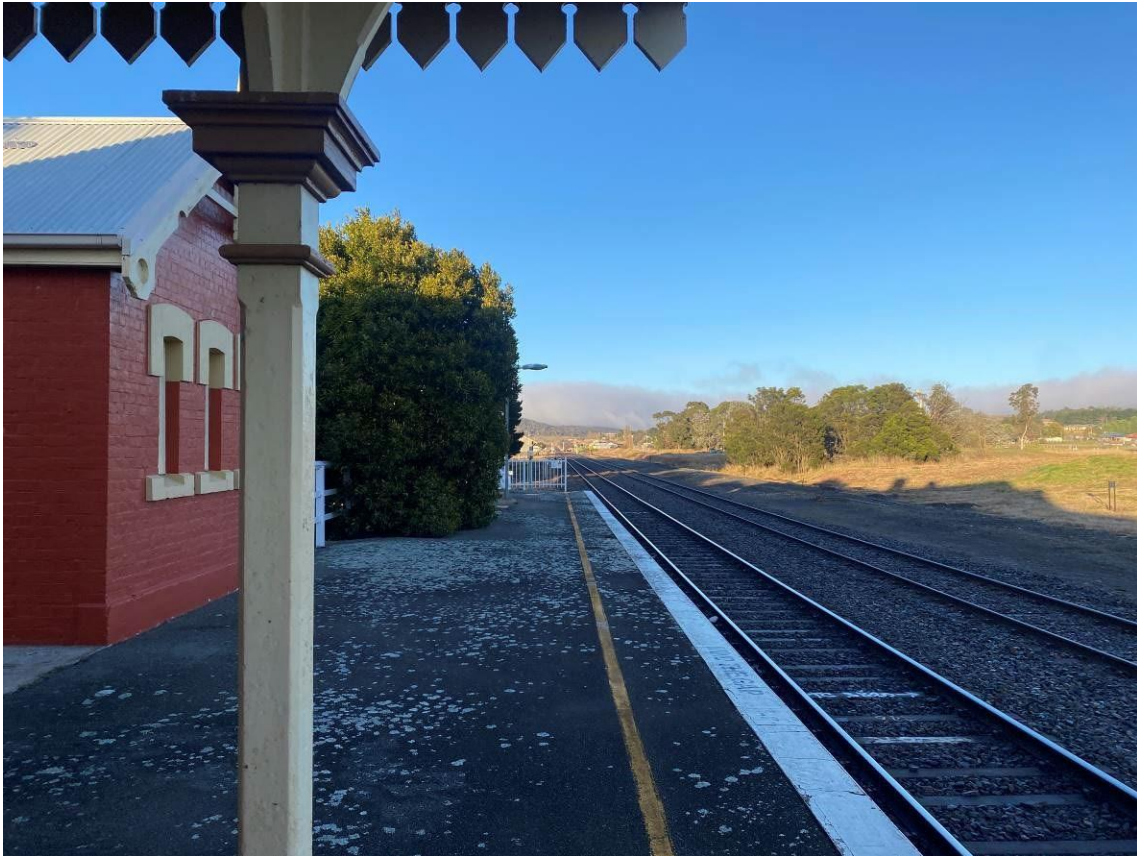
Photo 1: Picture at southern end of railway station facing south west. No airborne dust visible in air or on surfaces.

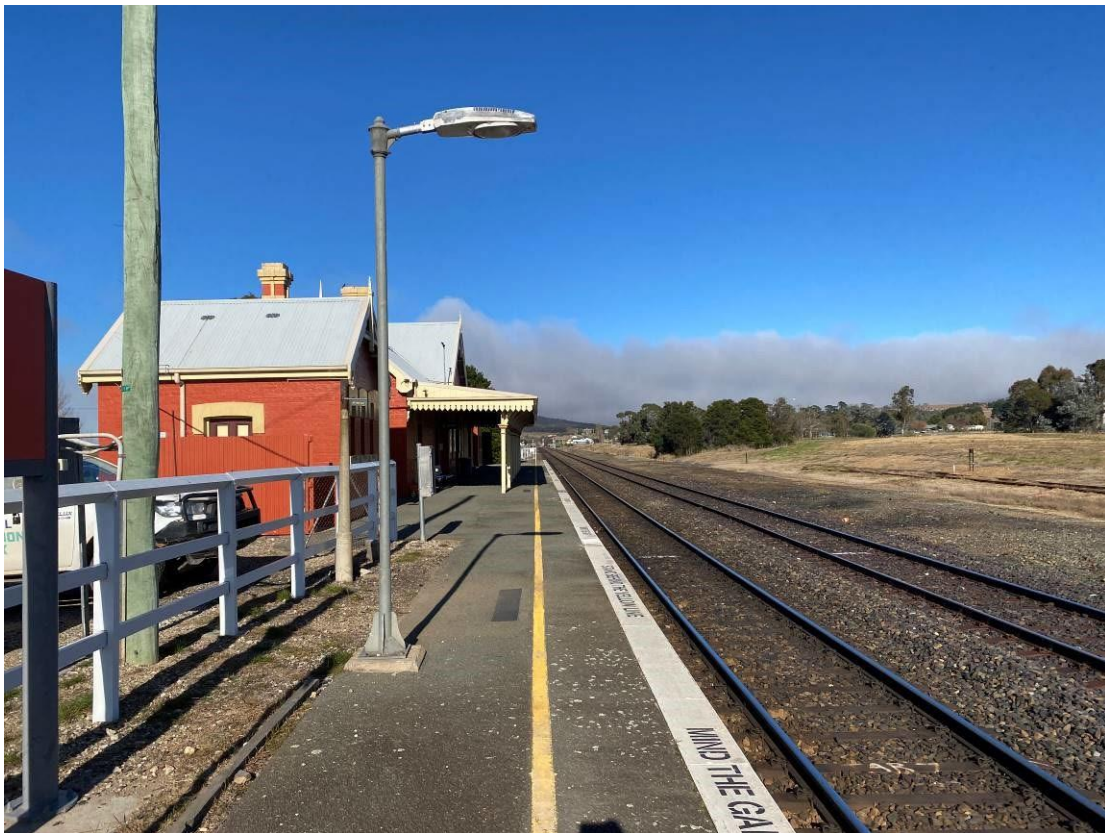
Photo 2: Picture at northern end of railway station facing south west. No airborne dust visible in air or on surfaces.

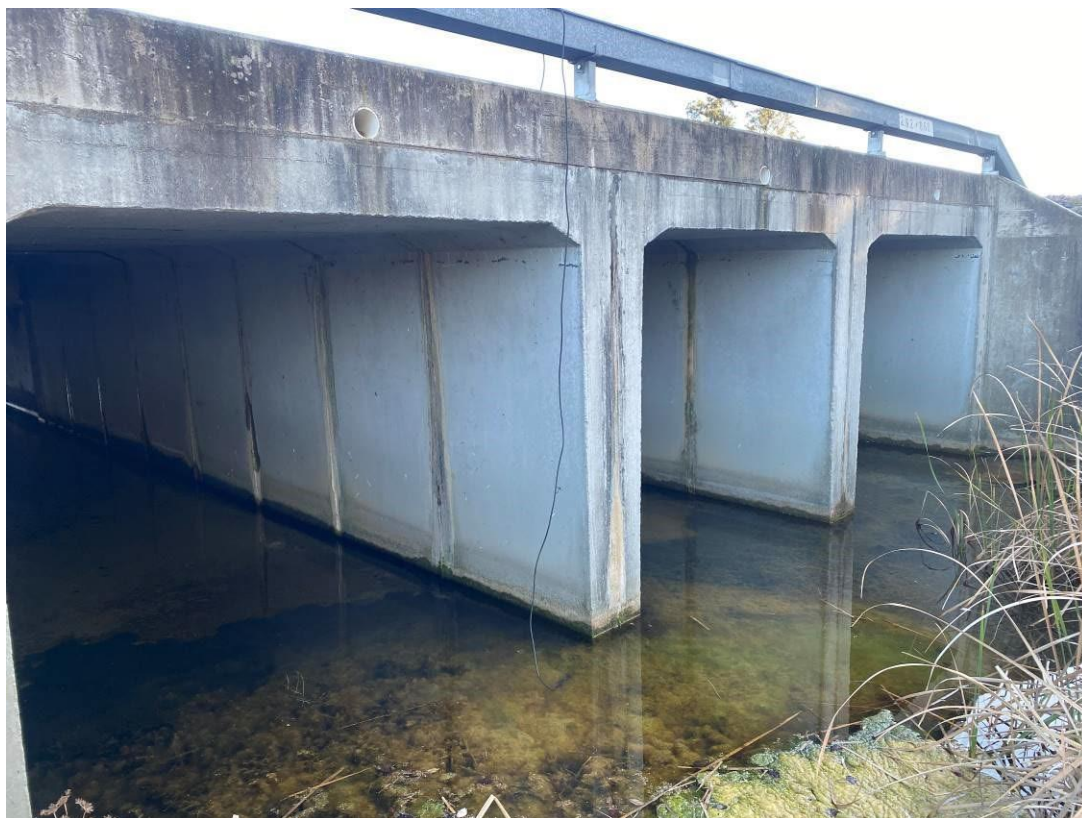
Yes. Surface water discharging at a slow rate from the southern culvert (Photo 3). Some pooled water observed on site and immediately downstream of middle culvert but not discharging off site (Photos 4 - 6). No surface water at northern culvert (Photos 7 - 8).			
Is there evidence of excavation or other works non-compliant with the Action Plan?			
No

Photo 3: Southern most culvert downgradient of rail line, showing evidence of surface water run off on site. Water is clear, no turbidity, with no observable sediment, some algae present.

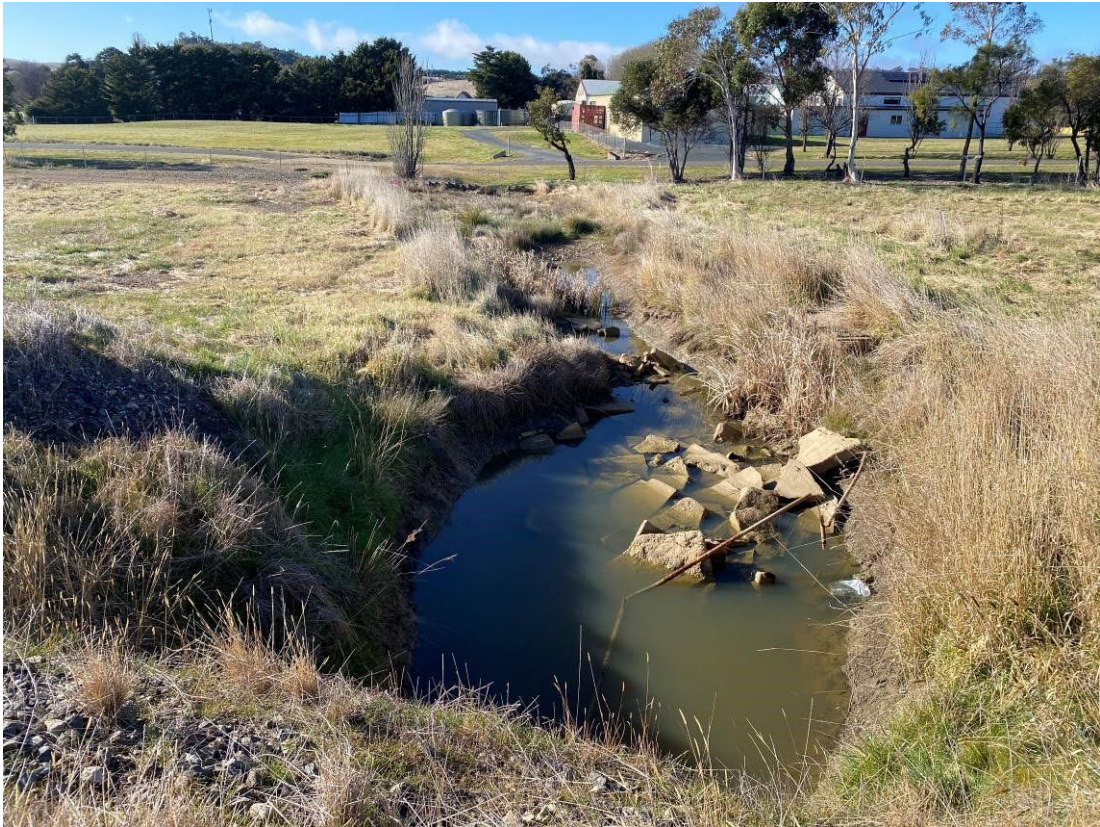
Photo 4: Downgradient of middle culvert showing pooled sediment laden water on site. Sediment has settled more on the bottom of the water body compared to last inspection. Brown, moderate turbidity. No surface water running off site at middle culvert.

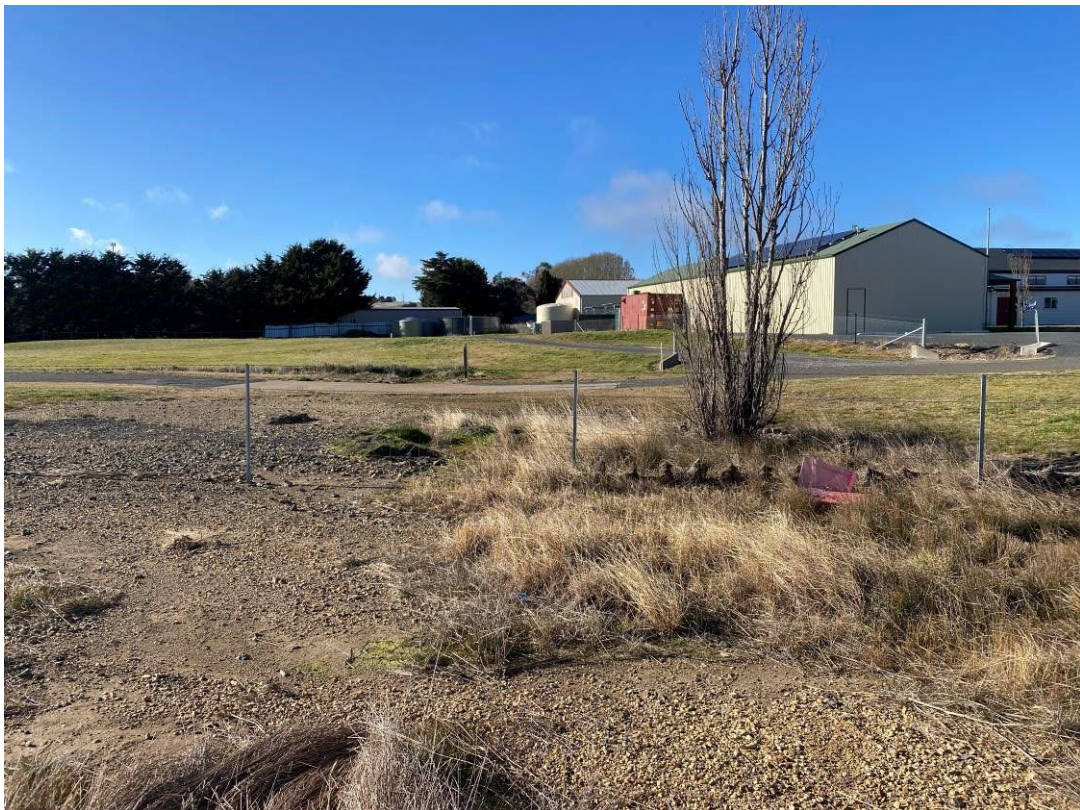
Photo 5: Downgradient of middle culvert. Dry beyond the pooled water and no evidence of current surface water run off on site.

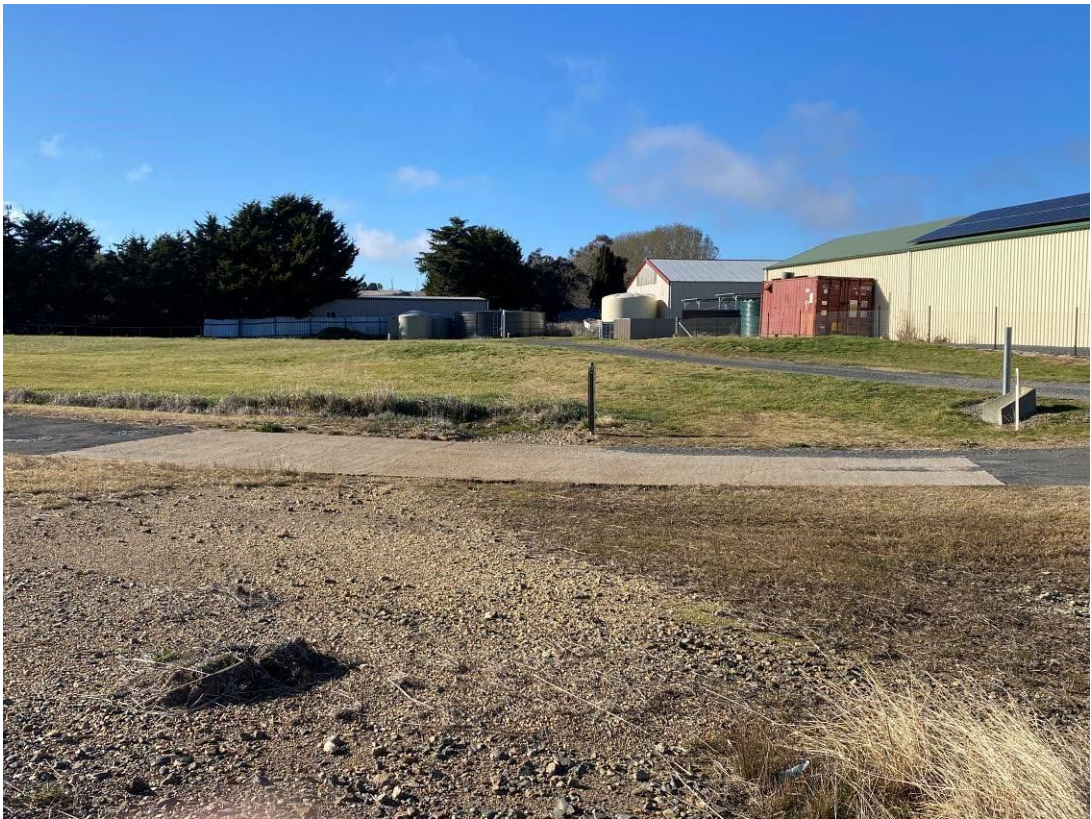
Photo 6: Causeway downgradient of middle culvert showing no evidence of current surface water run off on site. No visible sediment on road or vegetation nearby from sediment water was running off site in between inspections.

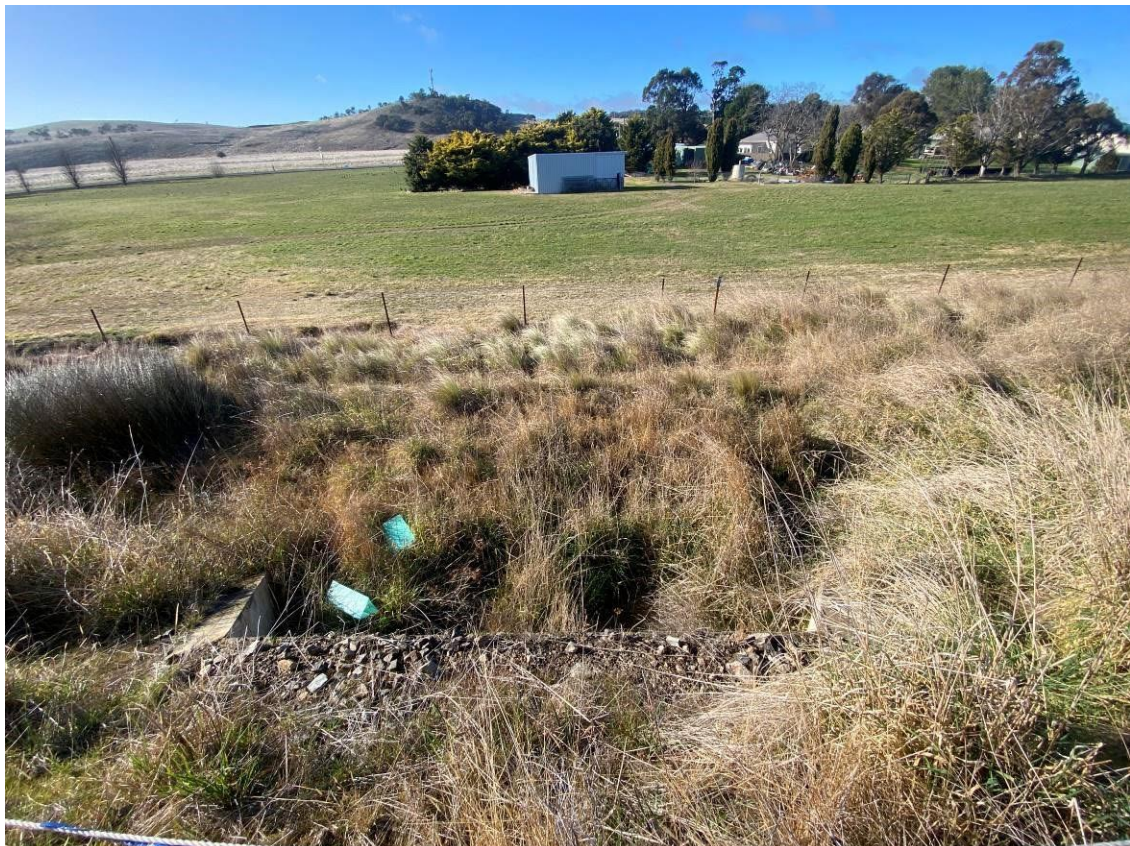
Photo 7: Downgradient of northernmost culvert showing evidence of no surface water runoff from site to neighbouring property.

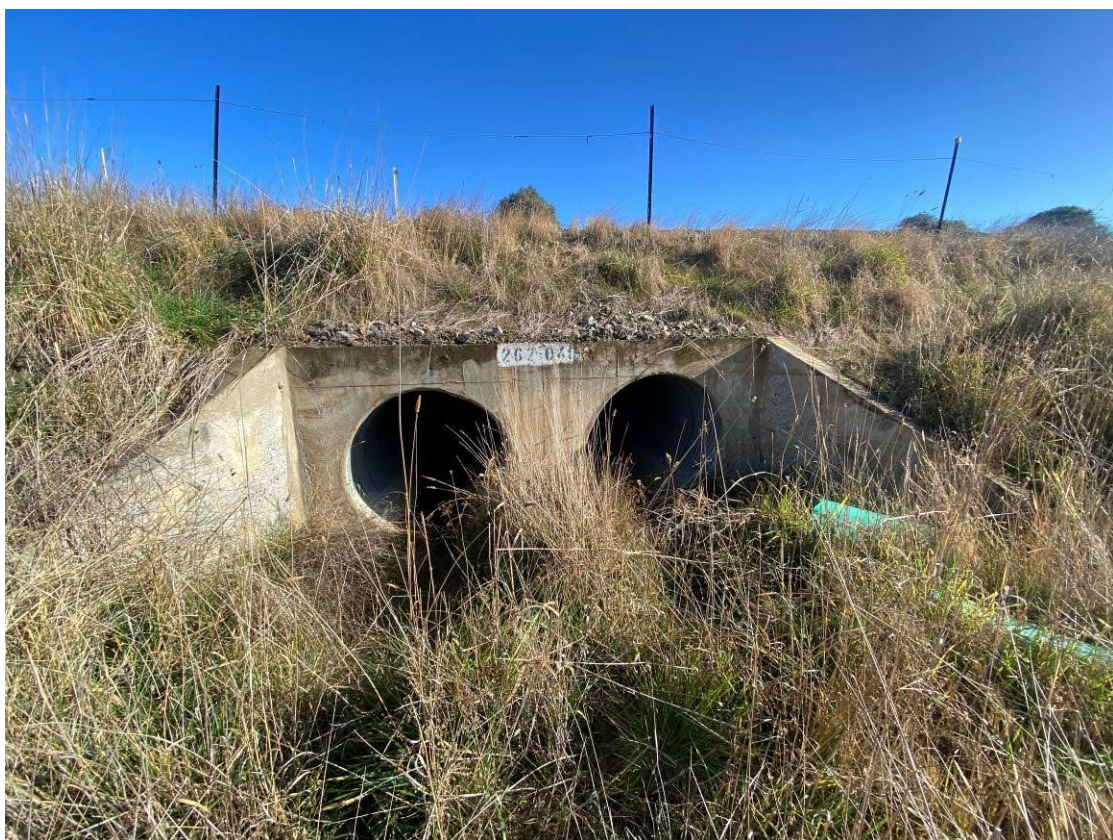
Photo 8: Downgradient of northernmost culvert showing evidence of no surface water surrounding.

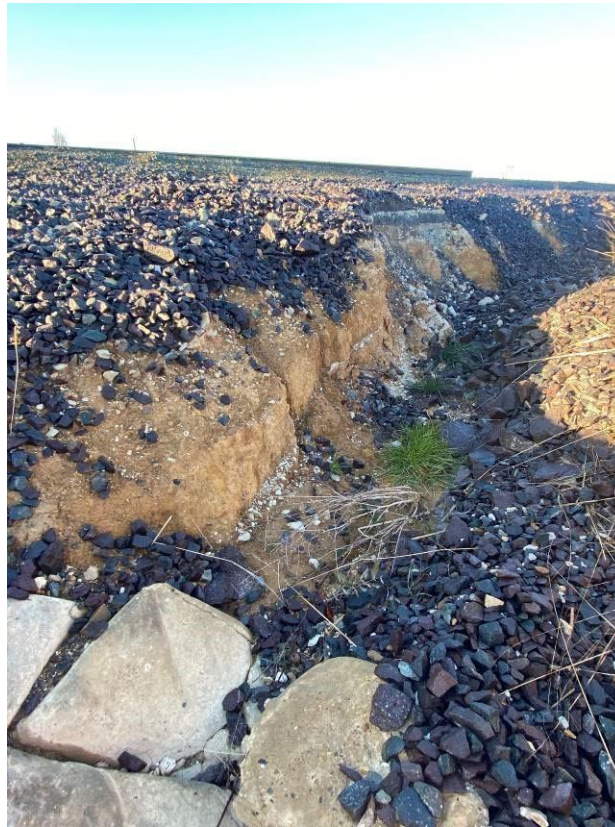
Evidence of erosion was noted upgradient of the southern most culvert in previous site inspection on 20 April 2023 and remains on site but stable (**Photo 9**). Additionally, evidence of similar erosion was noted at the culvert further upgradient (west) of the southern most culvert (**Photo 25**). However, no evidence of sediment was found in water flowing offsite at southern culvert. Ramboll recommends replacing ground cover material (ballast) if further erosion occurs at either locations or sediment is visible in the downstream surface water of the southern culvert.

Photo 9: Visible evidence of erosion due to loss of ground cover (ballast material) upgradient of southernmost culvert. Remaining stable and no major further erosion since last inspection. Facing south.

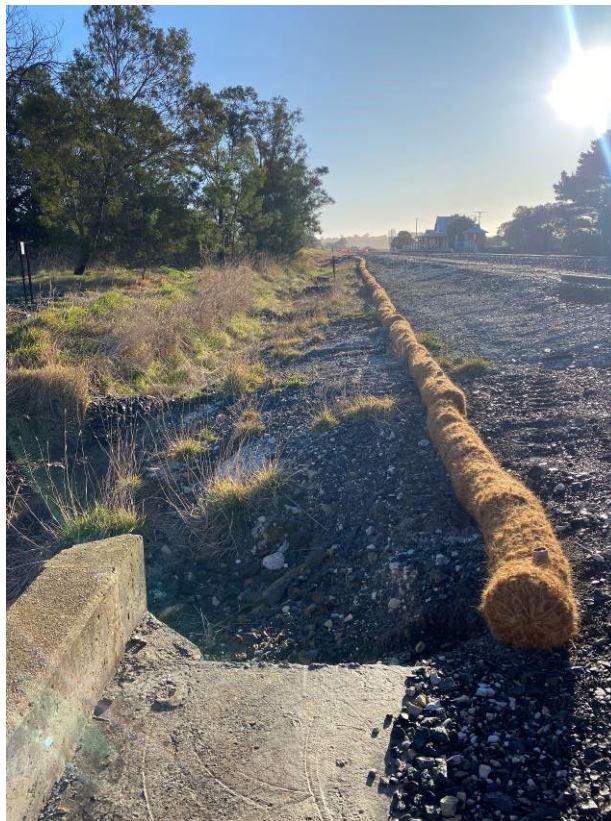
Photo 10: Upgradient of southernmost culvert showing previous silt fencing replaced by Coir sediment control logs, used as control measures for sediment control. Facing north.

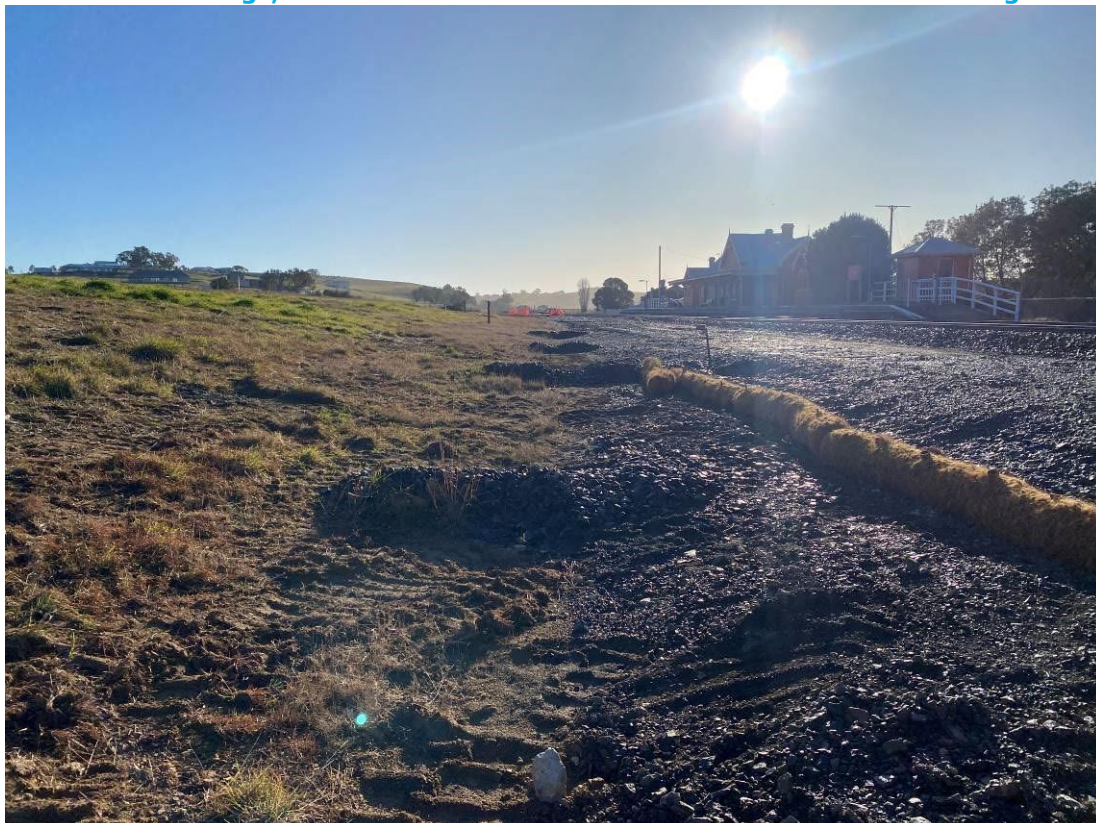
Photo 11: Rock checks running along former Woodlawn siding and between southern and middle culverts. Silt fencing replaced by Coir sediment control logs.

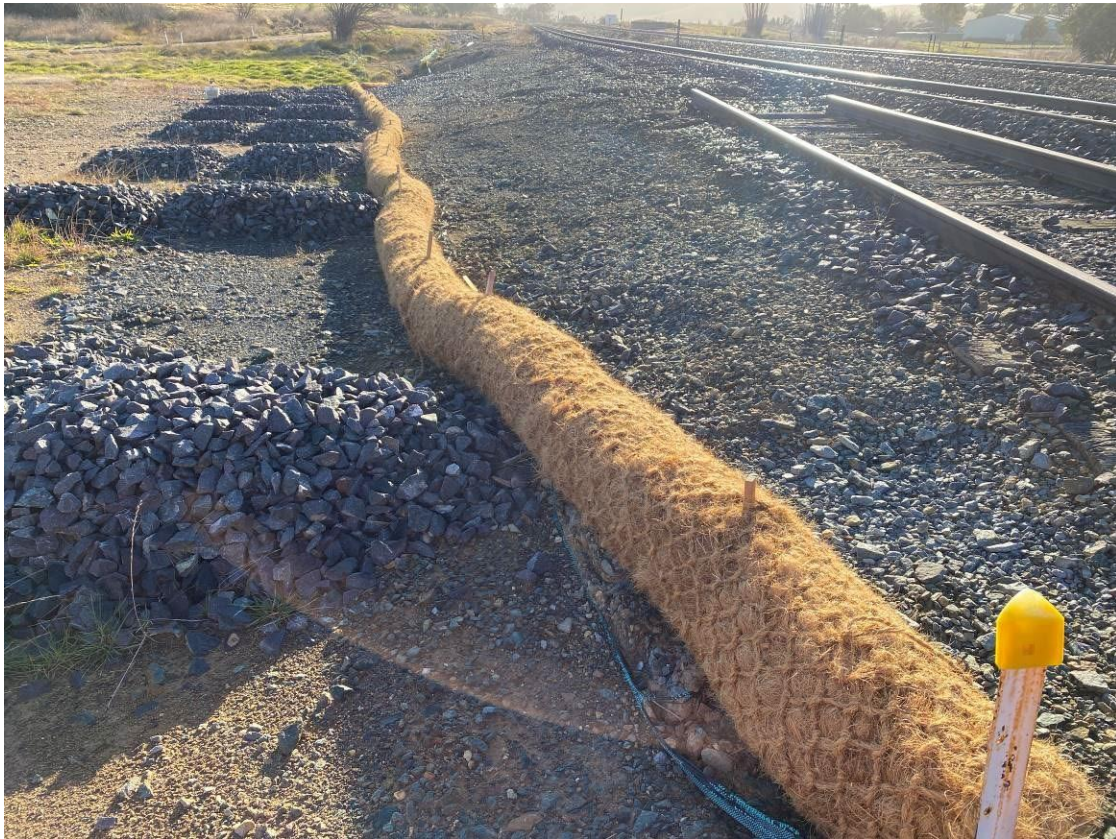
Photo 12: Rock checks running alongside former Woodlawn siding towards the middle culvert. Previous silt fencing with major damage replaced by Coir sediment control logs as recommended in previous inspections. No evidence of sediment build-up in rock armoury.

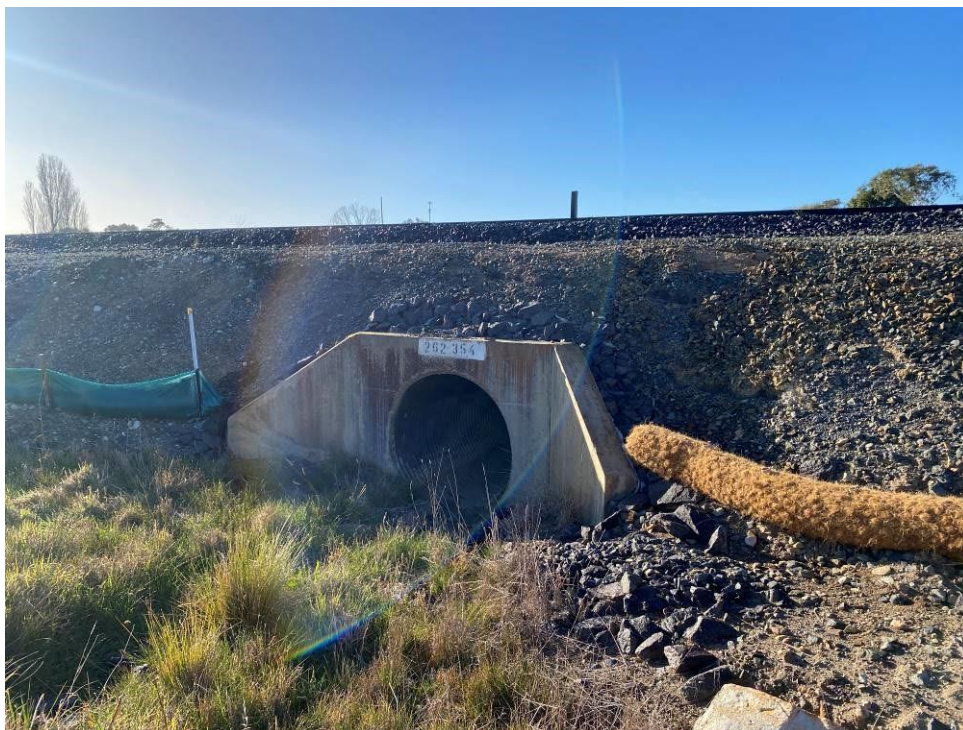
Photo 13: Upgradient of middle culvert showing signs of sediment in silt fencing on northern side. Silt fencing is full and sediment needs to be clear or fencing needs to be replaced before breakages. New Coir sediment control logs placed on southern side.

Evidence of build up of sediment in some silt fences upgradient of middle culverts (**Photo 13**). Ramboll recommends removing silt build up on fences using a shovel to prevent breakage of fences.

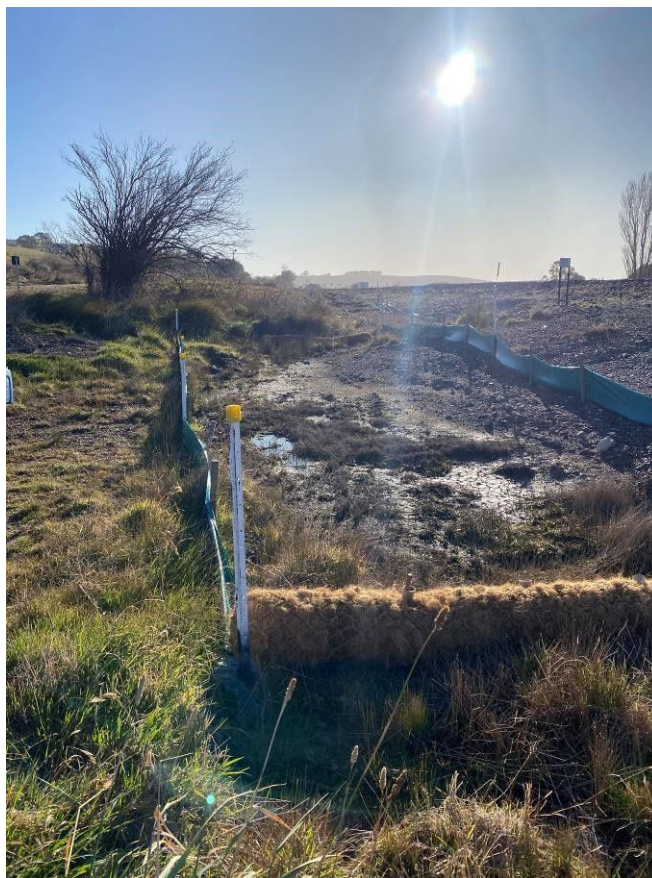
Photo 14: Upgradient of trainline culvert facing north, showing minor pooling on site near rock checks and silt fencing. New Coir sediment control log placed in drainage channel running towards middle culvert.

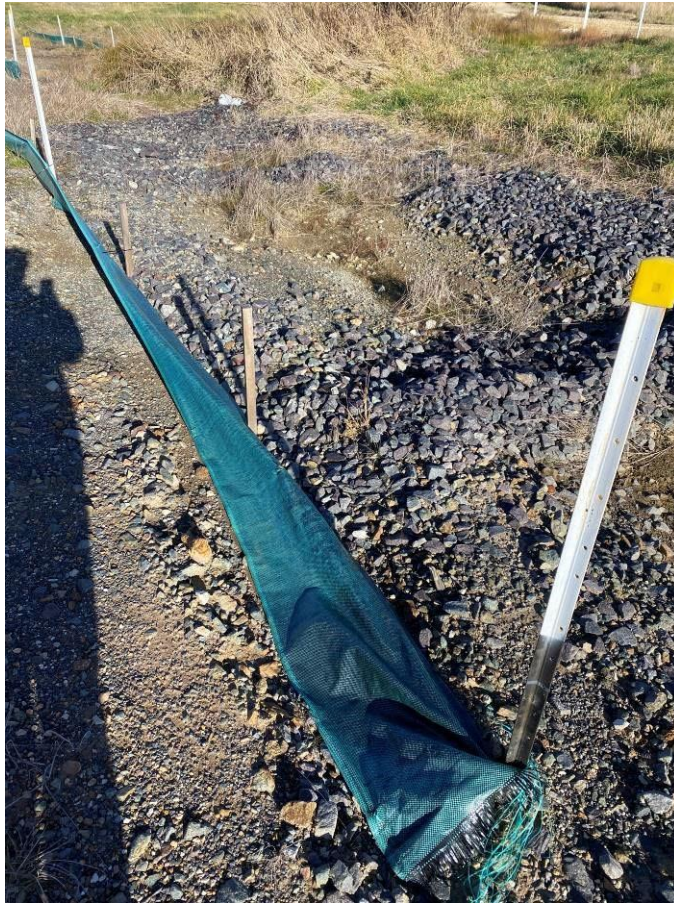
Are sediment controls still functional?	Yes, with the exception of silt fencing discussed in Photo 15 . Refer to 'Other Observations' for recommendations.

Photo 15: Silt fencing and rock armoury upgradient of trainline running from the middle to the north culvert. Silt fencing damaged and not attached to stakes.

Previous inspections identified major damage to the silt fencing uphill of the rail line (western side) and to the south of the middle culvert and minor damage to the silt fencing uphill of rail line and running between the southern and middle culverts. Ramboll notes that this silt fencing has been replaced by coir sediment control logs (**Photos 10 - 14**) as per recommendations from previous inspection checklist dated 15 May 2023. Ramboll notes minor damage to the silt fencing upgradient of trainline running from the middle to the north culvert (**Photo 15**) and recommends retying fencing to stakes.

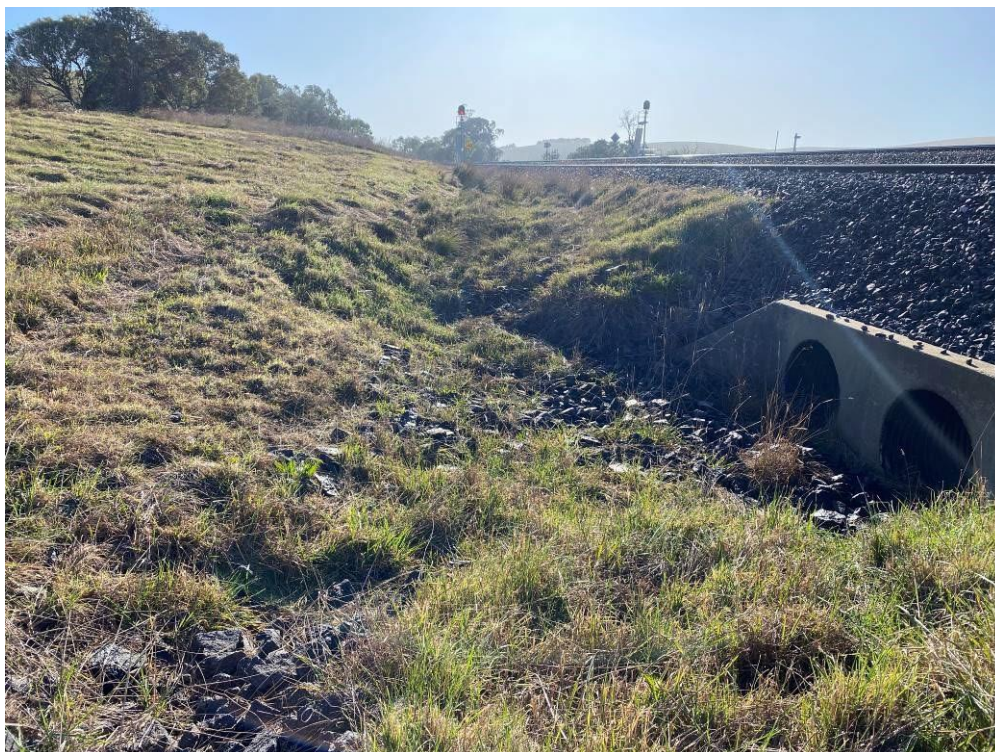
Photo 16: Upgradient of northernmost culvert. No evidence of surface water run off on site. No evidence of sediment buildup on rocks. Rock armory and natural vegetation allow for sediment control in surface water.

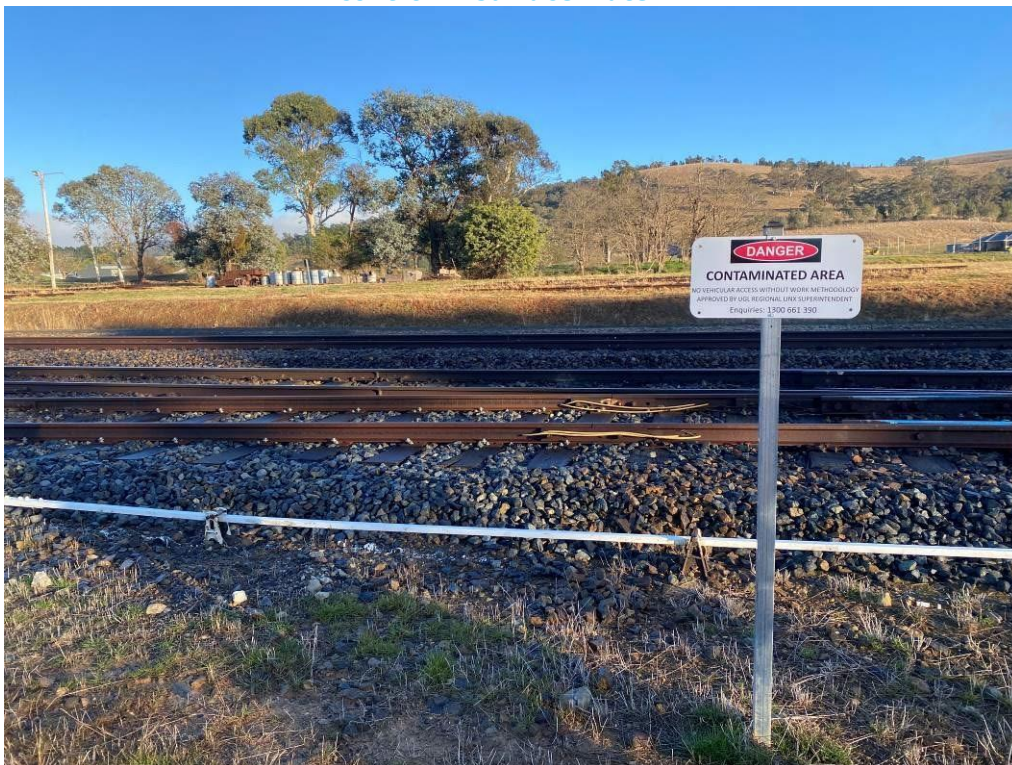
Photo 17: Exclusion zone signing placed periodically along contamination areas. Undamaged and in good condition.

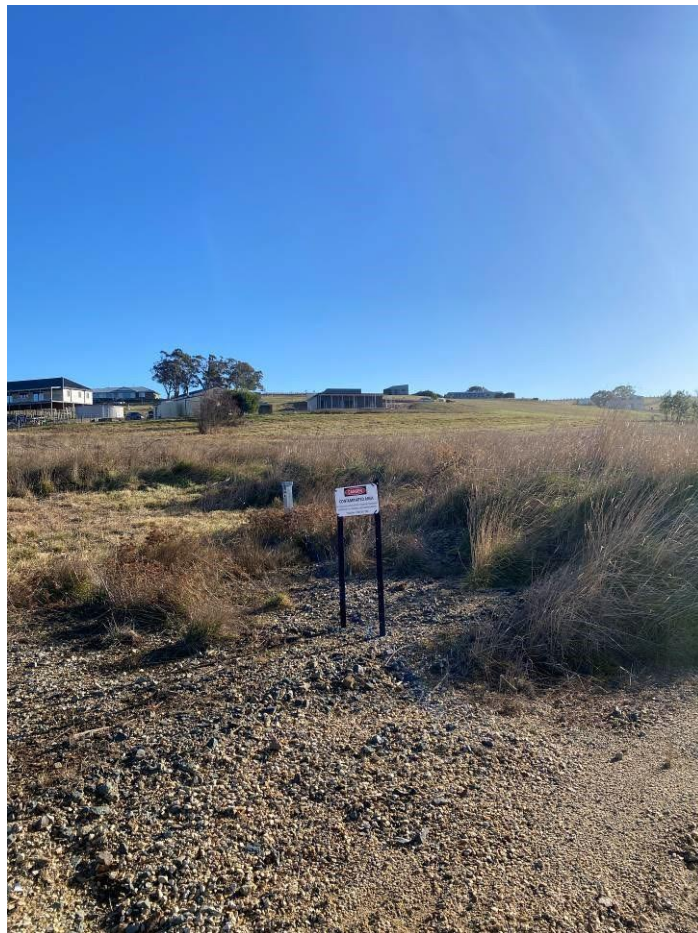
Photo 18: Additional exclusion zone signing placed periodically along contamination areas.

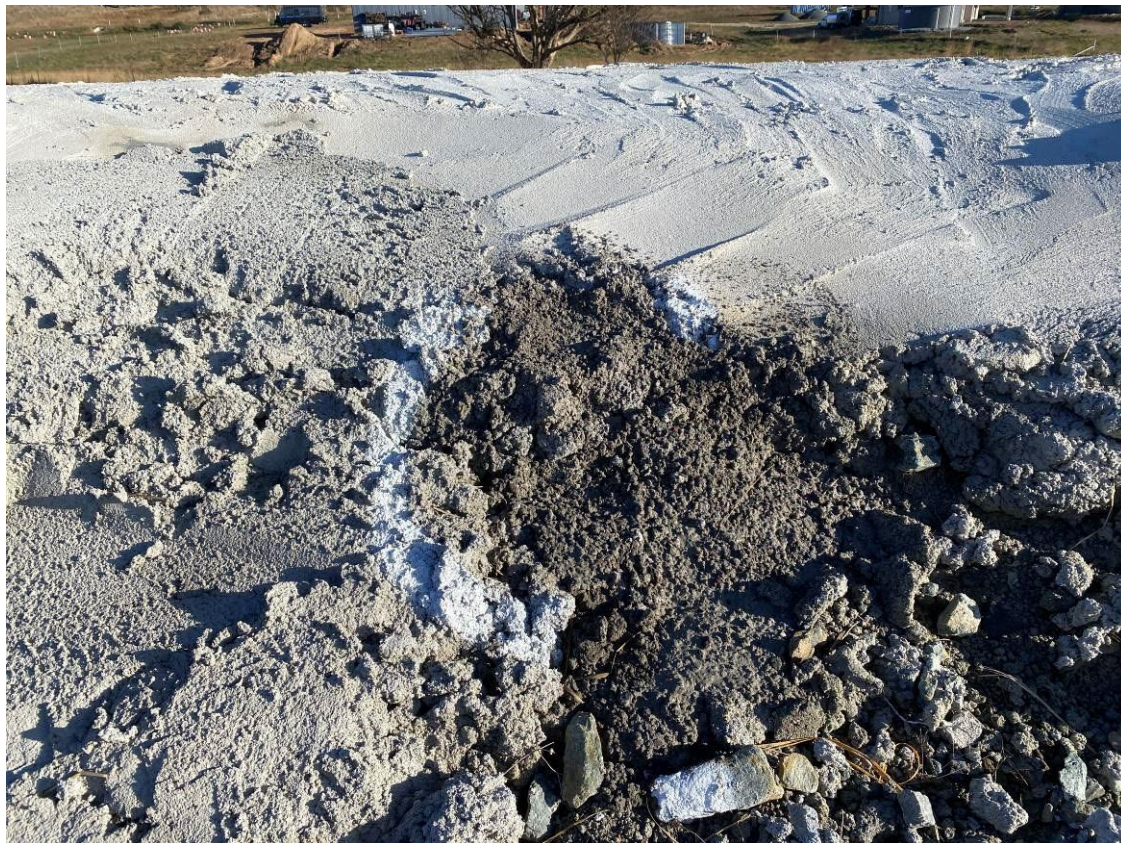
Photo 19: Geofabric marker layer visible in stockpile capping noted in previous inspection 20/04/23 had been patched as per recommendations.

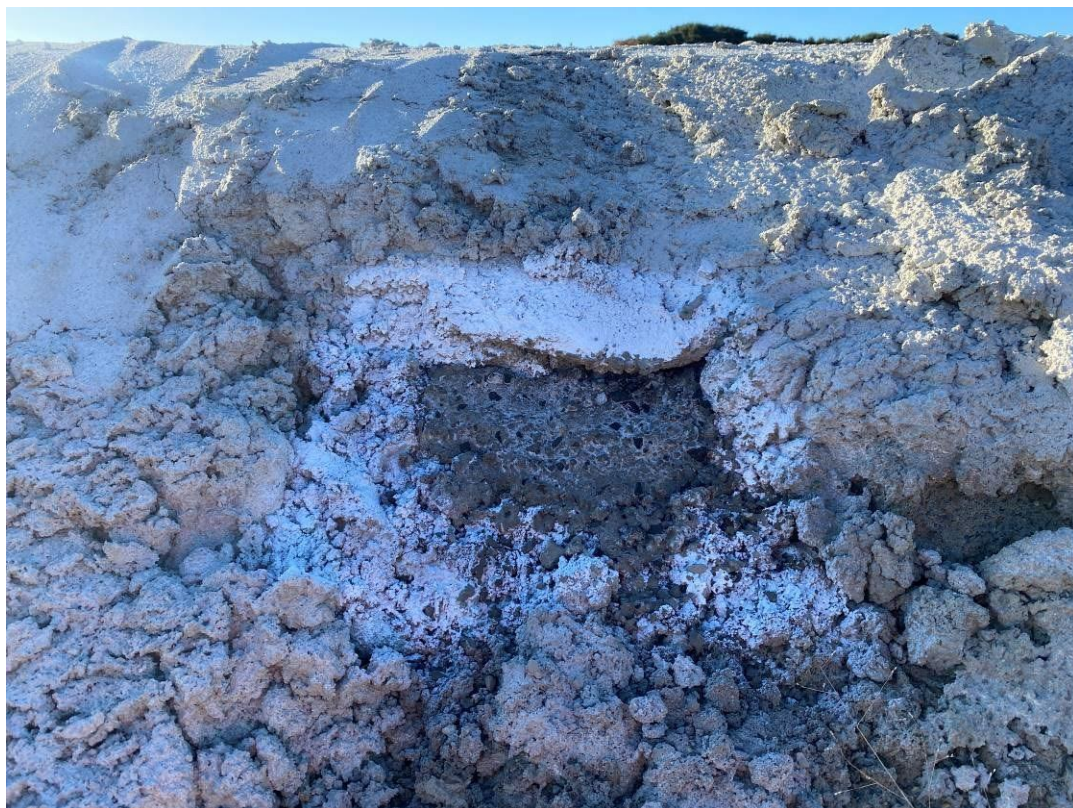
Photo 20: Geofabric marker layer visible in stockpile capping noted in previous inspection 20/04/23 had been patched as per recommendations.

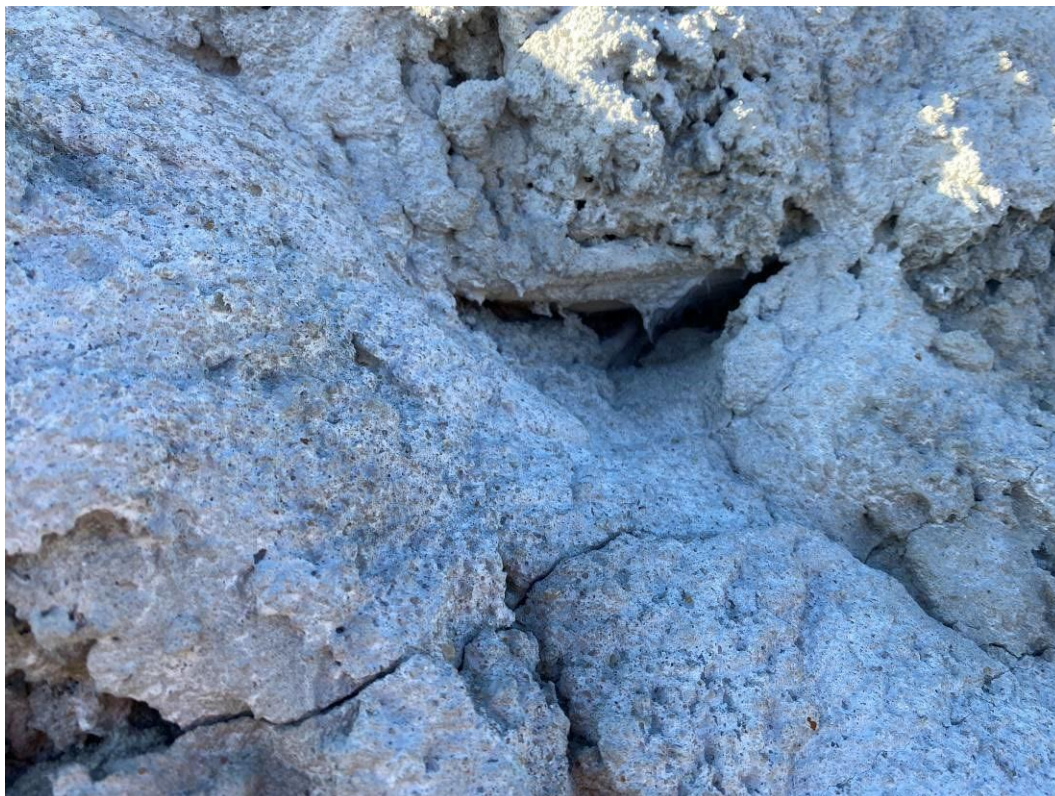
Photo 21. Geofabric marker layer visible in stockpile capping noted in previous inspection 15/05/23 remains. Approximately 5cm x 3cm.

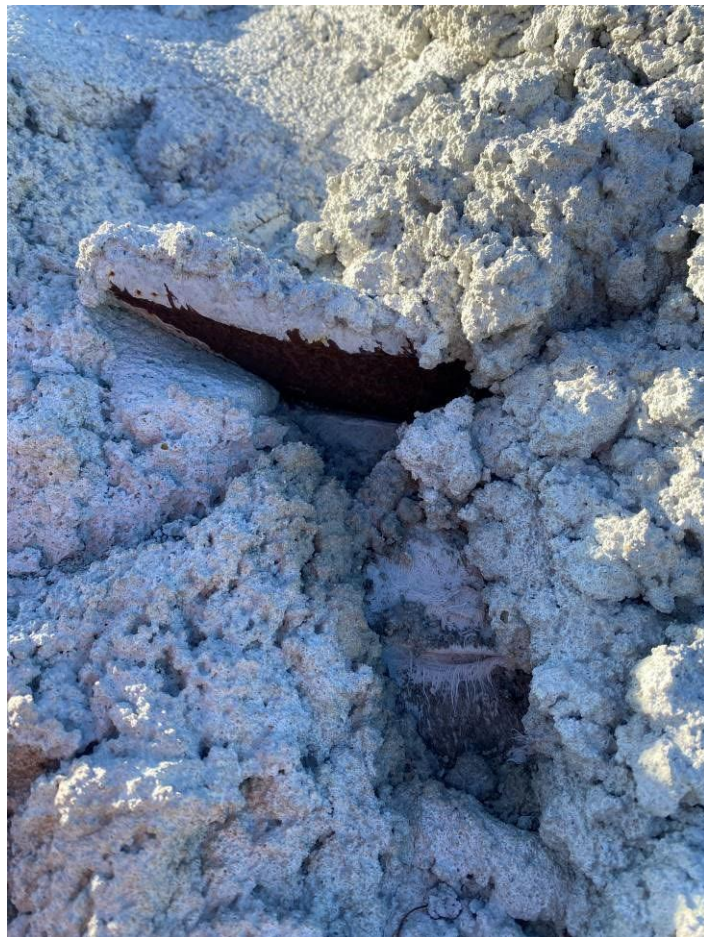
Is geofabric marker layer visible beneath capping of the existing stockpile? If so record in written form and through photographs and consolidate with this checklist. If marker layer is visible rectification work is required.	Yes, geofabric marker layer visible in three locations on west of stockpile. Location and size detailed in Photos 21 - 23 , refer to 'Other Observations' section for recommendations.

Photo 22. New location of geofabric marker layer visible in stockpile capping. Approximately 2cm x 5cm.

Evidence of patching of minor marker layer exposure (noted in a previous inspection checklist dated 20 April 2023) was seen (**Photos 19 - 20**). One minor marker layer exposure (noted in a previous inspection checklist 15 May 2023) remained (**Photo 21**). Additionally, two new marker layer exposure locations were identified (**Photos 22 - 23**), Ramboll recommends repairing these by patching with sand and cement mixture.

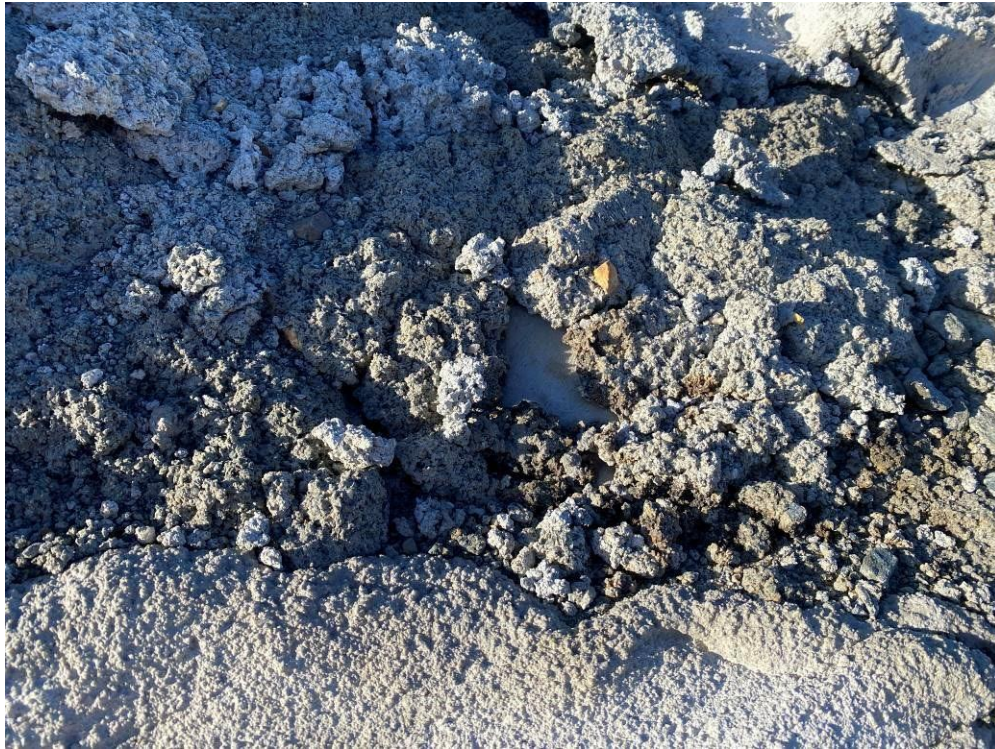
Photo 23. New location of geofabric marker layer visible in stockpile capping. Approximately 3cm x 3cm.

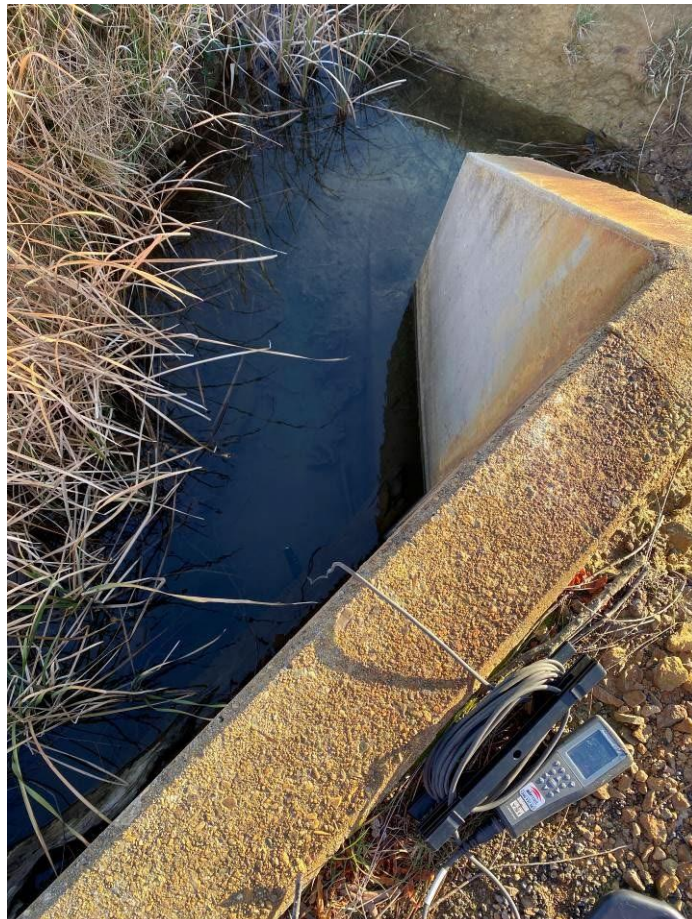
Photo 24. Quarterly surface water monitoring underway during monthly environmental monitoring plan inspection.

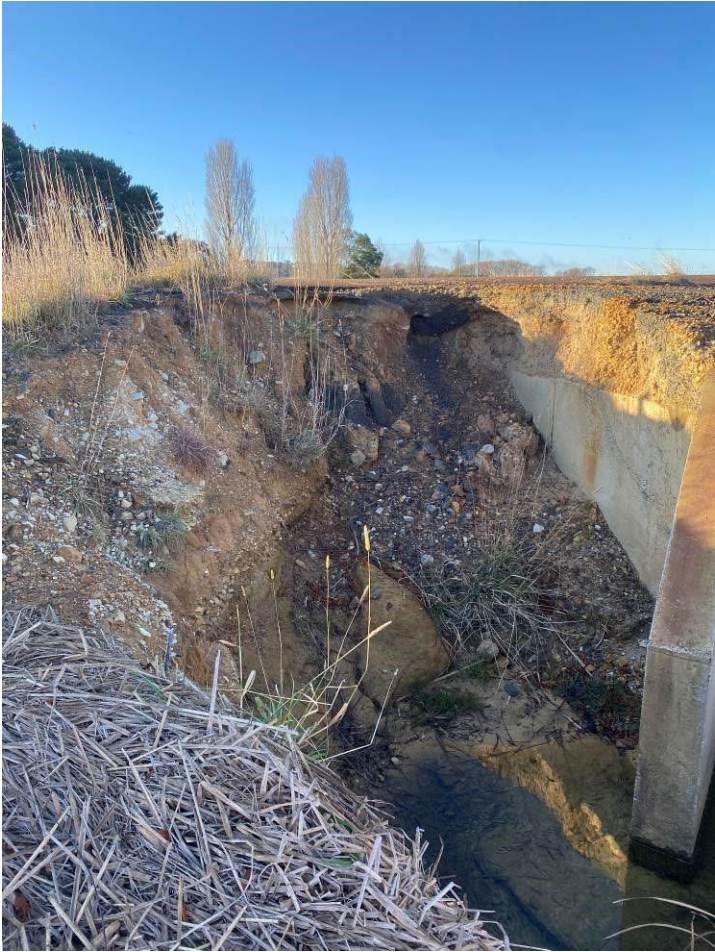
Photo 25. Notable erosion evident adjacent to the culvert further upgradient of the southernmost culvert. Surface water pooled near culvert and below erosion is clear with no visible signs of sediment. This erosion is not expected to impact surface water flowing off site.
