Tarago Action Plan Routine Inspection Checklist

Title: Tarago Rail Yard Inspection	Approved: SM	Project-Nr.: 318001704	Date: May 2023
Site: Tarago, NSW			
Client: UGL Regional Linx

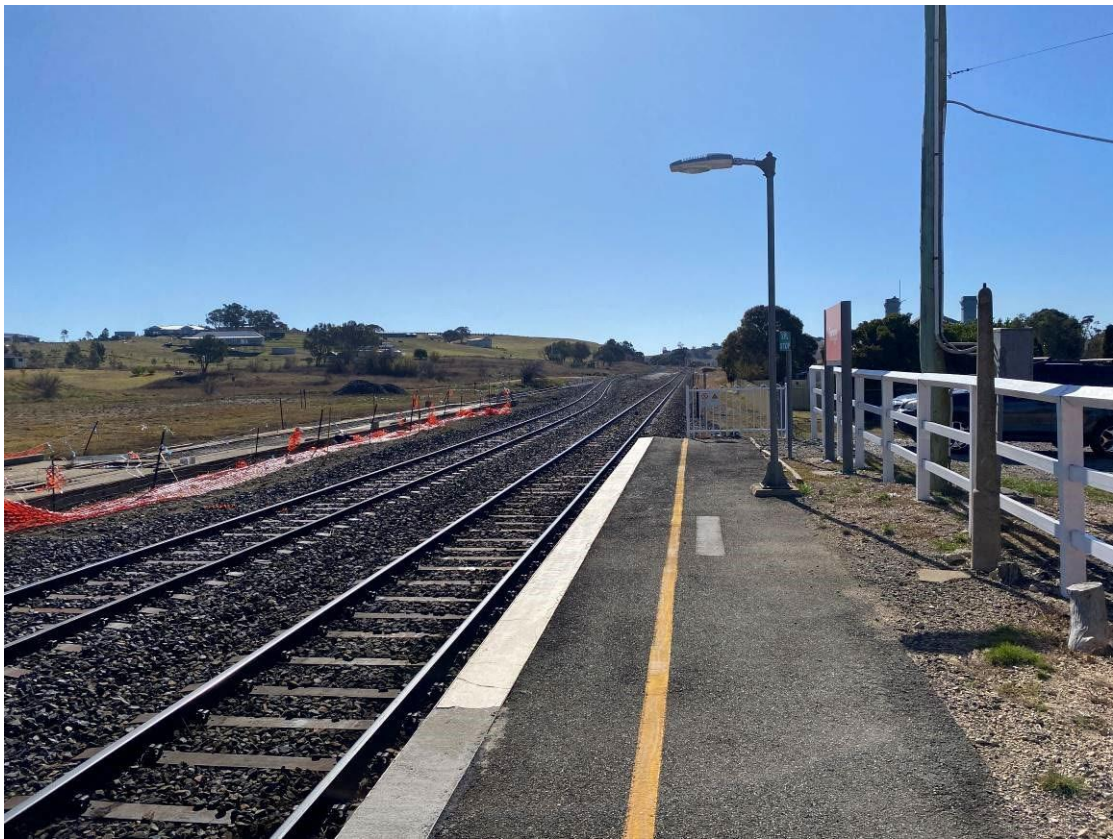
Photo 1: Picture of railway station facing north east. No airborne dust visible in air or on surfaces.

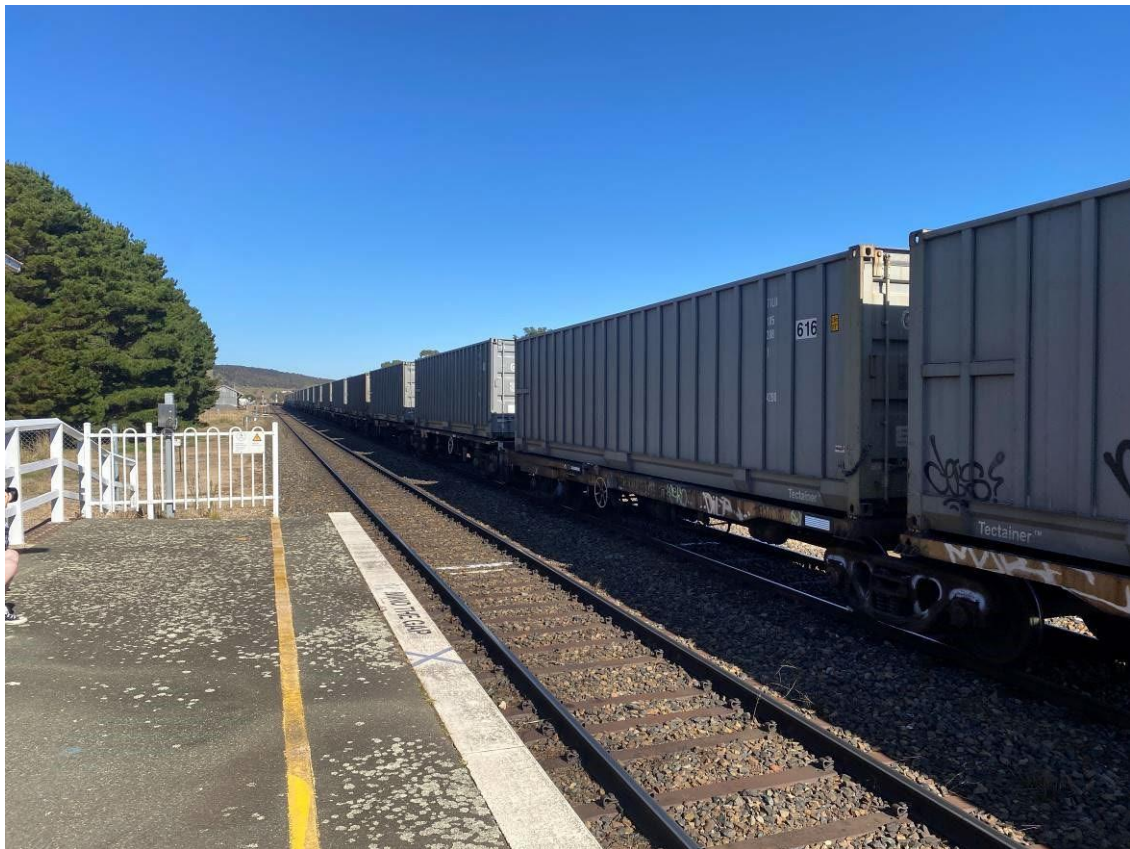
Photo 2: Train entering loop line from south west direction. No airborne dust visible in air or on surfaces during train movements.

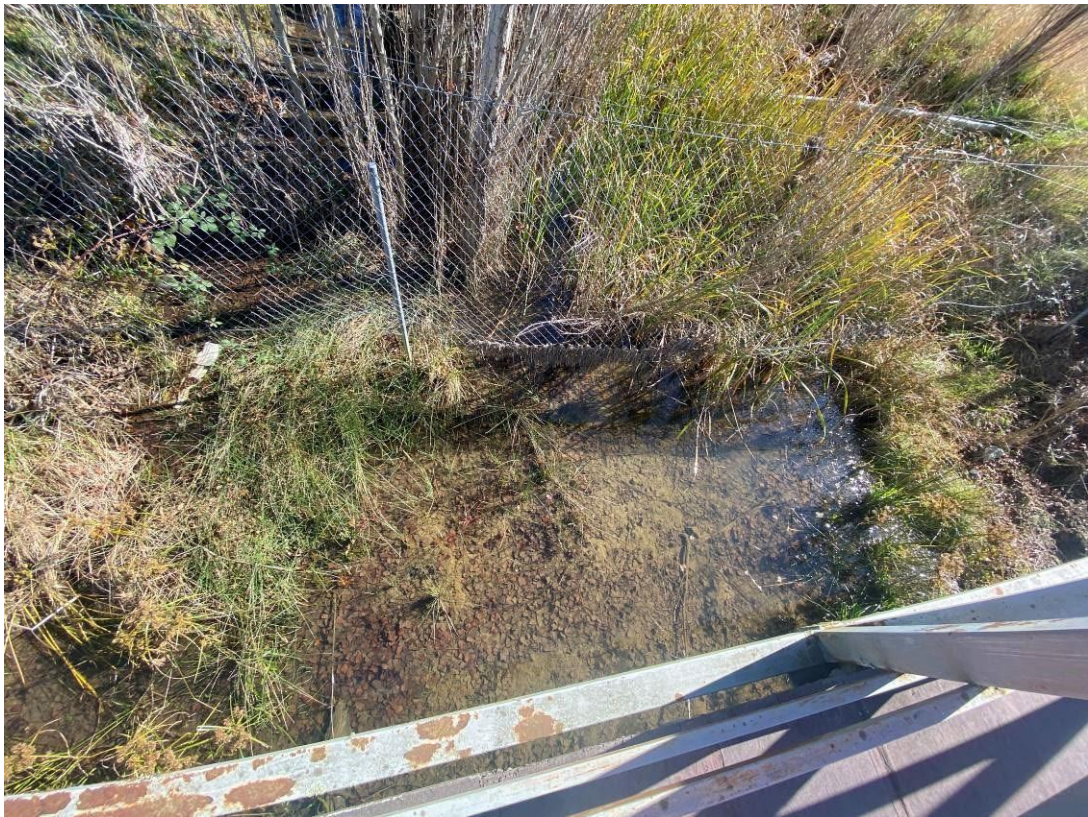
Photo 3: Southern most culvert discharge off site through culvert under Golburn street, showing evidence of surface water run off on site. Water is clear, no turbidity, with no observable sediment.

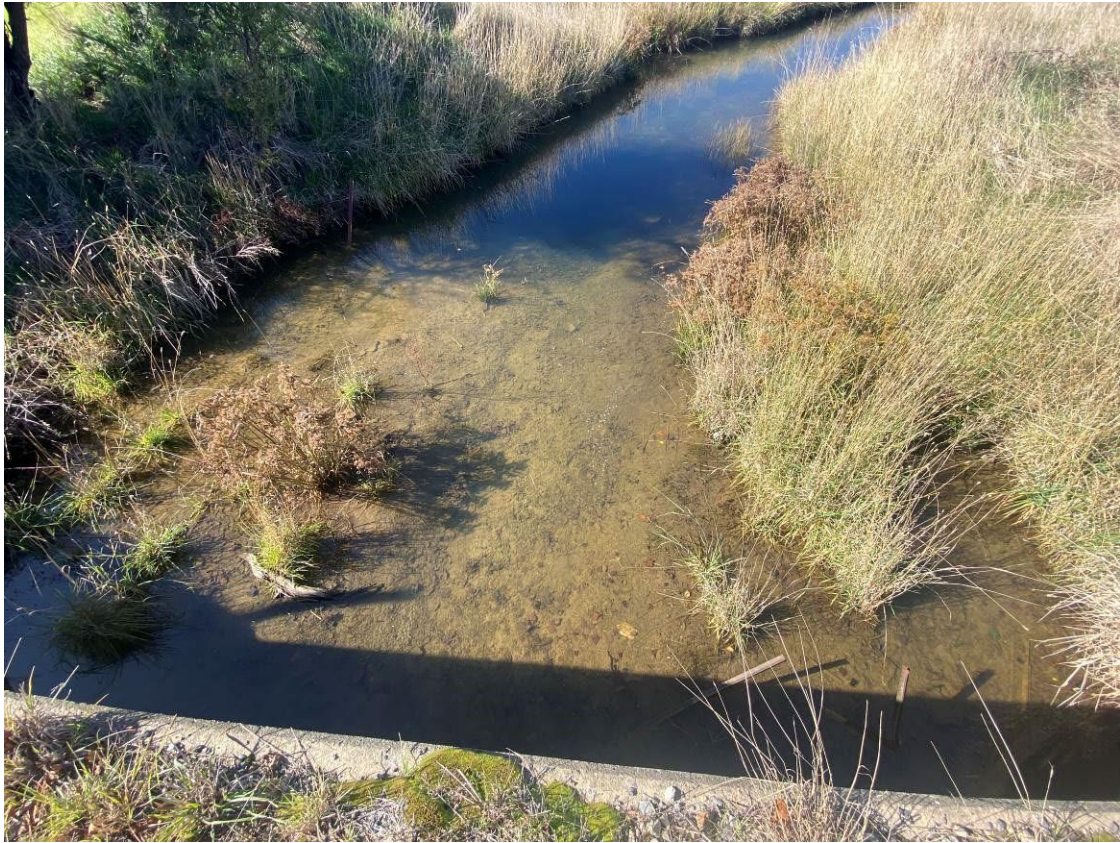
Photo 4: Outlet of culvert under Golburn street, downgradient of southernmost culvert on site, showing evidence of surface water run off on site. Water remains clear with no turbidity and no observable sediment.

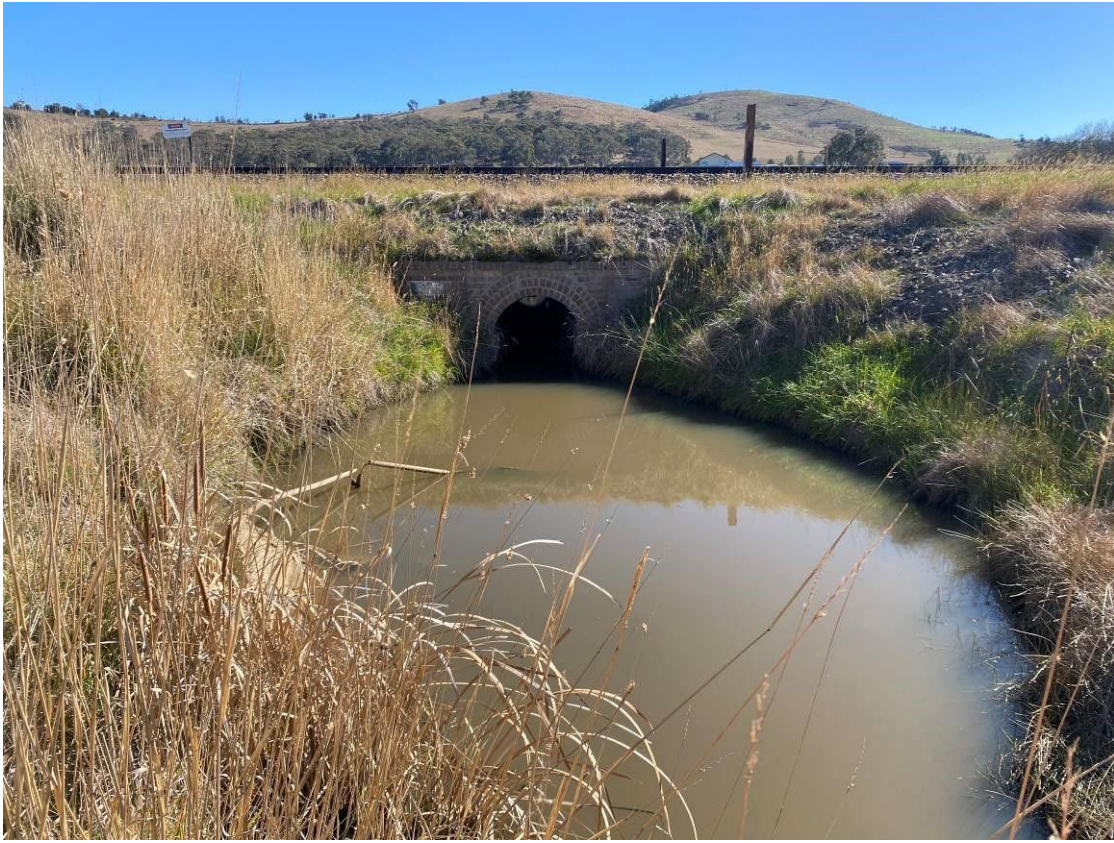
Photo 5: Downgradient of middle culvert showing pooled sediment laden water on site. Brown, moderate turbidity.

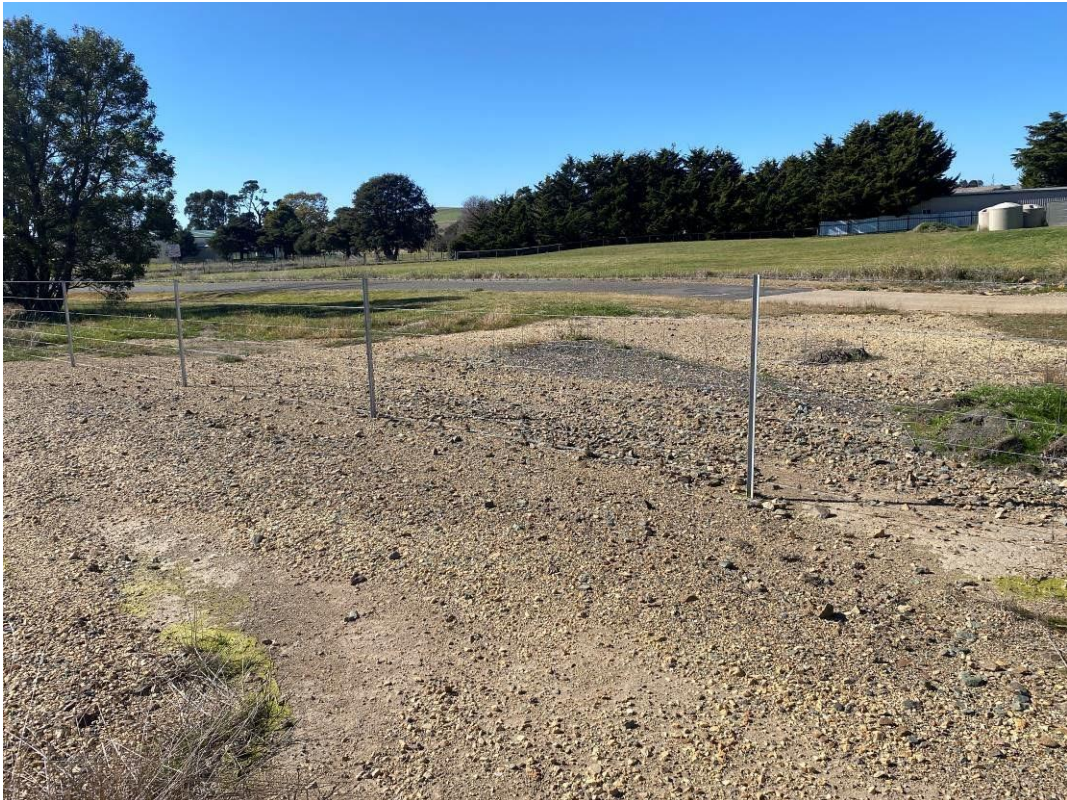
Photo 6: Downgradient of middle culvert. Dry beyond the pooled water and no evidence of current surface water run off on site.

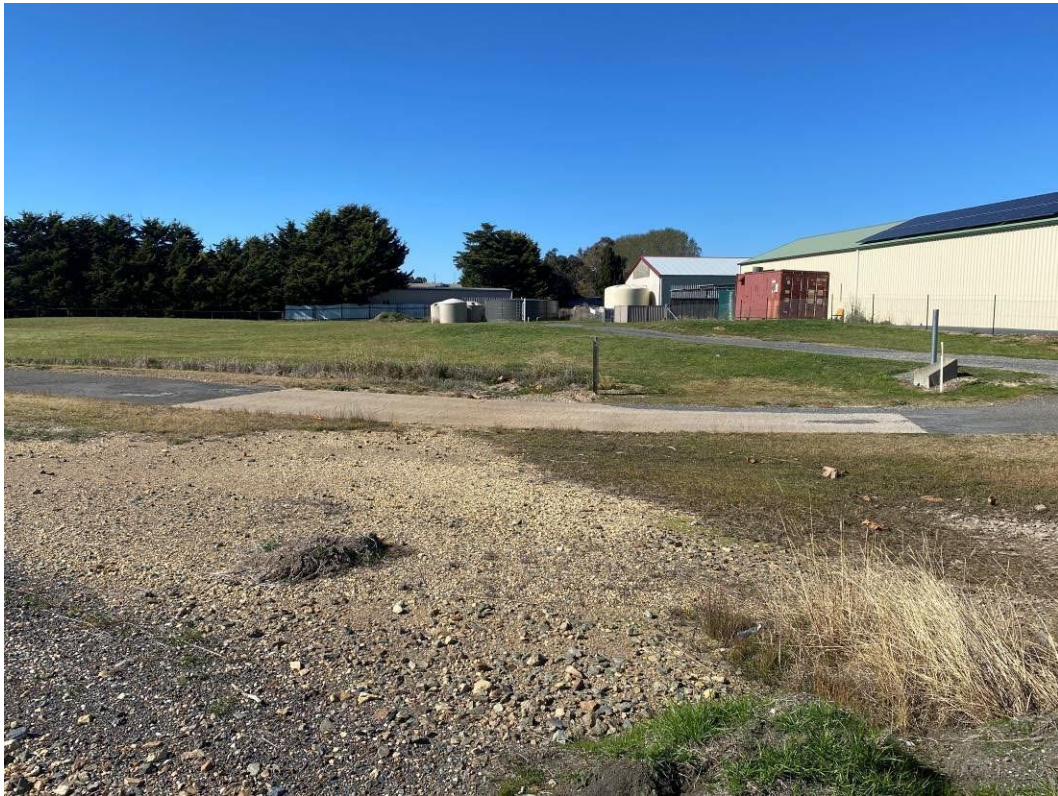
Photo 7: Causeway downgradient of middle culvert showing no evidence of current surface water run off on site. No visible sediment on road or vegetation nearby from sediment water was running off site in between inspections.

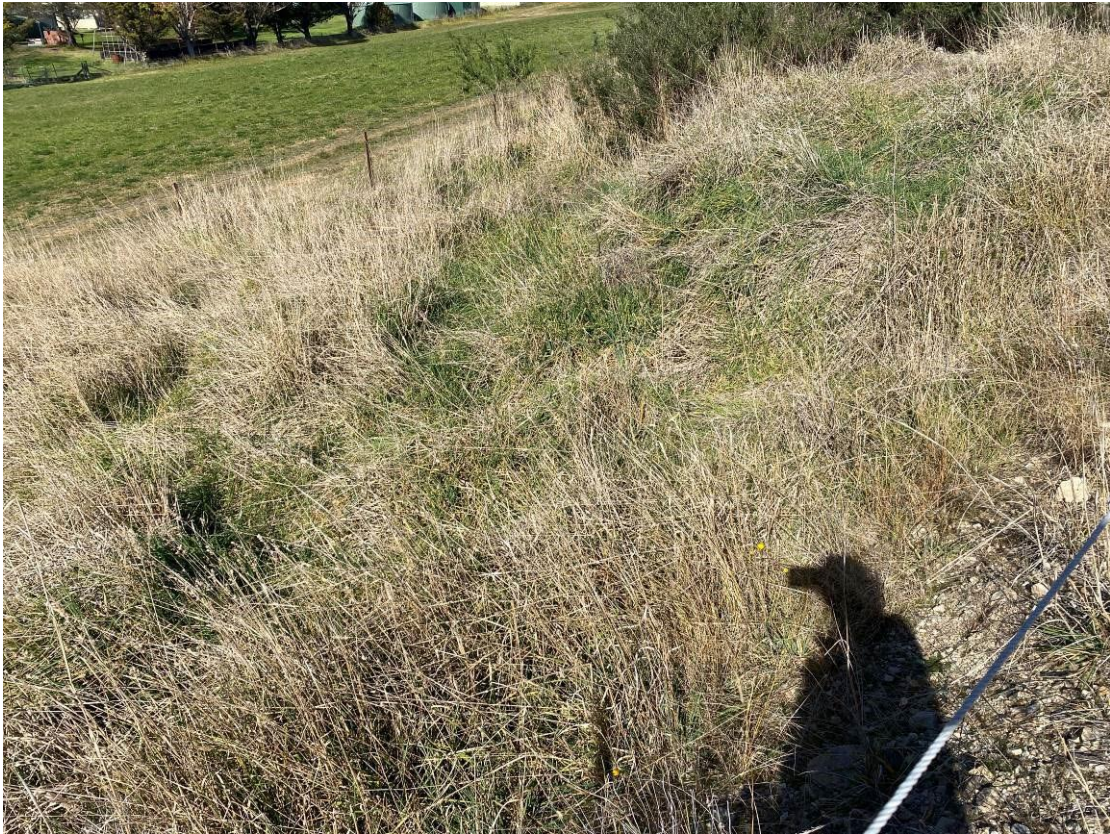
Photo 8: Downgradient of northernmost culvert showing evidence of no surface water runoff from site to neighbouring property.

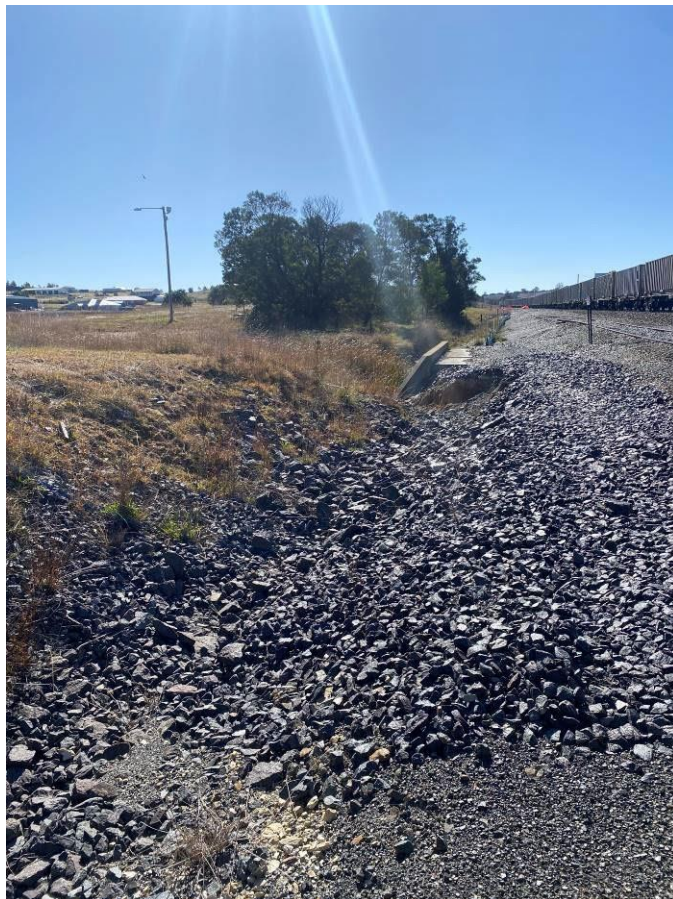
Photo 9: Upgradient of southernmost culvert showing silt fencing and rock armoury used as control measures for sediment control.

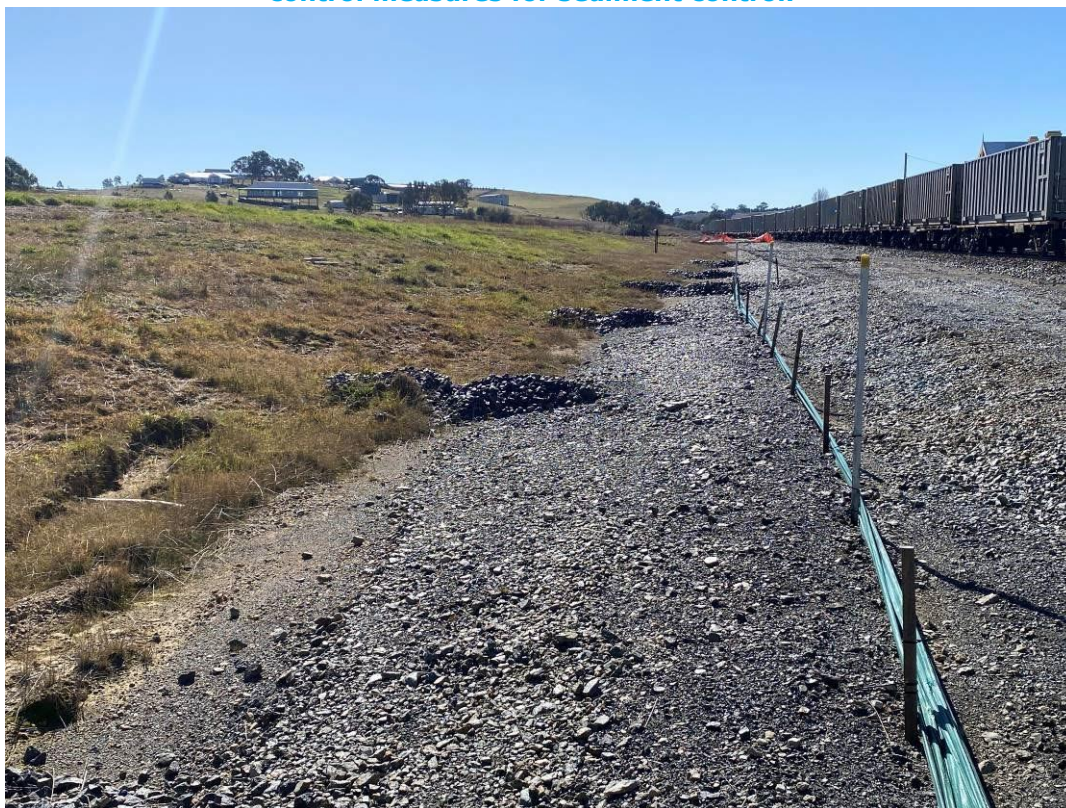
Photo 10: Rock checks and silt fences running along former Woodlawn siding and between southern and middle culverts. Minor sediment build-up on rock checks and fencing.

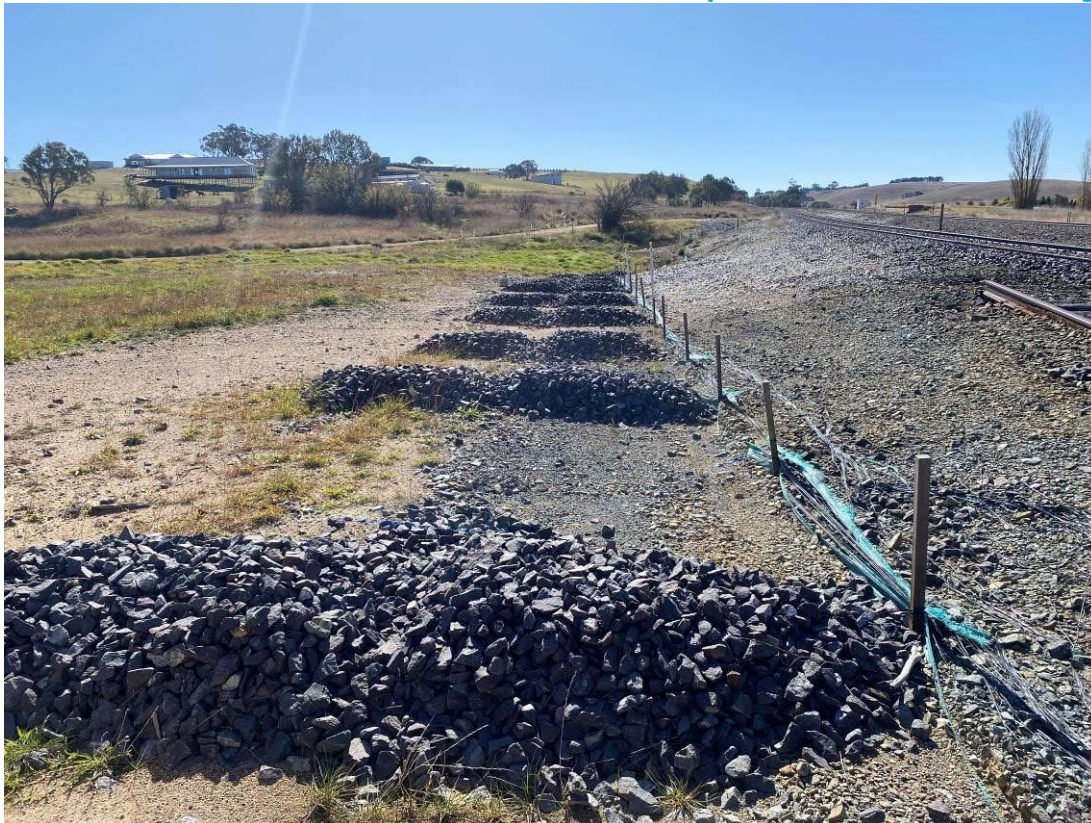
Photo 11: Rock checks and silt fences running alongside former Woodlawn siding towards the middle culvert. Major damage to silt fencing remaining on southern side. No evidence of sediment build-up in rock armoury.

Ramboll notes that the major damage to the silt fencing uphill of the rail line (western side) and to the south of the middle culvert remains (**Photo 11**). This was identified in April and March inspections also. Ramboll recommends this silt fencing be replaced as soon as possible. UGL Representative advised these works were planned to take place on the Friday 19th May 2023. Minor damage to the silt fencing uphill of rail line and running between the southern and middle culverts was also seen (**Photo 25**), Ramboll recommends retying silt fencing to stakes to prevent further damage.

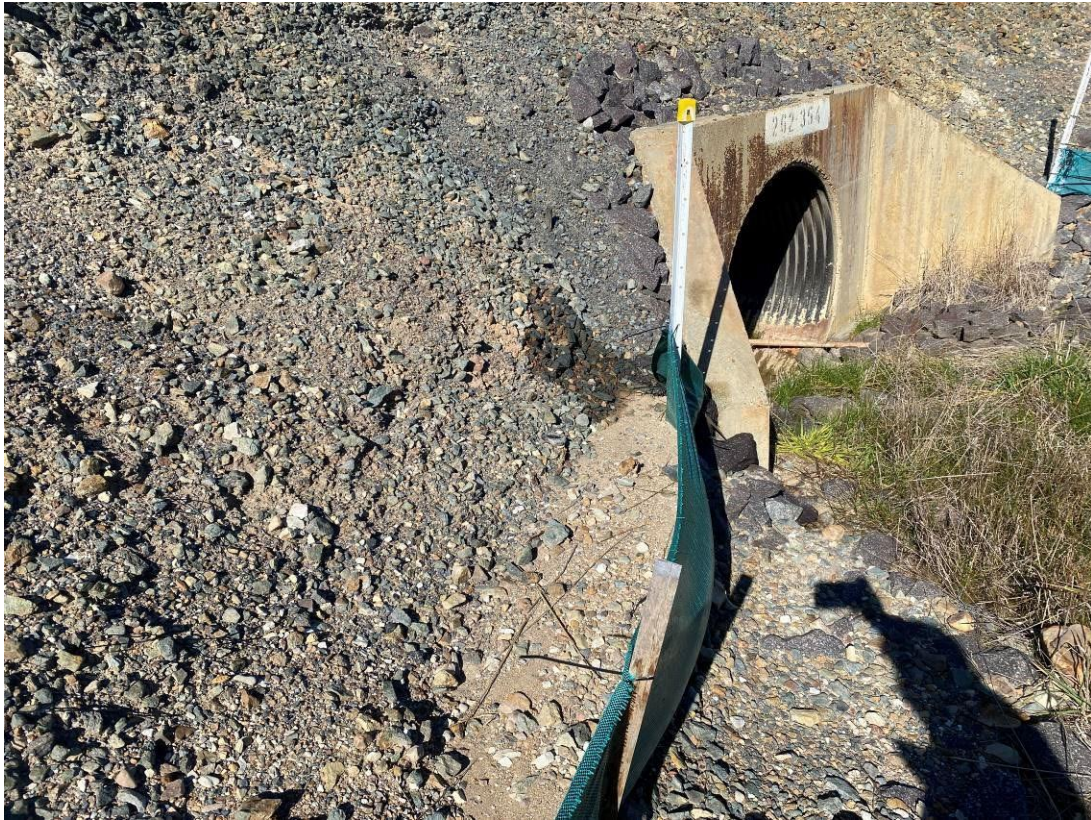
Photo 12: Upgradient of middle culvert showing signs of sediment in silt fencing on northern side. Silt fencing is full and sediment needs to be clear or fencing needs to be replaced before breakages.

Evidence of build up of sediment in some silt fences upgradient of middle culverts (**Photo 12**). Ramboll recommends removing silt build up on fences using a shovel to prevent breakage of fences.

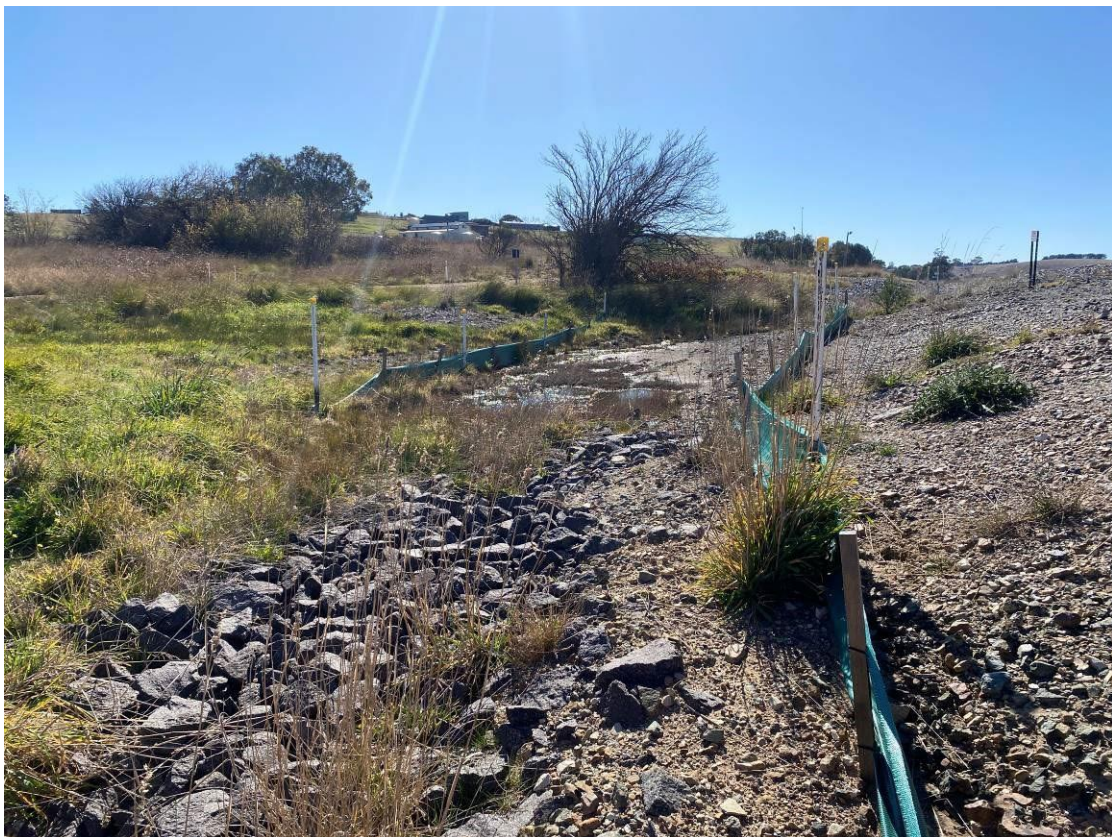
Photo 13: Upgradient of trainline culvert facing north, showing pooling on site near rock checks and silt fencing. Water is clear with no signs of turbidity and sediment.

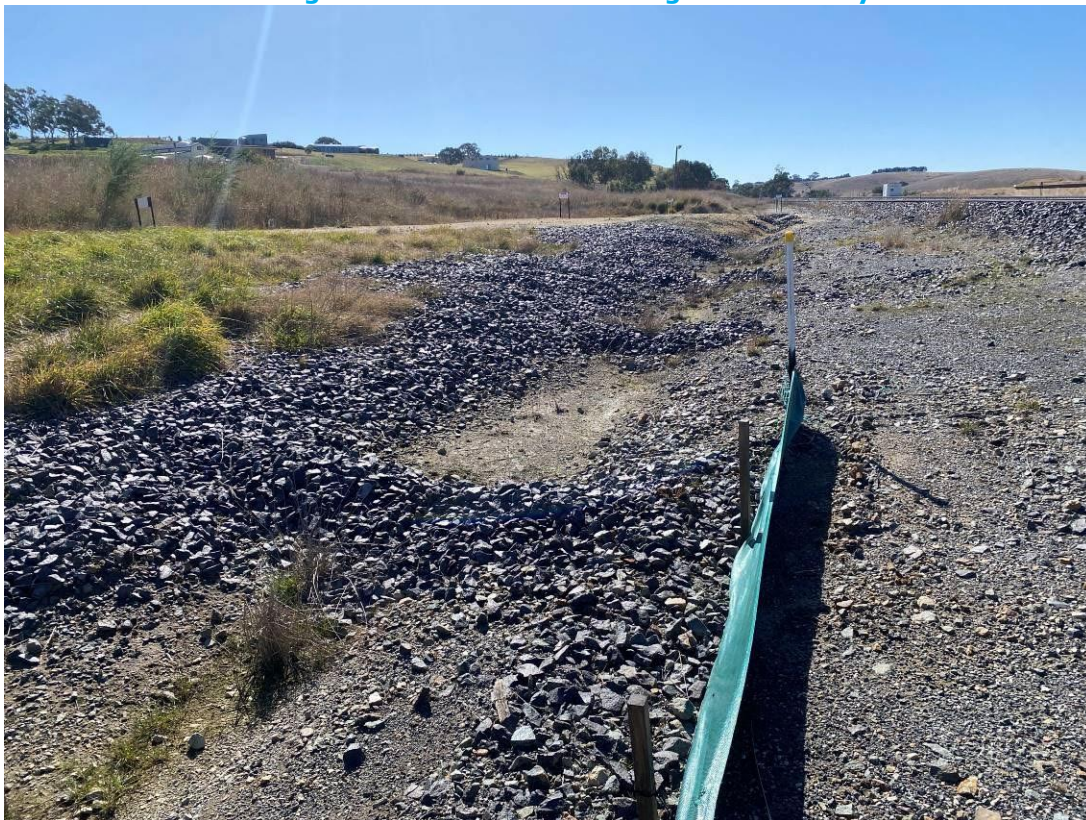
Photo 14: Silt fencing and rock armoury upgradient of trainline running from the middle to the north culvert. Some erosion evidence of soil and build-up of sediment on silt fencing and rock armoury.

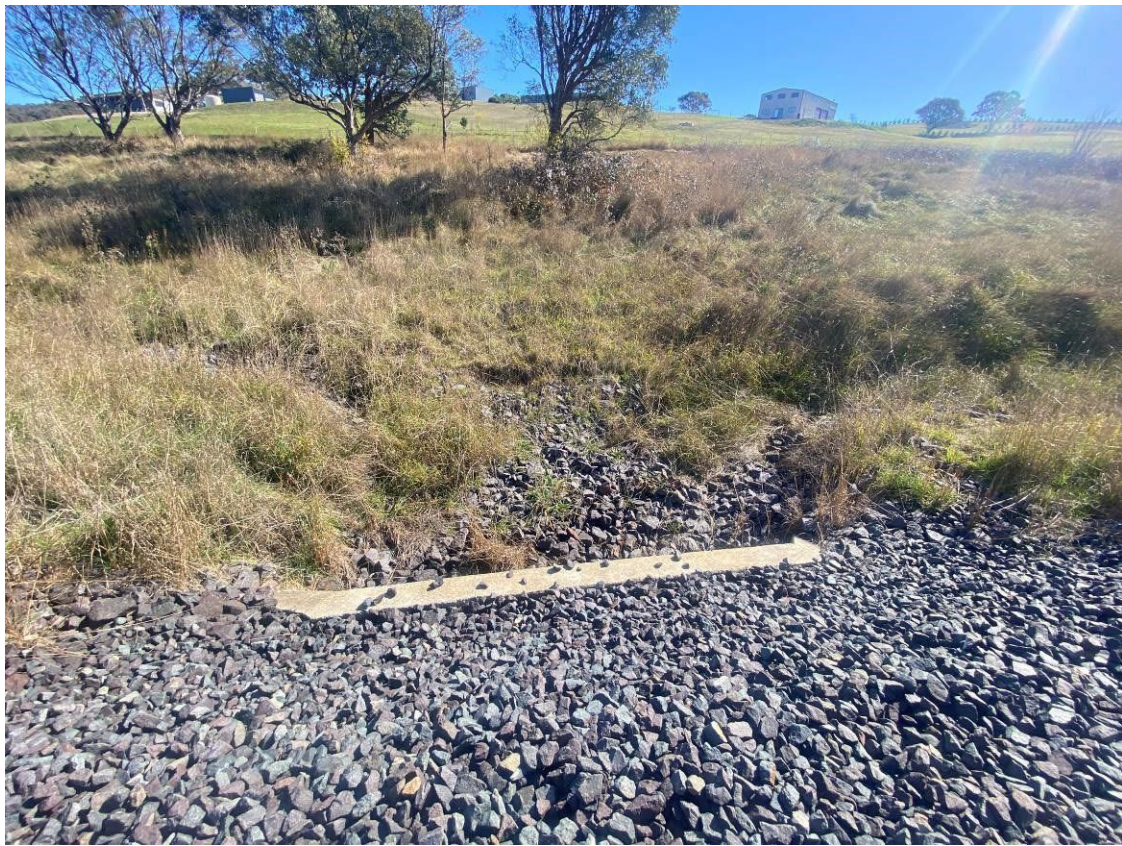
Photo 15: Upgradient of northernmost culvert. No evidence of surface water run off on site. No evidence of sediment buildup on rocks. Rock armory and natural vegetation allow for sediment control in surface water.

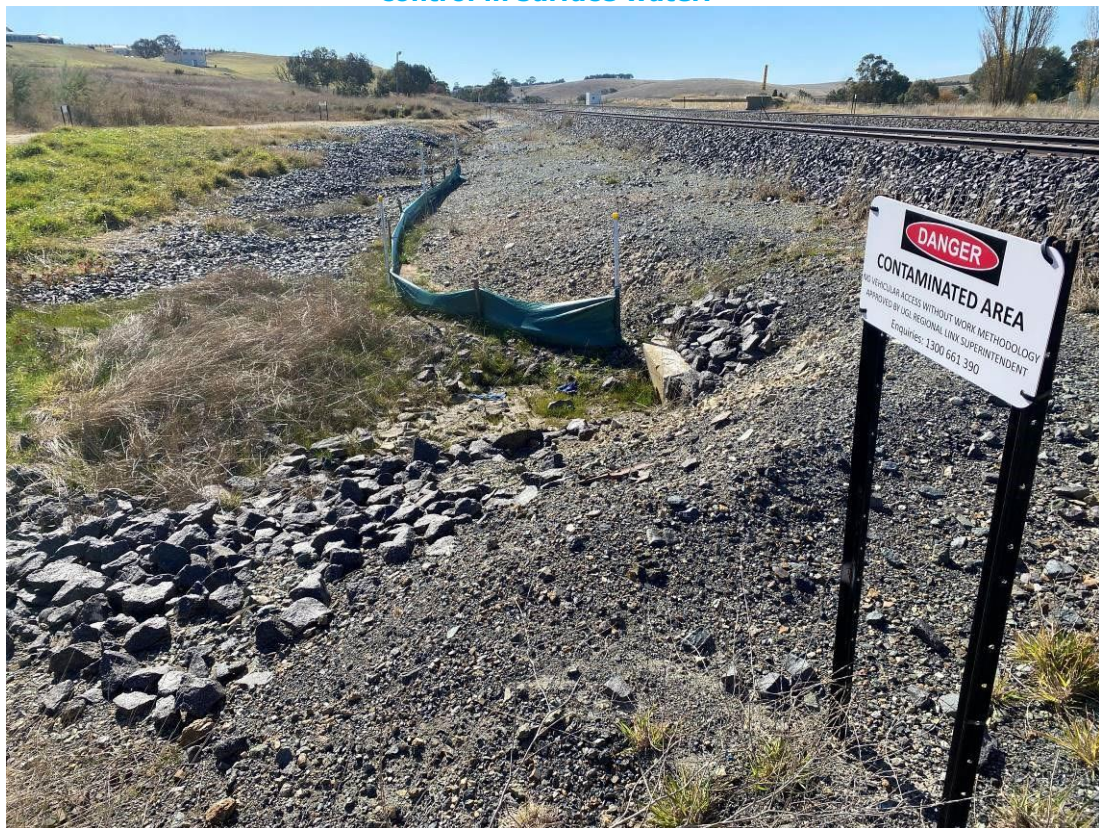
Photo 16: Exclusion zone signing placed periodically along contamination areas. Reverse side of more signing can be seen on opposite side of railway track.

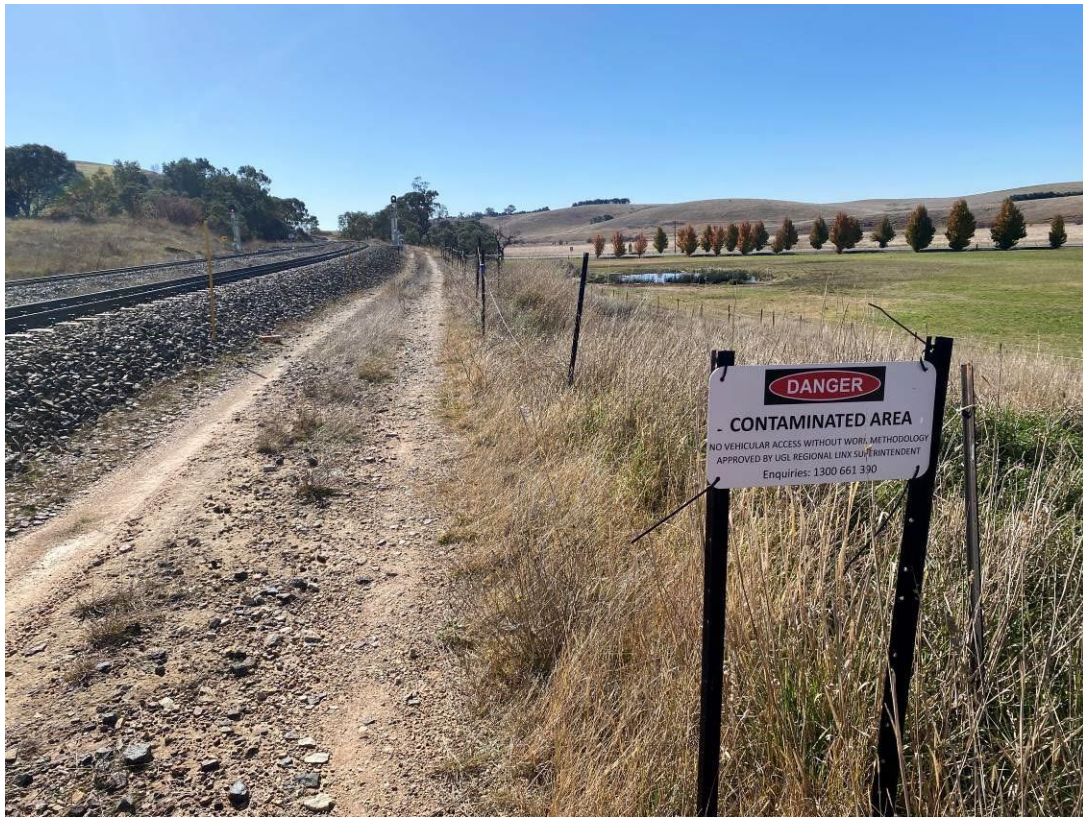
Photo 17: Additional exclusion zone signing placed periodically along contamination areas.

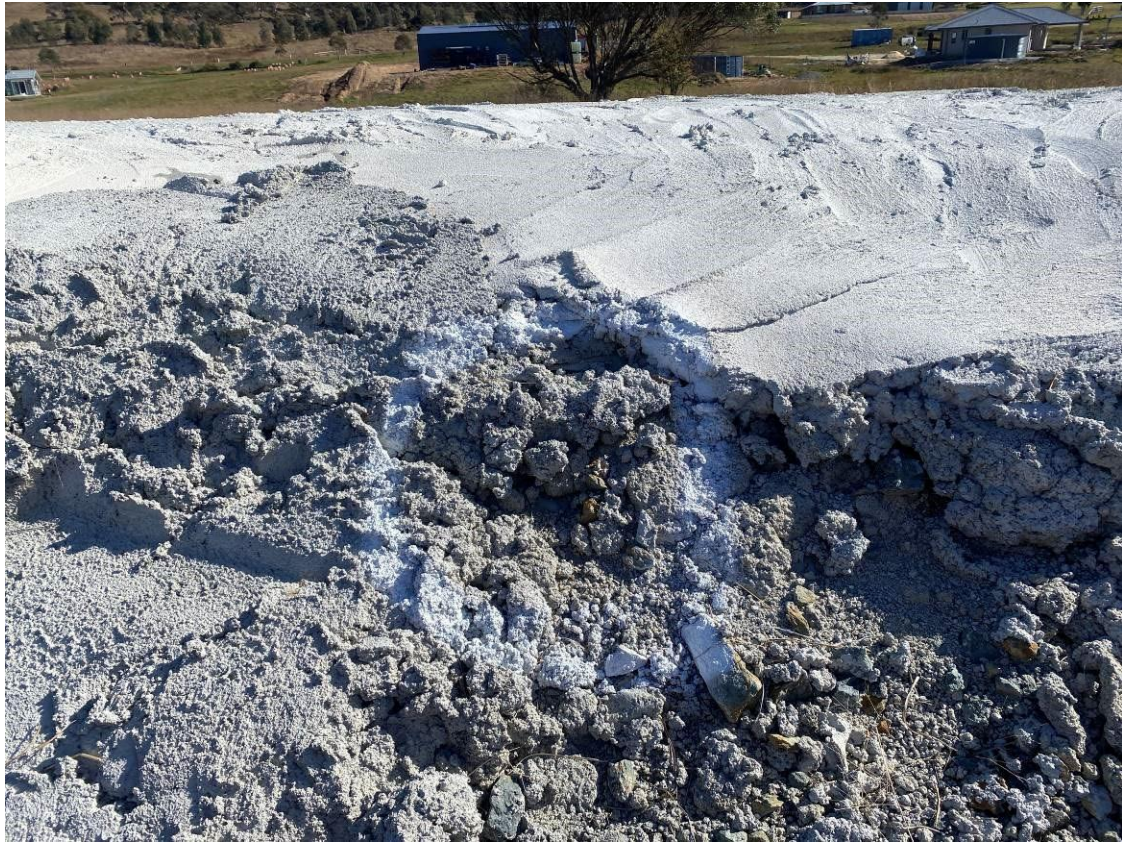
Is geofabric marker layer visible beneath capping of the existing stockpile? If so record in written form and through photographs and consolidate with this checklist. If marker layer is visible rectification work is required.	Yes, geofabric marker layer visible in three locations on west of stockpile. Location and size detailed in Photos 18 - 21 , refer to 'Other Observations' section for recommendations.

Photo 18: Geofabric marker layer visible in stockpile capping remained from previous inspection Approximately 10cm x 2cm. UGL representative stated patching works will take place Friday 19 May 2023.

Minor marker layer exposure was noted in three places on the western side of the stockpile in a previous inspection checklist dated 20 April 2023. These were marked and did not appear to have been patched in between site visits (**Photos 18 - 19**). Additionally, two new marker layer exposure locations were identified (**Photos 20 - 21**), Ramboll recommends repairing these by patching with sand and cement mixture. A UGL representative on site was notified of location and informed Ramboll representative of patching works planned to take place Friday 19 May 2023.

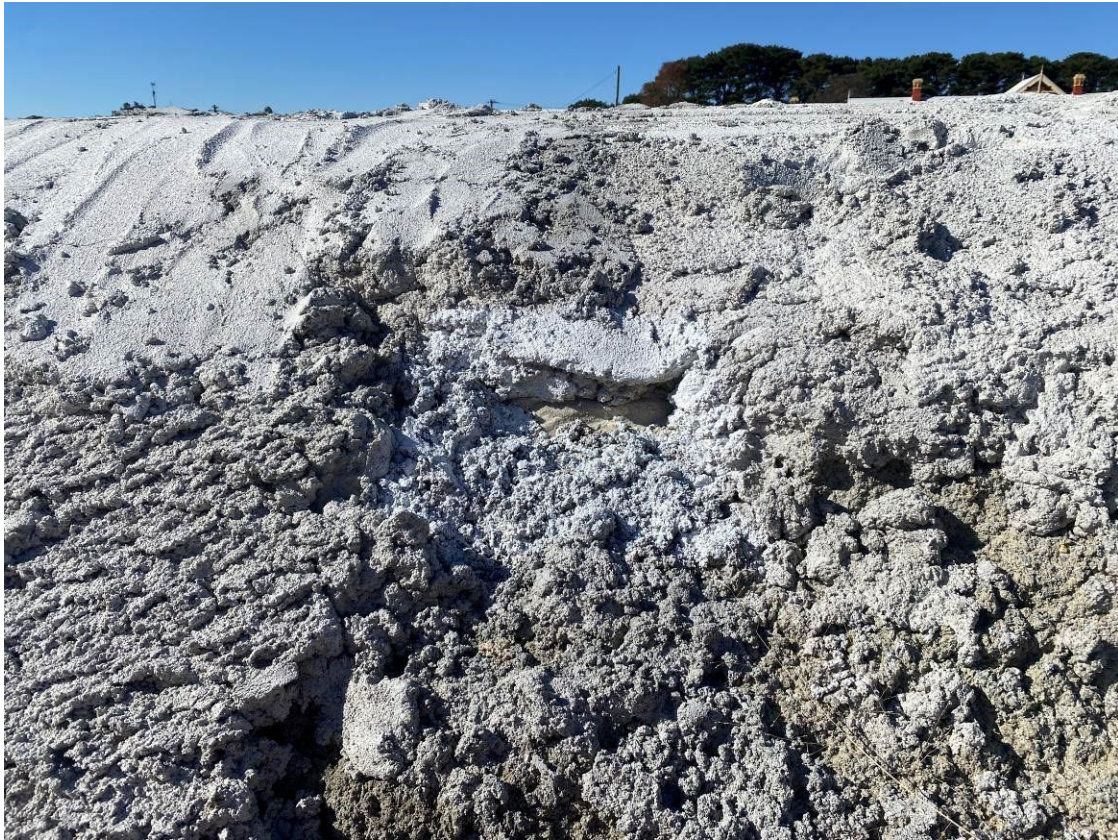
Photo 19. Geofabric marker layer visible in stockpile capping remained from previous inspection. Approximately 10cm x 2cm. UGL representative stated patching works will take place Friday 19 May 2023.

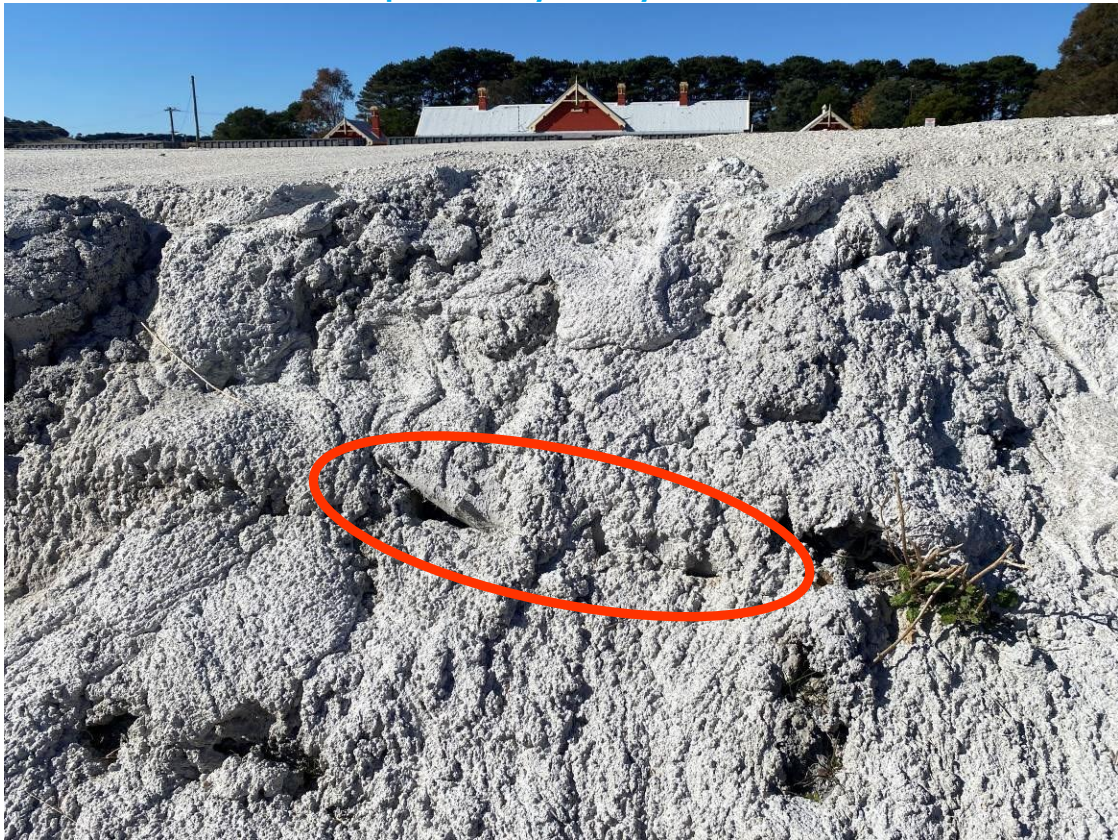
Photo 20. New location of geofabric marker layer visible in stockpile capping UGL on site representative was notified. Approximately 30cm x 2cm.

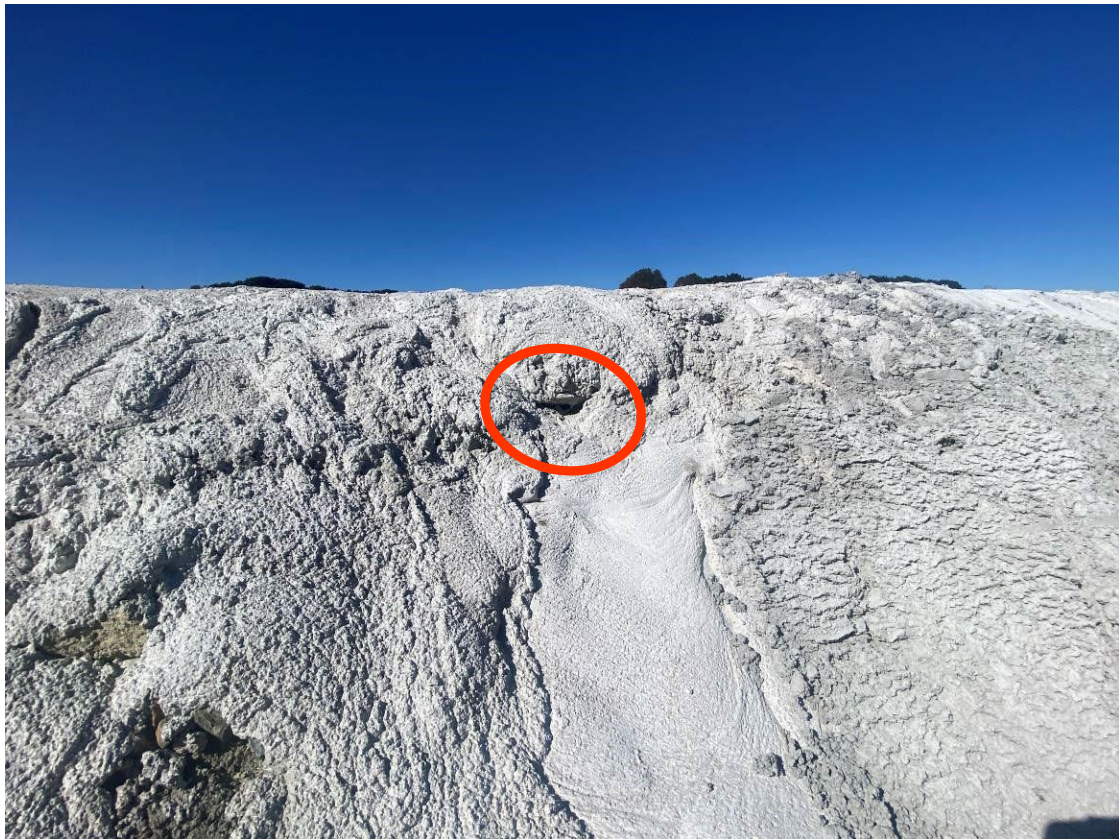
Photo 21. New location of geofabric marker layer visible in stockpile capping UGL on site representative was notified. Approximately 5cm x 3cm.

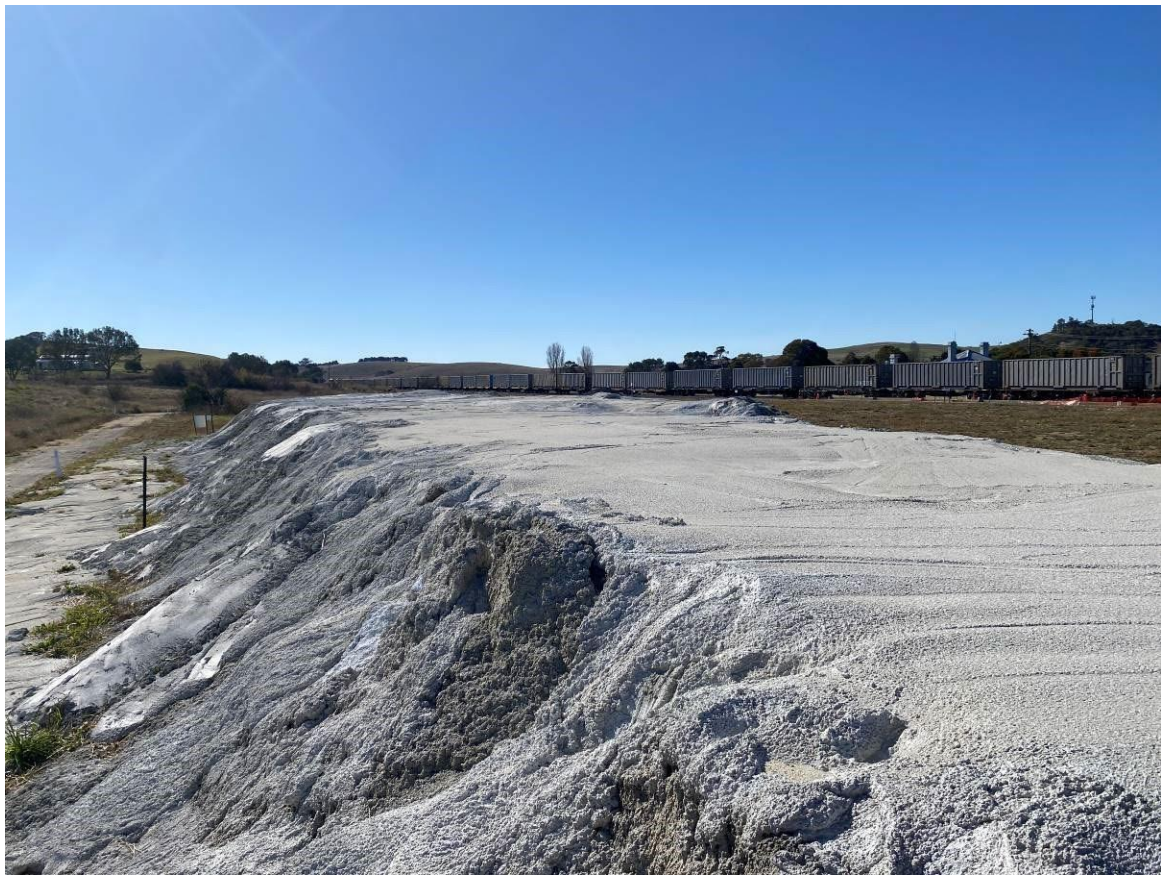
Photo 22. Picture of stable stockpile capping on site. Minimal cracks and breaks can be seen on the topside of the stockpile.

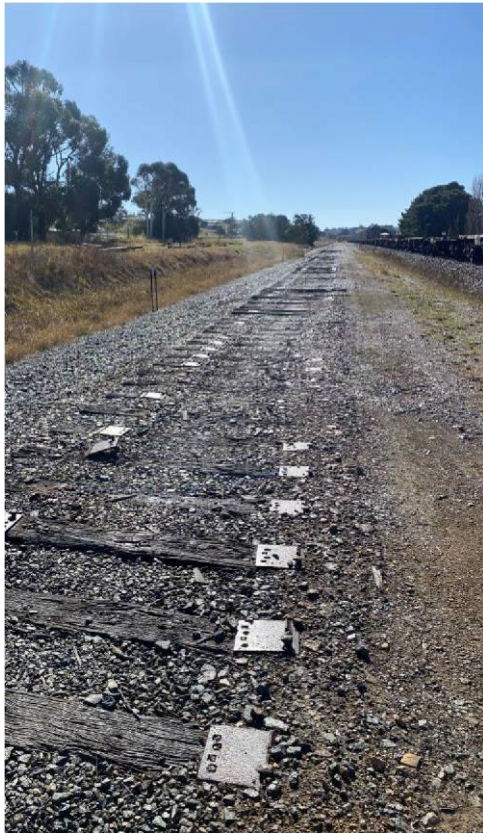
The poly-sealant application noted in inspection checklist 15 March 2023 remains on the Woodlawn siding (**Photo 23**) and was noted on site. Gravels are sealed together and layer of sealant evidence by shine.

Photo 23. Poly sealant application noted in inspection checklist 15 March 2023 remains on Woodlawn siding. Gravels are sealed together and layer of sealant evidence by shine.

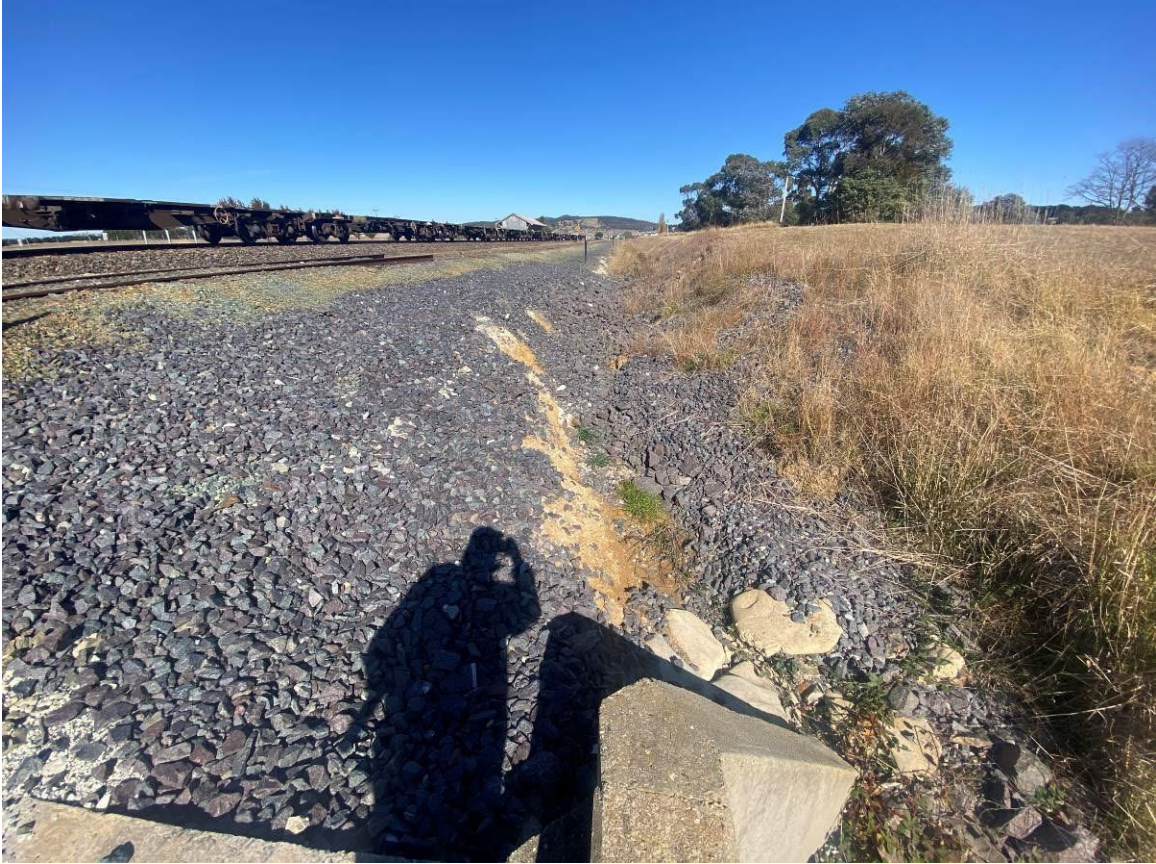
Photo 24. Evidence of erosion upgradient of southern most culvert noted in site inspection dated 20 April 2023 remains on site but stable.

Evidence of erosion was noted upgradient of the southern most culvert in previous site inspection on 20 April 2023 and remains on site (**Photo 24**). However, no evidence of sediment was found in water flowing offsite at southern culvert. Ramboll recommends replacing ground cover material (ballast) if further erosion occurs or sediment is visible in the downstream surface water of the southern culvert.
