Tarago Action Plan Routine Inspection Checklist

Title: Tarago Rail Yard Inspection	Approved: SM	Project-Nr.: 318001704	Date: May 2023
Site: Tarago, NSW			
Client: UGL Regional Linx

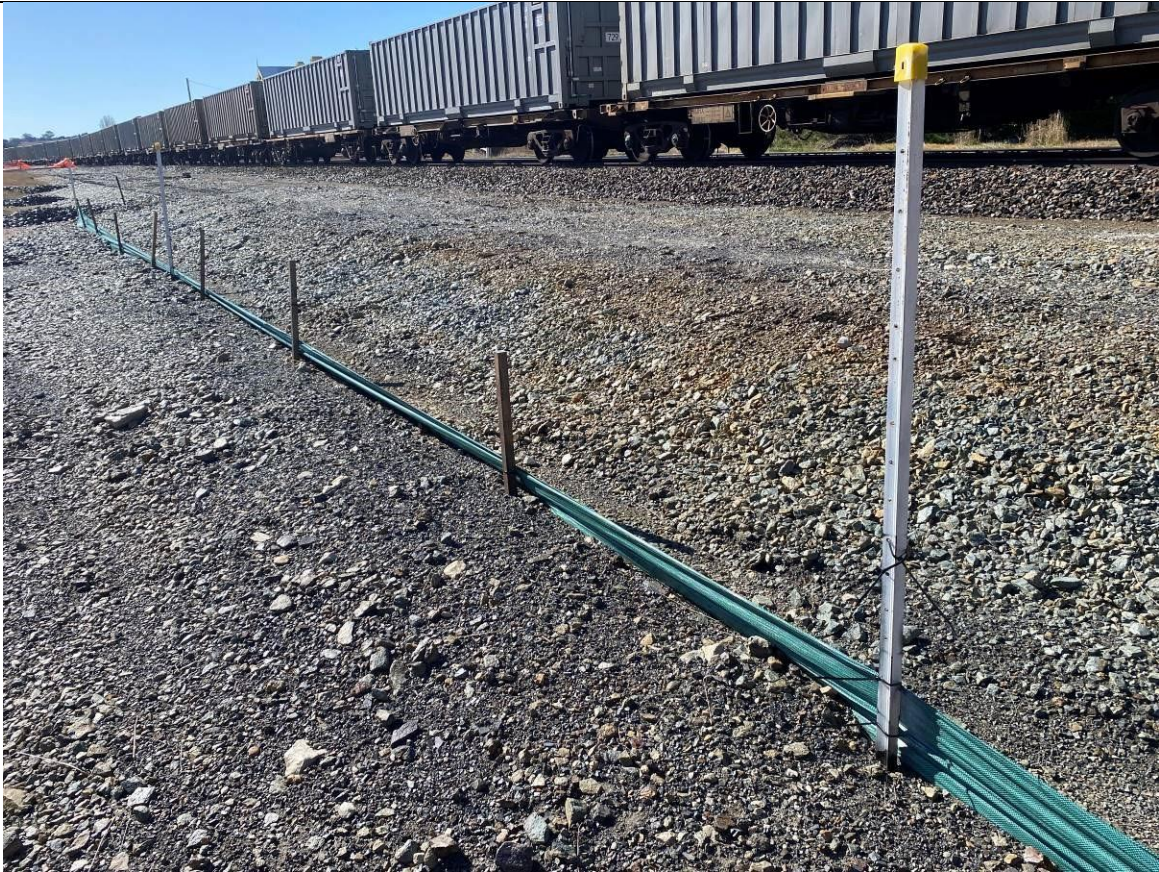
Photo 25. Damage to silt fencing between southern and middle culverts. Ties holding fencing to stakes are no longer functioning and silt fence cannot remain up. Ramboll recommends fixing or replacing this fencing.

Ramboll notes that the major damage to the silt fencing uphill of the rail line (western side) and to the south of the middle culvert remains (**Photo 11**). This was identified in April and March inspections also. Ramboll recommends this silt fencing be replaced as soon as possible. UGL Representative advised these works were planned to take place on the Friday 19th May 2023. Minor damage to the silt fencing uphill of rail line and running between the southern and middle culverts was also seen (**Photo 25**), Ramboll recommends retying silt fencing to stakes to prevent further damage.
