Routine Site Inspection Form

Date:	19/10/23	Site Reference:
Time in:	9:15 AM	Bungendore Rail Corridor (CRN Lands)
Time out:	10:00 AM	Additional Information:
Inspected by: [REDACTED] (Environmental Scientists)		12.1°C, 5.6°C lowest temp, 12.5°C highest temp, 0mm of rain since 9am, 20km/h highest wind gust, ENE 7km/h wind speed, 71% humidity, highest rainfall since last inspection: 12.8mm on 6/08/23

Title:	Bungendore Rail Corridor & Woolshed Siding Inspection	Approved: SM	Project-Nr.: 318001704	Date: October 2023
Site:	Bungendore, NSW			
Client:	UGL Regional Linx

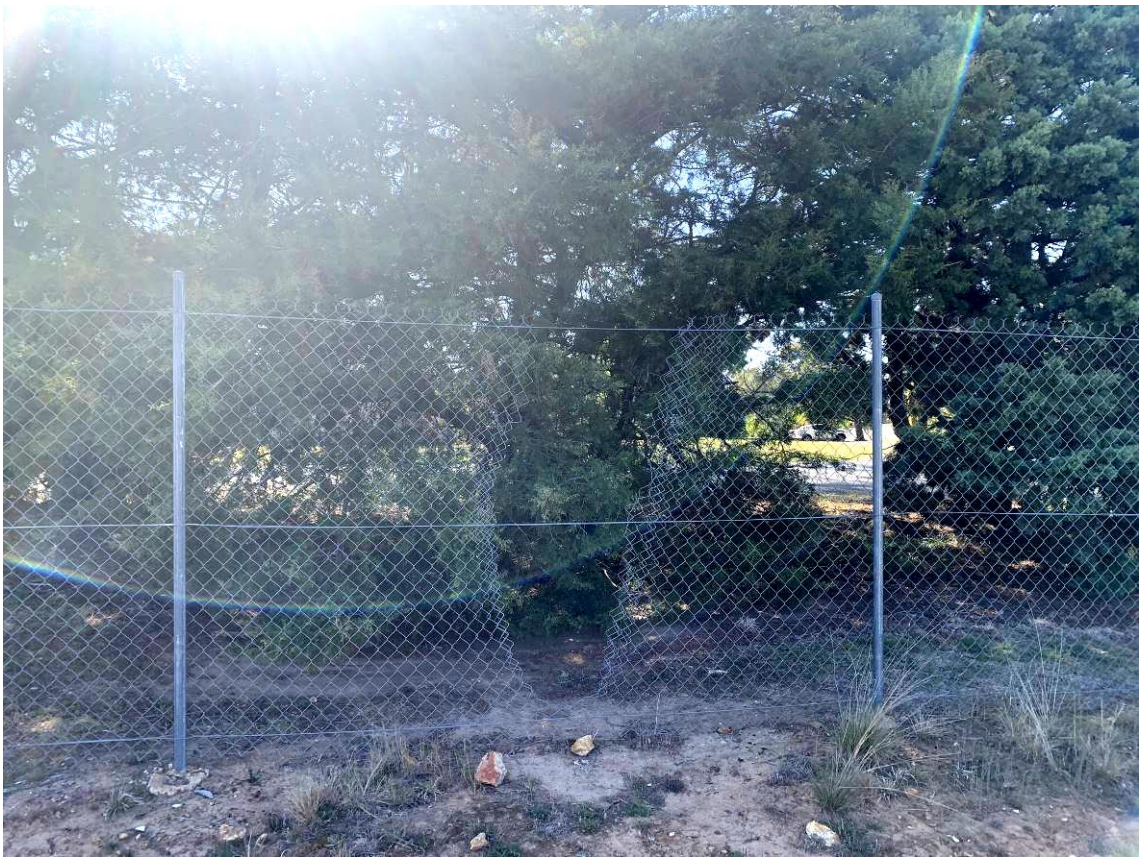
Yes	No	Comments/Observations
Is Site fencing secure and intact?		No	No: Break in fencing appearing to have been deliberately cut (Photo 1) and fencing appearing to have collapsed (Photo 2). At the time of inspection no activity was observed at the Bungendore Mens Shed. Site was locked and unoccupied (Photo 6 - 7).
Is there any evidence of trespassing since last inspection?	Yes		Fencing cut (Photo 1), therefore assumed trespassing entry to site from public
Is any surface water discharging from site?	Yes		Surface water is discharging from site at the location near Malbon Street Railroad Crossing (Photos 15 - 16). Noticeably drier conditions on site (Photos 12 - 14) compared to previous site visit (19/07/23). Turallo Creek slowly flows through sites northern boundary and appears clear with low turbidity (Photos 9 - 10). No sediment visible on Turallo Terrace Bridge (Photo 11).
if yes, describe water quality			(Circle One) <u>clear</u> /cloudy/turbid/sediment laden

Photo 1: Deliberately cut fencing on site, North-East from Tarago train station and facing Powell Street. Appears to be unfixed since last site inspection (19/07/23).

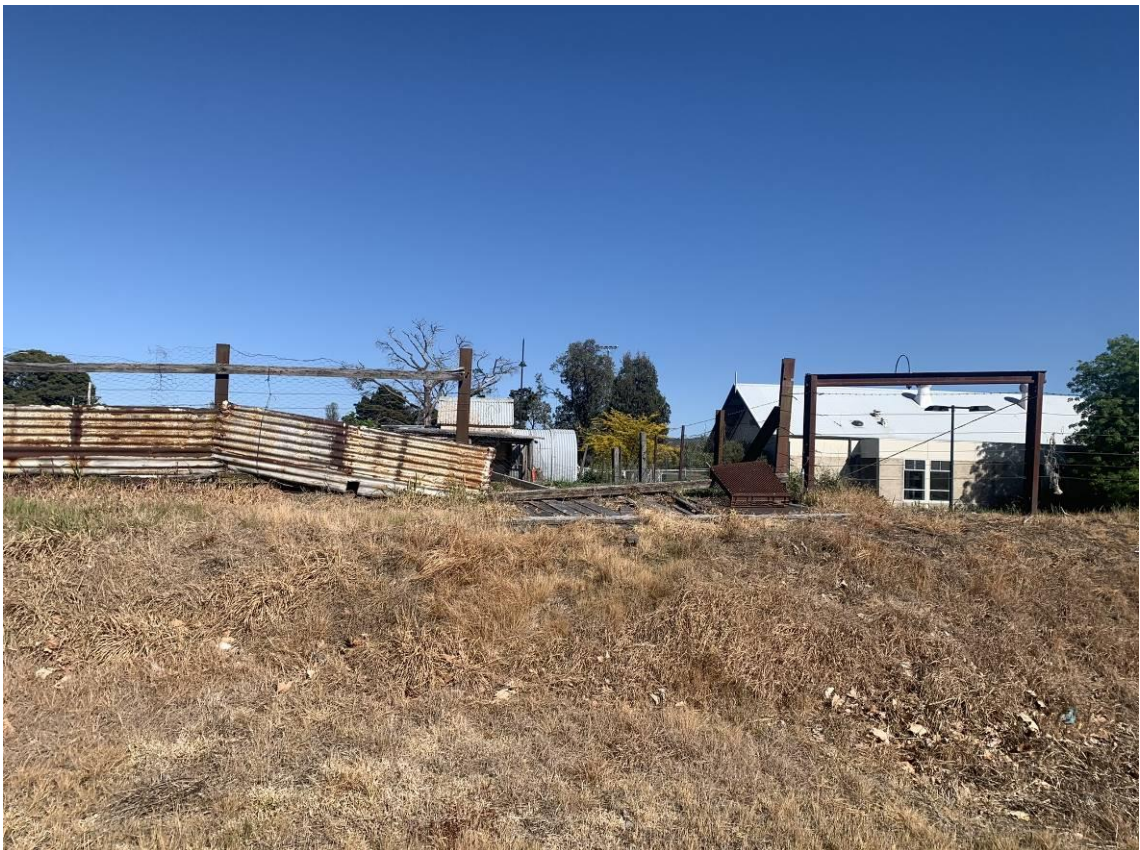
Photo 2: Collapsed fencing adjacent to rail tracks and north of Bungendore station on the side closest to Majara Street. Condition appears unchanged since last site inspection (17/07/23).

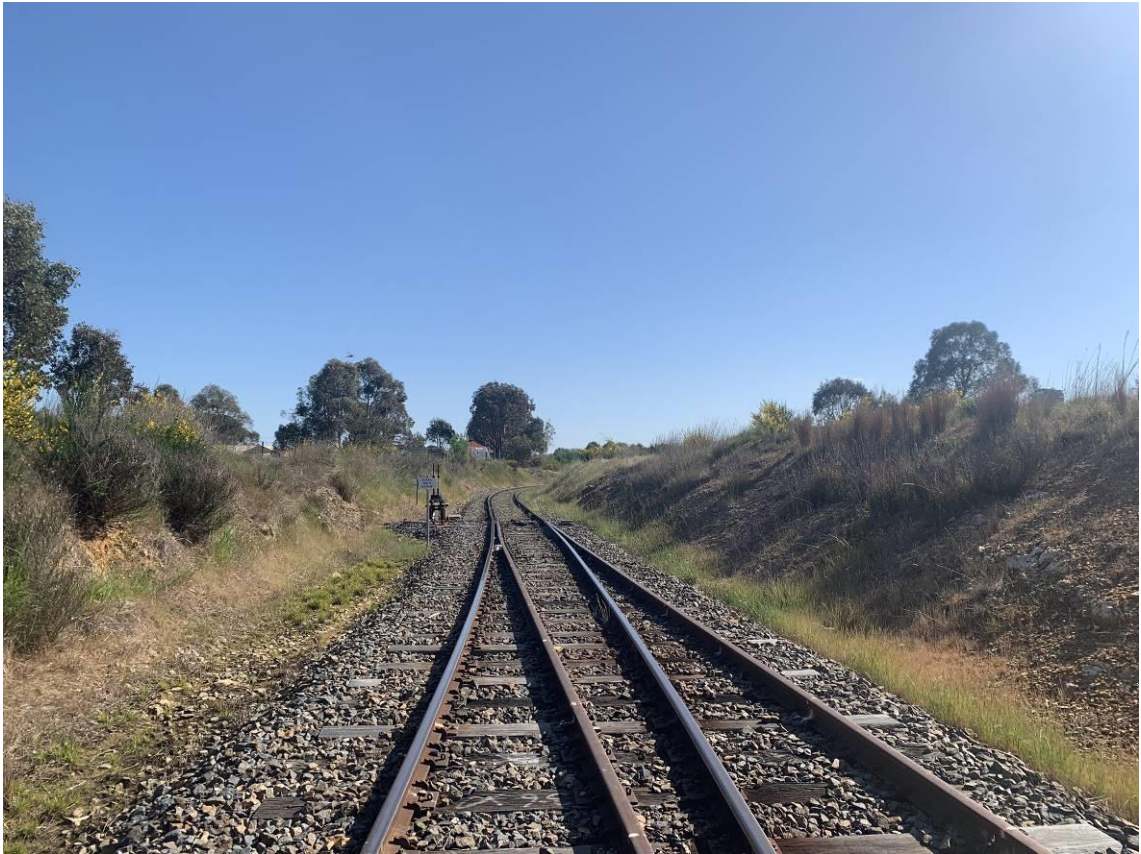
Photo 3: No pooled water adjacent to railway tracks. Looking before the turn, north of Bungendore station near track switch levers.

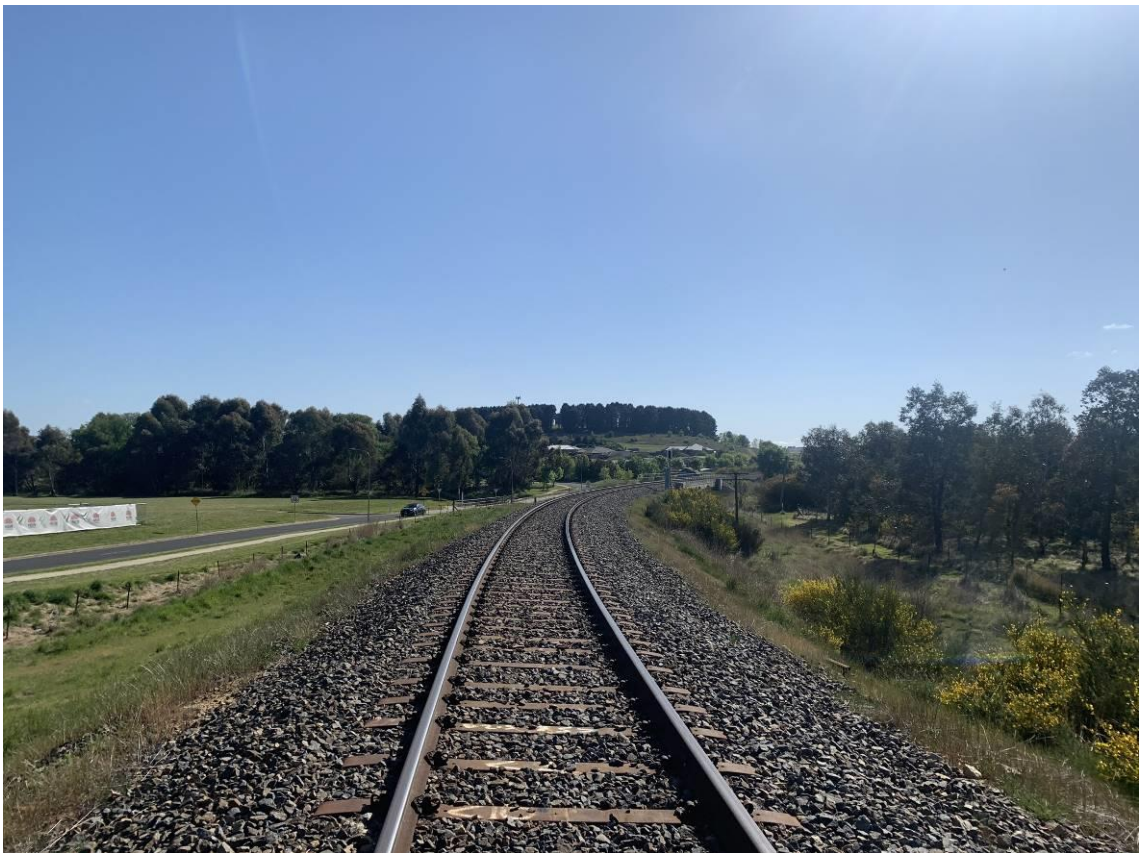
Photo 4: Picture of railway line facing north towards Turallo Creek. No airborne dust visible in air.

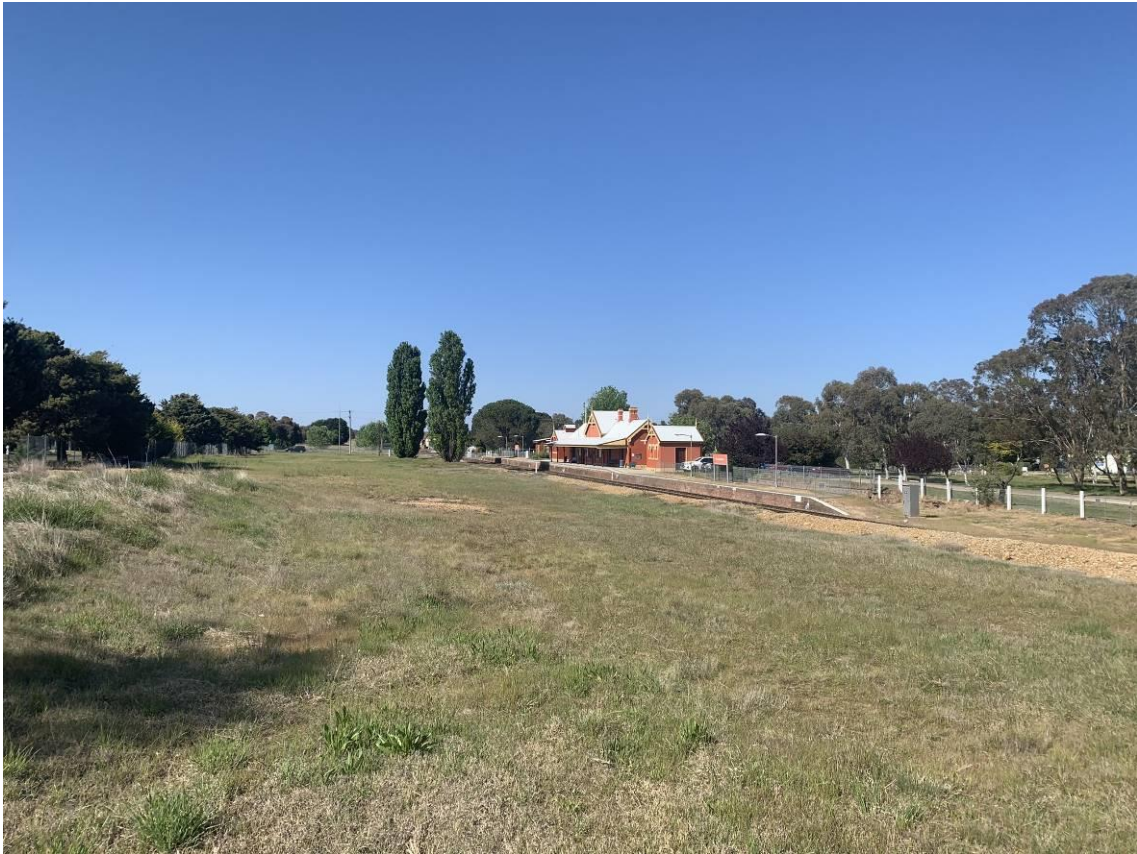
Photo 5: Picture of Bungendore railway station facing south-west. No airborne dust visible in air or on surface at station.

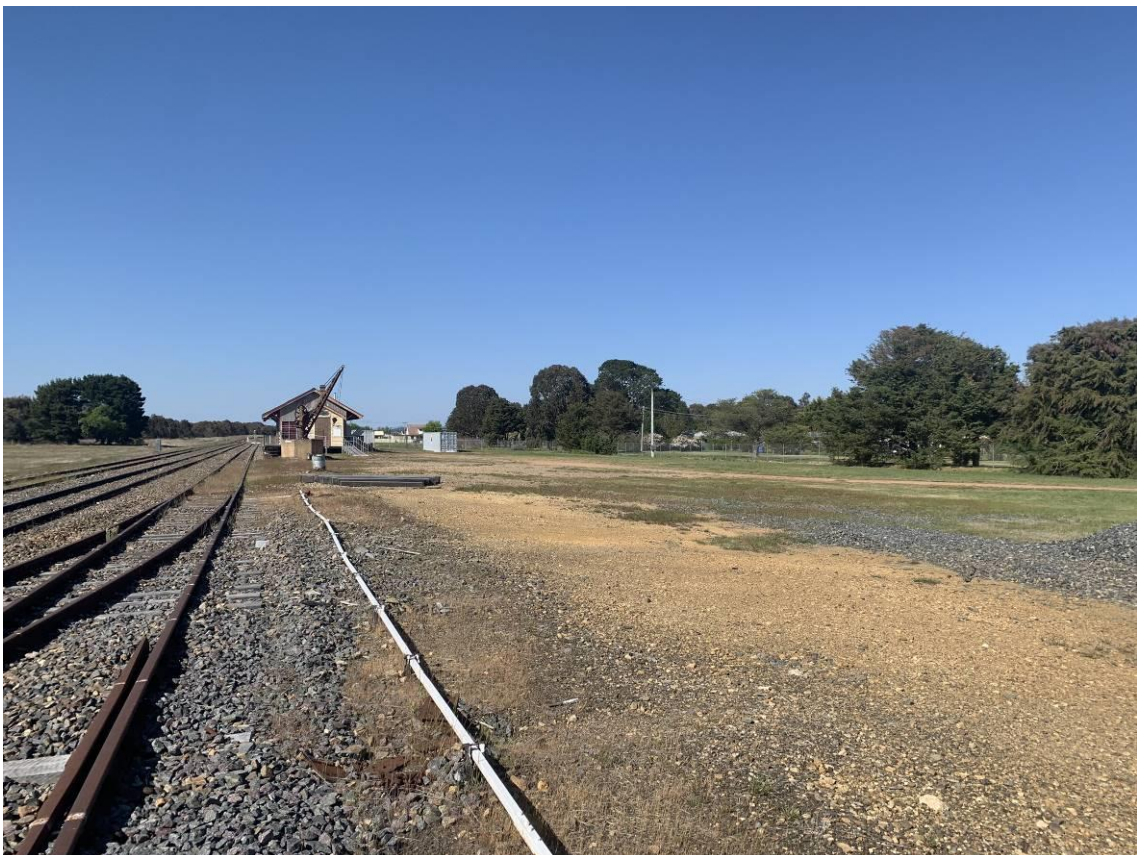
Photo 6: Bungendore Mens Shed, south of Bungendore train station, not occupied at time of inspection. No airborne dust visible in air. Facing South-West.

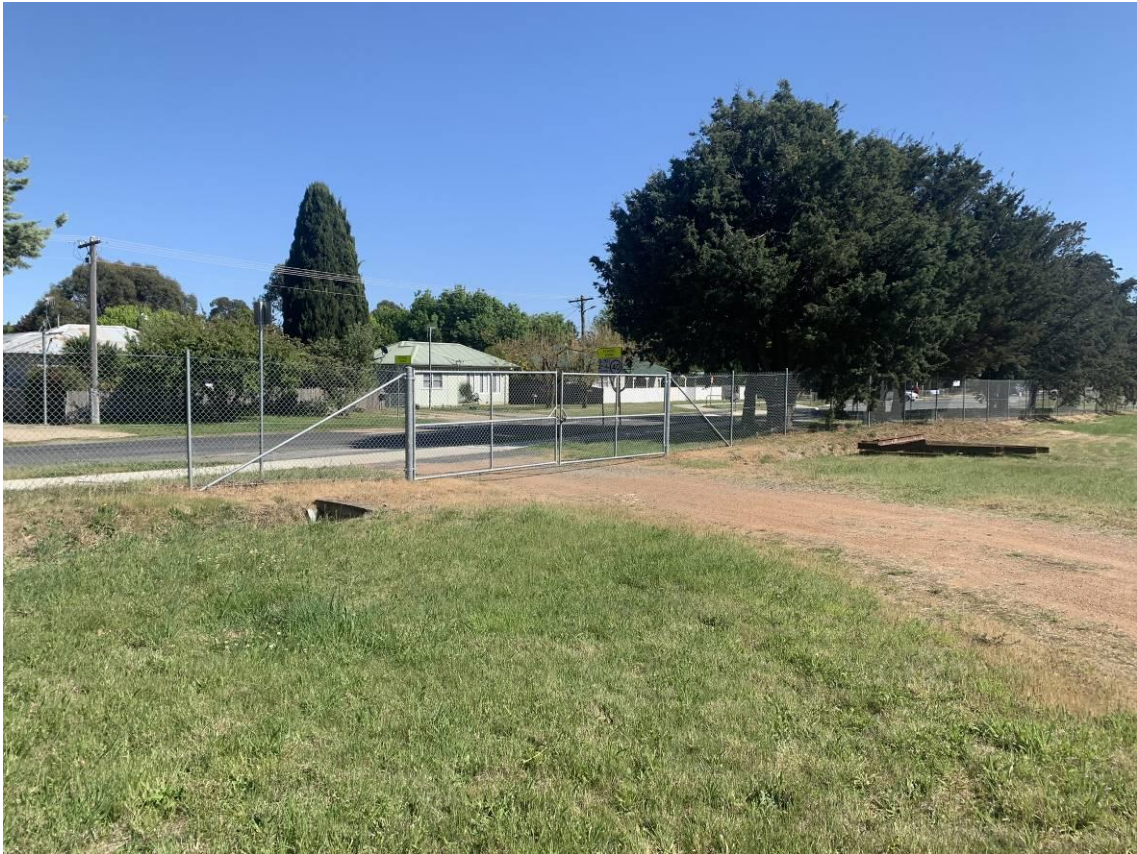
Photo 7: Facing north-west towards Majara Street. Perimeter gate is closed and locked preventing public access to the site and Mens Shed.

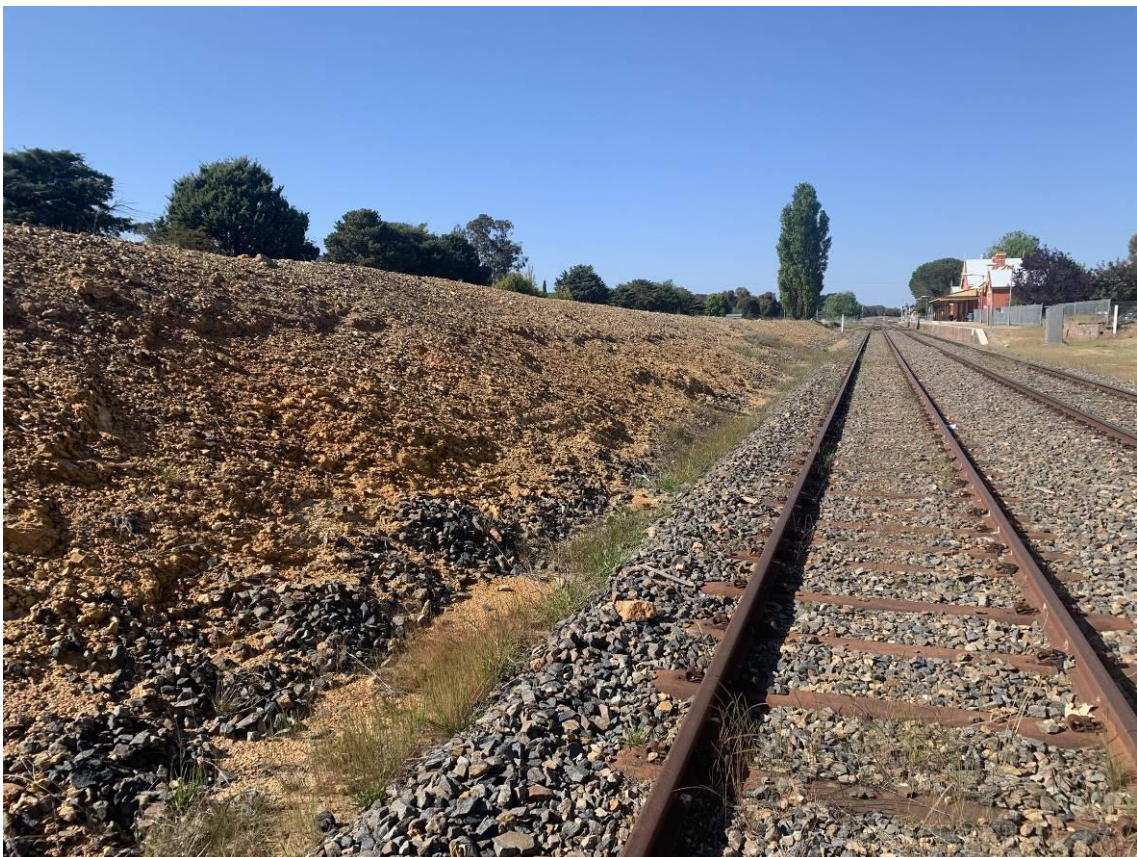
Are appropriate erosion and sediment controls in place and effective?	Yes		Evidence of erosion in some places (Photo 8), but unlikely to mobilise contaminated sediment which would present a risk to the receiving environment.
Is any dust being visibly generated at from the Site? If yes is dust leaving the Site boundary?		No	No airborne dust was visible (Photo 4 - 6)
Are any dust mitigation measures in place (binders, capping, grassing) if yes, are the measures in tact and effective?		No

Photo 8: Evidence of erosion upgradient of train line facing south-east towards Powell Street and opposite the Station Master Cottage. Bungendore Railway station to the right.

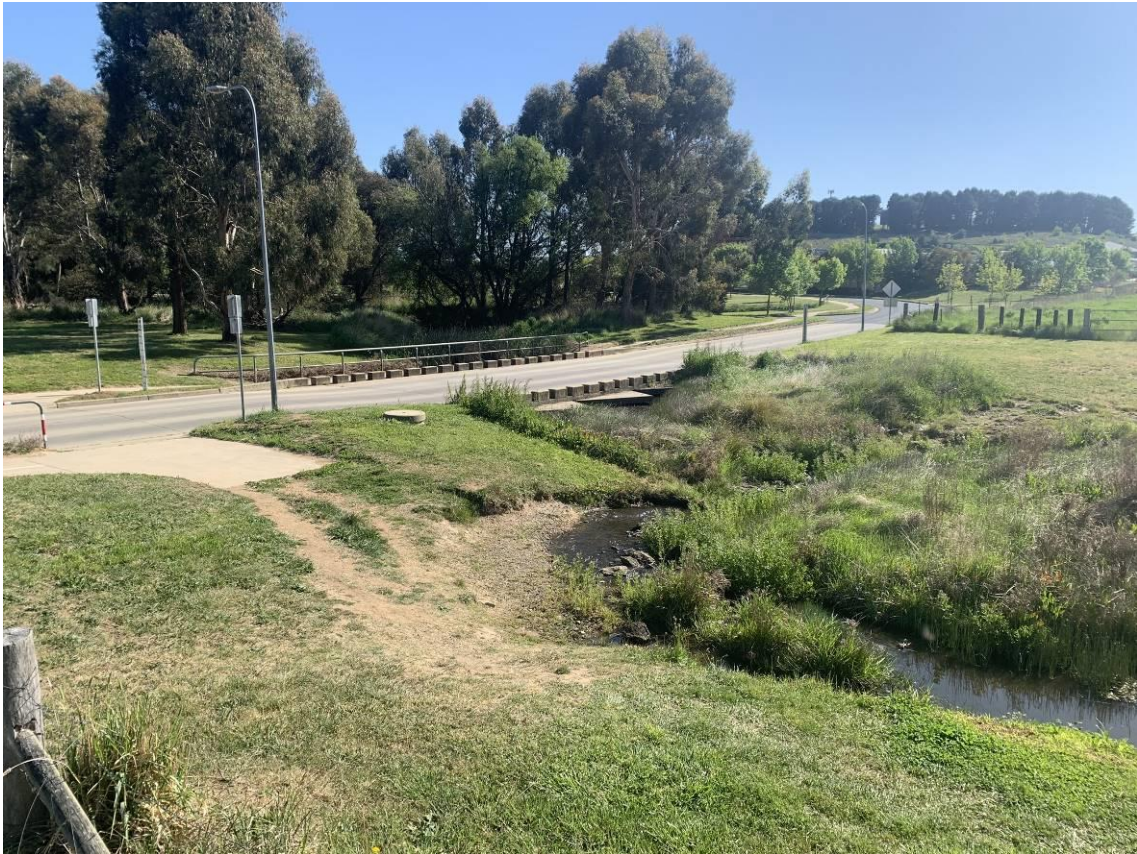
Photo 9: Turallo Creek north of Bungendore station at the track overpass near Turallo Terrace. Clear, low turbidity flowing water. Facing North.

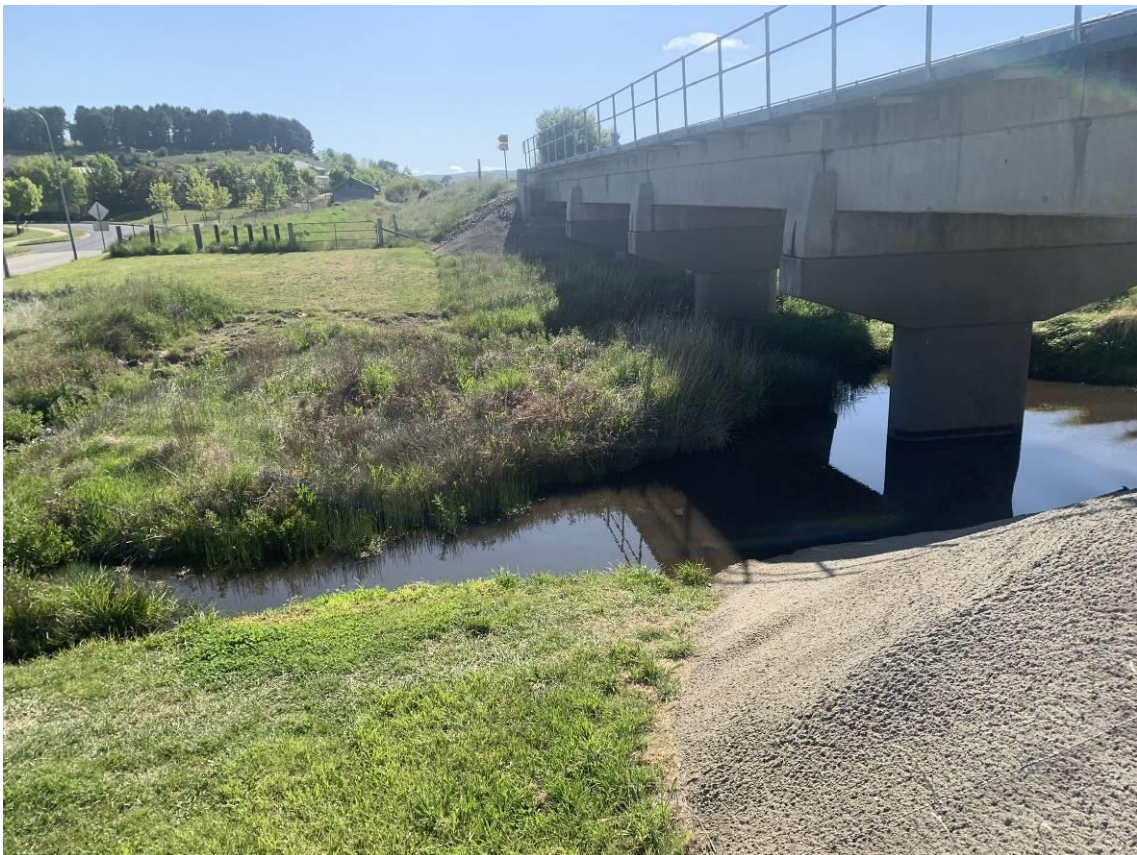
Photo 10: Turallo Creek with slow flowing water with low turbidity. Facing East.

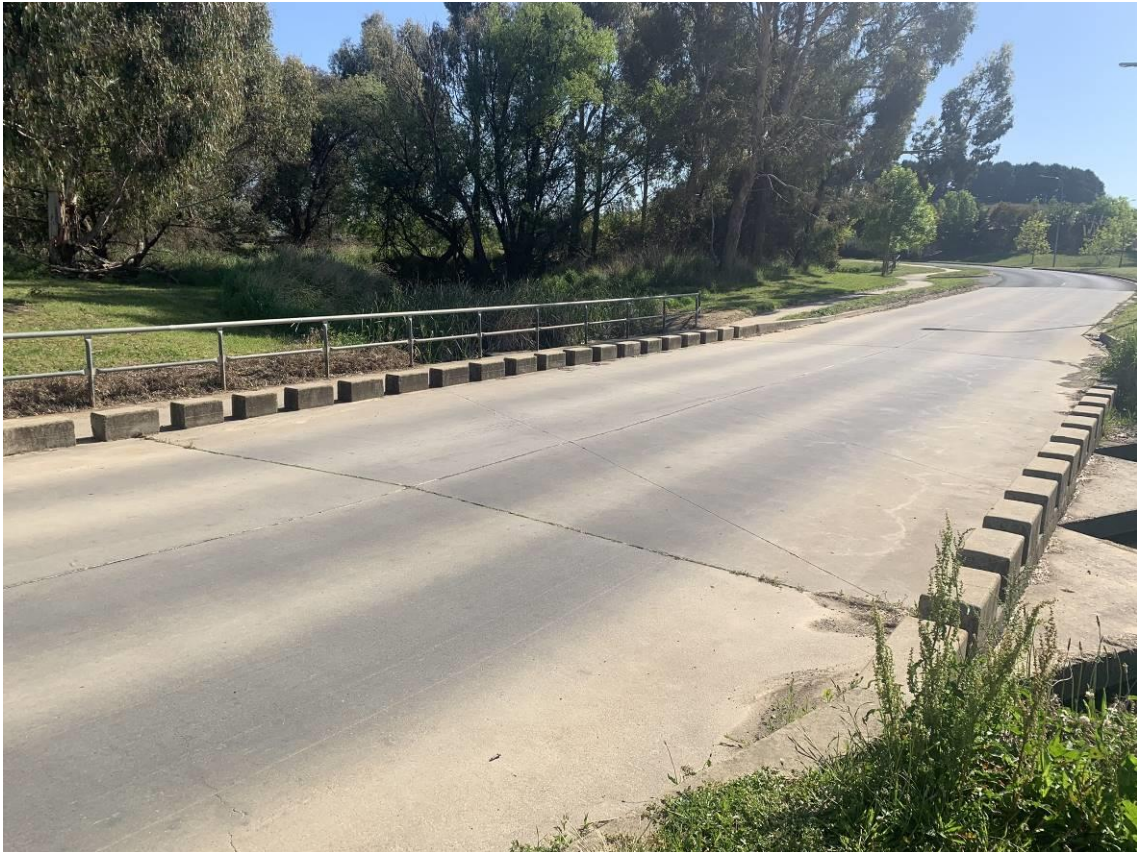
Photo 11: Turallo Terrace bridge dry. No sediment visible on road surface.

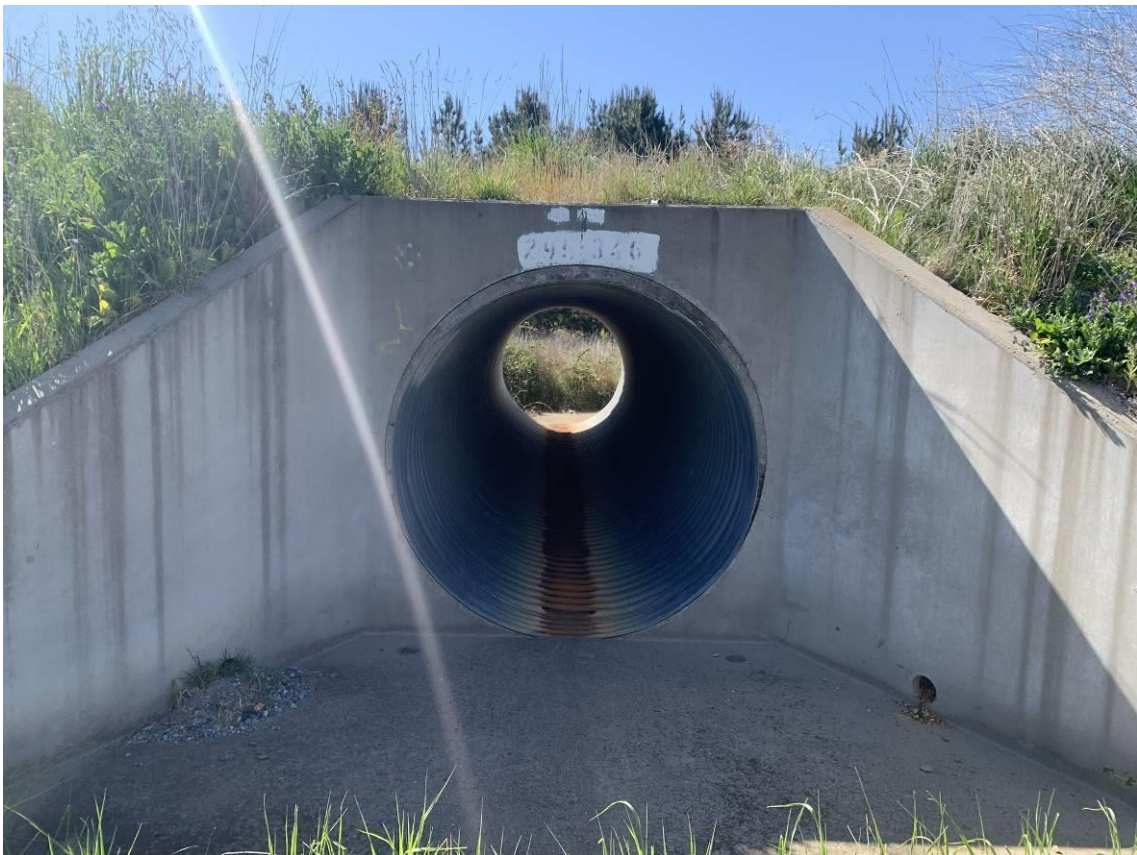
Photo 12: Downgradient of the first culvert encountered, coming from the South of the site. Dry, no surface water present with no visible sediment inside culvert or surrounding area.

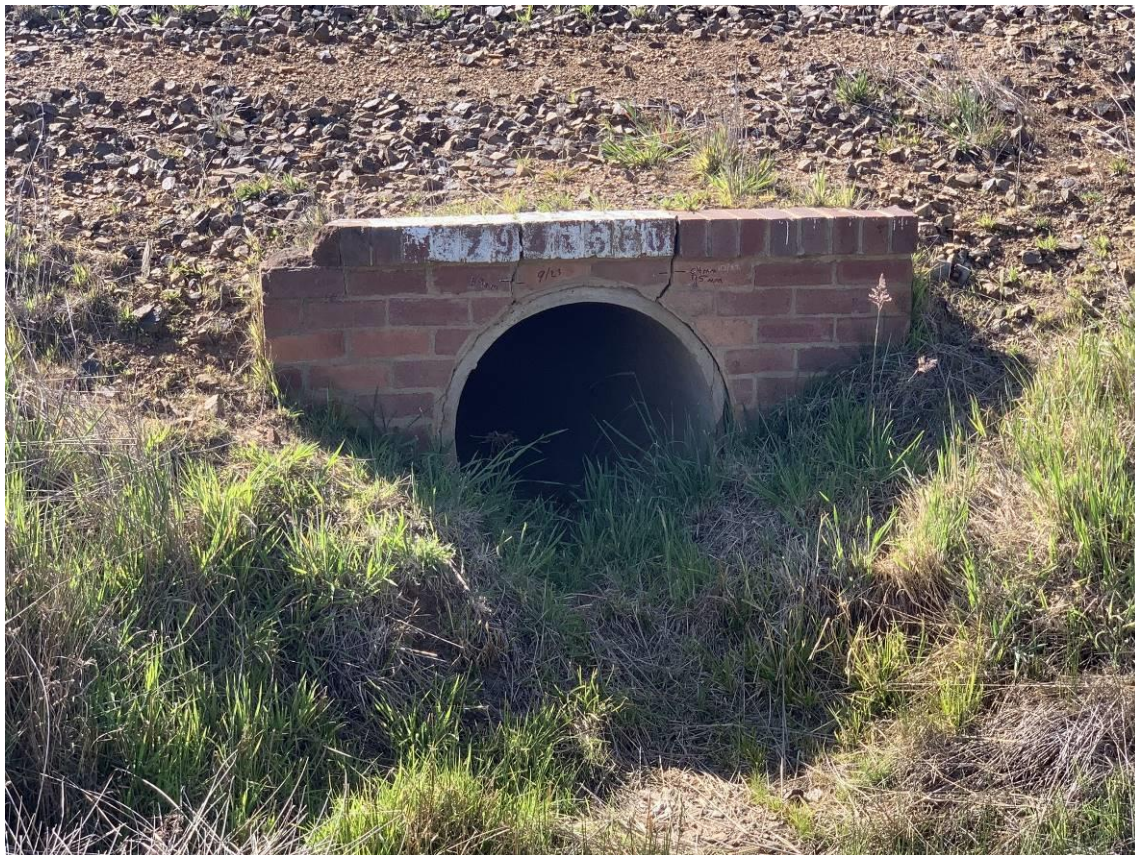
Photo 13: Downgradient of the second culvert encountered, coming from the South of the site. Dry, no surface water present with no visible sediment inside culvert or surrounding area.

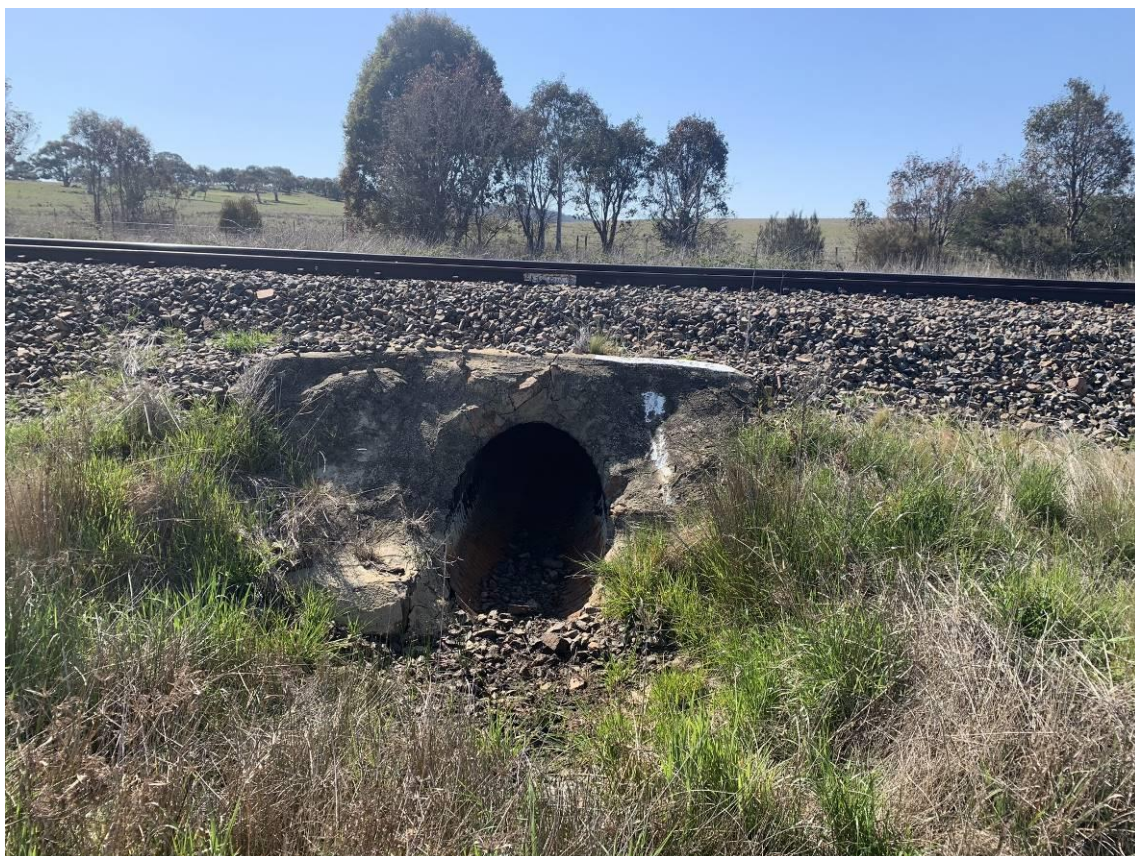
Photo 14: Downgradient of the third culvert encountered, coming from the South of the site. Dry, no surface water present, with no visible sediment inside culvert or surrounding area.

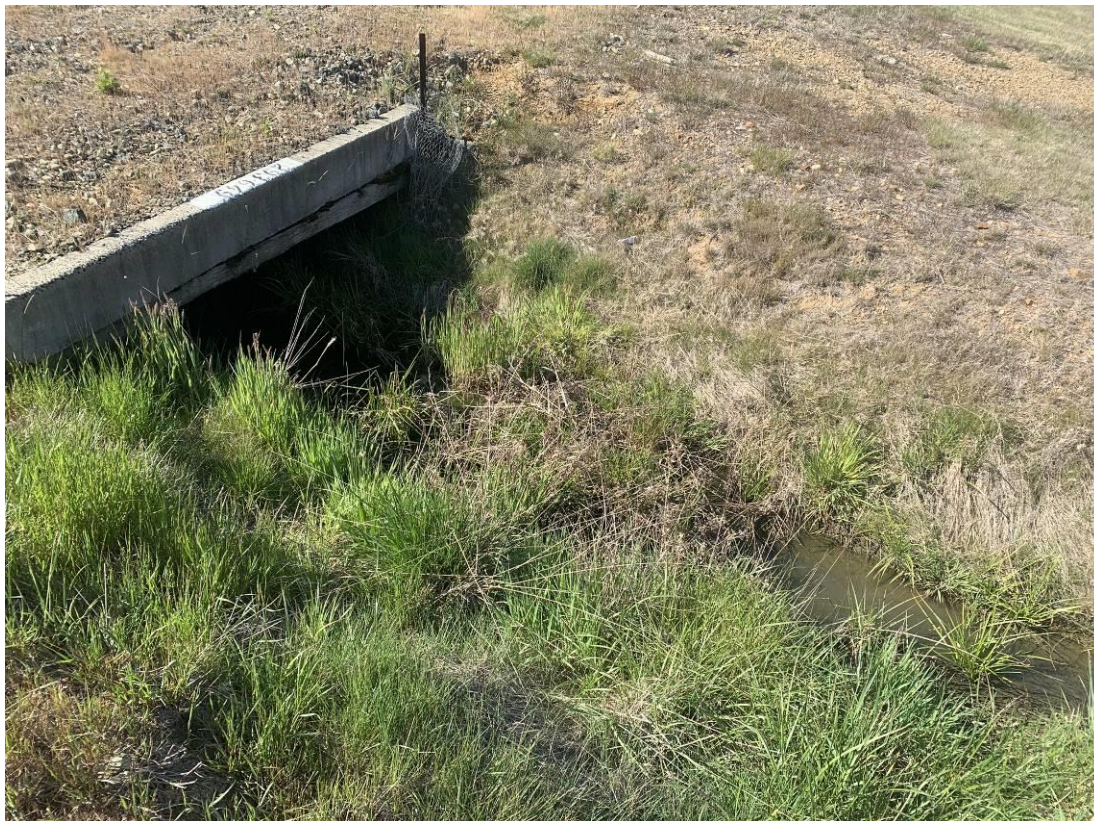
Photo 15: Downgradient of the fourth culvert encountered, coming from the South of the site, near to Malbon Street railroad crossing. Water slowly discharging through site. Low turbidity.

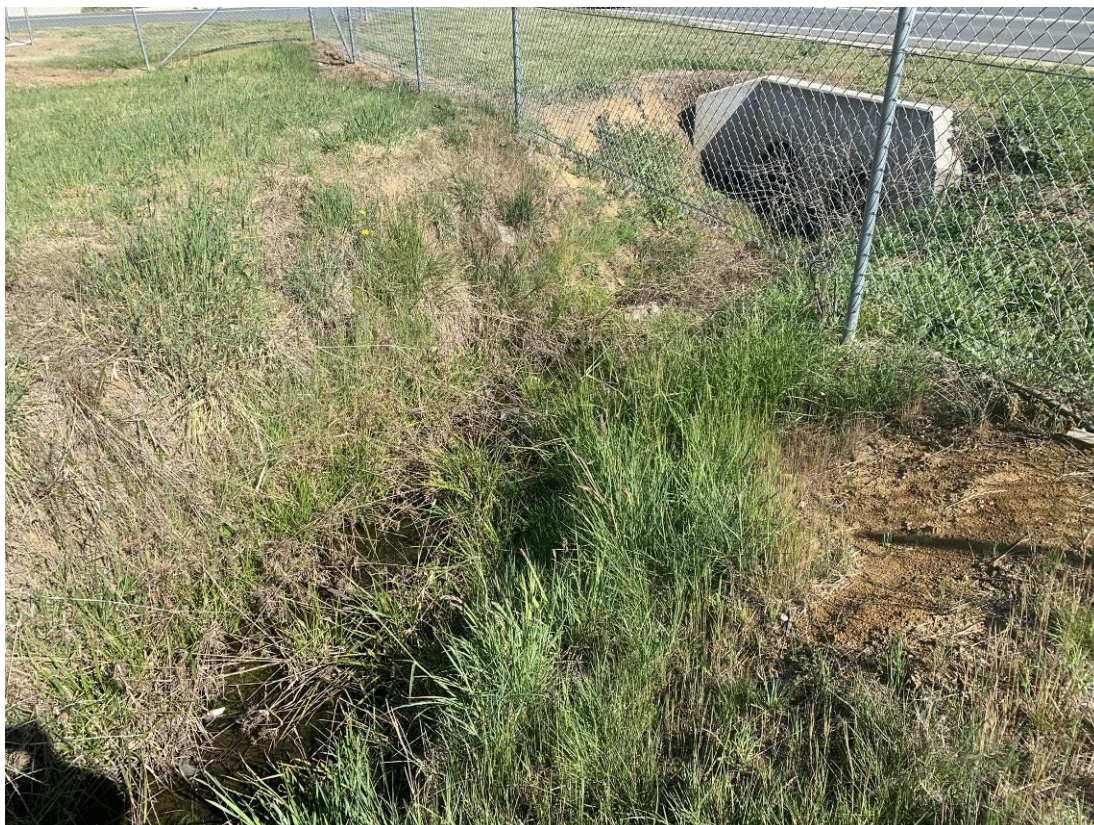
Photo 16: Downgradient of the fourth culvert encountered, coming from the South of the site, near to Malbon Street railroad crossing. Water slowly discharging through site. Low turbidity.
