Captains Flat EMP Inspection Checklist

Title: Captain's Flat Rail Corridor Inspection	Approved: SM	Project-Nr.: 318001704	Date: October 2023
Site: Captains Flat, NSW			
Client: UGL Regional Linx

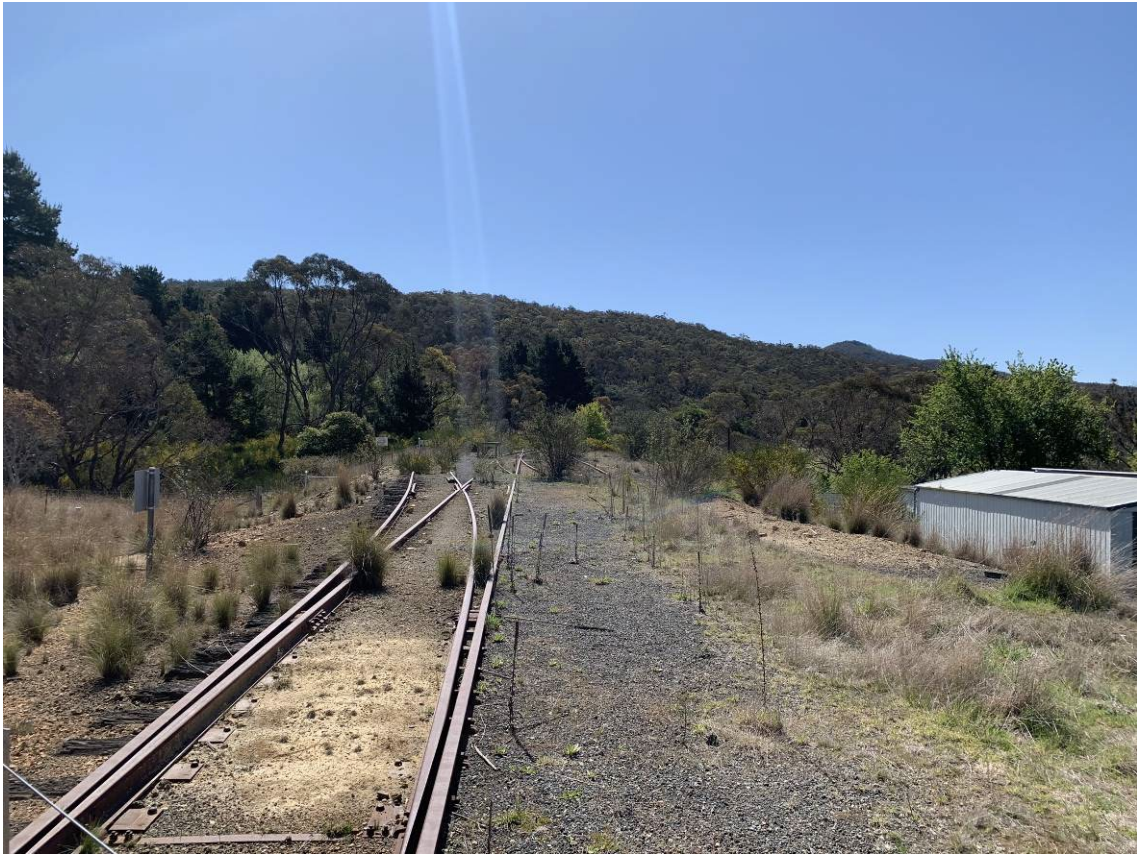
Photo 1: Trainlines behind fence facing north-west. Station Master Cottage on right of photo. No airborne dust was visible on site.

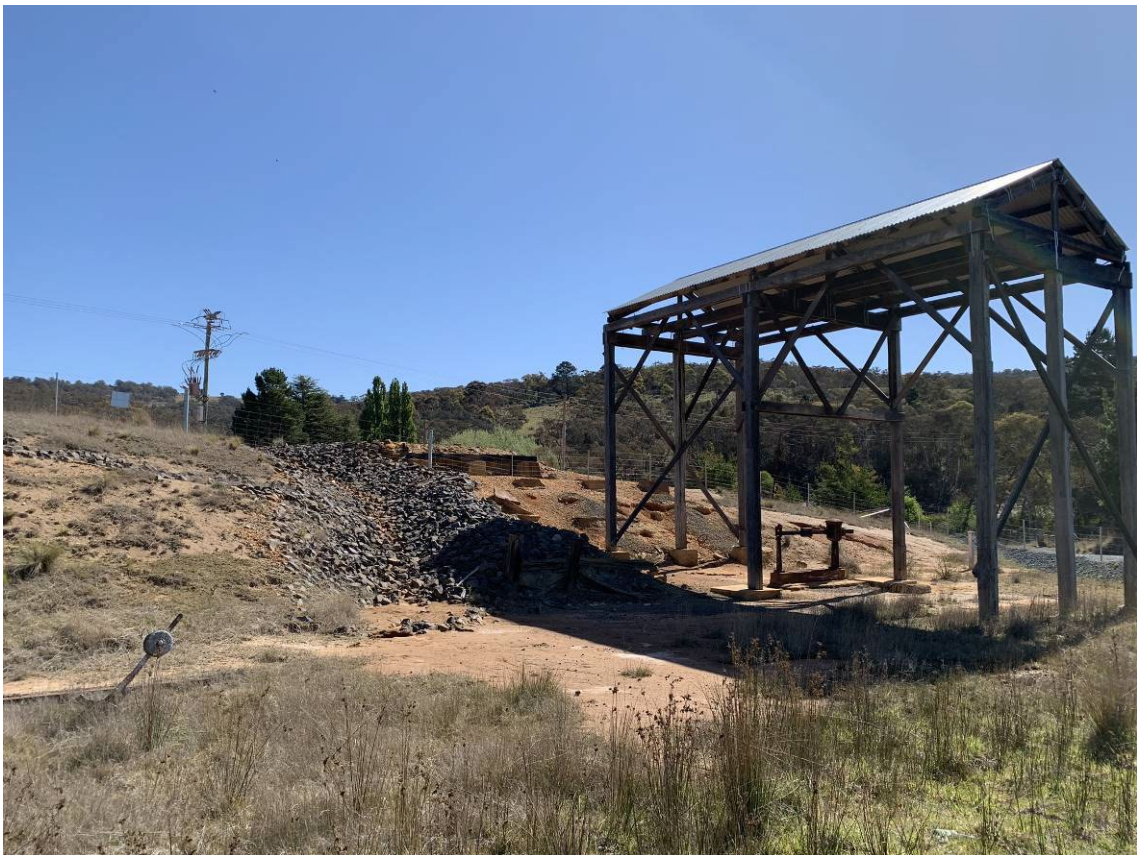
Photo 2: Former Loadout Facility and Weigh Bridge. No airborne dust was visible on site. Facing South-West

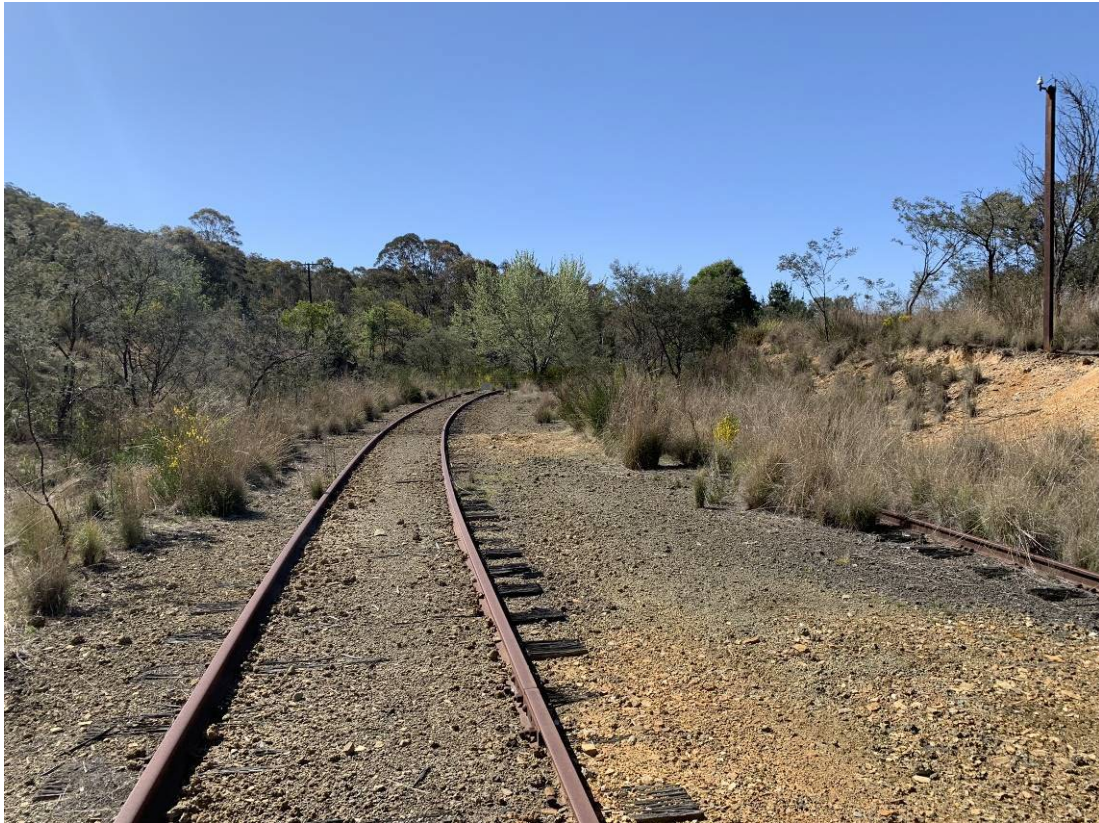
Photo 3: Railway tracks leading to the Former Captains Flat Railway Station. No airborne dust visible on site. Facing North to the northern most site boundary.

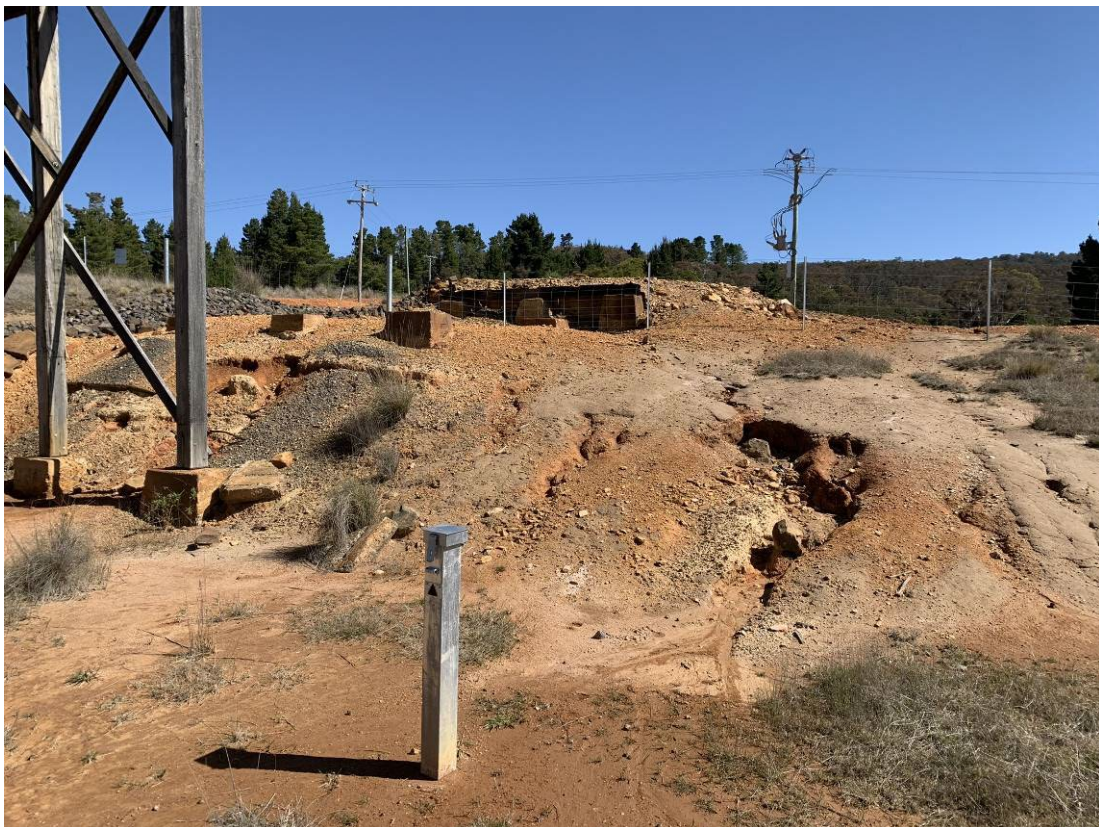
Photo 4: Evidence of erosion of soils on site. No evidence of current surface water runoff into Coppers Creek. Located adjacent to Former Loadout Facility and Weigh Bridge. Facing South.

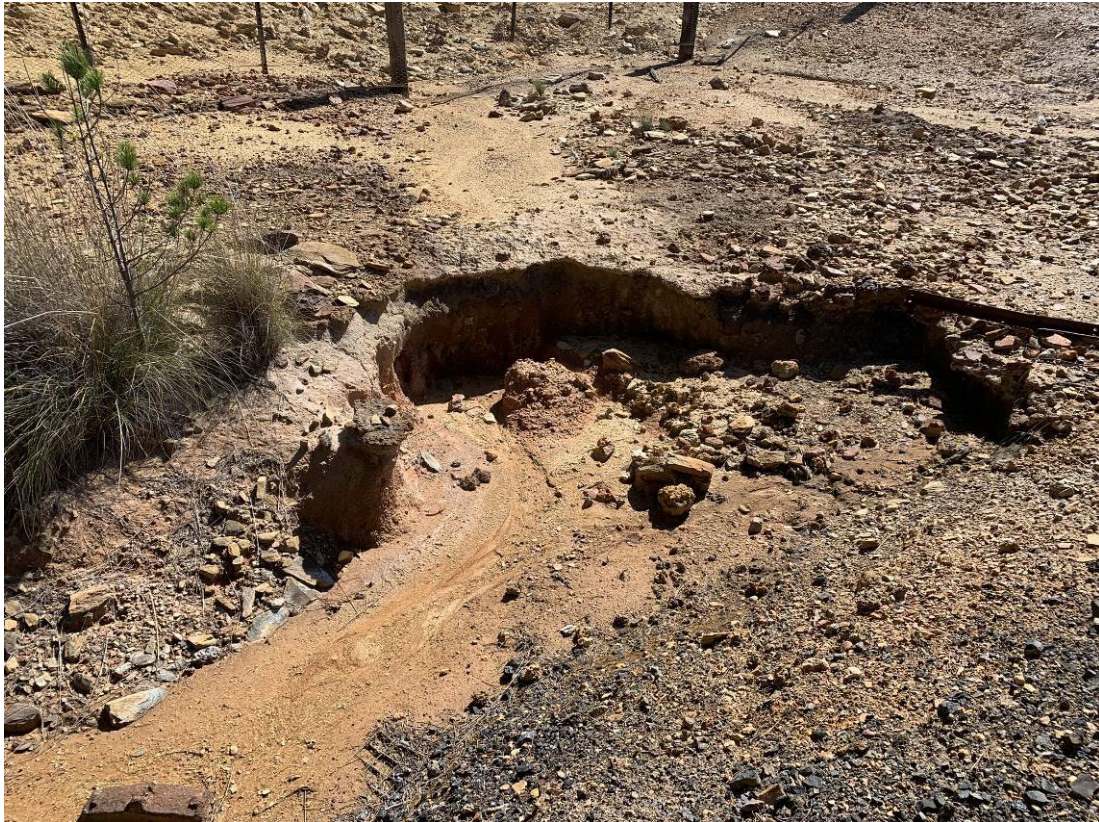
Photo 5: Evidence of erosion of soils on site. No evidence of current surface water runoff into Coppers Creek. Located south of the State Emergency Service (SES) facility.

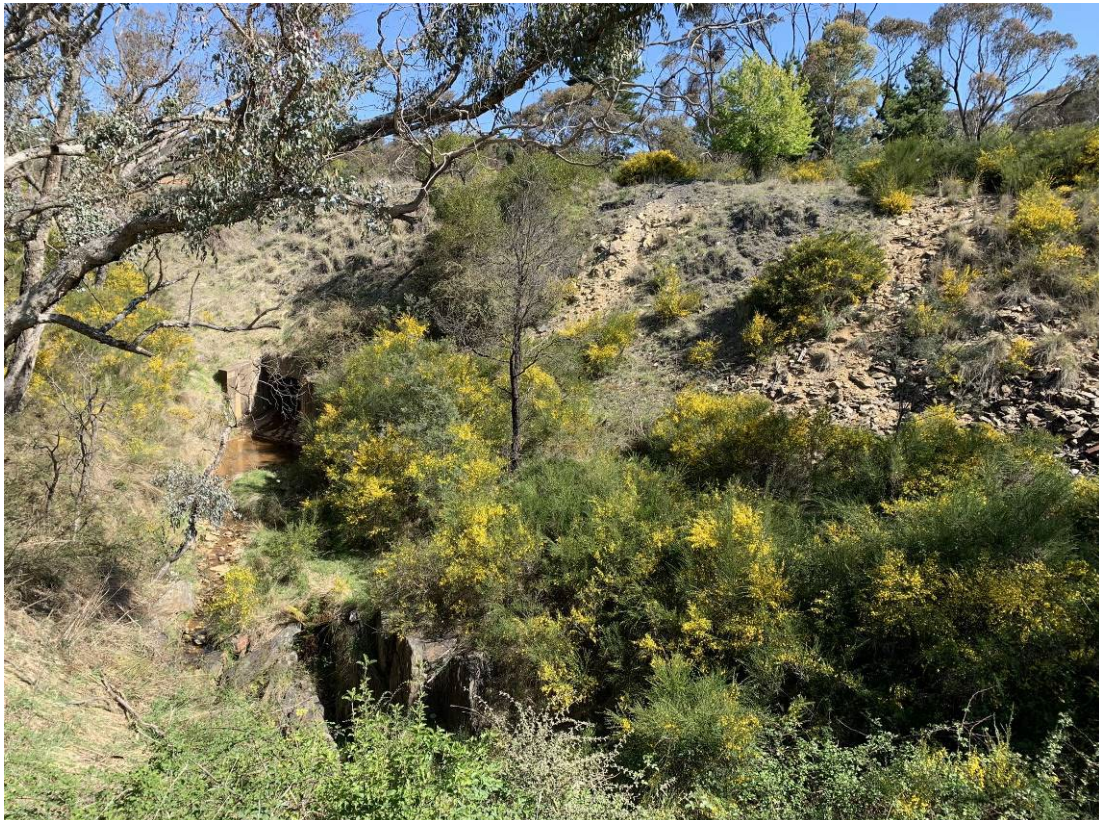
Photo 6: Photo taken from the Miners Road and Captains Flat Road intersection showing the southern boundary of site. Copper Creek culvert visible. No evidence of current onsite surface water runoff into Coppers Creek. Facing South-West.

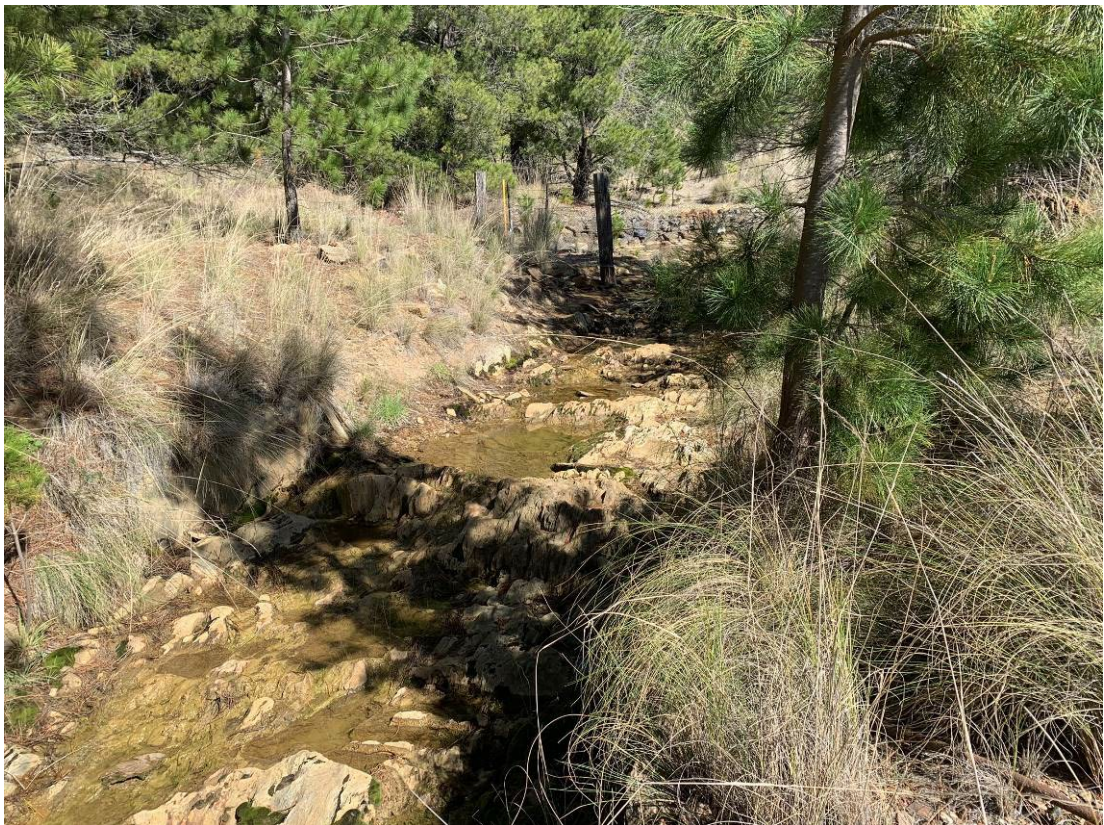
An unnamed creek off-site and down gradient from Captains Flat State Emergency Service shows cloudy surface water with sediment present. This creek is fed from the mine site upstream and is not expected to contain sediment from site (**Photo 7, 11**).

Photo 7: A small unnamed Creek slowly flowing through the South-Eastern half of the site. No additional surface water from on-site sources appear to currently contribute to the Creek and no evidence of sediment run off from site was visible.

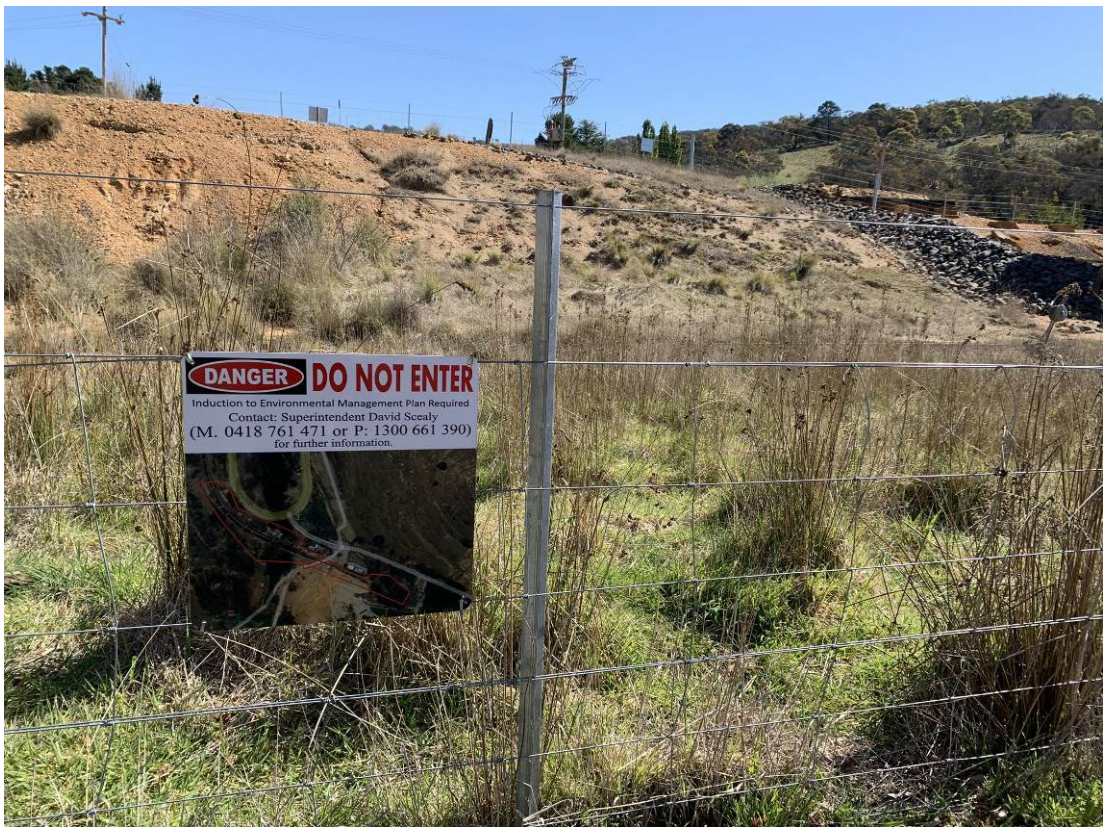
Photo 8: Exclusion zone signage placed periodically along contamination areas which are adjacent to Coppers Creek Road. Fencing in place to demark site.

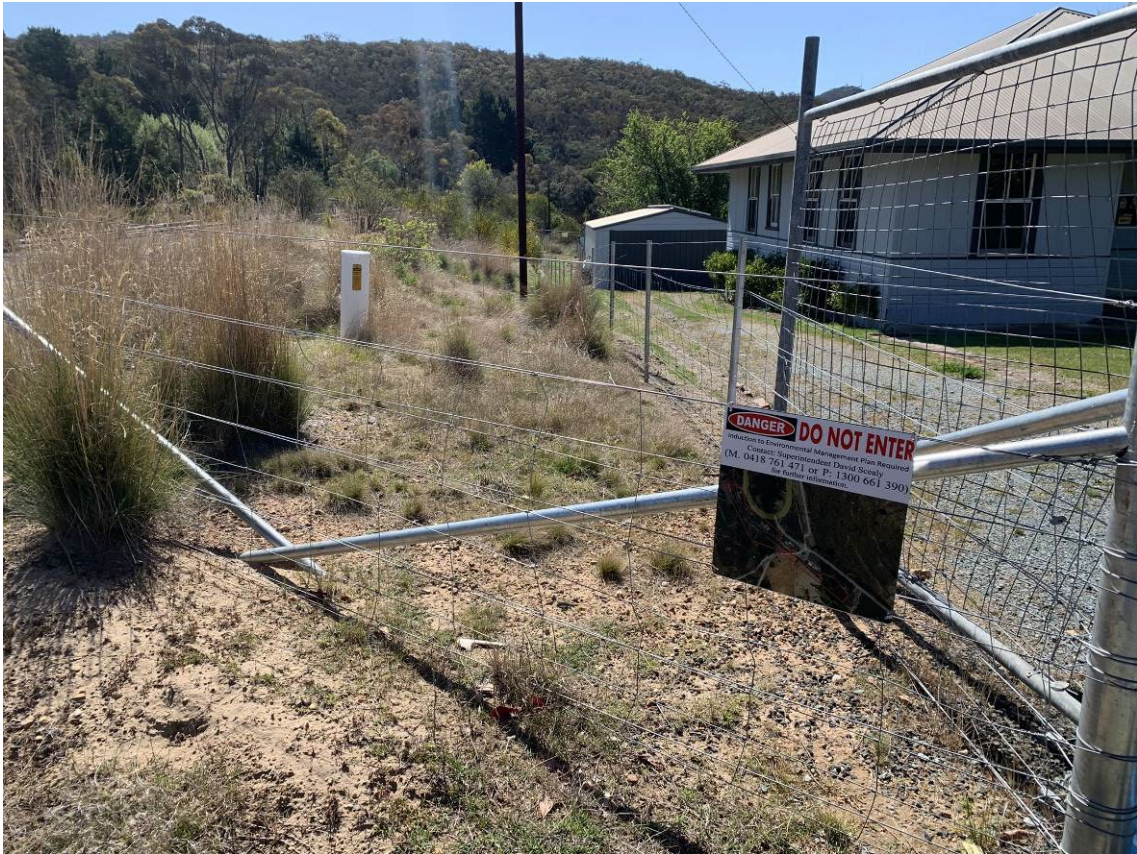
Photo 9: Exclusion zone signage placed at north-East boundary of the site with appropriate fencing.

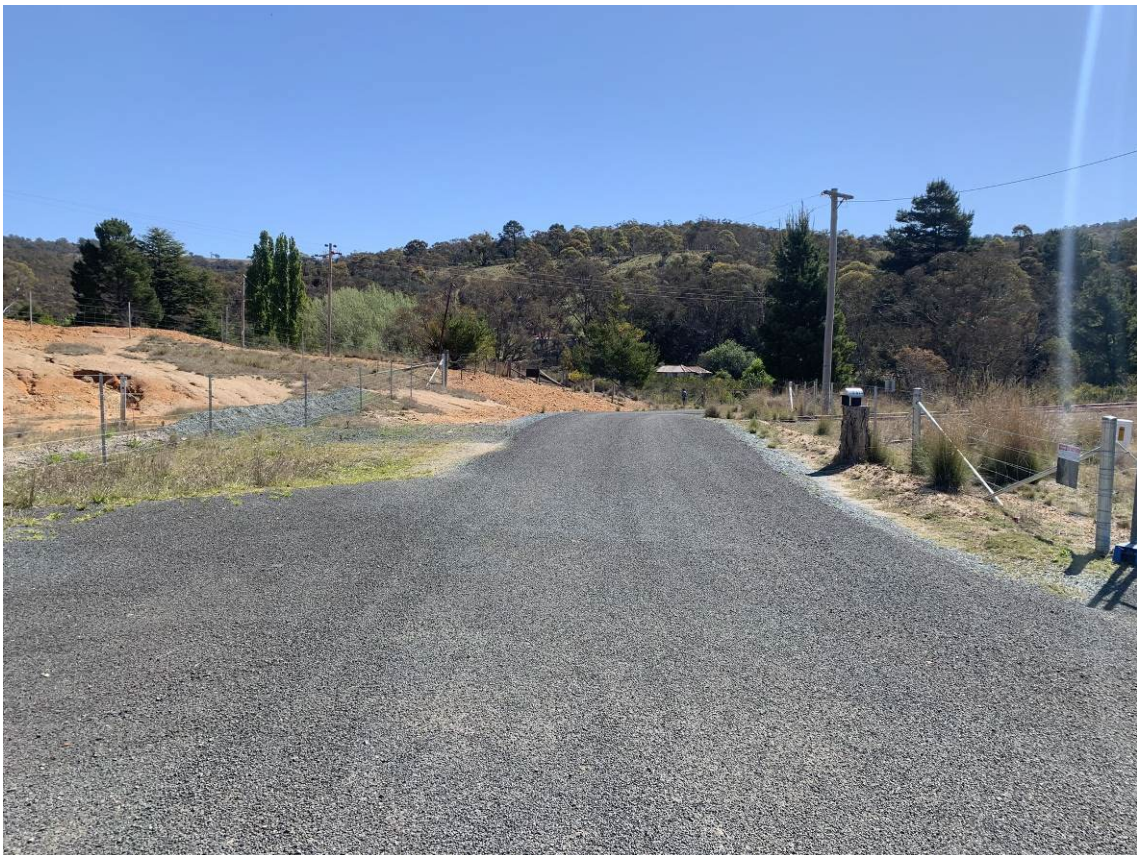
Has durable erosion resistant capping been applied over the Coppers Creek Road crossing?	Yes		Coppers Creek Road Crossing was covered with a sealed road, there is no evidence of sediment on the road (Photo 10).	
	Is capping over Coppers Creek Road preventing inadvertent access to site materials?	Yes		Copper Creek Road Crossing is a sealed road preventing access to soil underneath (Photo 10).	
	Is excavation occurring onsite?		No	n/a no excavation occurring on site	
Plan Ref	Control	Inspection		Corrective Action	Implemented?
		Yes	No		
	Is the UGL Environment Manager or delegated representative supervising the excavation?			n/a no excavation occurring on site	
	Are excavators operating with closed cabs?			n/a no excavation occurring on site

Photo 10: Sealed road over Copper Creek Road crossing, preventing inadvertent access to site materials underneath.

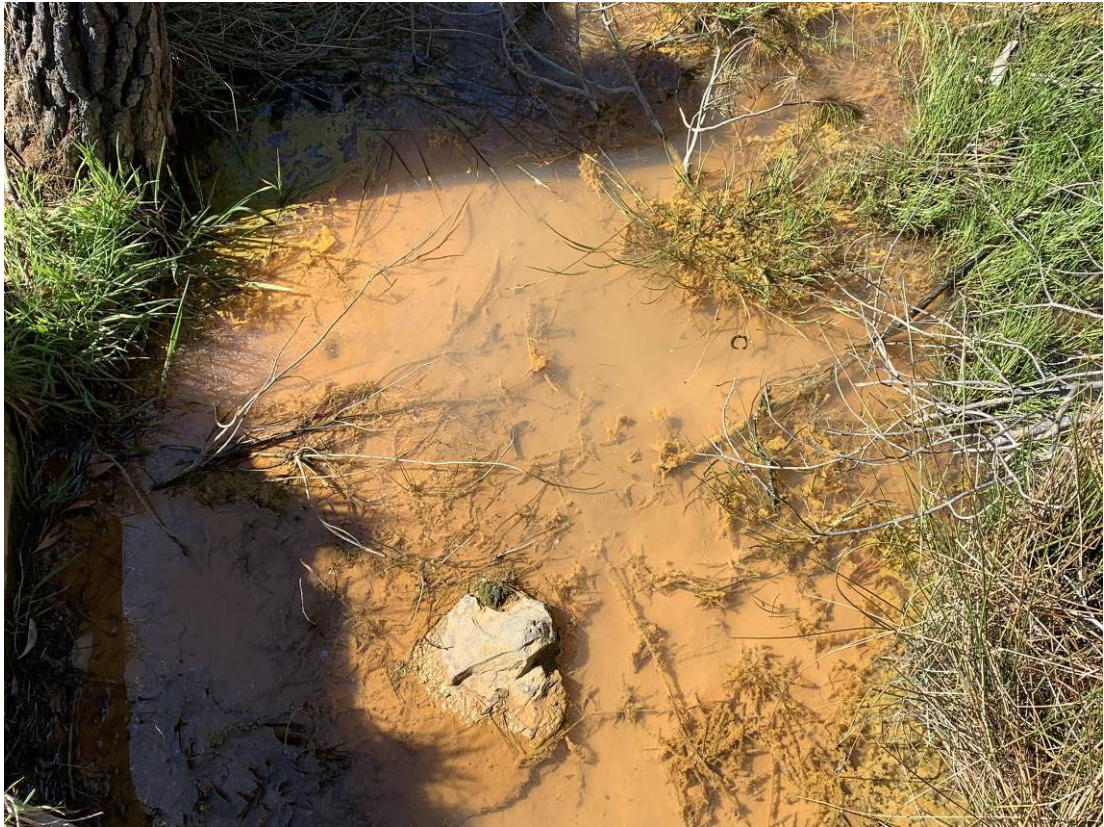
Photo 11: Unnamed watercourse off site and down gradient from Captains Flat State Emergency Service (SES) unnamed creek, showing cloudy surface water with sediment.

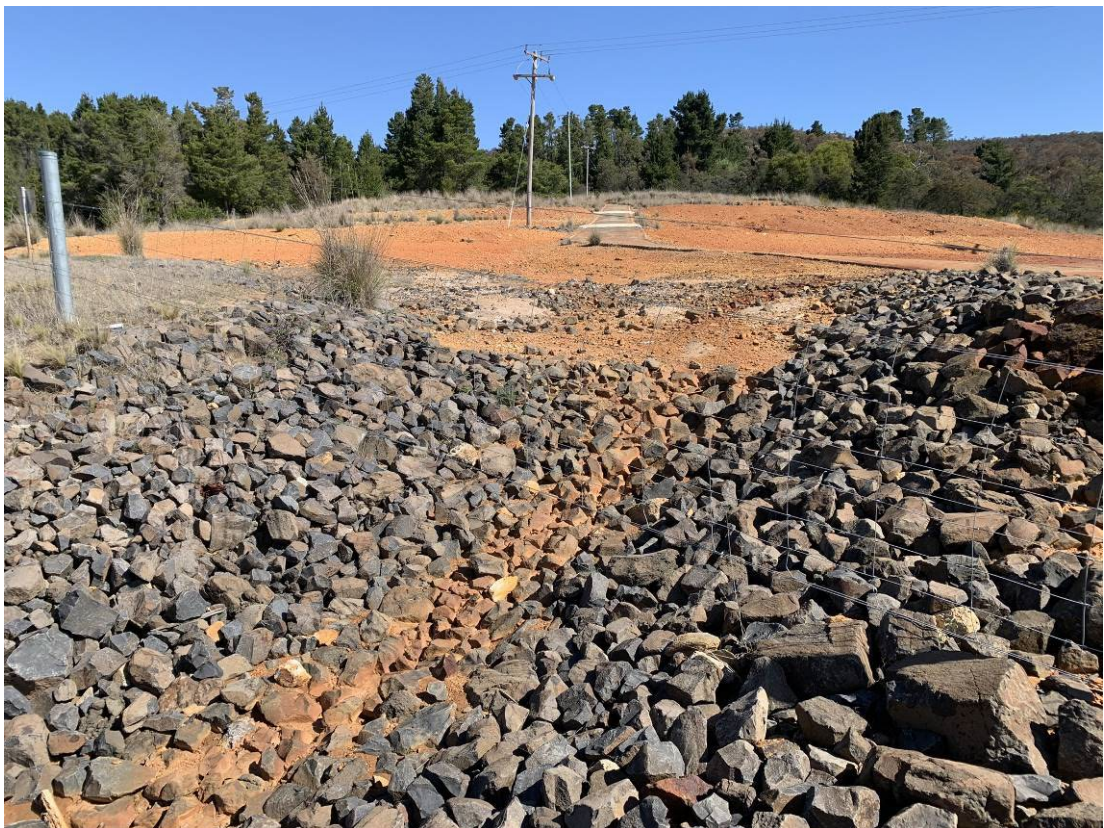
Some sediment is trapped in rocks on-site from upgradient source off-site. This sediment, having come from off-site, is not expected to be mobilised contaminated sediment from on-site (**Photo 12**).

Photo 12: Some sediment visibly trapped in rocks on site from an upgradient off-site location. Material is not expected to be mobilised contaminated sediment from on-site.

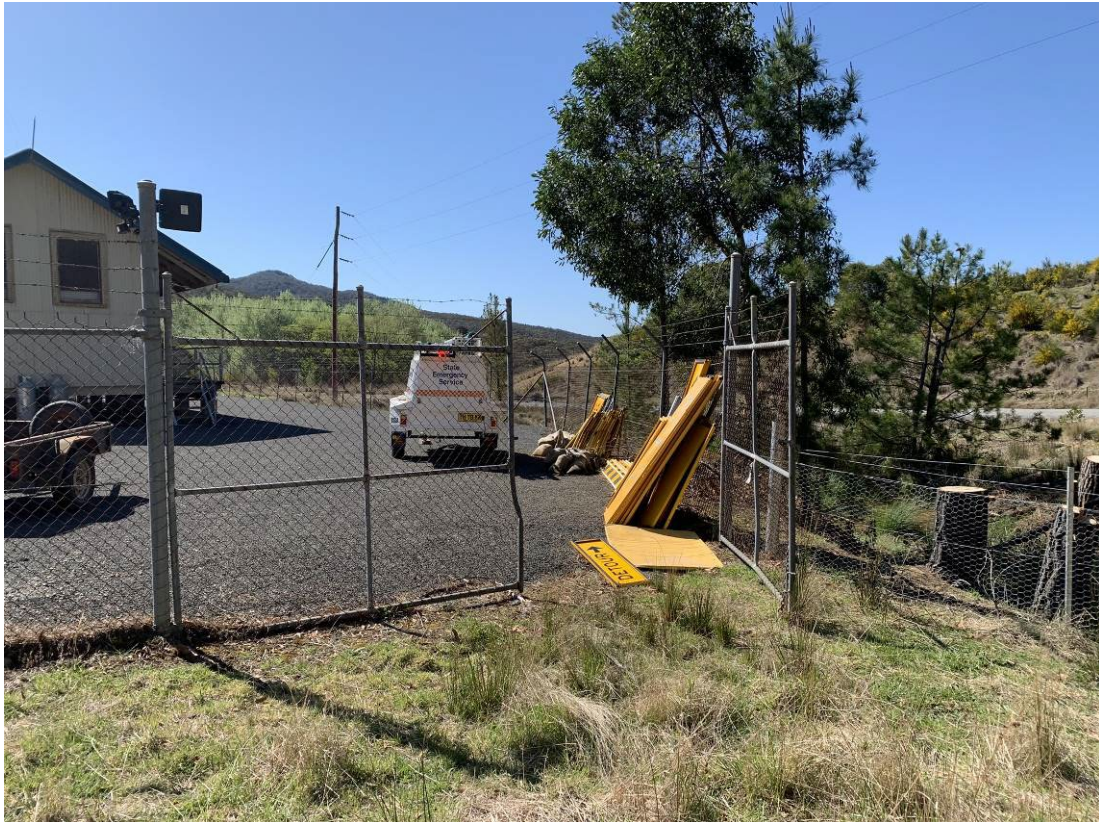
Photo 13: An unlocked and open gate located between the site and State Emergency Service (SES) Facility. The opened gate is located on the south-east boundary of the SES facility.

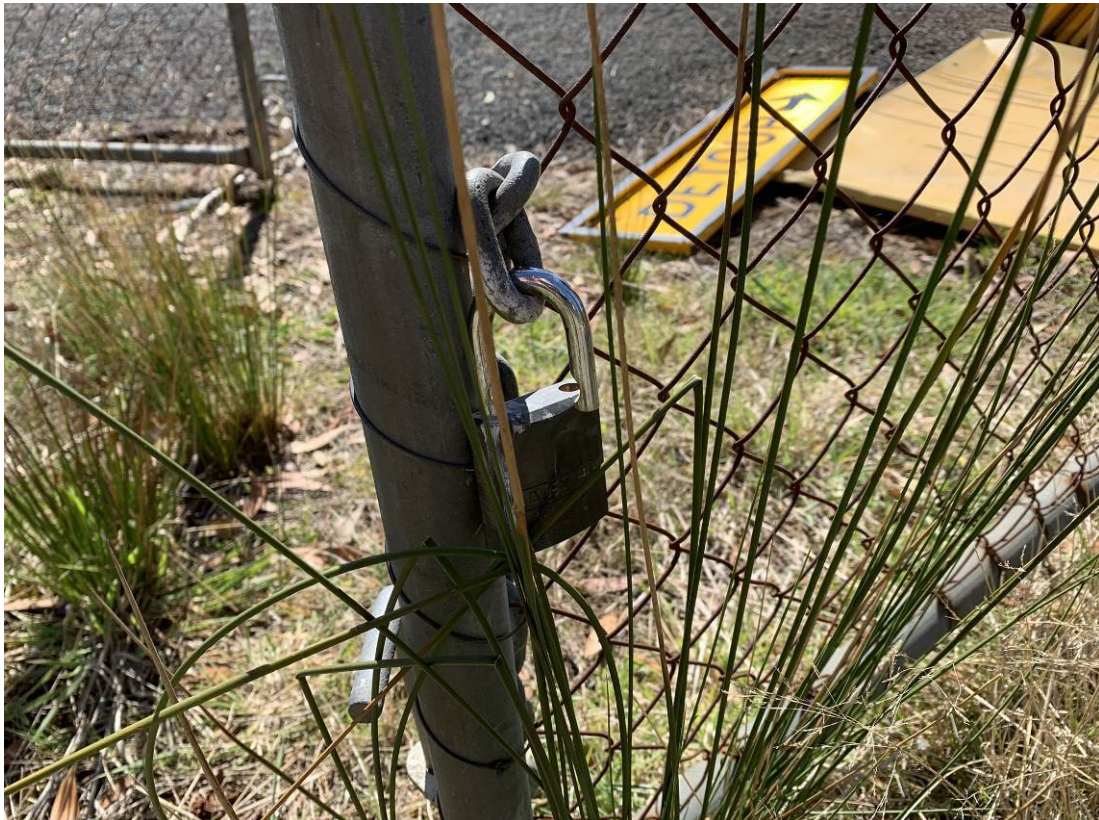
Photo 14: An unlocked and open gate between the site and State Emergency Service (SES) Facility. An unlocked padlock is visible. The opened gate is located on the south-east boundary of the SES facility.

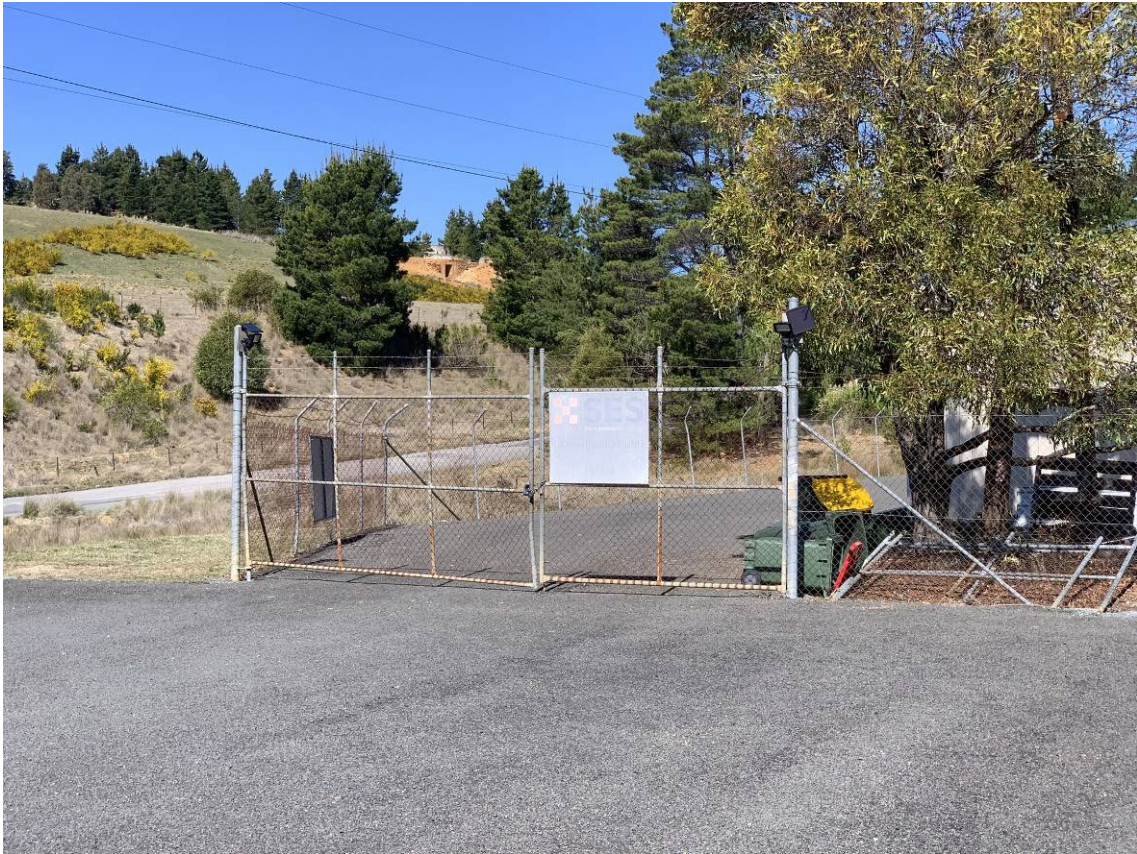
Photo 15: State Emergency Service (SES) facility front gate, locked and preventing public access.

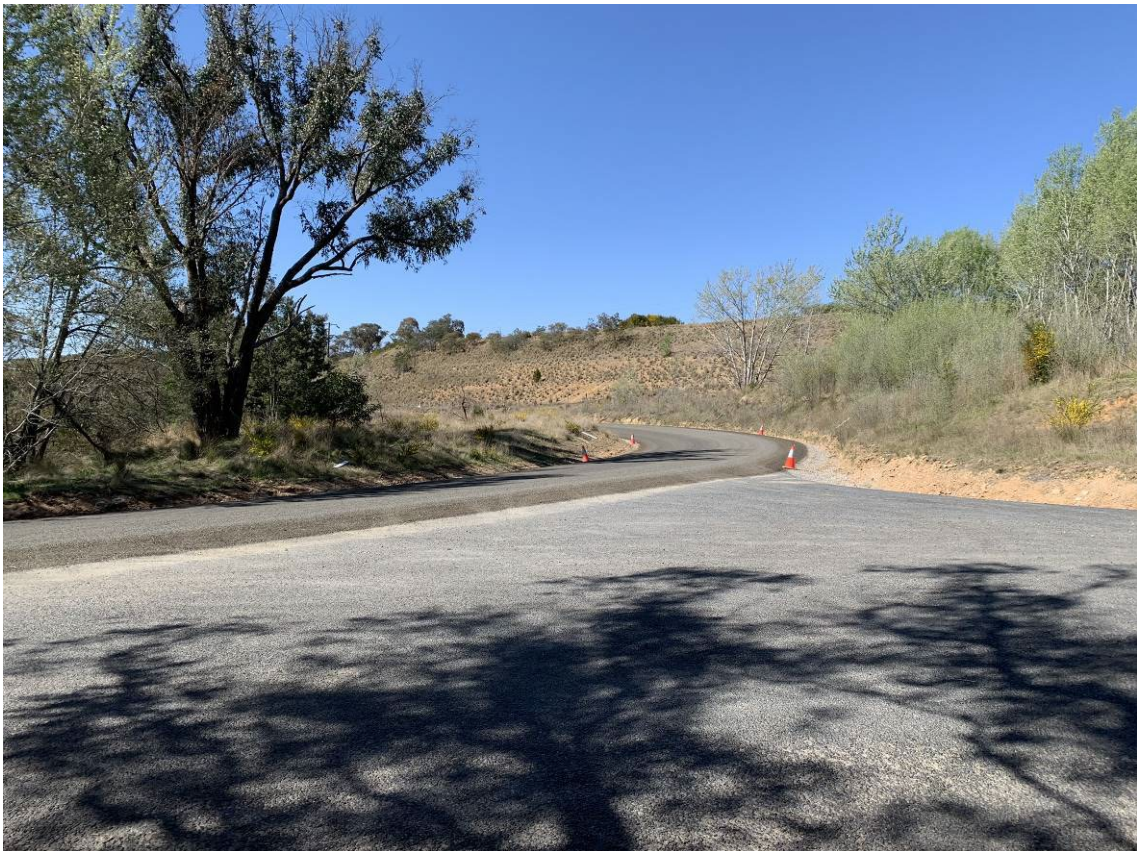
Significant road upgrade works have been occurring on Captains Flat Road, most notably near the Miners Road and Captains Flat Road intersection (**Photo 16**). Ramboll staff have observed heavy earthmoving machinery being involved in its development. Several silk screens are in place for sediment control into Coppers Creek (**Photos 17-18**). These works are not expected to concern the on-site contamination.

Photo 16: Captains Flat Road and Copper Creek Road intersection. Significant road upgrades and resurfacing have occurred on Captains Flat Road.

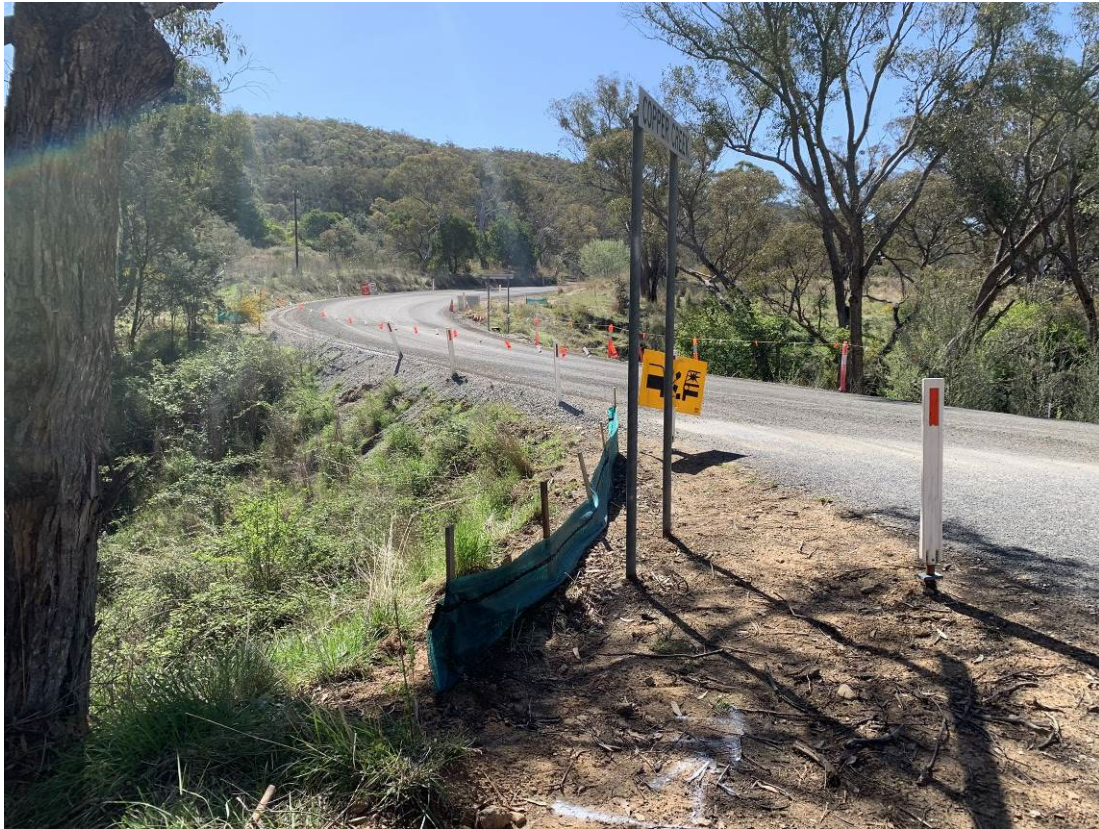
Photo 17: Captains Flat Road and Copper Creek Road intersection. Significant road upgrades and resurfacing have occurred on Captains Flat Road. Sediment silk screens are in place.

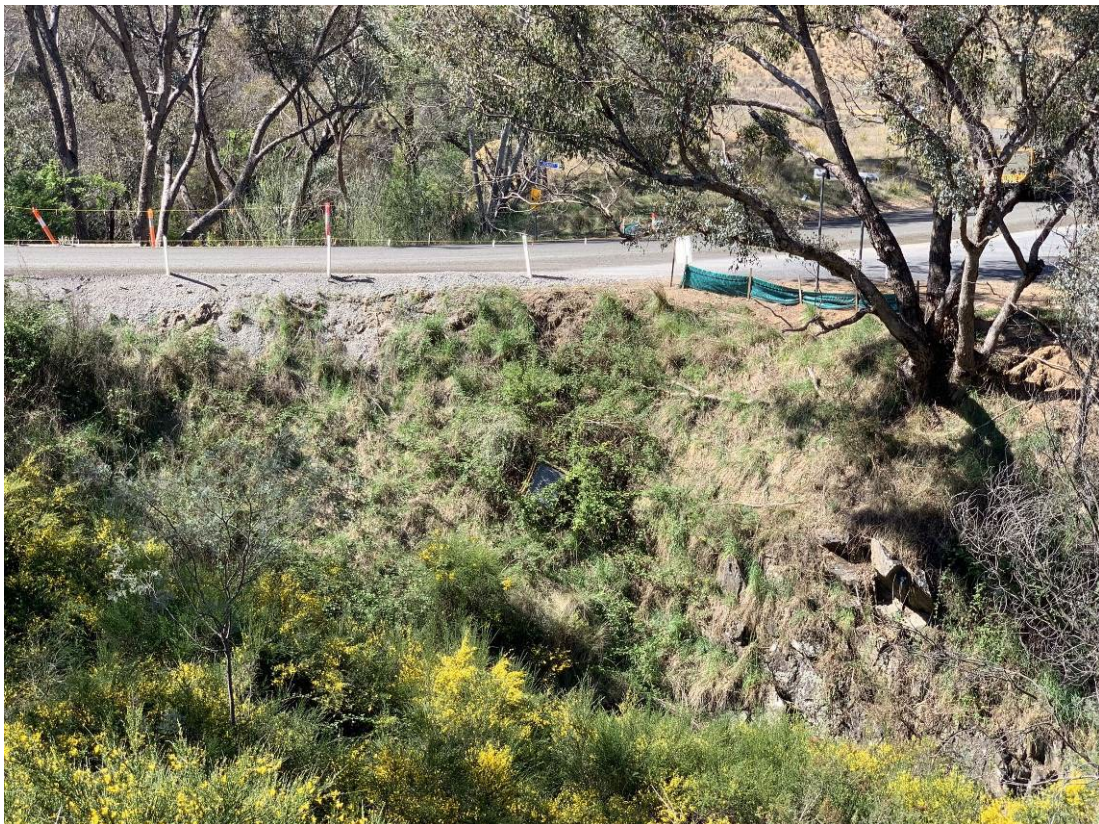
Photo 18: Captains Flat Road and Copper Creek Road intersection. Significant road upgrades and resurfacing have occurred on Captains Flat Road. Sediment silk screens are in place. A piece of construction signage appears to have fallen off the road towards Copper Creek.
