<b>Location:</b>	Dent, George and Hill Streets, North Lambton 2299
<b>Date Completed:</b>	05/07/2024
<b>Reason for Dilapidation:</b>	Trafficking by Construction Vehicles to allow turn around for entry into site
<b>Asset Owner:</b>	City of Newcastle
<b>Inspection Scope</b>	Photographic inspection report

Dent, George and Hill Streets, North Lambton – Pavement Dilapidation Report

Inspection Date: 05 July 2024

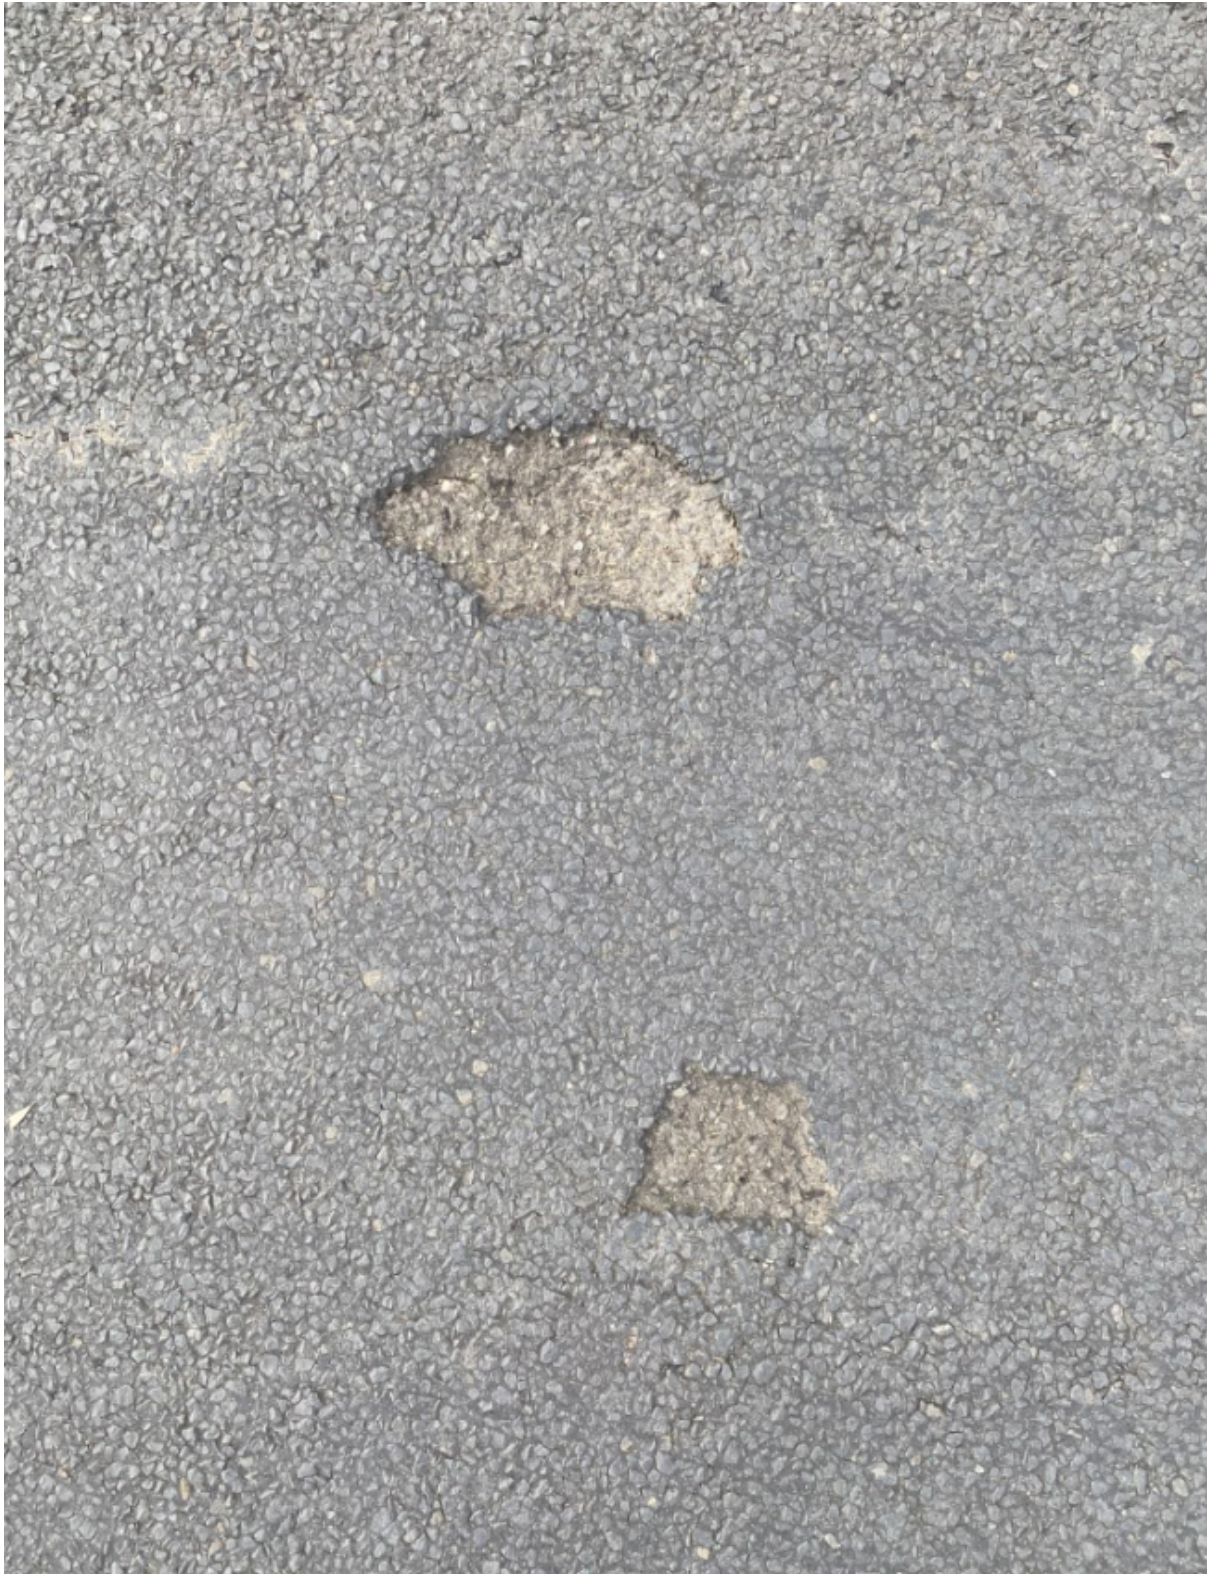
Photo 3: Pavement damage in pavement of Dent Street north bound lane

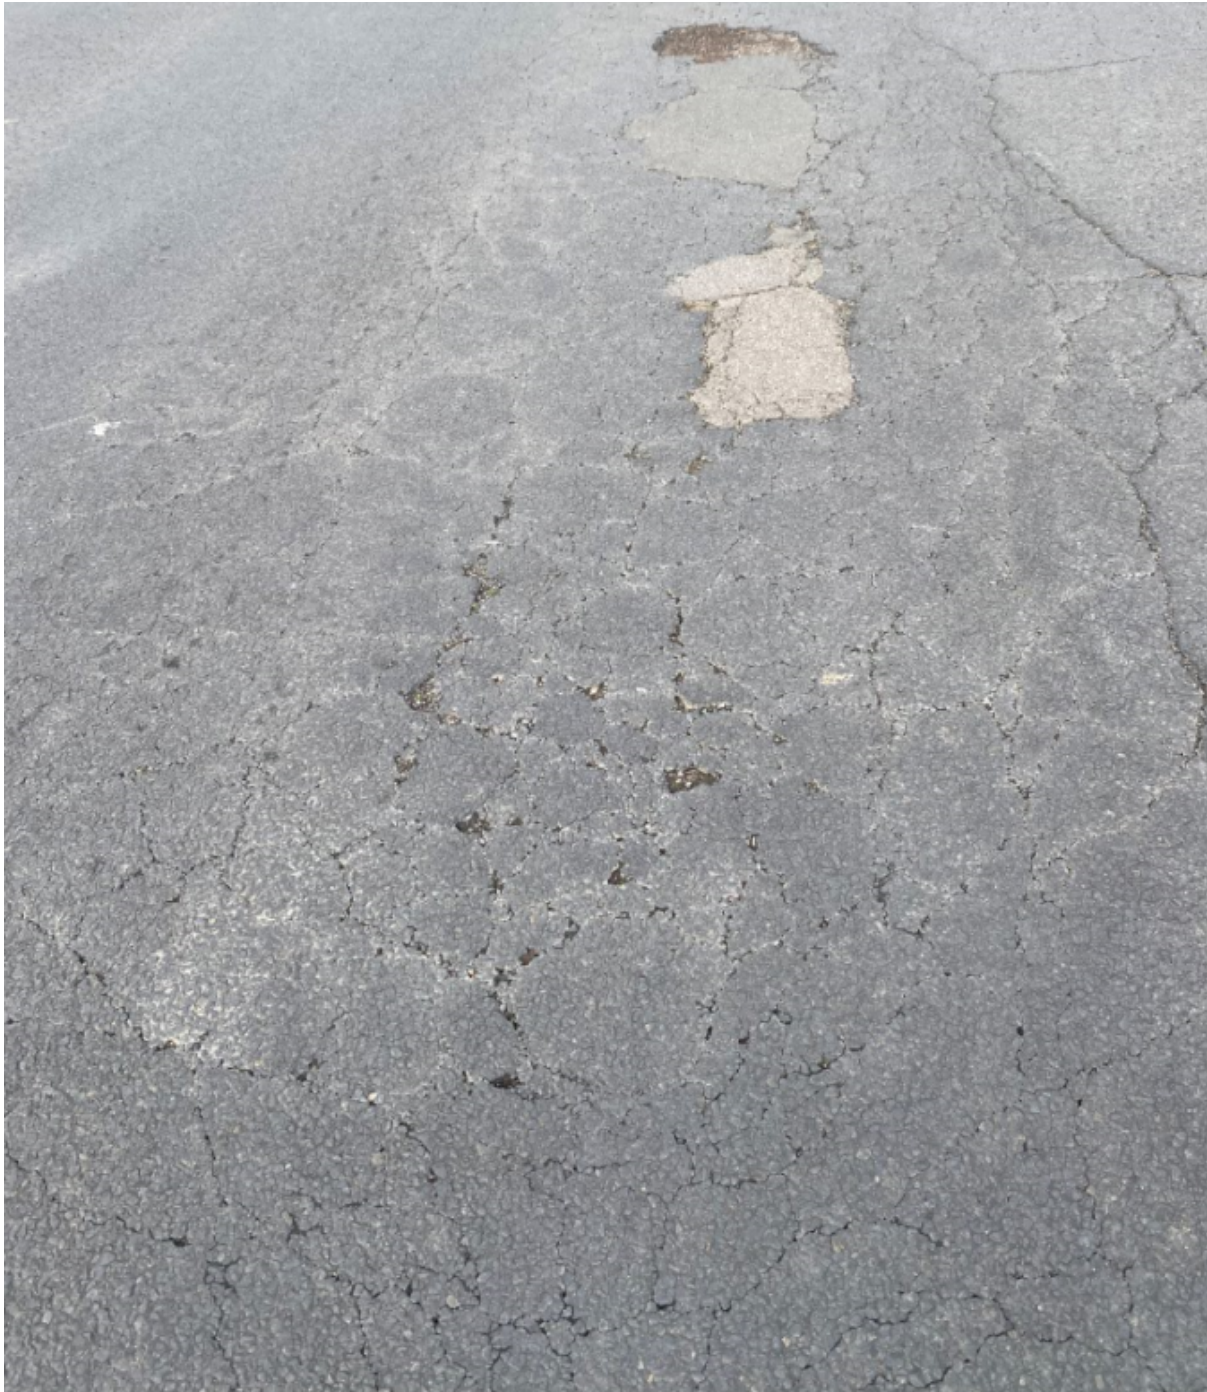
Photo 4: North bound lane pavement damage of Dent St at Hill St, facing south

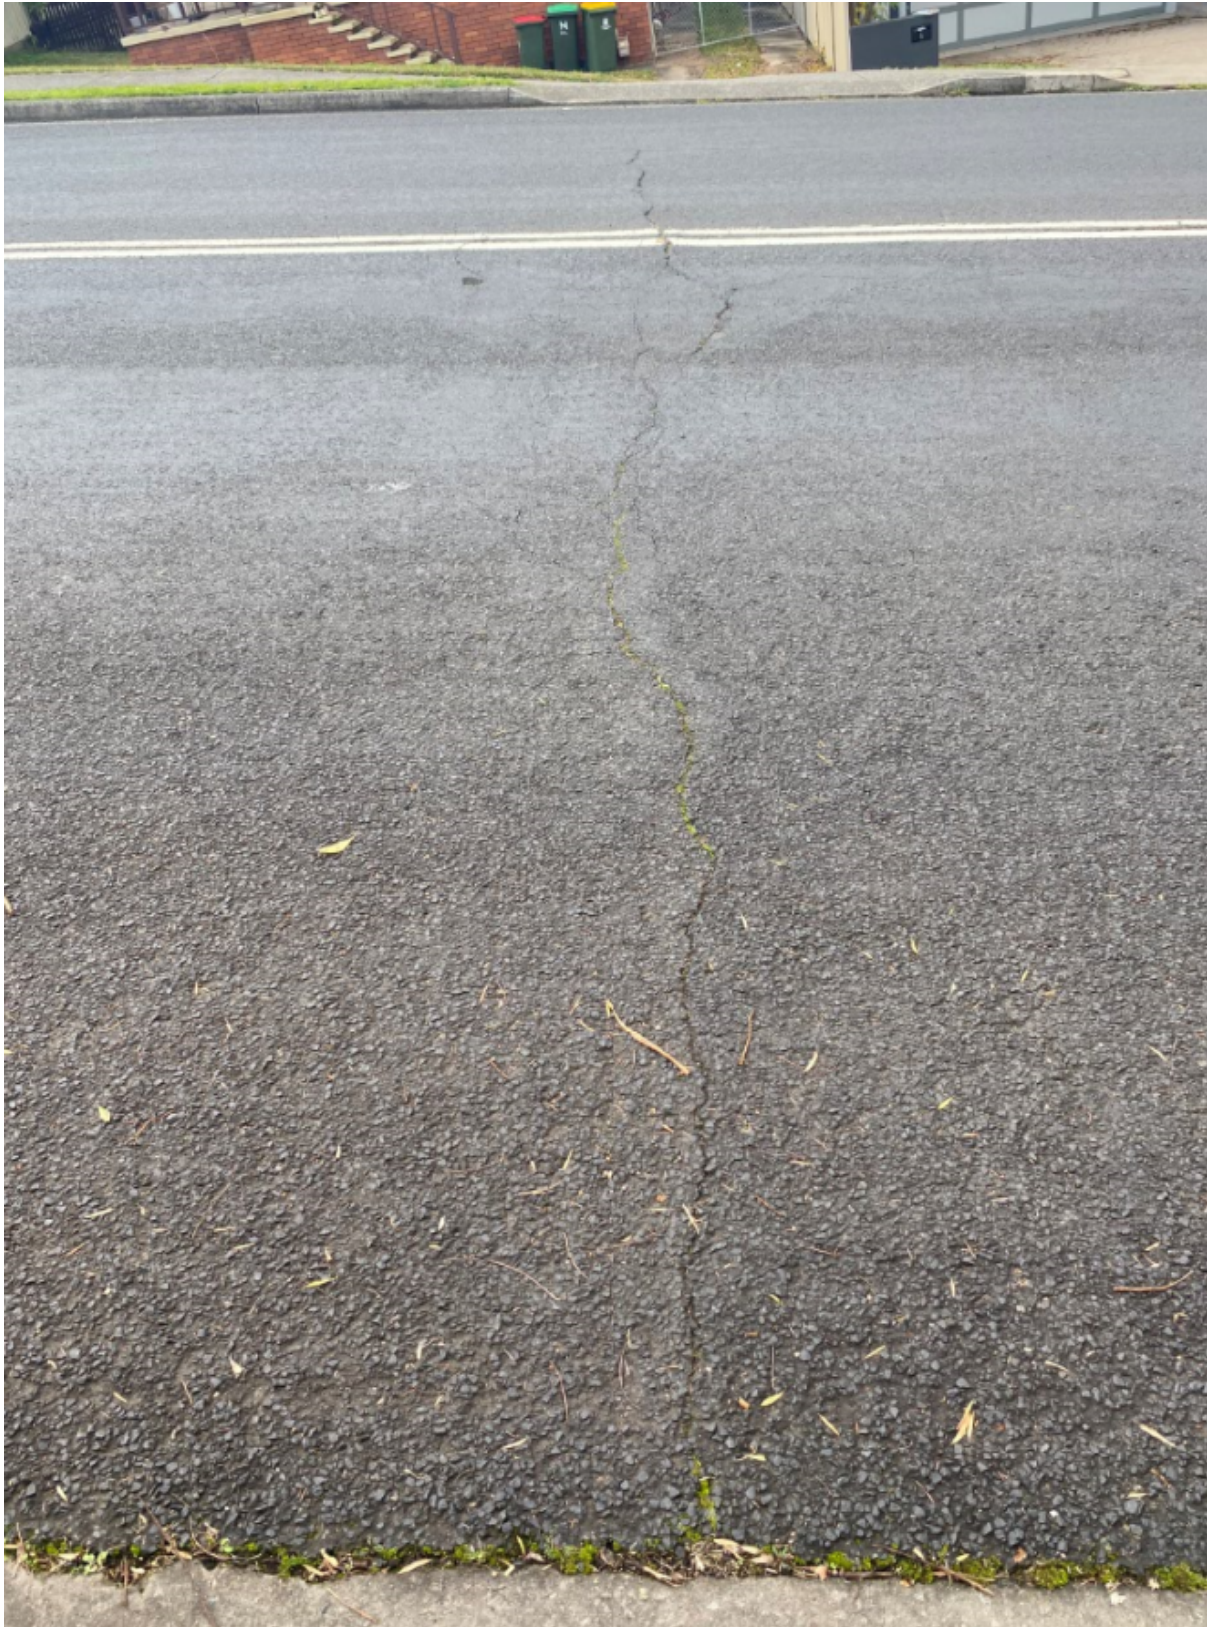
Photo 6: Pavement cracking of Dent St, between Hill and Chinchon Streets.

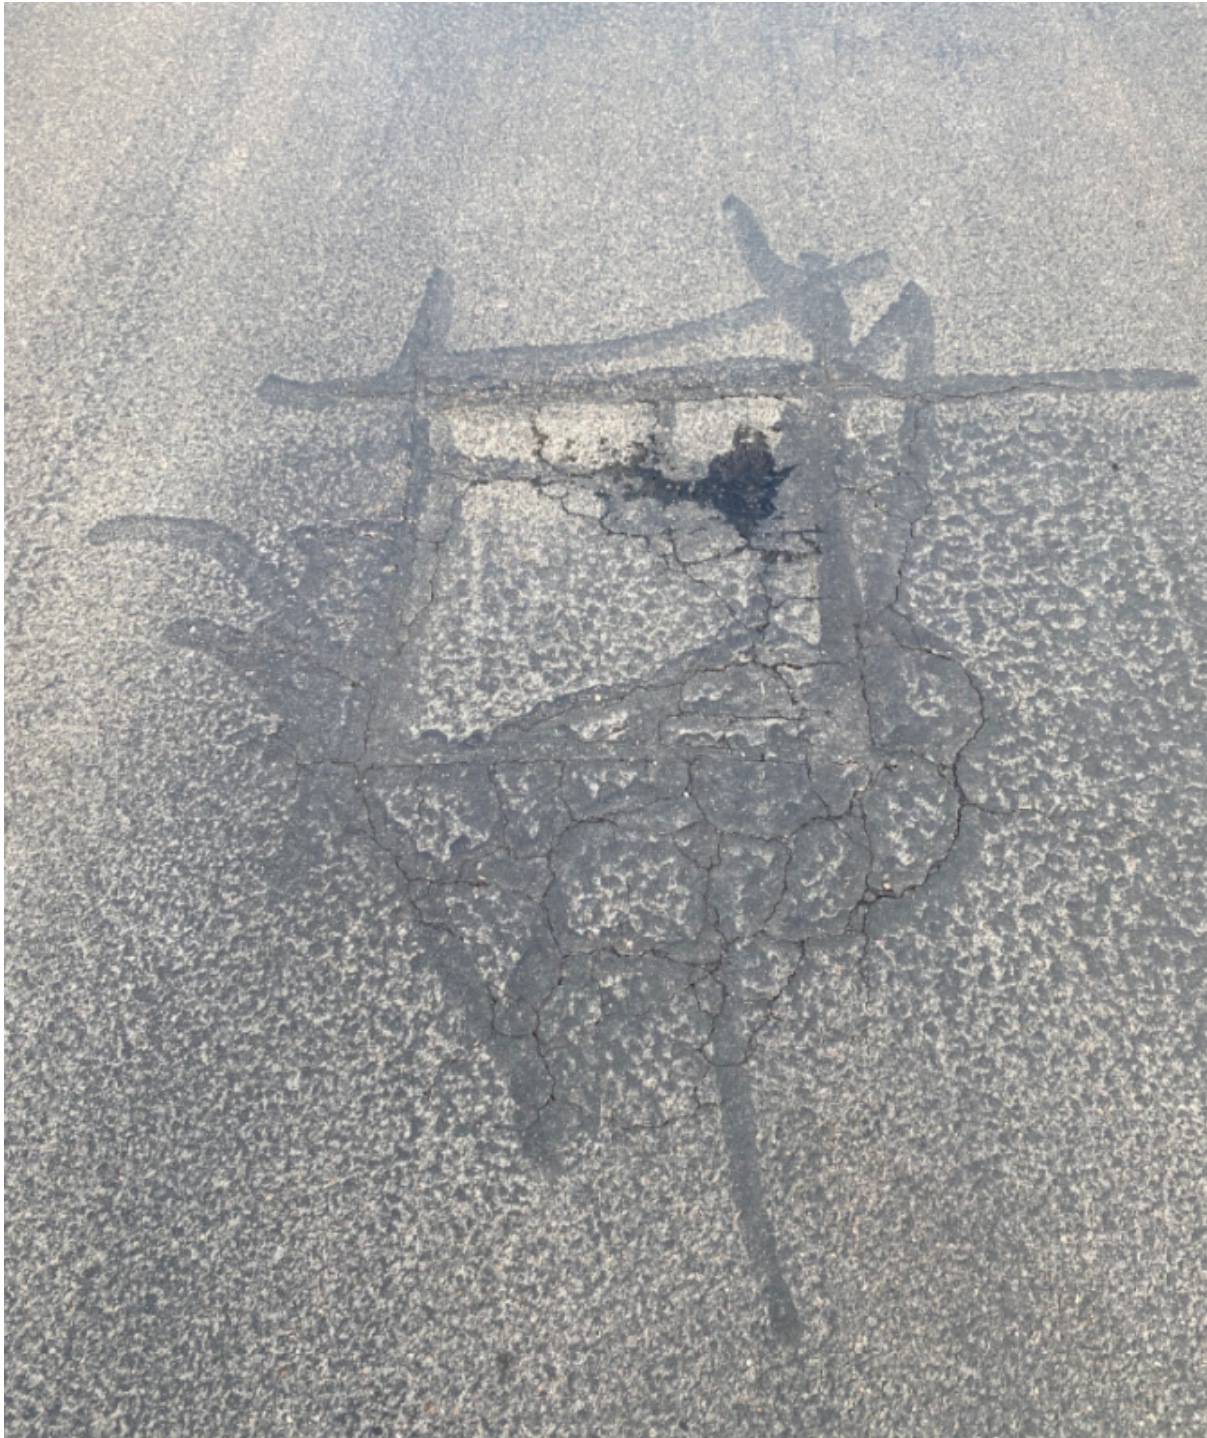
Photo 13: Existing pavement patching of George St south bound lane
