Tarago Action Plan Routine Inspection Checklist

Title:	Tarago Rail Yard Inspection	Approved: SM	Project-Nr.: 318001704	Date: November 2023
Site:	Tarago, NSW			
Client:	UGL Regional Linx

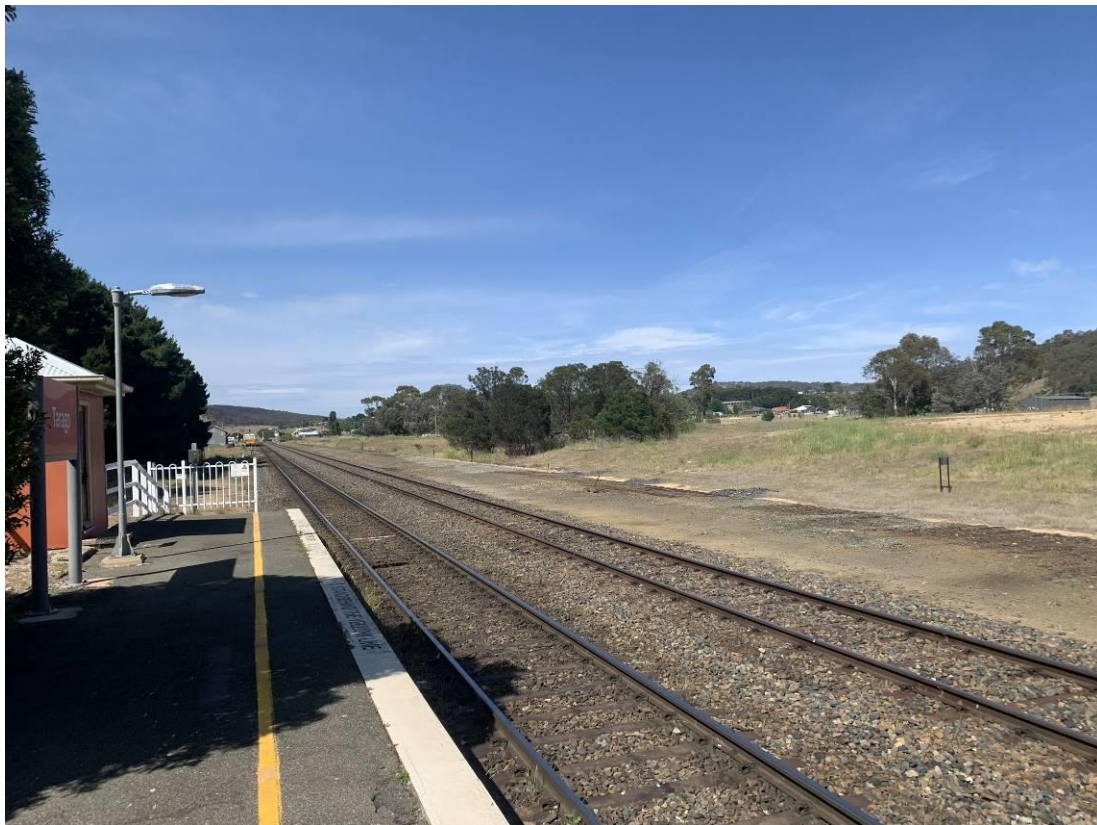
Photo 1: Picture at southern end of Tarago railway station platform facing south. No airborne dust visible.

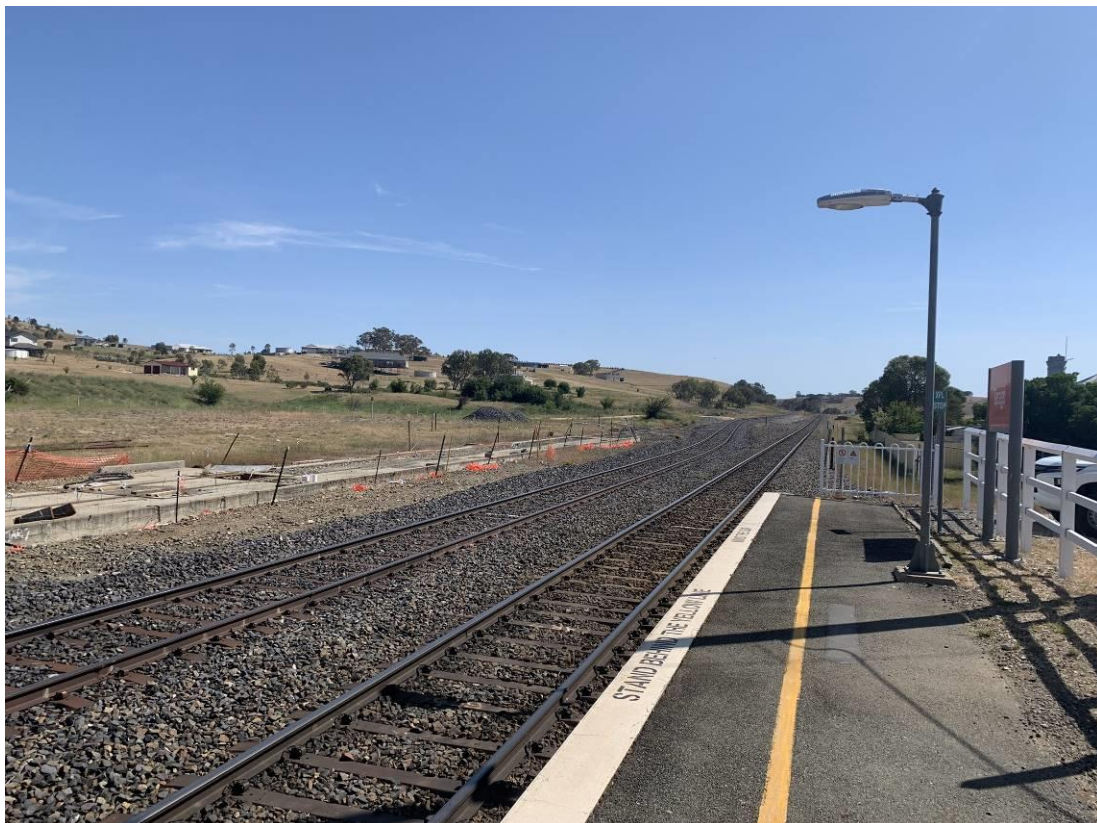
Photo 2: Picture at northern end of Tarago railway station facing north. No airborne dust visible.

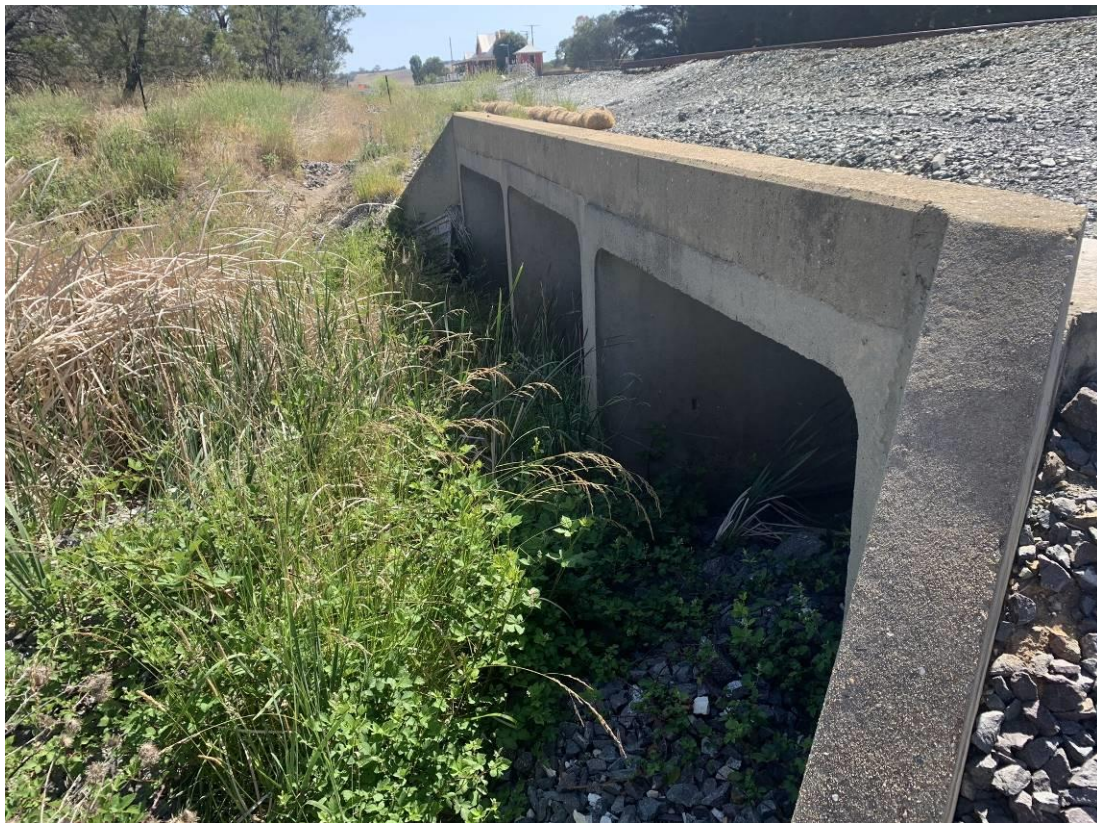
Photo 3: Southern culvert upgradient of the railway line with no flowing surface water. No observed build-up of sediment on rocks. Rock armor and natural vegetation providing sediment control for surface water.

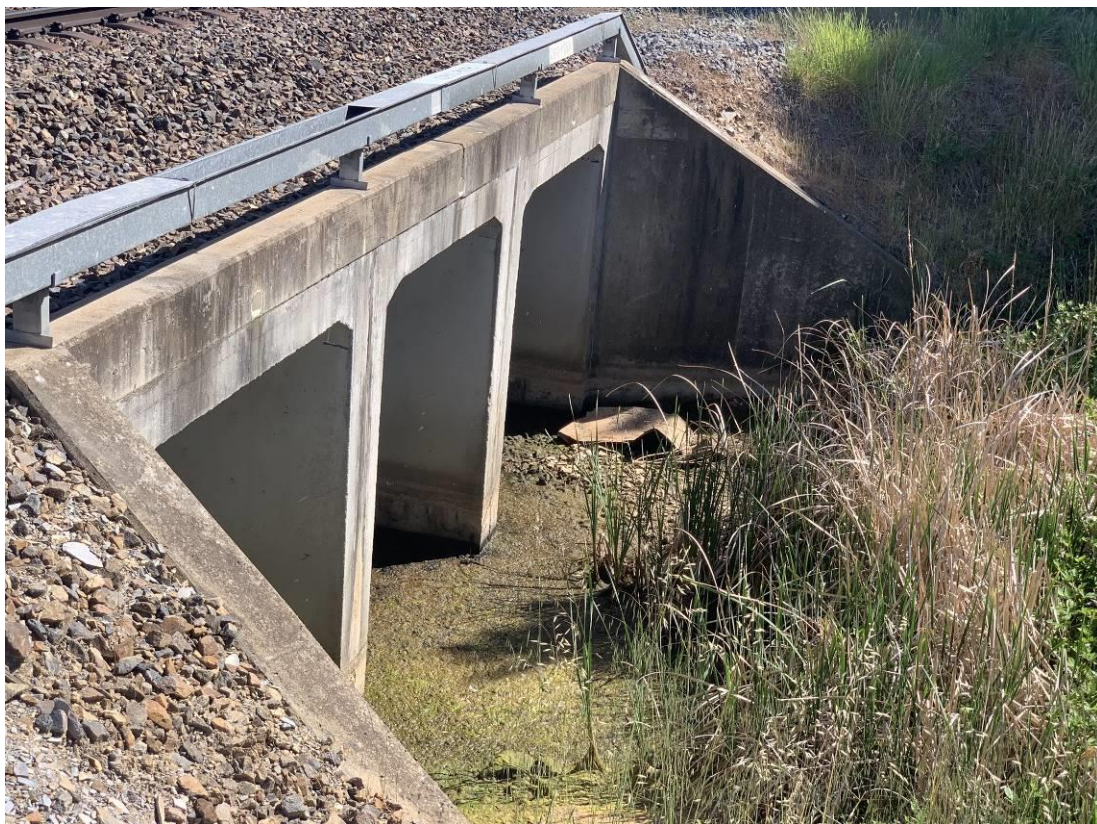
Photo 4: Southern culvert downgradient of the railway line with no flowing surface water. Damp soil with a small pool of water is present with low turbidity. No evidence of surface water travelling off-site at the southern culvert.

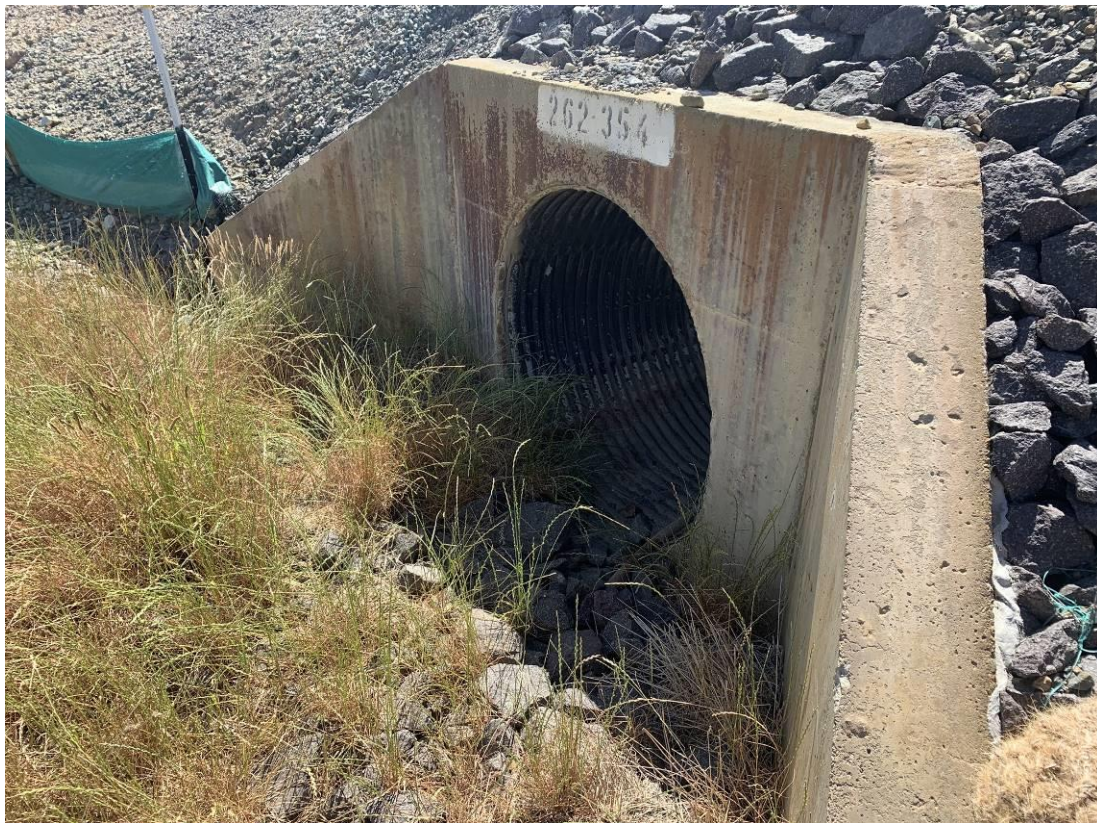
Photo 5: Middle culvert upgradient of the railway line with no flowing or pooled surface water. No observed build-up of sediment on rocks or in culvert. Rock armor and natural vegetation providing sediment control for surface water.

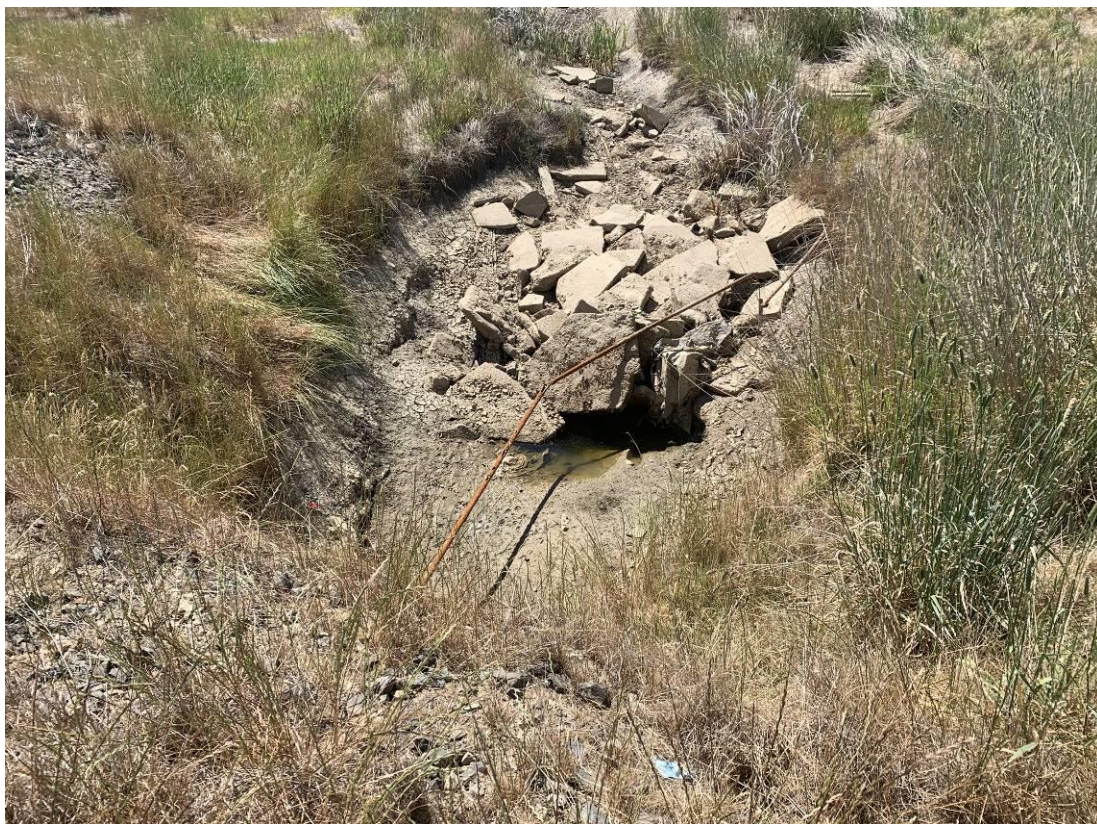
Photo 6: Middle culvert downgradient of the railway line with no flowing surface water. Soil dampness and a small pool of water is present. Water appeared to have low turbidity. No evidence of surface water currently running off site at middle culvert.

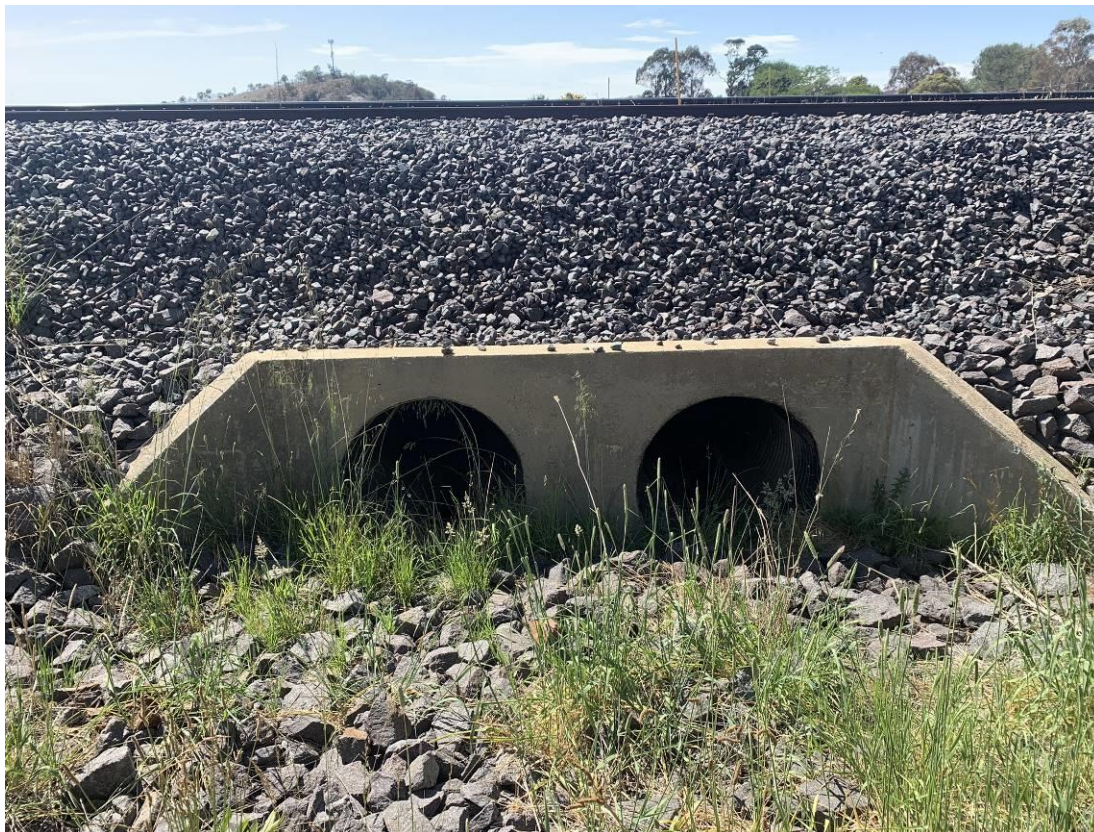
Photo 7: Northern culvert upgradient of the railway line with no flowing or pooled surface water. No observed build-up of sediment on rocks or in culvert. Rock armor and vegetation providing sediment control for surface water.

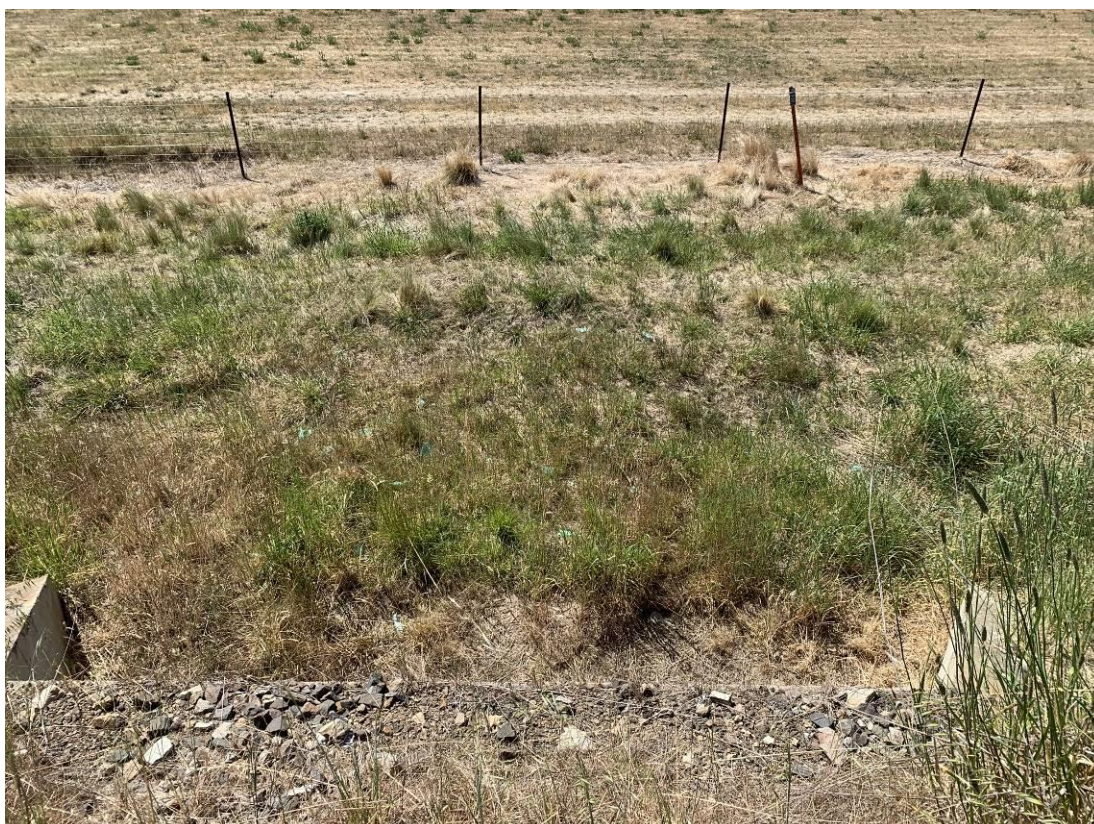
Photo 8: Northern culvert downgradient of the railway line with no flowing or pooled surface water. No evidence of surface water currently running off site.

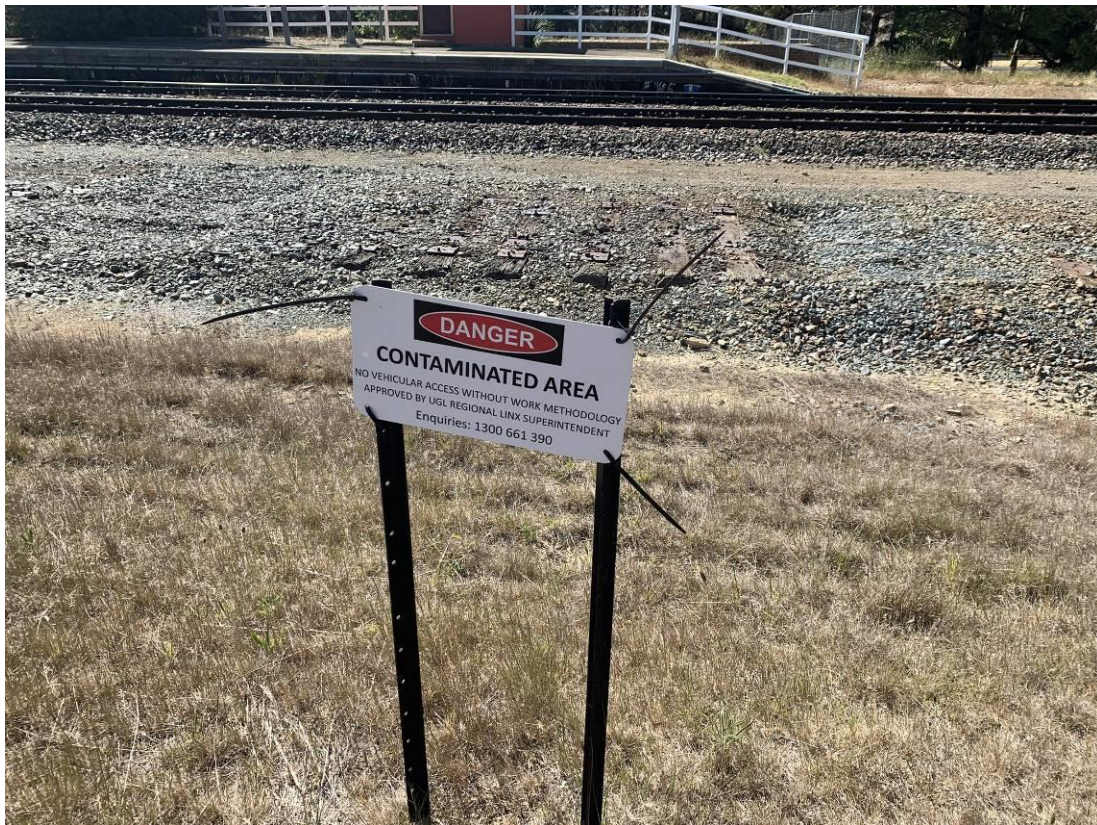
Photo 9: Exclusion zone signing placed periodically along contamination areas. Undamaged and in good condition. Facing south-east.

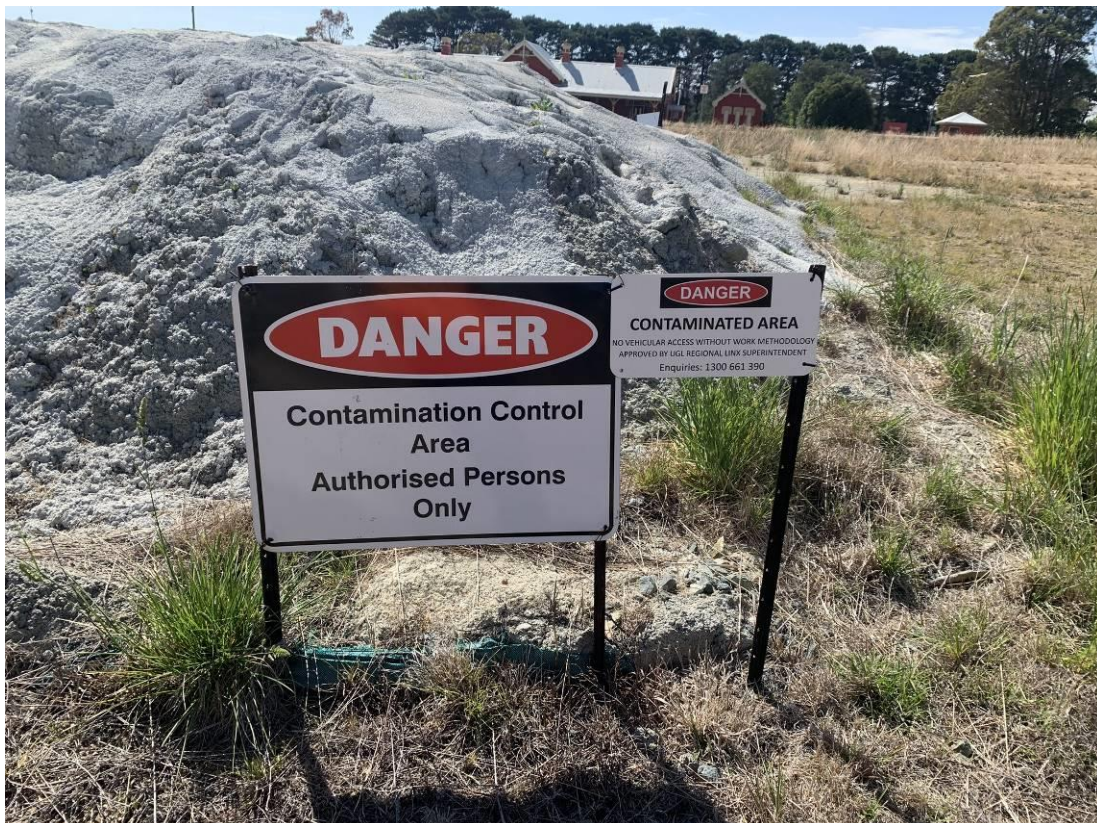
Photo 10: Exclusion zone signing placed periodically along contamination areas. Undamaged and in good condition. Facing east.

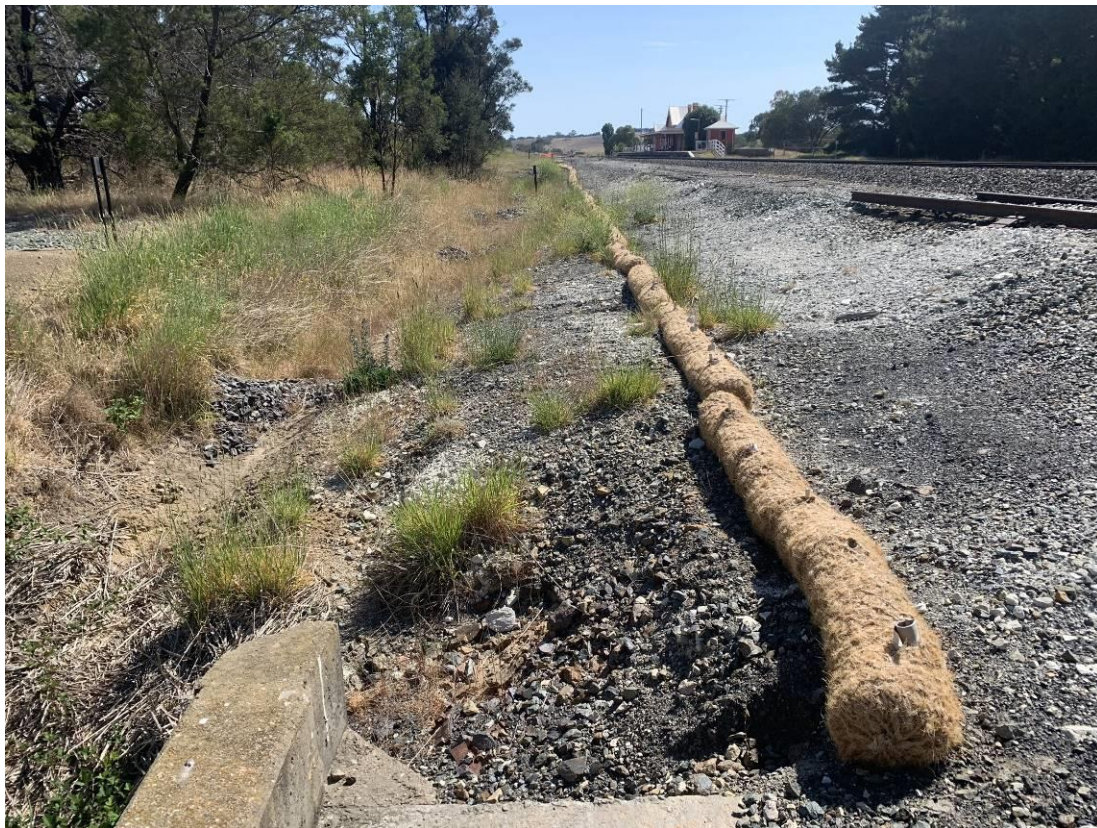
Photo 11: Upgradient of southern culvert showing Coir sediment control logs, used as control measures for sediment control. Facing north-east.

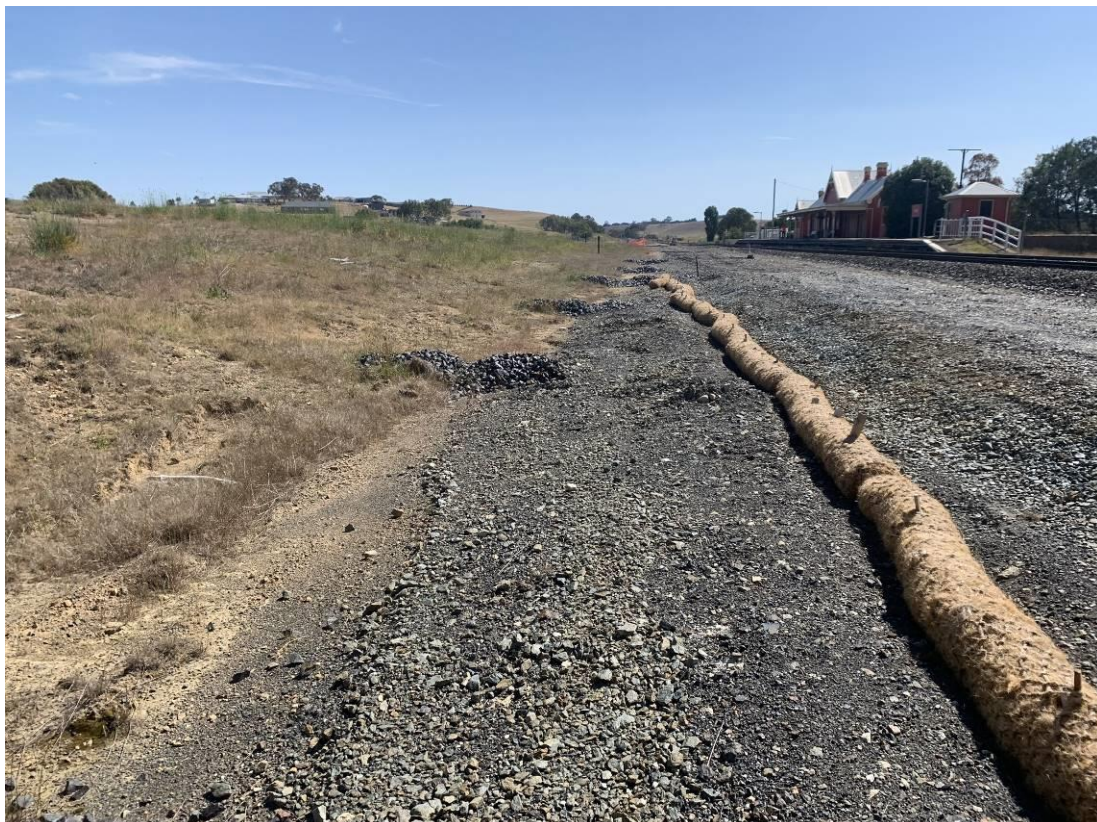
Photo 12: Rock checks running along former Woodlawn siding and between southern and middle culverts. Previously silt fencing, since replaced by Coir sediment control logs.

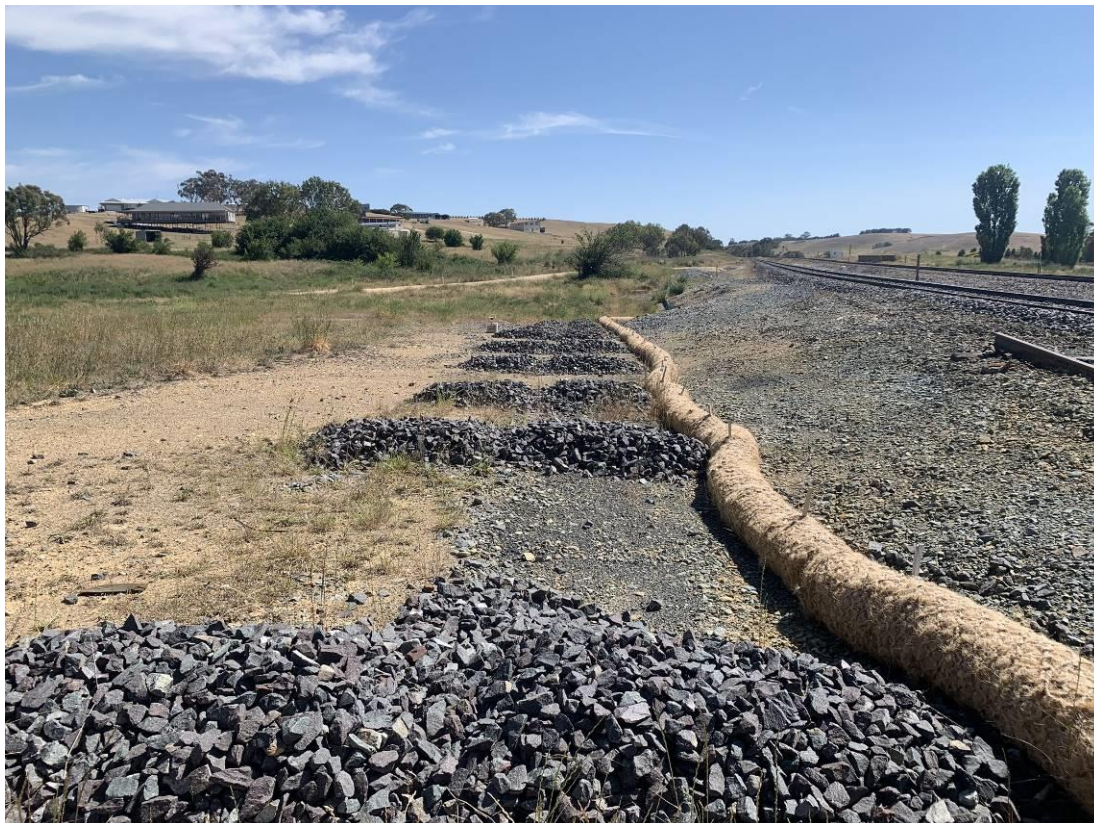
Photo 13: Rock checks running alongside former Woodlawn siding towards the middle culvert. No evidence of sediment build-up in rock armour or coir sediment control logs.

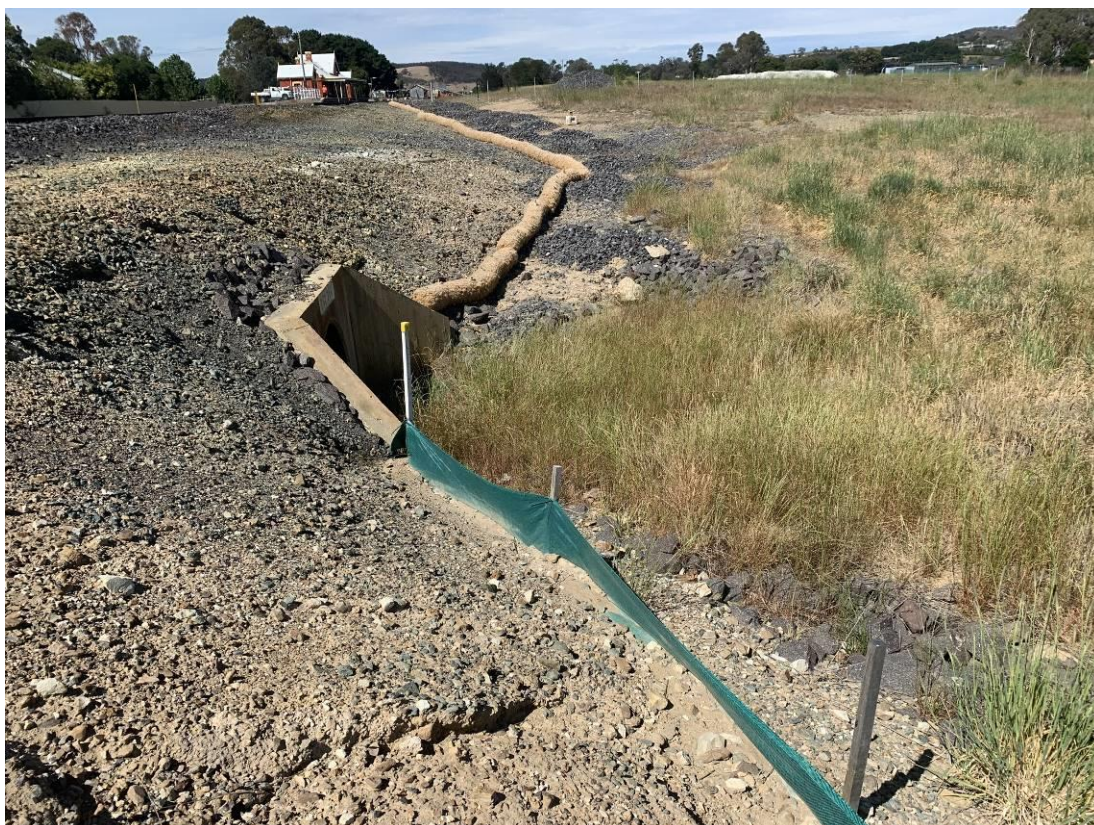
Photo 14: Upgradient of middle culvert facing east. Silt fencing is clear with some sediment visible.

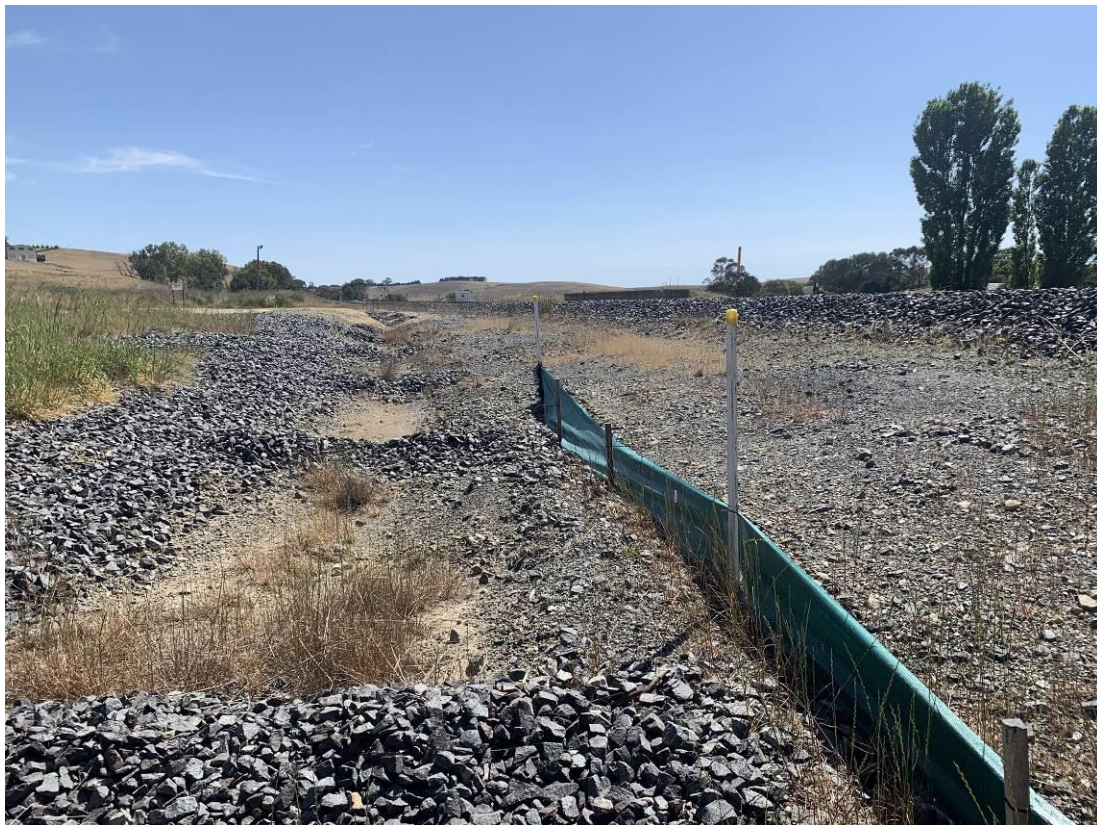
Photo 15: Rock armour west of the rail formation running from the middle to the north culvert. Some sediment visible on rock armour. Facing north-east.

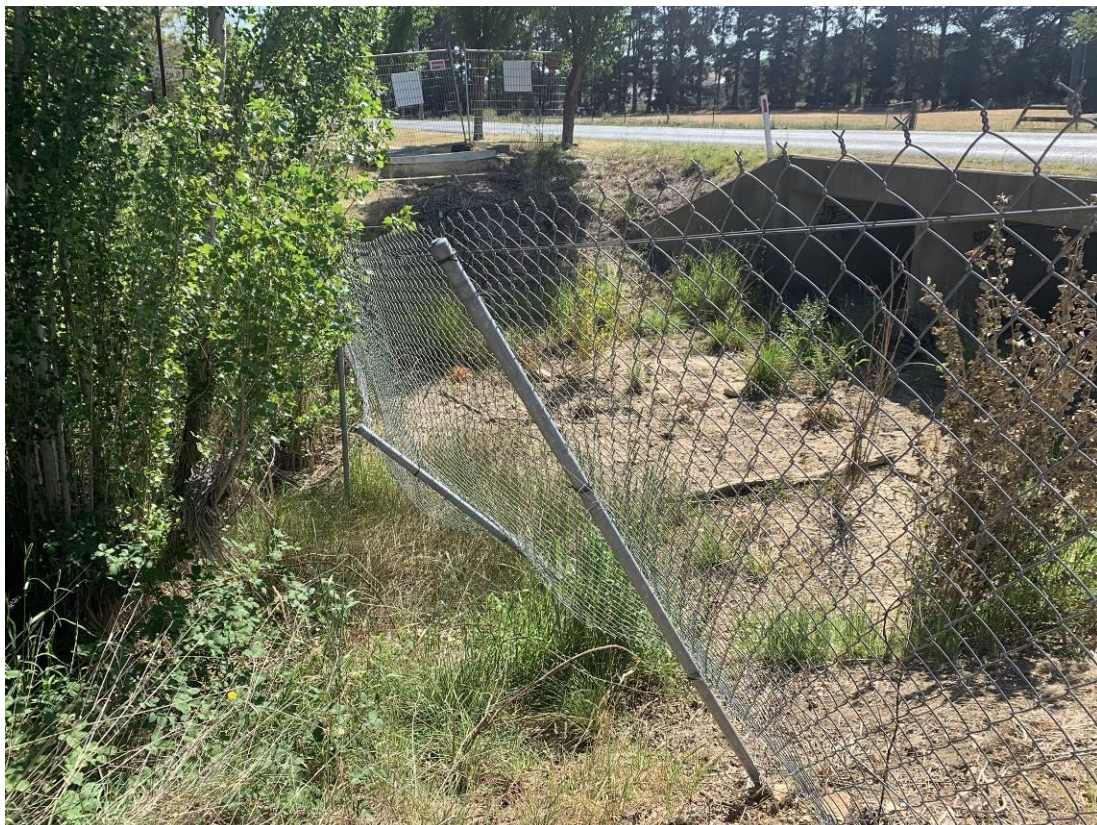
Photo 16: Southern culvert downgradient of railway line at the site boundary. No surface water discharging off-site.

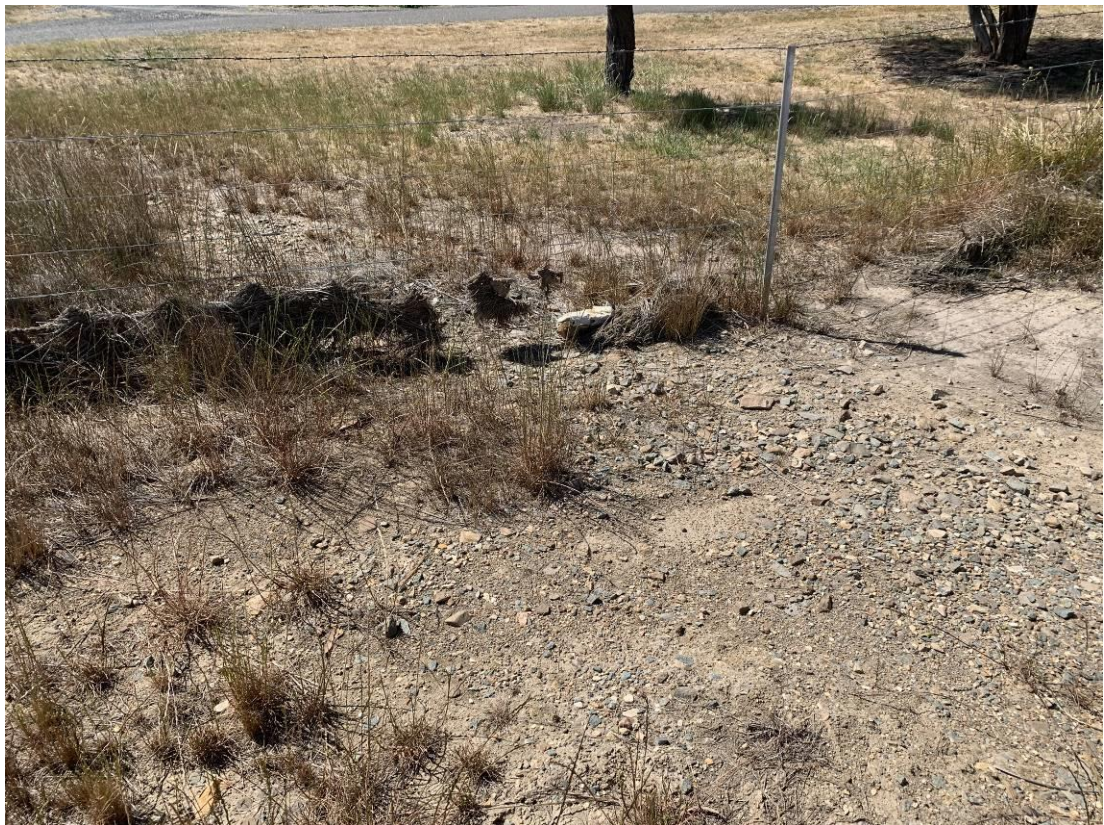
Photo 17: Downgradient of middle culvert. No surface water currently running off site at middle culvert.

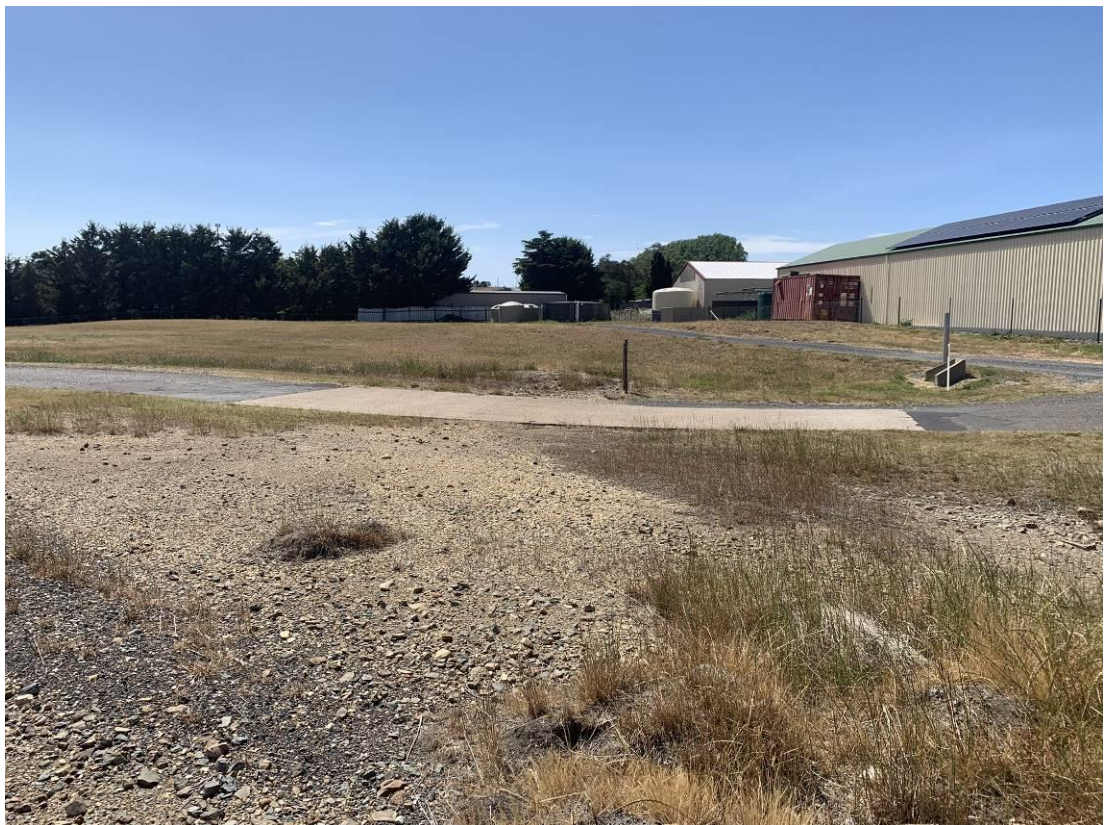
Photo 18: Causeway downgradient of middle culvert showing no evidence of current surface water moving off site.

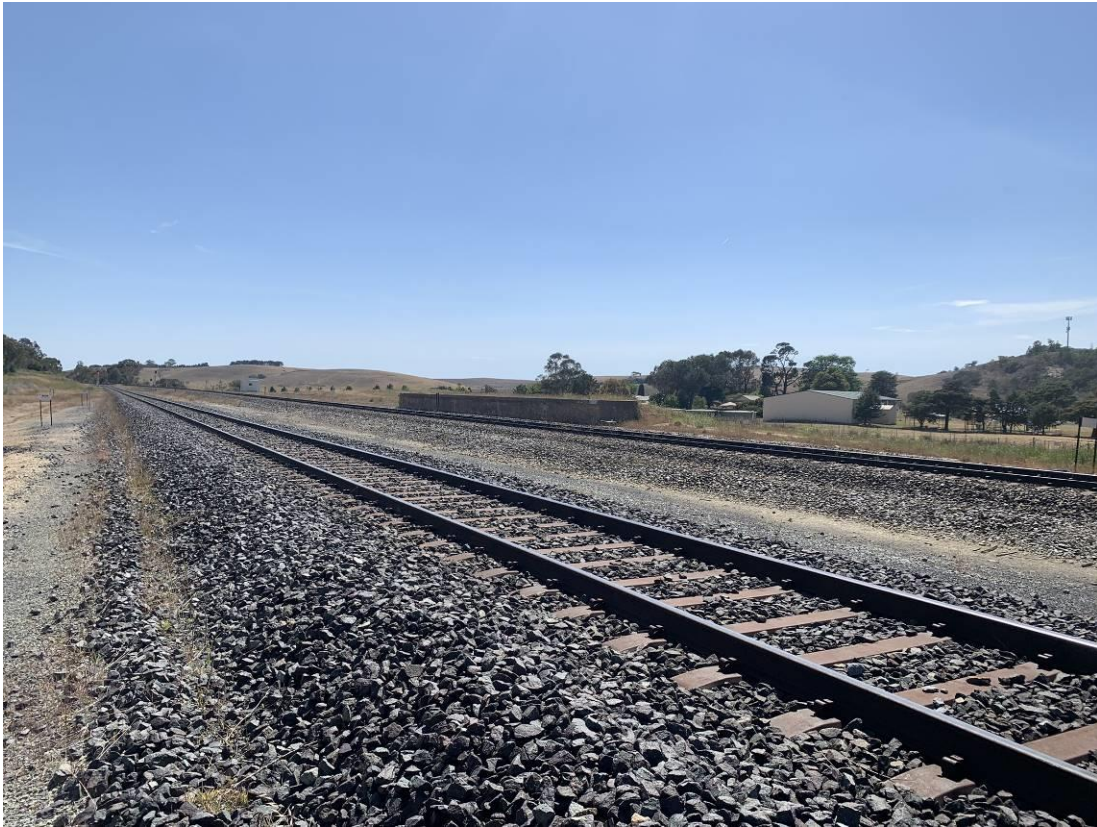
Photo 19: No pooled water adjacent to railway tracks. Facing north-east.

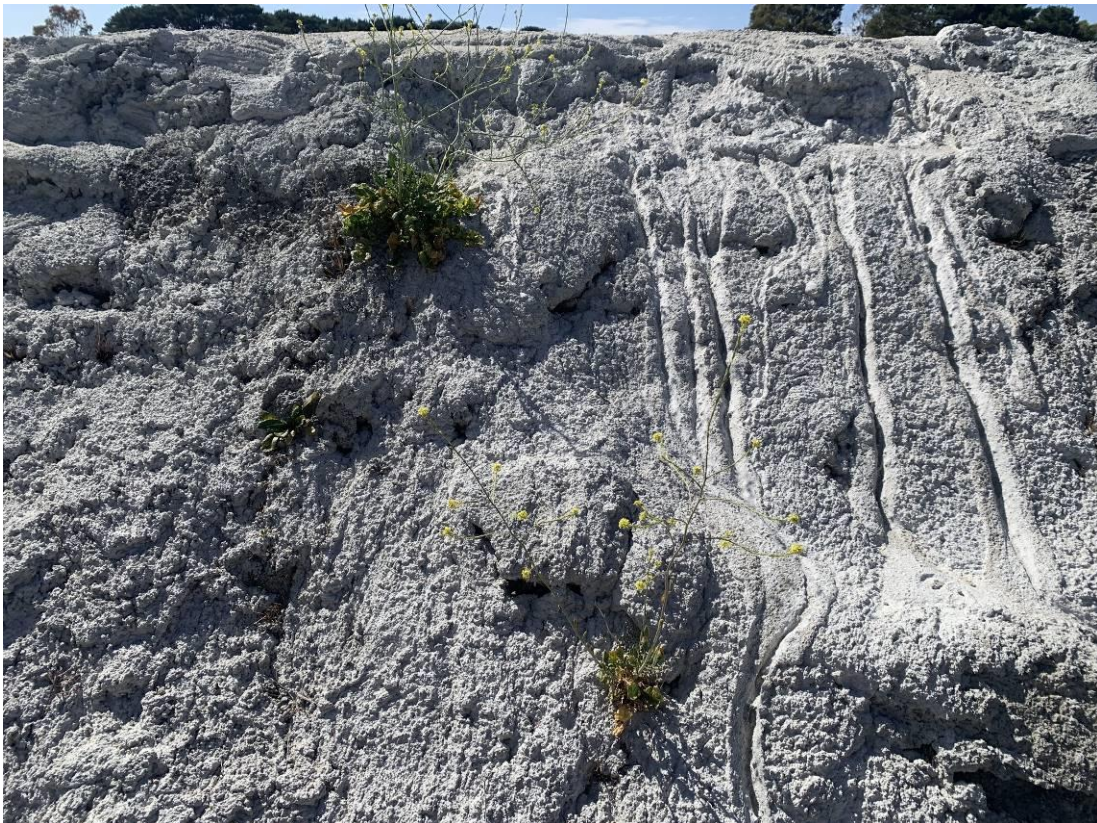
Is the existing stockpile covered securely to prevent surface water infiltration?	Yes		
	Are cracks present in the capping of the existing stockpile? If so record the width and length of cracks in written form and through photographs and consolidate with this checklist.	Yes, minor hairline cracking is present on the stockpile (observed during an inspection 15/03/23), these remain stable and are not expected to adversely affect cap competency in current condition.		
	Are there signs of erosion or sediment run-off on or relating to the existing stockpile? If so record in written form and through photographs and consolidate with this checklist.	No. No erosion of, or sediment from the stockpile was observed.		
	Are there signs of vegetation on the existing stockpile? If so record in written form and through photographs and consolidate with this checklist.	Yes, several small-medium sized weeds were identified growing out from the stockpile (Photo 20). Refer to 'Other Observations' section point 1 for additional comments.

Photo 20: Plant growth on the stockpile is present. Located on north-eastern side of stockpile.

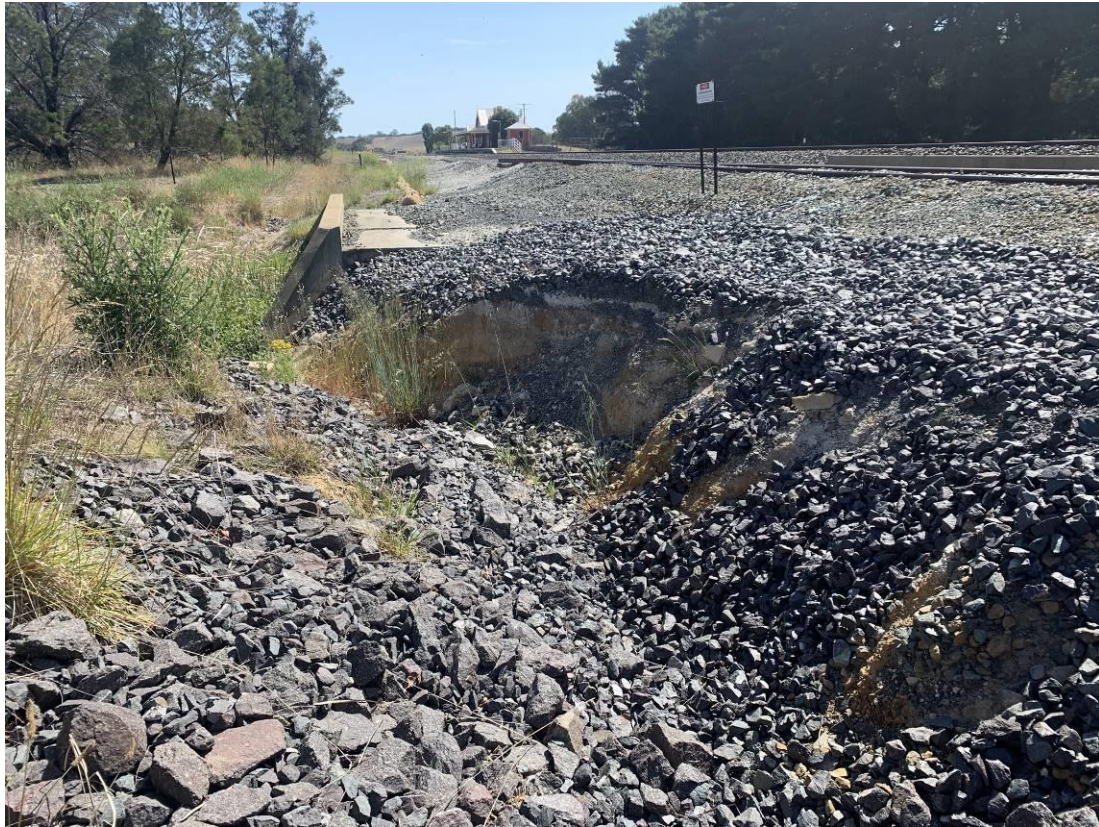
Photo 21: Visible evidence of erosion due to loss of ground cover (ballast material) upgradient of southernmost culvert. Remaining material is stable and no major further erosion is noted since last inspection (19/10/11). Facing north-east.

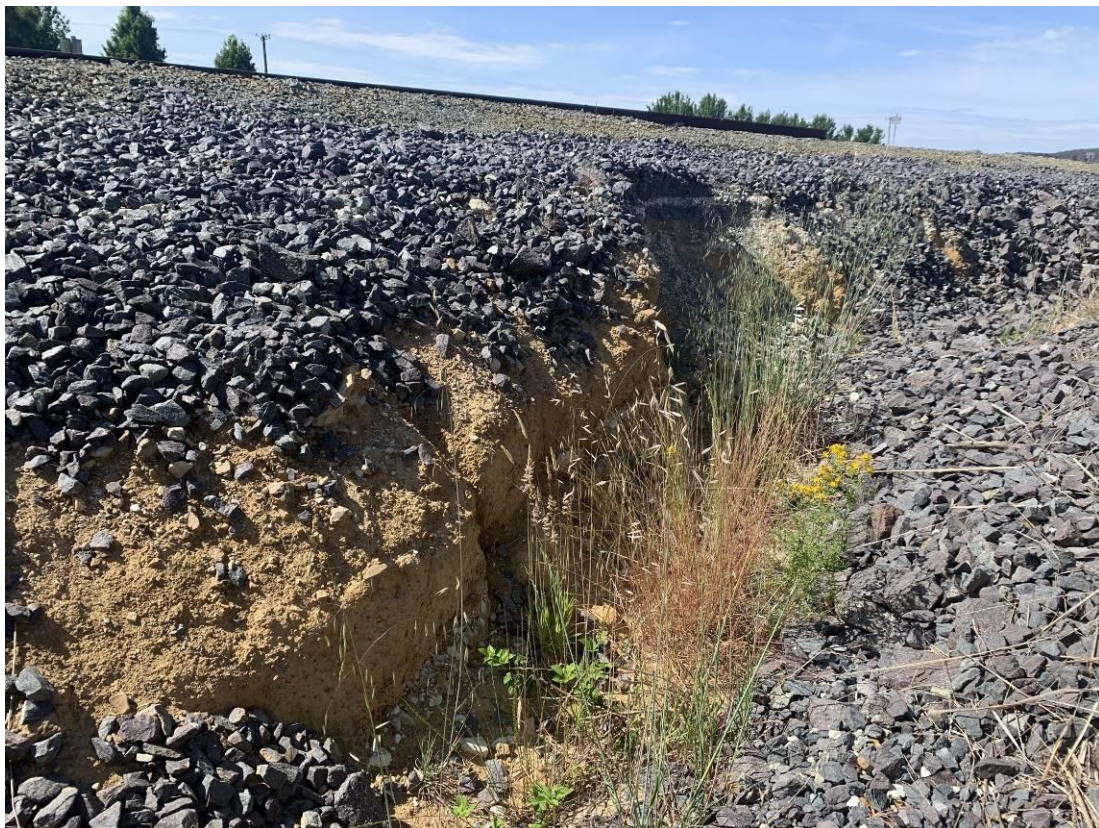
Photo 22: Additional photograph of erosion upgradient at southern culvert.

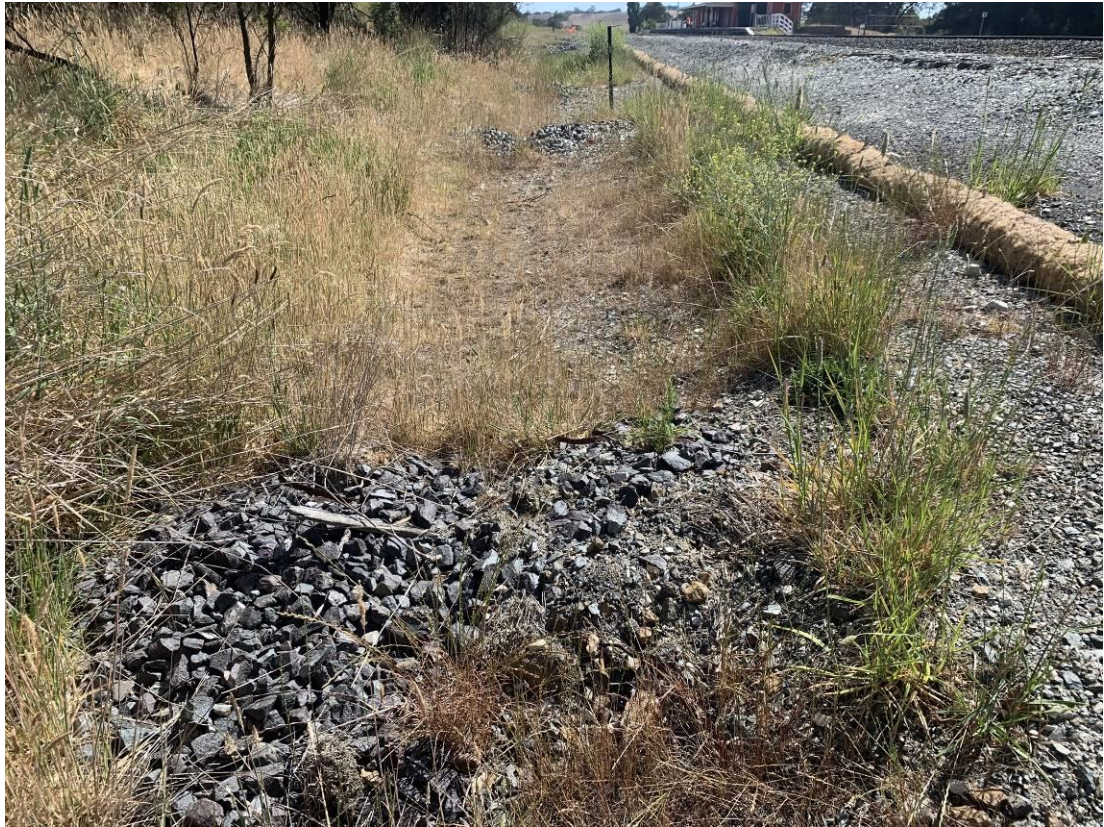
Photo 23: Southern culvert upgradient of railway tracks rock armour for sediment control.

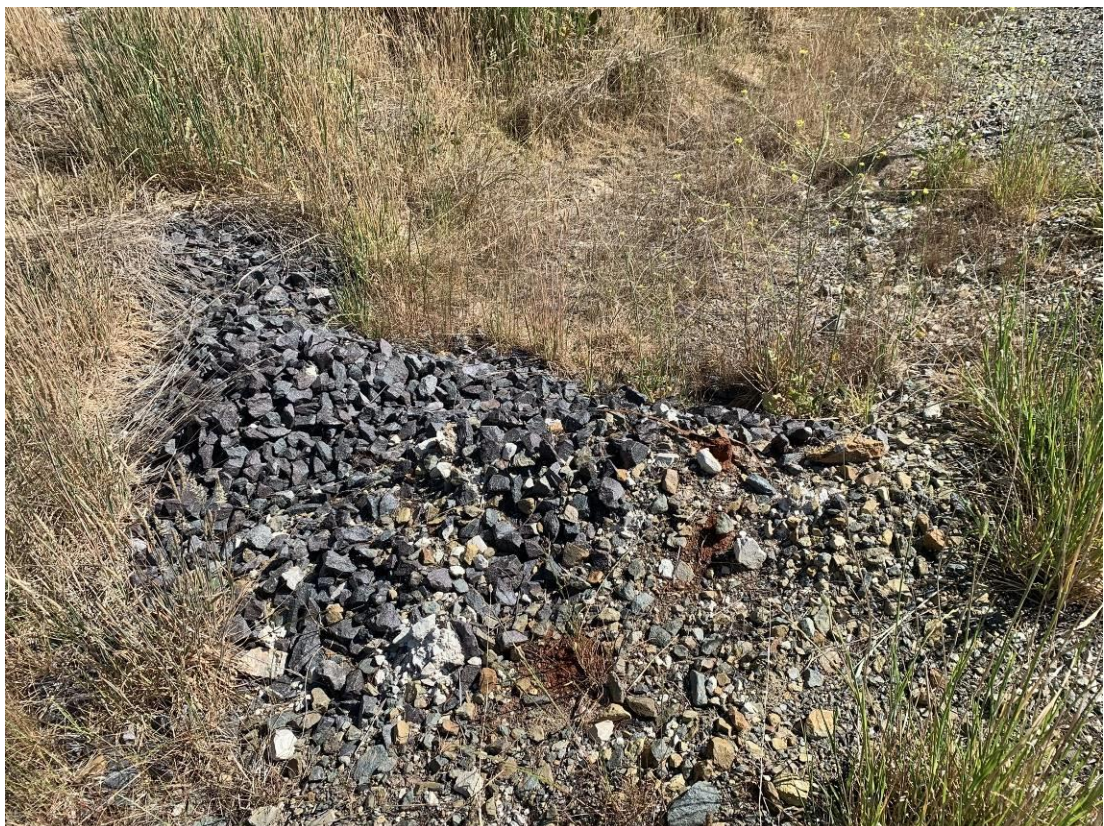
Photo 24: Additional photograph of southern rock armour with a build-up of debris.
