Tarago Action Plan Routine Inspection Checklist

Title:	Tarago Rail Yard Inspection	Approved: SM	Project-Nr.: 318001704	Date: November 2023
Site:	Tarago, NSW			
Client:	UGL Regional Linx

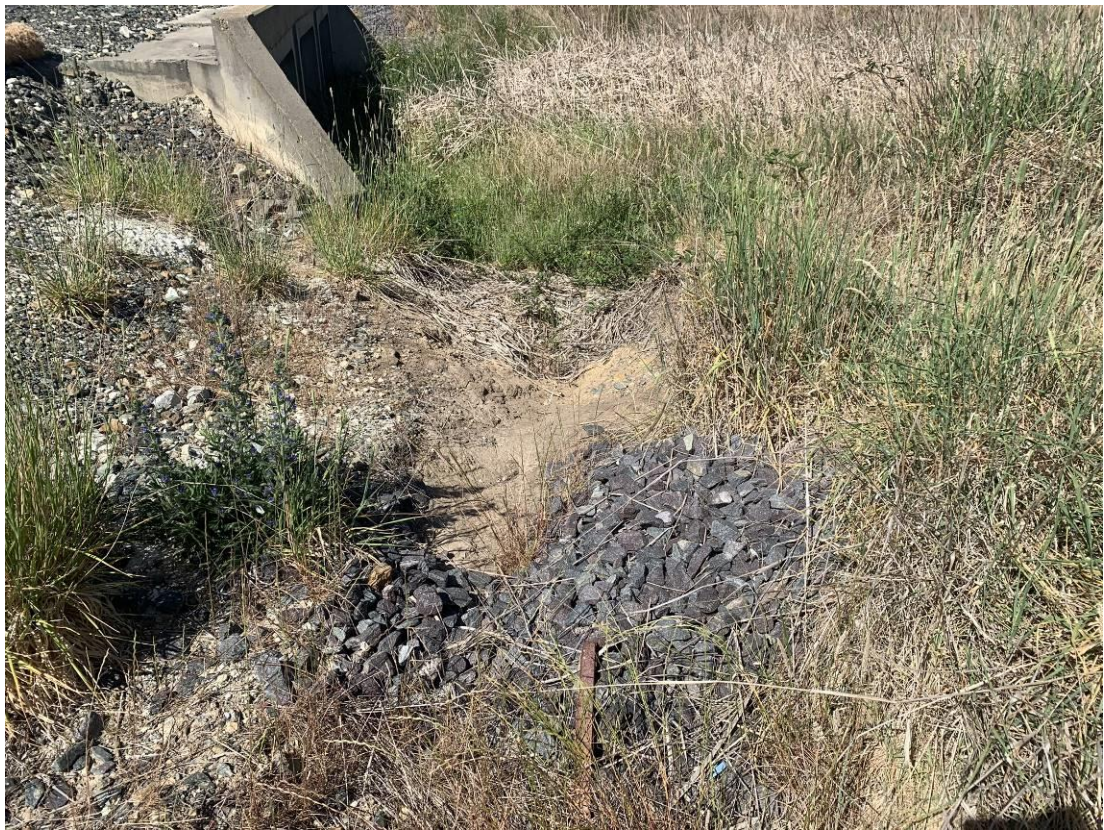
Photo 25: Additional photograph of southern rock armour. Pictured is the closest rock armour to the culvert opening appearing misshaped and with a build-up of sediment.
