Tarago Action Plan Routine Inspection Checklist

Date:	19-Oct-23	UGL RL Environmental Representative
Start time:	10:30 AM	completing inspection ¹ :
Finish time:	11:15 AM	[REDACTED]

Title: Tarago Rail Yard Inspection	Approved:	Project-Nr.: 318001704	Date: October 2023
Site: Tarago, NSW			
Client: UGL Regional Linx

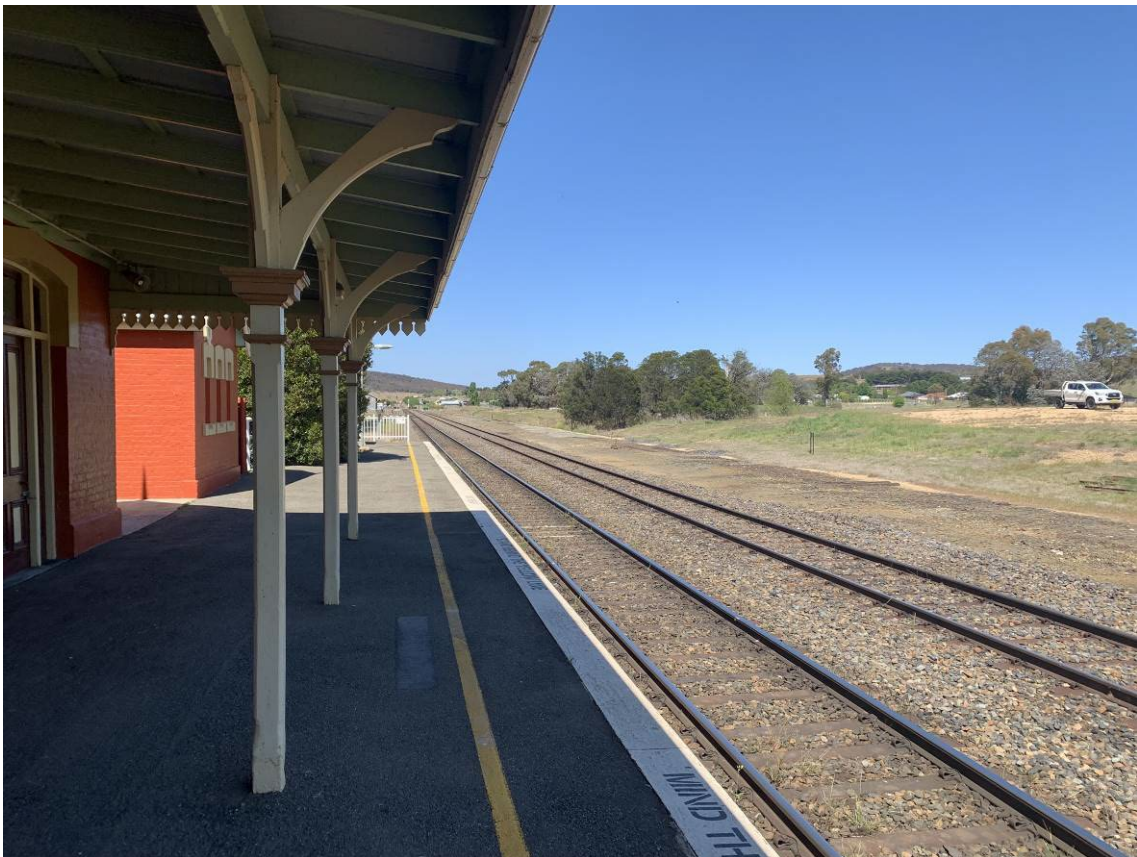
No airborne dust was visible (**Photos 1 - 2**)

Photo 1: Picture at halfway point at Tarago railway station platform facing south-west. No airborne dust visible.

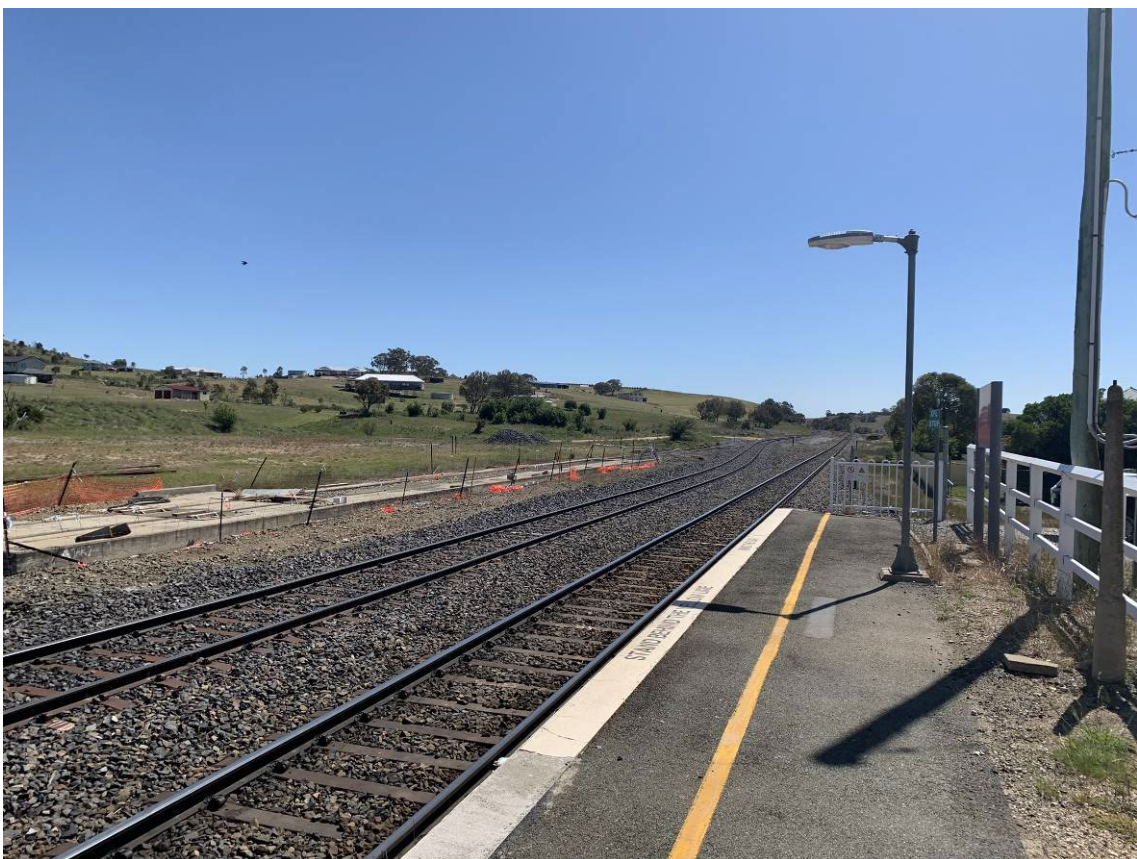
Photo 2: Picture at north-eastern end of Tarago railway station facing north-east. No airborne dust visible.

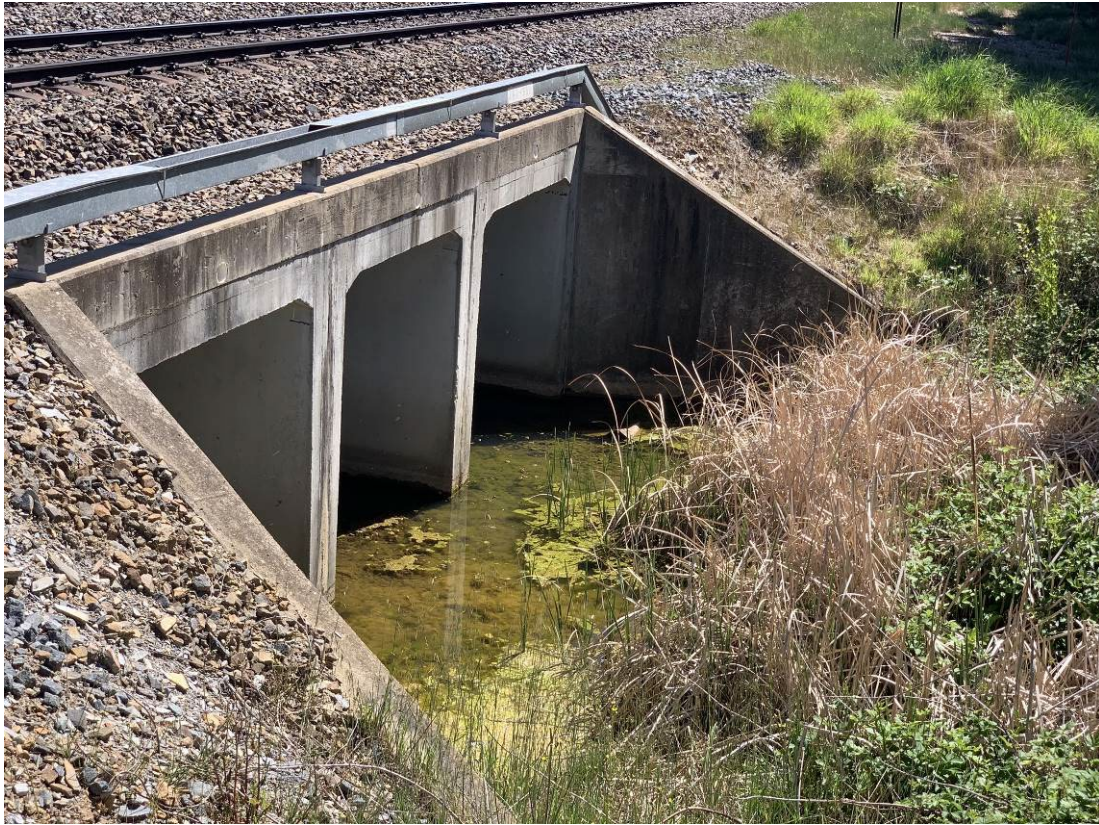
Yes. Surface water was discharging at a slow rate from the southern culvert through a thick layer of grass (**Photo 3**). A small pool of water was observed on site and immediately downstream of middle culvert but not discharging off site (**Photos 4 - 6**). There was no surface water discharging at the northern culvert (**Photos 7 - 8**).

Conditions on site appeared much drier than the previous site inspections (14/09/23). This was most notably apparent with less pooled water downgradient of the middle culvert (**Photo 4**) and less flowing water downgradient of the southern most culvert (**Photo 3**).

Photo 3: Southern most culvert downgradient of rail line, with slow moving surface water travelling off-site. Water is clear, low turbidity, minimal observable sediment, long grass and some algae present.

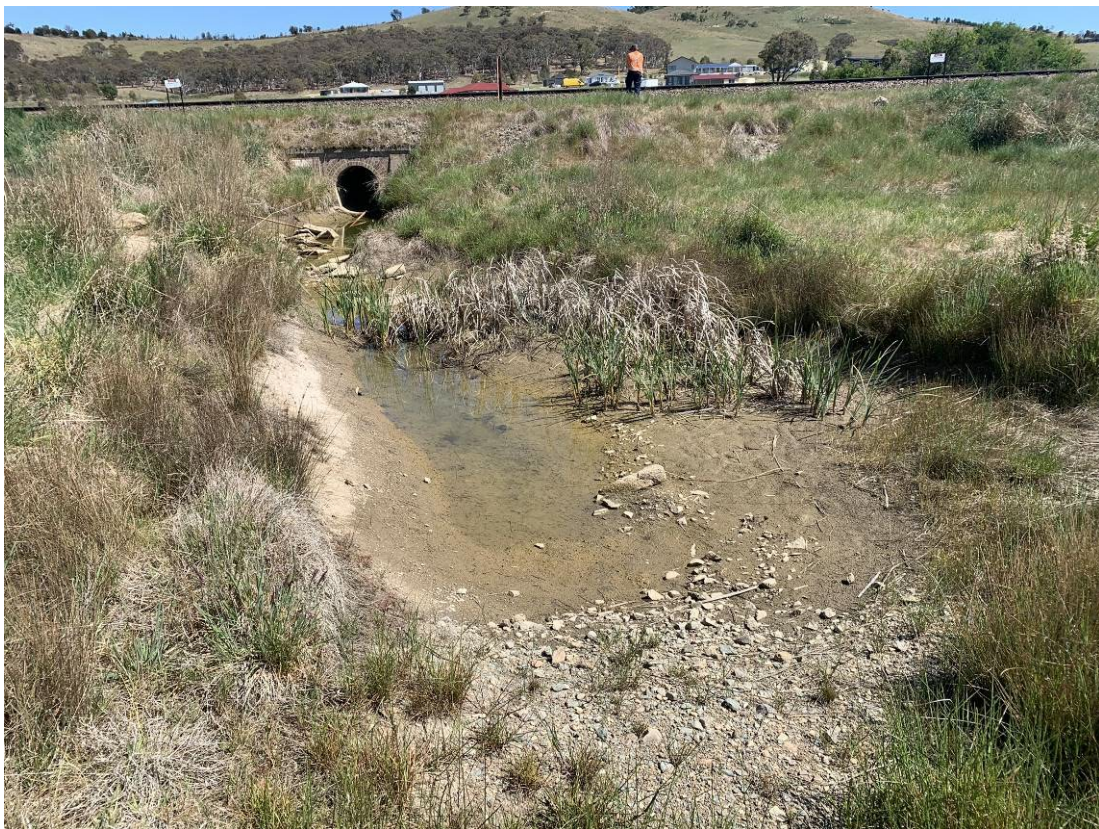
No. Minimal evidence of sediment was observed in pooled water on-site downgradient of the middle culvert (**Photo 4**), however there was no evidence of run-off of this water from site in between inspections (**Photos 5 - 6**). No evidence of sediment run-off past northern and southernmost rail culverts was visible (Photos 3, 7, 8, 13, 16).

Photo 4: Downgradient of middle culvert showing brown turbid water on site. Surface water levels notably less than in the previous inspection (14/09/23). No surface water currently running off site at middle culvert.

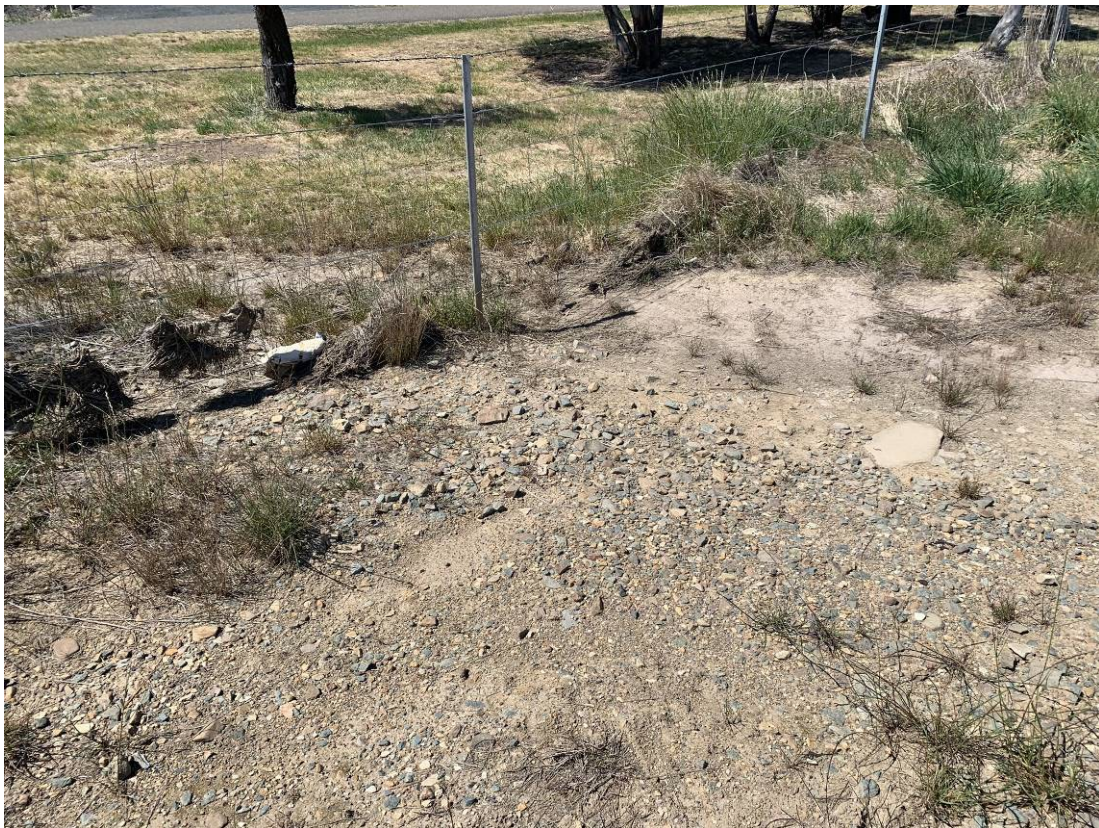
Photo 5: Downgradient of middle culvert. No water or damp soil found pooling adjacent to site boundary fencing compared to previous inspection (14/09/23). No surface water currently running off site at middle culvert.

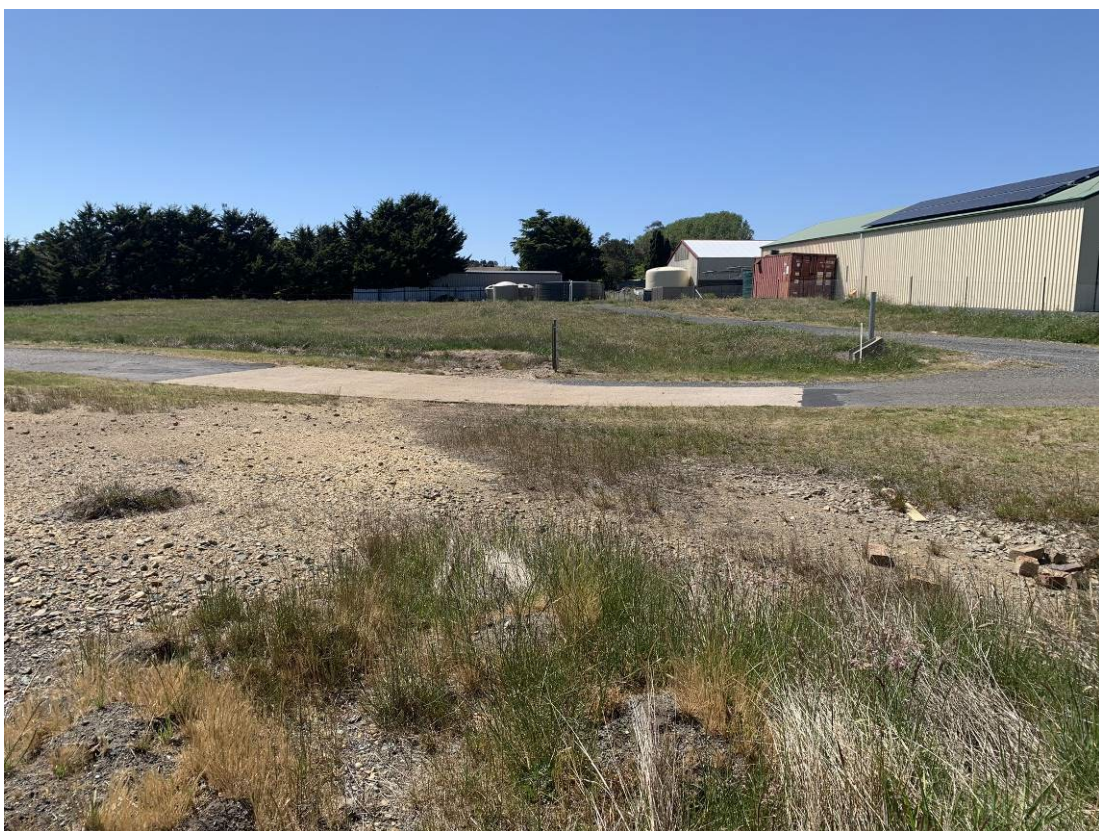
Photo 6: Causeway downgradient of middle culvert showing no evidence of current surface water moving off site. No visible sediment on road or vegetation nearby from sediment water was running off site in between inspections.

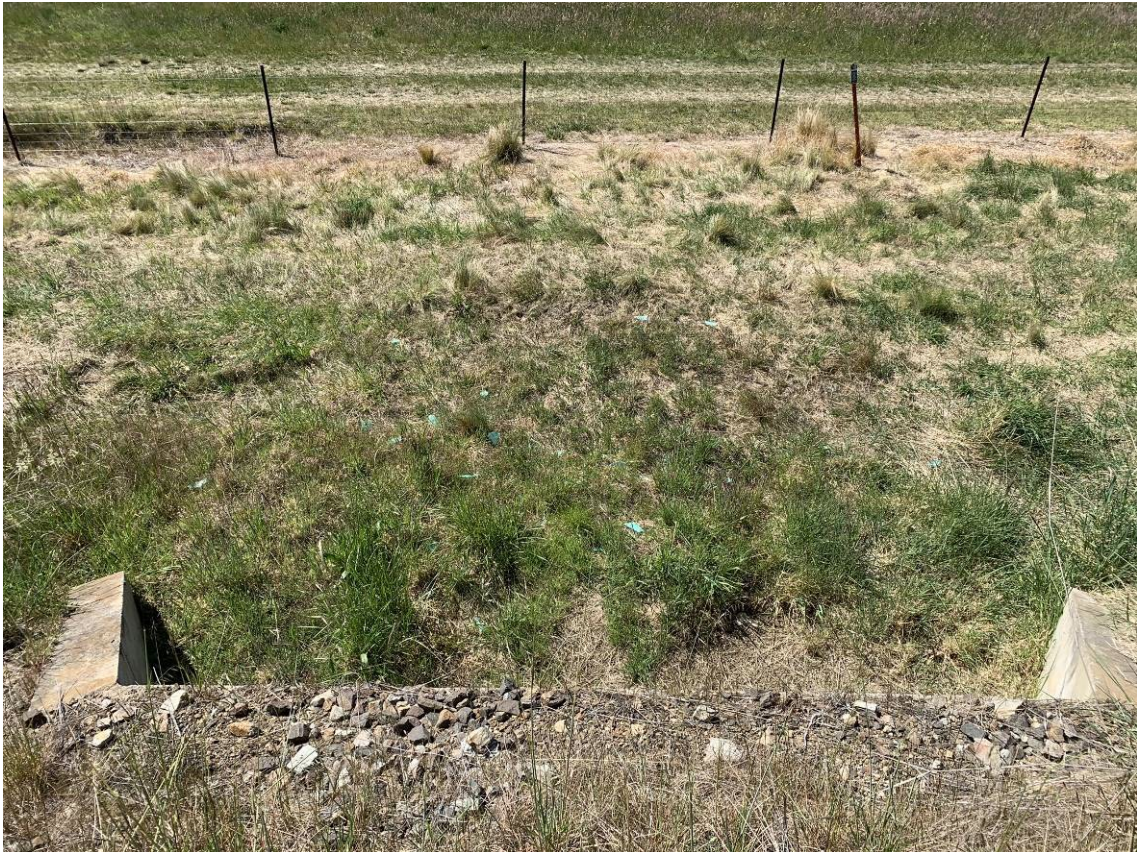
Photo 7: Downgradient of northernmost culvert showing evidence of no surface water runoff from site into neighbouring property.

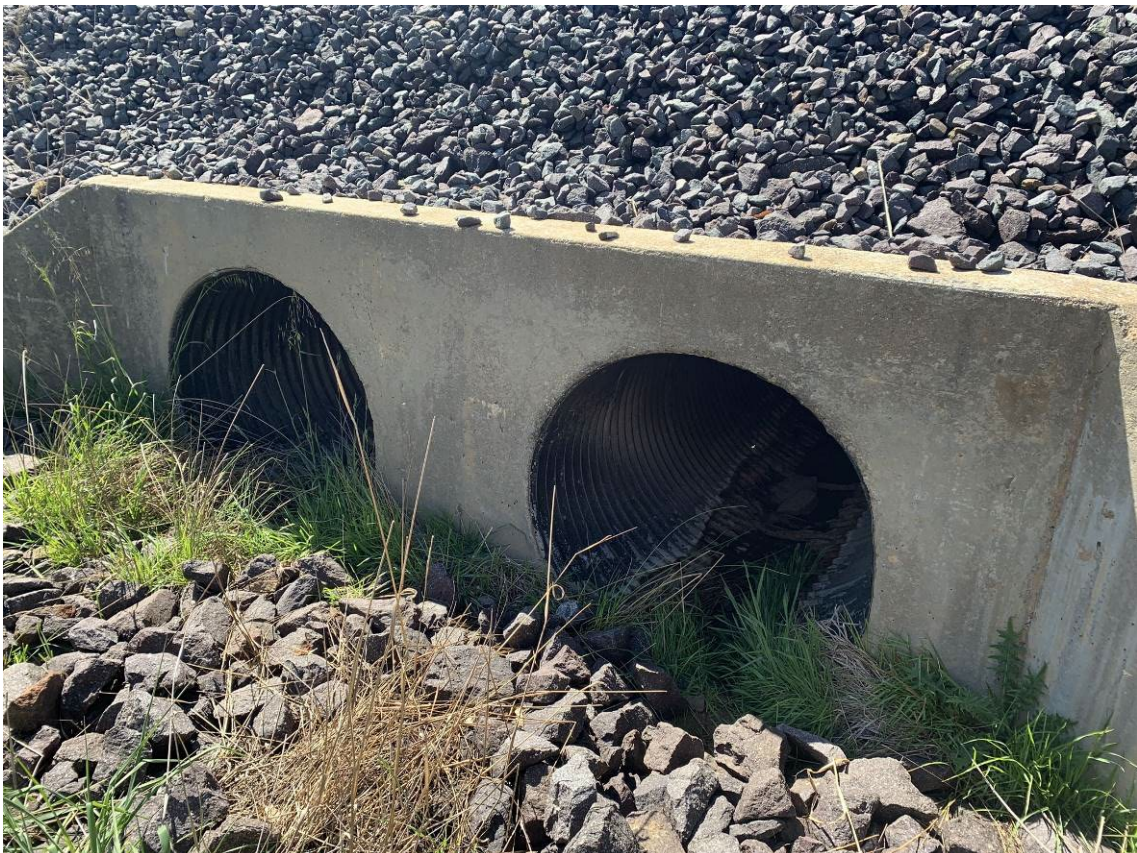
Photo 8: Upgradient of northernmost culvert showing evidence of no surface water present.

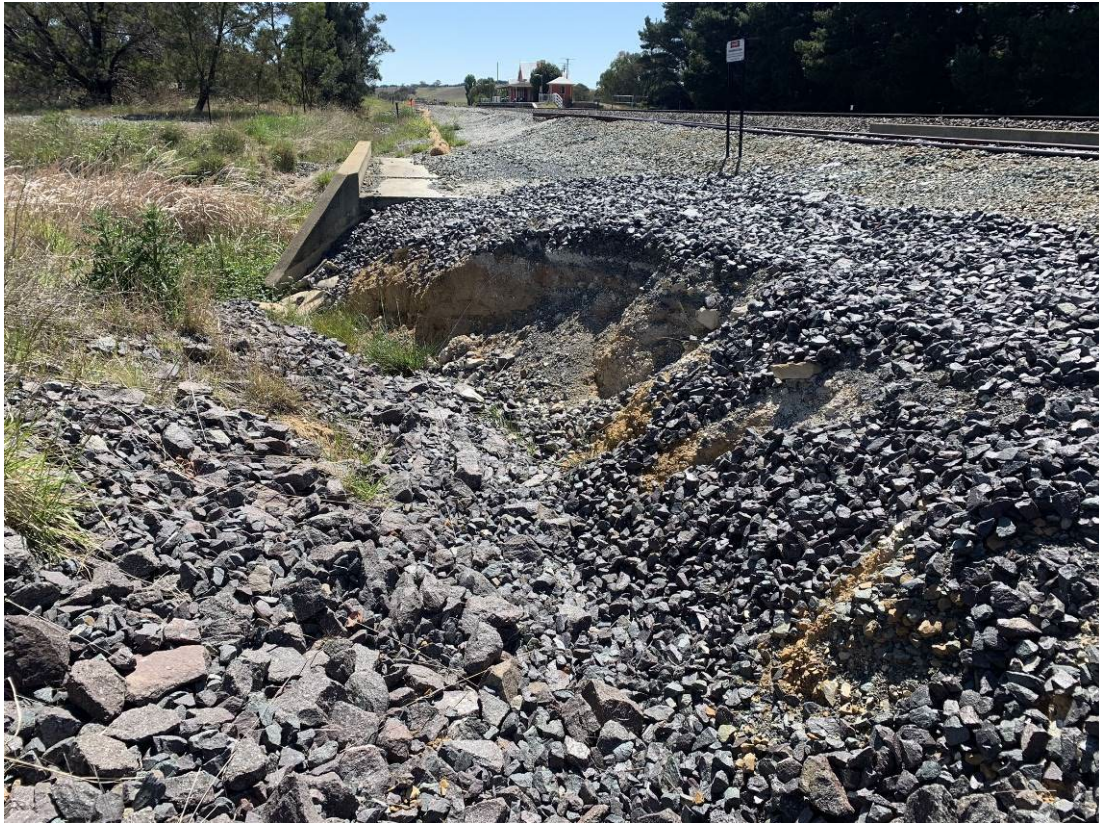
Evidence of erosion has been noted upgradient of the southern most culvert in multiple previous site inspections and remains on site but in a stable condition (**Photo 9**). No evidence of sediment was found in water flowing offsite at southern culvert. Ramboll recommends replacing ground cover material (ballast) if further erosion occurs or sediment is visible in the downstream surface water of the southern culvert.

Photo 9: Visible evidence of erosion due to loss of ground cover (ballast material) upgradient of southernmost culvert. Remaining material is stable and no major further erosion is noted since last inspection. Facing north-east.

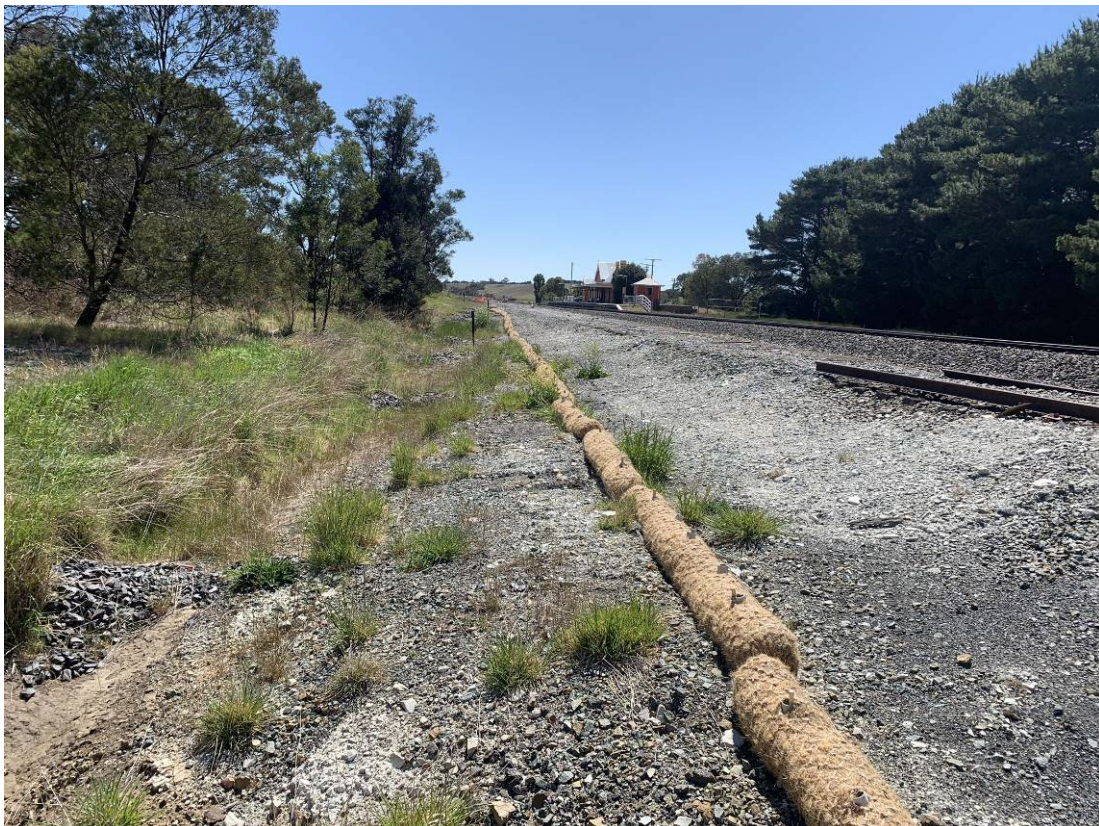
Photo 10: Upgradient of southernmost culvert showing Coir sediment control logs, used as control measures for sediment control. Facing north-east.

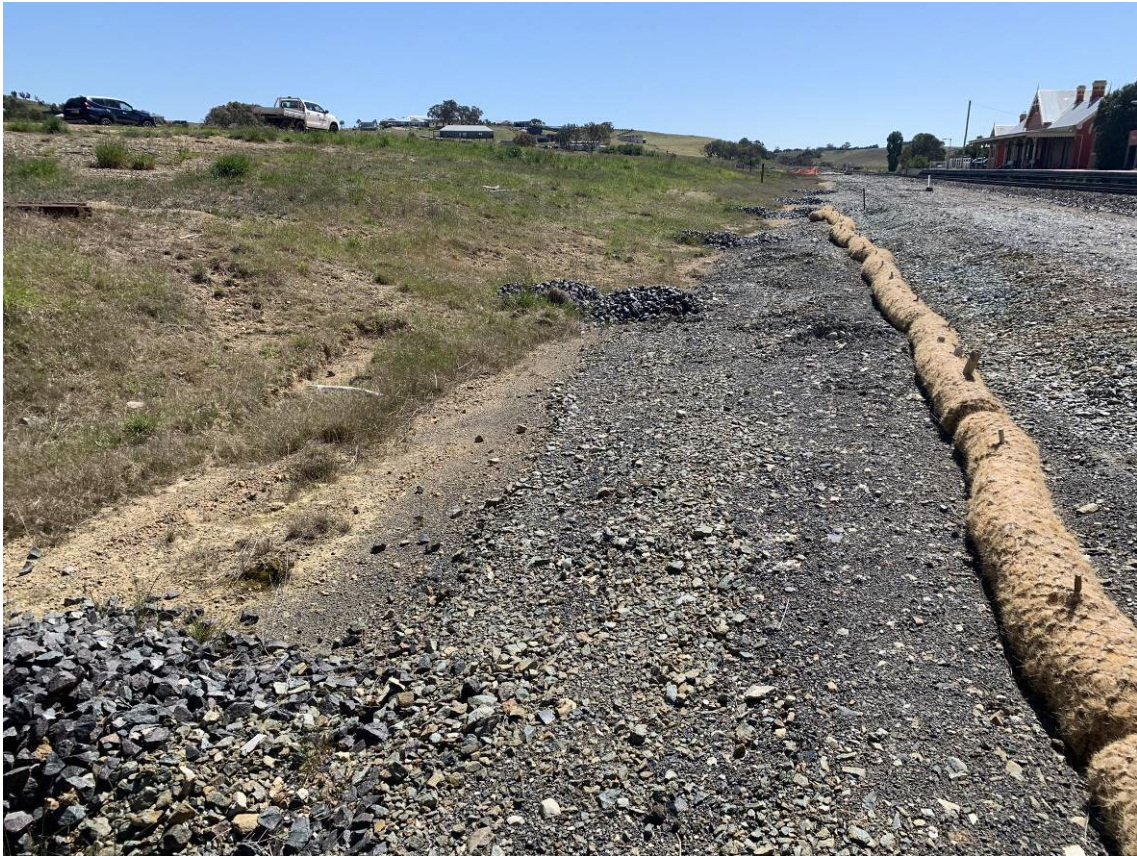
Photo 11: Rock checks running along former Woodlawn siding and between southern and middle culverts. Silt fencing replaced by Coir sediment control logs.

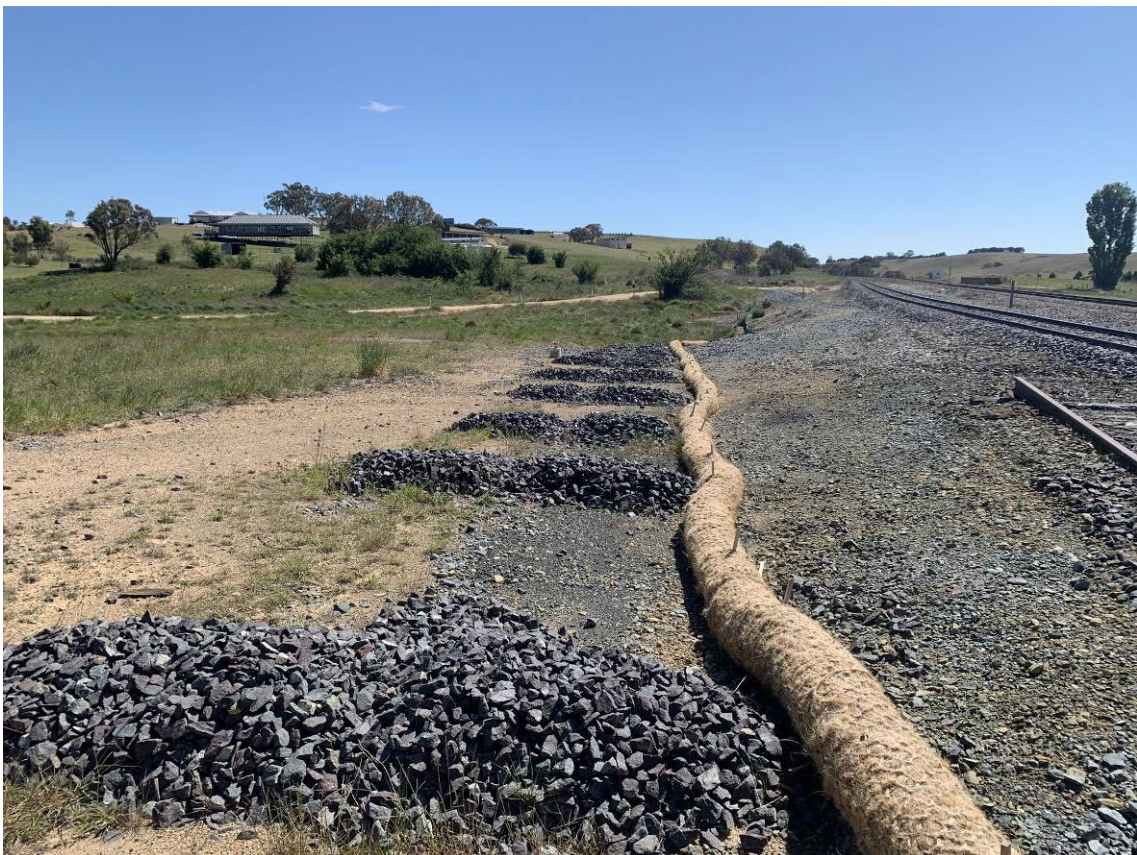
Photo 12: Rock checks running alongside former Woodlawn siding towards the middle culvert. No evidence of sediment build-up in rock armoury or Coir sediment control logs.

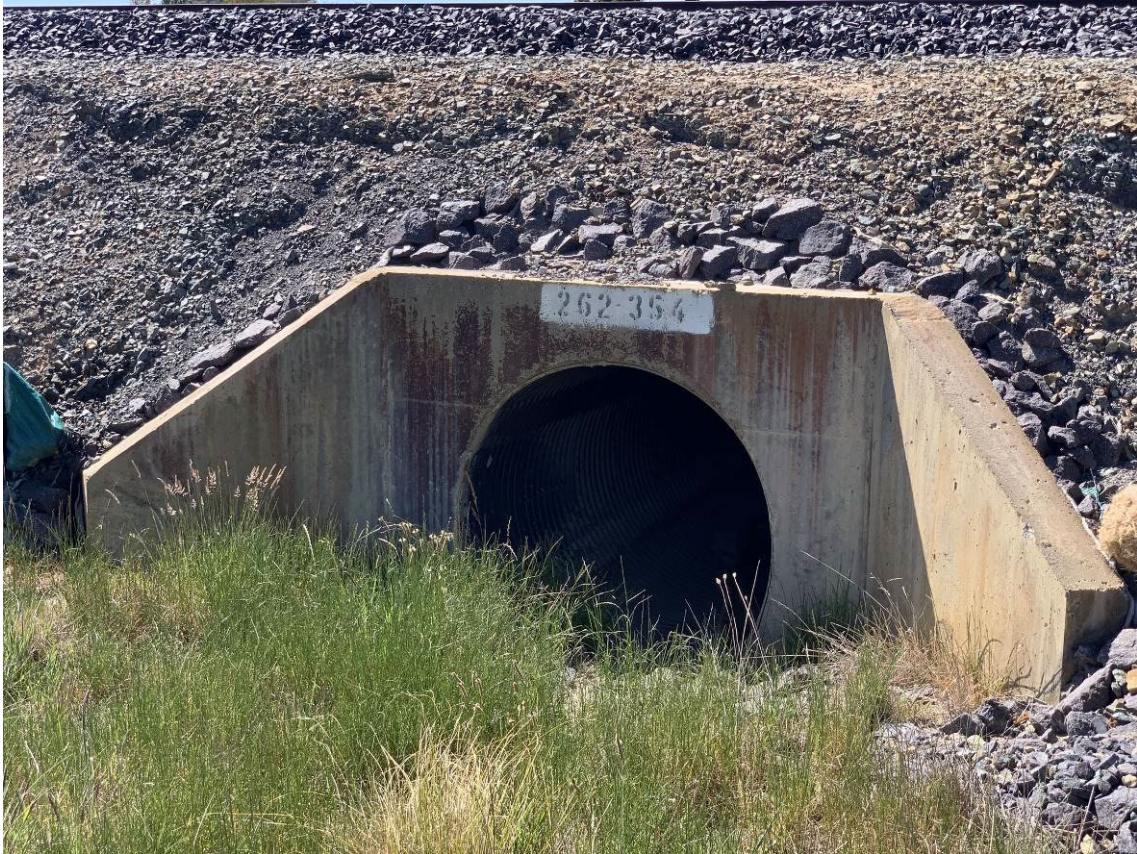
Photo 13: Upgradient of Middle culvert showing no flowing or pooled water. No evidence of sediment build-up in culvert.

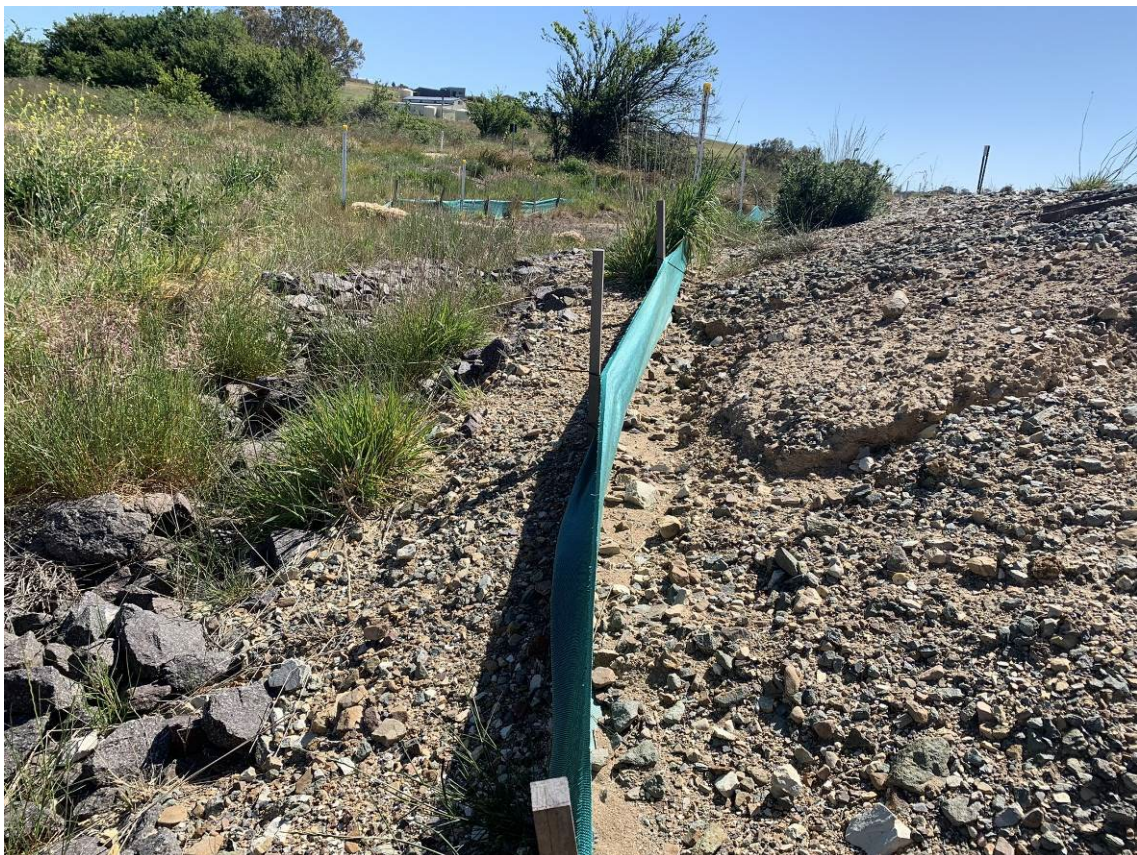
Photo 14: Upgradient of middle trainline culvert facing east. Silt fencing is clear with some sediment visible.

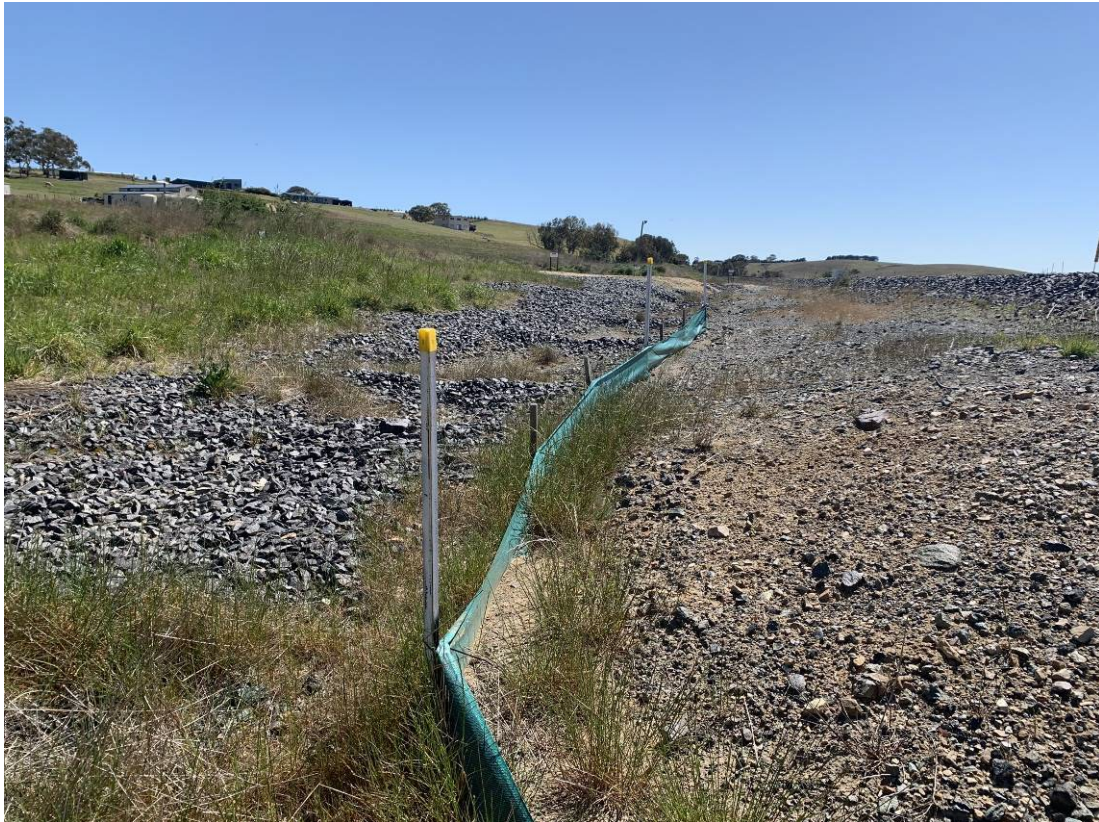
Photo 15: Rock armour upgradient of trainline running from the middle to the north culvert. Some sediment visible on rock armour. Facing north-east.

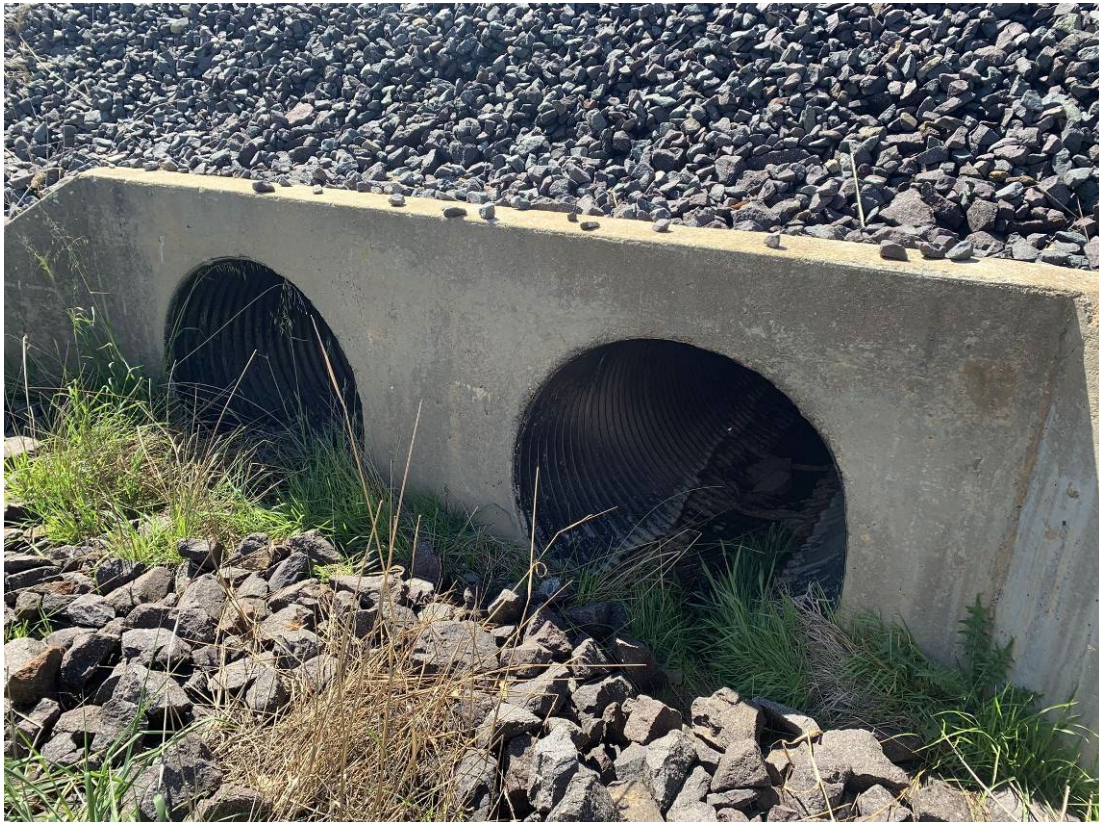
Photo 16: Upgradient of northernmost culvert. No evidence of surface water run off on site. No evidence of sediment buildup on rocks. Rock armor and natural vegetation allow for sediment control in surface water.

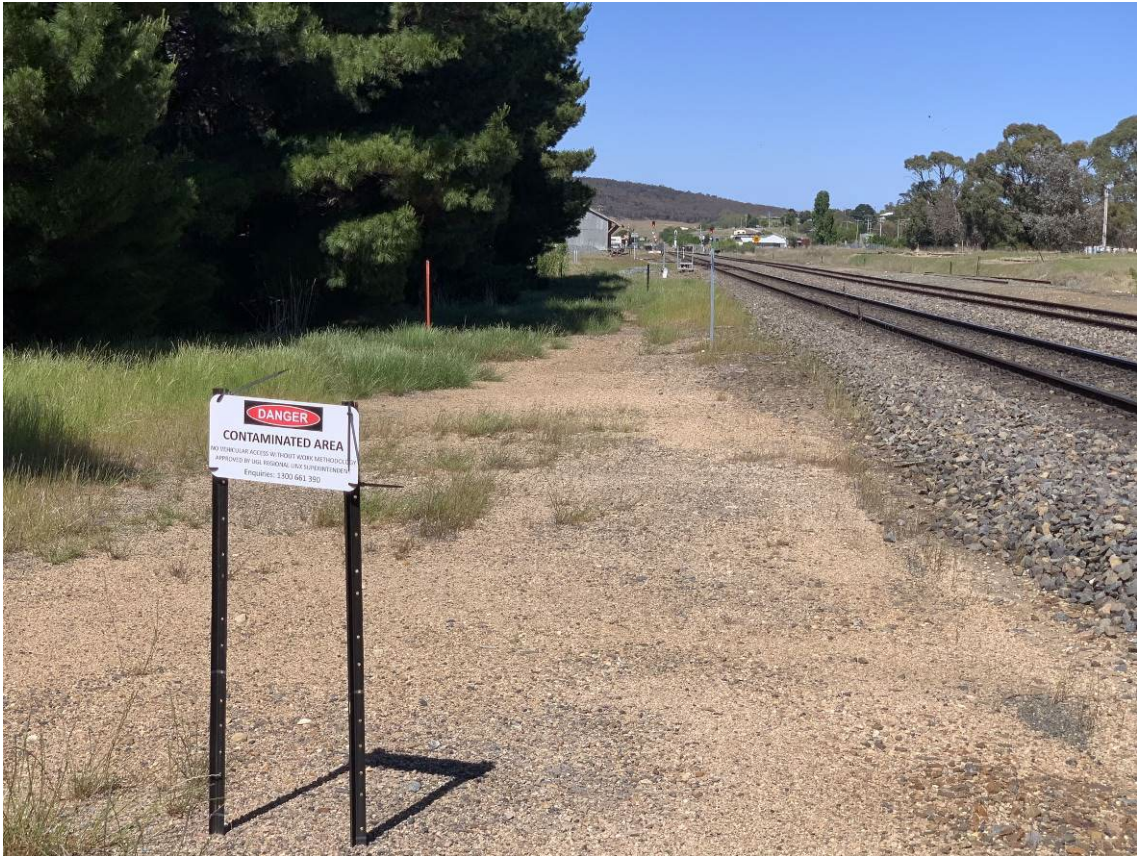
Photo 17: Exclusion zone signing placed periodically along contamination areas. Undamaged and in good condition. Facing South-West.

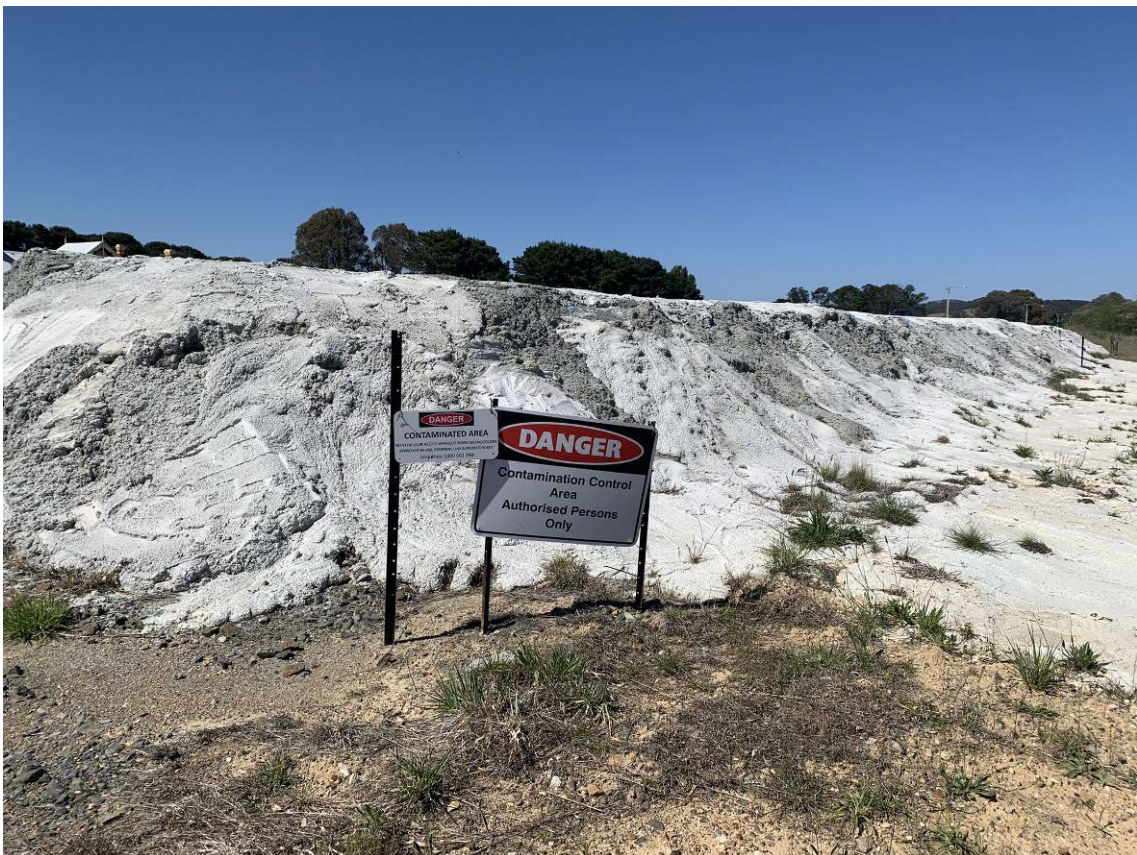
Photo 18: Exclusion zone signing placed periodically along contamination areas. Undamaged and in good condition. Facing South-East.

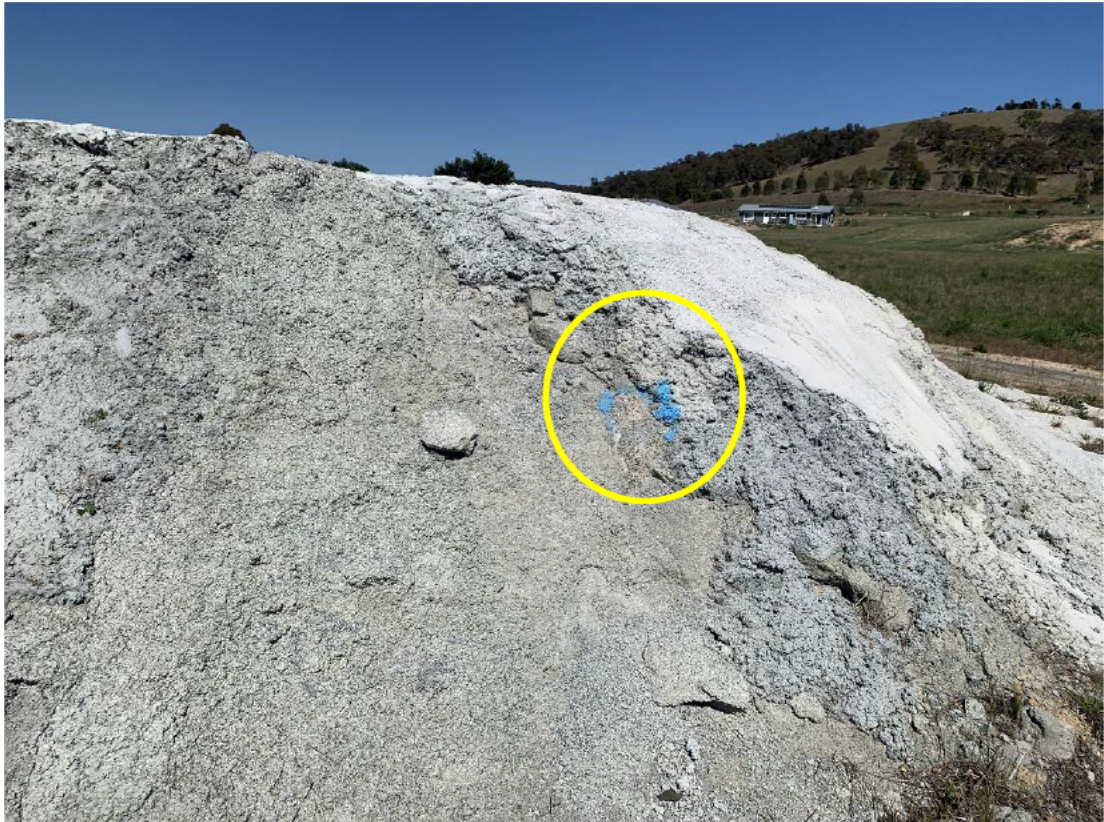
Regarding the stockpile, the previous site inspection (14/09/23) identified two new locations where the marker layer was exposed, with Ramboll providing the recommendation for them to be repaired. On this inspection the two exposure locations appear to have been rectified as they have now been covered with concrete (**Photos 19 - 20**). These repairs satisfy the recommended actions previously provided and no further action is needed.

Photo 19: Exposed geofabric layer marker on main stockpile which was identified during the previous inspection (14/09/23), that has since been filled in with concrete. Repaired location indicated by yellow circle. Located on North-Eastern side of stockpile.

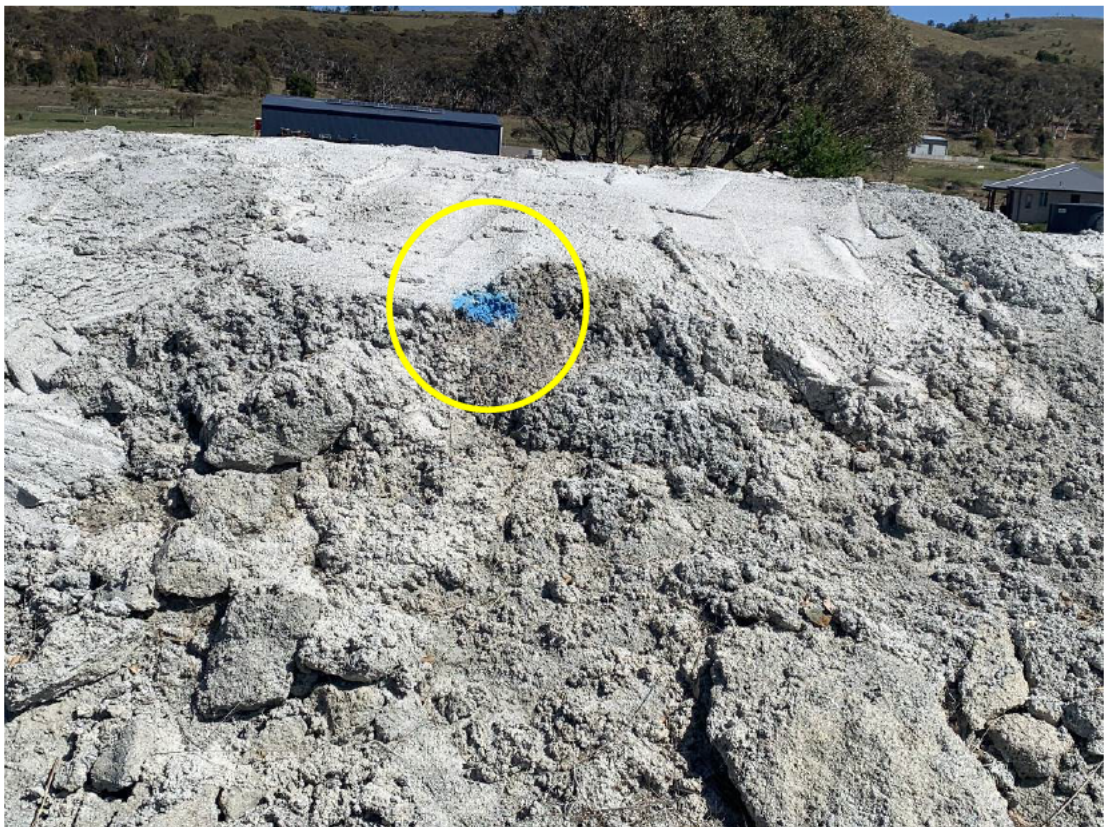
Photo 20: Exposed geofabric layer marker on main stockpile which was identified during the previous inspection (14/09/23), that has since been filled in with concrete. Repaired location indicated by yellow circle. Located on South-Eastern side of stockpile.

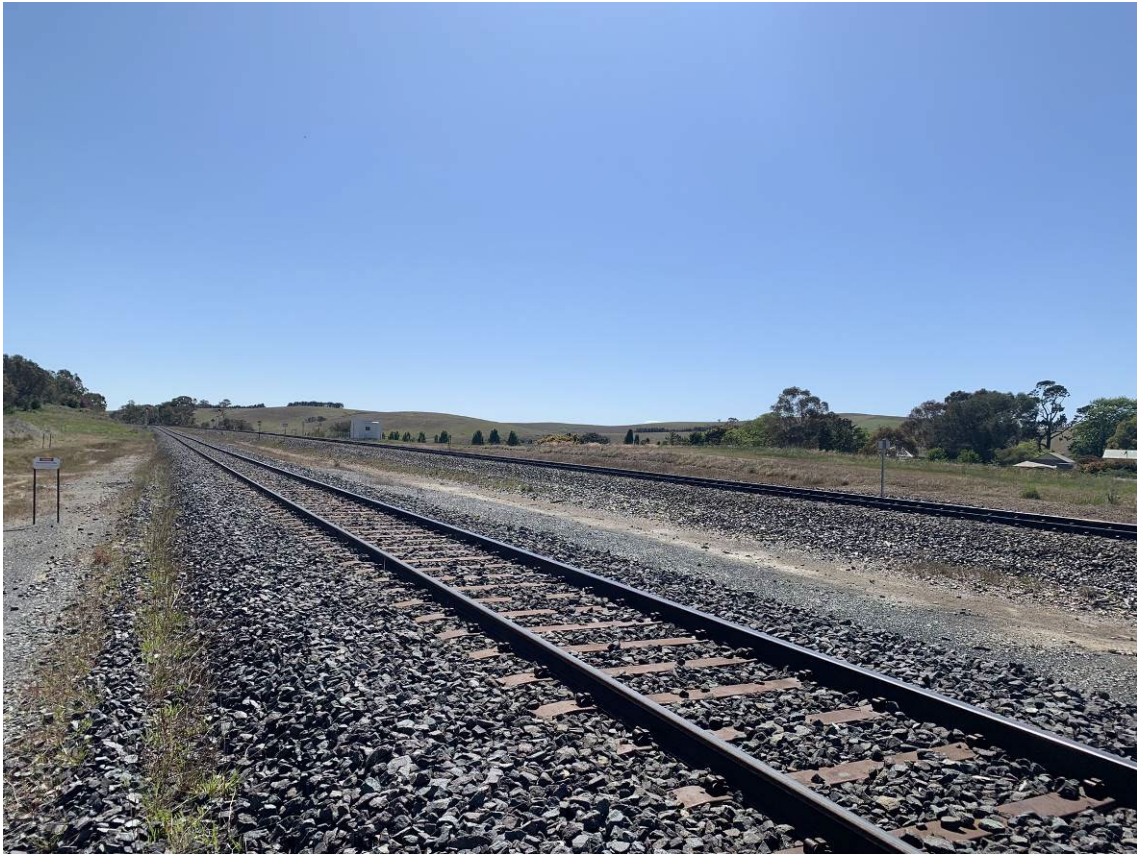
Photo 22: No pooled water adjacent to railway tracks. Facing North-East.
