## Tarago Action Plan Routine Inspection Checklist

<b>Title:</b> Tarago Rail Yard Inspection	<b>Approved:</b> SM	<b>Project-Nr.:</b> 318001704	<b>Date:</b> 20 December 2023
<b>Site:</b> Tarago, NSW			
<b>Client:</b> UGL Regional Linx

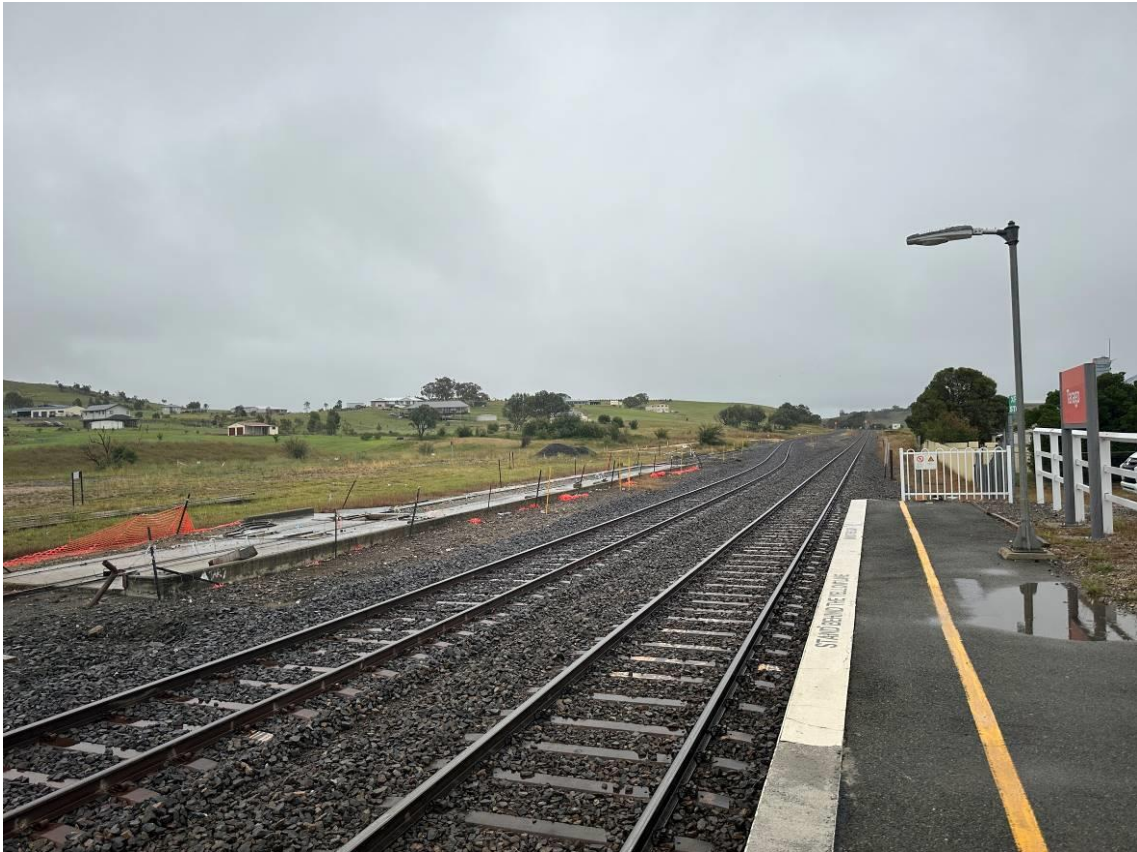
**Photo 1: Picture at northern end of Tarago railway station platform facing north. No airborne dust visible.**

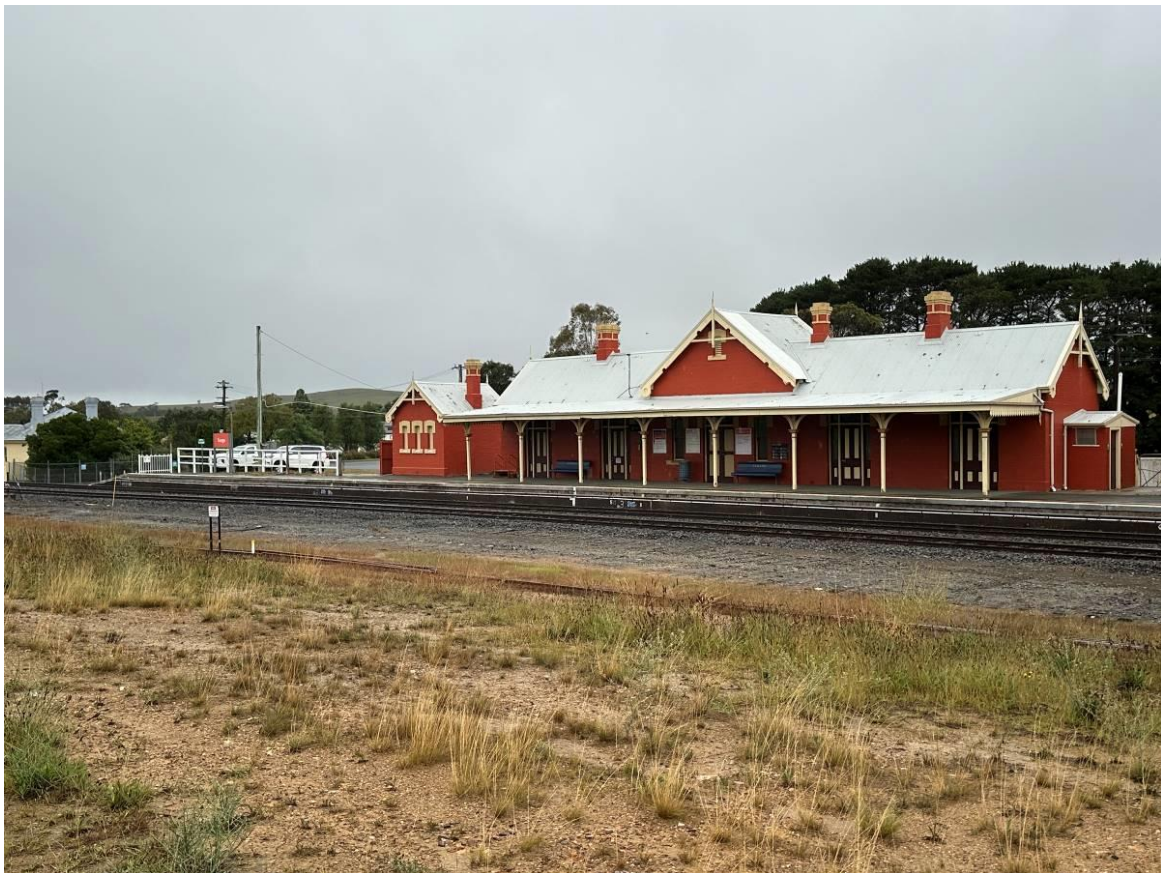
**Photo 2: Picture at of Tarago railway station. No airborne dust visible.**

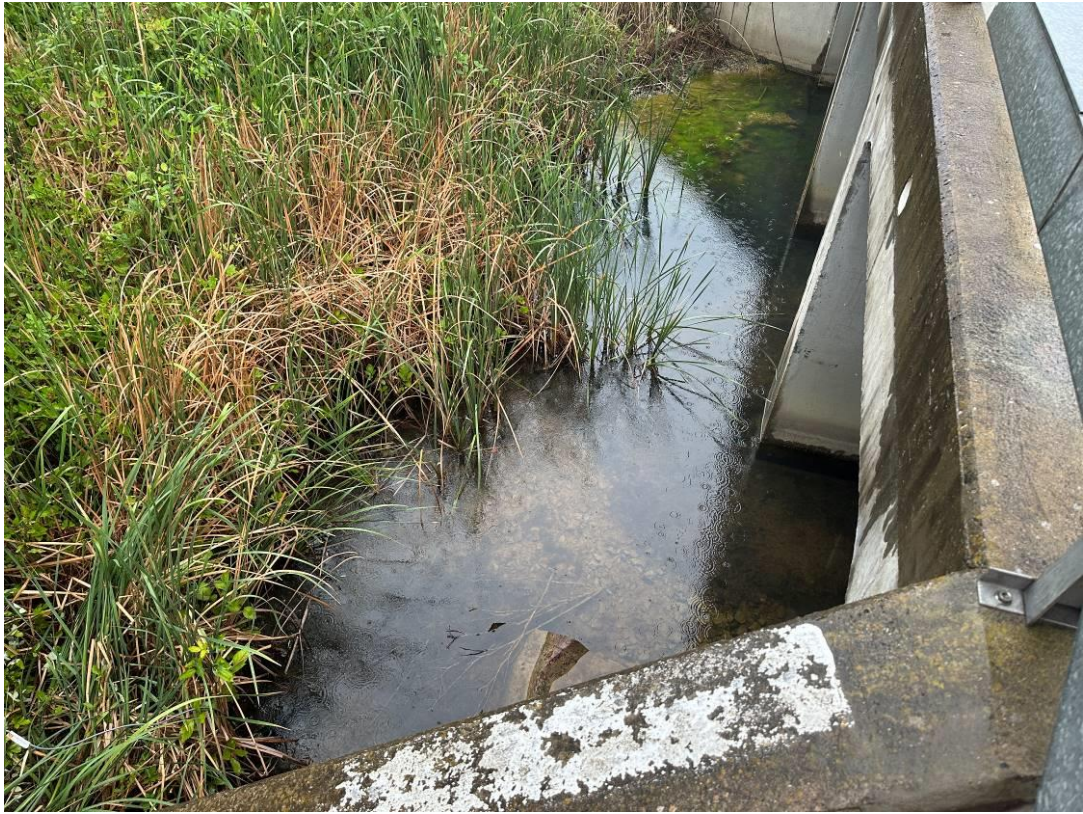
Surface water was observed discharging from the site at the southernmost culvert ( <b>Photos 3 and 4</b> ). Surface water was observed at the middle culvert pooled on site ( <b>Photo 6</b> ). No other flowing surface water was observed onsite during the inspection.		
<u>Is there evidence of excavation or other works non-compliant with the Action Plan?</u>		
No		
<u>Other observations?</u>		
<p>1. Exposed marker layer location that was identified during the previous inspection had been patched using a cement mixture (<b>Photo 12</b>). One new marker layer location (<b>Photo 13</b>) was identified during the current inspection. UGL Representative was made aware of the location.</p> <p>2. The rock armour at the southernmost culvert, upgradient of the railway, appeared to be in a weathered condition in a previous investigation (14/11/23). Ramboll recommended rock armour be reinstated by clearing the sediment and debris and repairing the misshaped rock armour. Ramboll notes this was not done before the current investigation.</p> <p>3. Minor suspected hydrocarbon spill was noted in a small area of pooled surface water on site (<b>Photos 16 and 17</b>). This is suspected to relate to recent rail operations and is unlikely to represent a risk to the receiving environment.</p> <p>4. During the time of inspection quarterly surface water monitoring sampling was being undertaken by Ramboll staff.</p>

**Photo 3: Downgradient of southern culvert with surface water flowing offsite. Surface water is clear with low turbidity.**

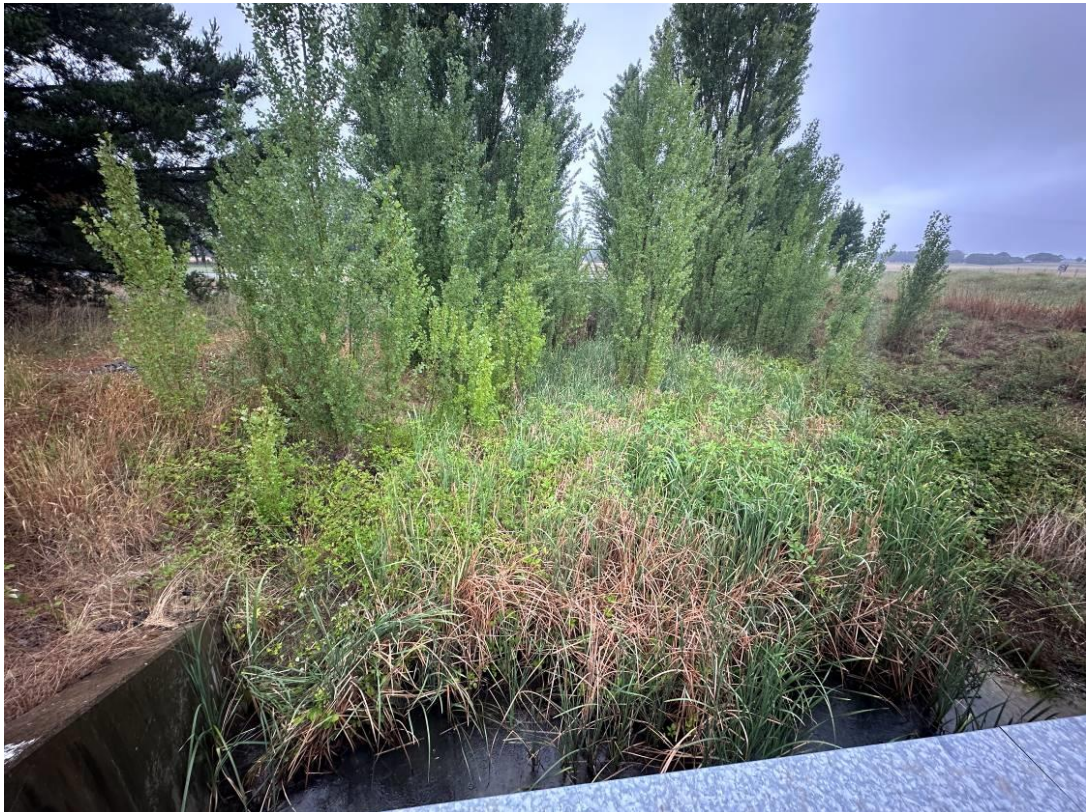
**Photo 4: Downgradient of southern culvert with surface water flowing offsite. Surface water is clear with low turbidity.**

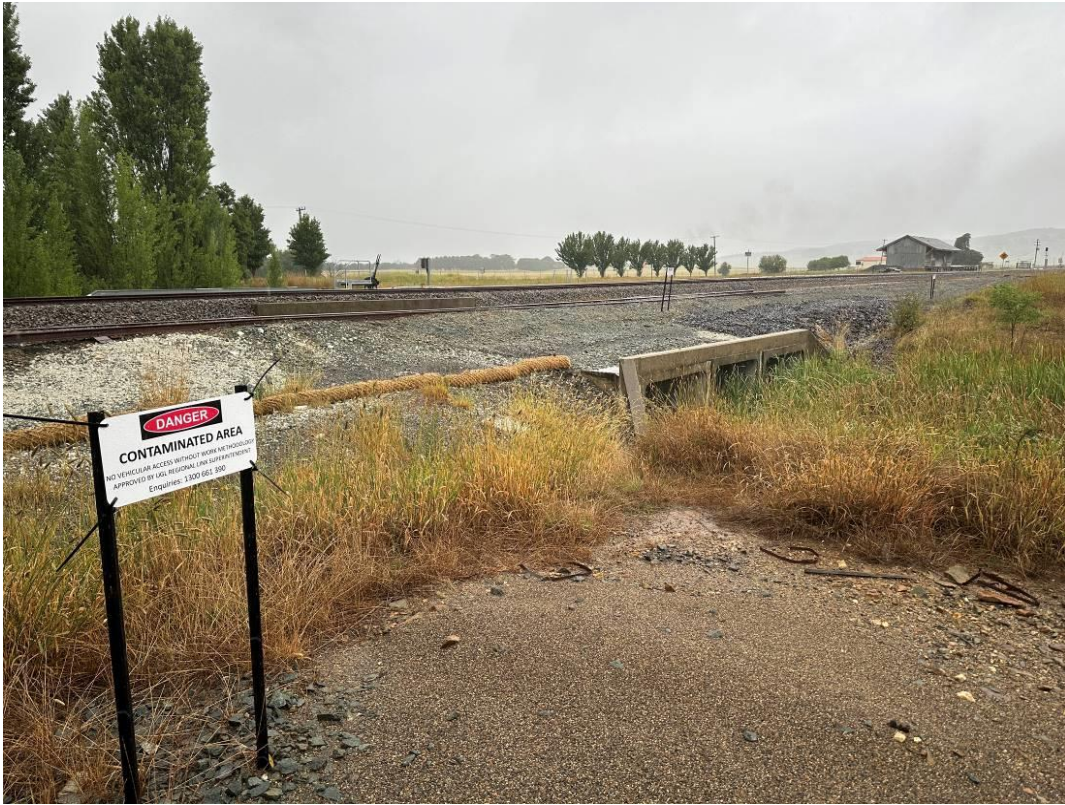
**Photo 5: Upgradient of southern culvert showing coir sediment control logs and reed bed vegetation with natural sediment control.**

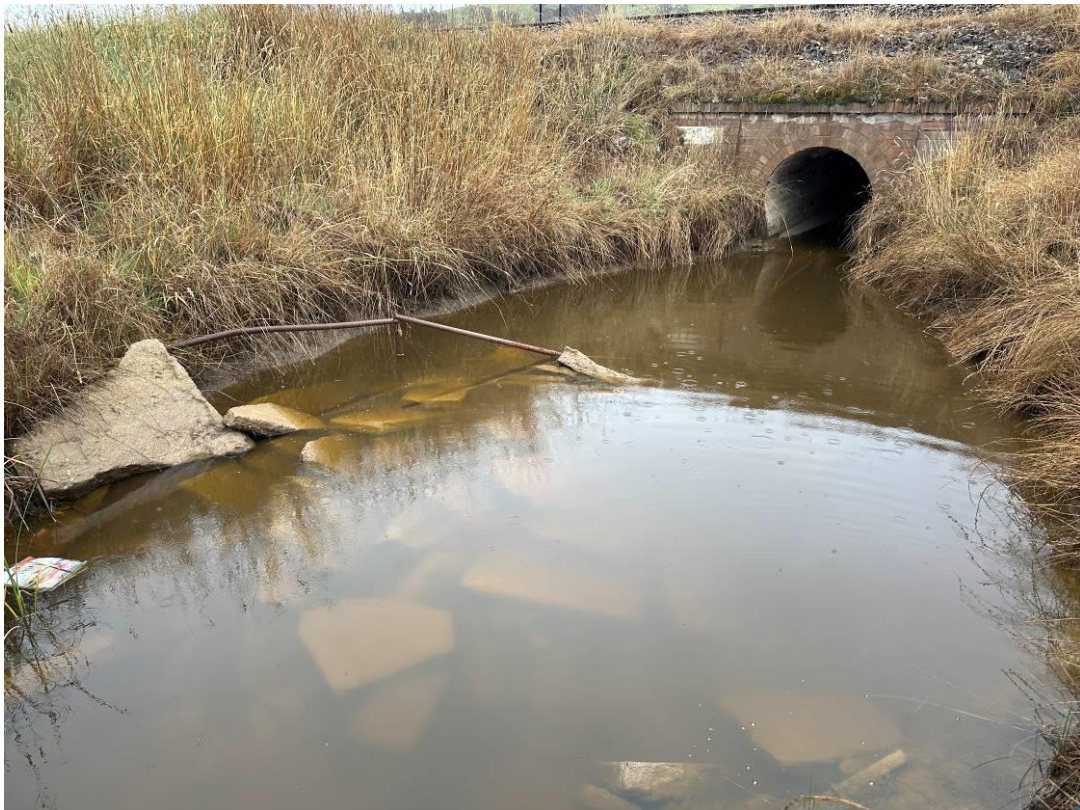
**Photo 6: Downgradient of middle culvert with pooled surface water. Surface water was clear with low turbidity.**

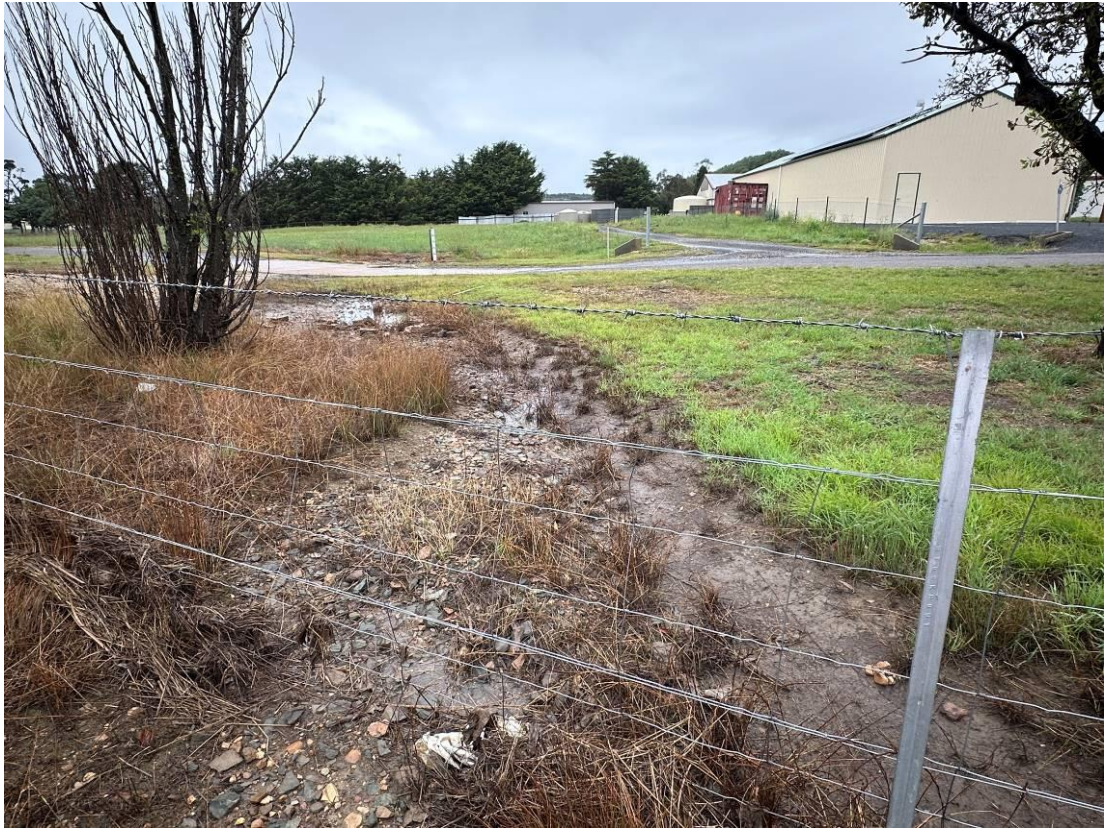
**Photo 7: Downgradient of middle culvert showing no surface water flowing off site. No sediment visible on road causeway off site.**

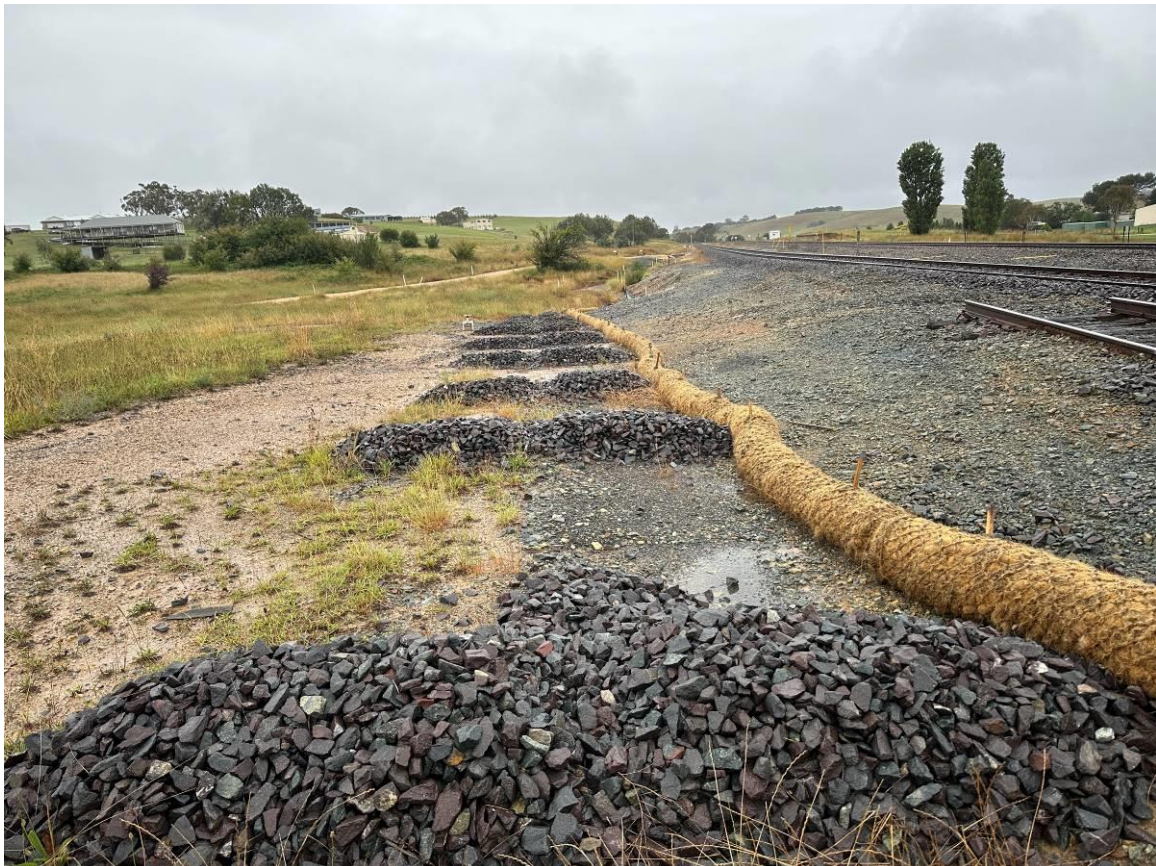
**Photo 8: Upgradient of middle culvert with no flowing surface water. Sediment control rock armour appears in good condition.**

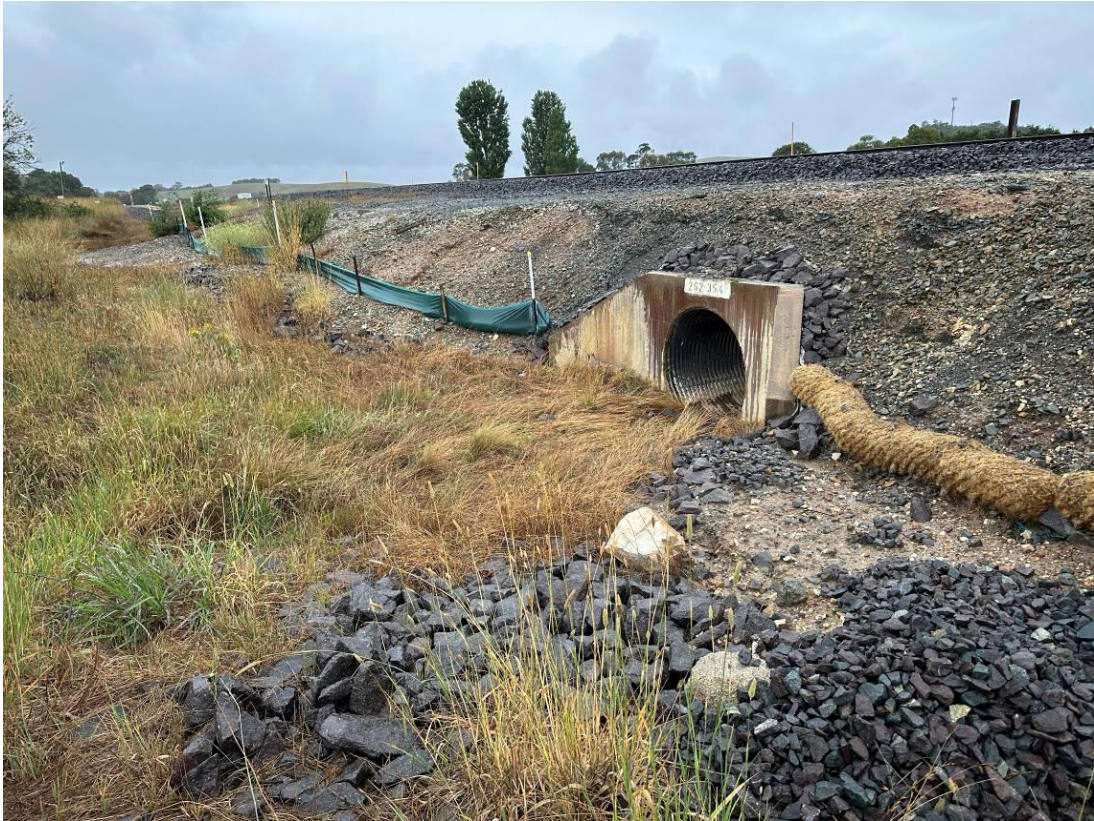
**Photo 9: Upgradient of middle culvert upgradient of the railway line with no flowing surface water. Minor observed build-up of sediment fencing.**

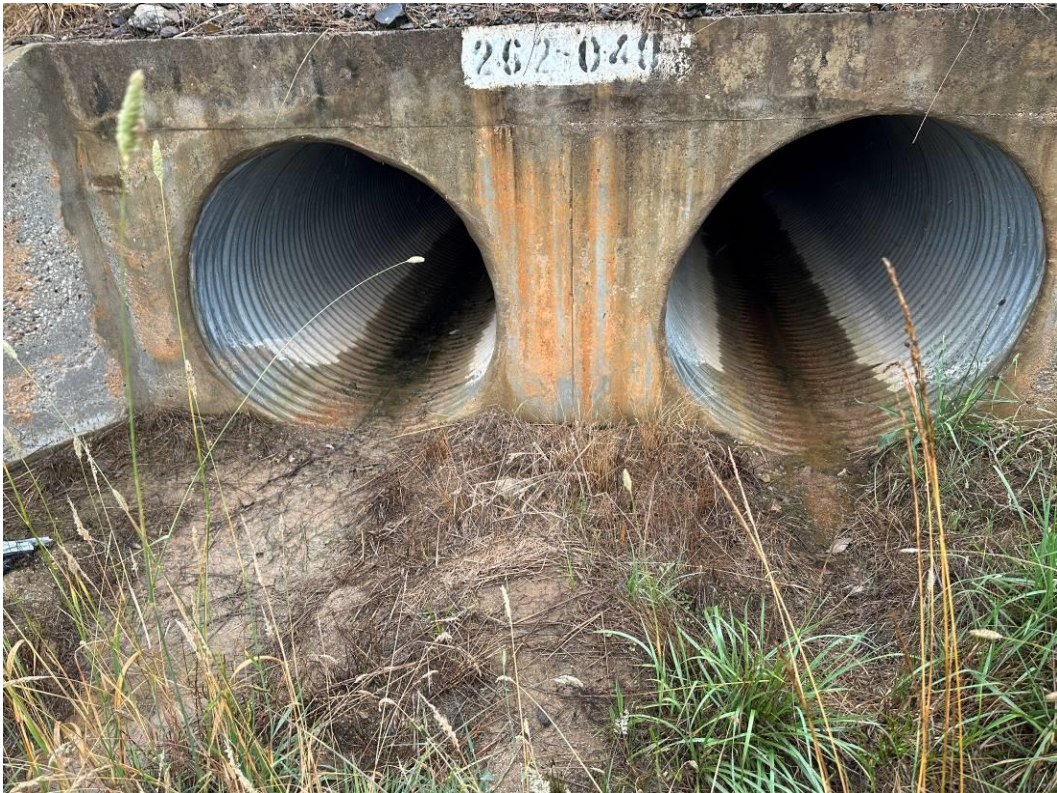
**Photo 10: Downgradient of northernmost culvert with no flowing surface water.**

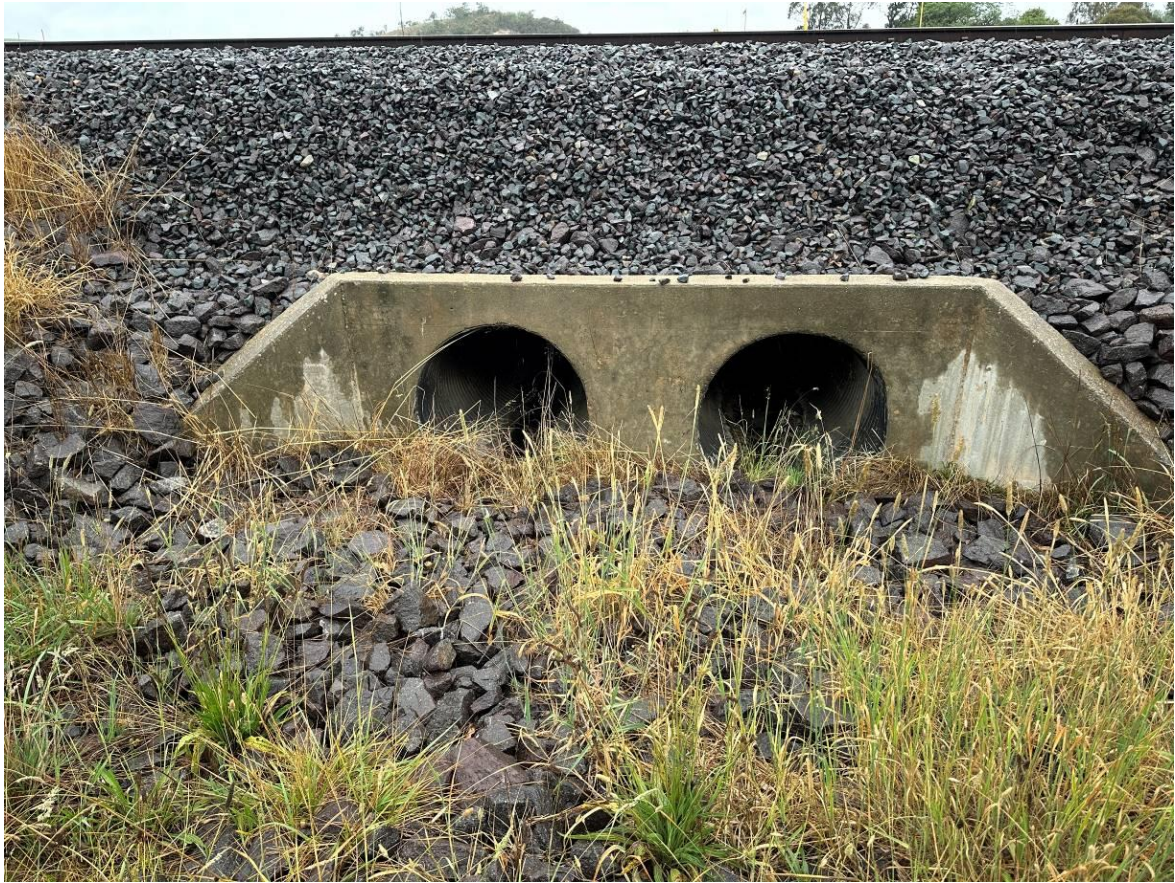
**Photo 11: Upgradient of northernmost culvert. No surface water flowing through culvert. Minimal sediment build up on rock armoury.**

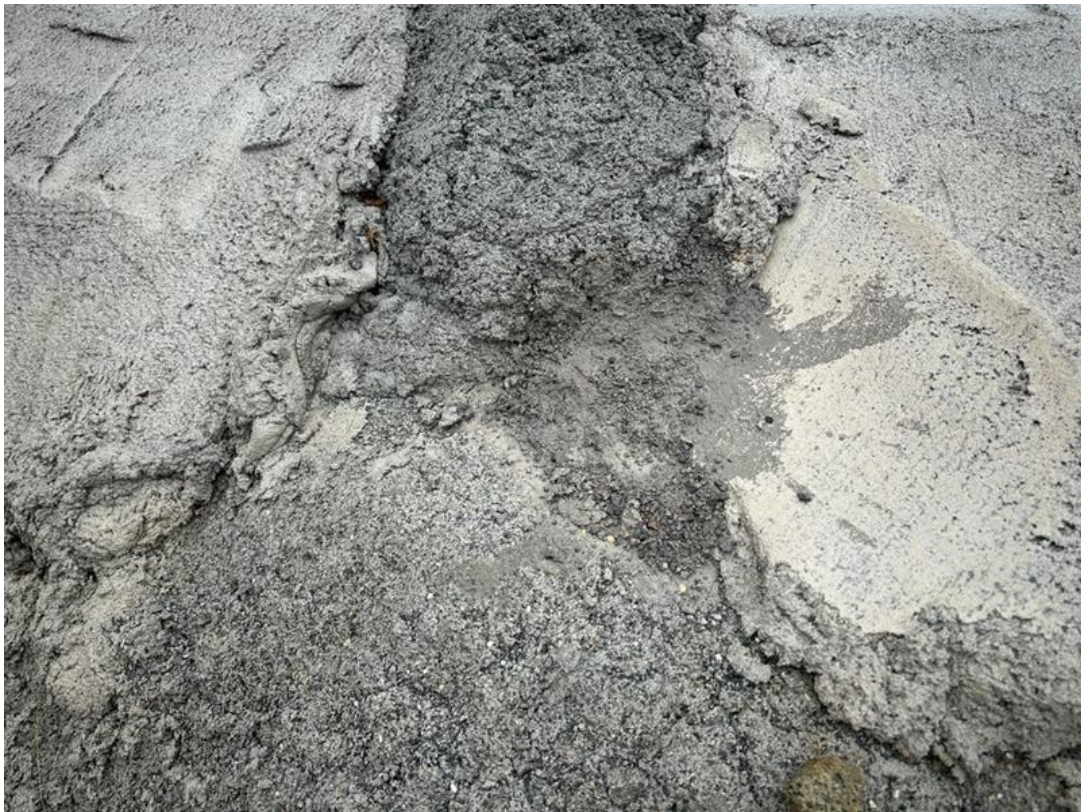
**Photo 12: Geofabric marker layer visible in stockpile capping in previous inspection. Covered with cement by UGL Representatives as advised.**

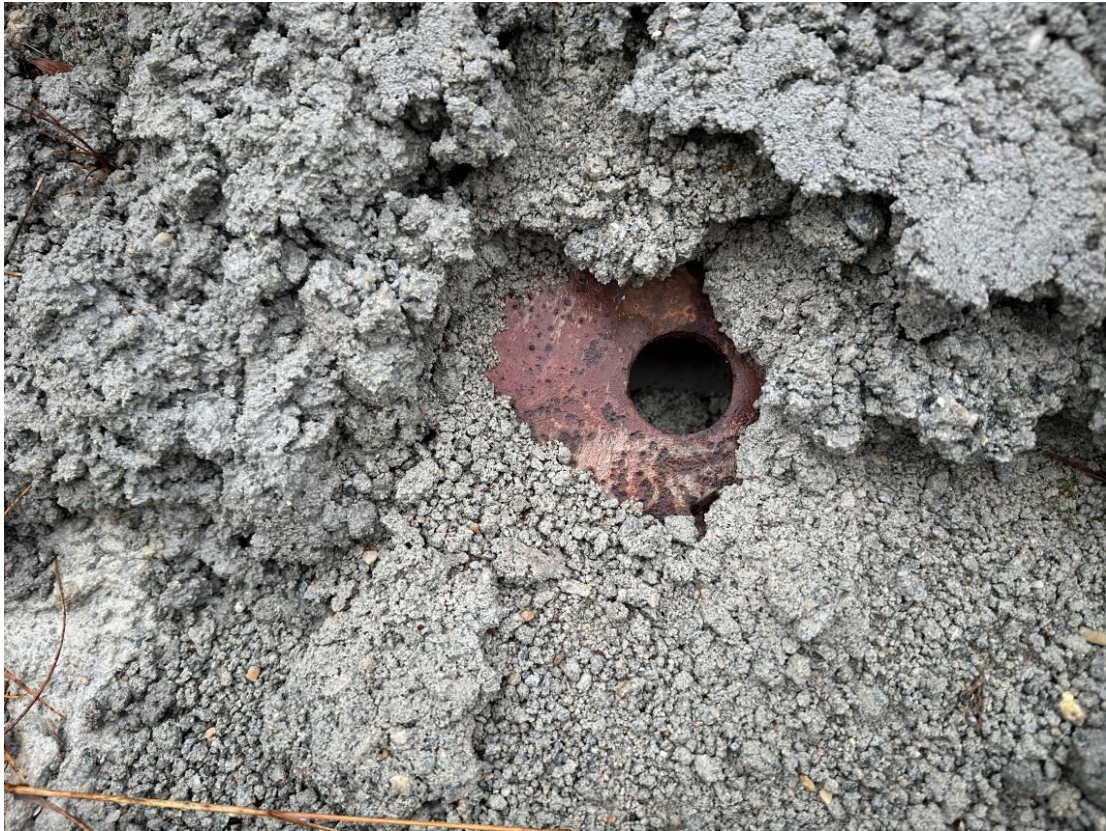
Is geofabric marker layer visible beneath capping of the existing stockpile? If so record in written form and through photographs and consolidate with this checklist. If marker layer is visible rectification work is required.	Yes. One new marker layer exposure was noted on the stockpile. Refer to 'additional observations' section point 1 for comment'.

**Photo 13: Geofabric marker layer visible in stockpile capping underneath metal plate. UGL Representatives on site advised of location.**

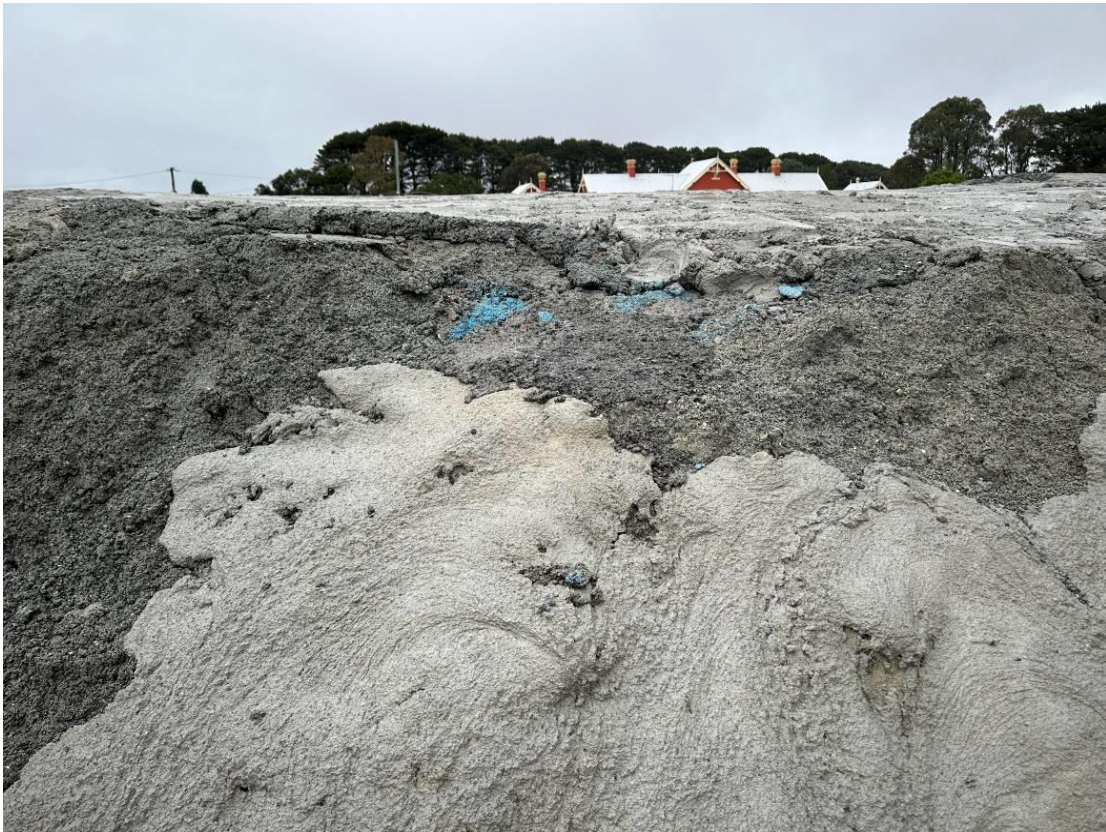
**Photo 14: Location of previous stockpile capping that was visible and then covered with cement. Cement mixture appears to have sufficiently covered area and been maintained for an extended period of time even with rainfall.**

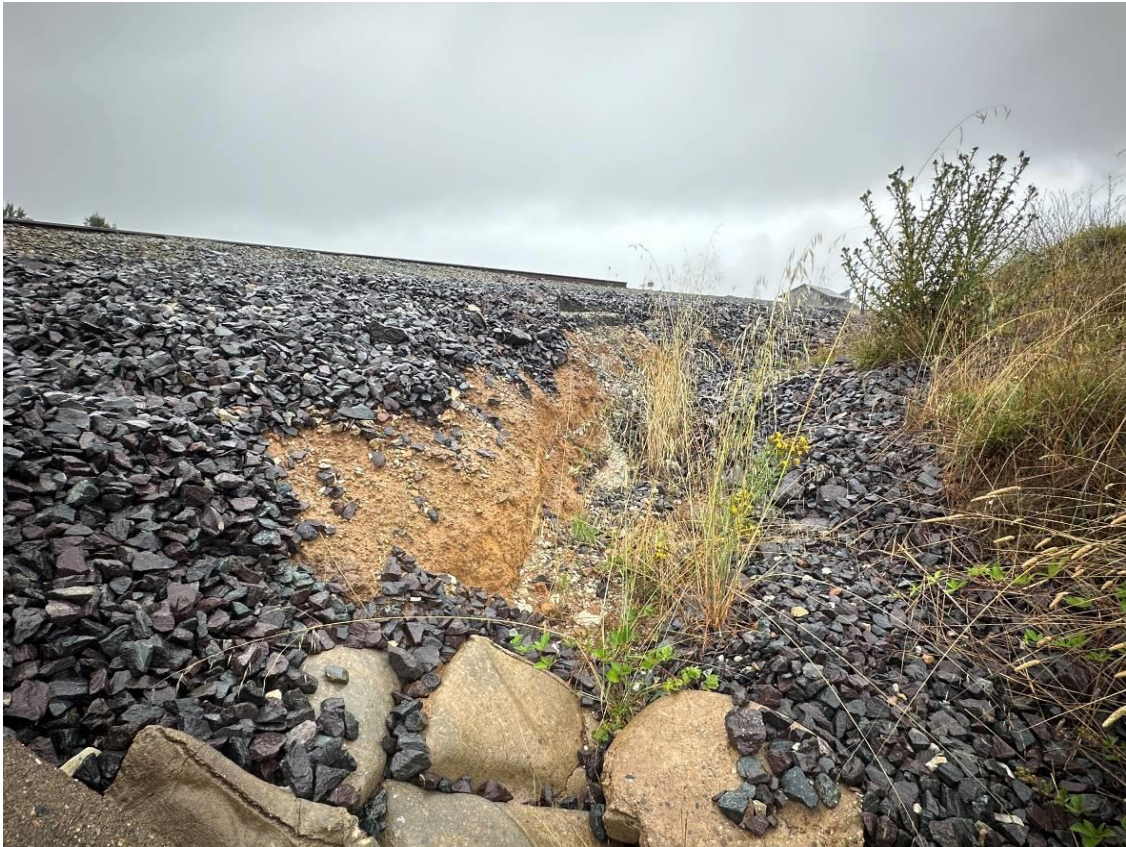
**Photo 15: Visible evidence of erosion due to loss of ground cover (ballast material) upgradient of southernmost culvert. Remaining material is stable and no major further erosion is noted since previous inspections.**

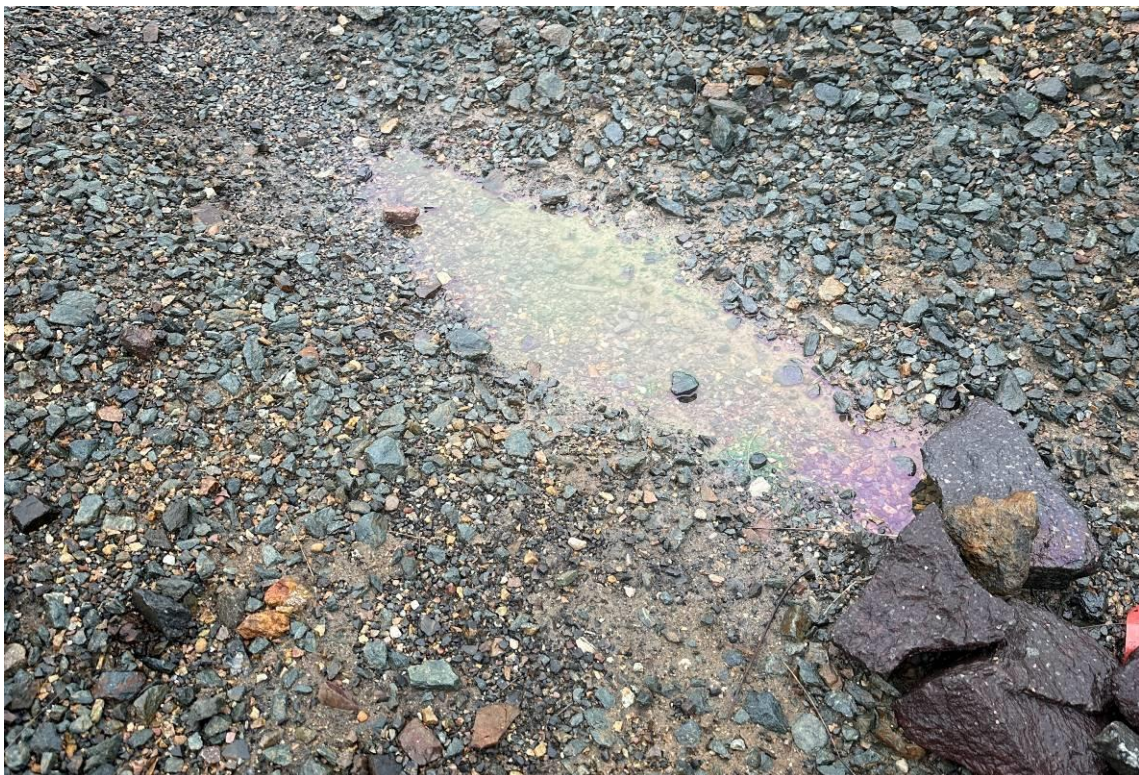
**Photo 16: Minor suspected hydrocarbon spill noted in pooled surface water on site. Located between rail lines near drain between middle and northernmost culverts.**

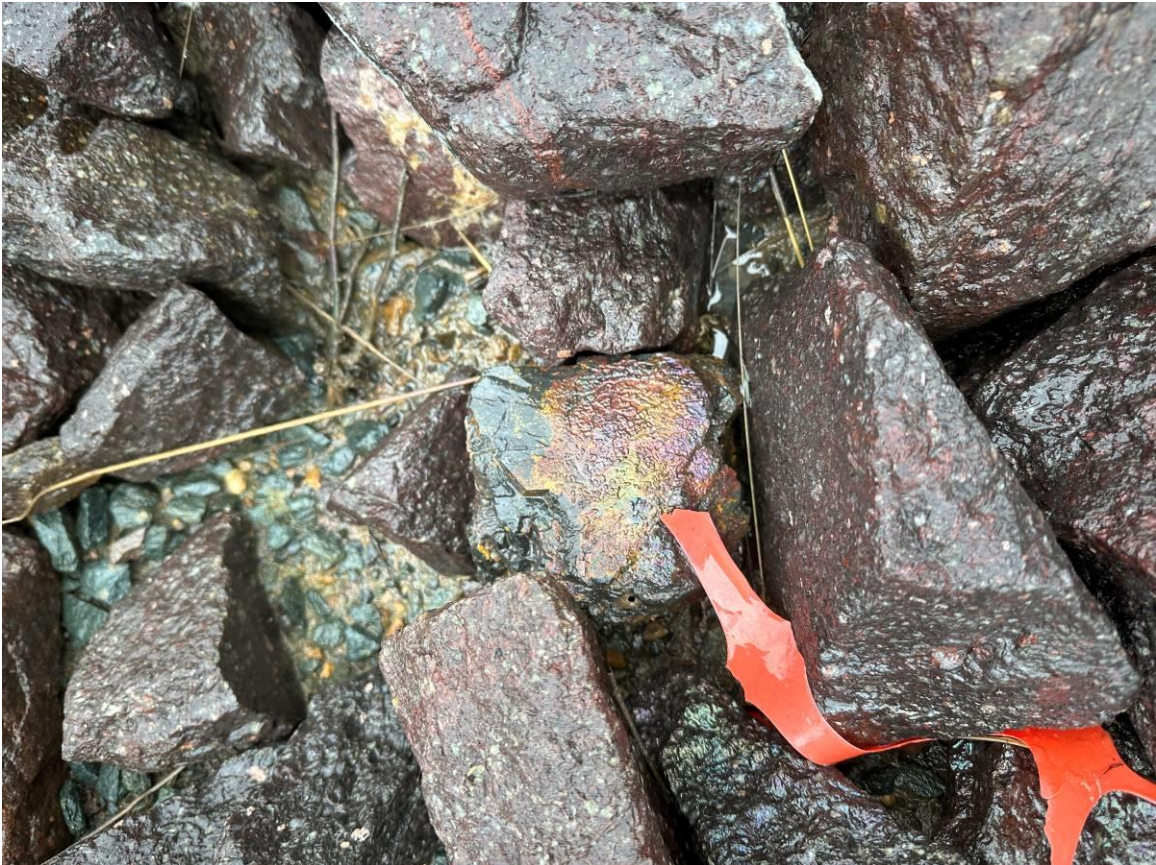
**Photo 17: Minor suspected hydrocarbon spill noted on wet ballast material on site. Located between rail lines near drain between middle and northernmost culverts.**
