JBS&G 64627 – 154,525

L006 (Interim Audit Advice - Tarago Woodlawn Siding Rev 0)

L006 Interim Audit Advice (0503-2303-006) – Tarago Woodlawn Siding NSW – Air Quality and Surface Water Monitoring Changes

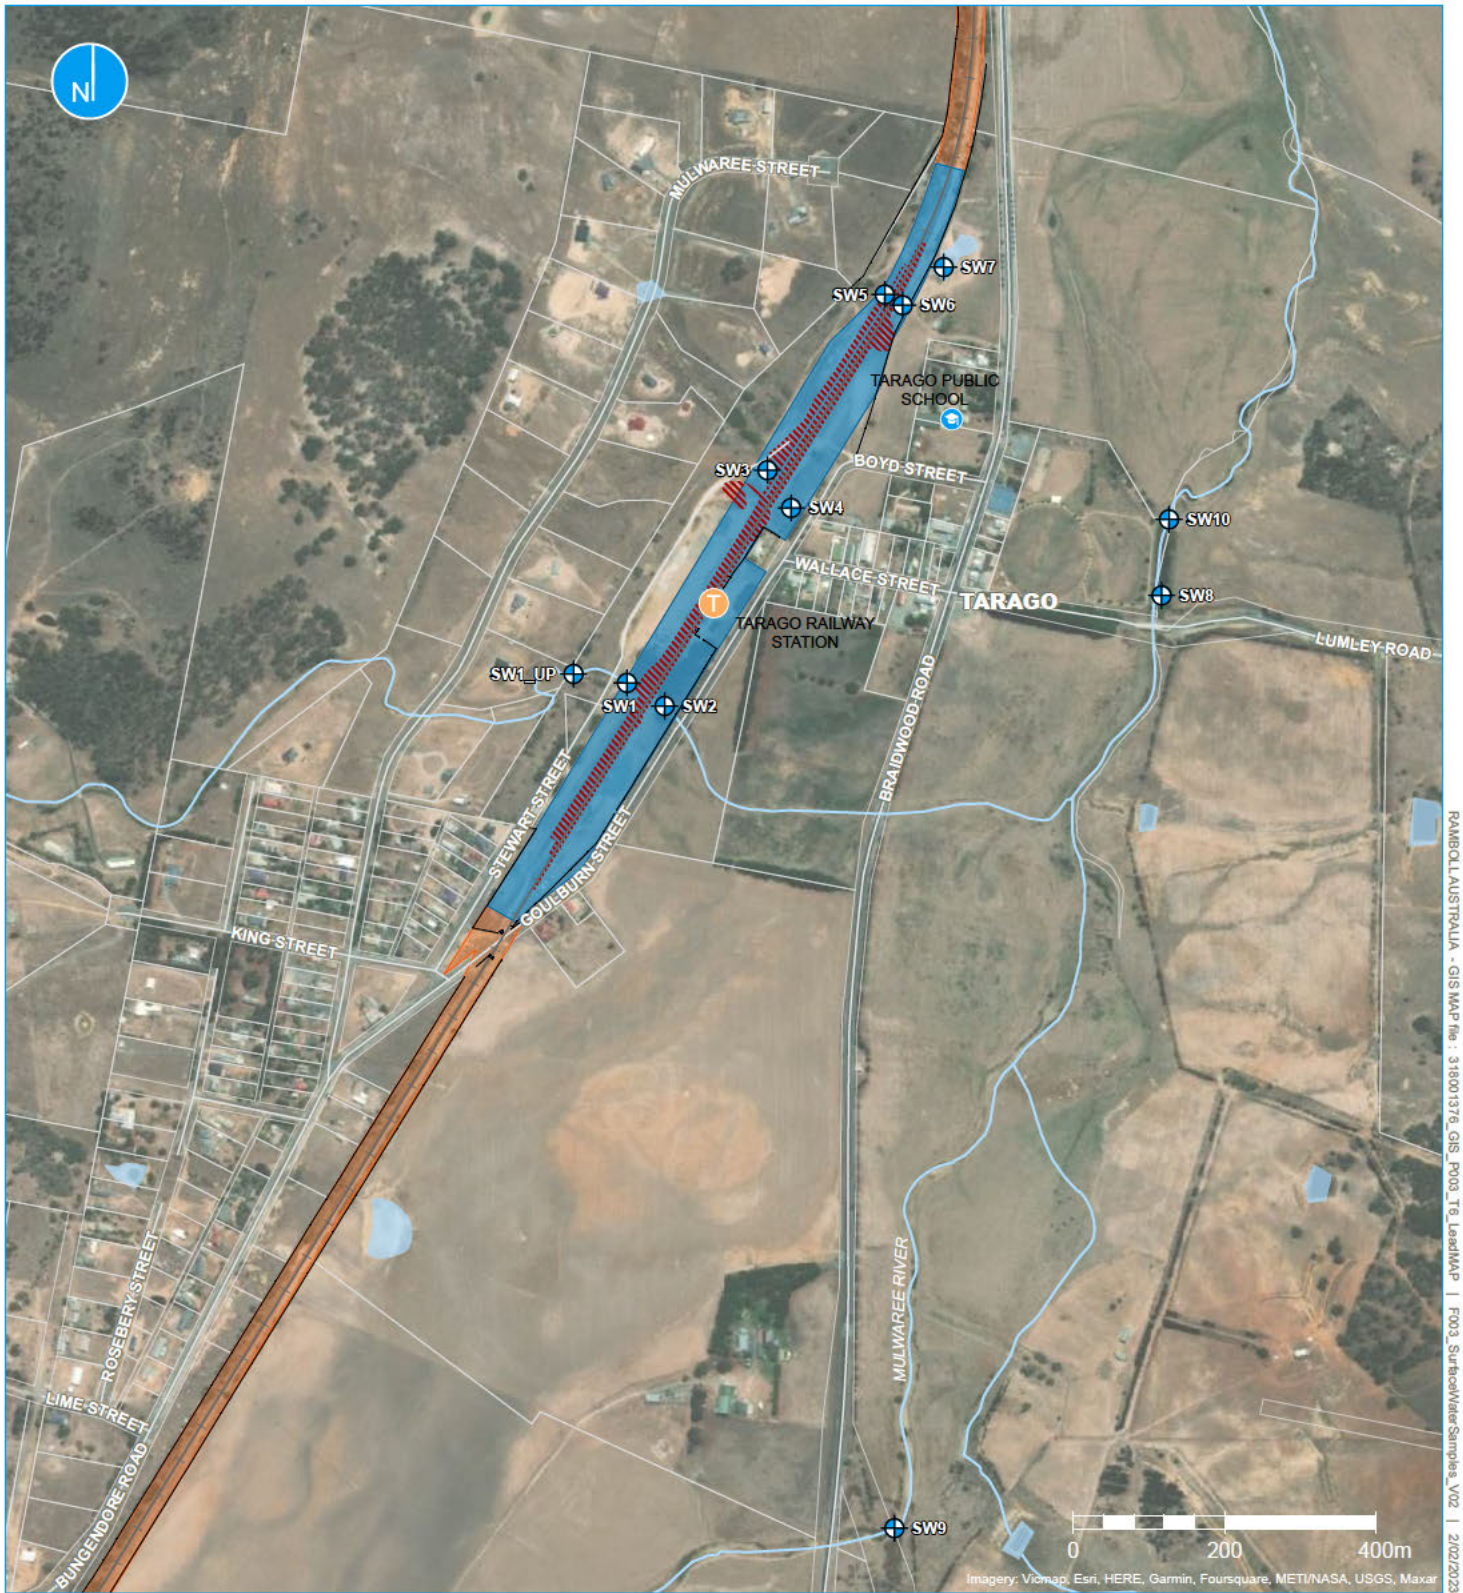
Figure 3 | Surface water and sediment sampling locations

Surface water sampling locations are shown in Figure 3 in Attachment 2.

Analyte	No. of Samples	No. of Detects	Minimum (mg/L)	Maximum (mg/L)	Average (mg/L)	Exceedances of Criteria and Trends
On or Near Site (SW1_UP, SW1, SW2, SW3, SW4, SW5 and SW6)						
Total lead	76	59	<0.001	0.17	0.02	No exceedances Stable (SW1_UP and SW4), decreasing (SW2) or no trend (SW1, SW3 and SW4).
Dissolved lead	69	43	<0.001	0.033	0.006	No exceedances Stable (SW1_UP, SW4 and SW5), decreasing (SW3) or no trend (SW1, SW2 and SW6).
Mulwaree River (SW8, SW9 and SW10)						
Total lead	30	7	<0.001	0.002	0.001	No exceedances. Concentrations reported at least 50 times lower than the recreational water criterion. Stable (SW8, SW9 and SW10) or decreasing trend (SW7).
Dissolved lead	28	0	<0.001	<0.001	<0.001	All samples reported concentrations below laboratory limit of reporting and adopted ecological criterion.

- There is no evidence that contaminant concentrations above the adopted guideline levels are migrating from the site;
- There are no exceedances of the adopted human health criteria for the contaminant of concern; [REDACTED] concentrations are stable or decreasing.
- Risks to human health and ecological receptors from detected concentrations of lead in surface water are considered to be low.

- Surface water monitoring conducted upstream and downstream of the site between August 2019 and September 2023 has not detected concentrations of contaminants that pose unacceptable risks to human health or ecological receptors. The auditor concurs with the conclusions reached by the consultant (Ramboll 2023h) and is satisfied that ongoing surface water monitoring prior to remedial or other activities that may result in the disturbance of ground surfaces at the site, is not required.
Should surface water monitoring be altered or ceased then the Lead Management Action Plan (Ramboll 2023g) will require amendment.

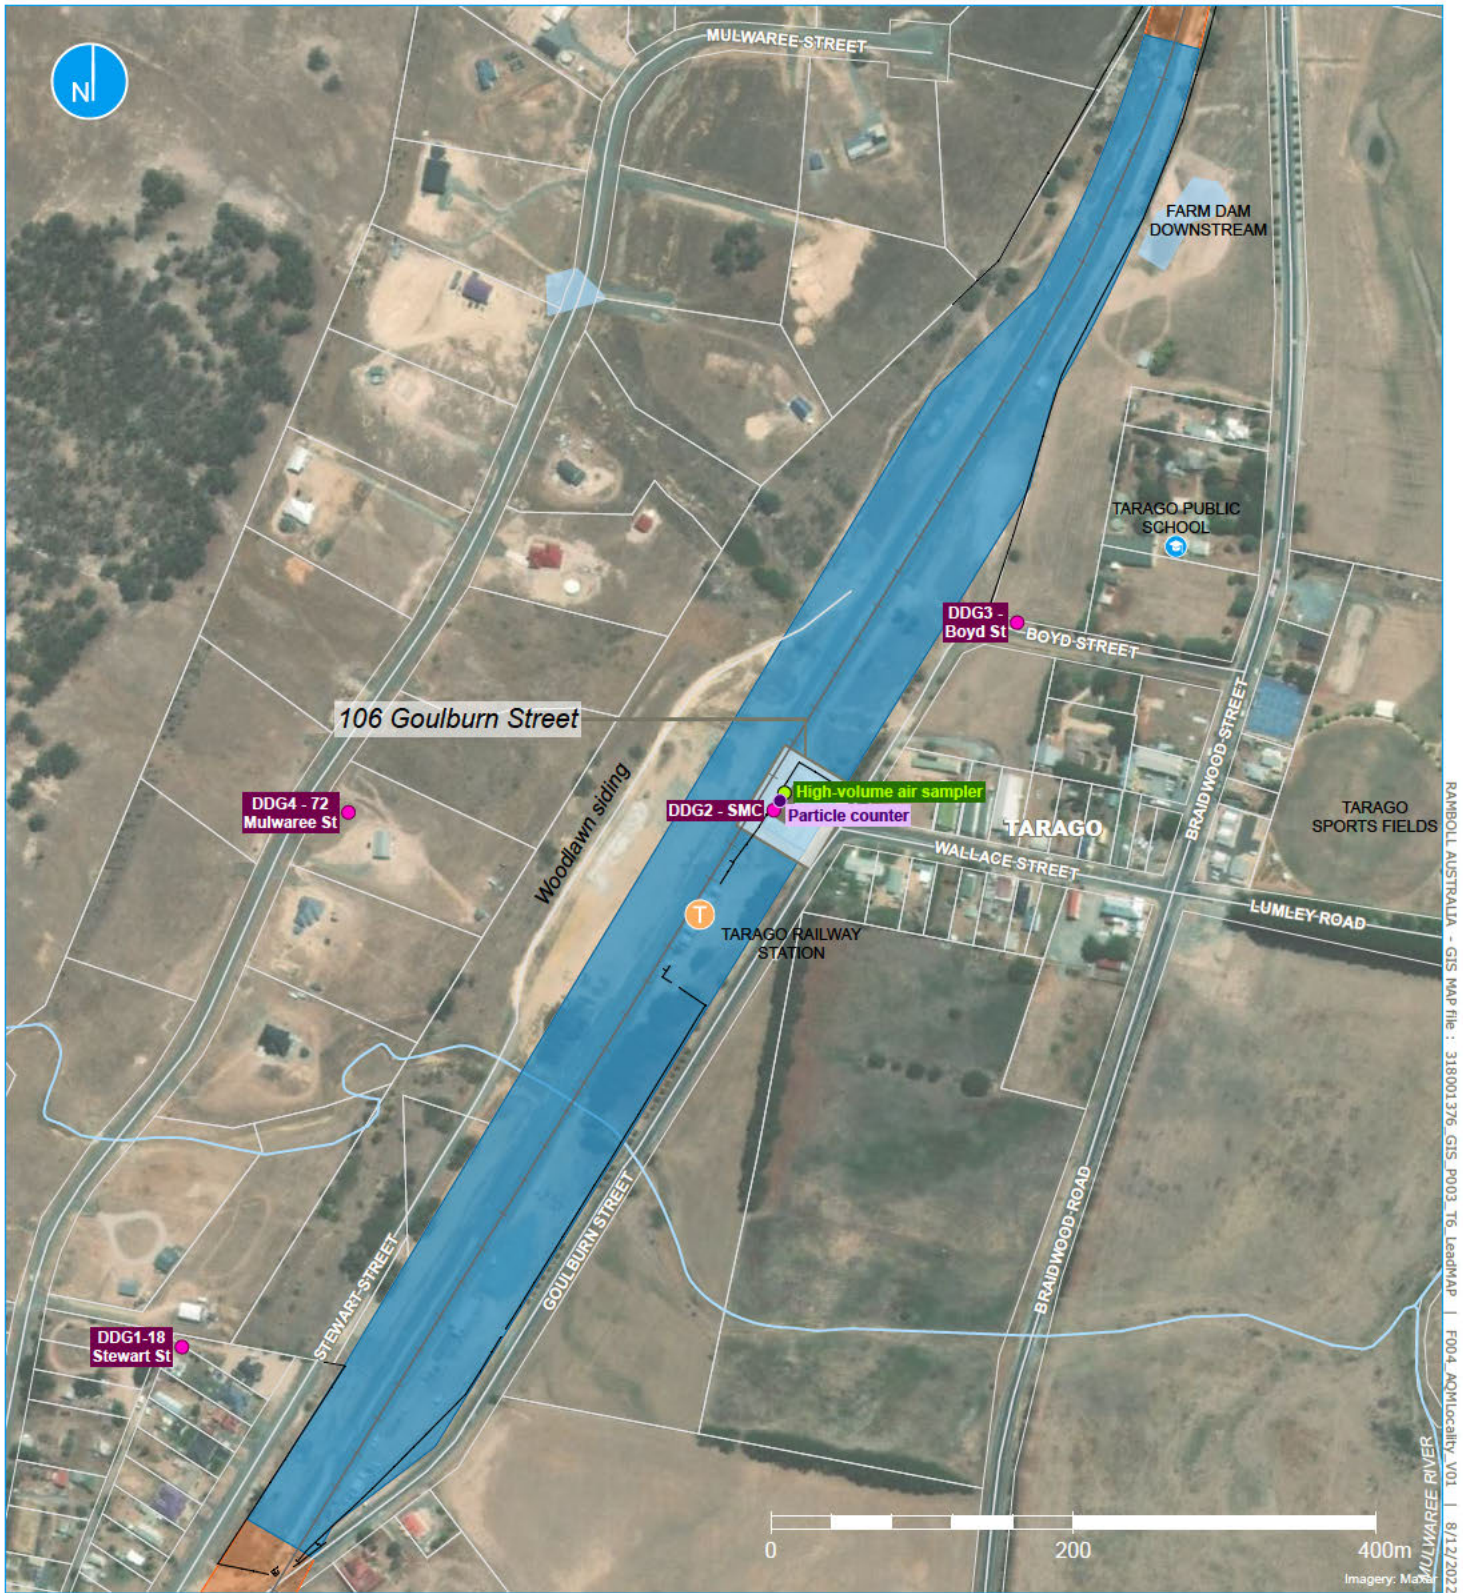
Figure 4 | Air quality monitoring locations

Deposited dust sampling was reinstated at the same locations as previous sampling with the exception of 96 Mulwaree Street Tarago where access was denied. A new location at 72 Mulwaree Street, referred to as DDG4-B, located 200 metres south-south-west of former location DDG4, was sampled and considered to be representative of potential impacts to the west of the rail siding.

Air quality sampling locations are shown in Figure 4 in Attachment 2.

Concentrations of deposited dust (insoluble solids) were recorded below the annual average criterion of 4 g/m²/month at all locations with the exception of DDG4-B sampled in Dec/Jan 2023. The rolling annual average was below the criterion at all locations. Lead was not measured above the detection limit (1 µg) at any of the monitoring locations.

Concentrations of lead were recorded below the annual average criterion of 0.5 µg/m³ at all locations. Concentrations of TSP were recorded below the annual average criterion of 90 µg/m³.

Based on the data collected during the monitoring period, lead containing TSP originates from the west to west-northwest of the monitoring location, in the direction of the siding. The highest TSP lead concentration was recorded on a day when regional winds originated from the south-east.

- Based on lead not being detected in deposited dust above the detection limit at any monitoring location and concentrations of lead in particulates detected below the annual average criterion during the nine months of air quality monitoring between October 2022 and October 2023, the auditor is satisfied that ongoing air quality monitoring prior to remedial or other activities that may result in the disturbance of ground surfaces at the site, is not required.
Should air quality monitoring (dust deposition, lead deposition and TSP measurement) be altered or ceased then the Lead Management Action Plan (Ramboll 2023g) will require amendment.
