JBS&G 64627 – 154,525

L007 (Interim Audit Advice Tarago Woodlawn Siding Rev 0)

L007 Interim Audit Advice (0503-2303-007) – Tarago Woodlawn Siding NSW – Remedial Options Assessment Tarago Rail Corridor

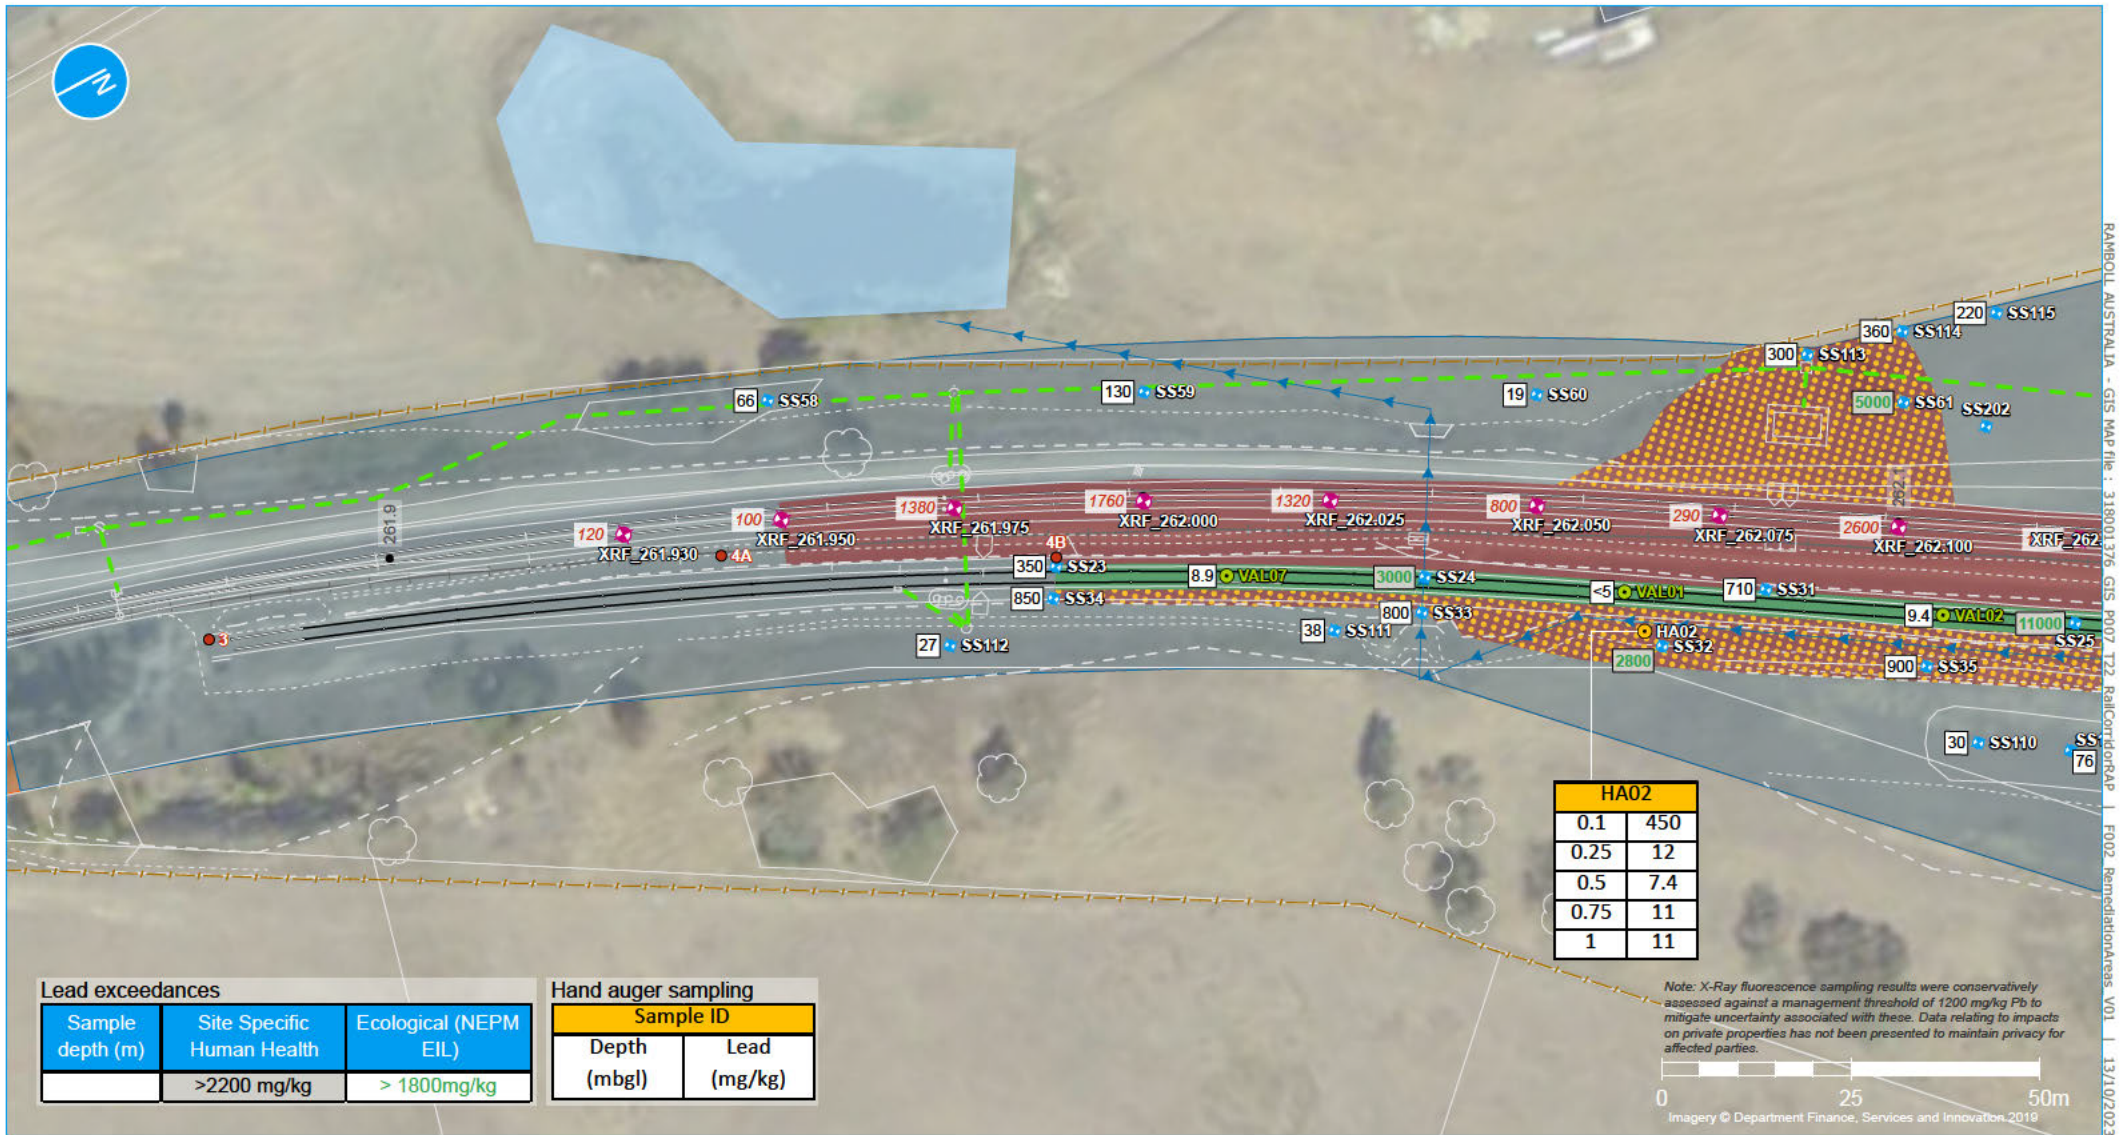
Figure 2a | Site Plan

Within the rail corridor, ballast within the rail siding, loop line, main line and adjacent soils have been identified as being contaminated with lead. The location and extent of the site are shown in Figures 1 and 2, in Attachment 2.

The proposed remediation extent is shown in Figures 2a-2e, Attachment 2.

Area to be Remediated/ Managed	Area (m ²)	Depth (m bgl)	Volume (m ³)
Lead impacted ballast and soil surrounding siding (excluding the rail formation) – excavation	6,300	0.3	1,890
Redundant Woodlawn siding - excavation	4,000	0.5	2,000
Former Station Masters Cottage (excluding house footprint) - excavation	1,000	0.25	250
Railway sleepers – General Solid Waste			100
Total	11,300		4,240

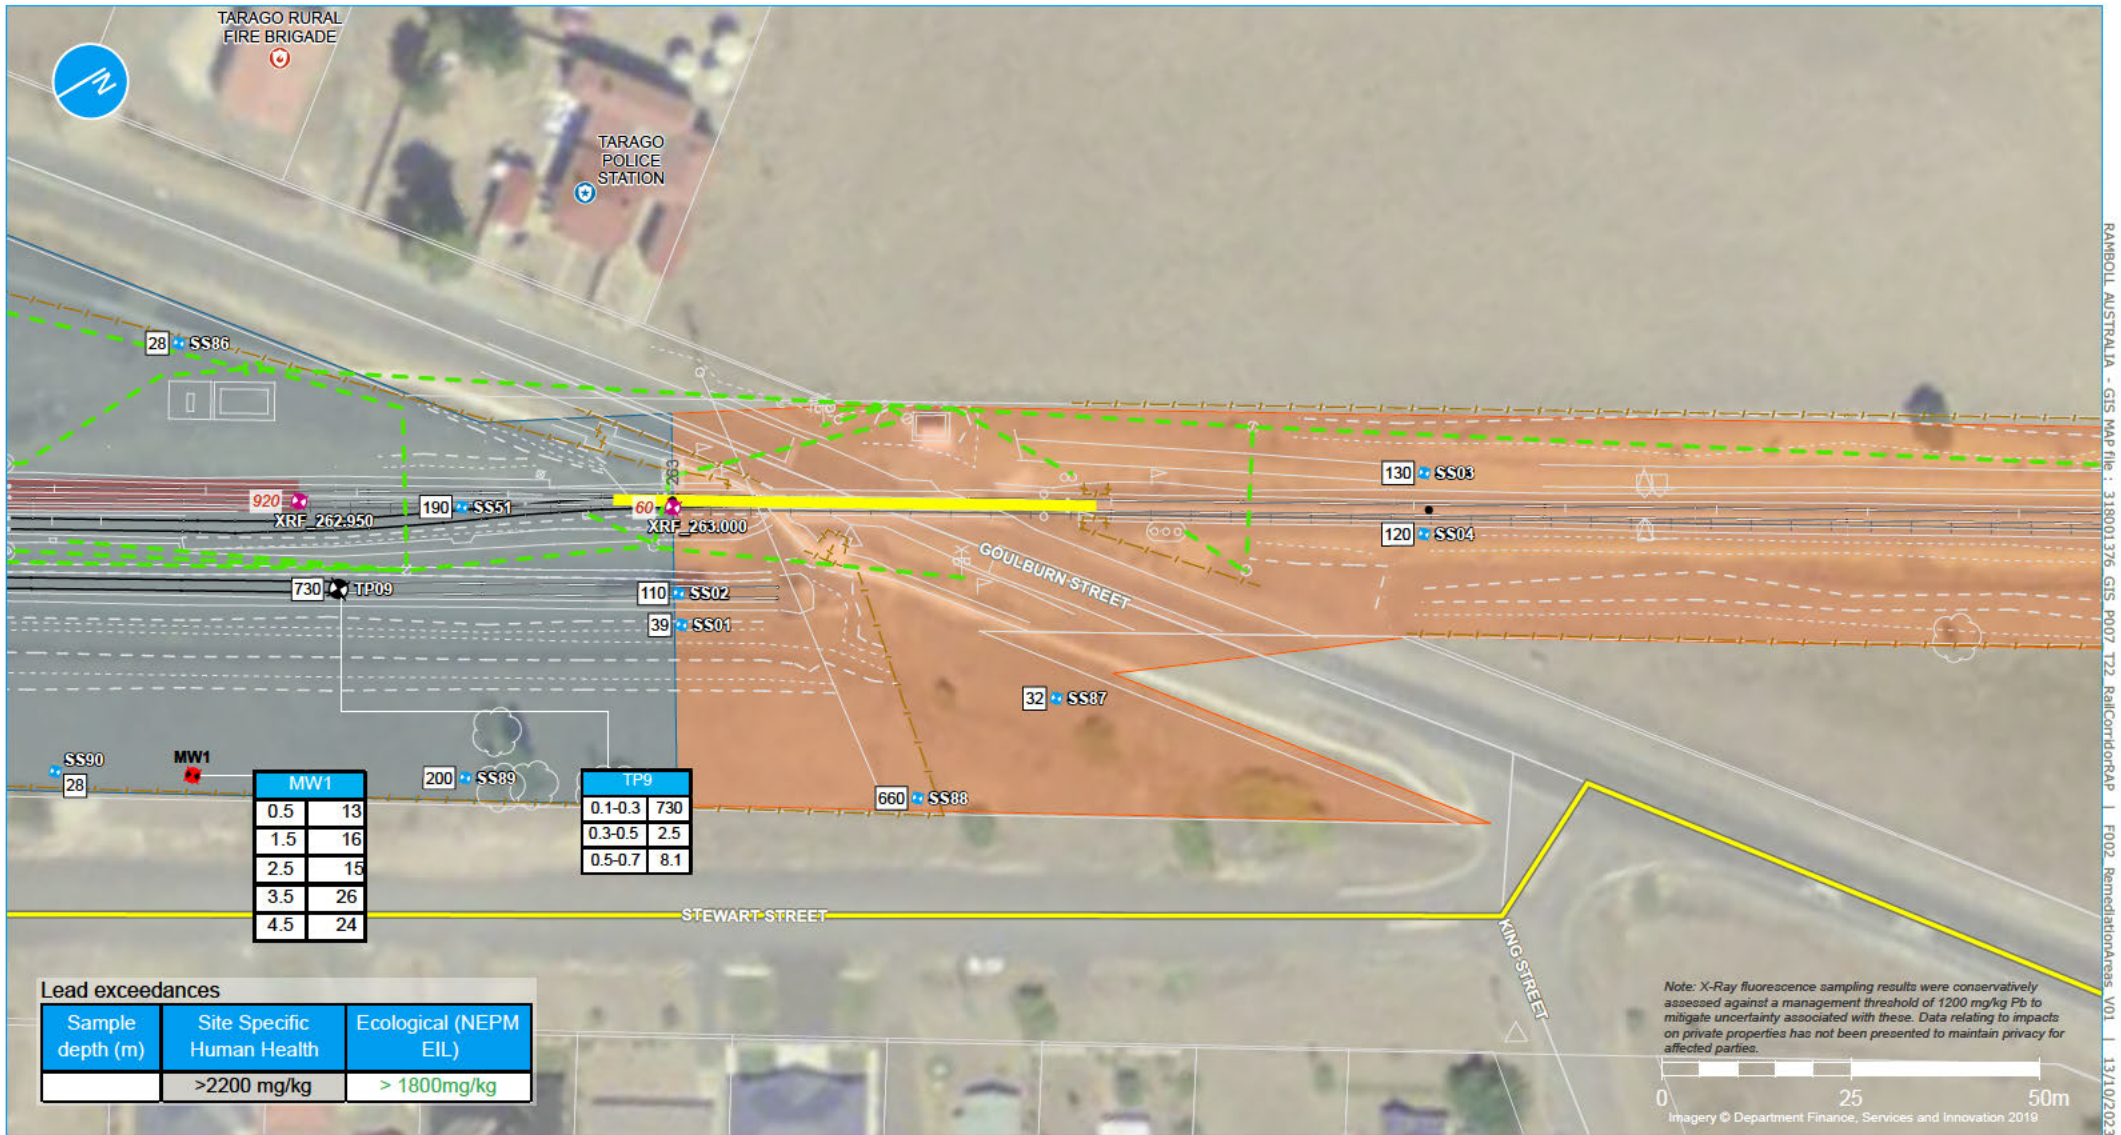
Figure 2e | Site Plan

An area of 20,800 m² of impacted soil is to remain at an estimated depth of 0.5 m bgl below the existing rail formation.
