L003 (Interim Audit Advice Tarago Former Station Masters Cottage Rev 1)

21 November 2023

L003 Interim Audit Advice 003 – Tarago Former Station Masters Cottage 106 Goulburn Street Tarago NSW

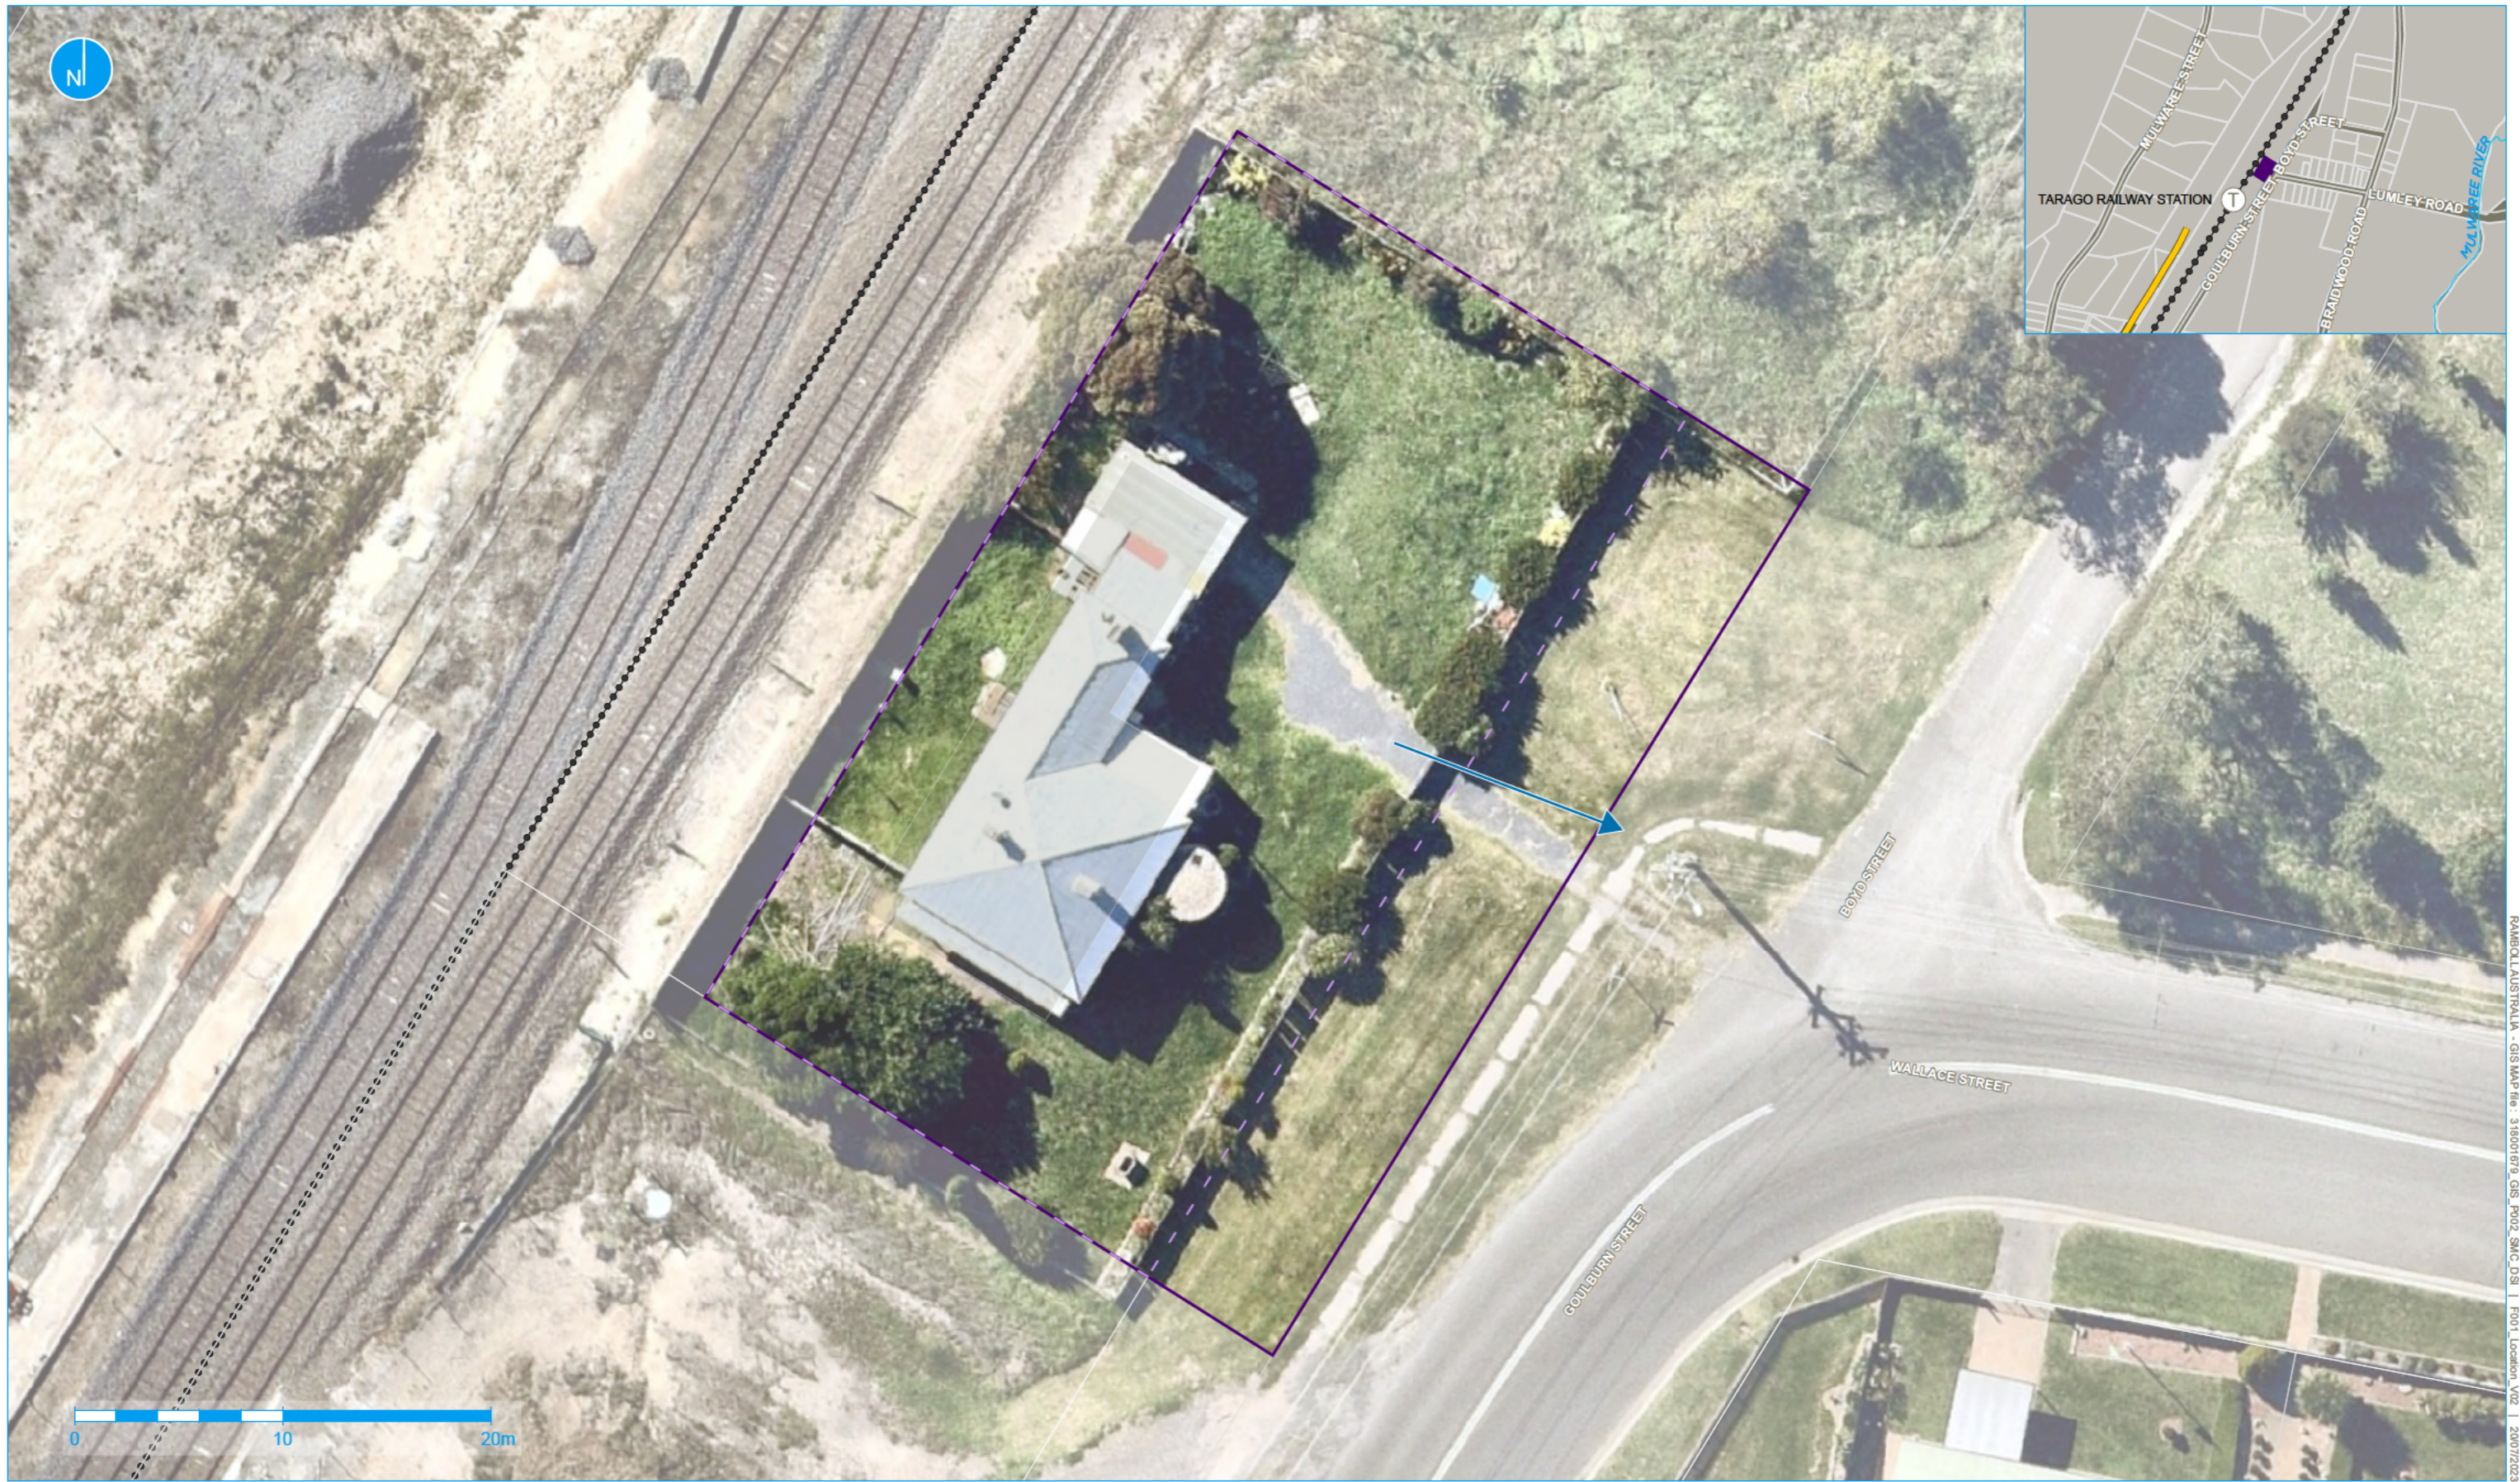
RAMBOLL Figure 1 : Site Layout

Andrew Lau of JBS&G Australia Pty Ltd (JBS&G), has been engaged by Transport for NSW (TfNSW, the client) to conduct a site audit for Lot 1 in Deposited Plan (DP) 816626. Lot 1 DP 816626 is a block of land of approximately 1,550 square metres (m²) known as the former Tarago Station Masters Cottage (the site). The extent of the site area and the location of the site are shown in Figure F1, in Attachment 2.
