L004 (Interim Audit Advice Tarago FSMC IEMP Rev 0)

Transport for NSW

L004 Interim Audit Advice 004 – Tarago Former Station Masters Cottage Interim Environmental Management Plan 106 Goulburn Street Tarago NSW

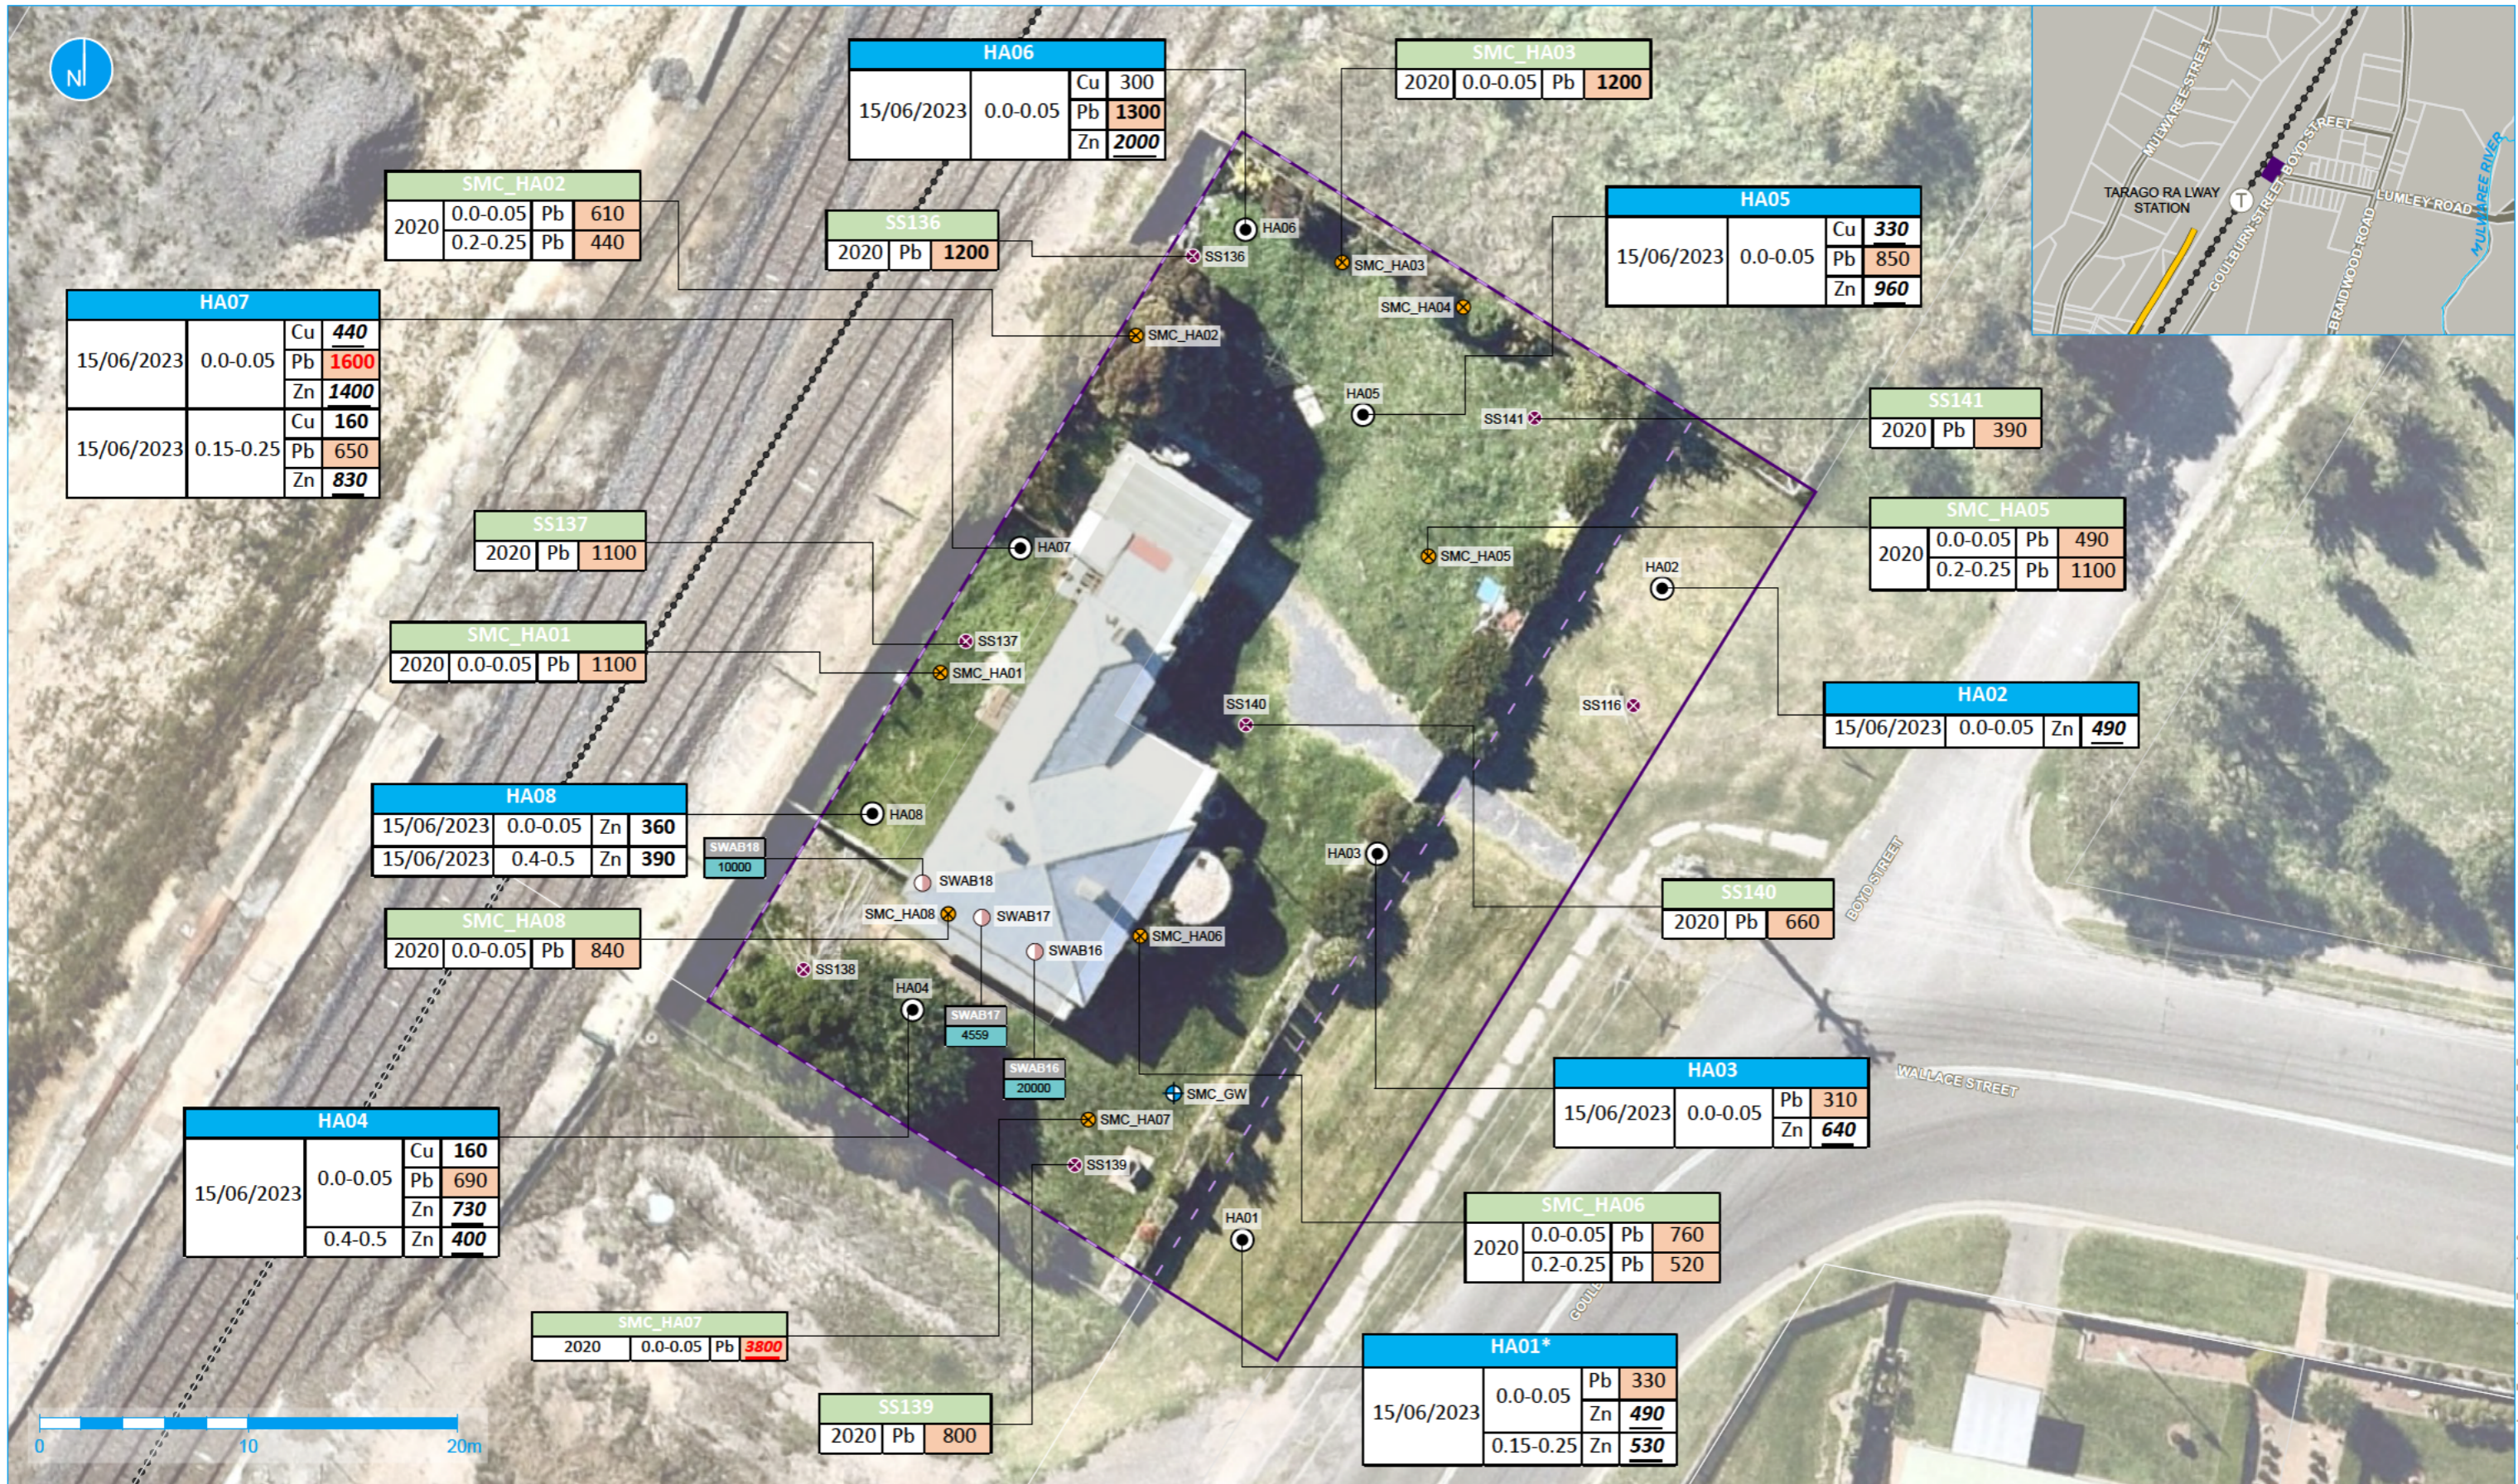
RAMBOLL Figure 2 : External building and soil samples and exceedances

- Soil contamination was identified on-site. The main source of contamination was identified as historic ore concentrate loading and transport activities in the adjacent rail corridor. The mechanism of contamination is surface deposition with limited migration via leaching.
- The key contaminant of concern for human health is lead generally in surface to shallow soils (to a depth of 0.1 m bgl) with some occurrences to a depth of 0.25 m bgl.
- Concentrations of lead, zinc and copper present in shallow soils may pose a risk to ecological health (transient wildlife, grass and shrubs).

- Flaking lead-based paints from degradation of the former station masters cottage building/structures (front verandah) has been identified as a source of soil contamination.
