STRATEGIC ENVIRONMENTAL  
AND ENGINEERING CONSULTING

our reference: 22000129-R-02  
your reference:

14 June 2022

### **Review of Surface and Ground Water Quality: Windsor Bridge**

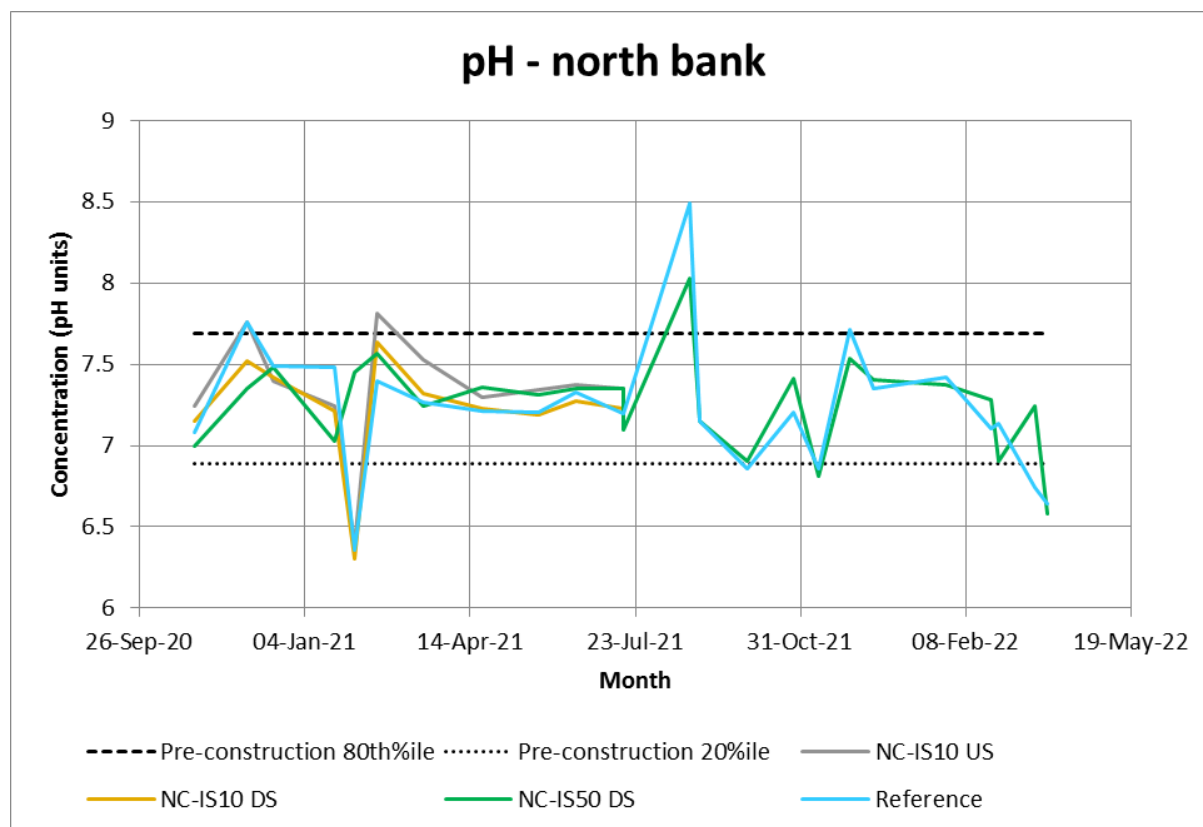
**Figure 4: Plot of pH at the north bank locations, post construction phase.**

Based on the data in Figure 4, pH is generally within the pre-construction SSTVs and within the ANZECC guideline values (8.5-6.5) except for 6.39 on 3 February 2021 and 6.29 on 22 March 2022, both of which were wet days. pH also decreased at the upstream reference site indicating that the variation was unlikely to be due to the Windsor Bridge project.

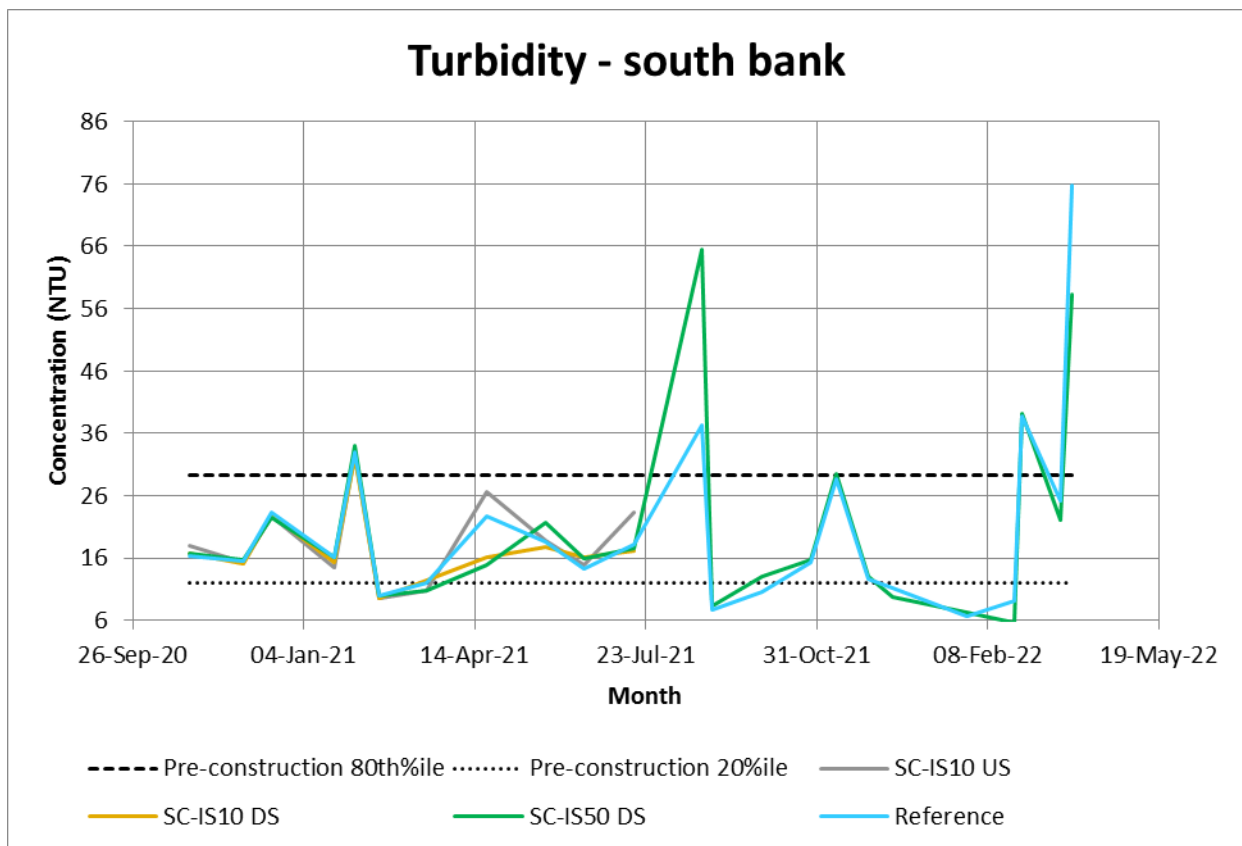
The south bank impact site 50m downstream of the bridge had two instances where turbidity exceeded the ANZECC trigger value. Both were following significant rainfall events in August 2021 and March 2022. The downstream turbidity during the August event exceeded the upstream reference site turbidity however the March event did not. This increase could have been due to exposed soil at the project site however given the possibility that turbidity could have been derived from surrounding agricultural lands, it is not possible to confirm this. Furthermore and as noted above, this anomaly was not repeated during the March 2022 wet weather event.

Several other high rainfall events occurred after the August 2021 round of monitoring, and the turbidity at the project impact site was consistently less than the reference site. This indicates that, if the August 2021 increase was due to construction activities, it had been resolved, possibly by the completion of works and the application of ground cover to limit erosion.

**Figure 7: Plot of Turbidity at the south bank locations, post construction.**

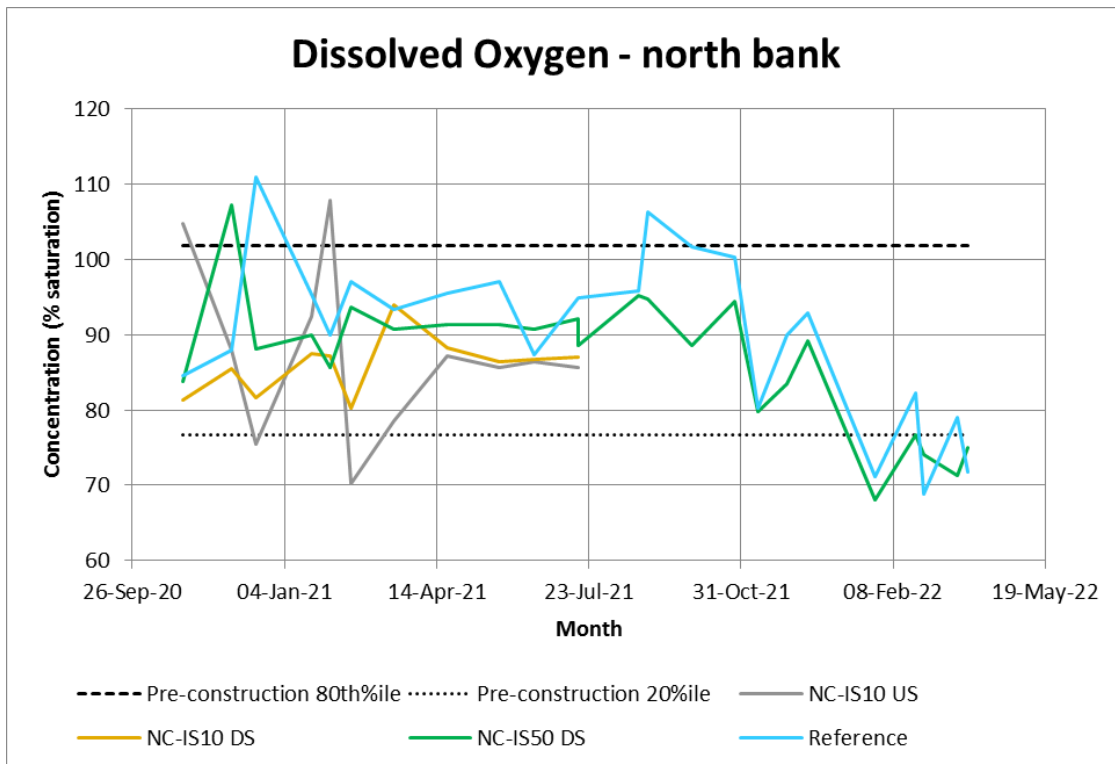
Figure 8: Plot of Dissolved Oxygen at the north bank locations, post construction.

Dissolved oxygen was generally within the SSTVs. Values dropped below the SSTVs at the north bank between February and March however this trend also occurred at

the reference site indicating that it is unlikely that the project was the cause for the observed change in dissolved oxygen levels.

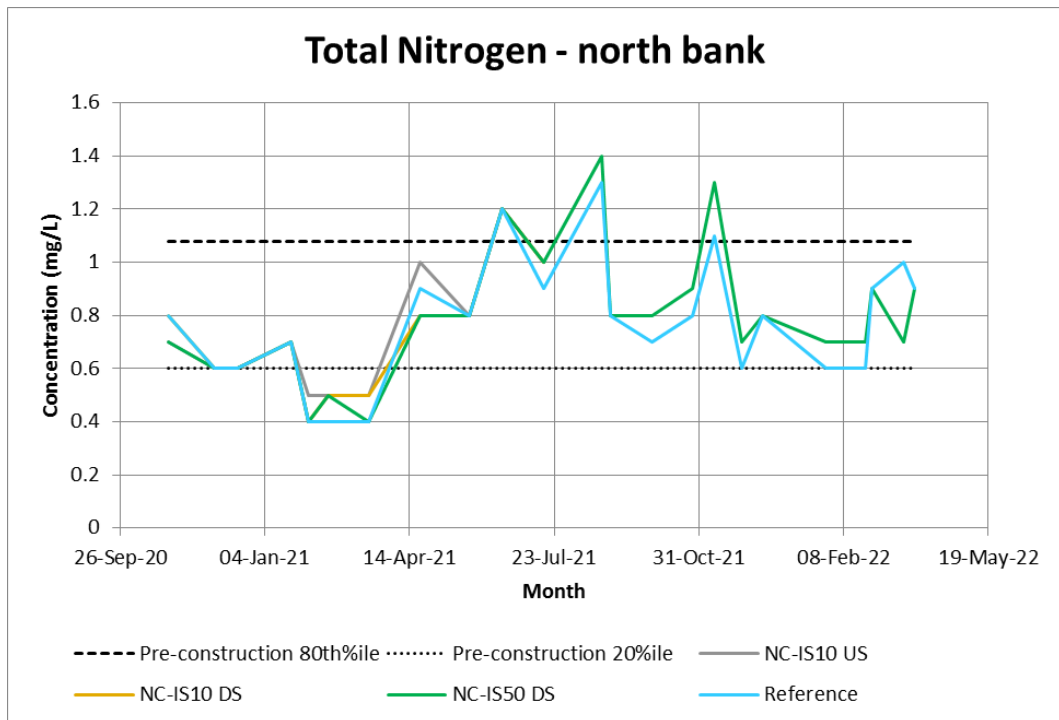
Figure 10: Plot of Total Nitrogen concentrations at the north bank locations, post construction.

Total nitrogen levels exceeded the ANZECC trigger value of 0.35mg/L but were generally within or below the SSTVs. Observed increases occurred after rainfall events apart from the elevated value observed on 17 June 2021. However this increase also occurred at the reference site indicating that it is unlikely that the

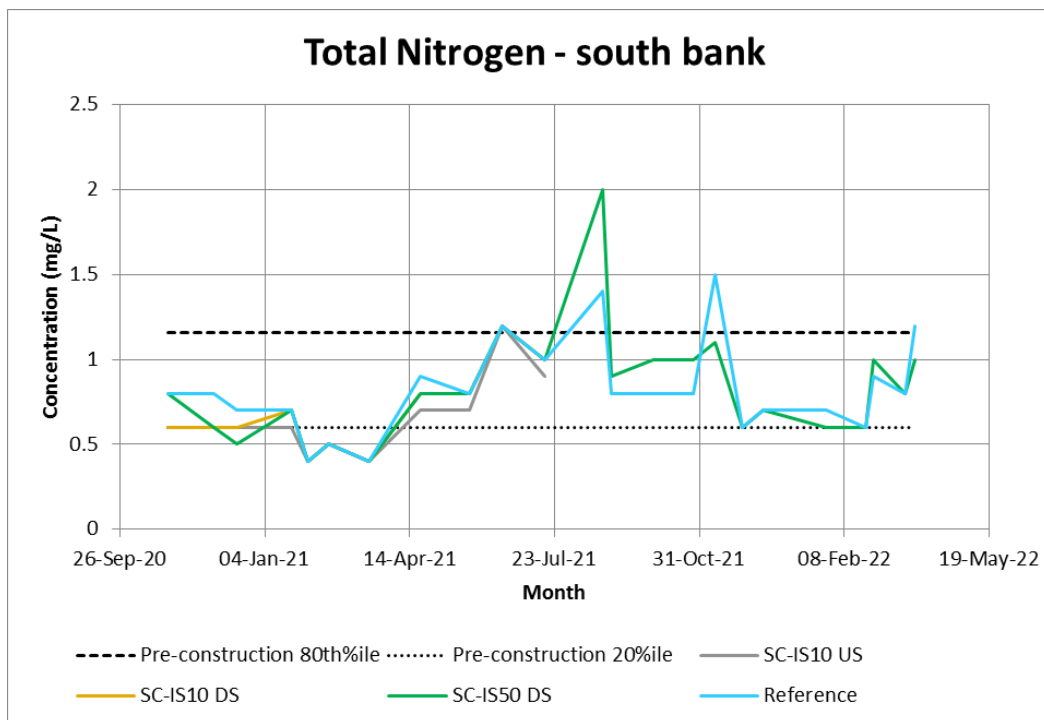
Figure 11: Plot of Total Nitrogen concentrations at the south bank locations, post construction.

project was the cause for the observed change in nitrogen concentrations. The south bank had a spike on 25 August 2021 following a significant rain event. It is unclear if this was due to the project, and we noted that nitrogen levels were below the reference site for all subsequent rain events.

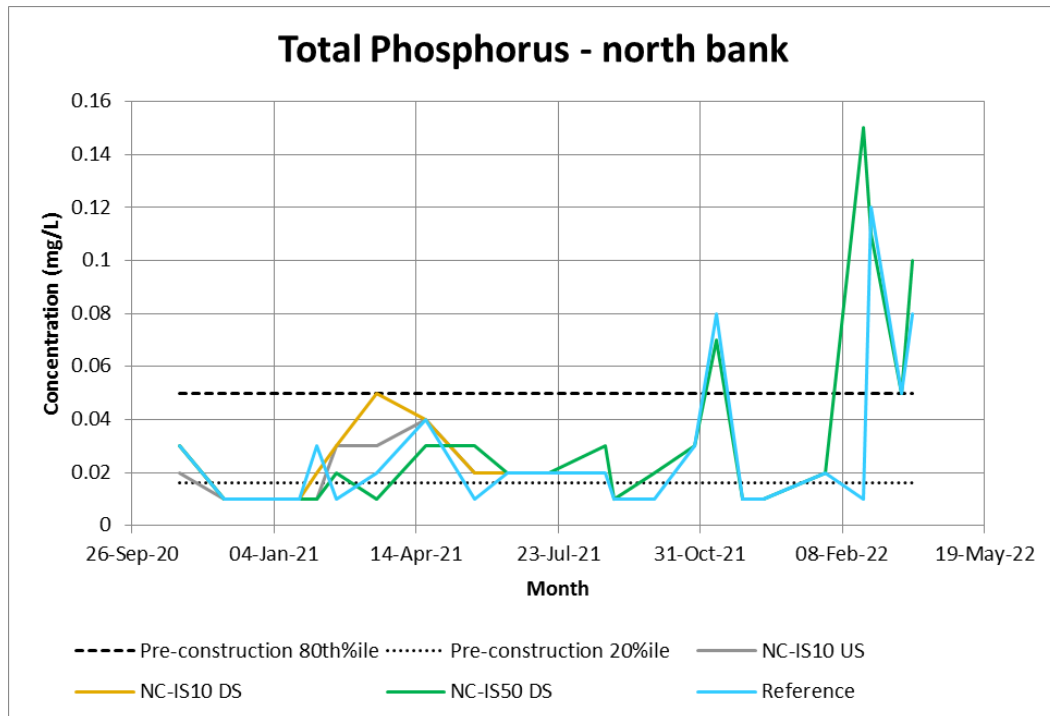
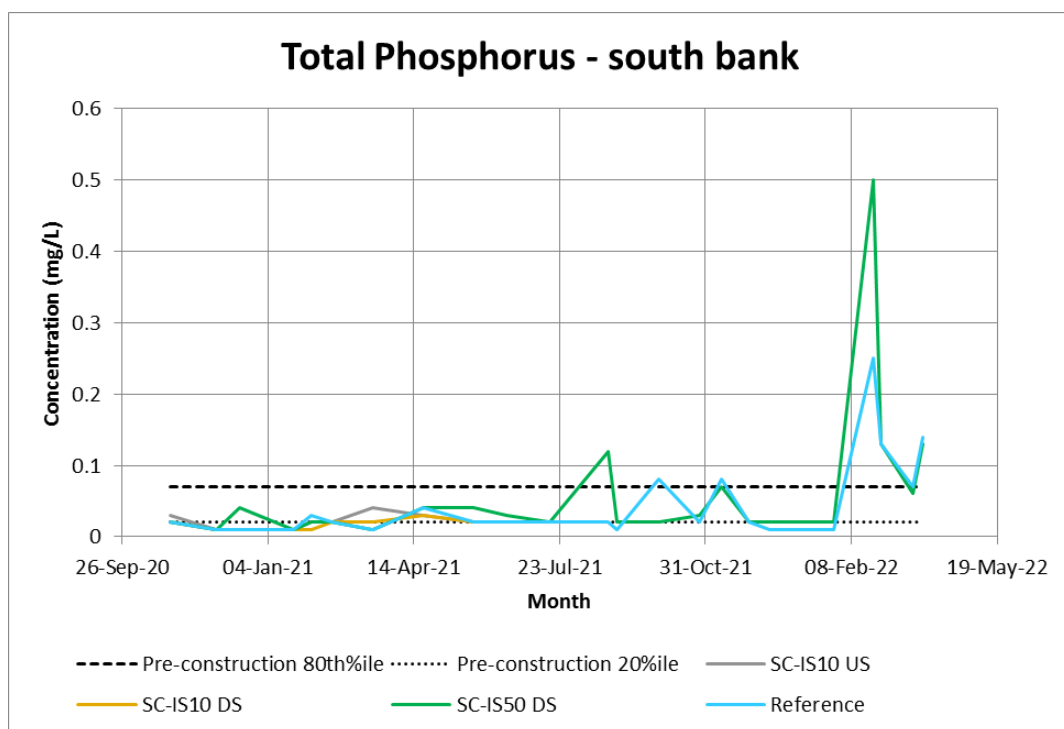
Figure 12: Plot of Total Phosphorus concentrations at the north bank locations, post construction.

Figure 13: Plot of Total Phosphorus concentrations at the south bank locations, post construction.

Total phosphorus levels exceeded the ANZECC trigger value of 0.025mg/L several times but were generally within the SSTVs. Observed increases occurred after rainfall at both the impact sites and at the reference site. The spike after the rainfall event on 23 February 2022 exceeded the reference site increase however the recorded value at SC-CS2 (upstream south bank wet weather site) had a Total Phosphorus value of 0.51mg/L which was more than the value recorded downstream. As any increases also occurred upstream or at the reference site it is unlikely that the project caused any change in observed phosphorus concentrations.

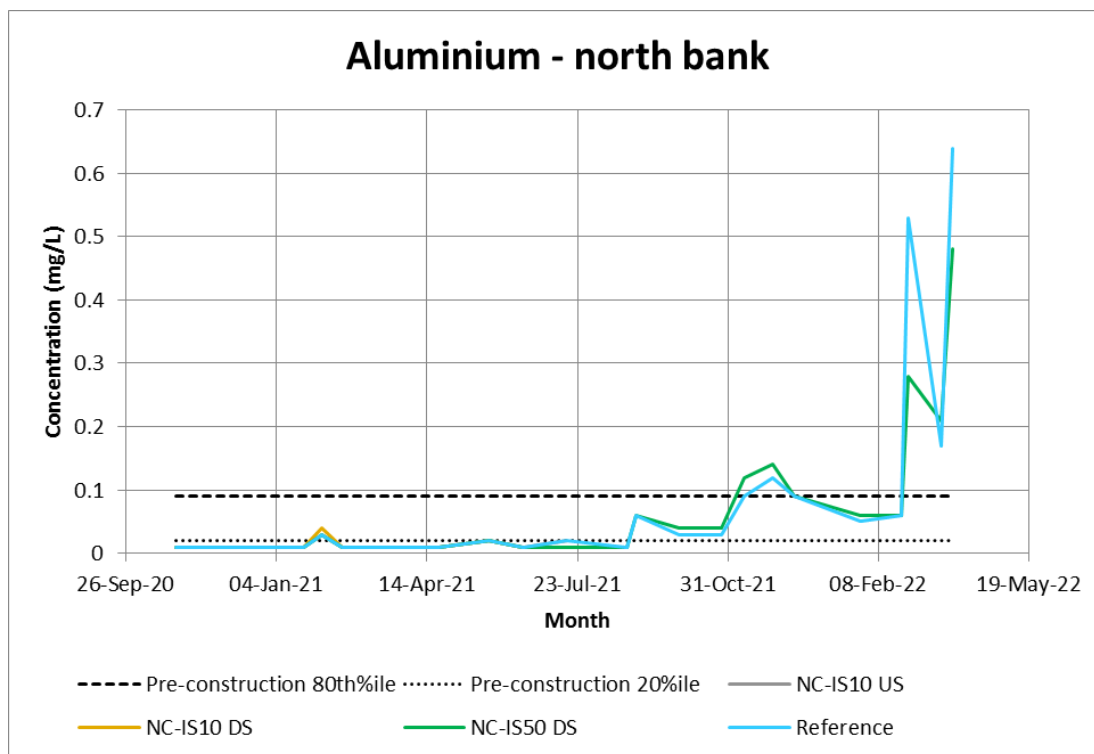
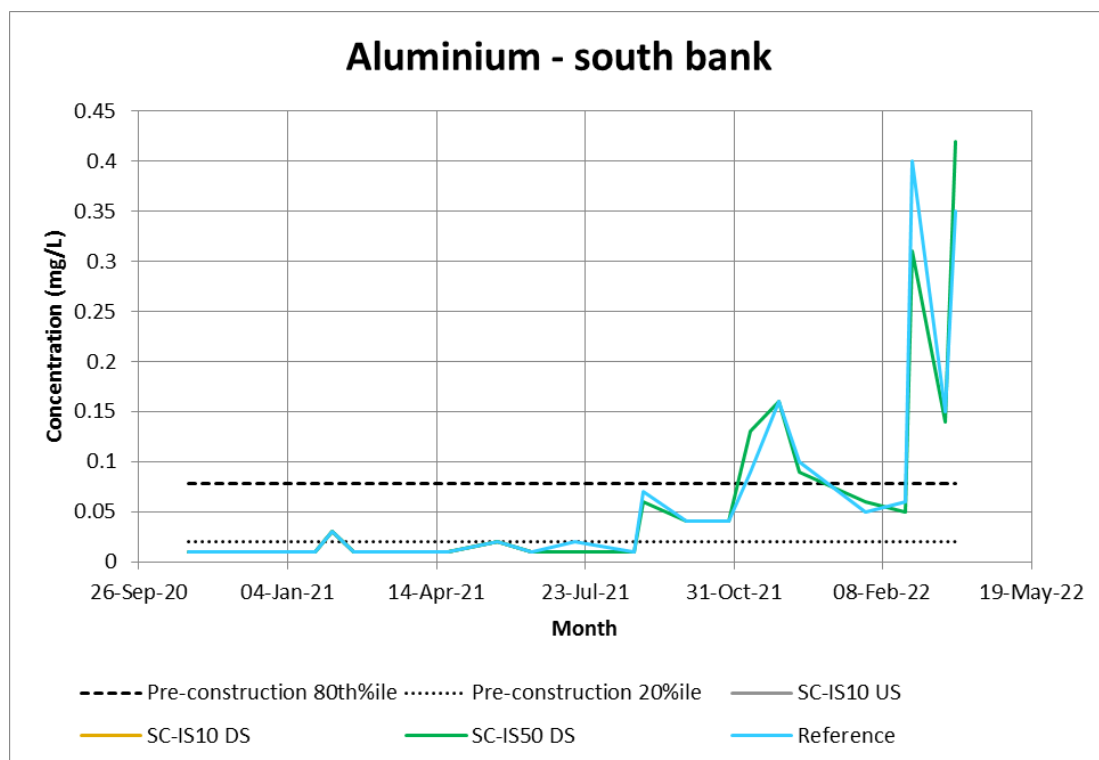
Figure 14: Plot of Aluminum concentrations at the north bank locations, post construction.

**Figure 15: Plot of Aluminum concentrations at the south bank locations, post construction.**

Aluminium levels were below the SSTV and ANZECC trigger value of 0.055mg/L between September 2020 and August 2021 (i.e. during the construction period). However after this date aluminium levels spiked above the SSTV and the ANZECC trigger levels. This increase also occurred at the upstream reference site indicating that it is unlikely that the project was the cause of the observed change in aluminium concentrations.

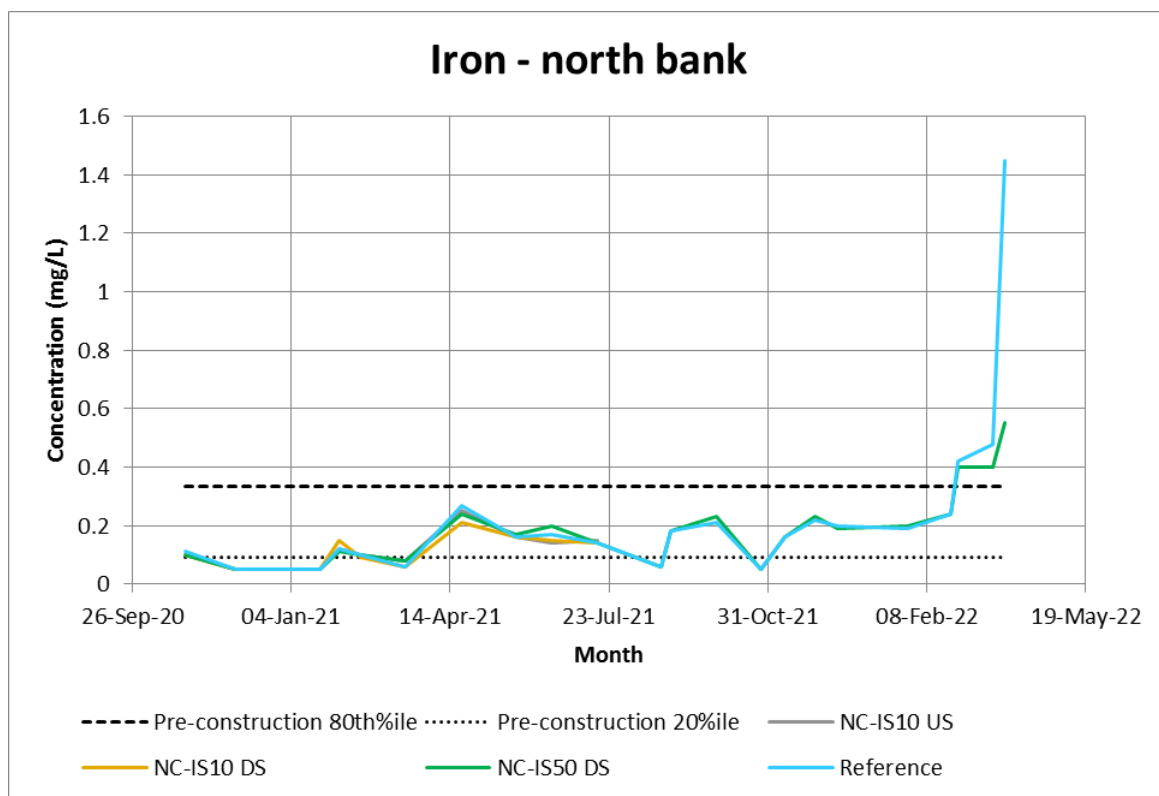
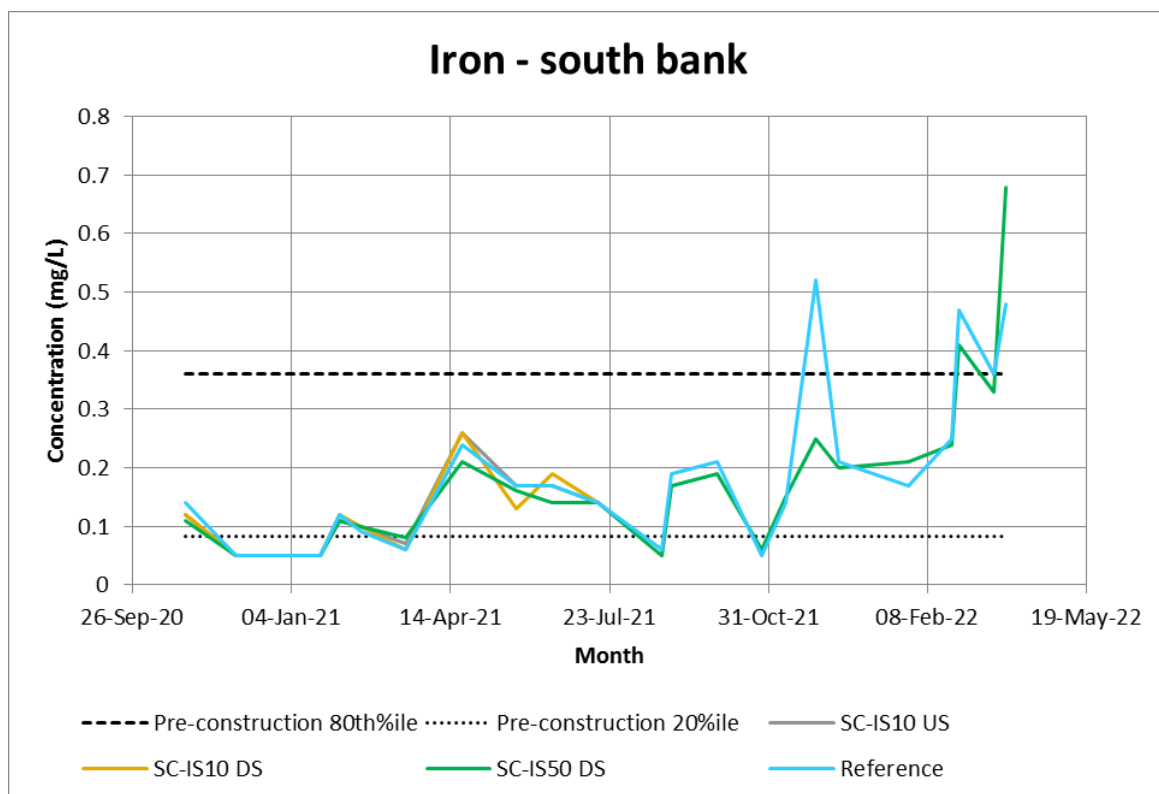
**Figure 16: Plot of Iron concentrations at the north bank locations, post construction.**

**Figure 17: Plot of Iron concentrations at the south bank locations, post construction.**

Similar to the observed aluminium concentrations, iron levels were below the ANZECC trigger value of 0.3mg/L and then spiked towards the end of the

monitoring period. Prior to this time there were no increases above the SSTV. The final observed iron concentration for the south bank exceeded the value recorded at the reference site and at the upstream wet weather monitoring site (SC-CS2). As the monitoring occurred after a major flood event (590mm recorded in March 2022) it is difficult to conclude that the increase is based solely as a result of the project when flood water would likely still be contaminated from runoff from an extended catchment well upstream of the project site.

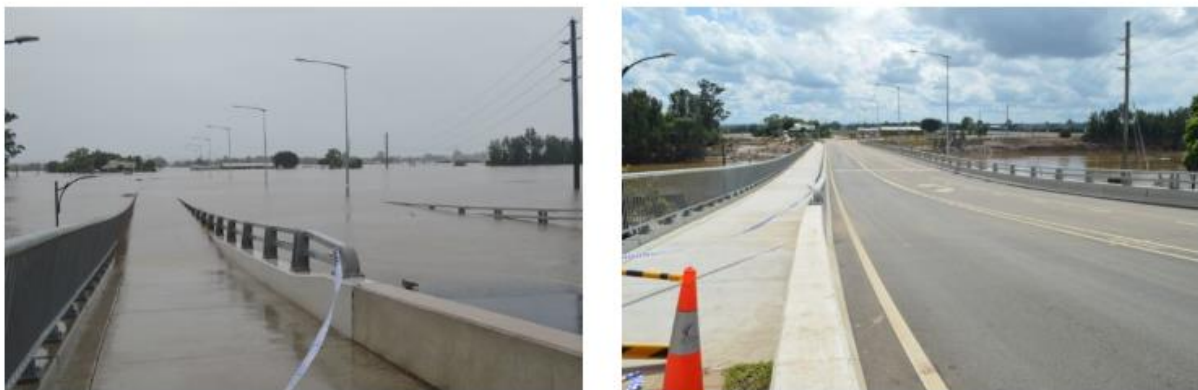
Figure 18: Photos of Windsor bridge during and after the March flood event. Source: <http://www.extremestorms.com.au/windsor-after-the-flood-the-cleanup-begins-sunday-13-march-2022/>

Andrew observed some flood damage to the soft landscaping which was in the process of being repaired. The bridge, bank and associated scour protection works appeared to be unaffected as the rock armouring was designed for the 1 in 2000 year Average Recurrence Interval (ARI) flood event. Given the full extent of flooding at the site, the observed level of damage appeared minimal.

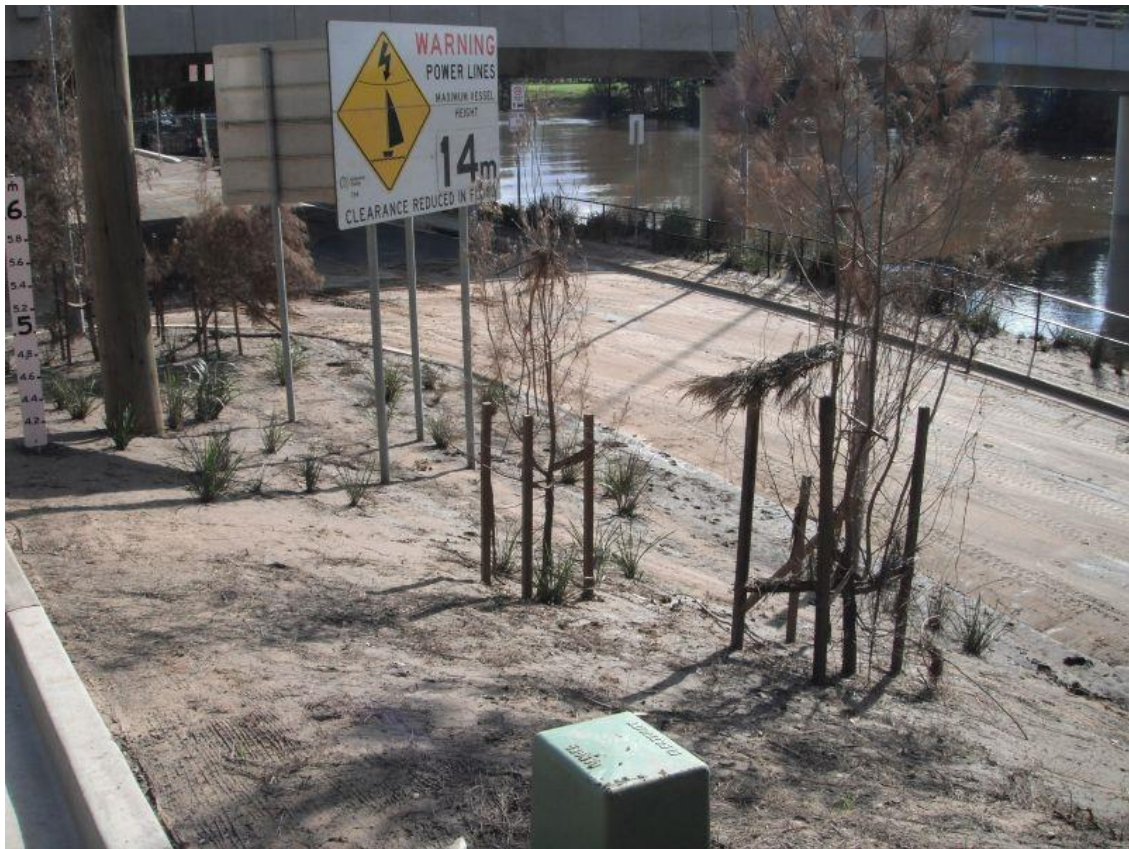
The site inspection indicated that the although the site was damaged by the recent floods, rehabilitated areas disturbed by the project have sufficient ground cover established to prevent erosion, and are considered to be adequately rehabilitated with a C-factor no higher than 0.05 (equivalent to at least 70 per cent ground cover in accordance with Landcom, 2004). As observed on site, maintenance work has been

**Figure 19: Landscaping damaged by floodwaters and deposited silt on service road.**

ongoing to repair and maintain an adequate level of groundcover after the recent flood events.

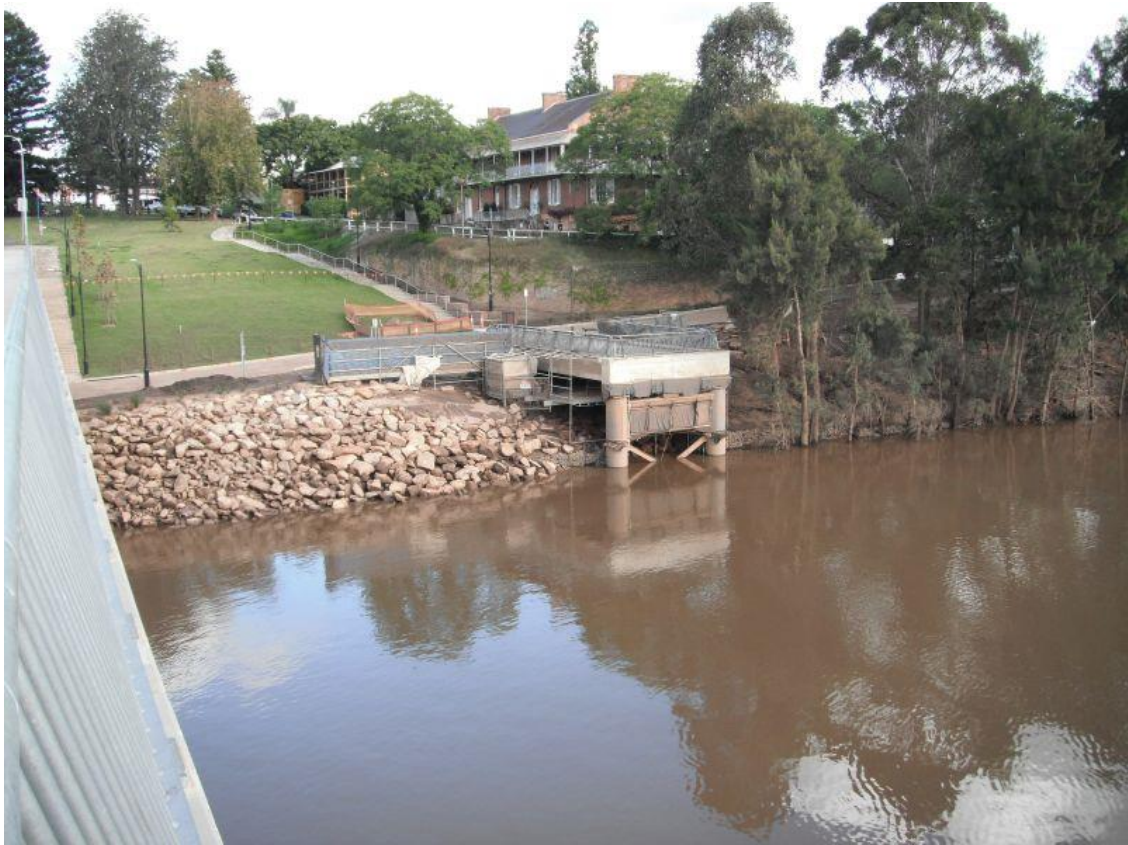
**Figure 22: Old bridge alignment with a rock armoured and grassed bank.**
