Captains Flat EMP Inspection Checklist

Title:	Captain’s Flat Rail Corridor Inspection	Approved:	Project-Nr.: 318001704	Date: 18 April 2024
Site:	Captains Flat, NSW			
Client: UGL Regional Linx

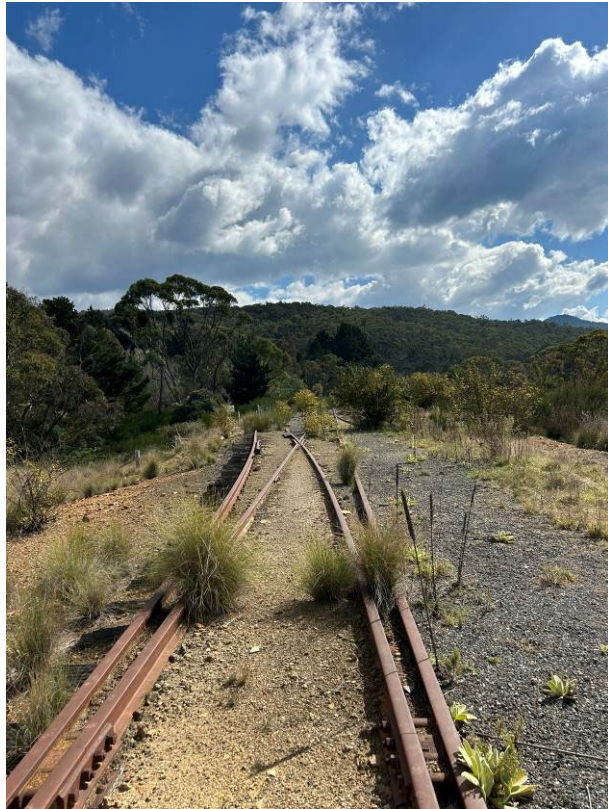
Photo 1: Trainlines behind fence facing north-west. Station Master Cottage to the right of photo. No airborne dust was visible on site.

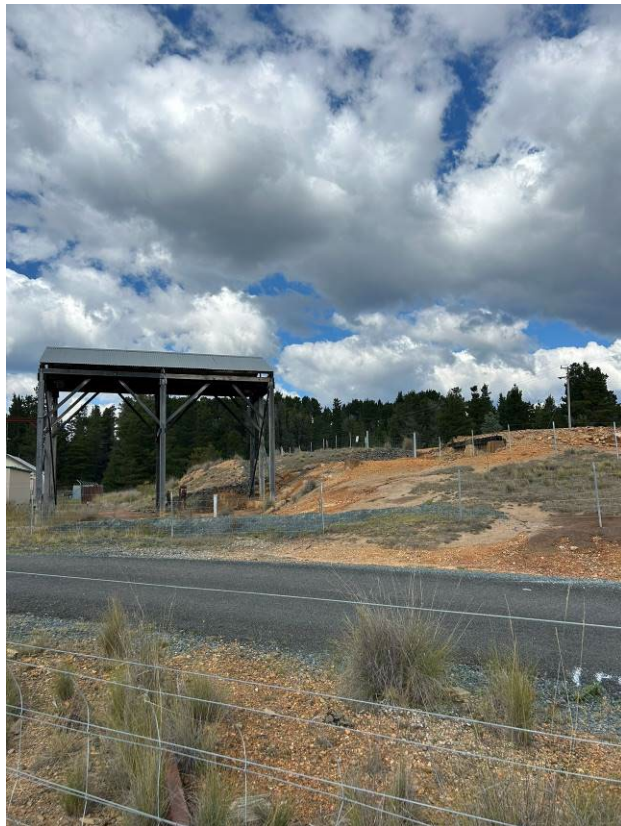
Photo 2: Former Loadout Facility and Weigh Bridge. No airborne dust was visible on site. Facing south-west.

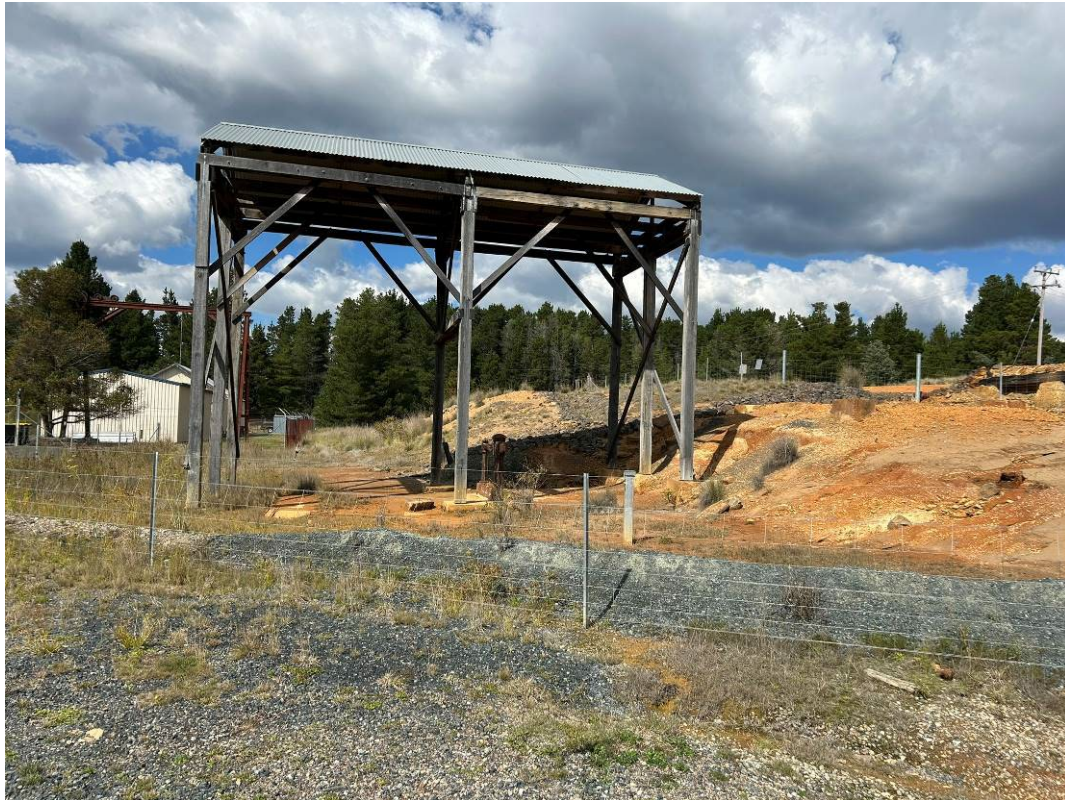
Photo 3: No clear evidence of erosion of soils on site. Located adjacent to Former Loadout Facility and Weigh Bridge. Facing south.

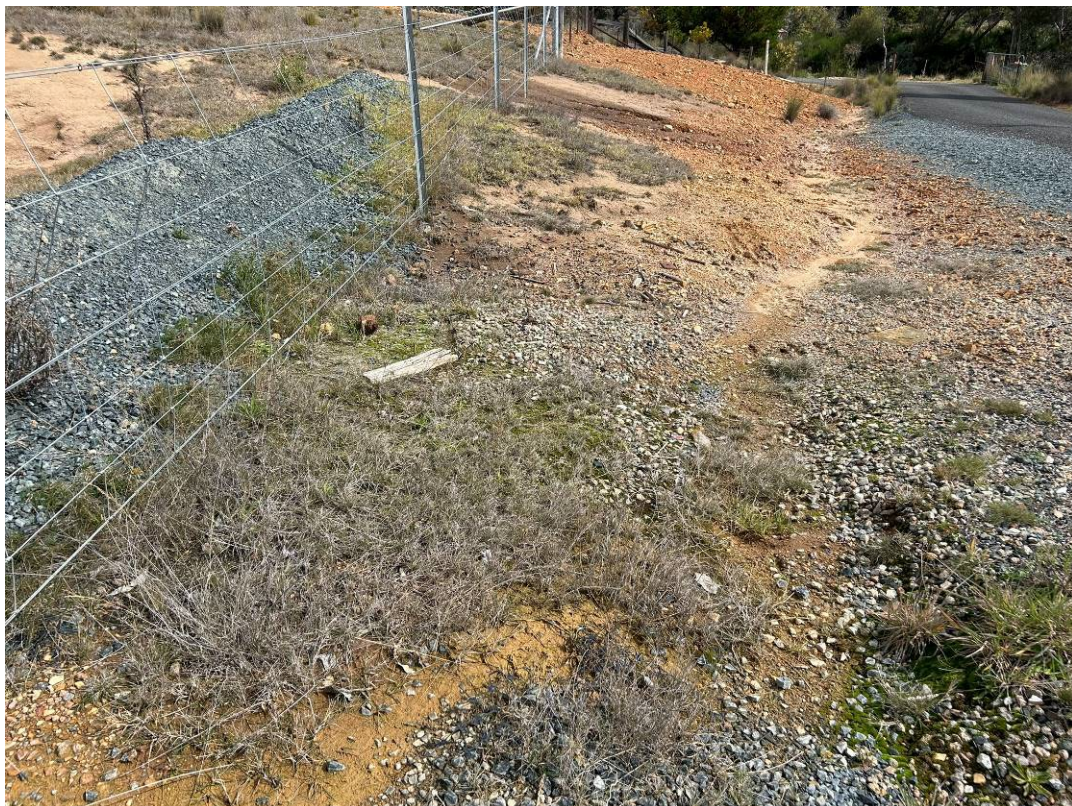
Photo 4A: Evidence of past surface water and sediment runoff into Coppers Creek.

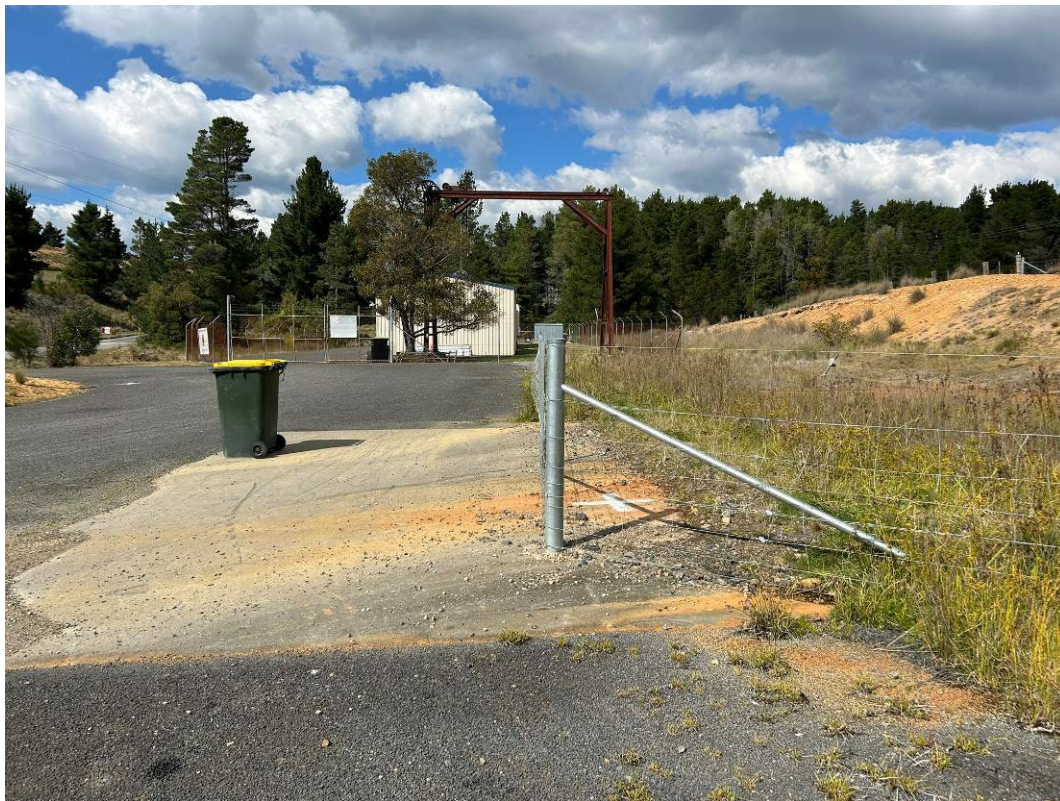
Orange/brown staining on asphalt adjacent the replica ore loading ramp consistent with evidence of mine drainage (**Photo 4B**). High rainfall precedent to the inspection could be expected to have contributed to increased run-off.

Photo 4B: Some sediment visibly trapped in asphalt on site from an upper gradient location. Material is likely to be mobilised contaminated sediment from on-site.

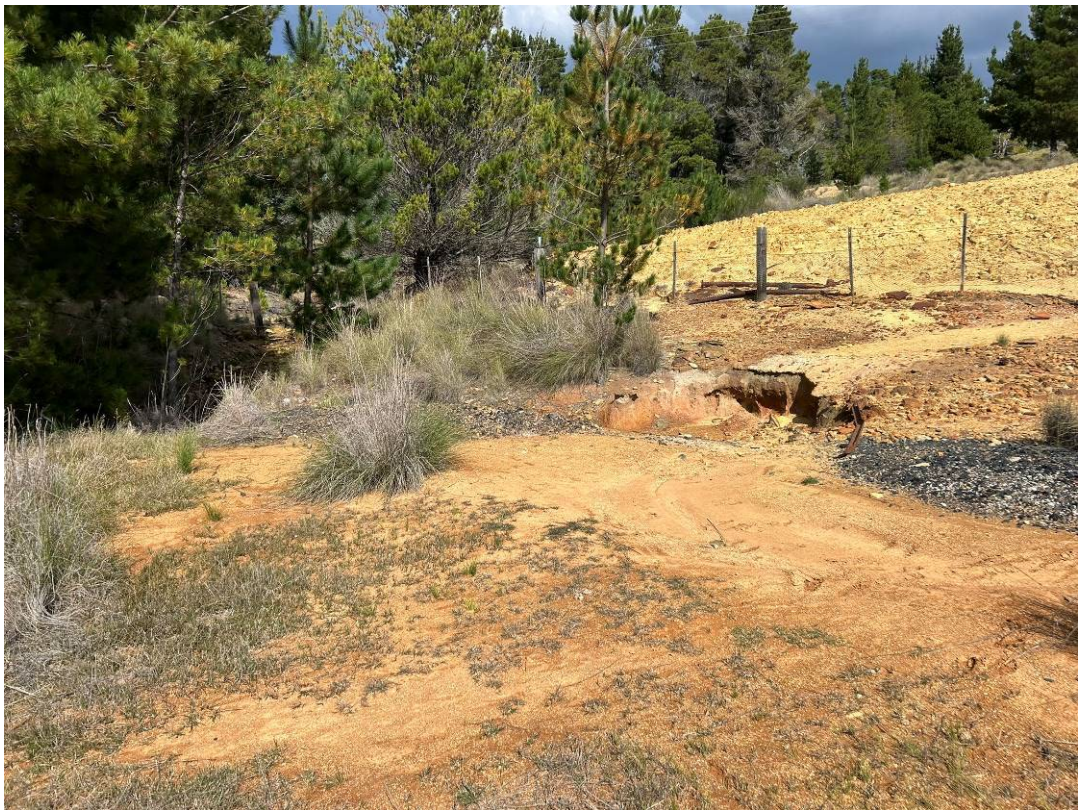
Photo 5: Evidence of erosion of soils on site. No evidence of current surface water runoff into Coppers Creek. Located south of the State Emergency Service (SES) facility.

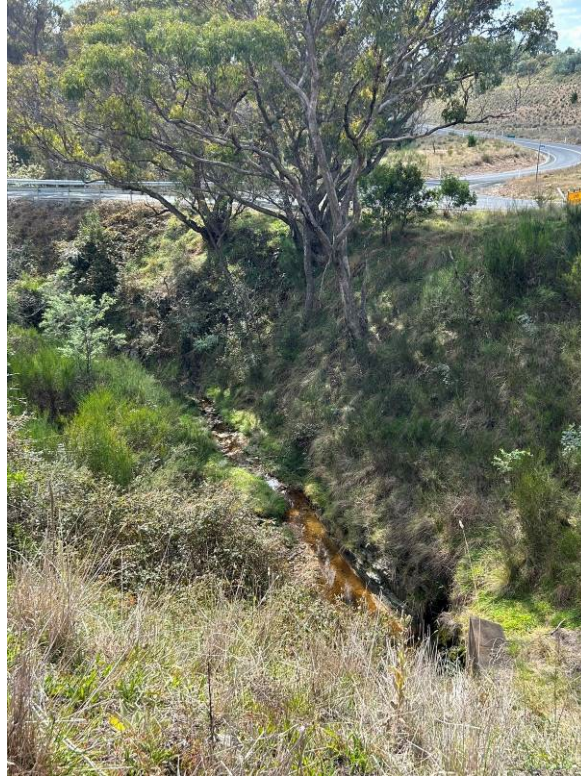
Photo 6: Photo taken from abandon rail track (southern boundary of site). Copper Creek visible. No evidence of current onsite surface water runoff into Coppers Creek. Facing north-east.

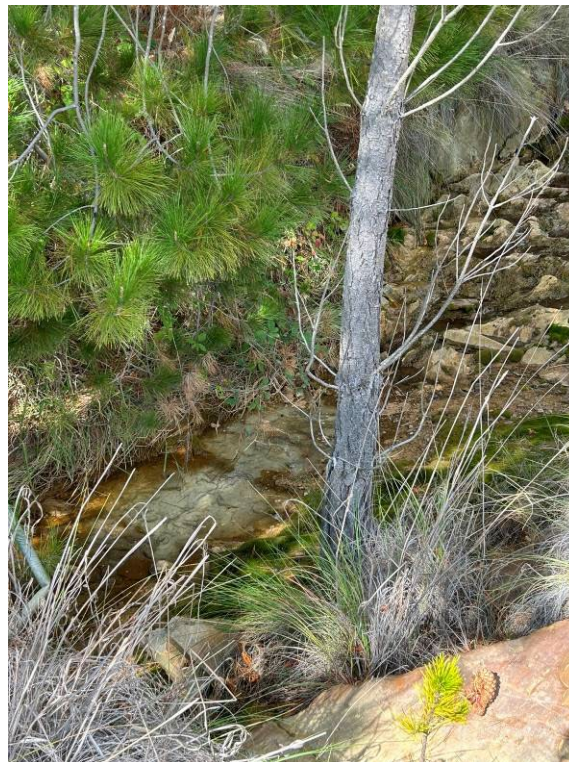
An unnamed creek off-site and down gradient from Captains Flat State Emergency Service shows slightly cloudy surface water with sediment present. This creek is fed from the mine site upstream and is not expected to contain sediment from site (**Photo 7 and 9**).

Photo 7: A small unnamed Creek slowly flowing through the South-Eastern half of the site. There is no sign of additional surface water from on-site sources contributing to the Creek and no evidence of sediment run off from site was observed.

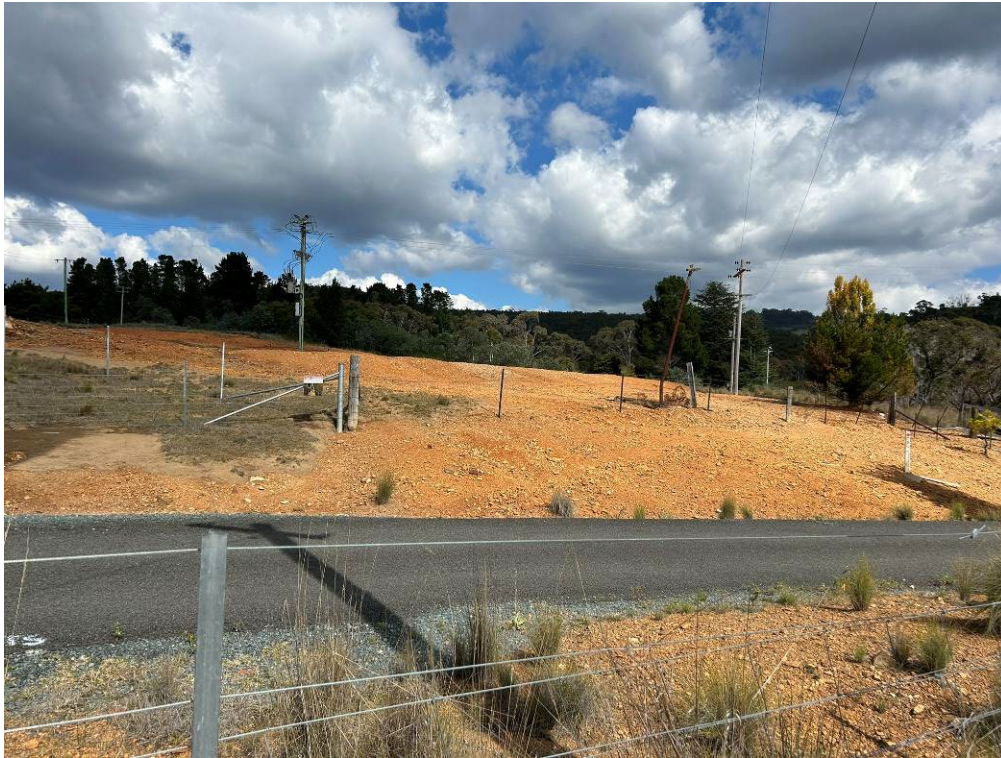
Is capping over Coppers Creek Road preventing inadvertent access to site materials?	Yes		Copper Creek Road Crossing is a sealed road preventing access to soil underneath (Photo 8).	
	Is excavation occurring onsite?		No	n/a no excavation occurring on site	
Plan Ref	Control	Inspection		Corrective Action	Implemented?
		Yes	No

Photo 8: Sealed road over Copper Creek Road crossing, preventing inadvertent access to site materials underneath. There is sign of surface water runoff.

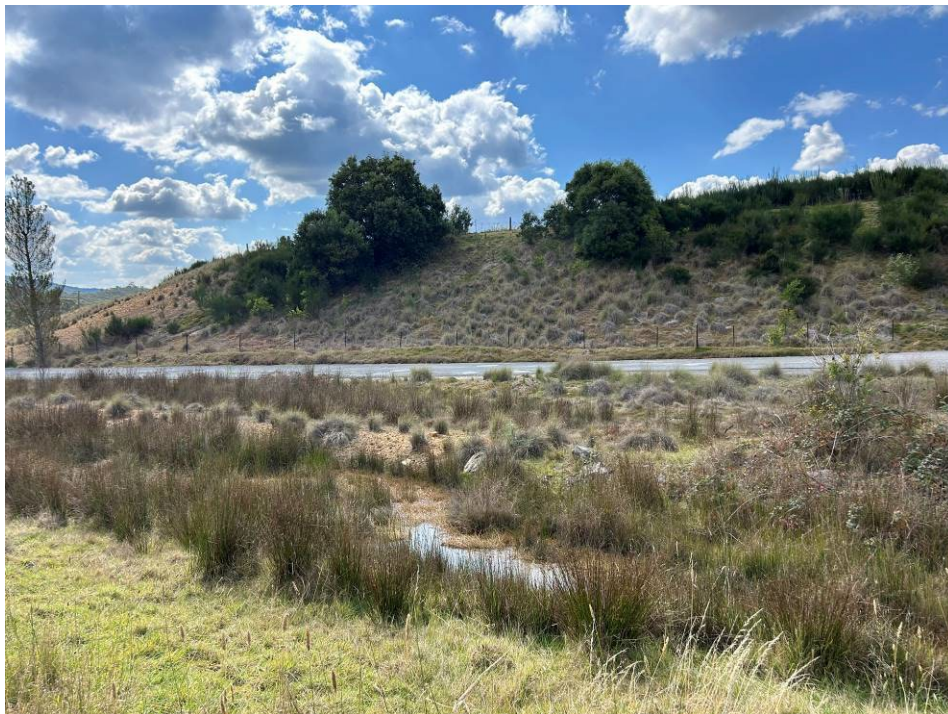
Photo 9: Unnamed watercourse off site and down gradient from Captains Flat State Emergency Service (SES) unnamed creek, showing cloudy surface water with sediment.
