Captains Flat EMP Inspection Checklist					
Date:	18-Jul-24	UGL Representative completing inspection:			
Start time:	2:30 PM				
Finish time:	3:05 PM				
Weather:	7.6°C, 5.4°C lowest temp, 9.3°C highest temp, 0mm of rain since 9am, WNW 22 km/h wind speed, 67% humidity.				
				BoM	
Date and volume of maximum rainfall in a 24hr period since last inspection?					
Date:	12-May-24				
Max volume (mm) in 24hr period:	19.4				
Plan Ref	Control	Inspection		Corrective Action	Implemented?
		Yes	No		
General Observations					
NA	Is airborne dust from site evident?		No	No airborne dust was visible (Photo 1 - 2)	
	Is sediment run-off evident?		No	Evidence of erosion and sediment run-off adjacent the former loader (Photos 4 - 5). Erosion and sediment controls should be reviewed in this area.	
	Is surface water discharging from site?	Yes		Coppers Creek flowing through site, no surface water was running off site into Coppers Creek (Photo 6). Small unnamed creek flowing through south-east corner of site fed by upstream mine site (Photo 7).

Title:	Captain's Flat Rail Corridor Inspection	Approved: JA	Project-Nr.: 318001704	Date: 18 July 2024
Site:	Captains Flat, NSW			
Client:	UGL Regional Linx

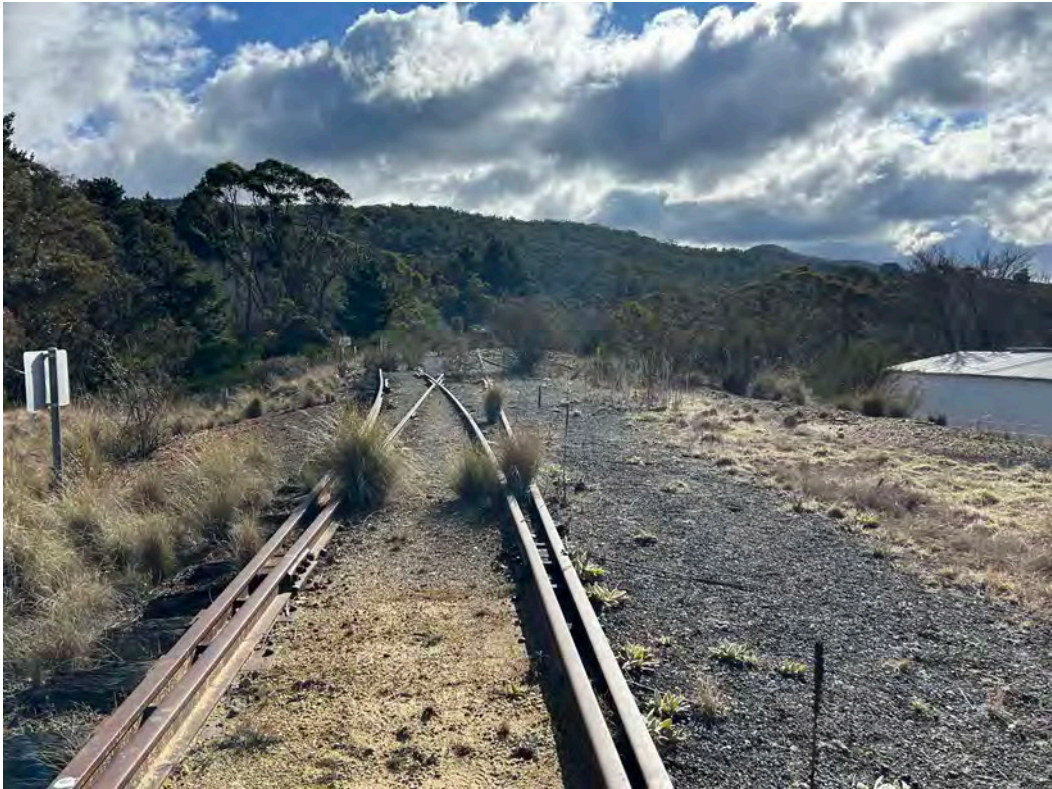
Photo 1: Trainlines behind fence facing north-west. Station Master Cottage to the right of photo. No airborne dust was visible on site.

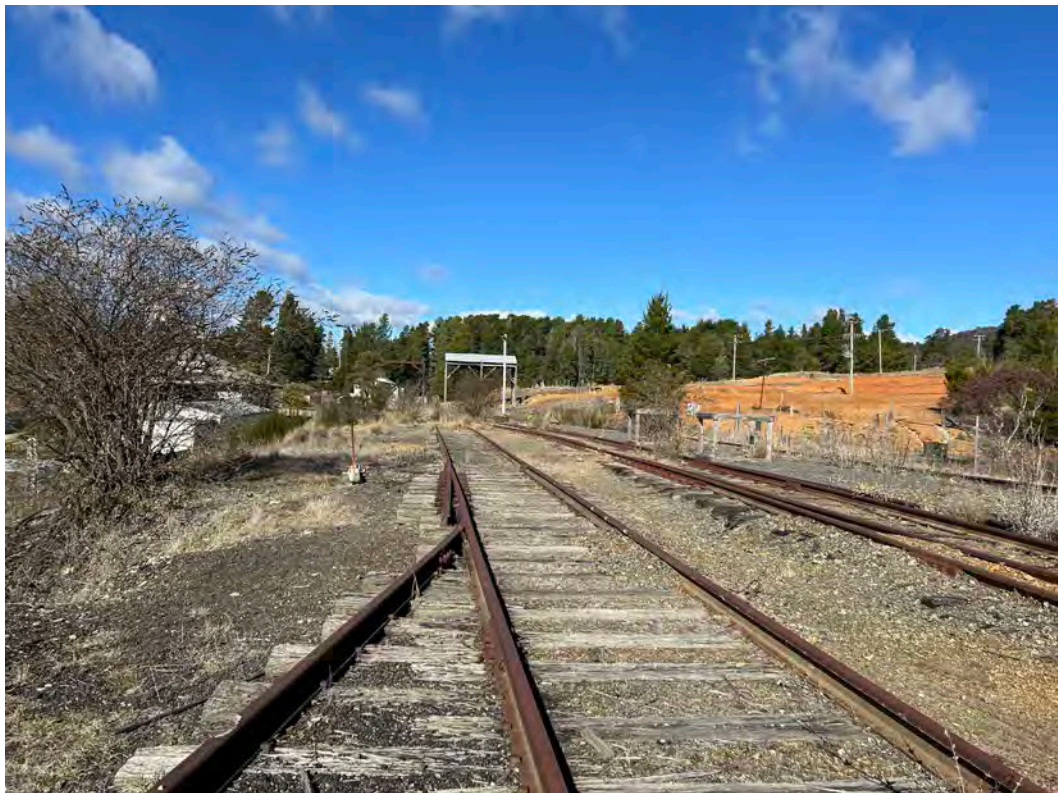
Photo 2: Former Loadout Facility and Weigh Bridge. No airborne dust was visible on site. Facing south-west.

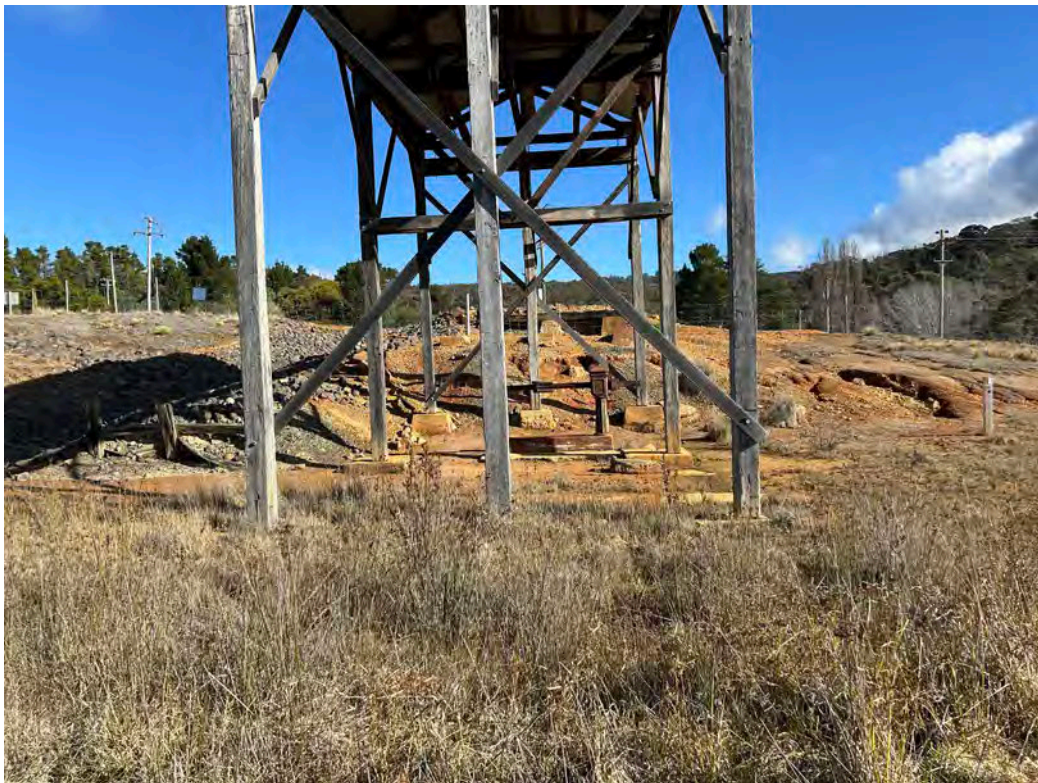
Photo 3: Minor evidence of erosion of soils on site. Located adjacent to Former Loadout Facility and Weigh Bridge. Facing south.

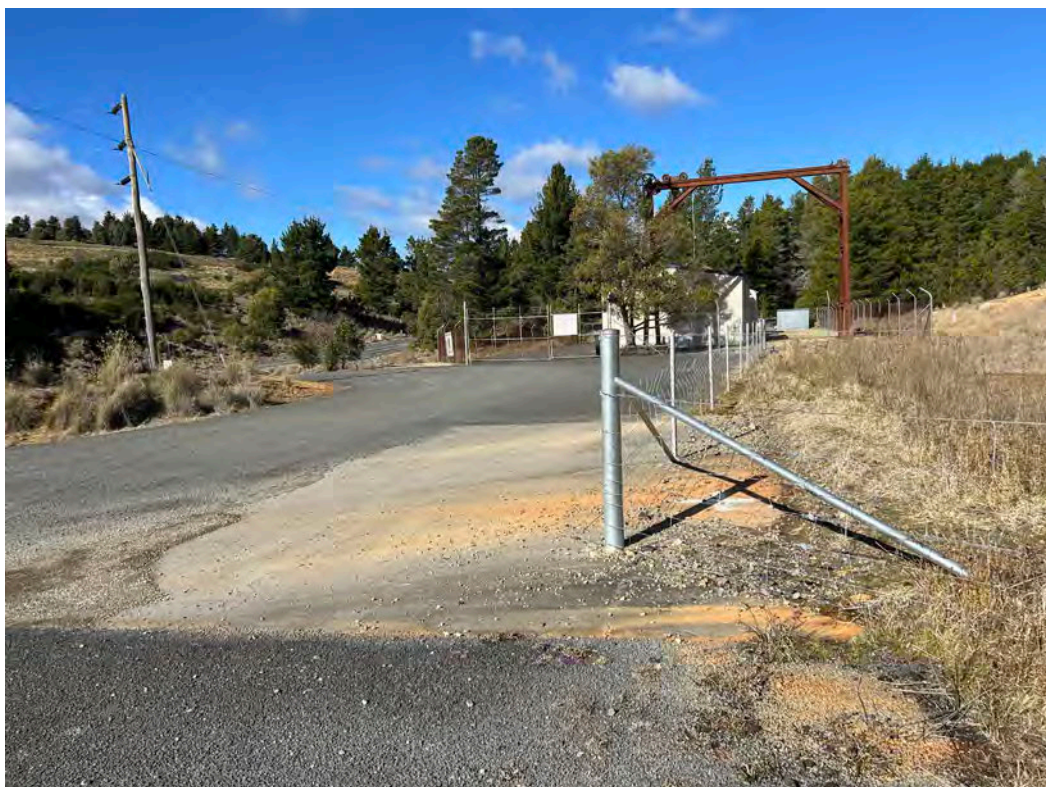
Is there evidence of excavation or other works non-compliant with the EMP?		No	n/a no excavation occurring on site	
Table 3-1					
3.3	Is signage in place adjacent the Copper Creek Road crossing and at other readily accessible areas?	Yes		Multiple signposts on fences along where site is accessible from the roadside.	
	Is fencing in place to prevent access via the Coppers Creek Road crossing?	Yes		Fencing is placed to restrict access to site from Coppers Creek Road crossing (Photo 4).	
	Exclusion Zone fencing and signage undamaged?	Yes		All fencing and signage was in good condition.	
	Is evidence of unauthorised site access visible?		No	No evidence of unauthorised site access visible.	
	Has durable erosion resistant capping been applied over the Coppers Creek Road crossing?	Yes		Coppers Creek Road Crossing was covered with a sealed road. Some evidence of sediment was observed on the road (Photo 4).

Orange/brown staining on asphalt adjacent the replica ore loading ramp consistent with evidence of mine drainage (Photo 4).

Photo 4: Some sediment visible on asphalt surface on site upgradient of Coppers Creek.

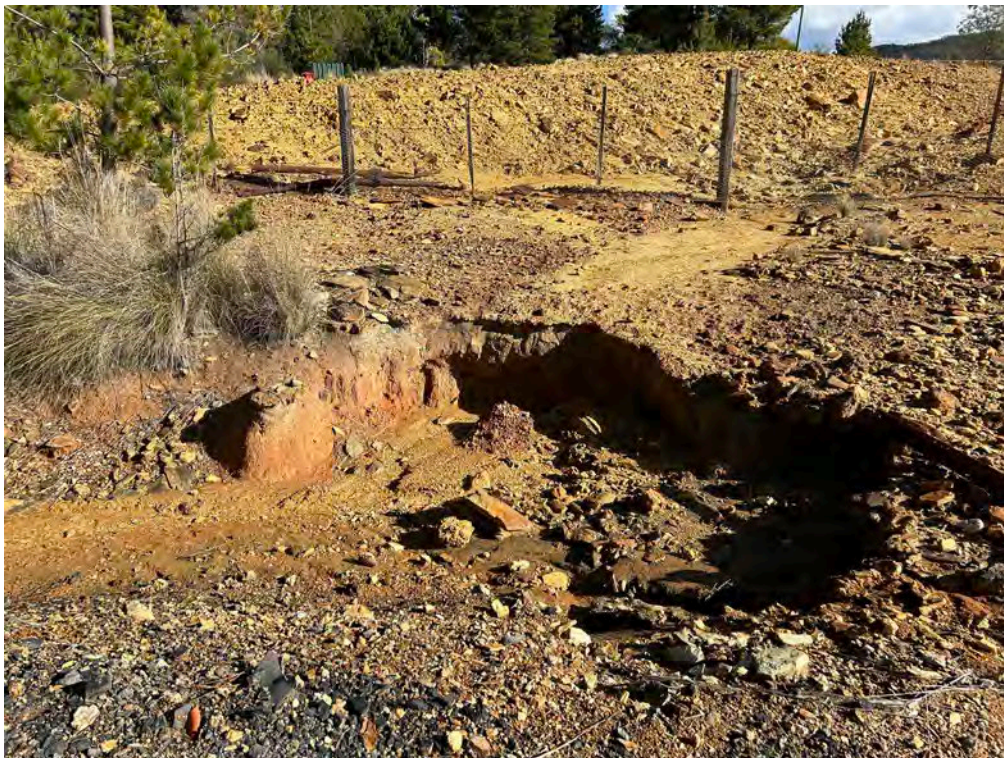
Photo 5: Evidence of erosion of soils on site. No evidence of current surface water runoff into Coppers Creek was observed. Located south of the State Emergency Service (SES) facility.

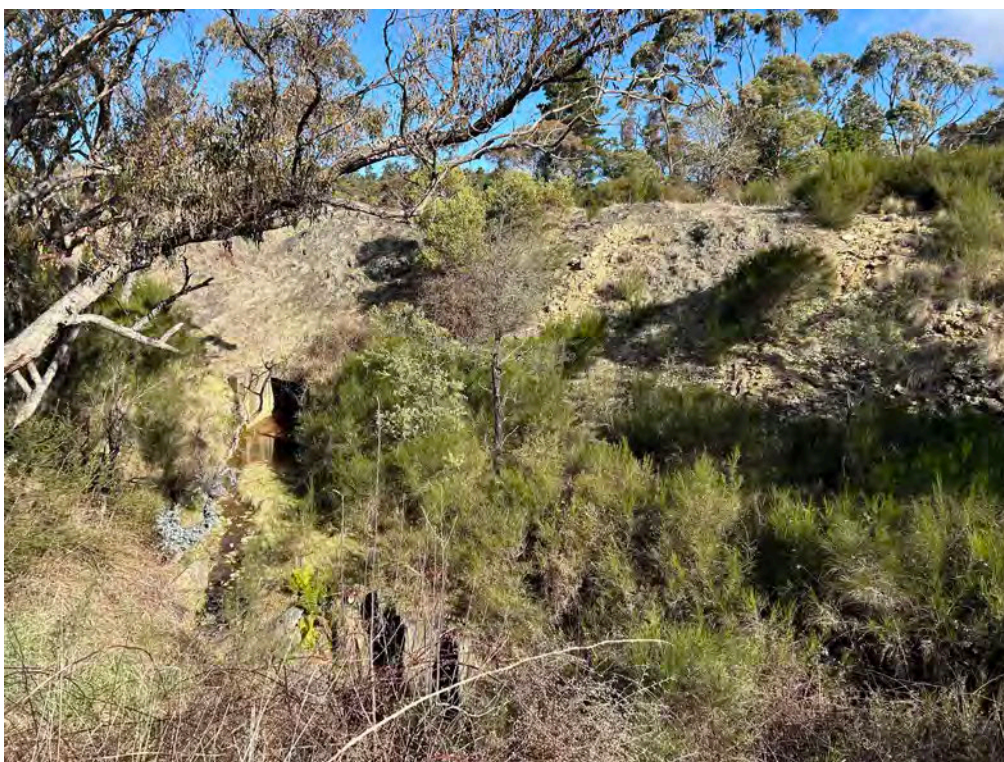
Photo 6: Copper Creek visible. No evidence of current onsite surface water runoff into Coppers Creek. Facing south.

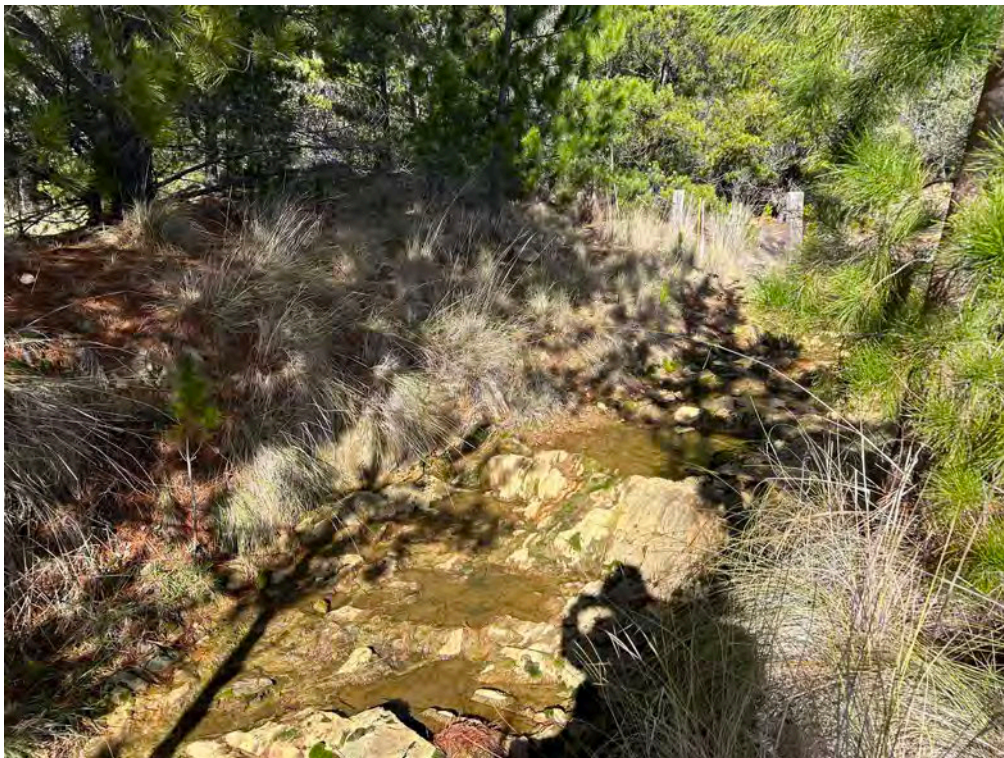
An unnamed creek off-site and down gradient from Captains Flat State Emergency Service shows slightly cloudy surface water with sediment present. This creek is fed from the mine site upstream and is not expected to contain sediment from site (Photo 7 and 9).

Photo 7: A small unnamed Creek slowly flowing through the south-eastern half of the site. No sign of additional surface water from on-site sources contributing to the Creek and no evidence of sediment run off from site was observed.

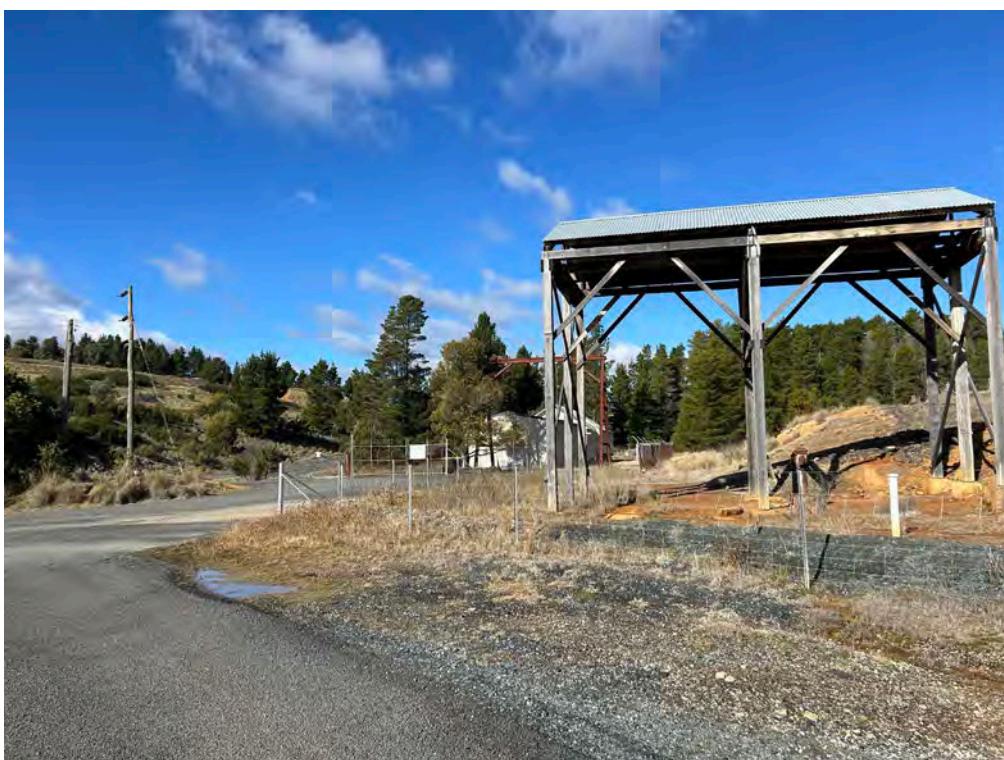
Is capping over Coppers Creek Road preventing inadvertent access to site materials?	Yes		Copper Creek Road Crossing is a sealed road preventing access to soil underneath (Photo 8).	
	Is excavation occurring onsite?		No	n/a no excavation occurring on site	
Table 3-1					
Plan Ref	Control	Inspection		Corrective Action	Implemented?
		Yes	No

Photo 8: Sealed road over Copper Creek Road crossing, preventing inadvertent access to site materials underneath. Pooled water was observed.

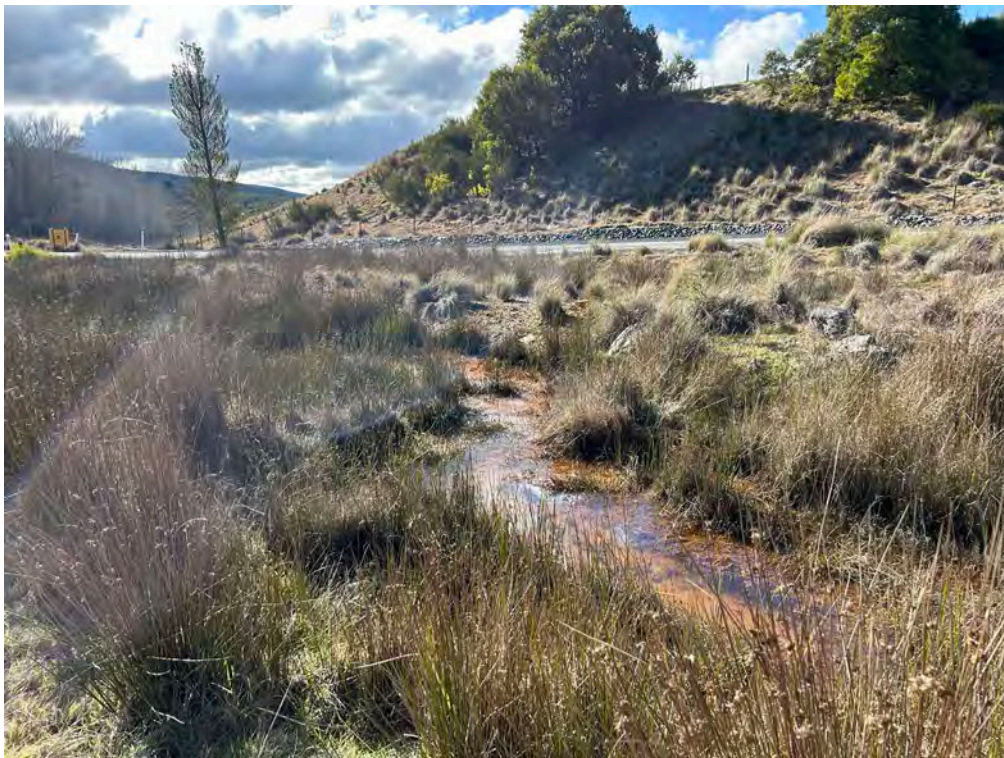
Photo 9: Unnamed stream off site and down gradient from Captains Flat State Emergency Service (SES), showing cloudy surface water with low sediment.

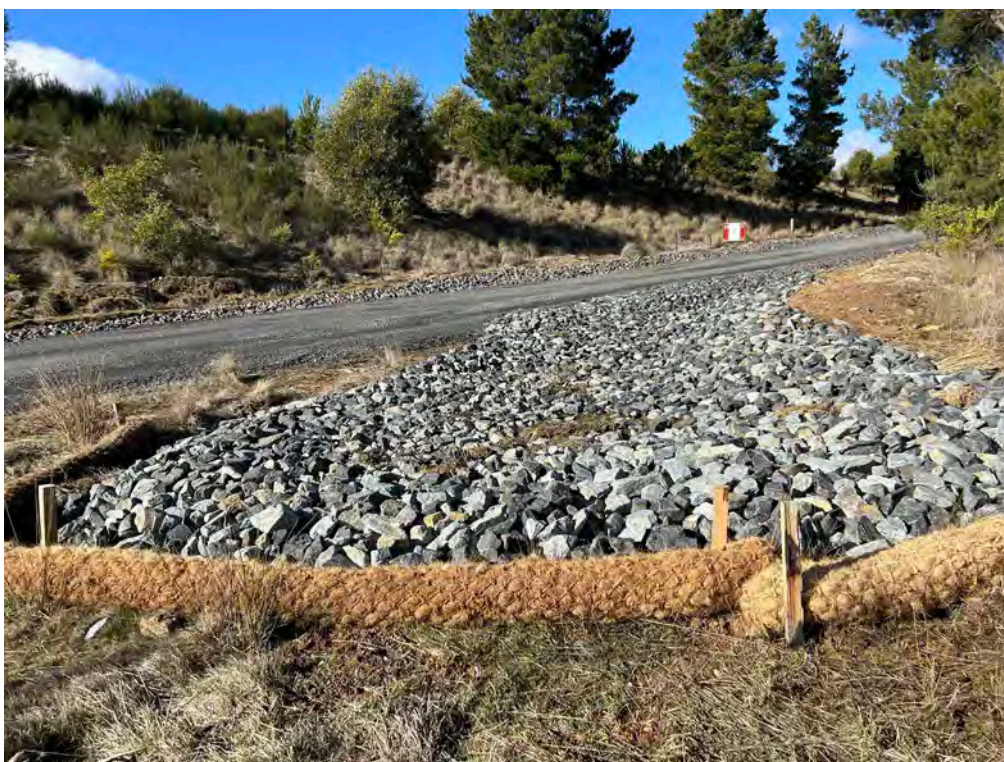
New rock armoury and sediment coir logs adjacent to the north of the site was observed during the inspection (Photo 10). This is suspected to be related to the mine site remediation program occurring upgradient of the site.

Photo 10: New rock armoury and sediment coir logs adjacent to the north of the site was observed during the inspection.
