# Tarago Action Plan Routine Inspection Checklist

| <b>Title:</b> | <b>Tarago Rail Yard Inspection</b> | <b>Approved:</b><br><b>SM</b> | <b>Project-Nr.:</b><br><b>318001704</b> | <b>Date:</b><br><b>19 January 2024</b> |
| <b>Site:</b> | <b>Tarago, NSW</b> | | | |
| <b>Client:</b> | <b>UGL Regional Linx</b> | | | |

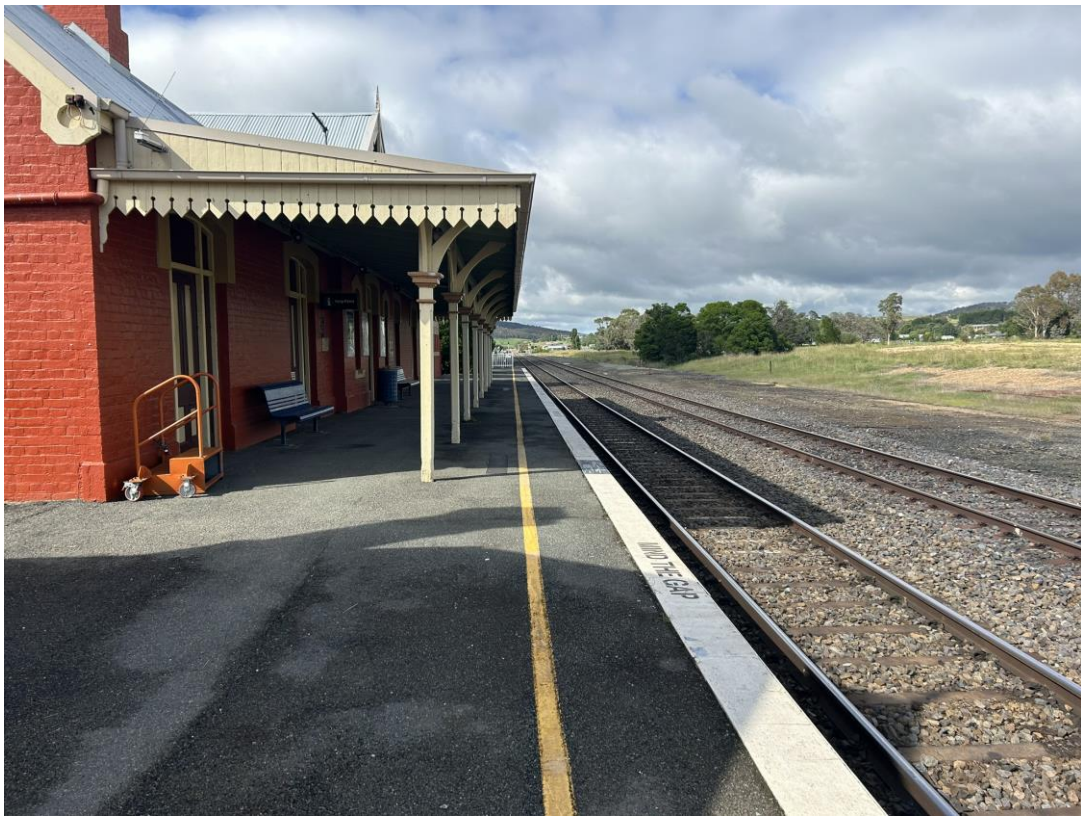
| No airborne dust was visible ( <b>Photos 1 - 2</b> ). Train in station and no airborne dust generated during transit. | | | |

**Photo 1: Picture at northern end of Tarago railway station platform facing south. No airborne dust visible.**

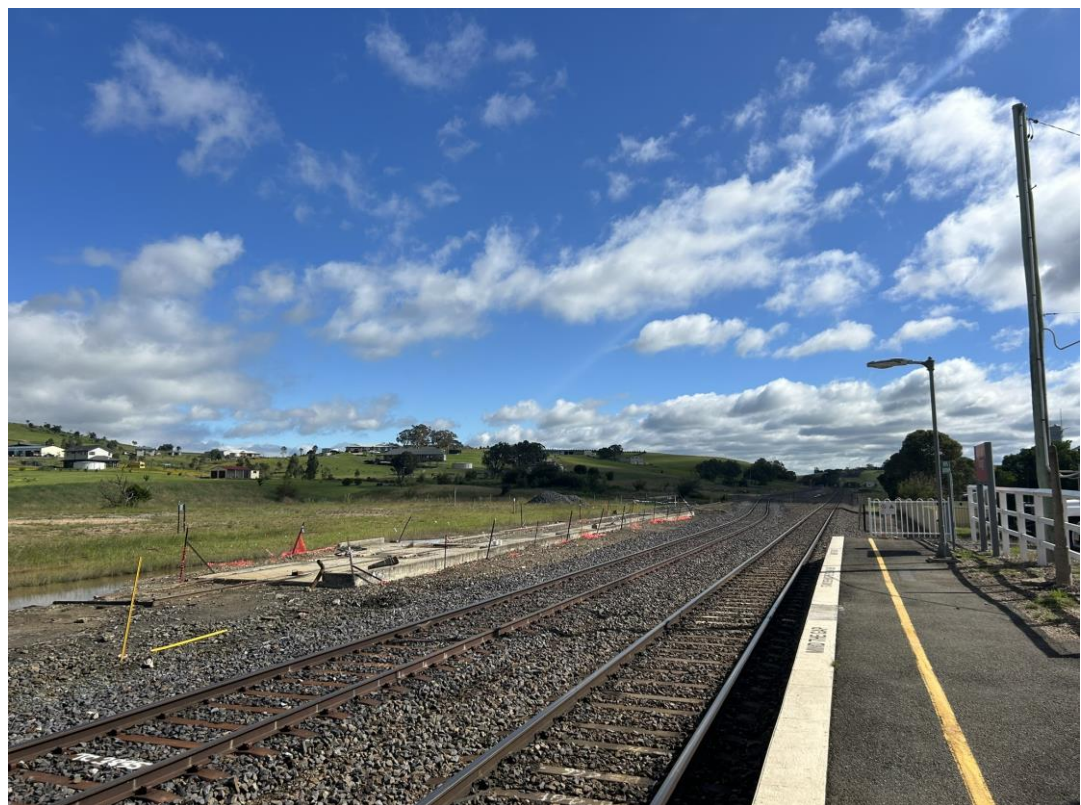
**Photo 2: Picture at northern end of Tarago railway station facing north. No airborne dust visible.**

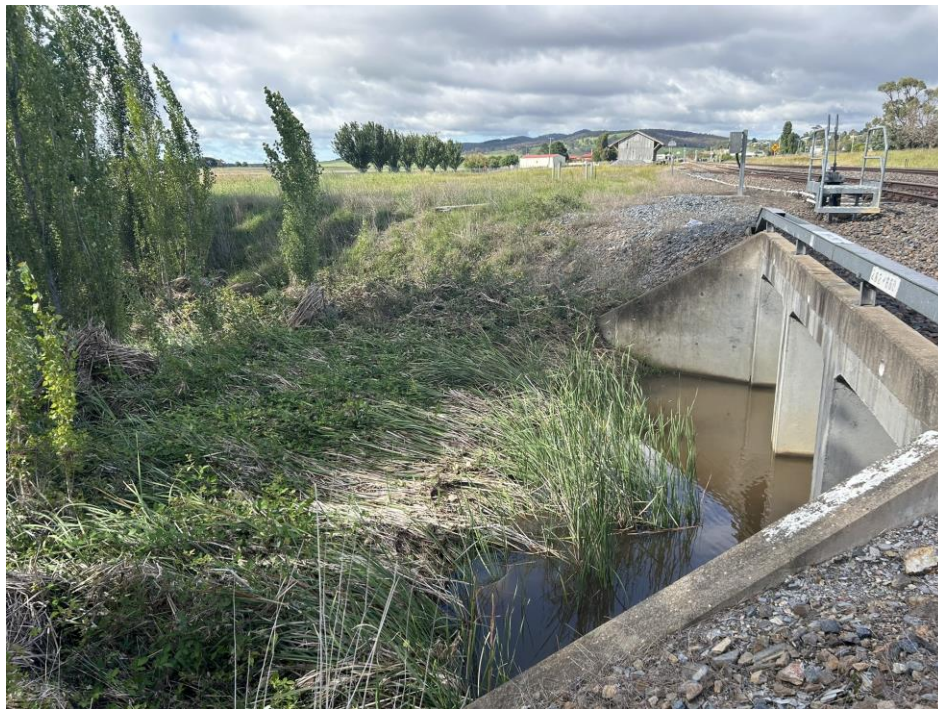
| Some sediment run-off seen in surface water flowing off-site at southern culvert ( <b>Photo 3</b> ). No evidence of sediment run-off from northern culvert with no flowing surface water observed. Minor observed sediment buildup of sediment on rocks was observed upgradient of railway line at middle culvert ( <b>Photos 7 and 8</b> ). | | | |
| Surface water was observed discharging from the site at the southern and middle culvert ( <b>Photos 3, 5, 6, 11</b> ). Surface water was observed between the middle and northern culvert pooled both on and off site ( <b>Photos 8 and 10</b> ). Pooled water was observed in multiple locations on site ( <b>Photos 4, 8, 9</b> ). No other flowing surface water was observed onsite during the inspection. Surface water with light to dark-red-brown colour was discharging across road causeway downgradient of middle culvert ( <b>Photo 6</b> ). | | | |

**Photo 3: Southern culvert downgradient of railway line with surface water flowing offsite. Surface water is brown with high turbidity.**

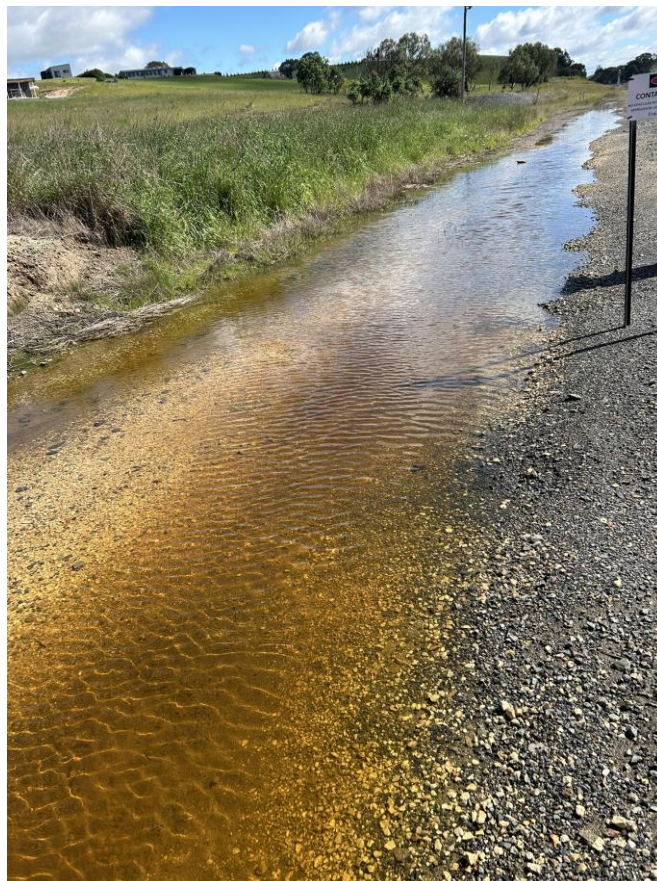
**Photo 4: The on-site surface water exhibited a red-brown coloration with minor turbidity.**

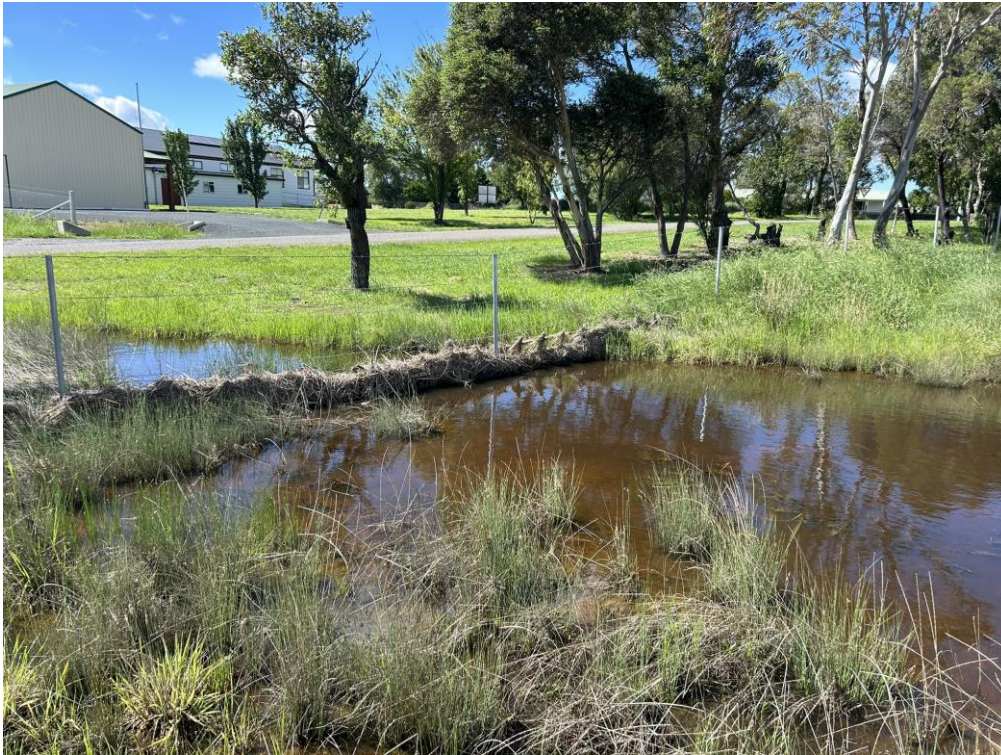
**Photo 5: Downgradient of middle culvert with pooled surface water. Surface water was dark red-brown with minor turbidity.**

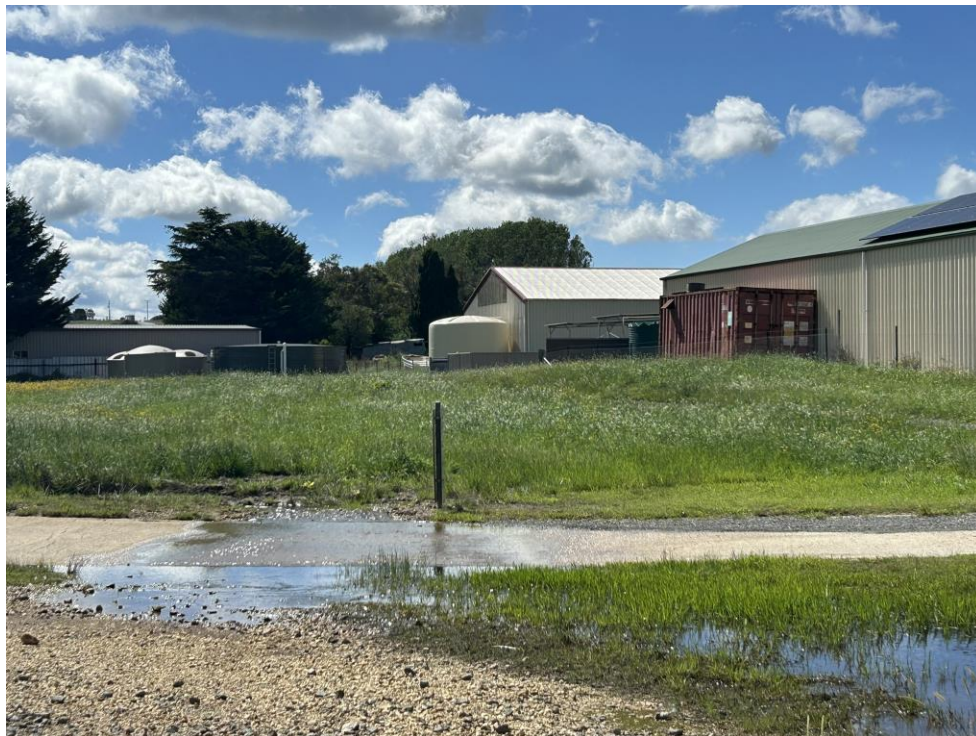
**Photo 6: Downgradient of middle culvert facing south with flowing surface water. Surface water across road causeway appeared dark red-brown with low to intermediate turbidity.**

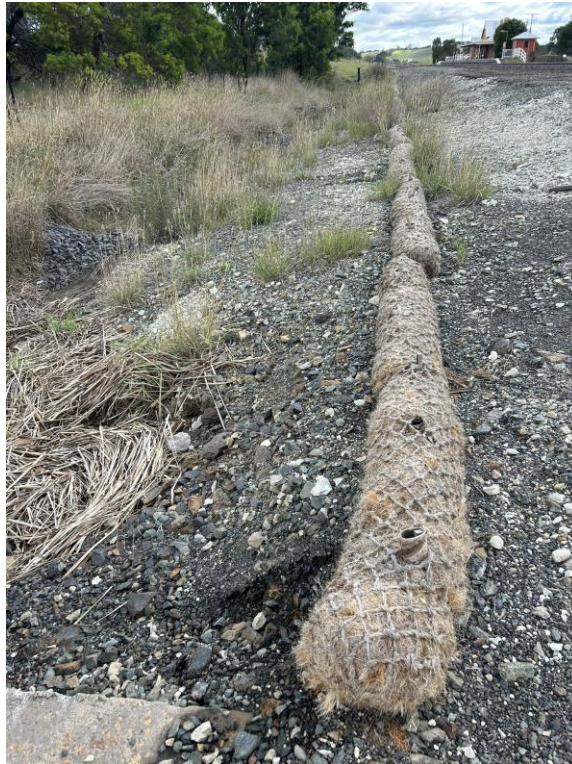
**Photo 7: Middle culvert upgradient of the railway line with no flowing surface water. Minor observed build-up of sediment on rocks.**

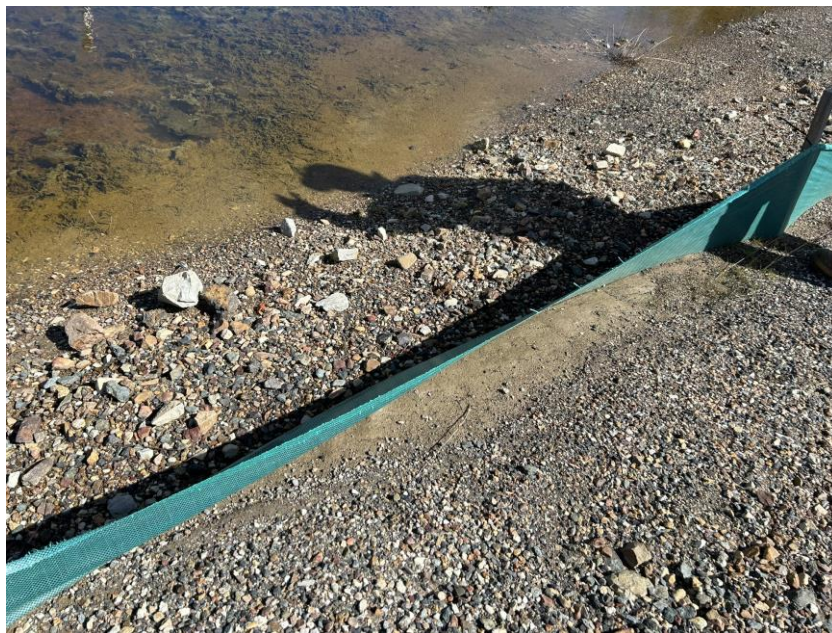
**Photo 8: Middle culvert upgradient of the railway line with no flowing surface water. Observed build-up of sediment fencing.**

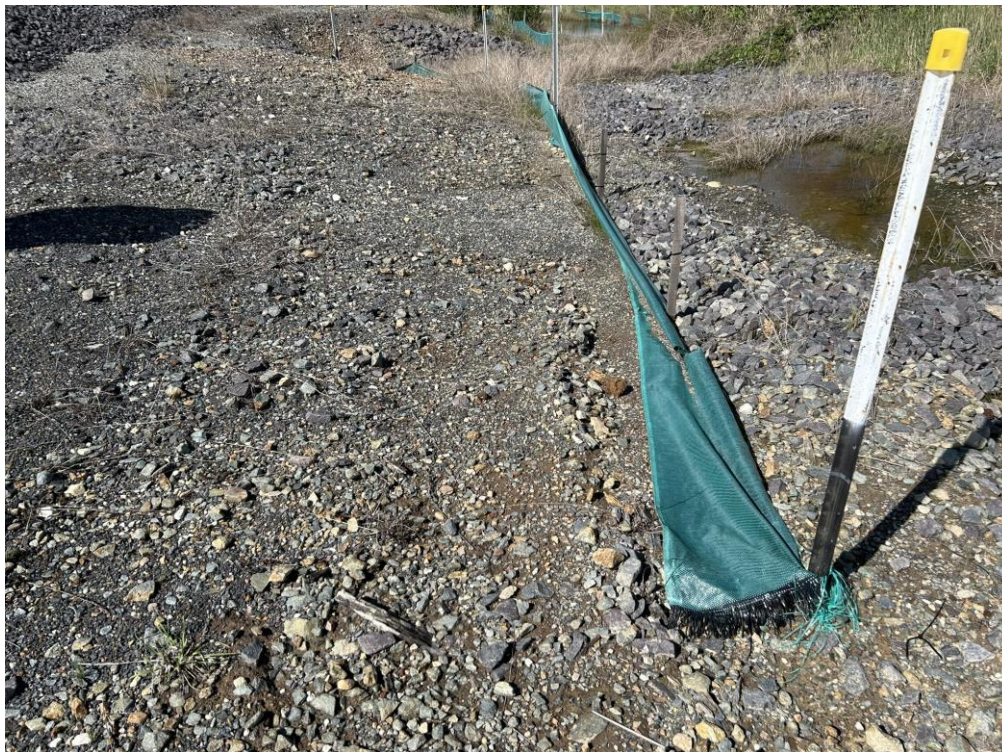
| <p>1. Several damages observed in the concrete-capped stockpile (<b>Photo 12, 13</b>).</p> <p>2. Minor damage of geofabric silt curtain (sediment fencing) was observed upgradient of middle trainline culvert (<b>Photo 9</b>). UGL representative mentioned that repair of silt curtain will be undertaken.</p> | | | |

**Photo 9: Sign of damaged sediment fencing at the diddle culvert upgradient of the railway line.**

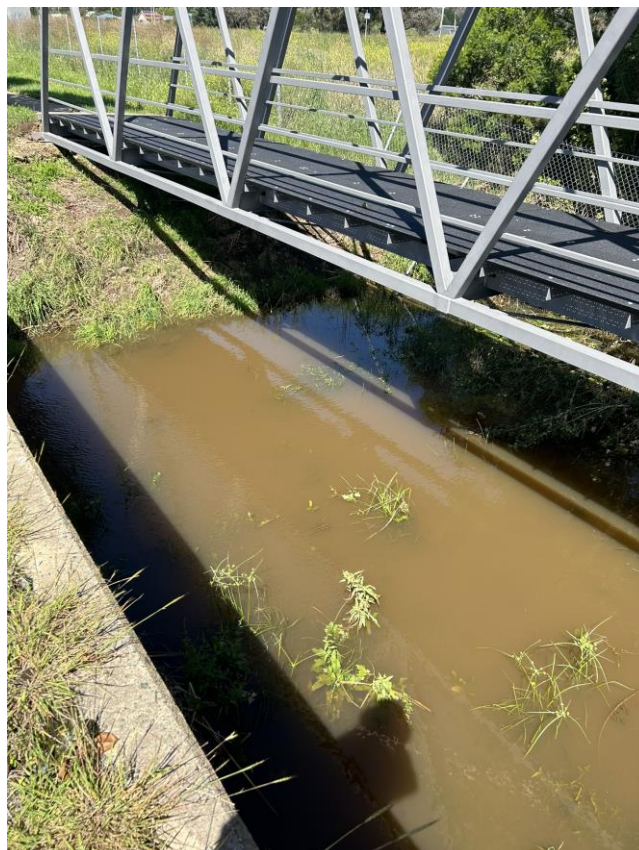
**Photo 10: Water flowing out downgradient of the site, light brown and turbid.**

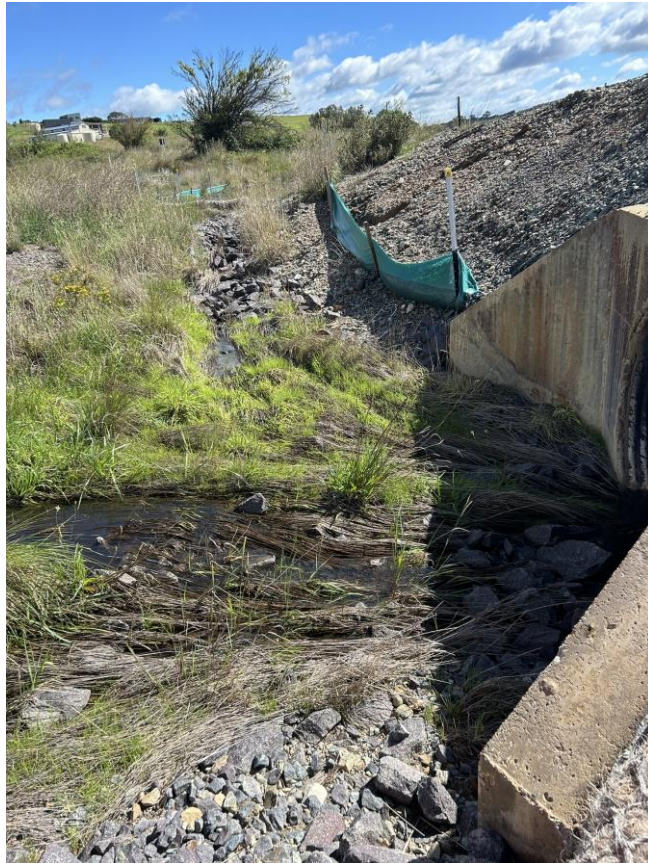
Photo 11: Sign of surface water flowing in the upgradient of the site.

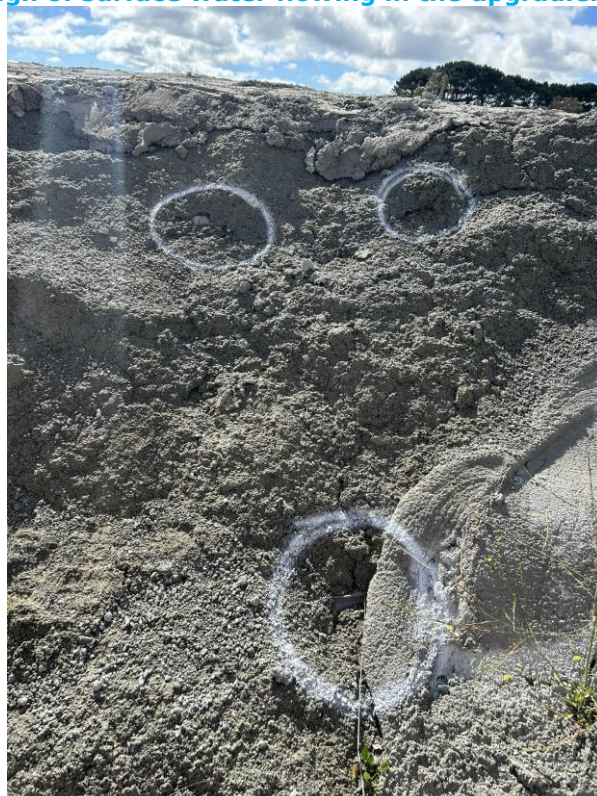
| | Are cracks present in the capping of the existing stockpile? If so record the width and length of cracks in written form and through photographs and consolidate with this checklist. | Yes, minor hairline cracking is present on the stockpile, minor damages were observed ( <b>Photos 12 and 13</b> ) |
| 7.3 | Is geofabric marker layer visible beneath capping of the existing stockpile? If so record in written form and through photographs and consolidate with this checklist. If marker layer is visible rectification work is required. | Yes (Photos 12 and 13) |

Photo 12: Concrete capped stockpile. New signs of damage (1). Facing north.

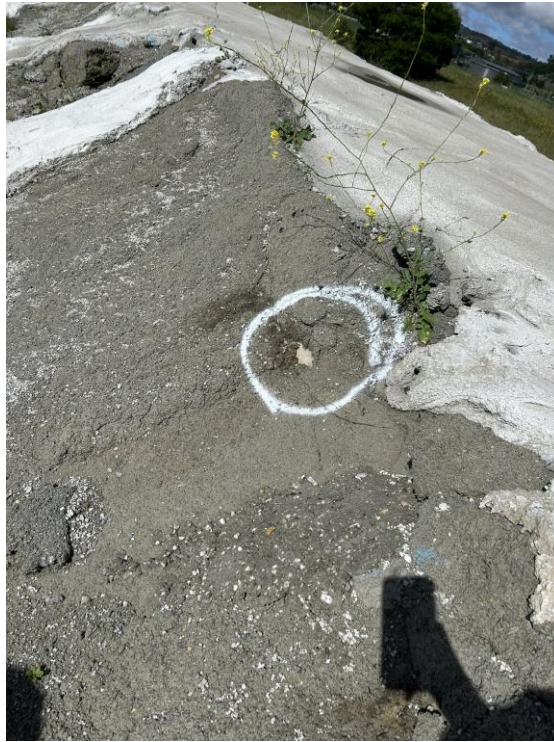
**Photo 13: Concrete capped stockpile. New signs of damage (2). Facing north.**

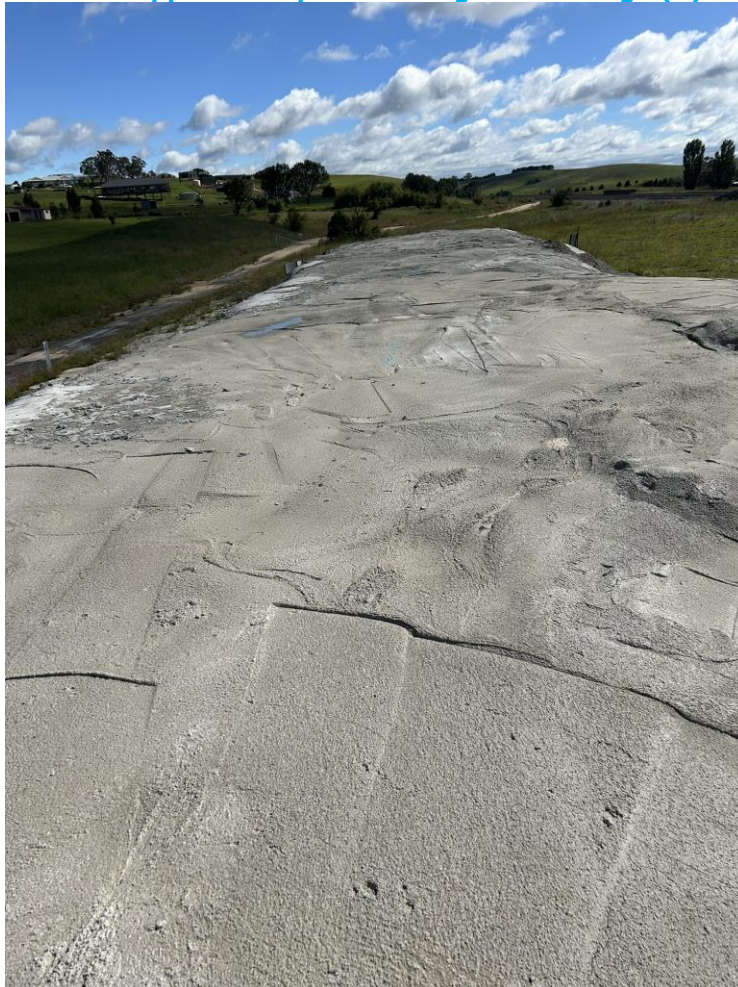
**Photo 14: Concrete capped stockpile. Top surface, undamaged, no sign of cracks.**

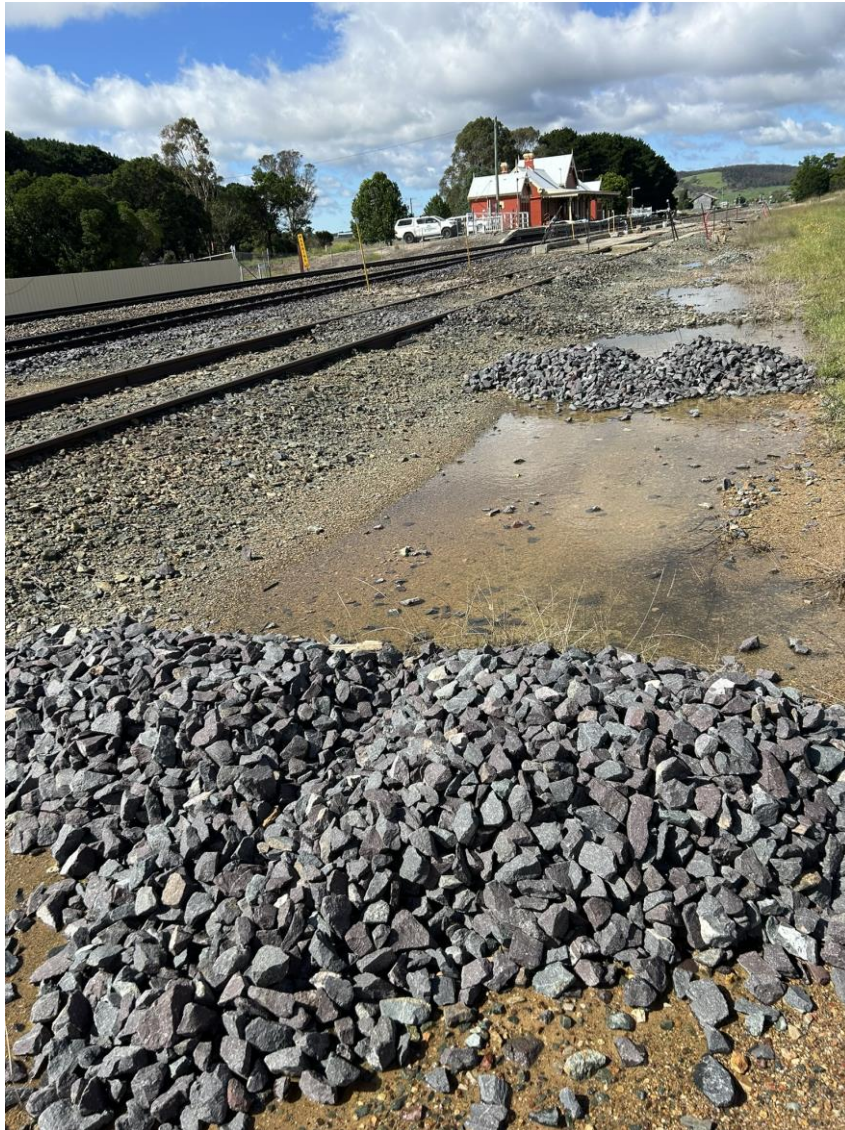
**Photo 14: Rock checks and rock armour appeared in good condition.**
