# Tarago Action Plan Routine Inspection Checklist

| Date: | 08-Apr-24 | Ramboll and UGL RL Environmental |

| <b>Title:</b> Tarago Rail Yard Inspection | <b>Approved:</b> | <b>Project-Nr.:</b><br>318001704 | <b>Date:</b><br>8 April 2024 |
| <b>Site:</b> Tarago, NSW | | | |

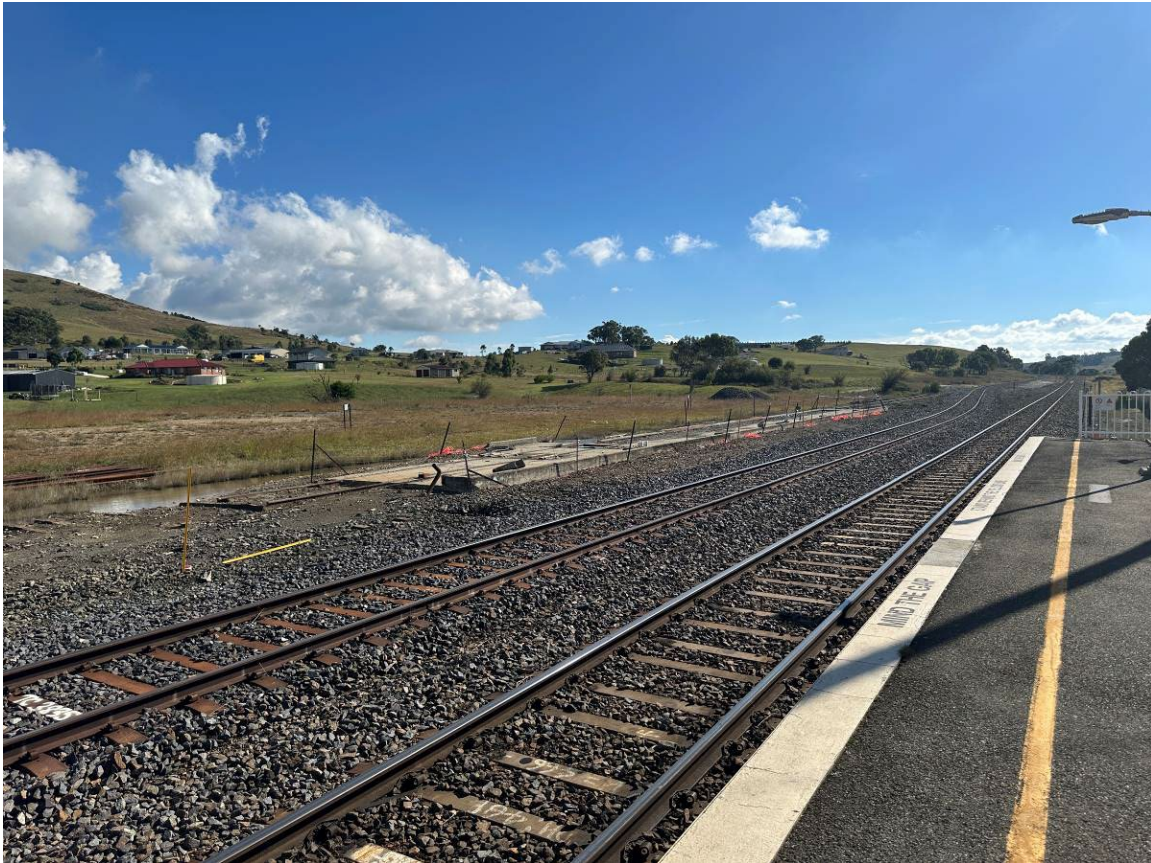
| No airborne dust was visible ( <b>Photos 1 - 2</b> ). | | |

**Photo 1: Picture of Tarago railway facing north east. No airborne dust visible.**

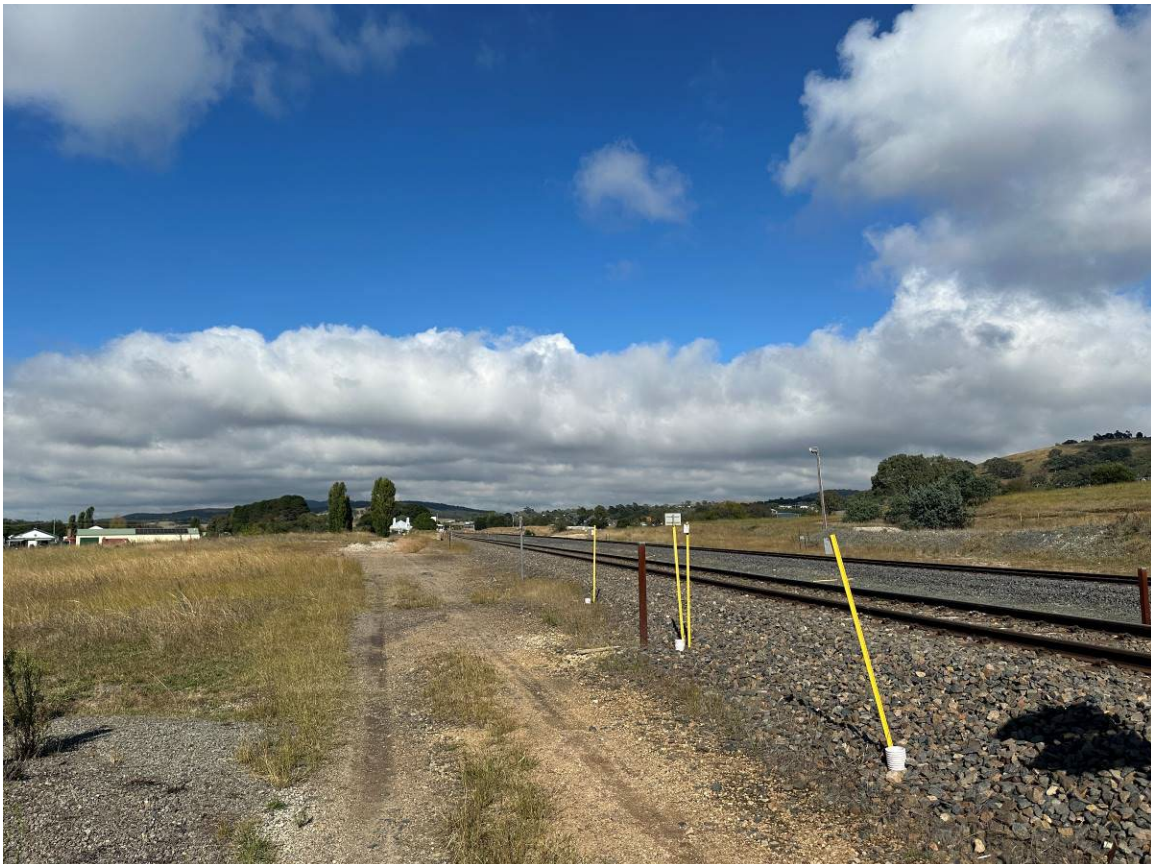
**Photo 2: Picture of Tarago railway facing south west towards platform. No airborne dust visible.**

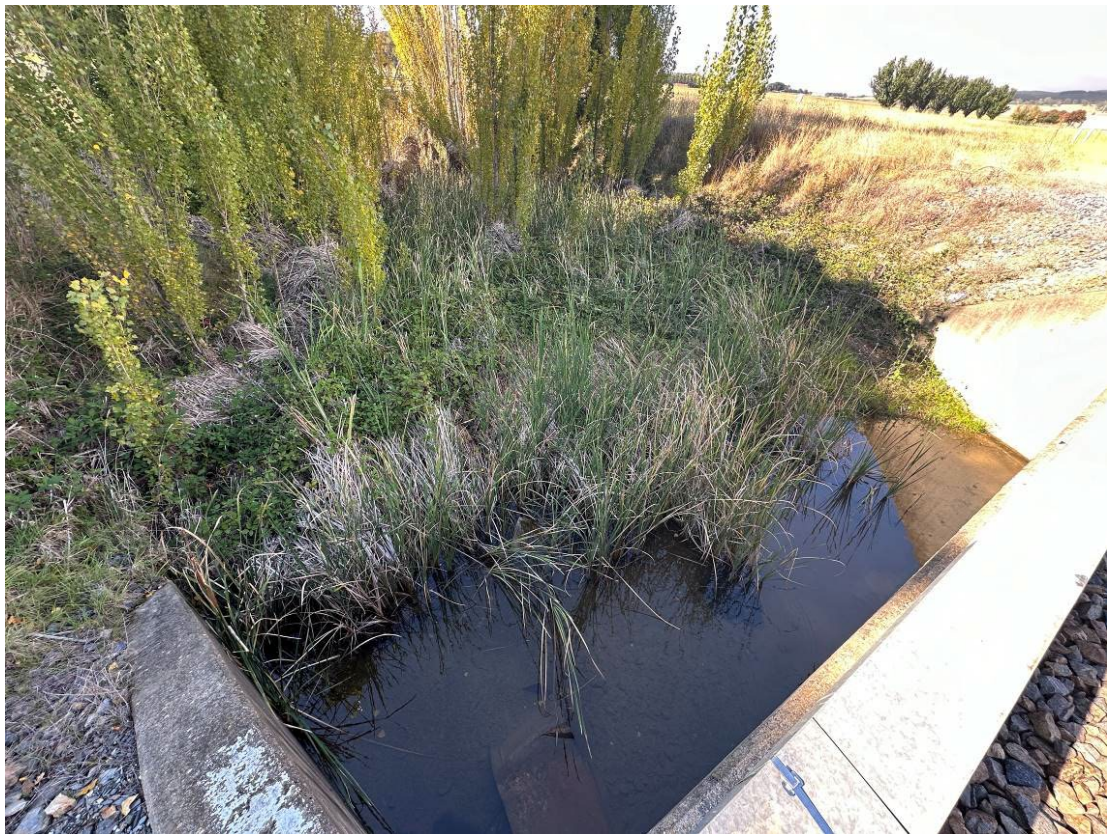
**Photo 3: Southern culvert downgradient of railway line with surface water flowing offsite. Surface water is clear with low to no turbidity.**

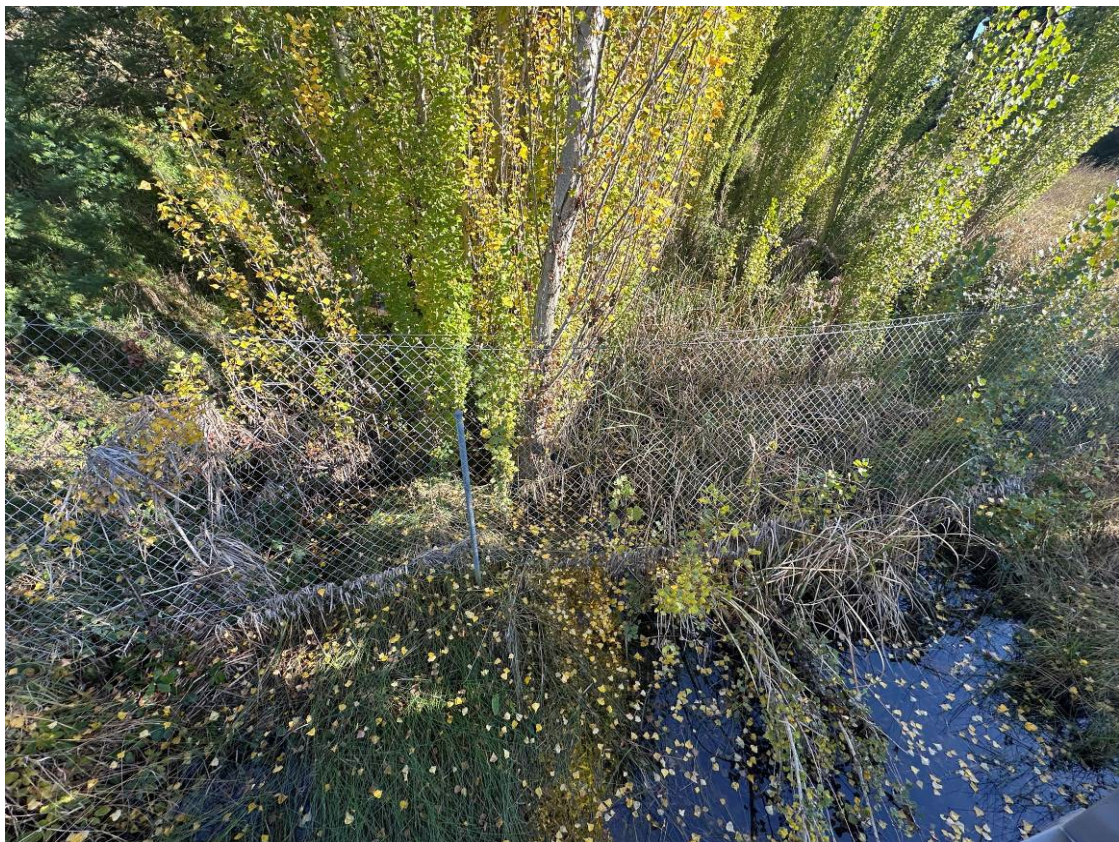
**Photo 4: Southern culvert downgradient of site fence line with surface water flowing offsite. Surface water is clear with a slight brown tint and low to no turbidity. Lots of natural sediment controls present (i.e. reedy vegetation).**

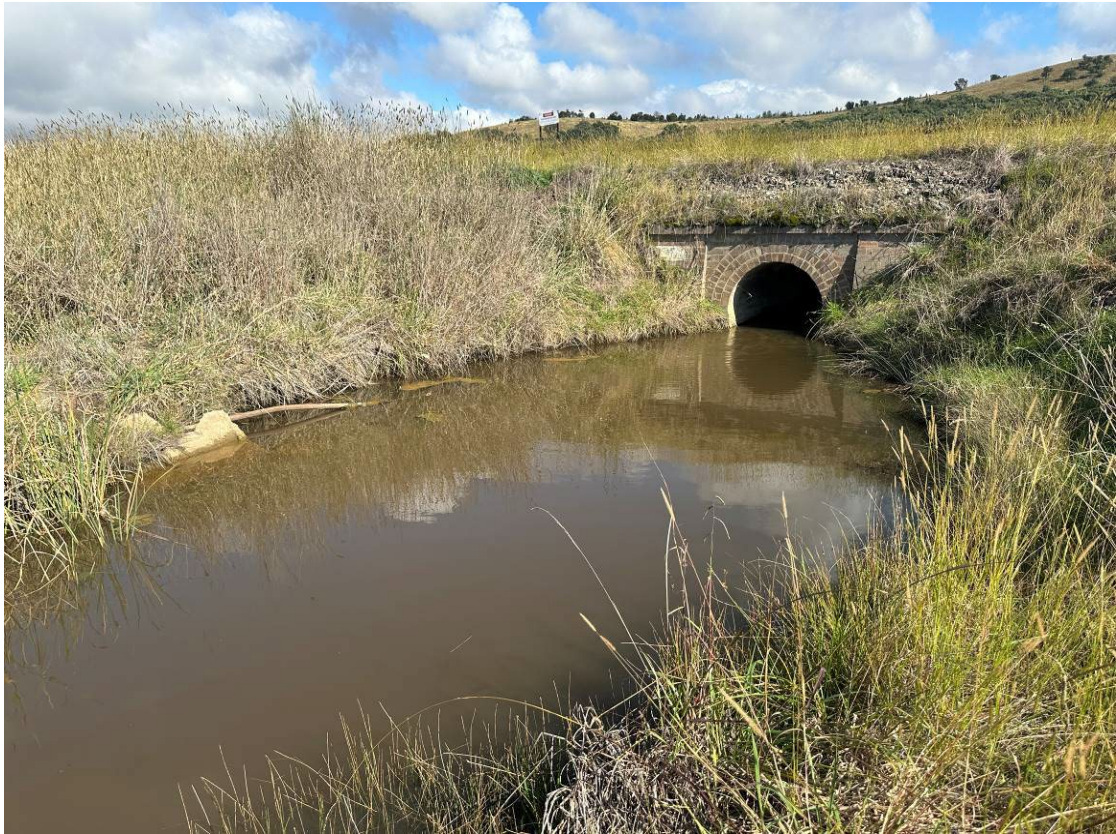
**Photo 5: Downgradient of middle culvert with pooled surface water. Surface water was brown with moderate turbidity.**

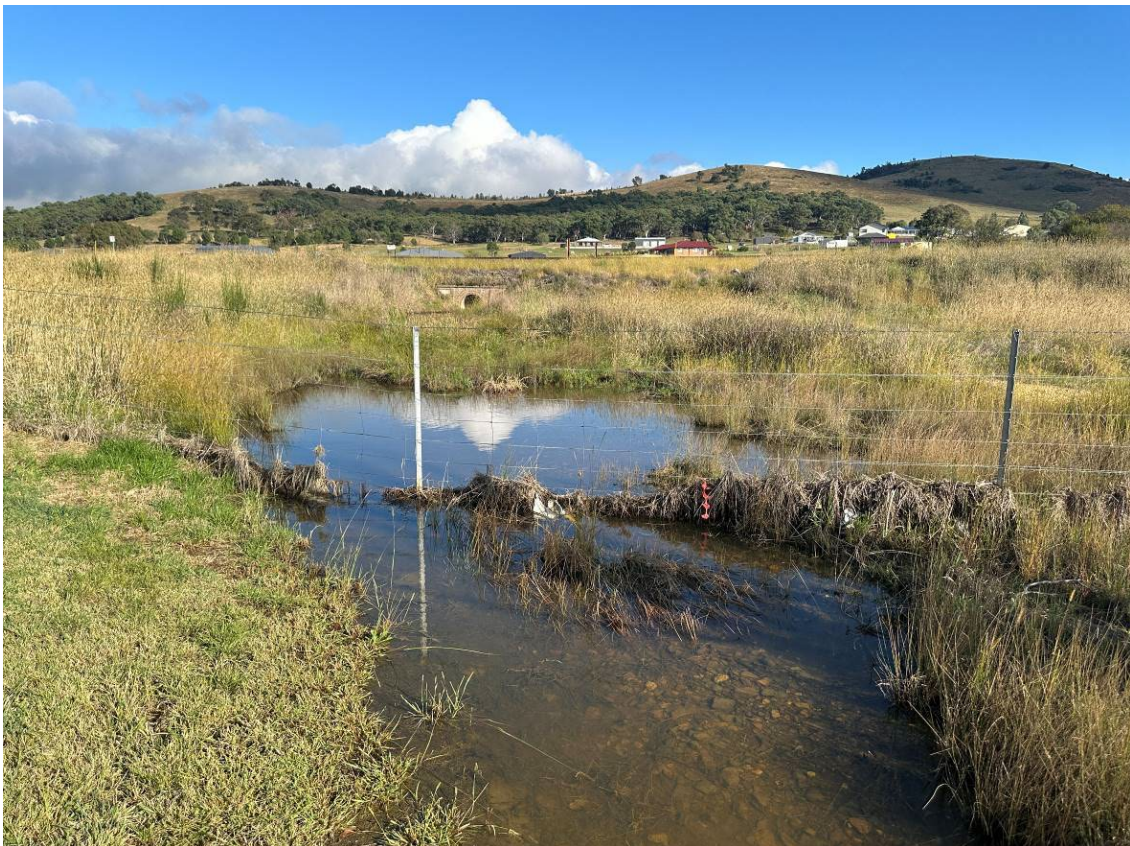
**Photo 6: Downgradient of middle culvert at fence line of site boundary with pooled surface water. Surface water before road causeway appeared clear with low to no turbidity and no suspended solids.**

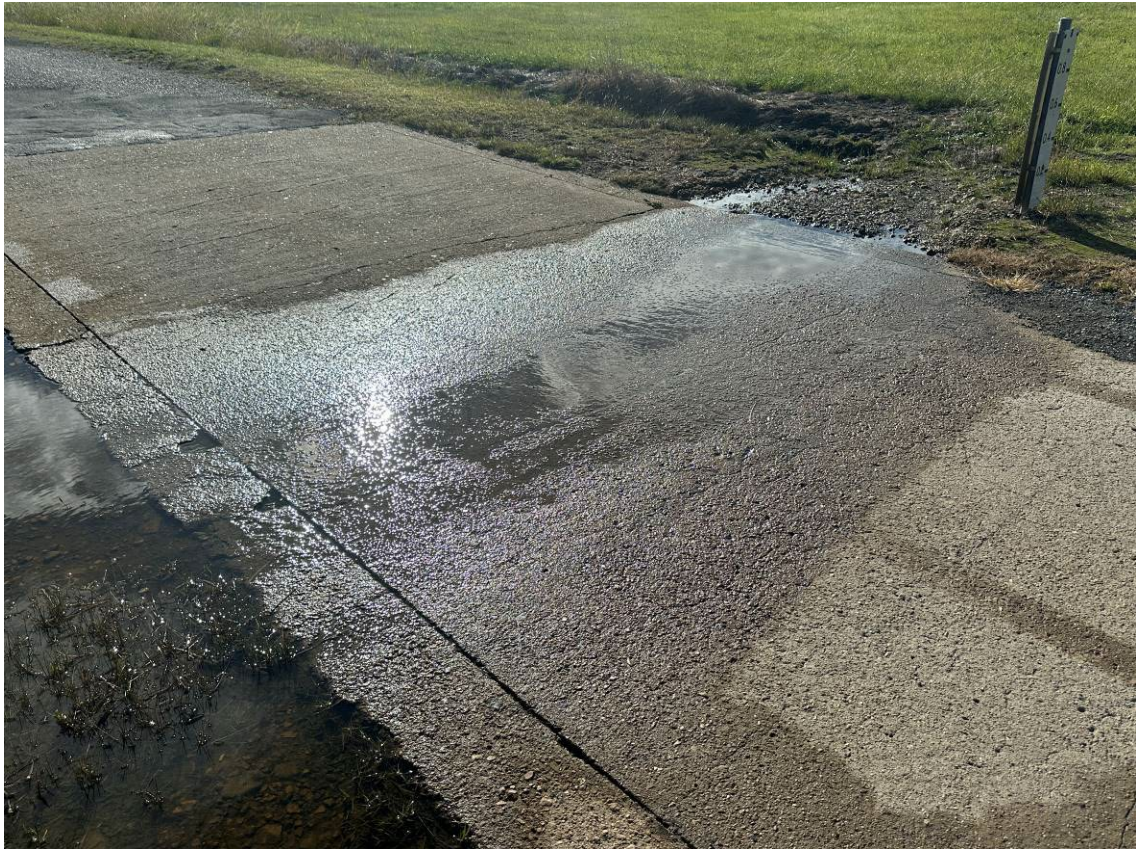
**Photo 7: Causeway located downgradient of middle culvert facing east with pooled surface water. No sediment located on causeway.**

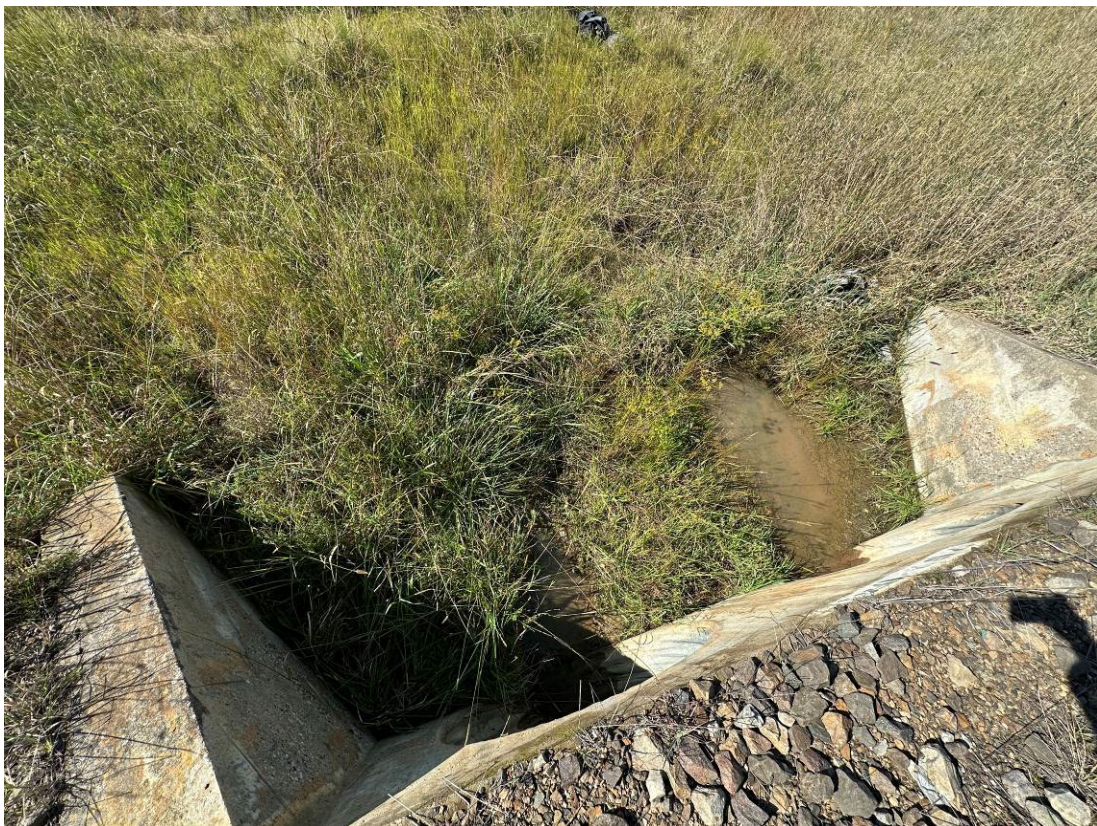
| No sediment run-off seen in surface water flowing off-site at southern and middle culverts ( <b>Photos 3 - 7</b> ). No evidence of sediment run-off from northern culvert with only pooled surface water observed ( <b>Photo 8</b> ). | | |

**Photo 8: Downgradient of northernmost culvert with pooled surface water. Water was clear with slight brown tint, and low turbidity.**

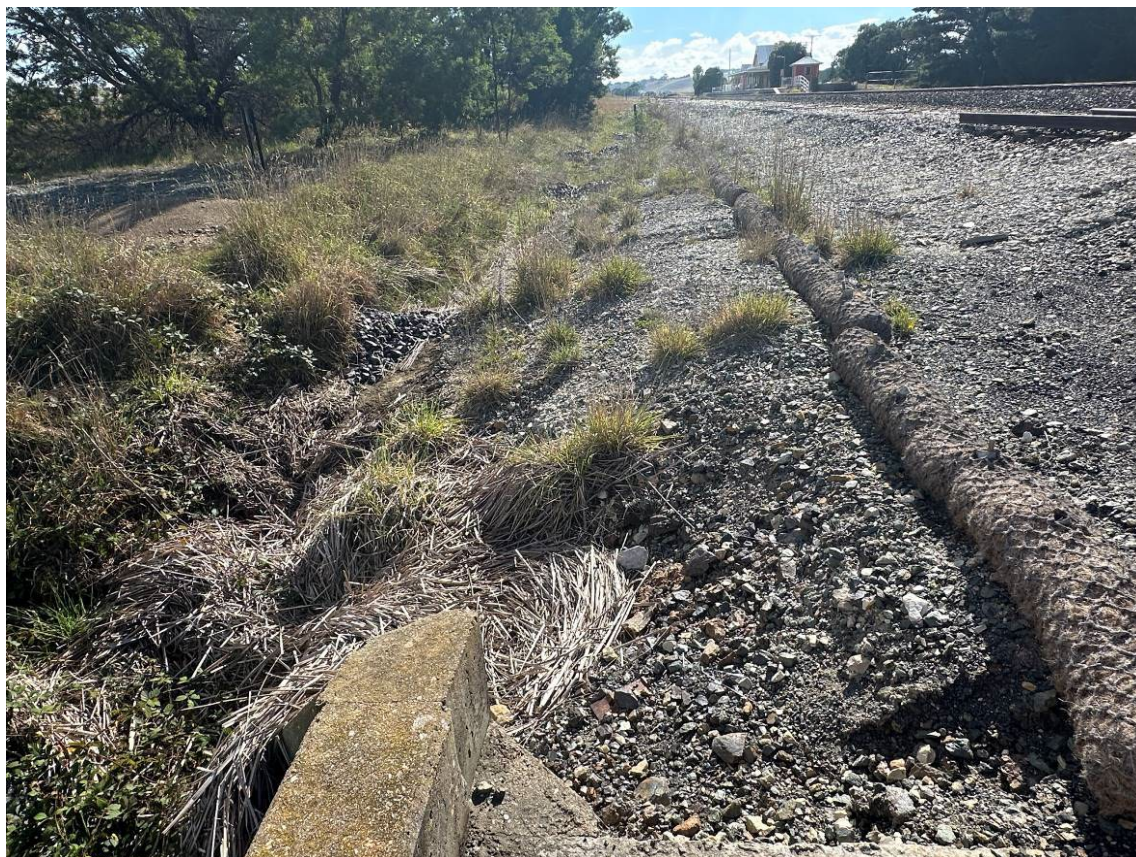
**Photo 9: Southernmost culvert upgradient of the railway line with flowing surface water.**

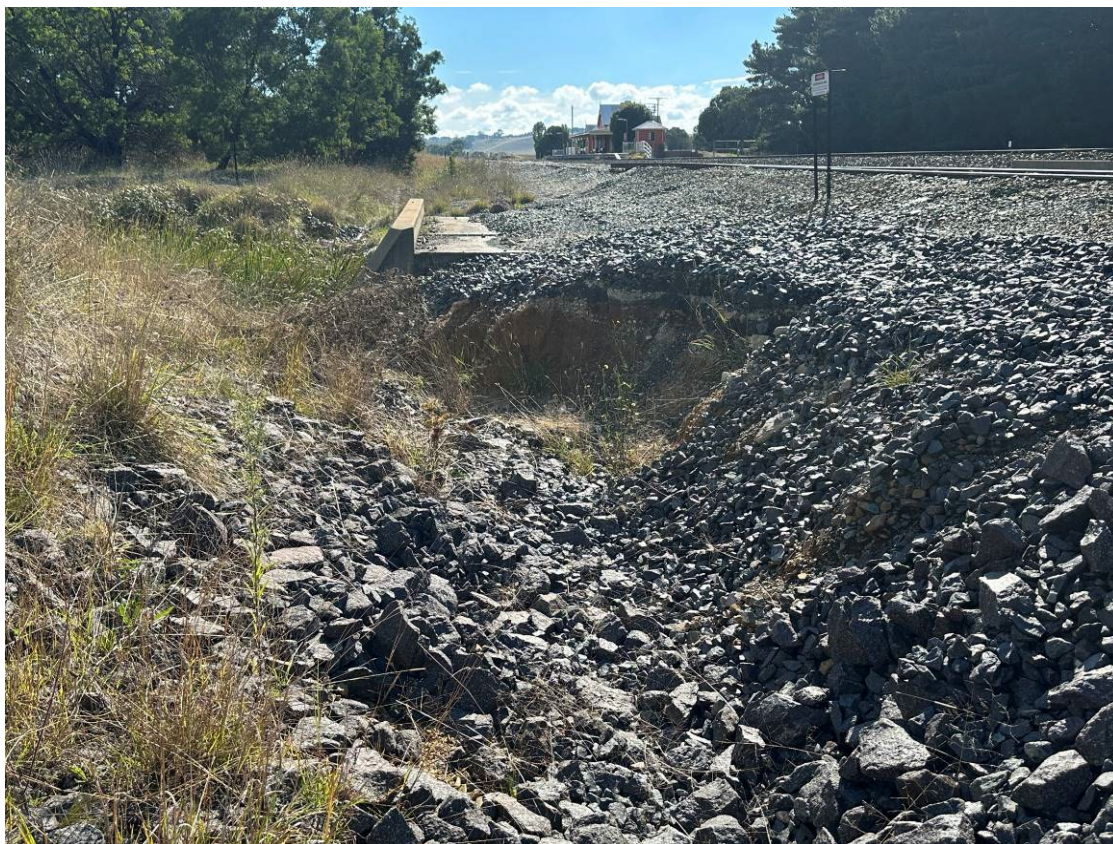
**Photo 10: Facing towards southernmost culvert upgradient of the railway line. Rock armoury within drainage line to culvert. Some evidence of erosion.**

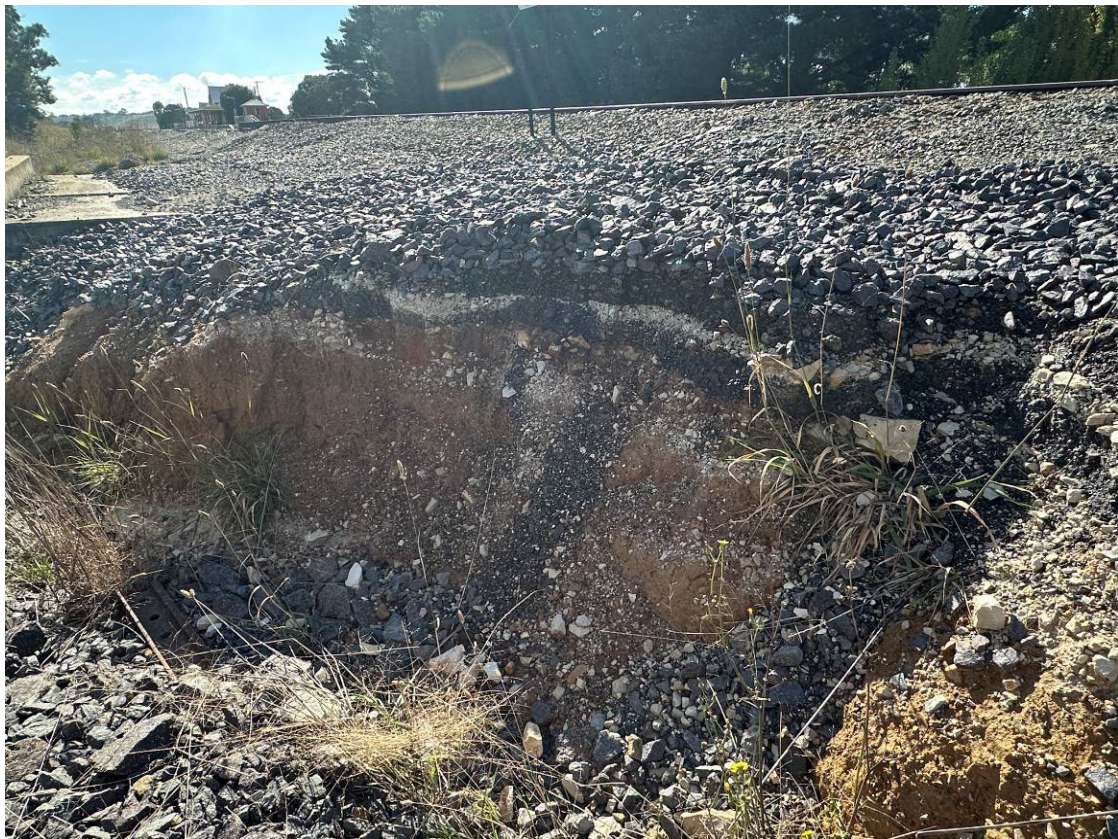
**Photo 11: Southernmost culvert upgradient of the railway line. Evidence of erosion due to lack of ground cover. Minor to no changes since previous inspection.**

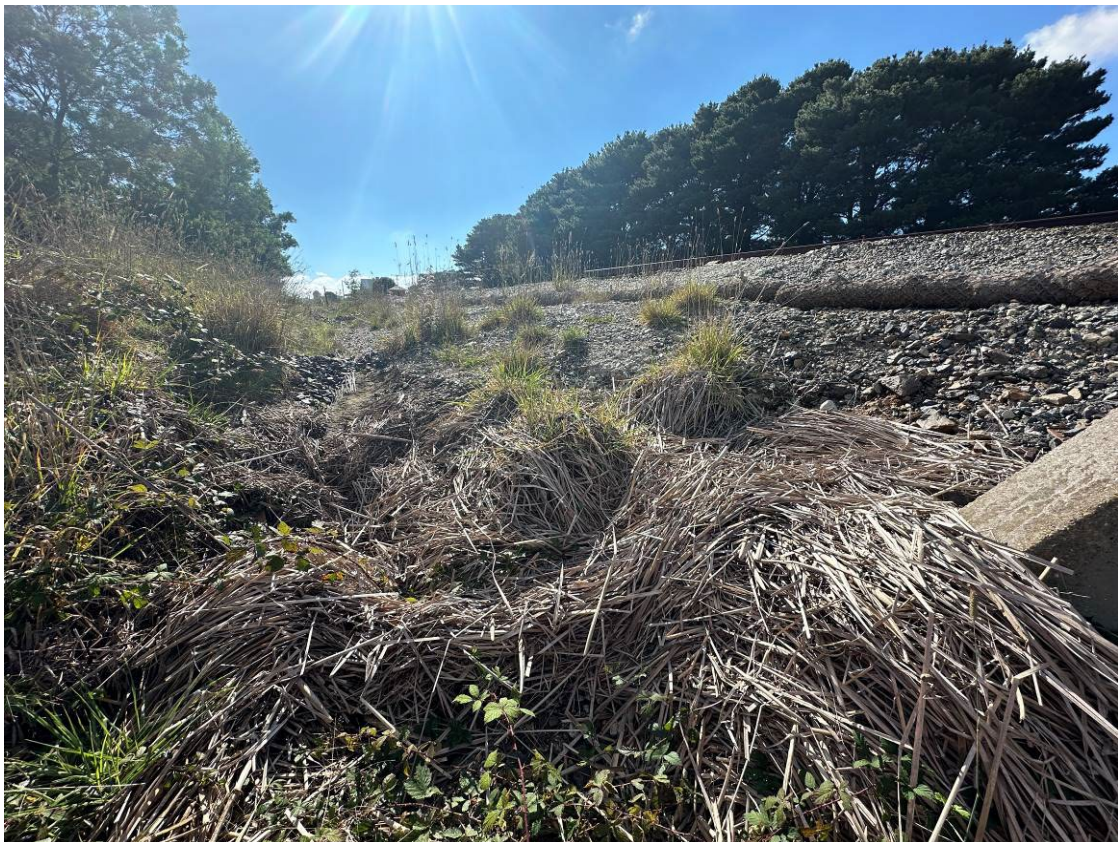
**Photo 12: Drainage line leading to southernmost culvert upgradient of the railway line. Evidence of previous high surface water flow (build-up of vegetation debris).**

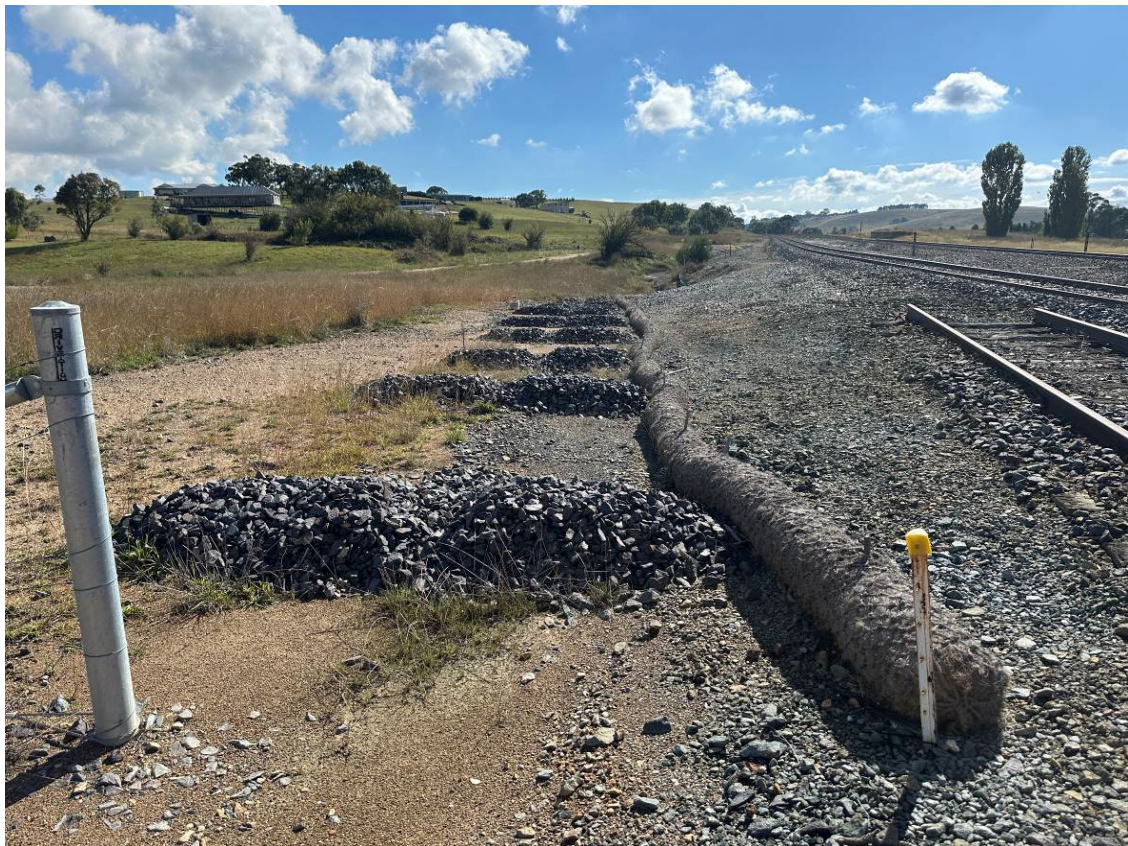
**Photo 13: Upgradient of middle culvert. Sediment controls in place (coir logs and rock armoury in good condition).**

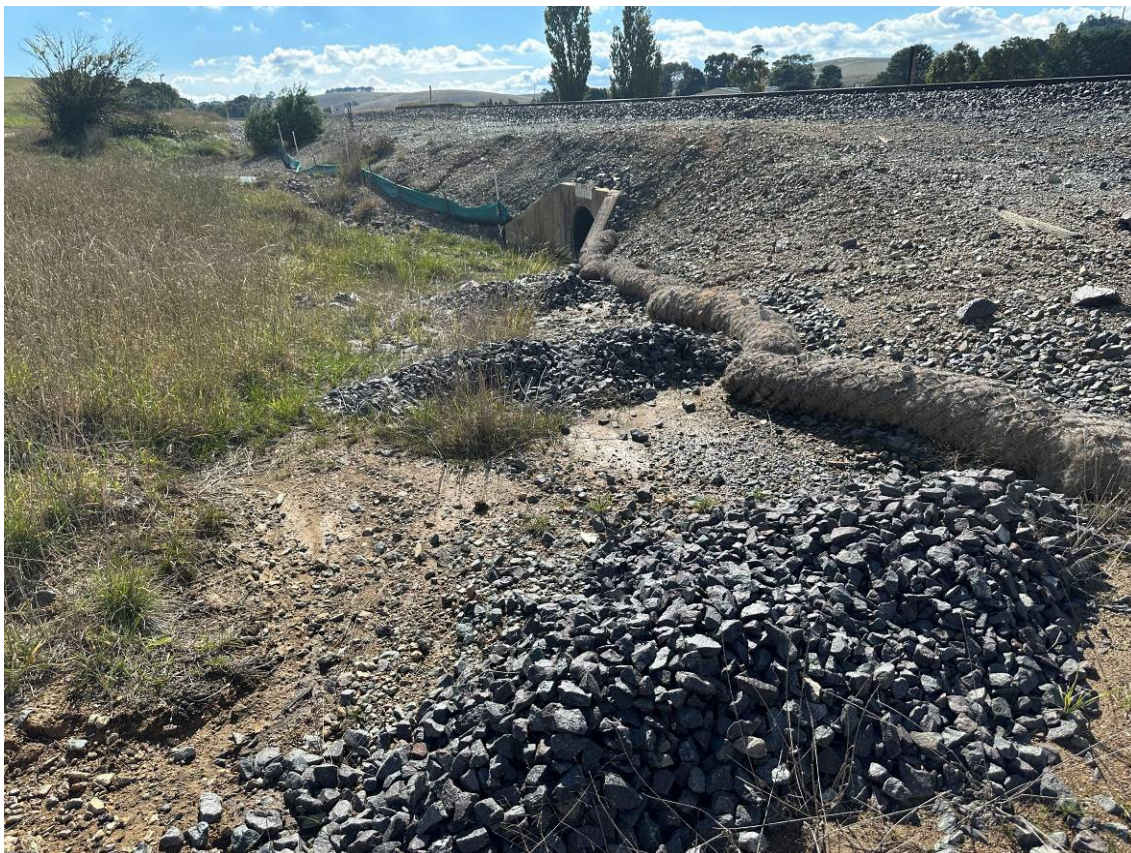
**Photo 14: Upgradient of middle culvert. Sediment controls in place (coir logs and rock armoury in good condition).**

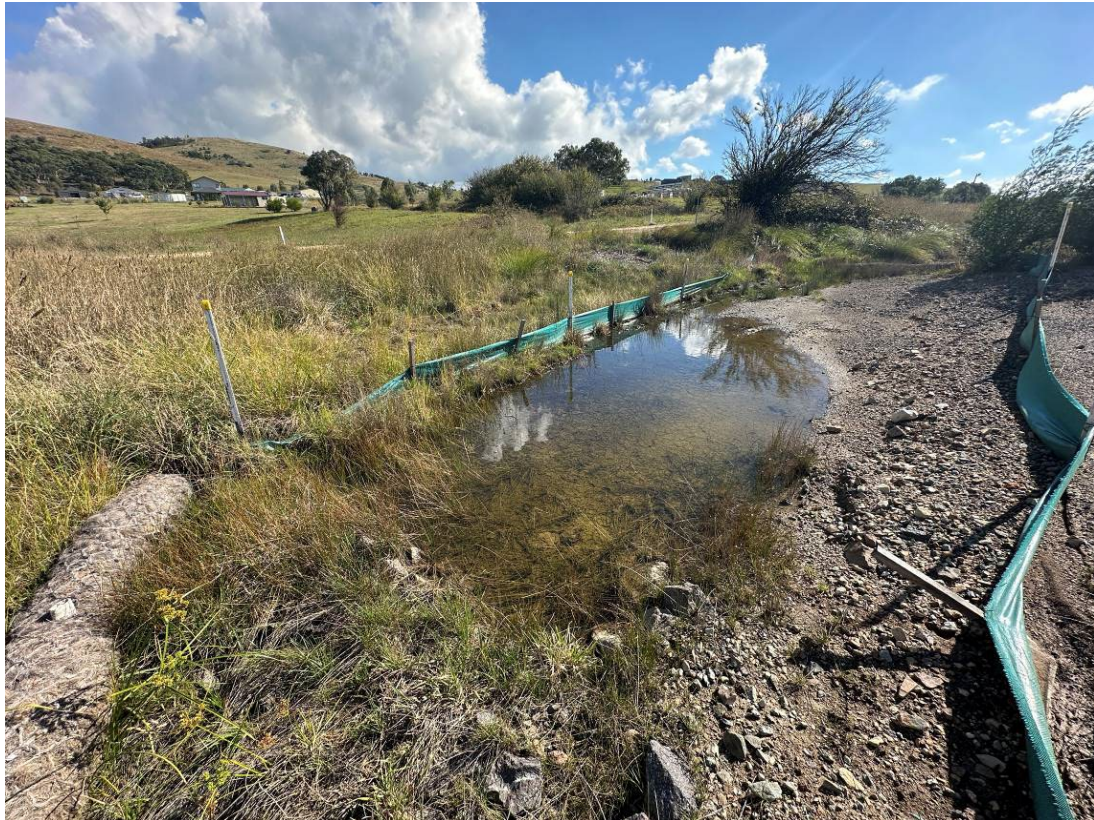
**Photo 15: Upgradient of middle culvert. Pooled surface water on site was clear with no turbidity. Sediment controls in place (coir logs and rock armoury in average condition).**

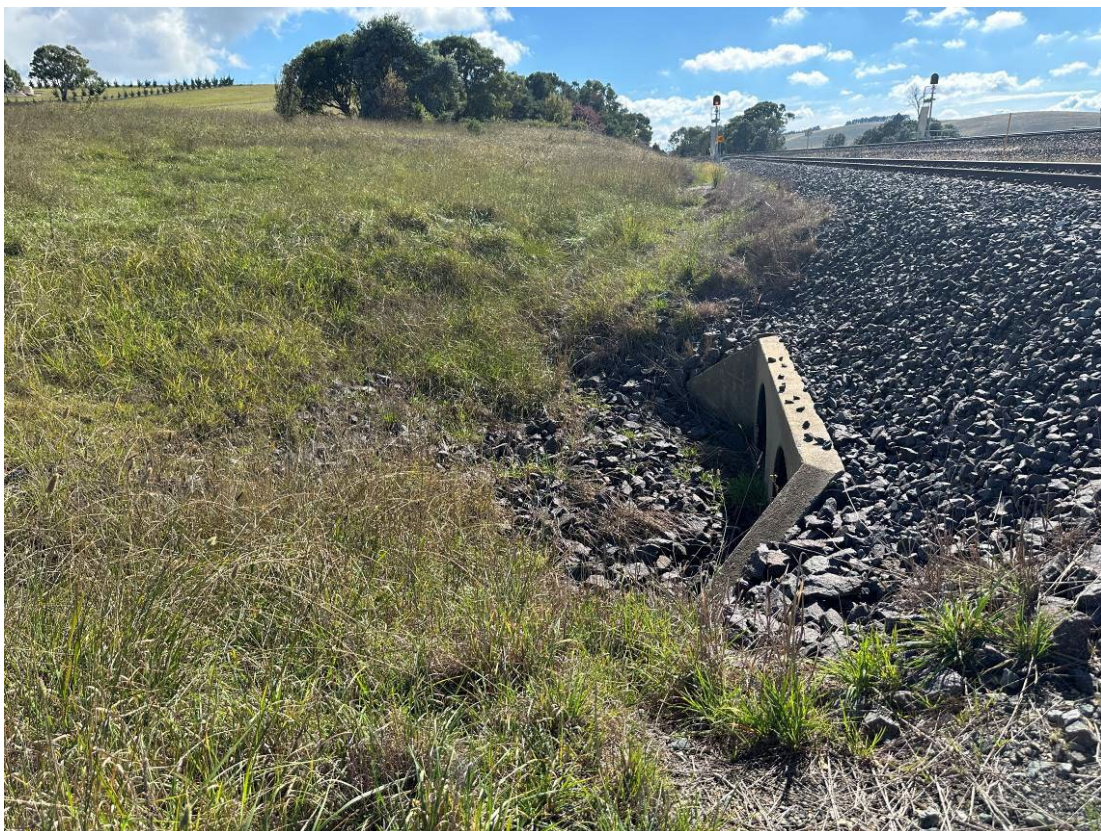
**Photo 16: Upgradient of northernmost culvert with no surface water. No sediment build up was noted on rock armoury.**

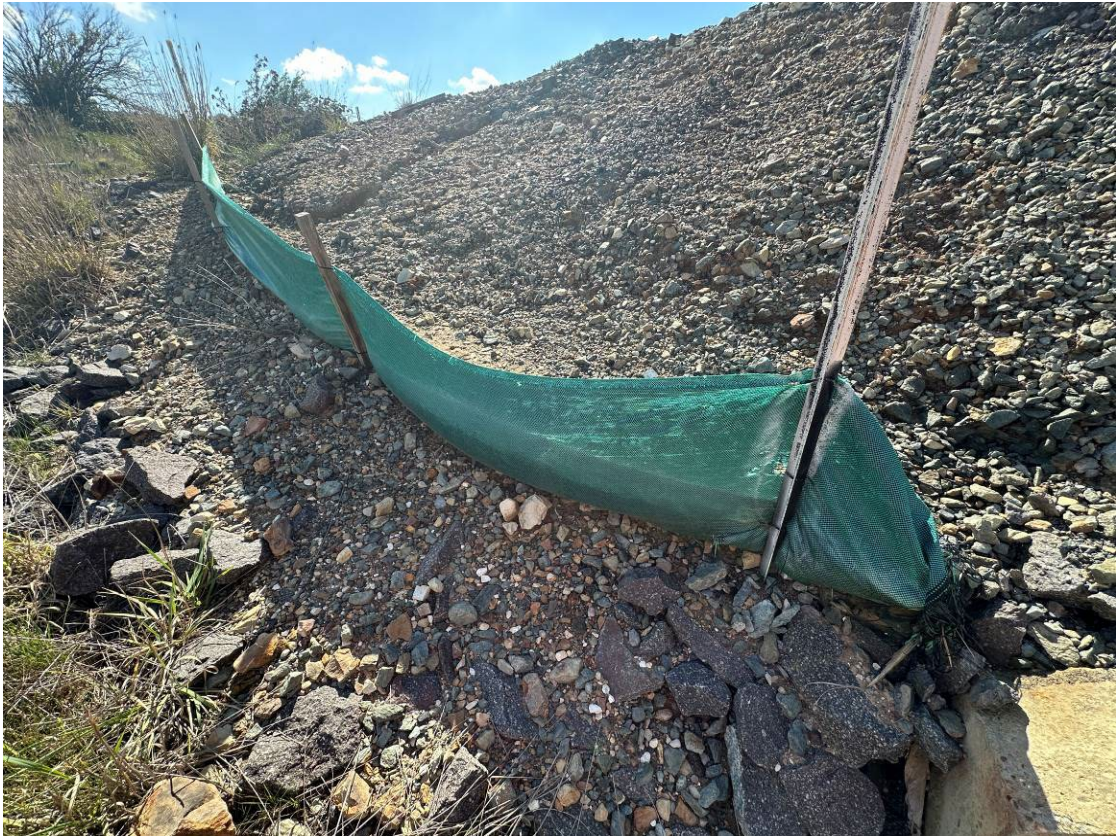
| Section | Control | Inspection | | Corrective Action |
|---|---|---|---|---|
| | If sediment is present what is the estimated depth of sediment? | Sediment build up on silt fencing present on site (approximately 5 cm). | | |

**Photo 17: Upgradient of railway line to the north of the middle culvert. Sediment fencing in place with large build-up of sediment.**

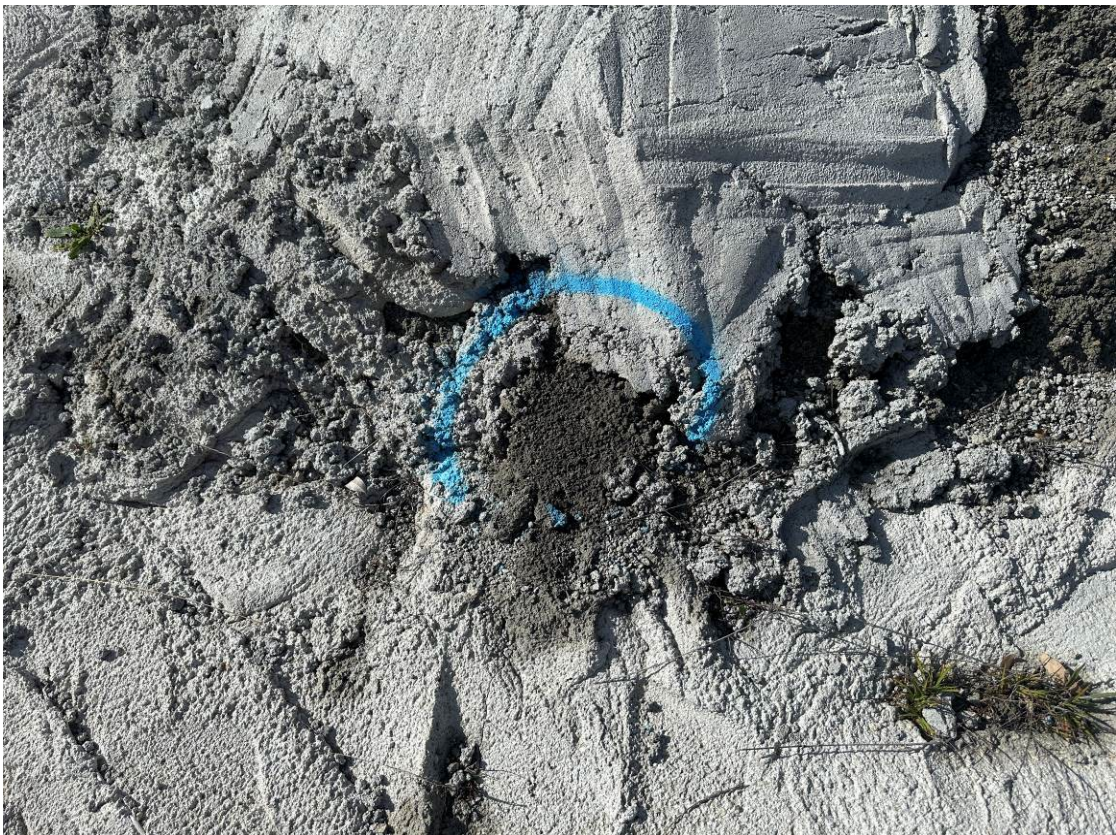
| <p>1. The previous monthly site inspection in March identified one new locations where the marker layer was exposed. During this inspection, the exposure location appeared to have been covered with concrete (<b>Photo 18</b>). No further damages to the concrete capping of the stockpile were observed during this inspection (<b>Photo 19</b>).</p> <p>2. The geofabric silt curtain (sediment fencing) located upgradient of middle trainline culvert (<b>Photo 17</b>) was noted to have large sediment build up. Ramboll recommends the removal of the build up to ensure the sediment fencing remains undamaged and an adequate control.</p> <p>3. Evidence of erosion has been noted upgradient of the southern most culvert in multiple previous site inspections and remains on site but in a stable condition (<b>Photos 10 and 11</b>). No evidence of sediment was found in water flowing offsite at southern culvert during this site inspection. Ramboll recommends replacing ground cover material (ballast) if further erosion occurs or sediment is visible in the downstream surface water of the southern culvert.</p> | | |

| Section | Control | Inspection | | Corrective Action |
|---|---|---|---|---|
| | Is geofabric marker layer visible beneath capping of the existing stockpile? If so record in written form and through photographs and consolidate with this checklist. If marker layer is visible rectification work is required. | No. One new exposed location was identified during the previous March inspection. This inspection verified the location has since been sealed. Refer to 'Other Observations' section for additional comments. | | |

**Photo 18: Previously exposed geofabric layer marker on stockpile, noted during March EMP Inspection had been filled with cement.**

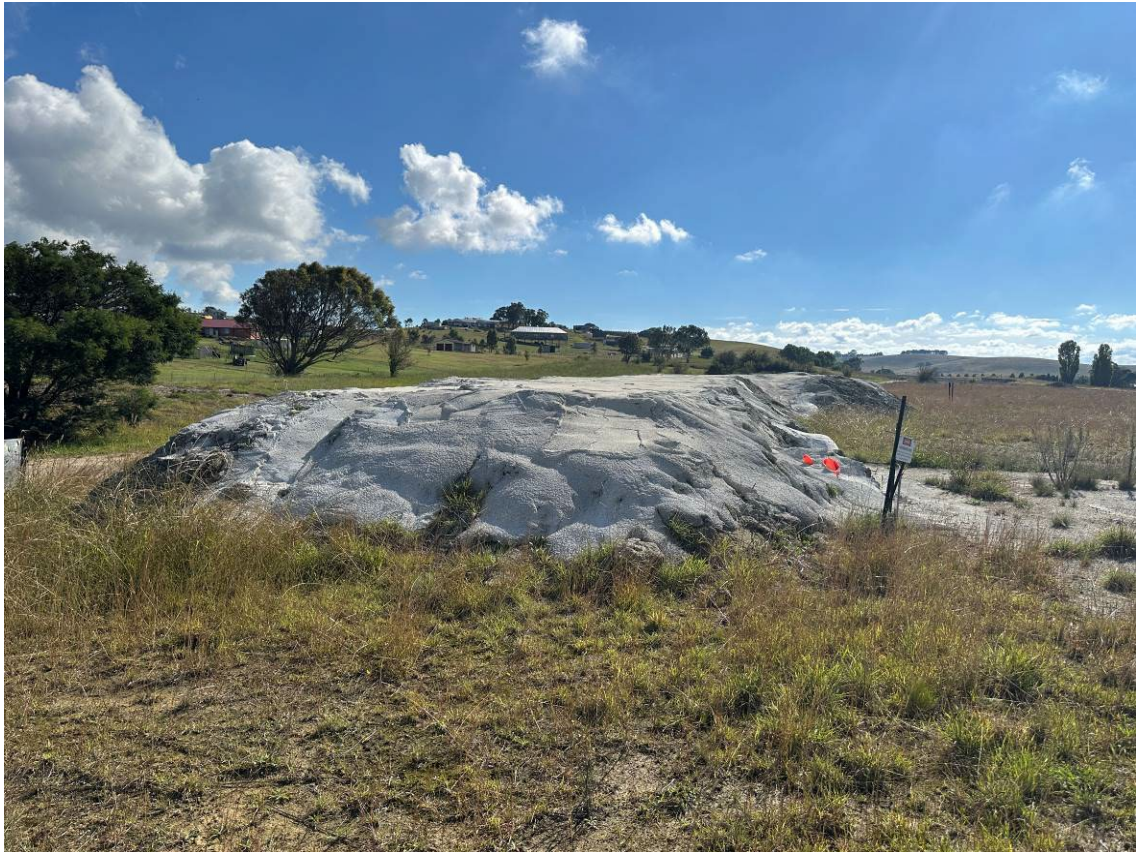
| Section | Control | Inspection | | Corrective Action |
|---|---|---|---|---|
| | Are cracks present in the capping of the existing stockpile? If so record the width and length of cracks in written form and through photographs and consolidate with this checklist. | Yes, minor hairline cracking is present on the stockpile (observed during an inspection 15/03/23), these remain stable and are not expected to adversely affect cap competency in current condition. | | |
| 7.3 | Are there signs of vegetation on the existing stockpile? If so record in written form and through photographs and consolidate with this checklist. | Yes, several small-medium sized weeds were identified growing out from the stockpile from previous inspections. These are not expected to affect stockpile capping effectiveness. | | |

**Photo 19: Concrete capped stockpile. No major signs of exposure marker layer and erosion damage. Some vegetation growing but not expected to impact capping integrity.**

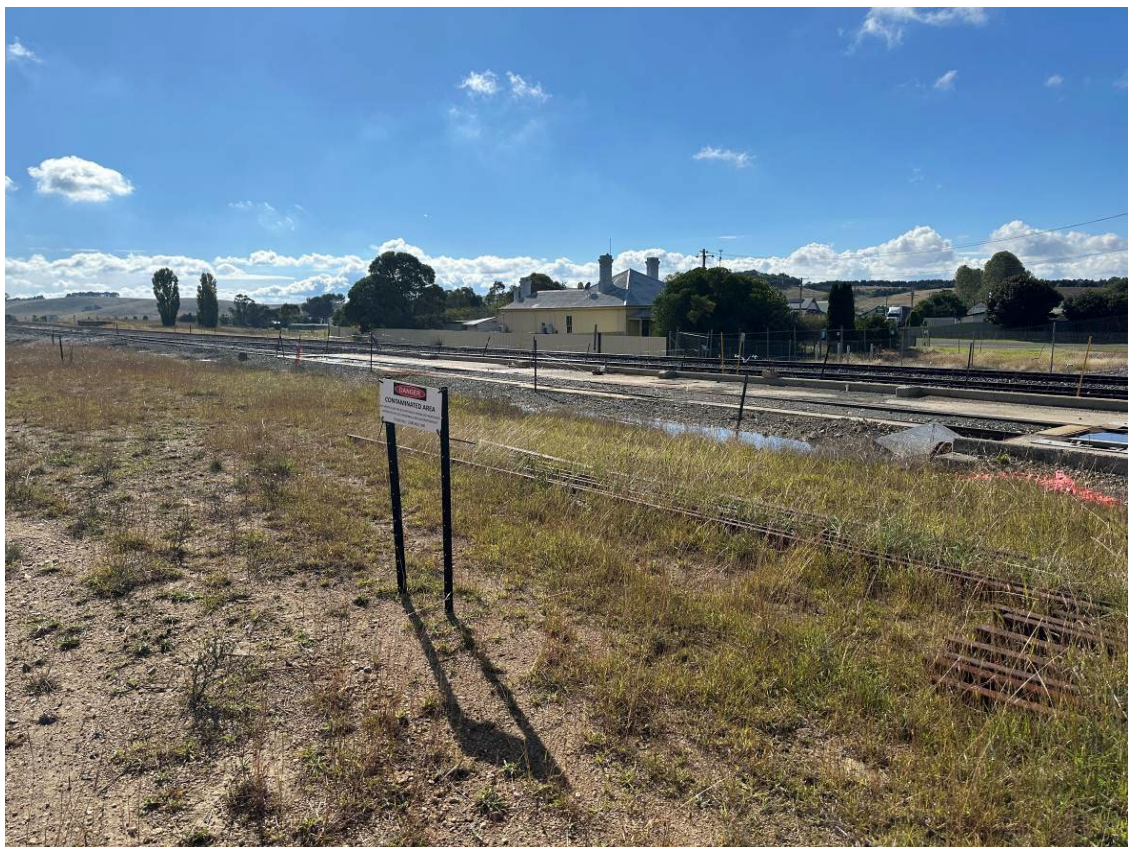
| Section | Control | Inspection | | Corrective Action |
|---|---|---|---|---|
| 5.1 | Is Exclusion Zone signage present as recommended on Figures 2a - 2e Appendix 1 to demarcate contamination in the rail formation and adjacent soils? | Yes ( <b>Photo 20</b> ) | | |
| | Is Exclusion Zone signage undamaged? | Yes, exclusion zone signage appeared in good condition | | |

**Photo 20: Contaminated land signage in good conditions, placed at appropriate intervals along the site.**
