# Tarago Action Plan Routine Inspection Checklist

| Date: | 13-Jun-24 | Ramboll and UGL RL Environmental |

| Title: | Tarago Rail Yard Inspection | Approved: | Project-Nr.:<br>318001704 | Date:<br>13 June 2024 |
| Site: | Tarago, NSW | | | |

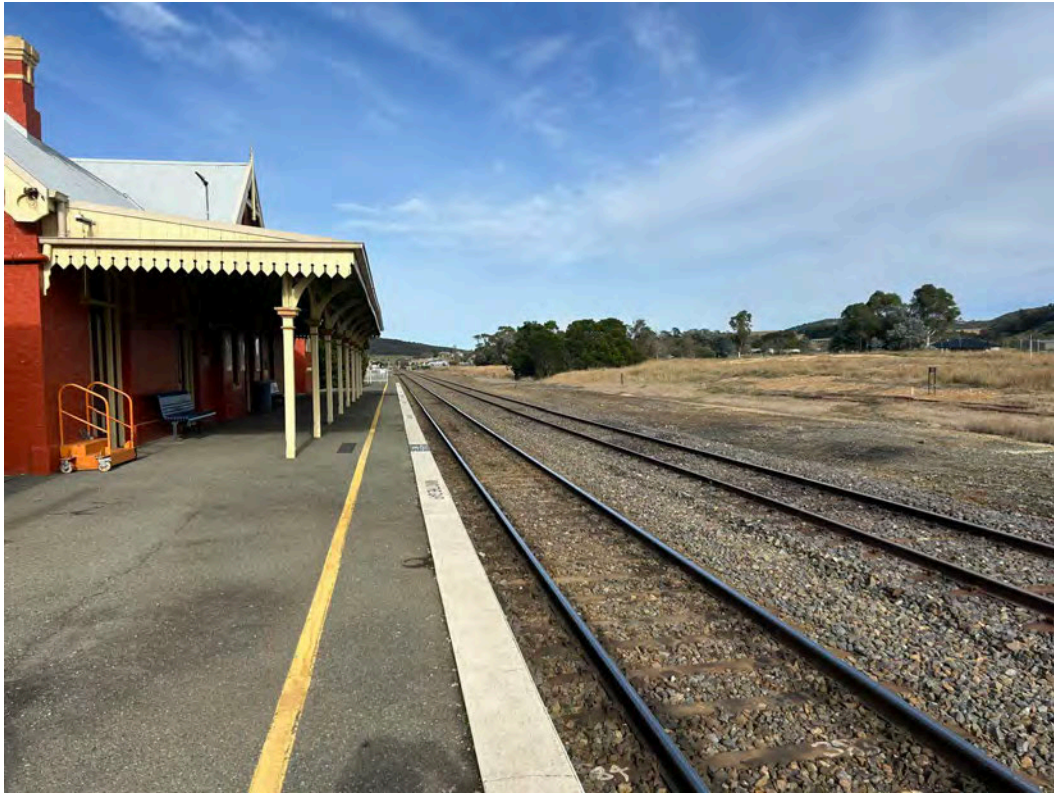
| No airborne dust was visible ( <b>Photos 1 - 2</b> ). | | |

Photo 1: Picture at northern end of Tarago railway station platform facing south, no airborne dust visible.

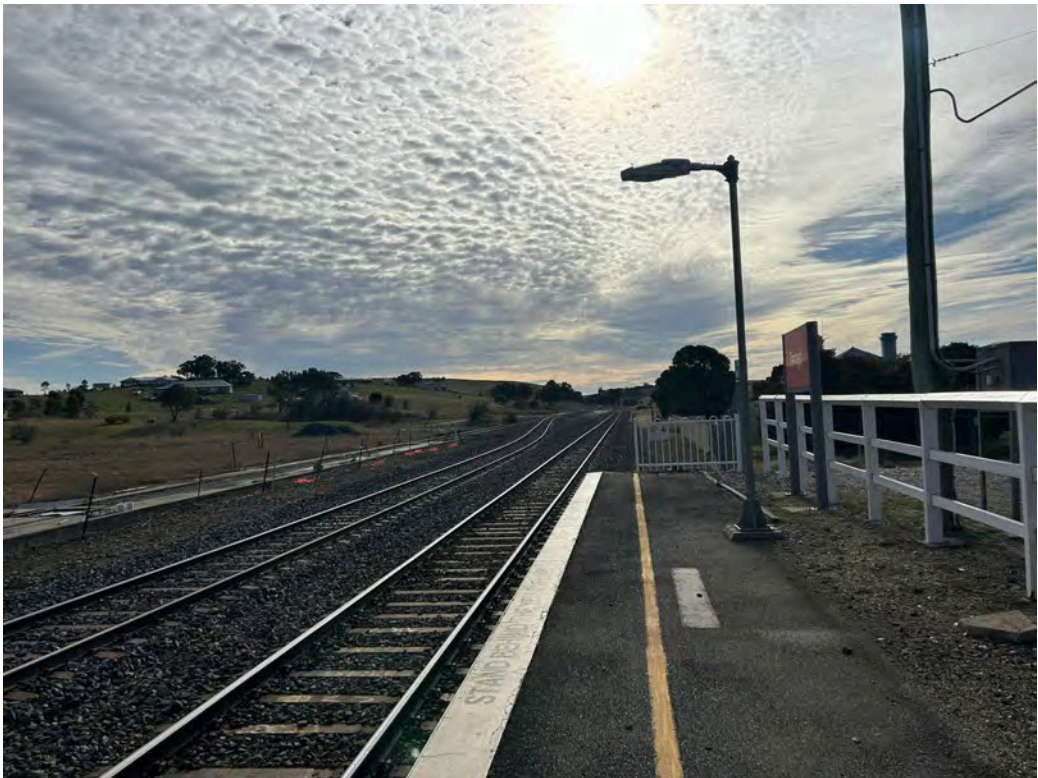
Photo 2: Picture at northern end of Tarago railway station facing north, no airborne dust visible.

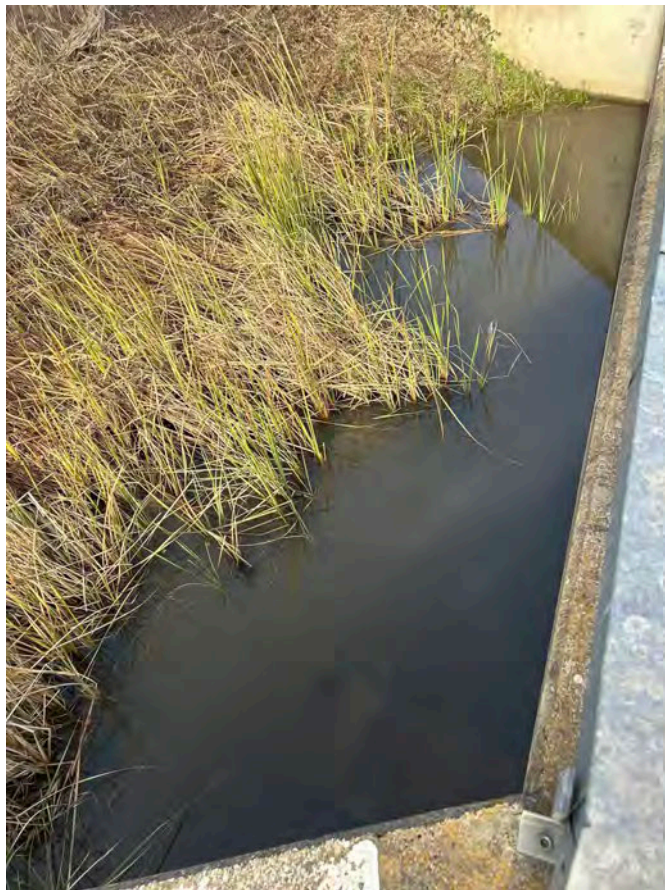
| No sign of sediment run-off seen in surface water flowing off-site at southern culvert ( <b>Photo 3</b> ) and middle culvert ( <b>Photo 5</b> ). No evidence of sediment run-off from northern culvert with only pooled, no flowing, surface water observed ( <b>Photo 6</b> ). | | |
| Surface water was observed discharging from the site at the southern and middle culvert ( <b>Photos 3, 4, and 5</b> ). Pooled water was observed in multiple locations on site ( <b>Photos 6, 13 and 14</b> ). No other flowing surface water was observed onsite during the inspection. | | |

**Photo 3: Southern culvert downgradient of railway line with surface water flowing offsite. Surface water was light to dark grey with no-low turbidity.**

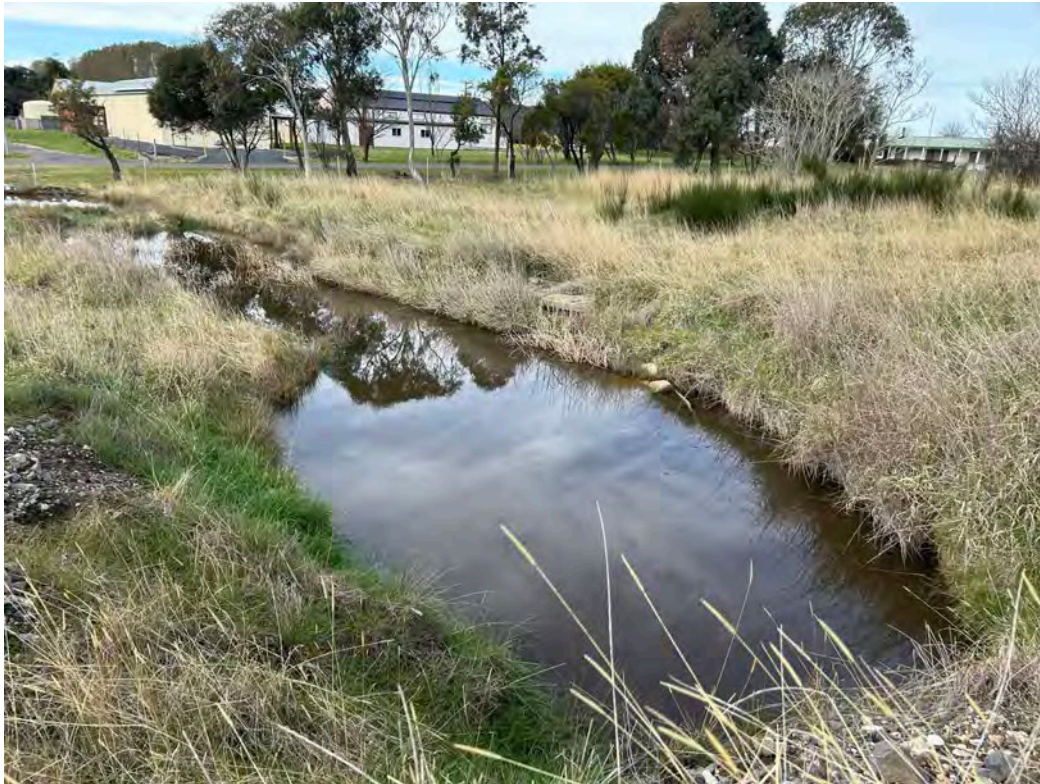
**Photo 4: Downgradient of middle culvert with flowing surface water. Surface water near culvert was light to dark grey with low to moderate turbidity.**

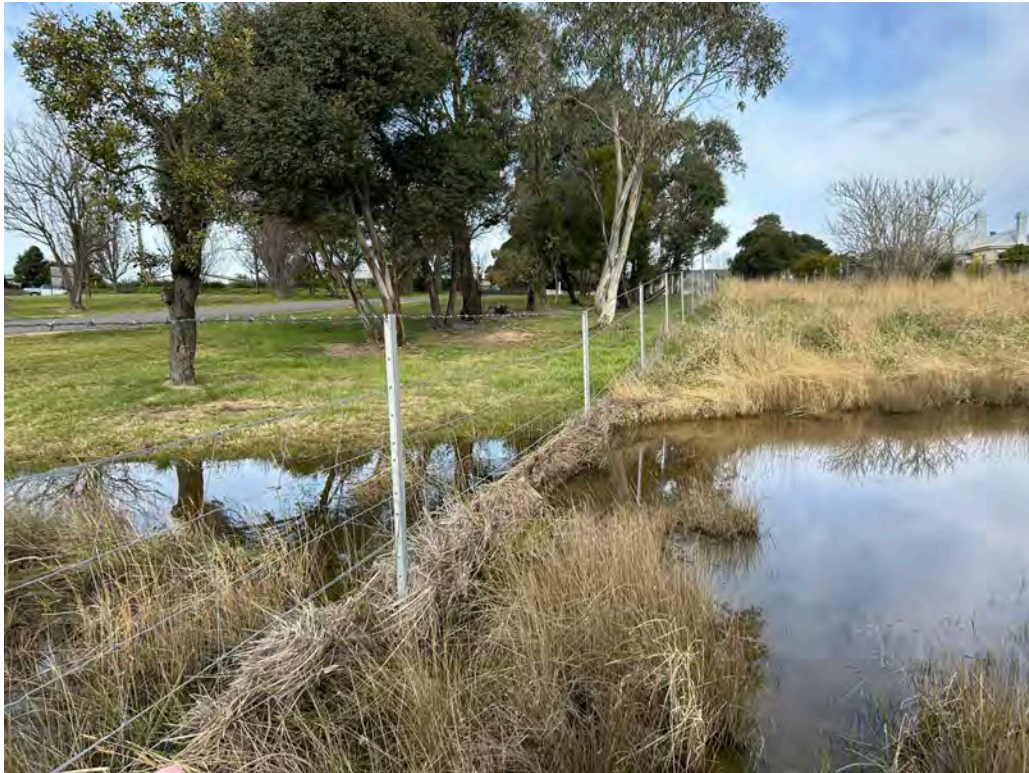
**Photo 5: Downgradient of middle culvert facing south with surface water flowing off site at fence line. Surface water was slightly grey, clear, very low to no turbidity.**

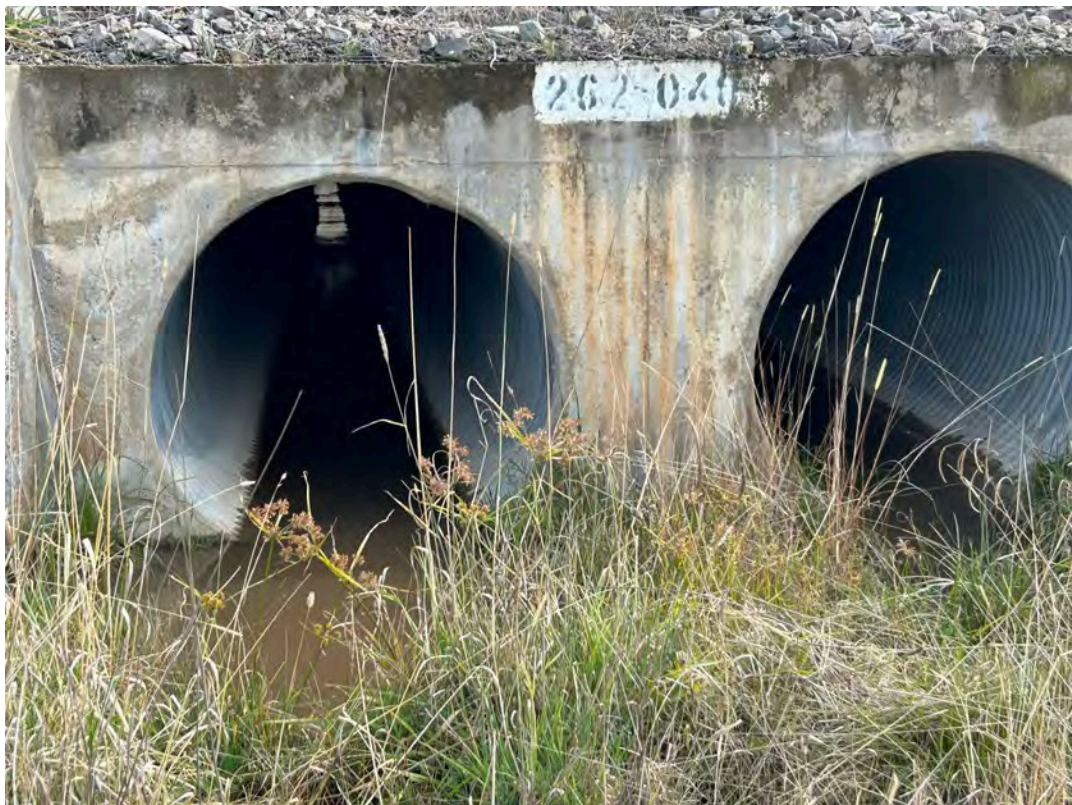
**Photo 6: Downgradient of northernmost culvert with pooled surface water. Water was moderately turbid with slight brown to grey in colour. Not flowing off site to adjacent property.**

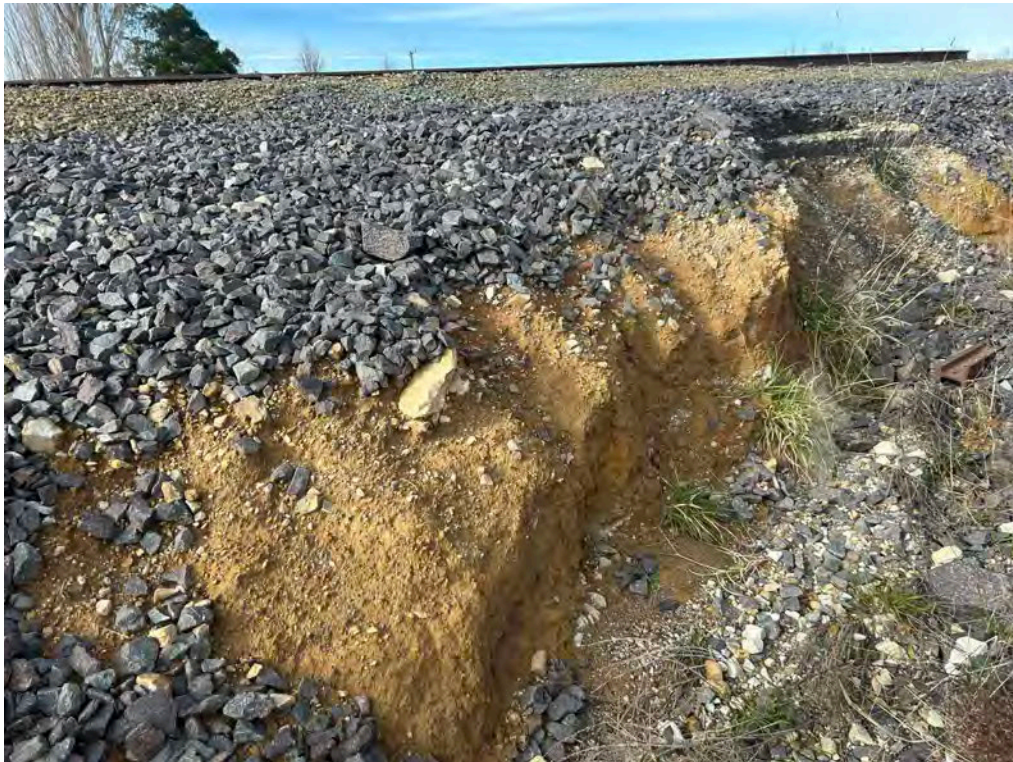
**Photo 7: Southernmost culvert upgradient of the railway line. The erosion due to lack of ground cover observed during previous inspections is still present.**

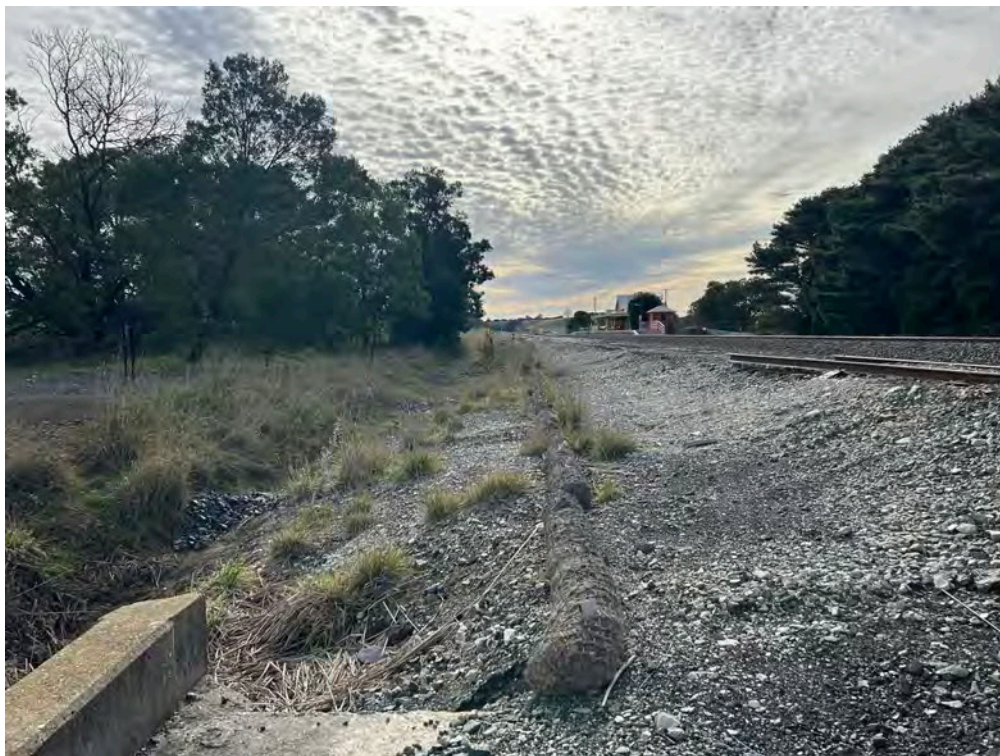
**Photo 8: Southernmost culvert upgradient of the railway line. Sediment control coir logs in place and in good condition.**

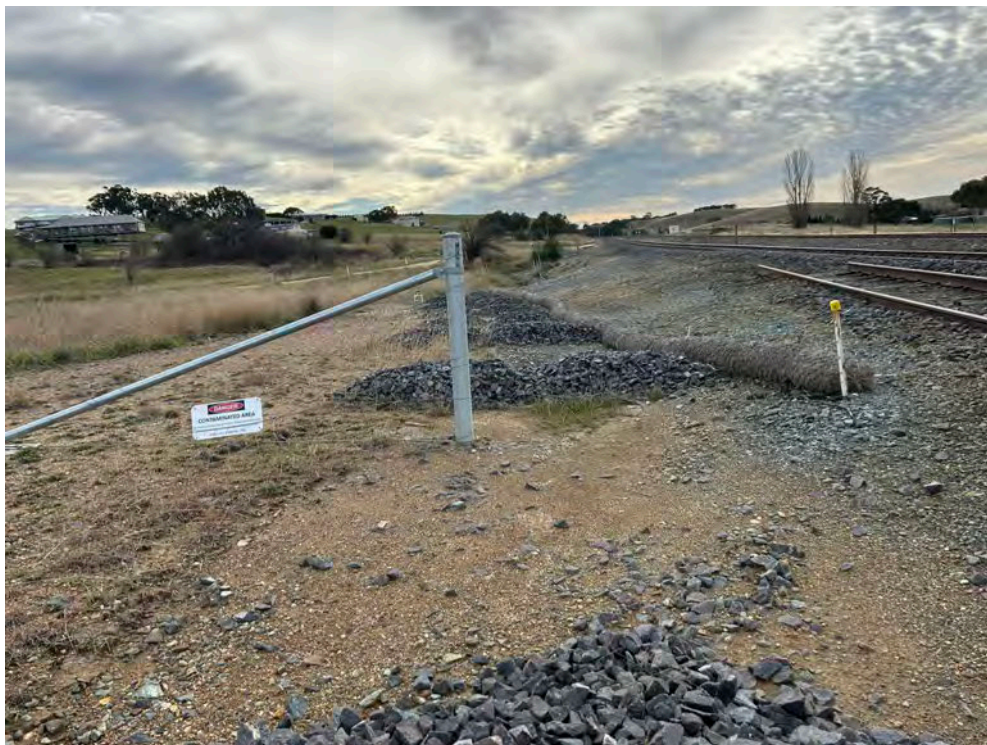
| Section | Control | Inspection | | Corrective Action |
|---|---|---|---|---|
| 5.1 | Is Exclusion Zone signage present as recommended on Figures 2a - 2e Appendix 1 to demarcate contamination in the rail formation and adjacent soils? | Yes ( <b>Photo 10 and 18</b> ) | | |

**Photo 10: Rock armoury and sediment coir logs adjacent to old rail siding in good condition. No surface water was observed.**

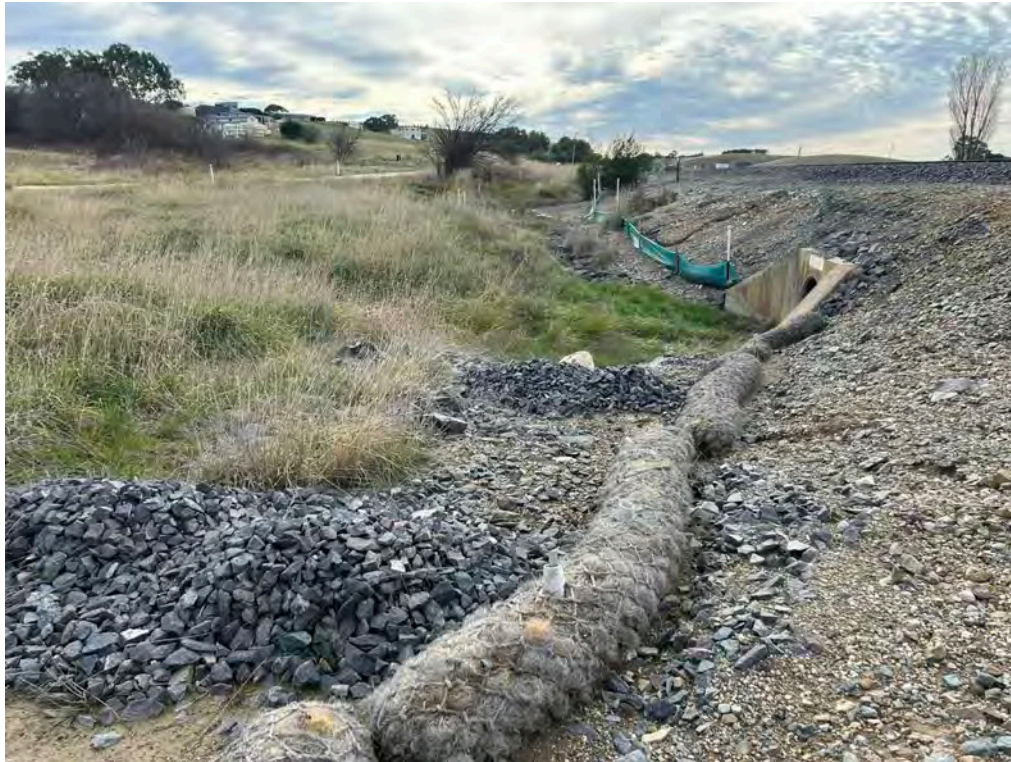
**Photo 11: Rock armoury and sediment coir logs following drainage to upgradient of middle culvert in good condition with minor build-up of sediment**

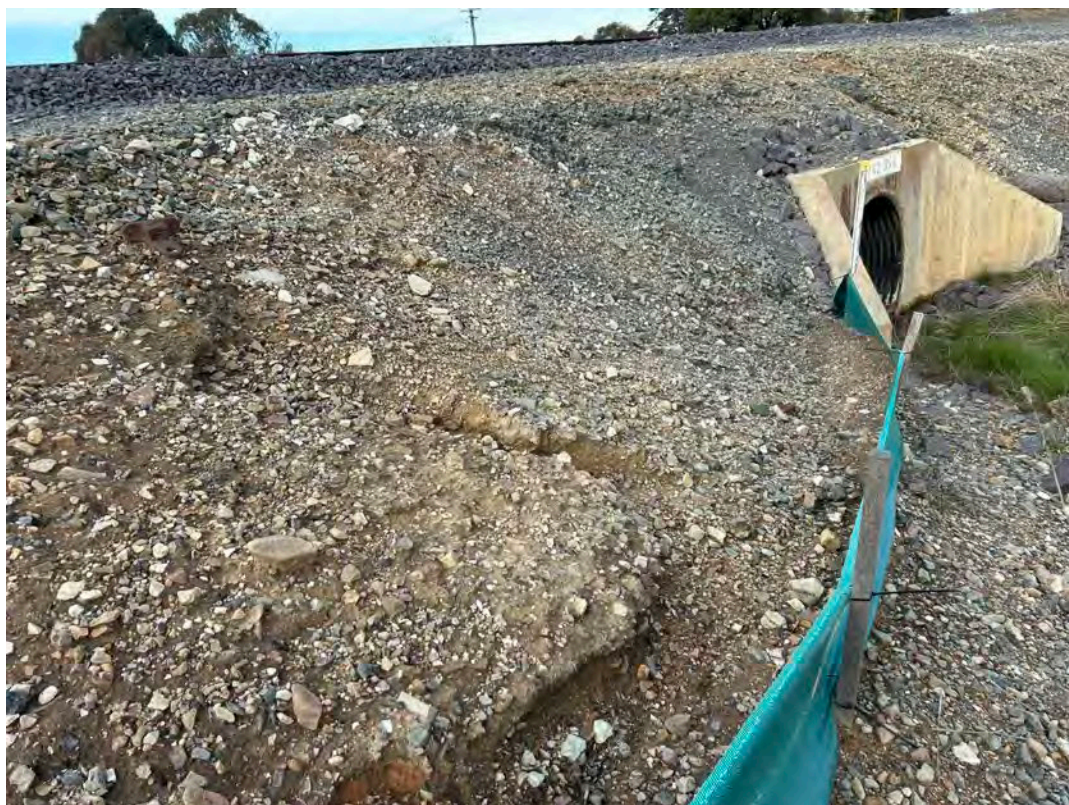
| <p>1. Damages observed in the concrete-capped stockpile during the last inspections were noted to have been fixed (<b>Photo 17</b>) during this inspection.</p> <p>2. The geofabric silt curtain (sediment fencing) located upgradient of middle trainline culvert (<b>Photo 12</b>) was noted to have large sediment build up during previous and current inspections. Ramboll recommends the removal of the build up to ensure the sediment fencing remains undamaged and an adequate control.</p> <p>3. Evidence of erosion noted upgradient of the southern most culvert in previous site inspections remains on site but in a stable condition (<b>Photo 7</b>). No evidence of sediment was observed in water flowing offsite at southern culvert during this site inspection. In addition, some minor erosion due to inadequate ground cover was also observed upgradient of the railway line, to the north of the middle culvert. Ramboll recommends replacing ground cover material (ballast) if further erosion occurs or sediment is visible in the downstream surface water.</p> <p>4. Minor damage to sediment fencing to the north of the upgradient of the middle culvert was observed during previous inspections and remained the same during this inspection (<b>Photo 13</b>). Ramboll advises this be fixed.</p> <p>5. Rock armour in drainage channel between southern and middle culverts appear to be in average condition (<b>Photo 9</b>). Ramboll recommends replacing or replenishing the armour in this drainage channel.</p> | | |

**Photo 12: Upgradient of railway line to the north of the middle culvert. Sediment fencing in place with large build-up of sediment. Some minor erosion due to inadequate ground cover was observed.**

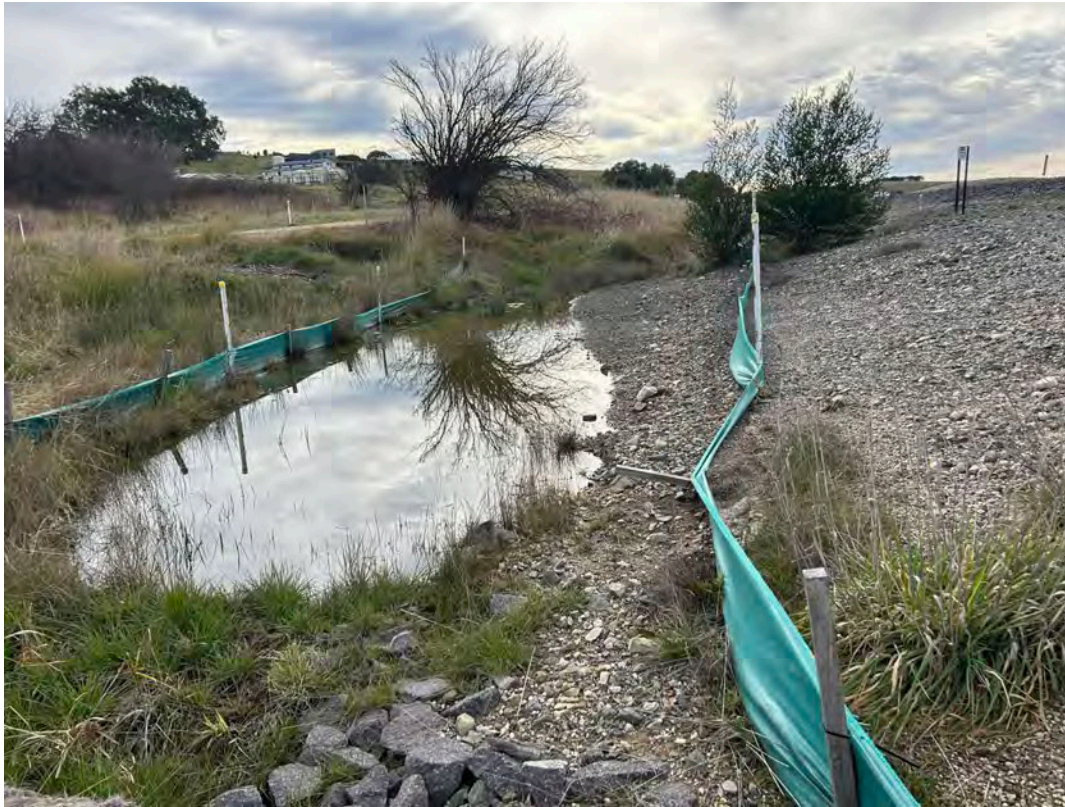
**Photo 13: Previous inspections noted that the sediment fencing in drainage line north of middle culvert has some damage and needs to be replaced. No change was noted in this inspection.**

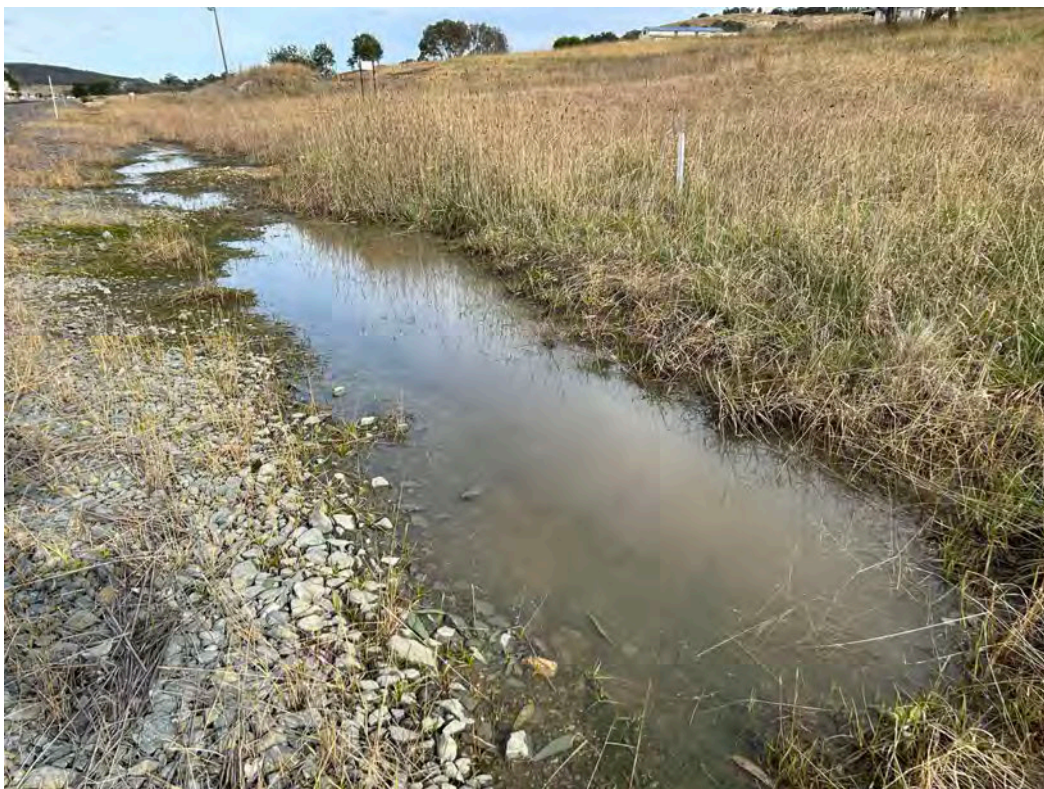
**Photo 14: Pooled surface water was found at multiple locations upgradient of the rail corridor in the northern portion of site. The water was light grey to light brown, moderately turbid, and not flowing offsite.**

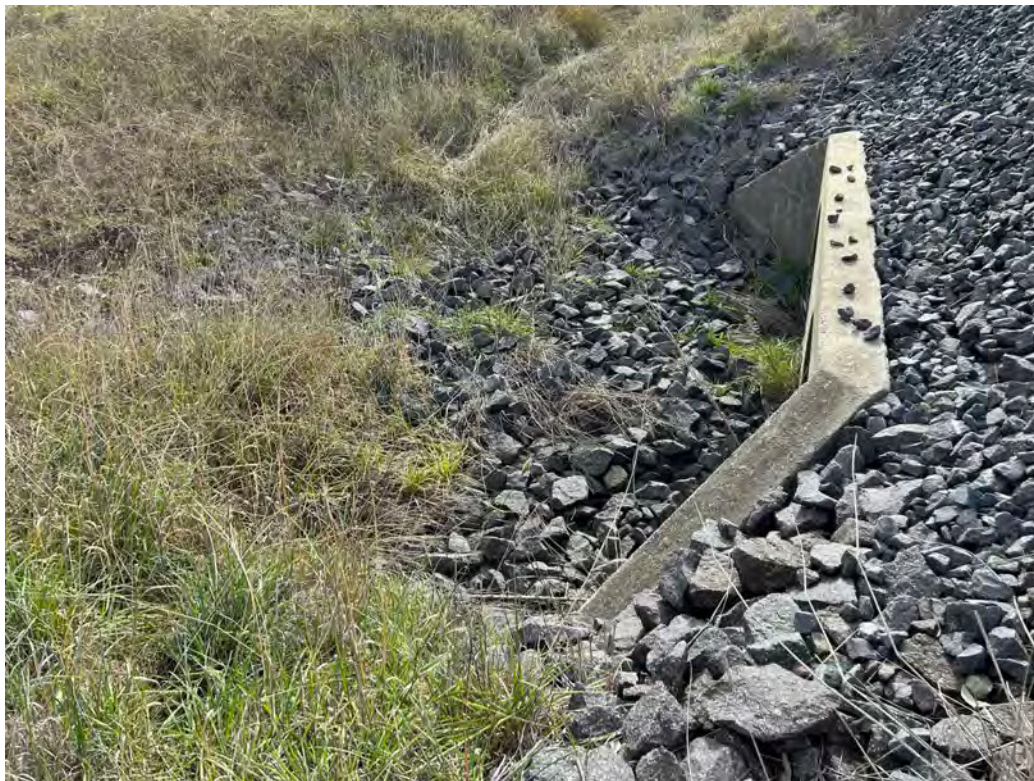
**Photo 15: Upgradient of northernmost culvert with no surface water. No sediment build up was noted on rock armoury.**

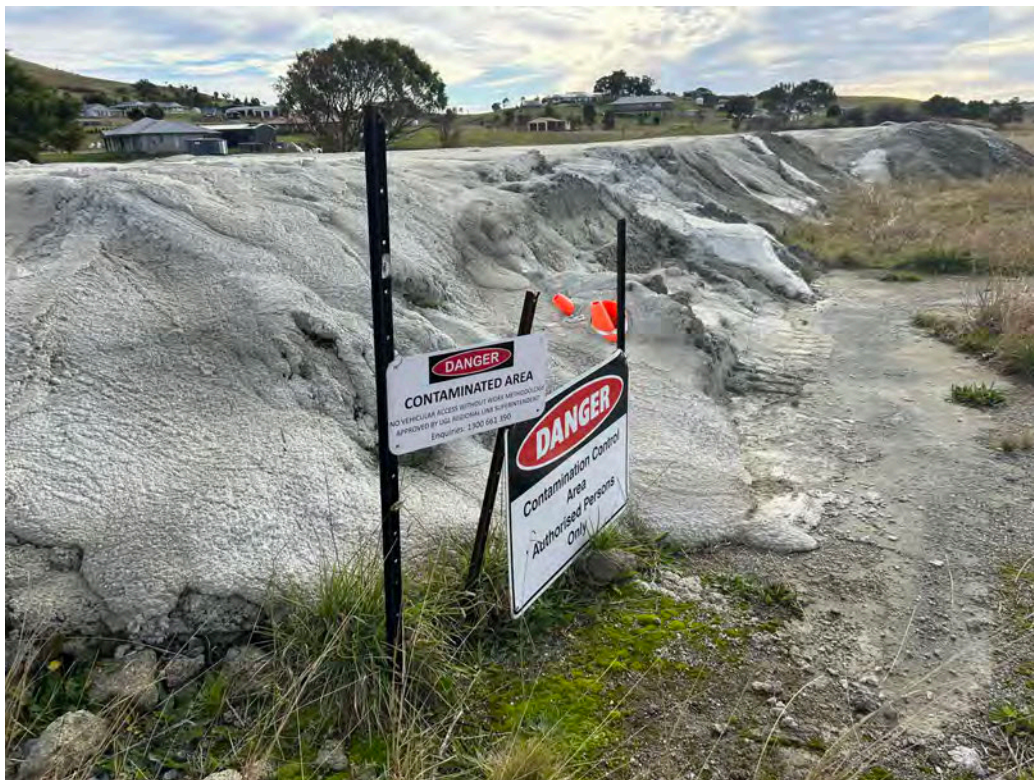
| Section | Control | Inspection | | Corrective Action |
|---|---|---|---|---|
| | Is Exclusion Zone signage undamaged? | Yes, exclusion zone signage appeared in good condition. One sign adjacent to the stockpile was slightly damaged during the inspection, but this was fixed by UGL personnel on site ( <b>Photo 16</b> ). | | |

**Photo 16: The concrete-capped stockpile is in good condition with no evidence of erosion. One contamination sign on the southeastern corner was slightly damaged but fixed by UGL personnel on site. All other signs were intact and in good condition.**

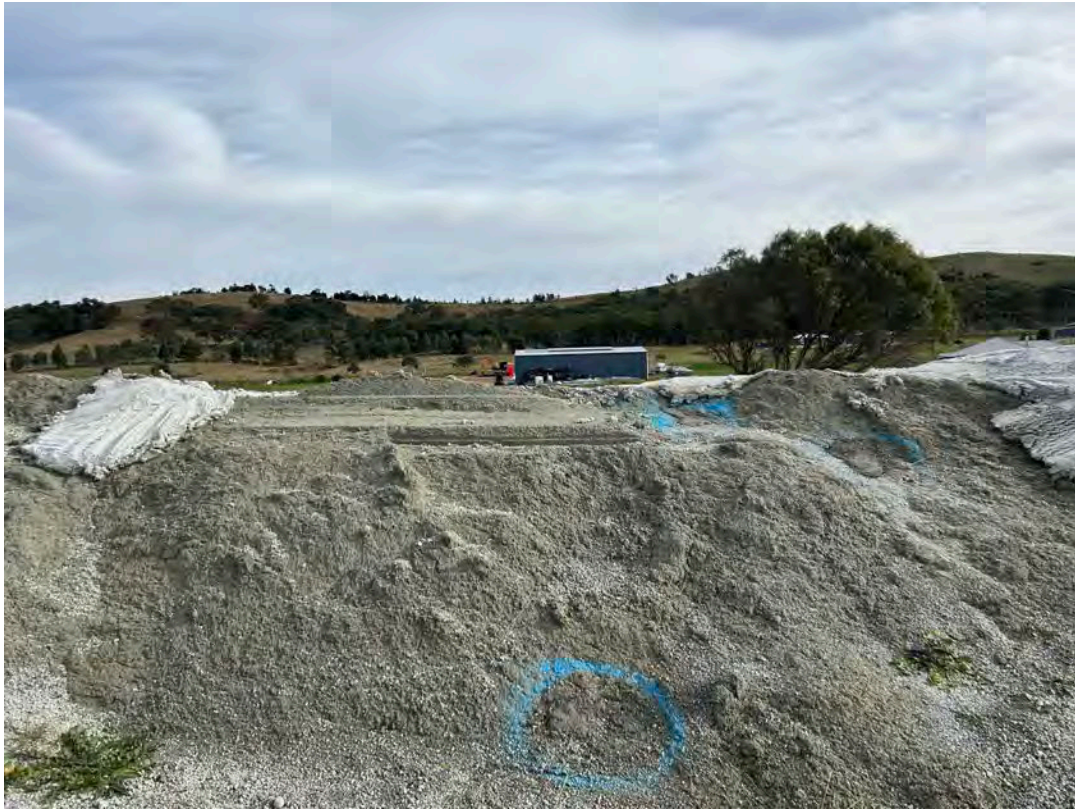
**Photo 17: Three locations of exposed geofabric layer marker on stockpile noted during previous inspections appeared to have been filled with cement.**

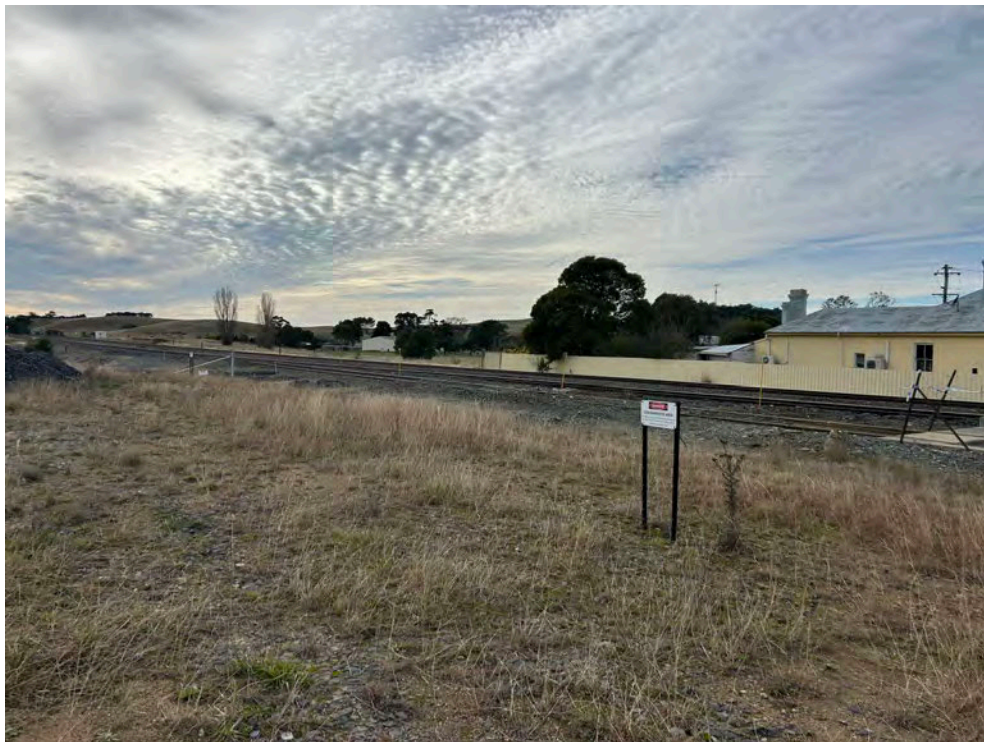
**Photo 18: Contaminated land signage in good conditions, placed at appropriate intervals along the site.**

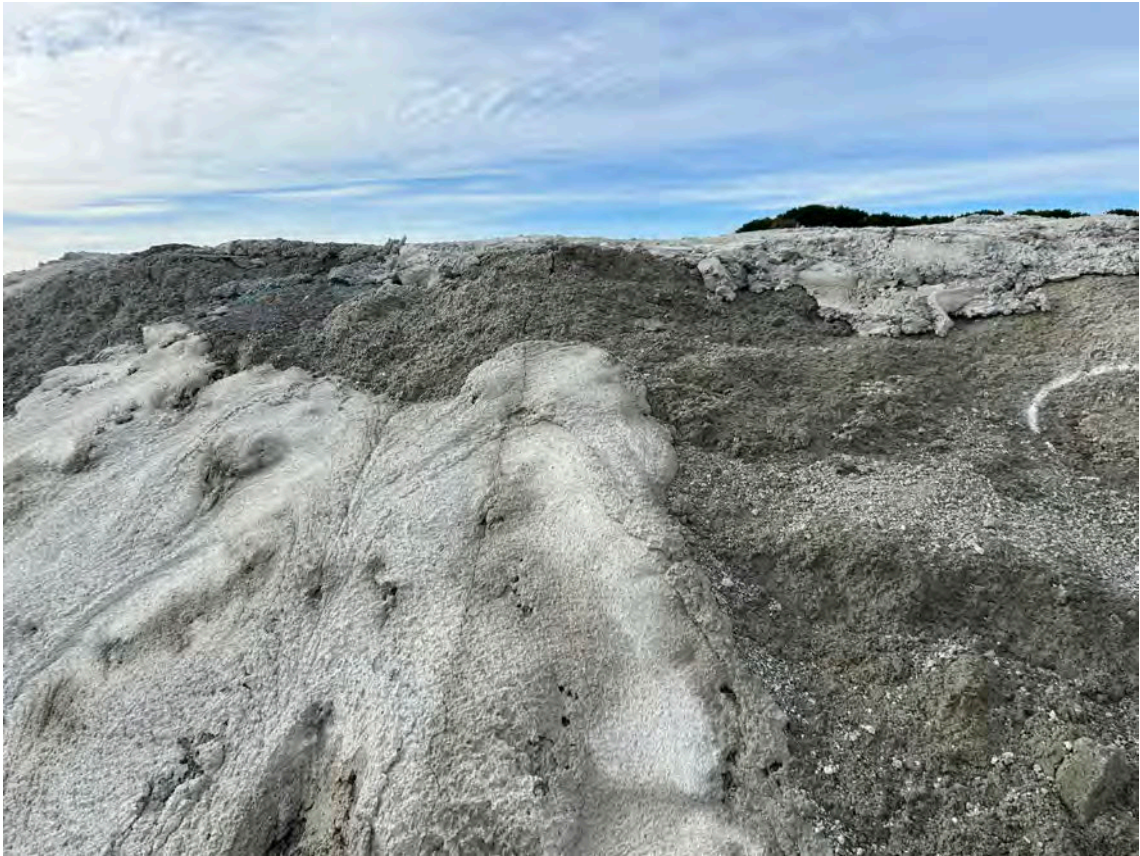
| Section | Control | Inspection | | Corrective Action |
|---|---|---|---|---|
| | Are cracks present in the capping of the existing stockpile? If so record the width and length of cracks in written form and through photographs and consolidate with this checklist. | Yes, minor hairline cracking is present on the stockpile ( <b>Photo 19</b> ), these remain stable and are not expected to adversely affect cap competency in current condition. | | |

**Photo 19: Minor hairline cracking is present on the stockpile**
