# Tarago Action Plan Routine Inspection Checklist

<b>Title:</b> Tarago Rail Yard Inspection	<b>Approved:</b>	<b>Project-Nr.:</b> 318001704	<b>Date:</b> September 2023
<b>Site:</b> Tarago, NSW			
<b>Client:</b> UGL Regional Linx

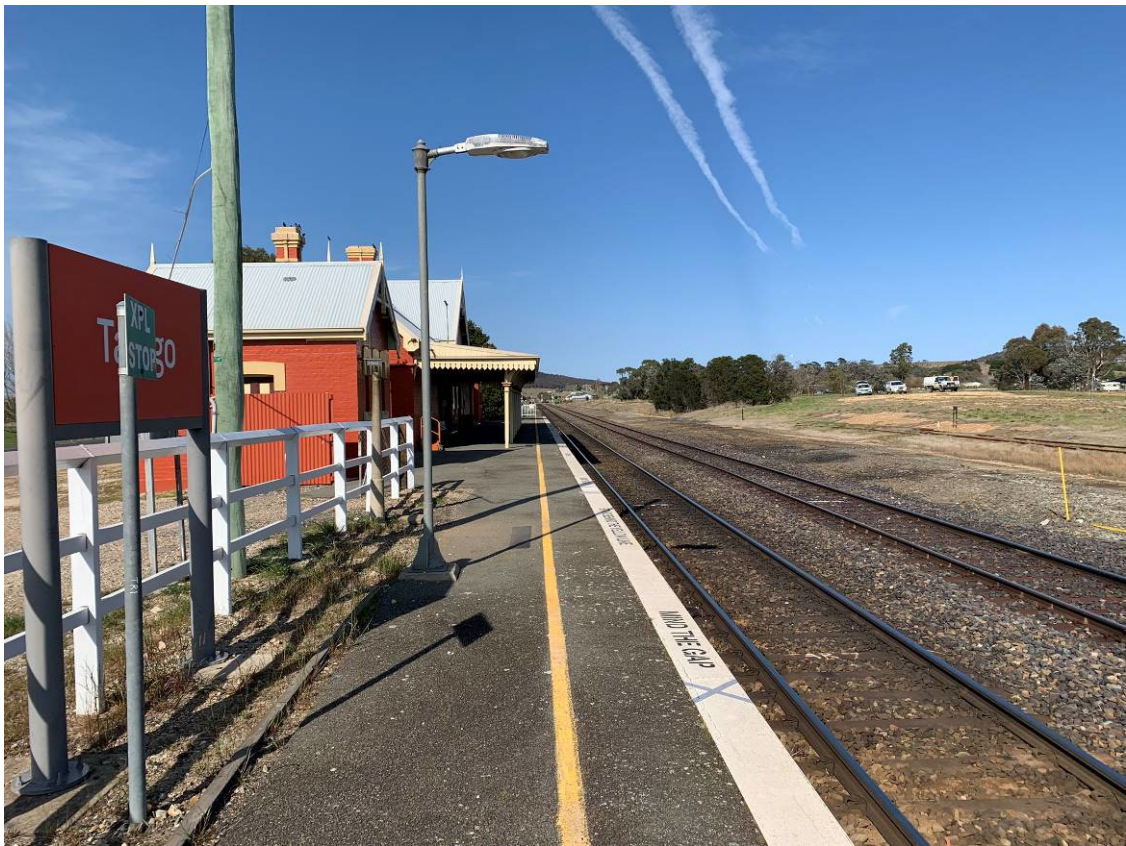
**Photo 1: Picture at north-east end of railway station facing south-west. No airborne dust visible.**

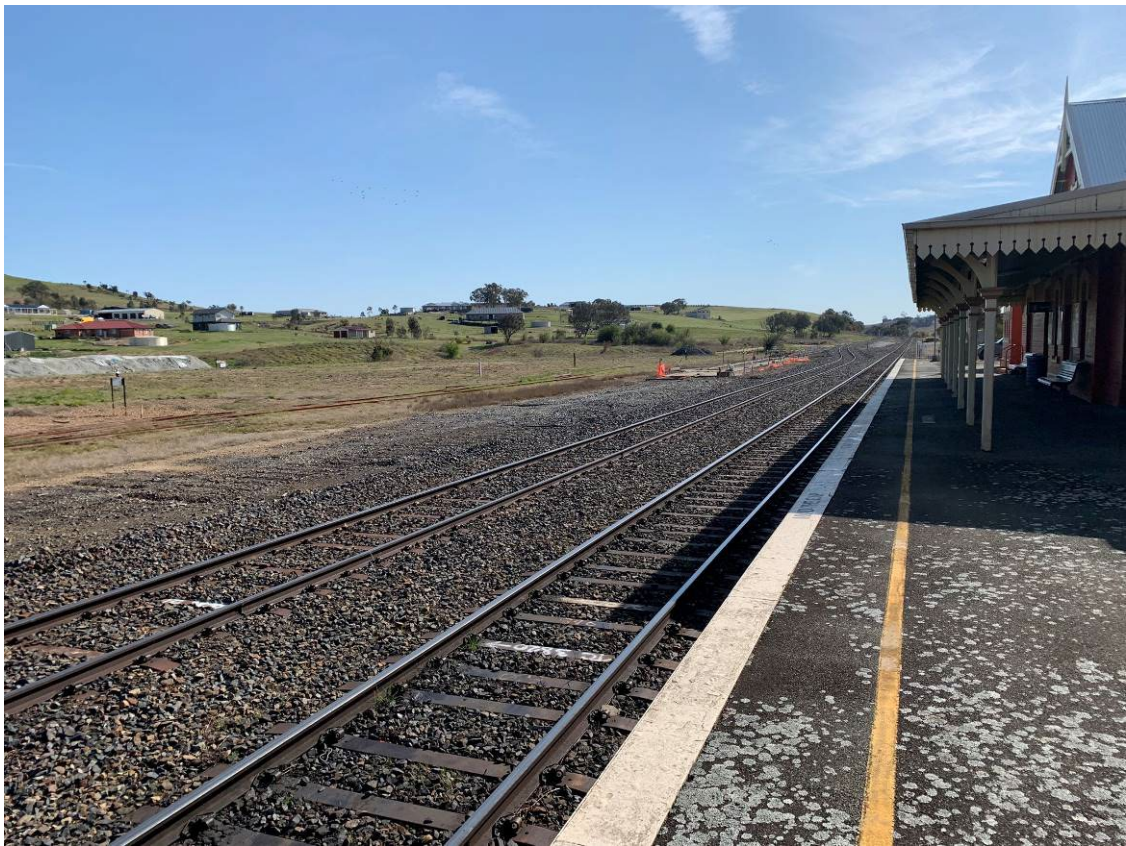
**Photo 2: Picture at south-western end of railway station facing north-east. No airborne dust visible.**

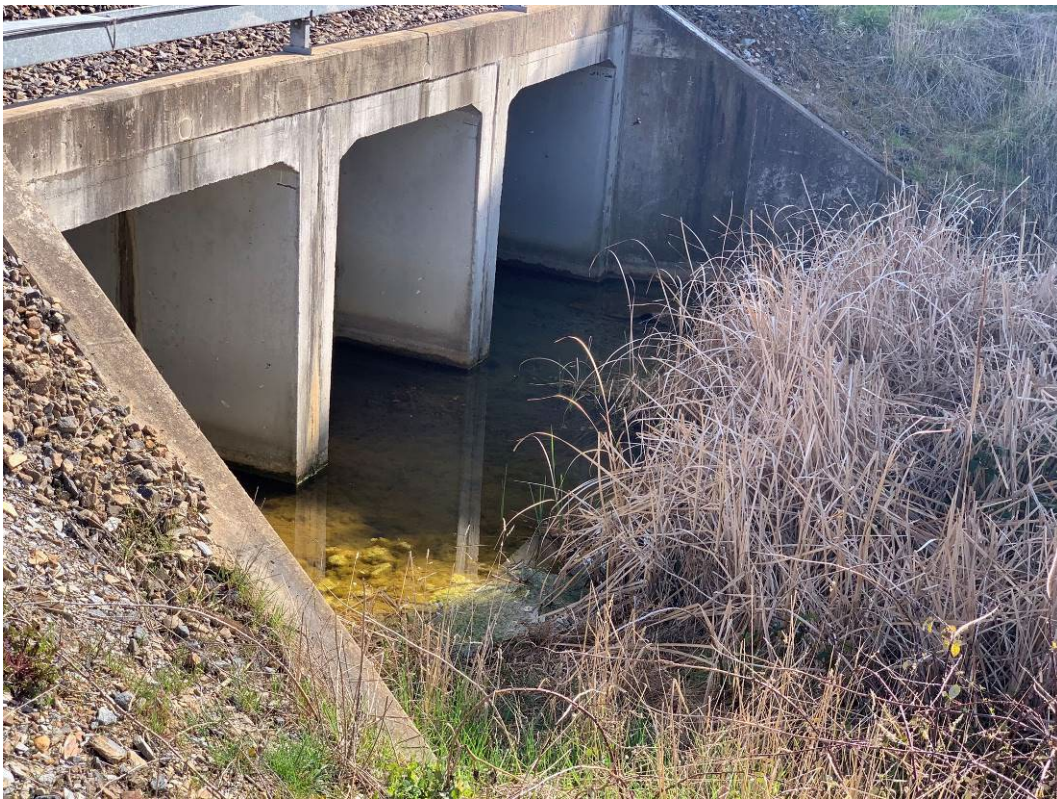
No evidence of sediment run-off beyond northern, middle and southernmost rail culverts ( <b>Photos 3, 7, 8, 13, 16</b> ).		
<u>Is surface water discharging from site?</u>		
Yes. Surface water was discharging at a slow rate from the southern culvert through a thick layer of grass ( <b>Photo 3</b> ). A large pool of water was observed on site and immediately downstream of middle culvert but not discharging off site ( <b>Photos 4 - 6</b> ). Damp soil off site, near an onsite pooled water source ( <b>Photo 19</b> ), suggests water running off site at some time since the last inspection. There was no surface water discharging at the northern culvert ( <b>Photos 7 - 8</b> ).		
<u>Is there evidence of excavation or other works non-compliant with the Action Plan?</u>		
No		
<u>Other observations?</u>		
Regarding the stockpile, this inspection identified two new locations where the marker layer was exposed ( <b>Photos 20 - 21</b> ). One location on the north-east side of the stockpile and another on the south-east side. Both locations were marked with blue paint. Ramboll recommends their immediate repair by applying a concrete patch to the exposed areas to seal them.

**Photo 3: Southern most culvert downgradient of rail line, with slow moving surface water travelling off-site. Water is clear, low turbidity, minimal observable sediment, long grass and some algae present.**

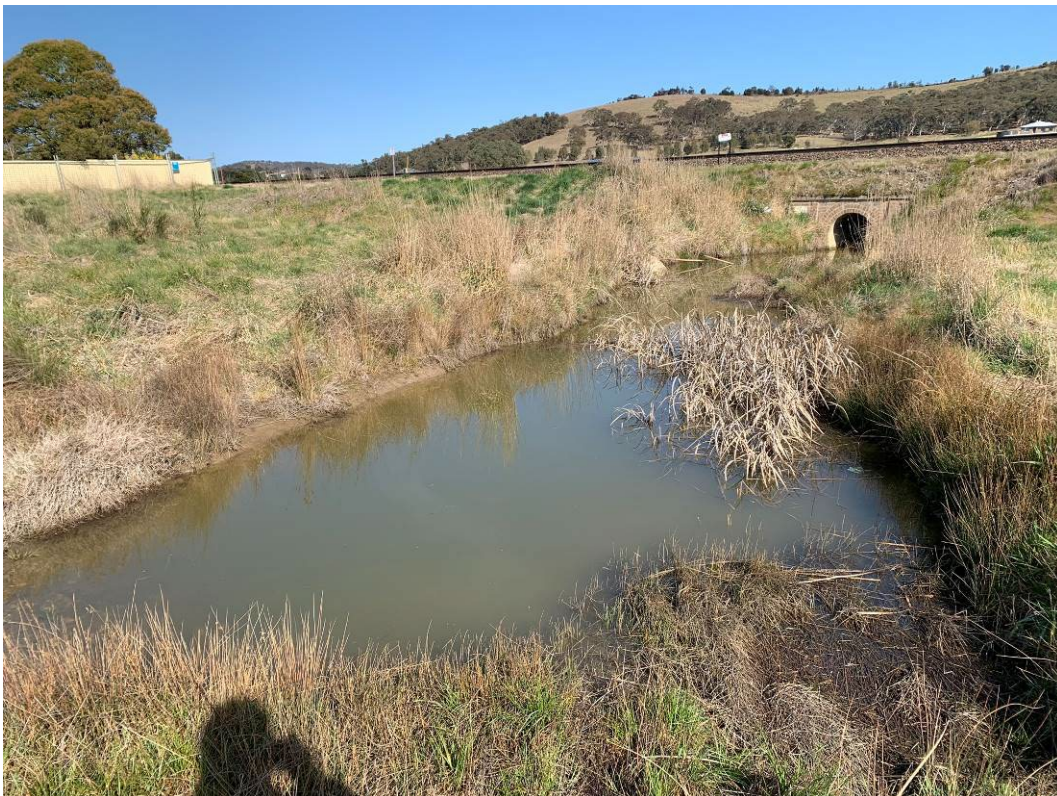
Section	Control	Inspection		Corrective Action
		Yes	No	
5.1	Is Exclusion Zone signage present as recommended on Figures 2a - 2e Appendix 1 to demarcate contamination in the rail formation and adjacent soils?	Yes ( <b>Photos 17 - 18</b> )		
	Is Exclusion Zone signage undamaged?	Yes, exclusion zone signage appeared in good condition ( <b>Photo 17 - 18</b> ).		
	Are sediment controls present in/adjacent each rail culvert?	Yes, rock checks and rock armour observed upgradient of each culvert. Coir sediment control logs west of former Woodlawn siding and along cess drain feeding the south and middle culverts ( <b>Photos 10 - 16</b> ). Silt fencing between middle and northern culvert.		
	If sediment is present what is the estimated depth of sediment?	Some sediment/turbid water present in pooled water on site downgradient of middle culvert ( <b>Photo 4</b> ). Minimal sediment present on silt fencing and rock checks.

**Photo 4: Downgradient of middle culvert showing brown turbid water on site. No surface water currently running off site at middle culvert.**

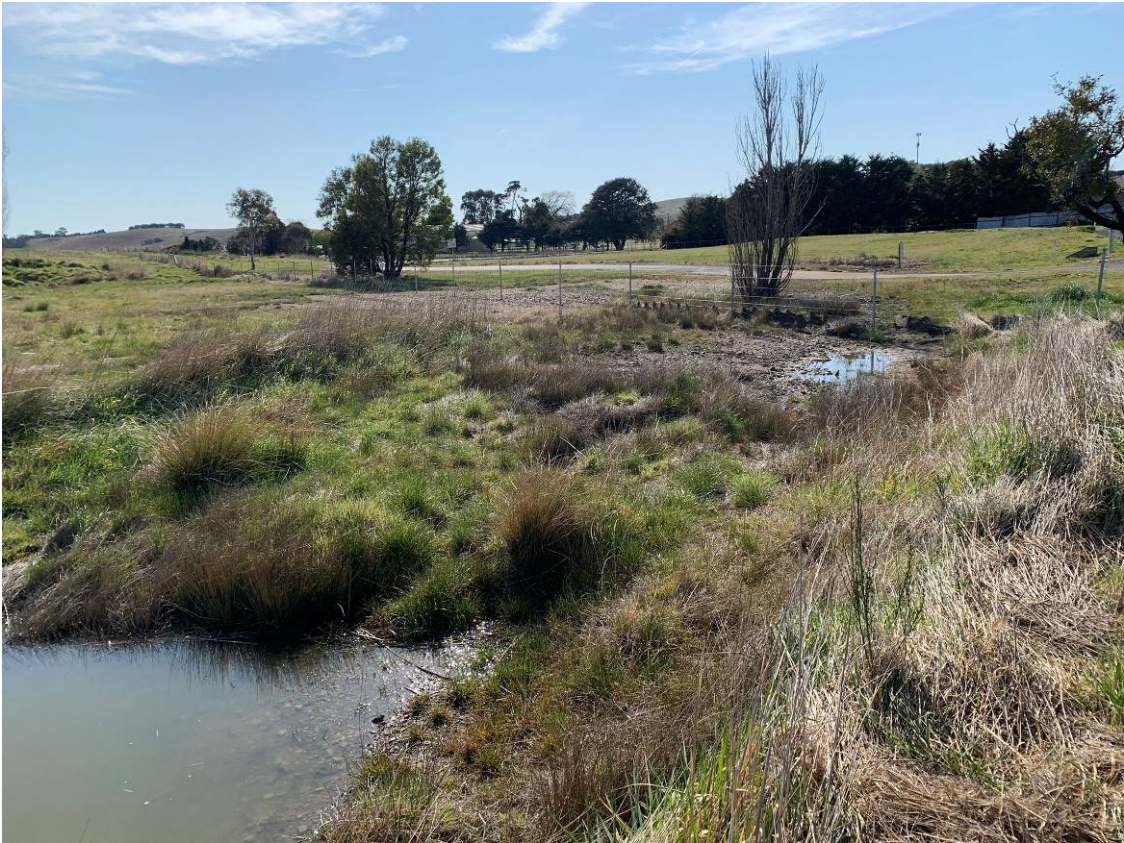
**Photo 5: Downgradient of middle culvert. Water is pooled adjacent to site boundary fencing. Extending to off-site damp soil, in line with the pooled water, was visible suggesting former run-off. No current water running off from site.**

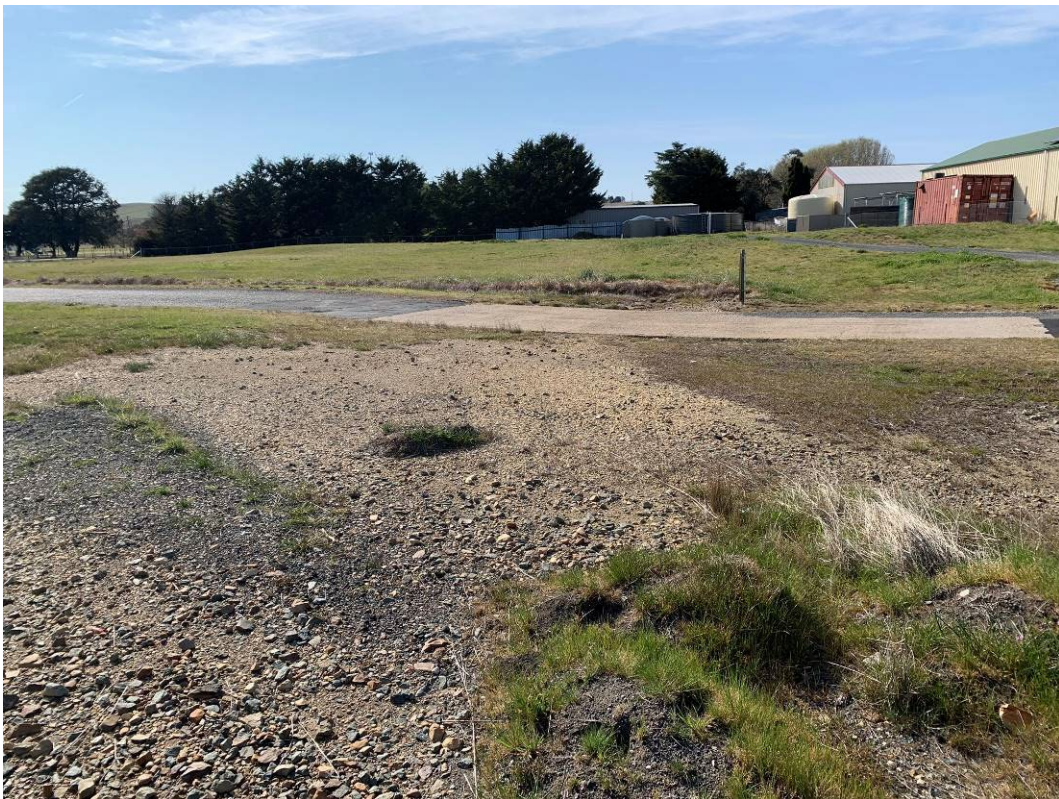
**Photo 6: Causeway downgradient of middle culvert showing no evidence of current surface water moving off site. No visible sediment on road or vegetation nearby from sediment water was running off site in between inspections.**

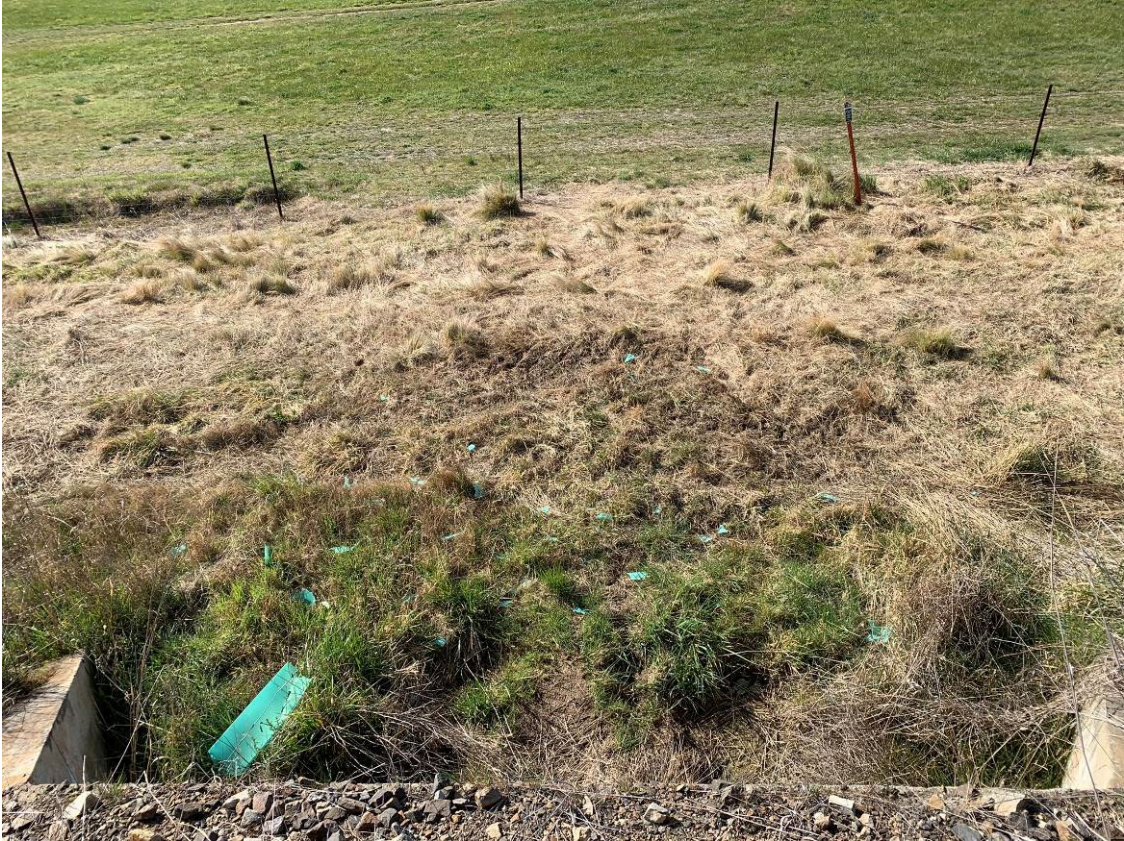
**Photo 7: Downgradient of northernmost culvert showing evidence of no surface water runoff from site to neighbouring property.**

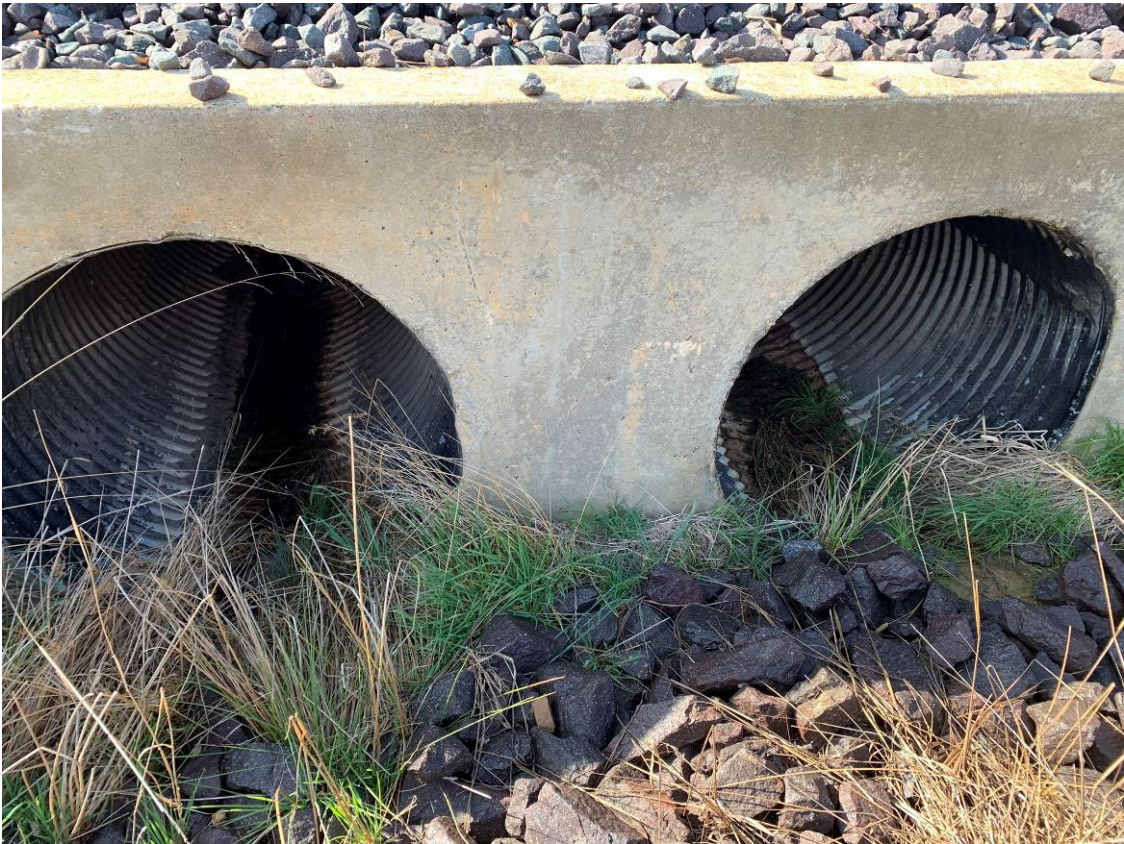
**Photo 8: Upgradient of northernmost culvert showing evidence of no surface water.**

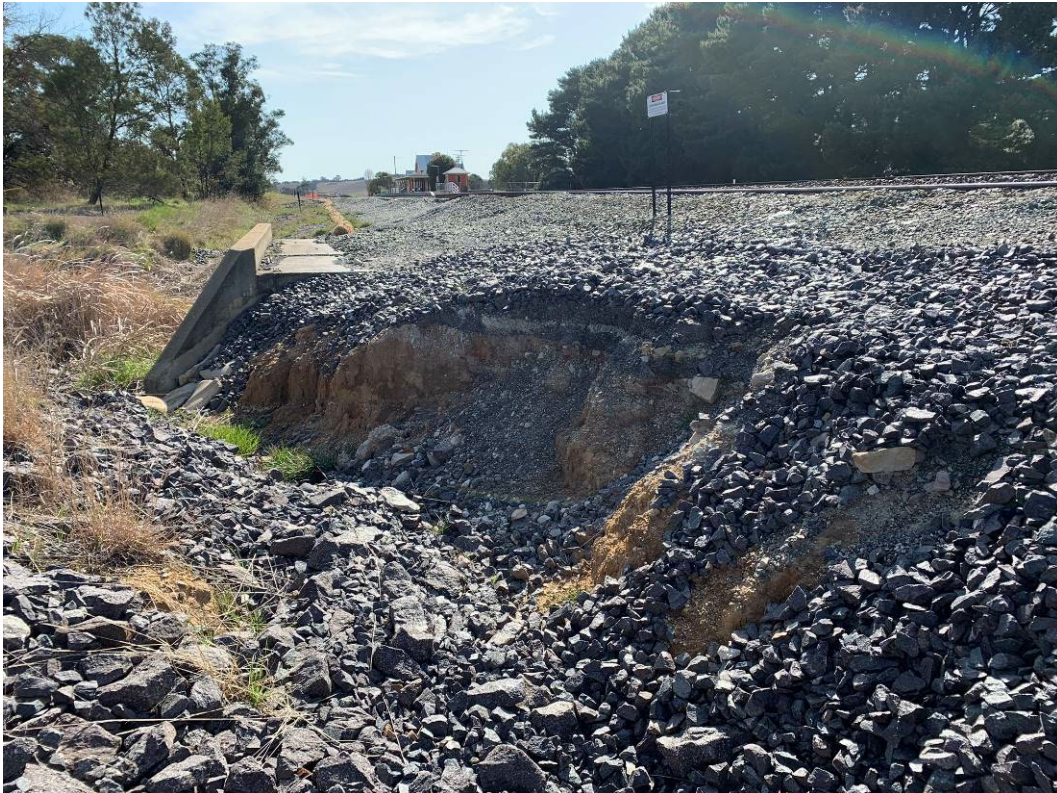
Evidence of erosion has been noted upgradient of the southern most culvert in multiple previous site inspections and remains on site but in a stable condition ( <b>Photo 9</b> ). No evidence of sediment was found in water flowing offsite at southern culvert. Ramboll recommends replacing ground cover material (ballast) if further erosion occurs or sediment is visible in the downstream surface water of the southern culvert.		
During the last inspection (16/08/23) pooled water was observed more frequently onsite alongside the railway tracks amongst the eastern half of the site. During this inspection, pooled water adjacent to the railway tracks was not present ( <b>Photo 22</b> ).

**Photo 9: Visible evidence of erosion due to loss of ground cover (ballast material) upgradient of southernmost culvert. Remaining stable and no major further erosion since last inspection. Facing north-east.**

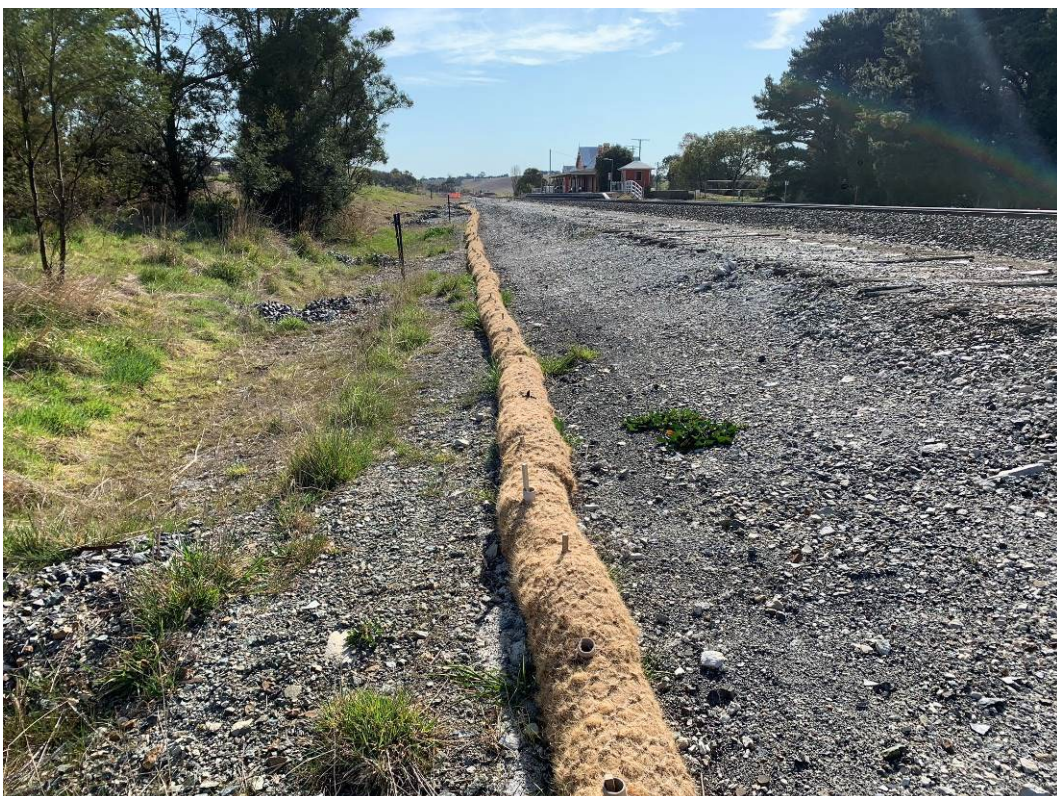
**Photo 10: Upgradient of southernmost culvert showing Coir sediment control logs, used as control measures for sediment control. Facing north-east.**

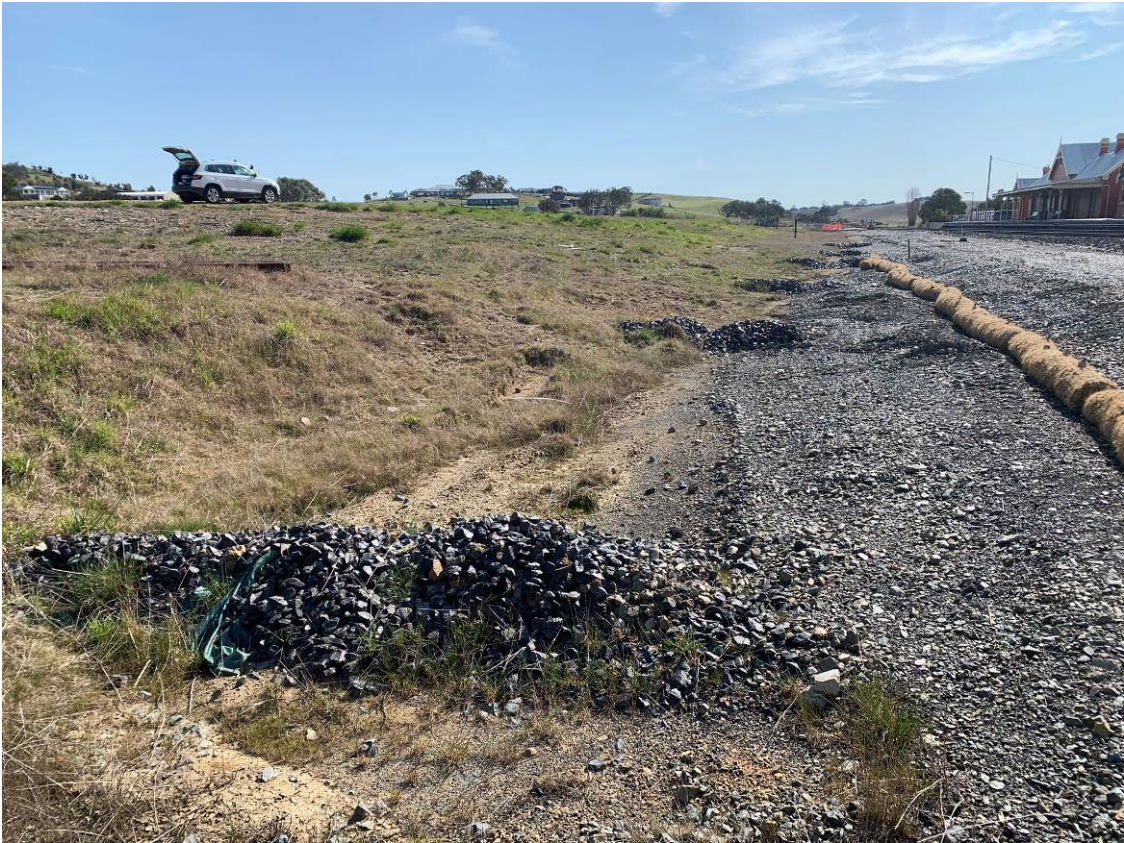
**Photo 11: Rock checks running along former Woodlawn siding and between southern and middle culverts. Silt fencing replaced by Coir sediment control logs.**

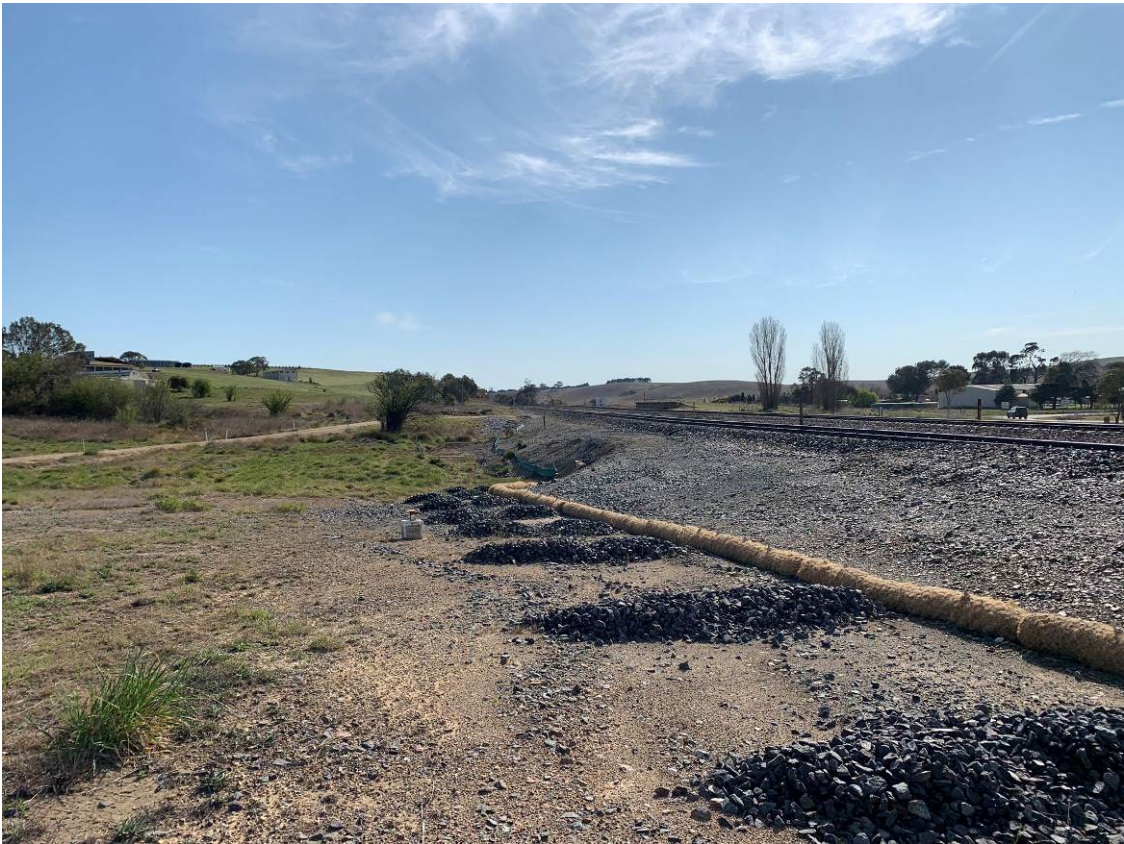
**Photo 12: Rock checks running alongside former Woodlawn siding towards the middle culvert. No evidence of sediment build-up in rock armoury or Coir sediment control logs.**

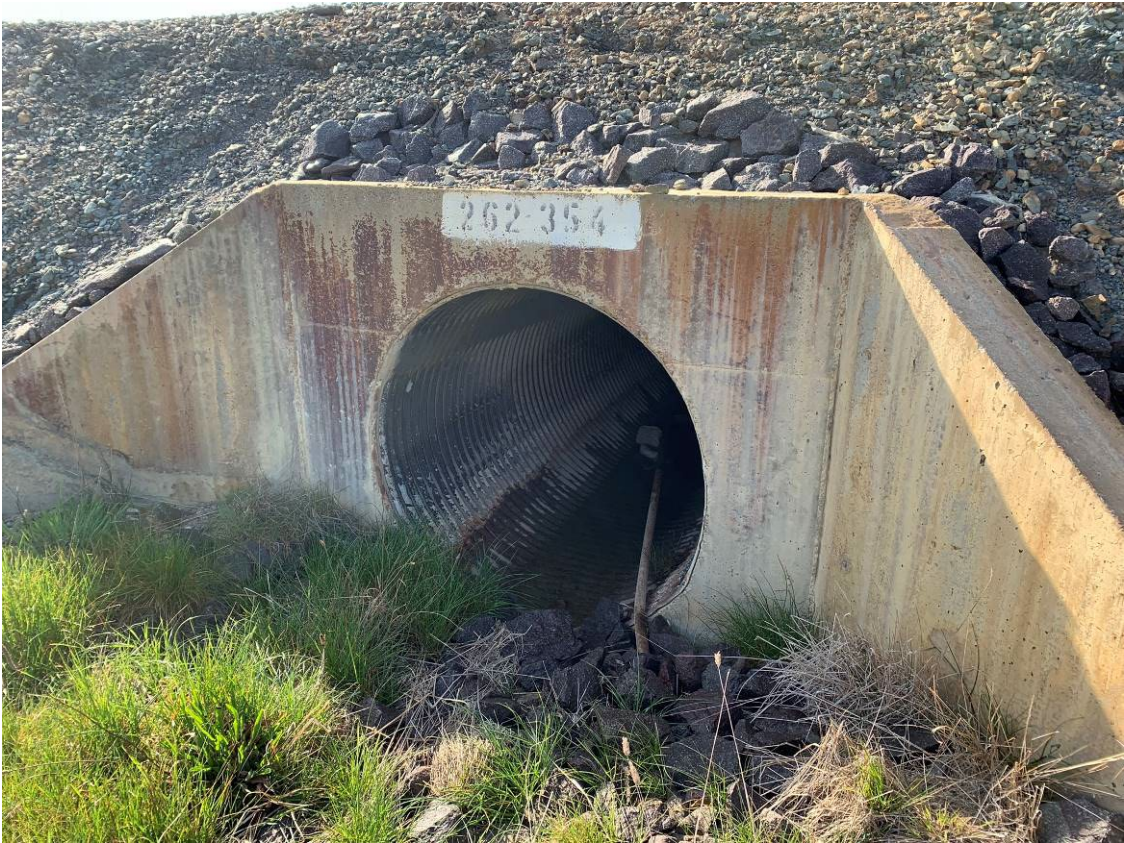
**Photo 13: Upgradient of Middle culvert showing no flowing or pooled water. No evidence of sediment build-up in culvert.**

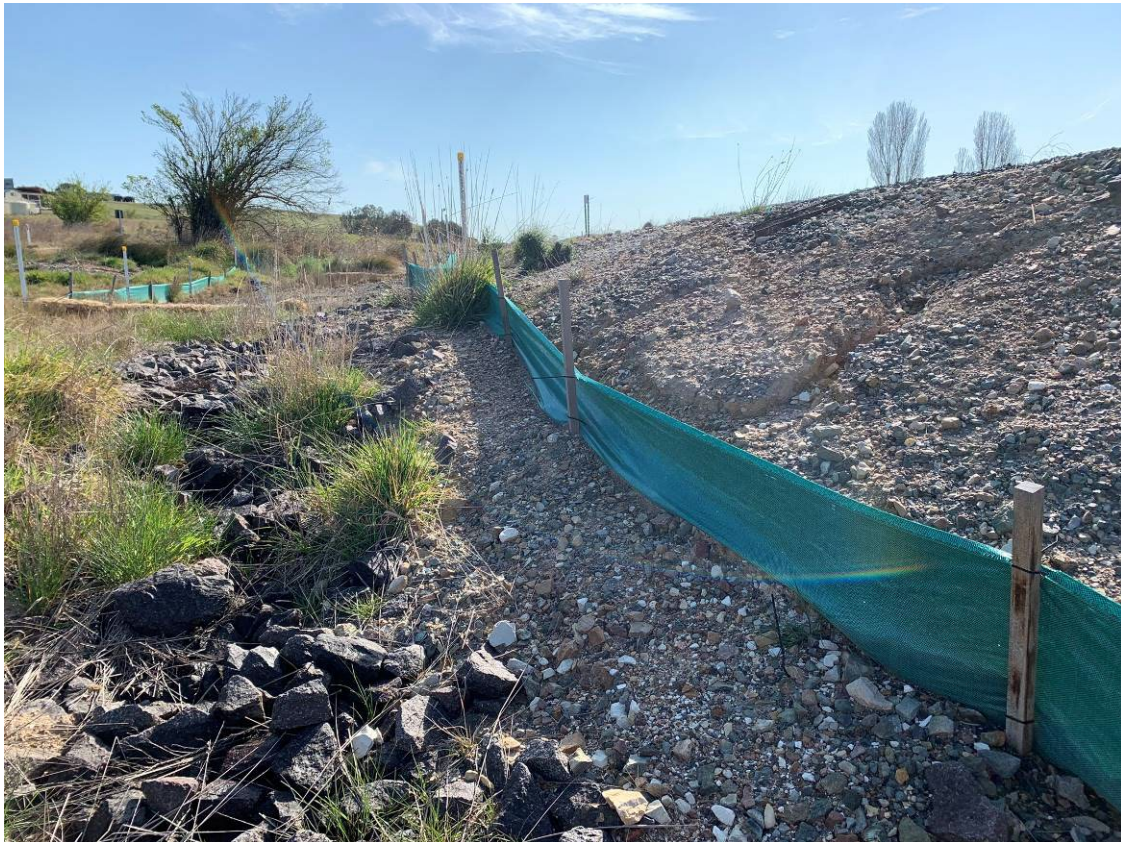
**Photo 14: Upgradient of middle trainline culvert facing east. Silt fencing is clear with no sediment visible.**

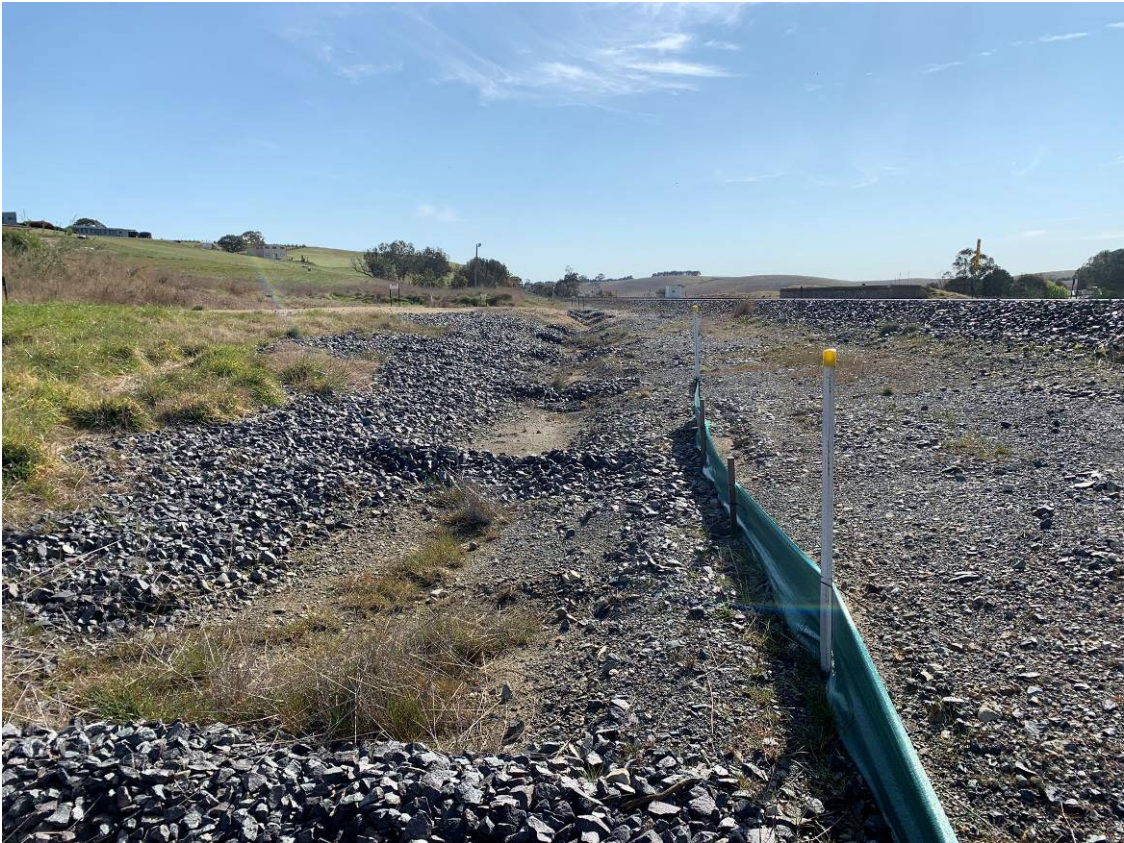
**Photo 15: Rock armour upgradient of trainline running from the middle to the north culvert. Some sediment visible on rock armour. Facing north-east.**

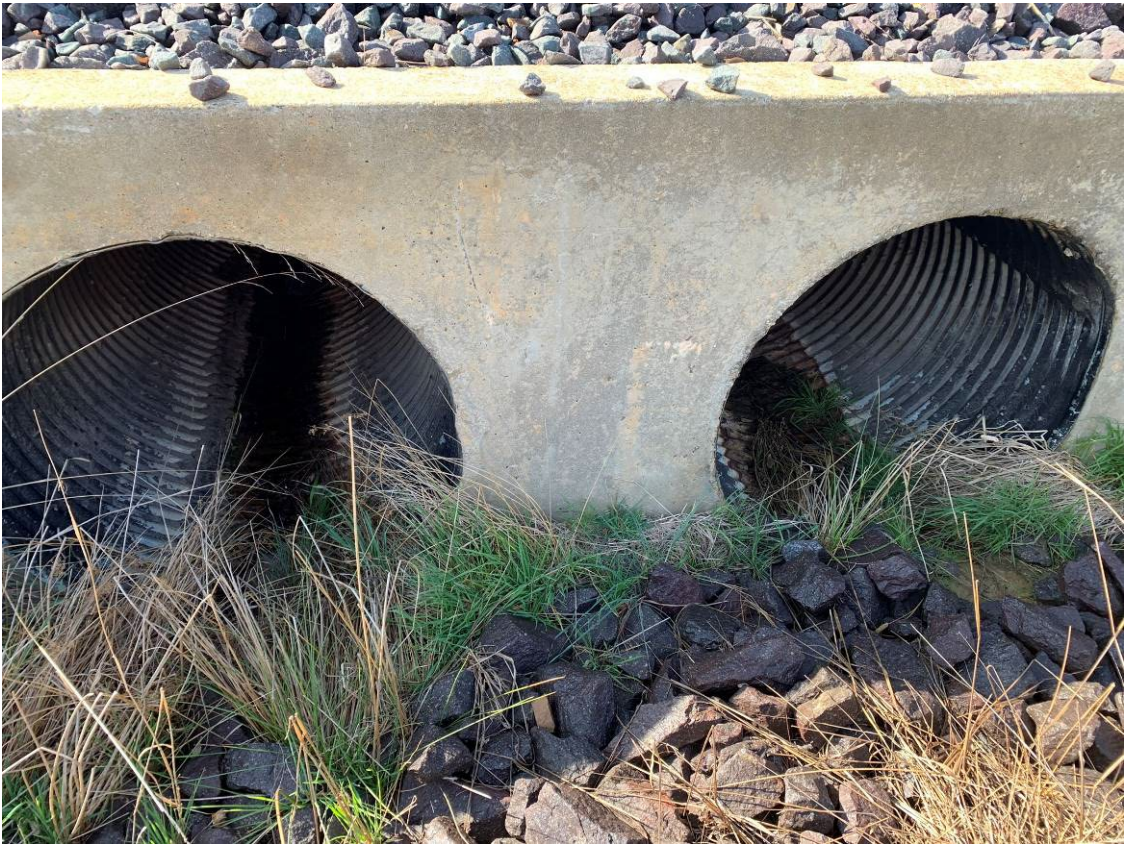
**Photo 16: Upgradient of northernmost culvert. No evidence of surface water run off on site. No evidence of sediment buildup on rocks. Rock armor and natural vegetation allow for sediment control in surface water.**

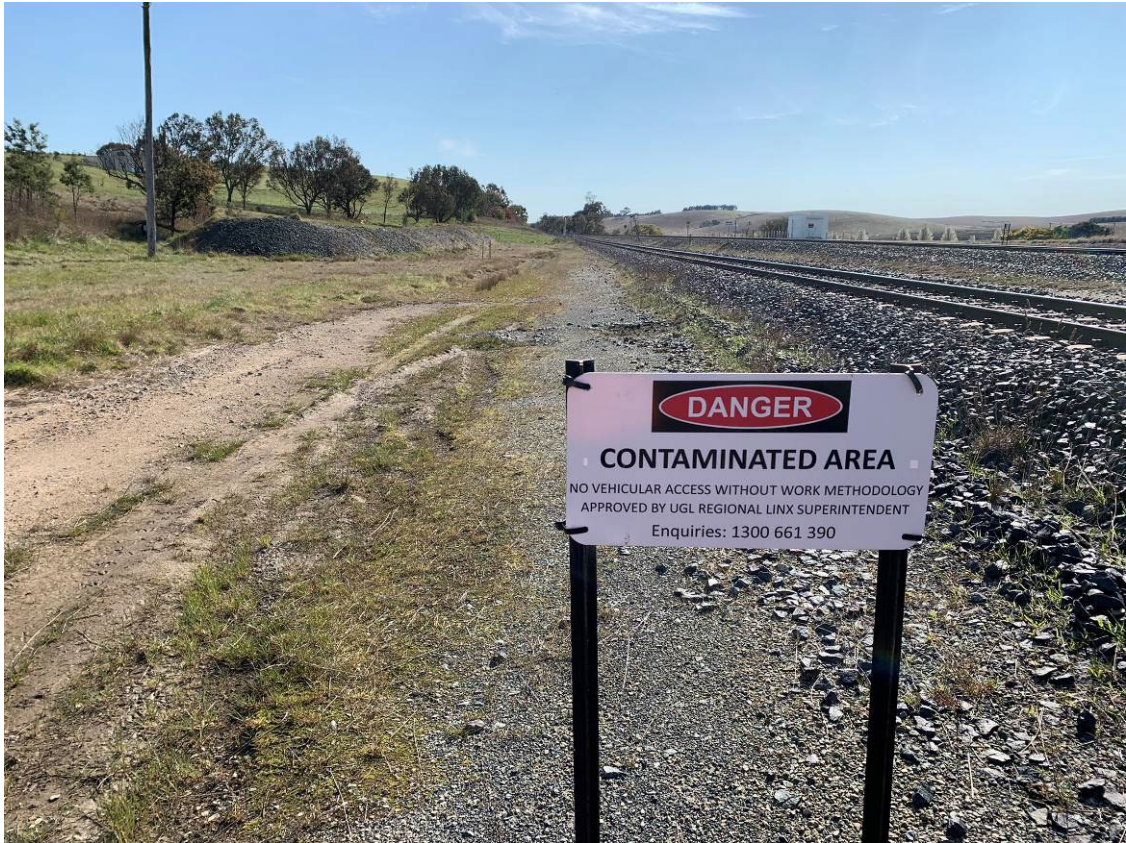
**Photo 17: Exclusion zone signing placed periodically along contamination areas. Undamaged and in good condition. Facing North-East.**

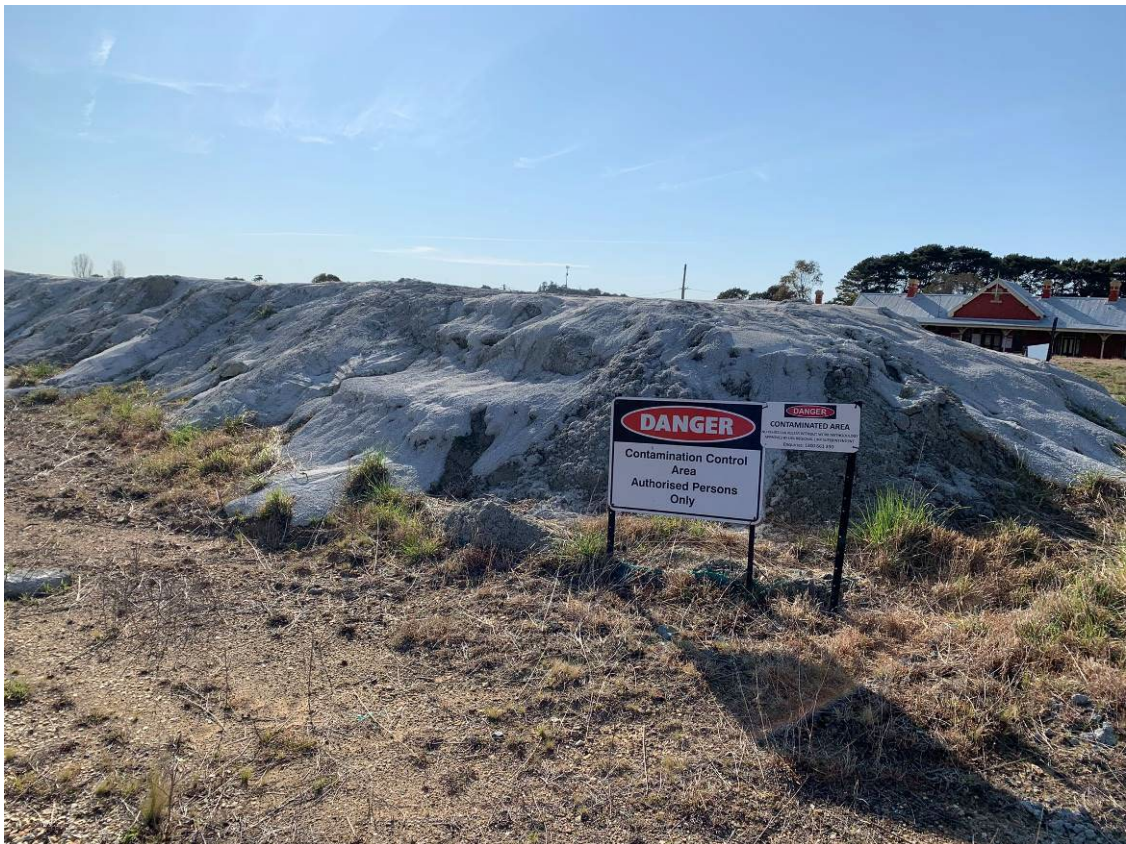
**Photo 18: Exclusion zone signing placed periodically along contamination areas. Undamaged and in good condition. Facing East.**

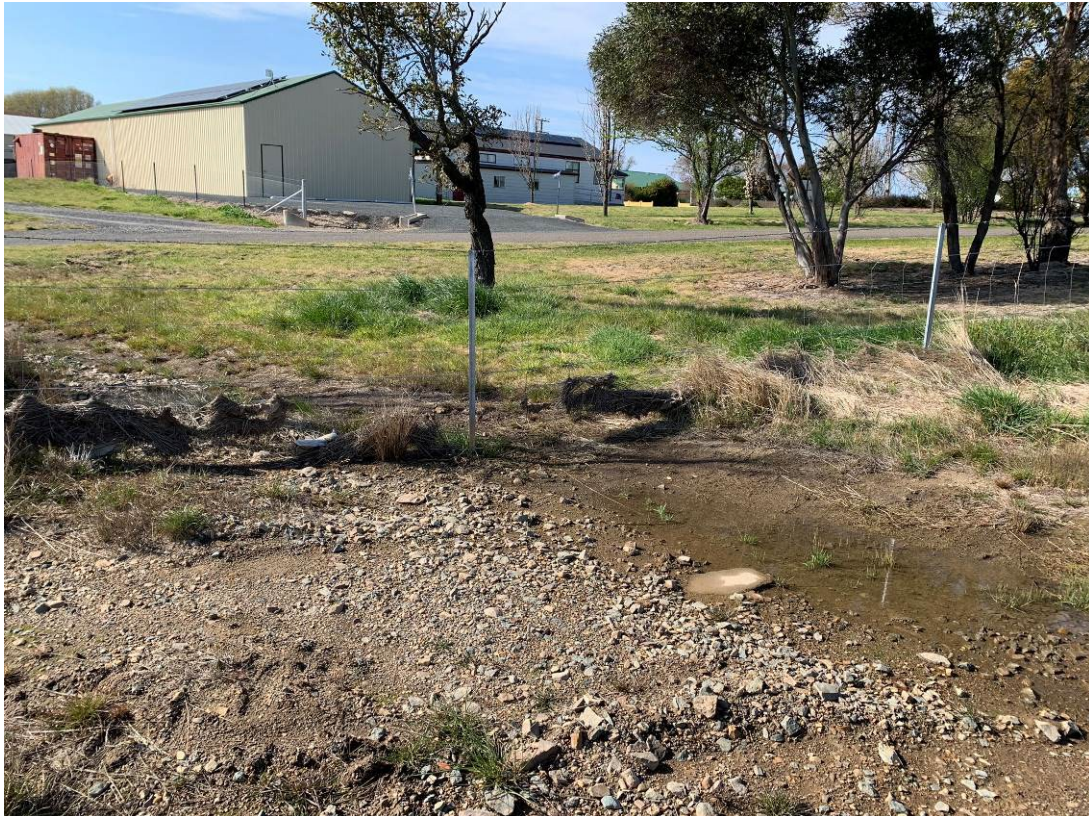
Date:	14-Sep-23	UGL RL Environmental Representative
Start time:	8:30 AM	completing inspection <sup>1</sup> :
Finish time:	9:30 AM	[REDACTED]
Weather:	10.3°C, -0.9°C lowest temp, 10.3°C highest temp, 0.2mm of rain since 9am (BOM) (13/09/23), 11km/h highest wind gust, SE 4km/h wind speed, 85% humidity	
Date and volume of maximum rainfall in a 24hr period since last inspection?		
Date:	23-Aug-23	
Max volume (mm) in 24hr period:	8.2mm	
<b>General Site Observations</b>		
<u>Is airborne dust from site evident?</u>		
No airborne dust was visible ( <b>Photos 1 - 2</b> )		
<u>Is sediment run-off evident that is not captured by sediment controls?</u>		
No. Some evidence of sediment was observed in pooled water on site downgradient of the middle culvert ( <b>Photo 4</b> ), however run-off between inspections appeared unlikely as meteorological records generally indicated light rainfall since the last inspection ( <b>Photos 5 - 6</b> ). In addition at this location, pooled water was found adjacent to the site boundary, though not flowing off site ( <b>Photo 19</b> ).

**Photo 19. Downgradient of middle culvert. Water is pooled adjacent to site boundary fencing. Extending to off-site damp soil, in line with the pooled water, was visible suggesting former run-off. No current water running off from site.**

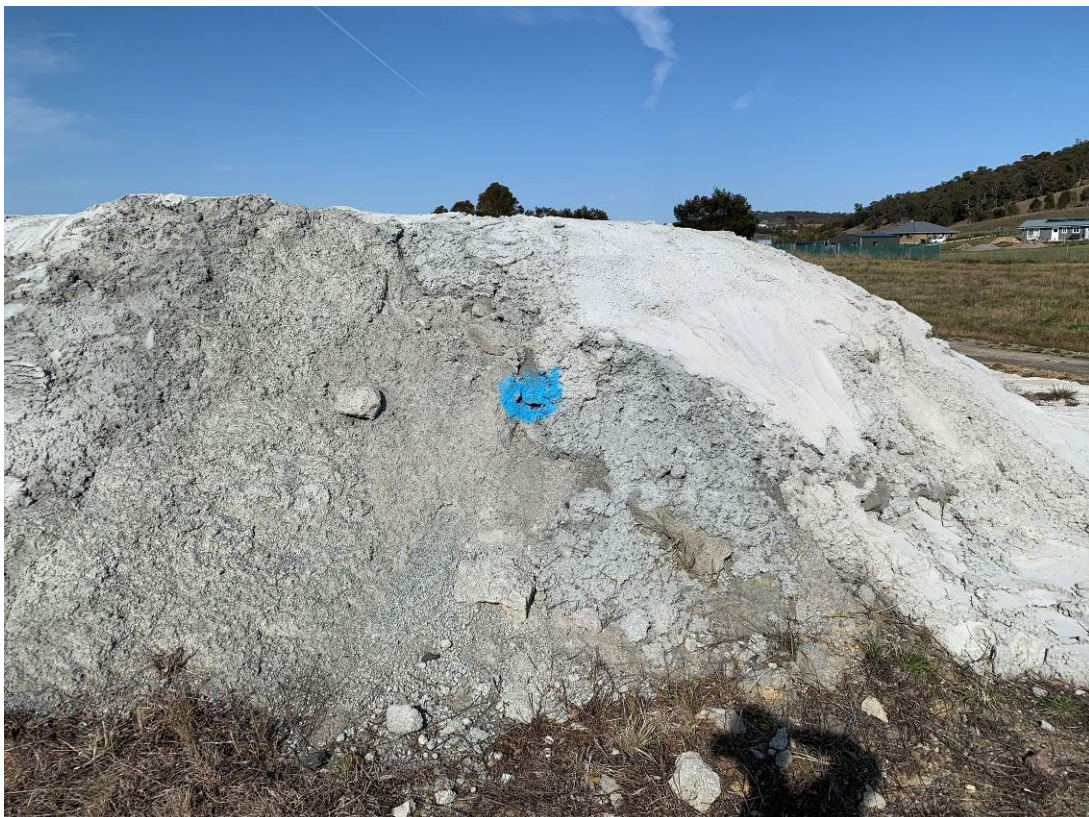
Is geofabric marker layer visible beneath capping of the existing stockpile? If so record in written form and through photographs and consolidate with this checklist. If marker layer is visible rectification work is required.	Yes. Two new exposed locations were identified. Refer to 'Other Observations' section for comments and required actions.

**Photo 20: Exposed geofabric layer marker on main stockpile newly identified during the inspection. Marked with blue paint. Facing the south-western side of stockpile.**

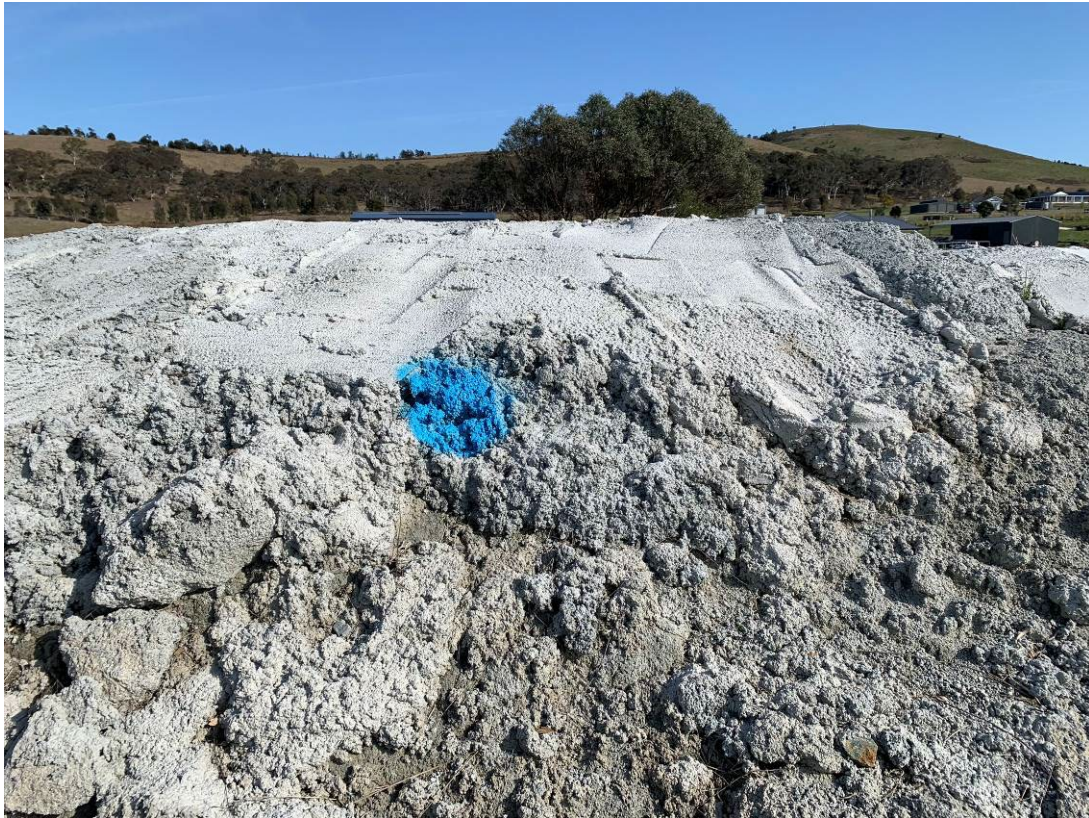
**Photo 21: Exposed geofabric layer marker on main stockpile newly identified during the inspection. Marked with blue paint. Facing the north-western side of stockpile.**

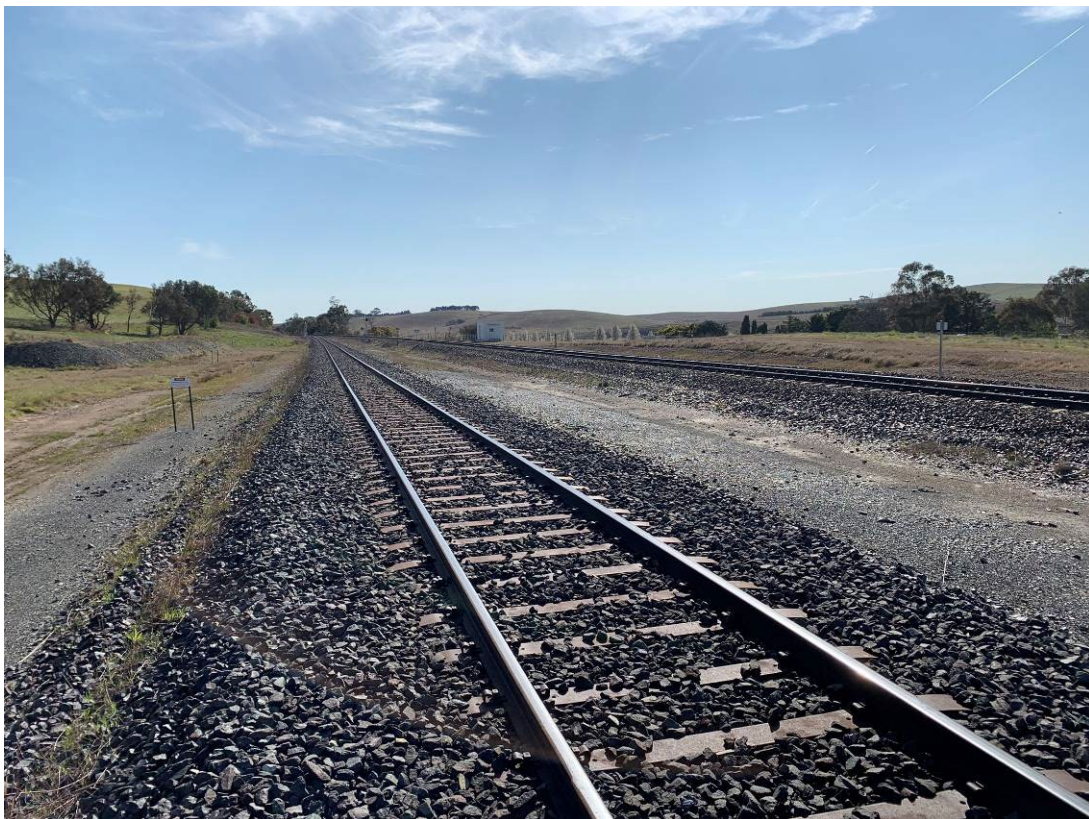
**Photo 22: No pooled water adjacent to railway tracks. Facing North-East.**
