# Tarago Action Plan Routine Inspection Checklist

| Date: | 16-Sep-24 | Ramboll and UGL RL Environmental |

| Title: | Tarago Rail Yard Inspection | Approved:<br>JA | Project-Nr.:<br>318001704 | Date:<br>16 September 2024 |
| Site: | Tarago, NSW | | | |

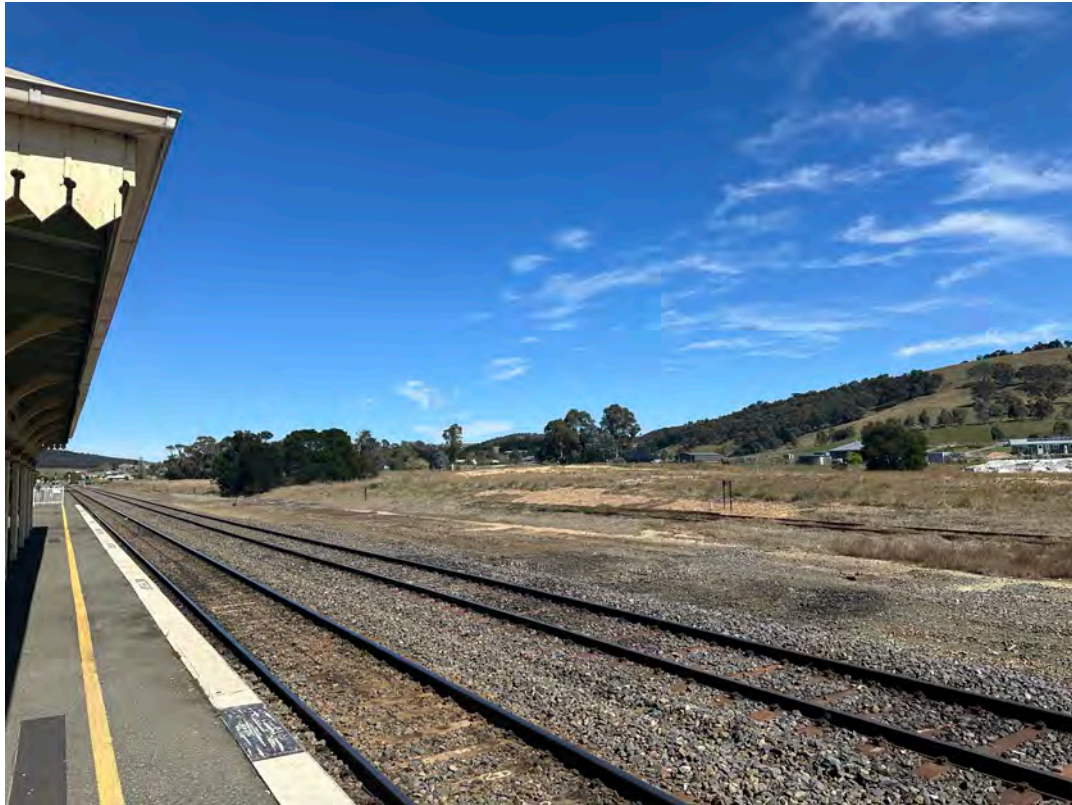
| No airborne dust was visible ( <b>Photos 1 - 2</b> ). | | |

Photo 1: Picture at northern end of Tarago railway station platform facing south, no airborne dust visible.

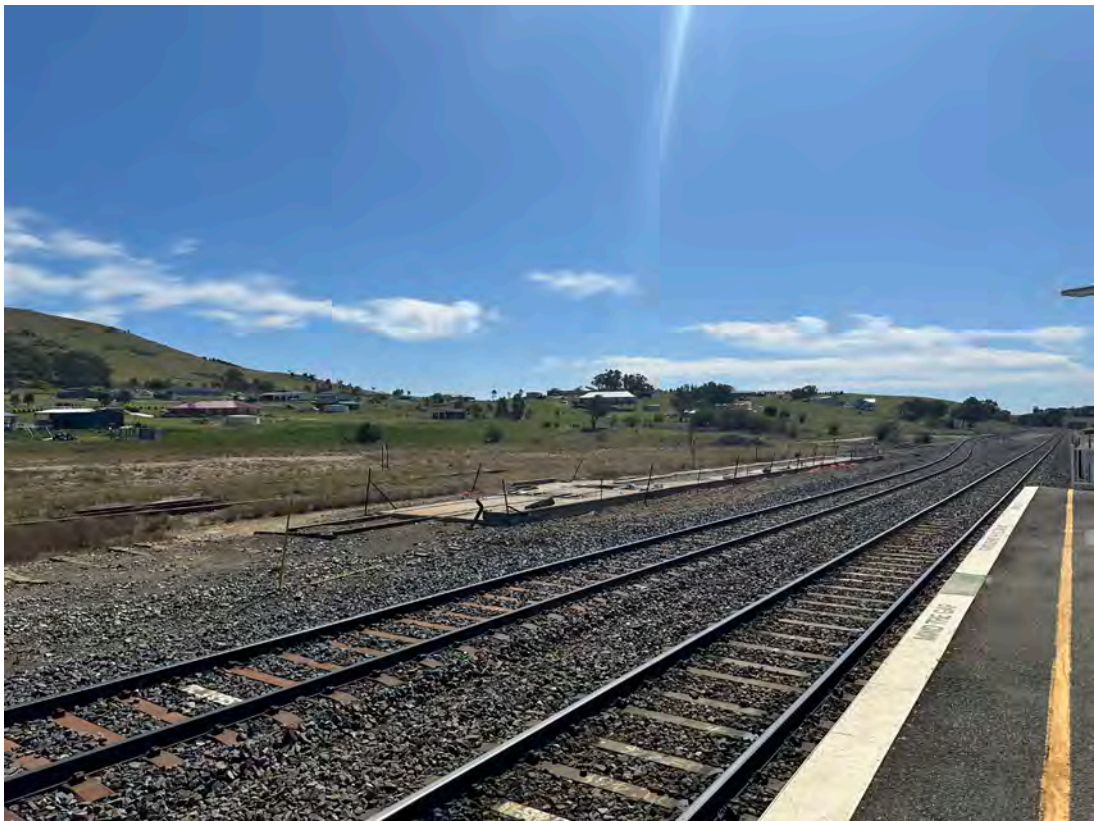
Photo 2: Picture facing north towards Tarago railway station, no airborne dust visible.

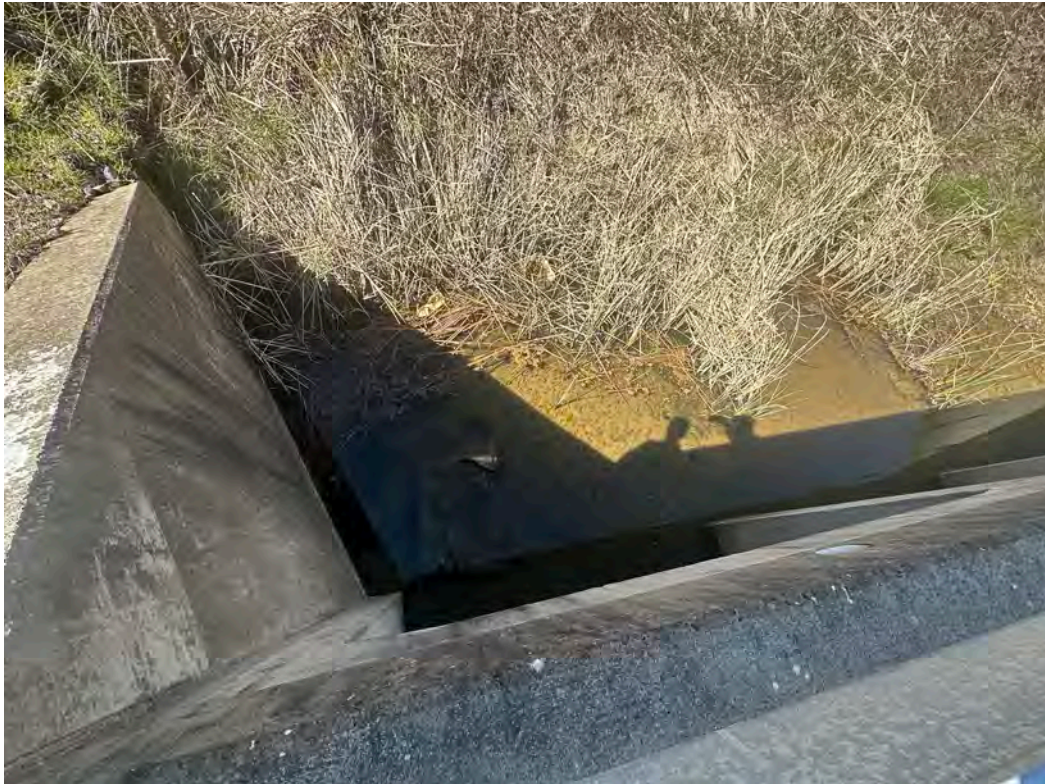
| No sign of sediment run-off seen in surface water flowing off-site at southern culvert ( <b>Photo 3</b> ). No evidence of sediment run-off from middle and northern culverts with only pooled, not flowing, surface water observed ( <b>Photos 4, 5 and 6</b> ). | | |
| Surface water was observed discharging from the site at the southern culvert ( <b>Photos 3</b> ). Pooled water was observed in a few locations on site ( <b>Photo 4</b> ). No other flowing surface water was observed onsite during the inspection. | | |

**Photo 3: Southern culvert downgradient of railway line with surface water flowing offsite. Surface water was clear with no visible turbidity or suspended solids.**

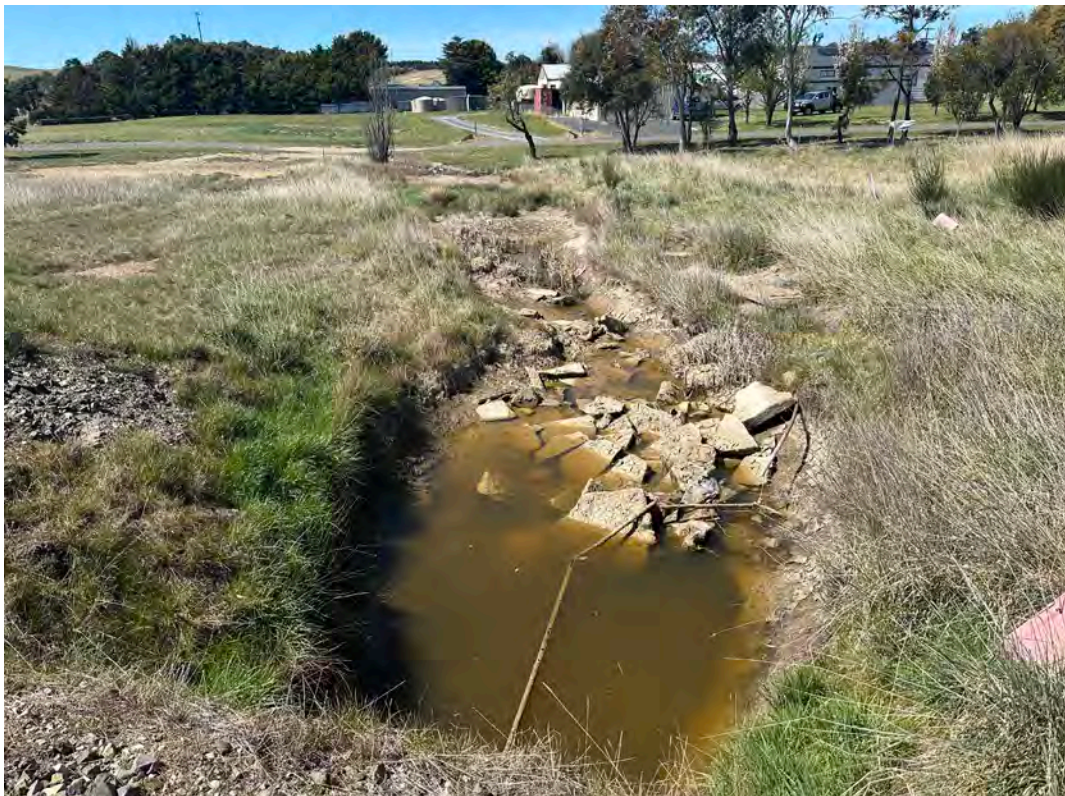
**Photo 4: Downgradient of middle culvert with pooled surface water, not flowing off site. Surface water near culvert was slightly brown with minor visible turbidity and suspended solids.**

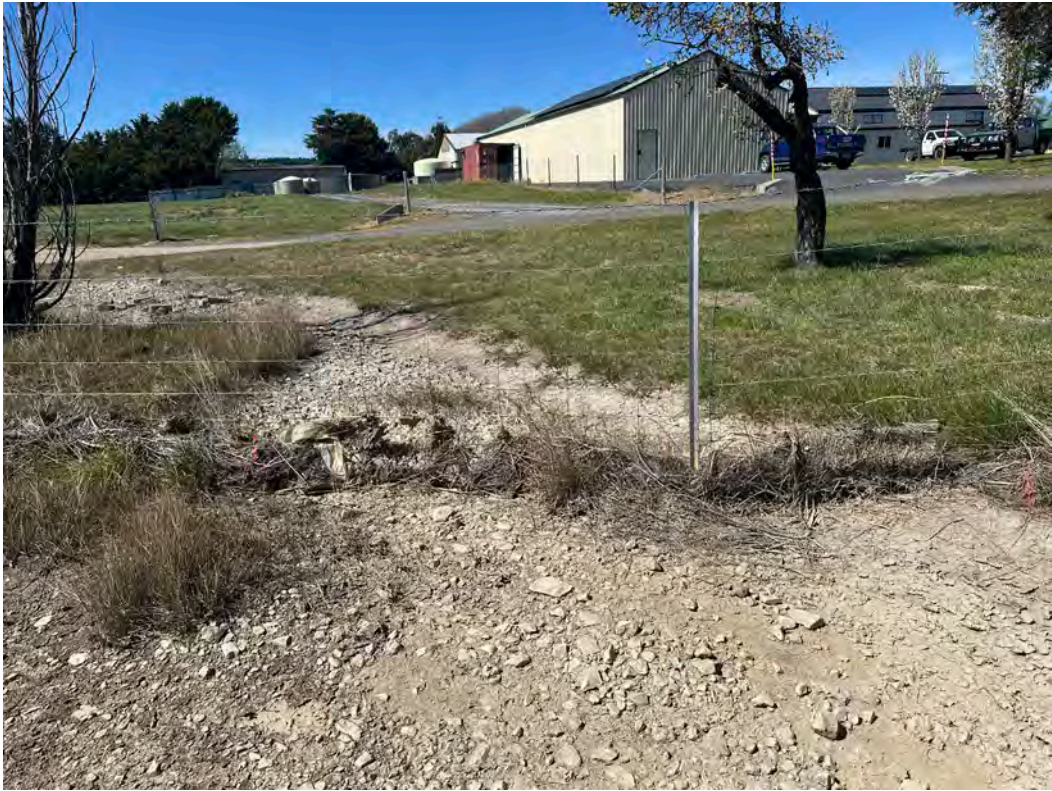
**Photo 5: Downgradient of middle culvert facing south with no surface water flowing off site at fence line.**

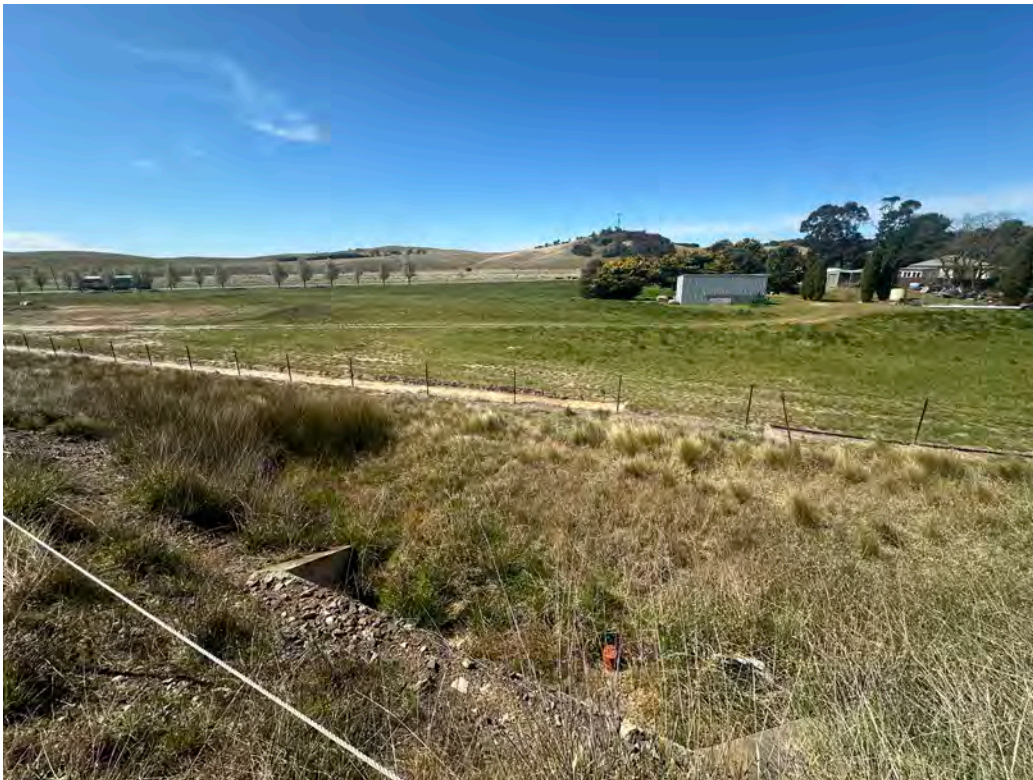
**Photo 6: Downgradient of northernmost culvert with no observed surface water. Trench line had been dug on adjacent property.**

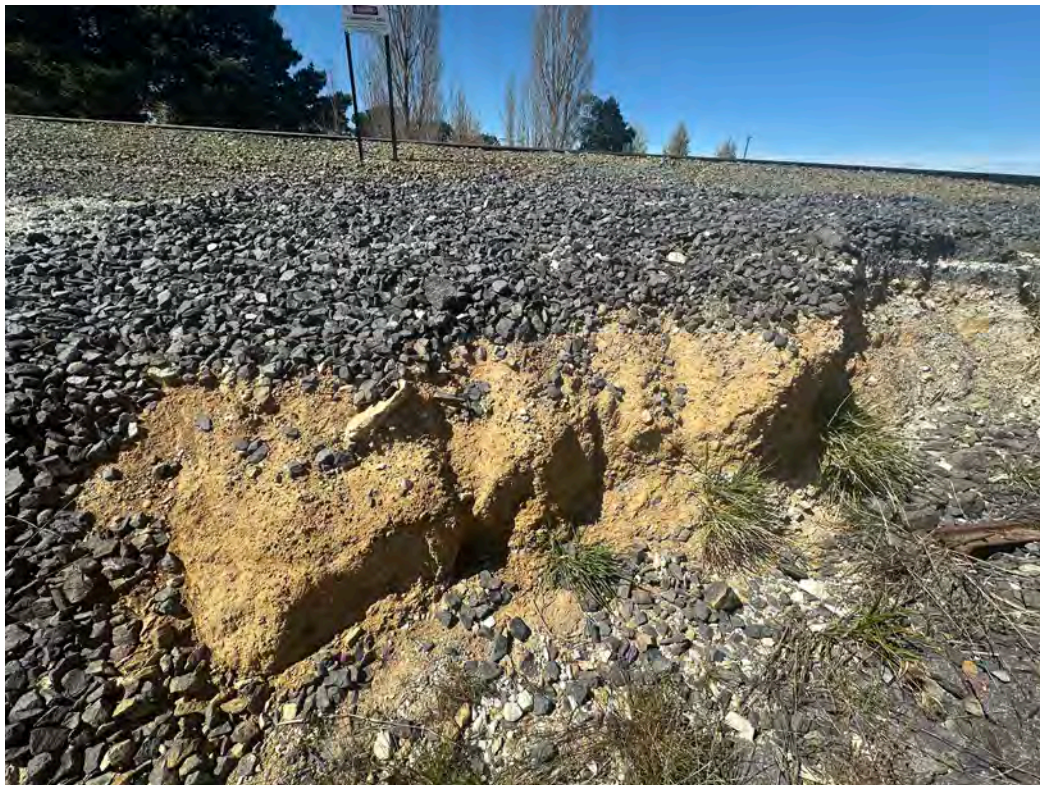
**Photo 7: Southernmost culvert upgradient of the railway line. The erosion due to lack of ground cover observed during multiple previous inspections is still present.**

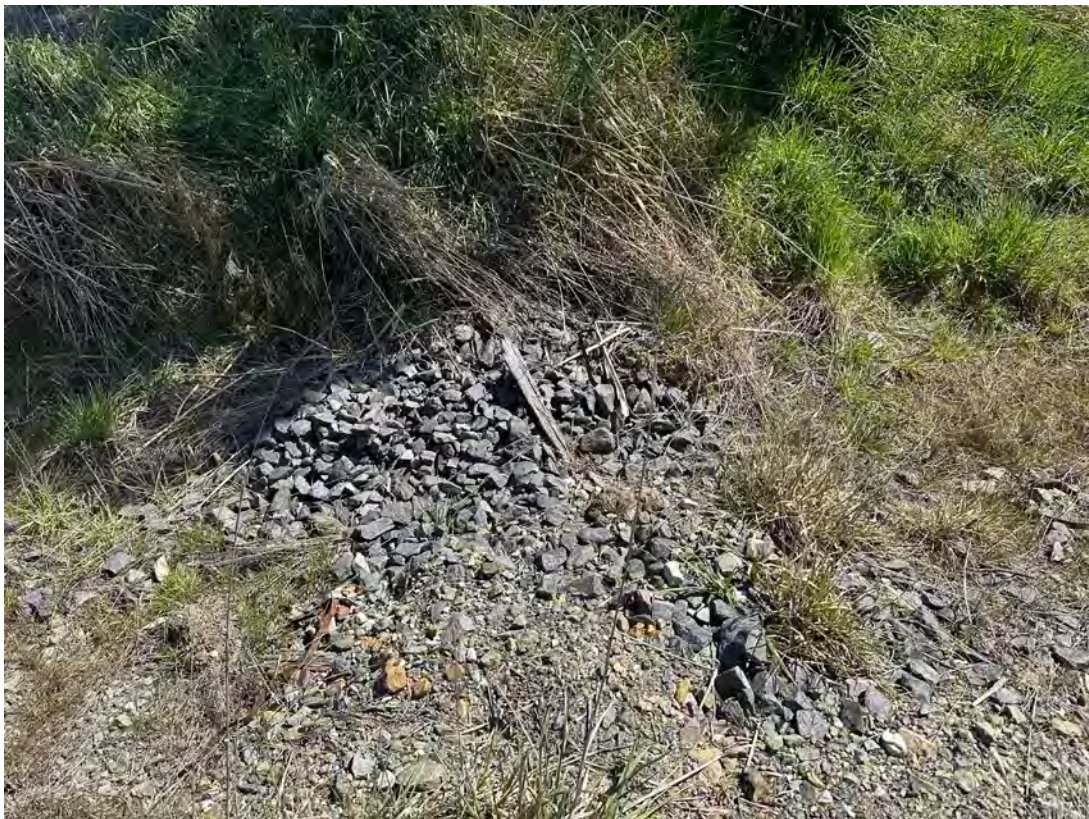
| <p>1. The geofabric silt curtain (sediment fencing) located upgradient of middle trainline culvert (<b>Photo 11</b>) was noted to have large sediment build up during previous and current inspections. Damage to sediment fencing to the north of the upgradient of the middle culvert was observed during previous inspections and evidence of repair was observed during the current inspection (<b>Photo 19</b>). New additional damage to the sediment fencing was also observed during the current site inspection (<b>Photos 12 and 13</b>). Ramboll advises this be fixed. Due to the repeated damage of the silt fencing in these locations, Ramboll recommends replacing the silt fencing with sediment control coir logs, which appear to be more effective in other locations on site.</p> <p>2. Evidence of erosion noted upgradient of the southern most culvert in previous site inspections remains on site but in a stable condition (<b>Photo 7</b>). No evidence of sediment was observed in water flowing offsite at southern culvert during this site inspection. In addition, some minor erosion due to inadequate ground cover was also observed upgradient of the railway line, to the north of the middle culvert (<b>Photo 11</b>). Ramboll recommends replacing ground cover material (ballast) if further erosion occurs or sediment is visible in the downstream surface water.</p> <p>3. Rock armour in drainage channel between southern and middle culverts appear to be in average condition (<b>Photos 8 and 9</b>). Ramboll recommends replacing or replenishing the armour in this drainage channel.</p> | | |

**Photo 9: Rock armoury in drainage channel between southern and middle culverts appear to be in average condition, with minor build-up of vegetation and sediment.**

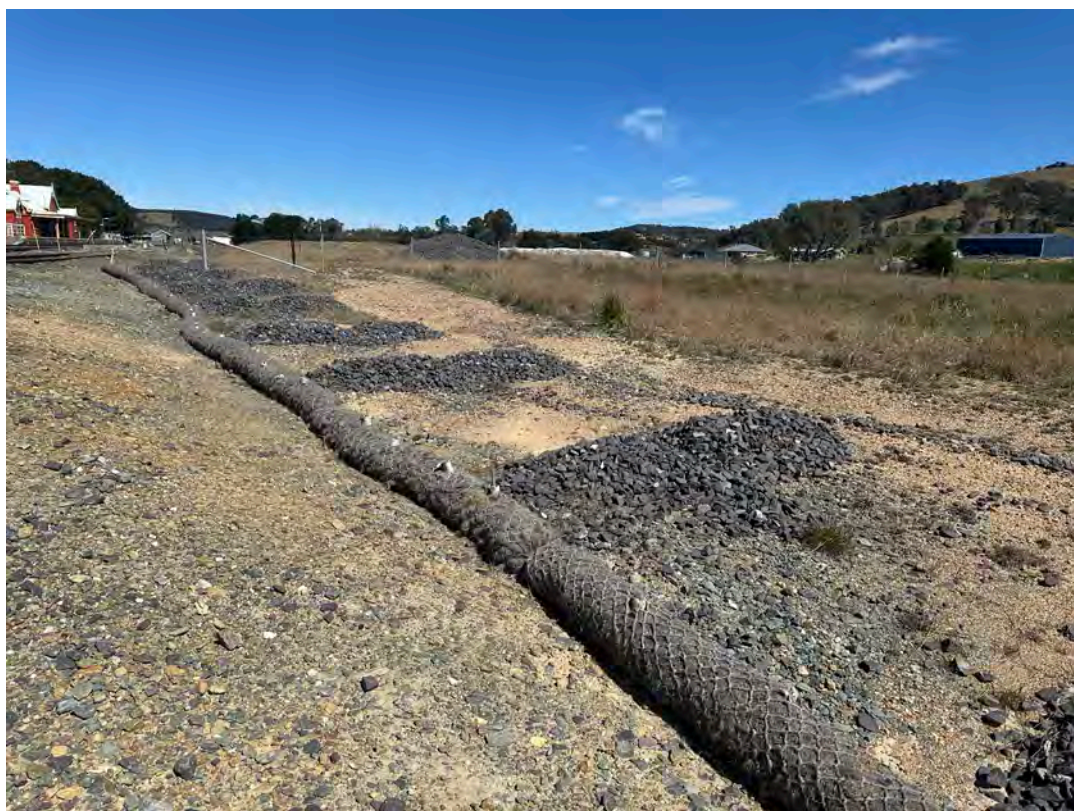
**Photo 10: Rock armoury in drainage channel between southern and middle culverts appear to be in good condition, with minor build up of vegetation and sediment.**

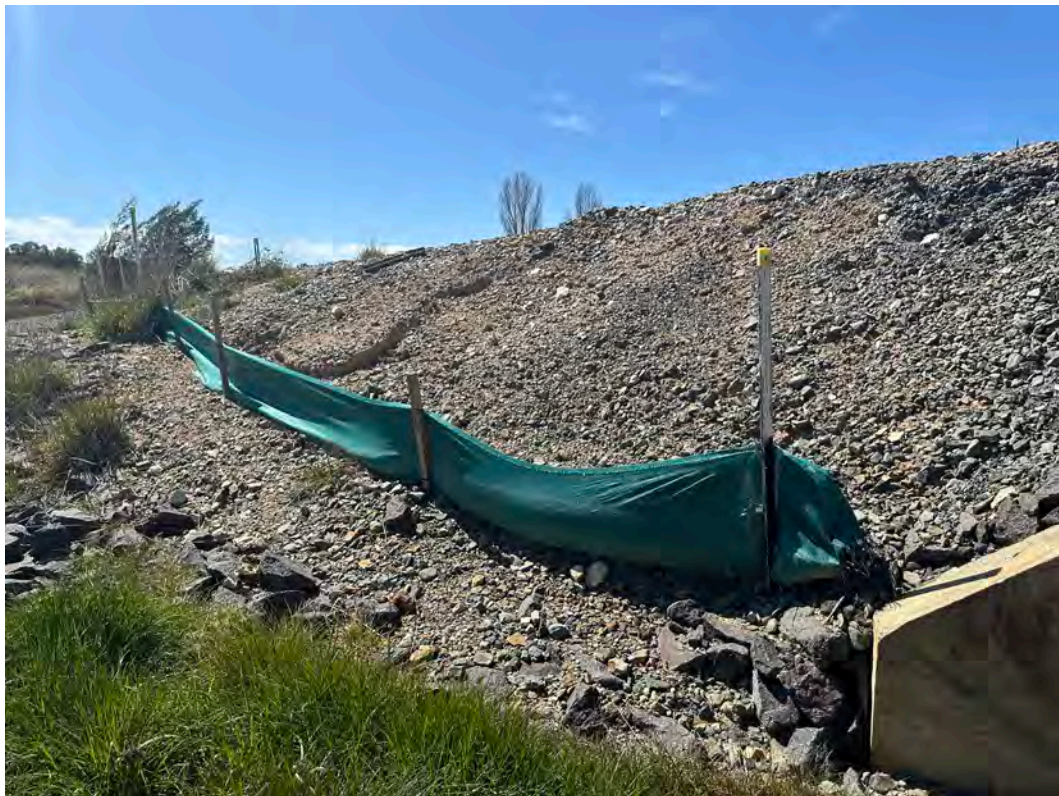
**Photo 11: Upgradient of railway line to the north of the middle culvert. Sediment fencing in place with large build-up of sediment. Some minor erosion due to inadequate ground cover was observed.**

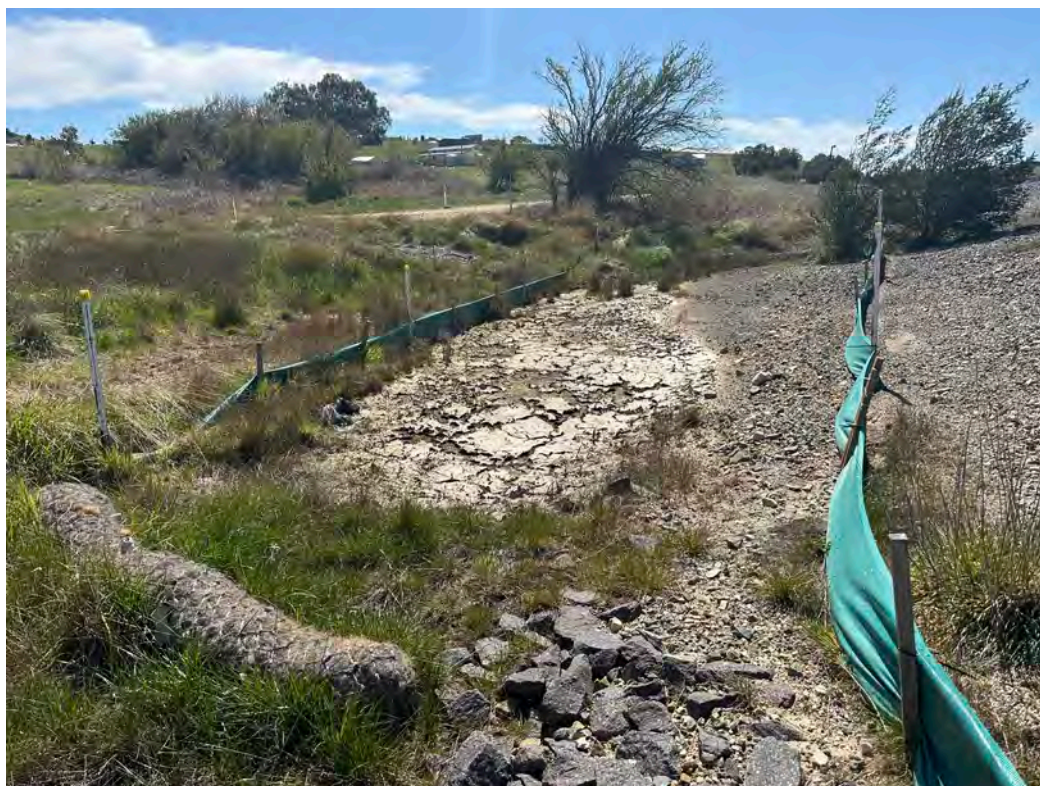
**Photo 12: Sediment fencing in drainage line north of middle culvert has some new damage and sediment build up and needs to be replaced.**

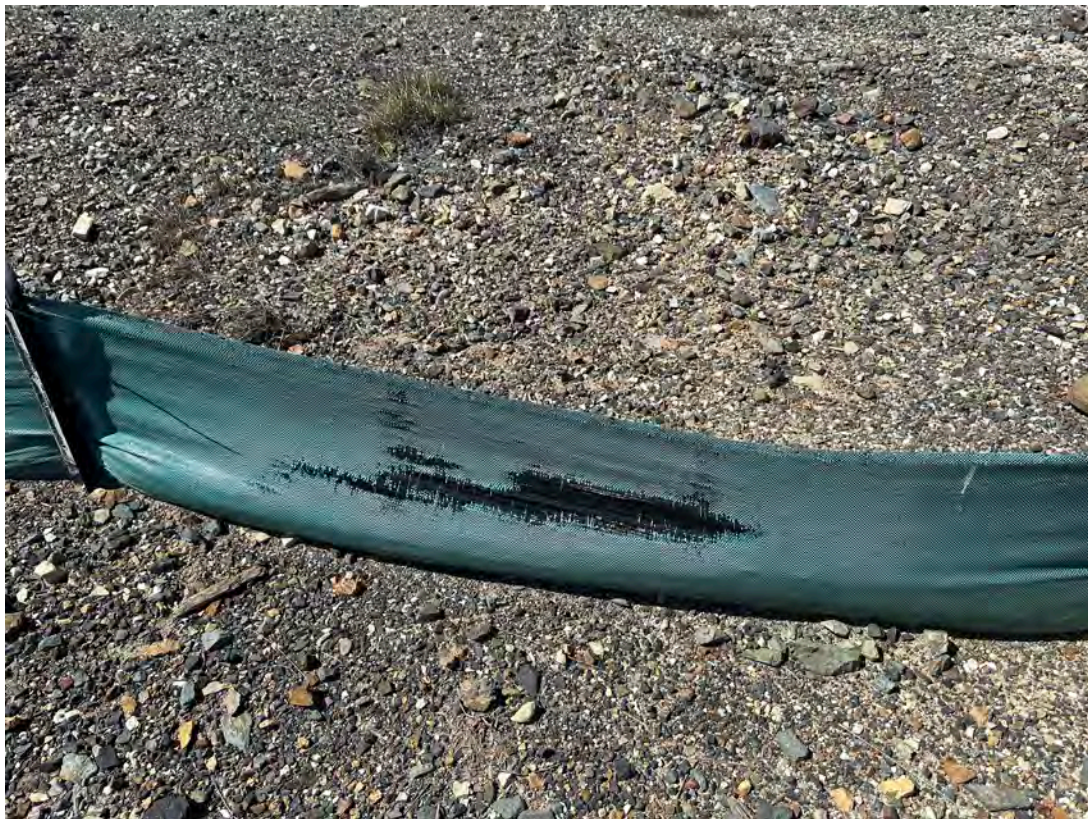
**Photo 13: Damage to sediment fencing in drainage line north of middle culvert that needs to be replaced.**

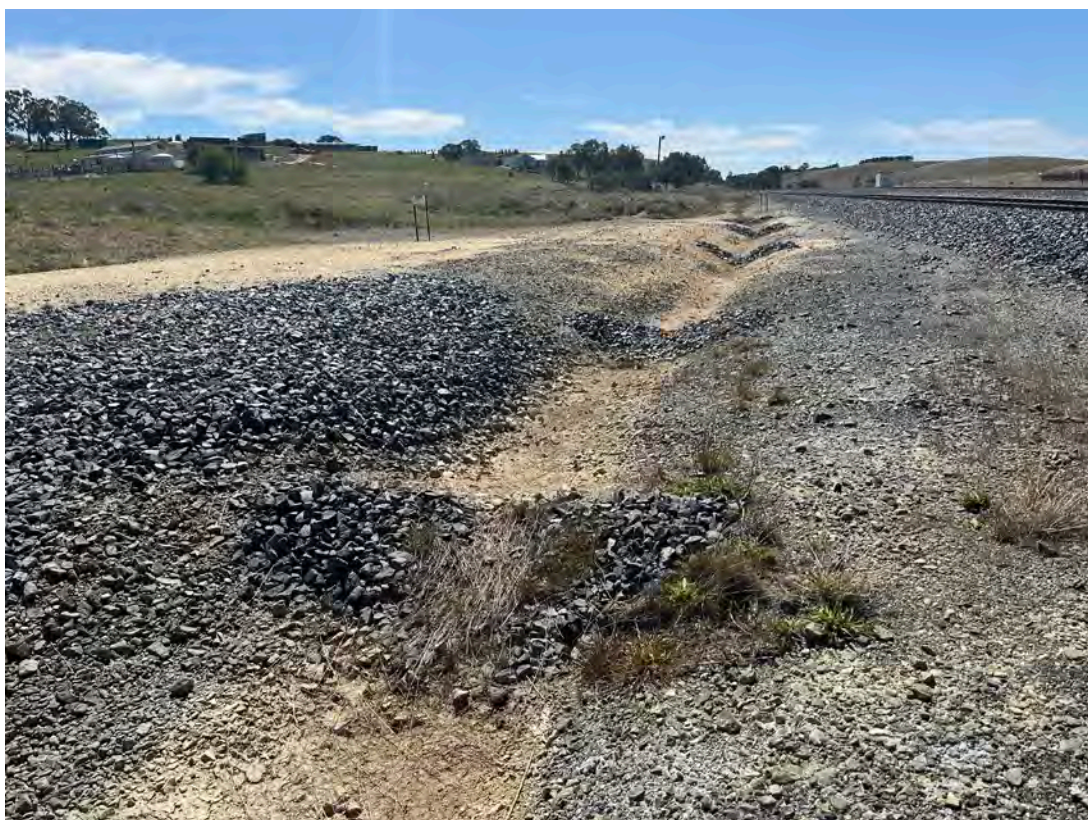
**Photo 14: Rock armoury in drainage channel between middle and northern culverts appear to be in good condition with minor vegetation and sediment build up.**

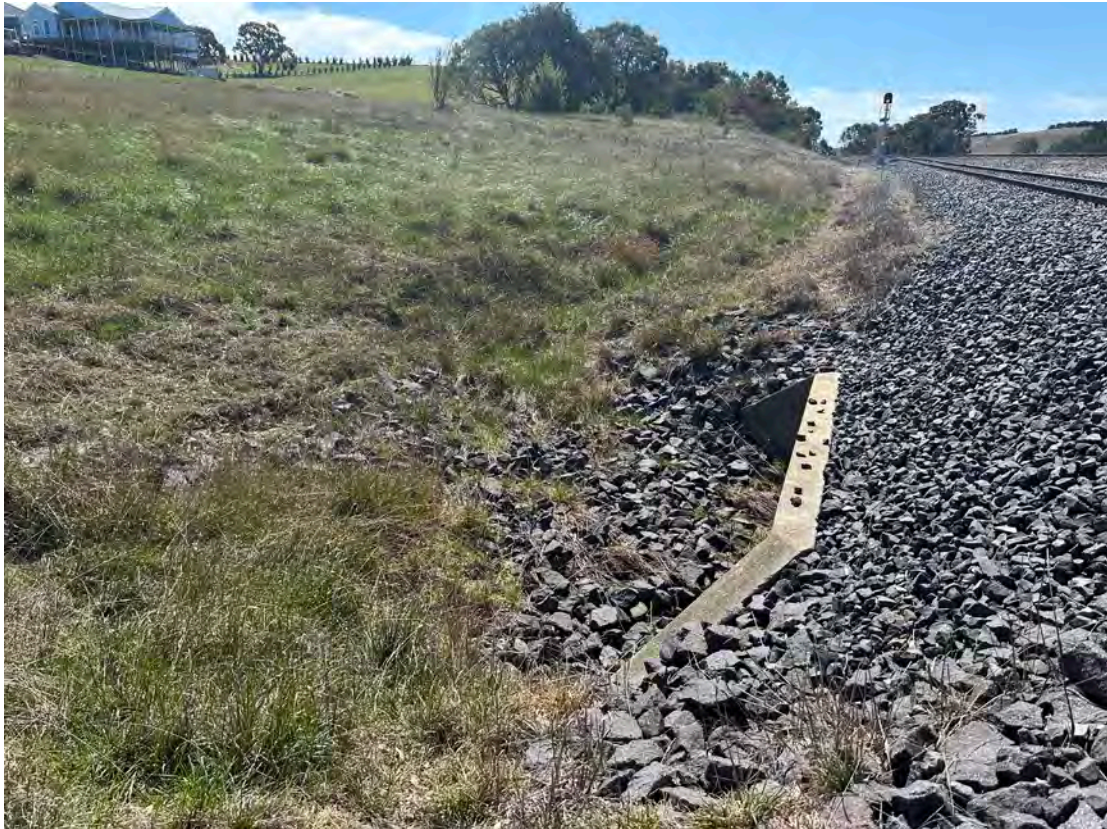
**Photo 15: Upgradient of northernmost culvert with no surface water. No sediment build up was noted on rock armoury.**

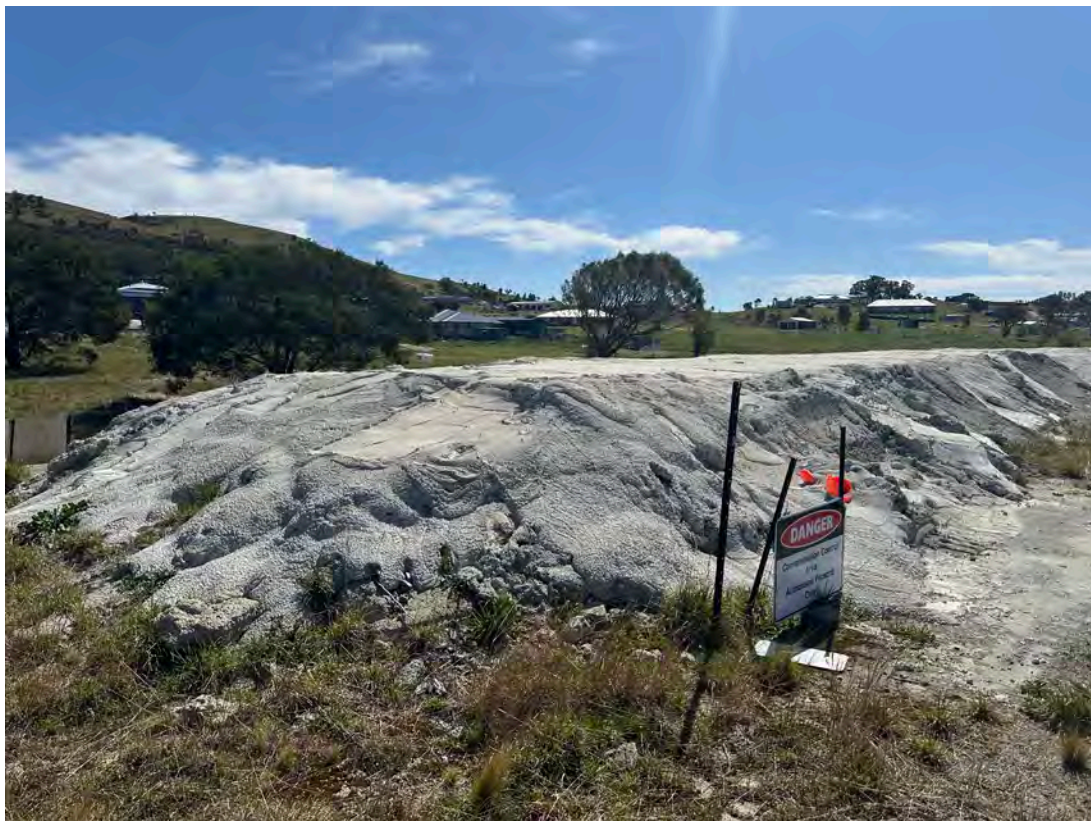
| Section | Control | Inspection | | Corrective Action |
|---|---|---|---|---|
| | Are cracks present in the capping of the existing stockpile? If so record the width and length of cracks in written form and through photographs and consolidate with this checklist. | Yes, minor hairline cracking is present on the stockpile, these remain stable and are not expected to adversely affect cap competency in current condition. | | |

**Photo 16: The concrete-capped stockpile is in good condition with no evidence of erosion.**

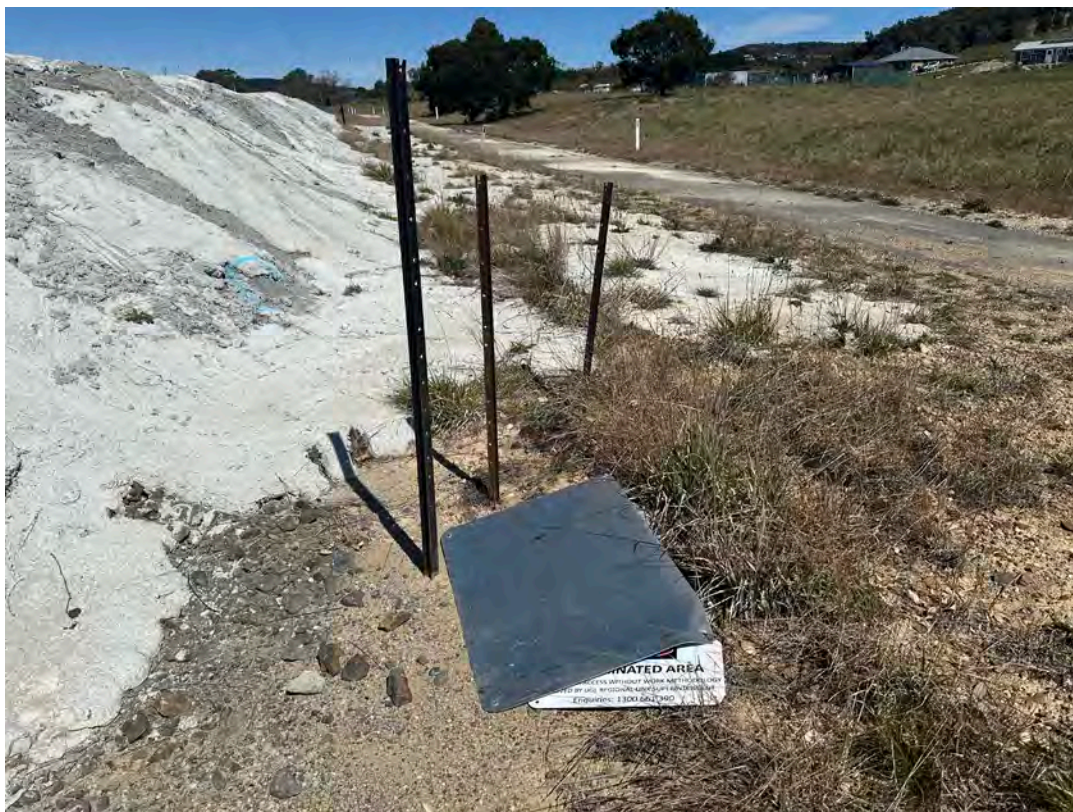
| Section | Control | Inspection | | Corrective Action |
|---|---|---|---|---|
| | Is Exclusion Zone signage undamaged? | Yes, exclusion zone signage appeared in good condition. Minor damage to signage surrounding concrete-capped stockpile was noted and this was fixed by UGL representatives on site post inspection. | | |

**Photo 17: Minor damage to signage surrounding concrete-capped stockpile. UGL representative fixed and replaced ties after the site inspection.**

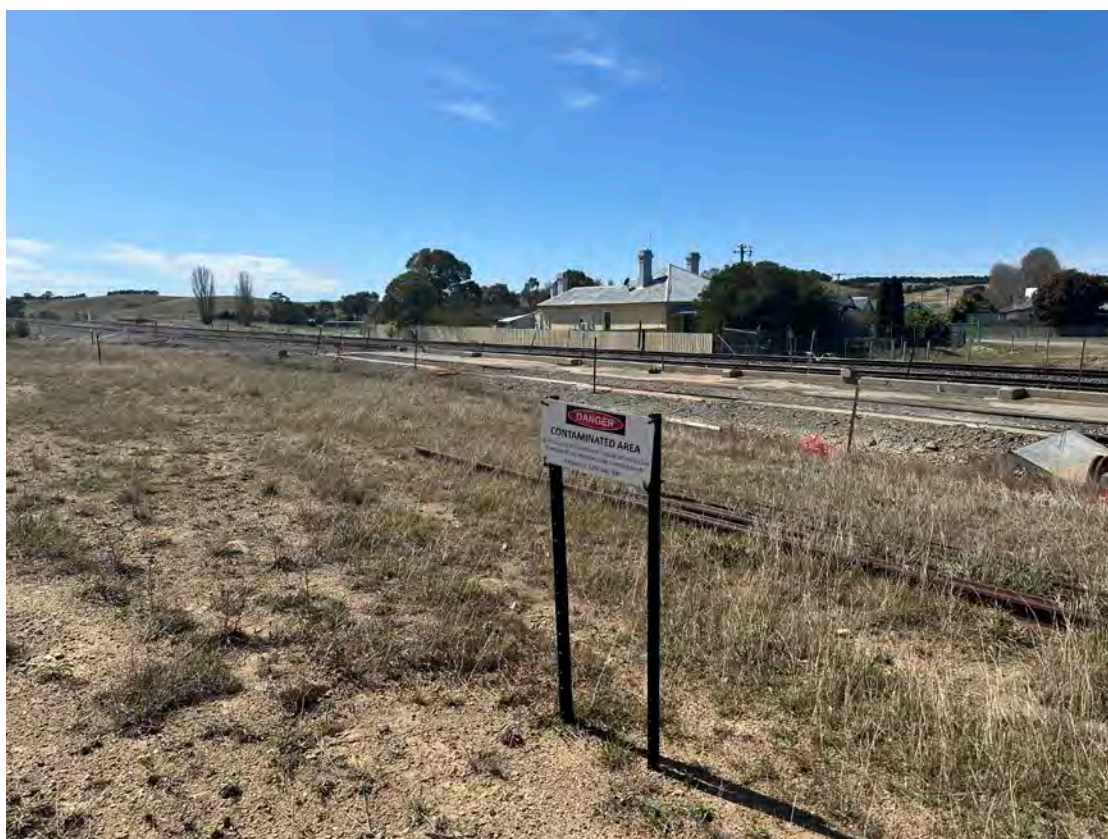
| Section | Control | Inspection | | Corrective Action |
|---|---|---|---|---|
| 5.1 | Is Exclusion Zone signage present as recommended on Figures 2a - 2e Appendix 1 to demarcate contamination in the rail formation and adjacent soils? | Yes ( <b>Photo 18</b> ) | | |

**Photo 18: Exclusion Zone signage present, undamaged and placed at appropriate intervals along the rail corridor.**

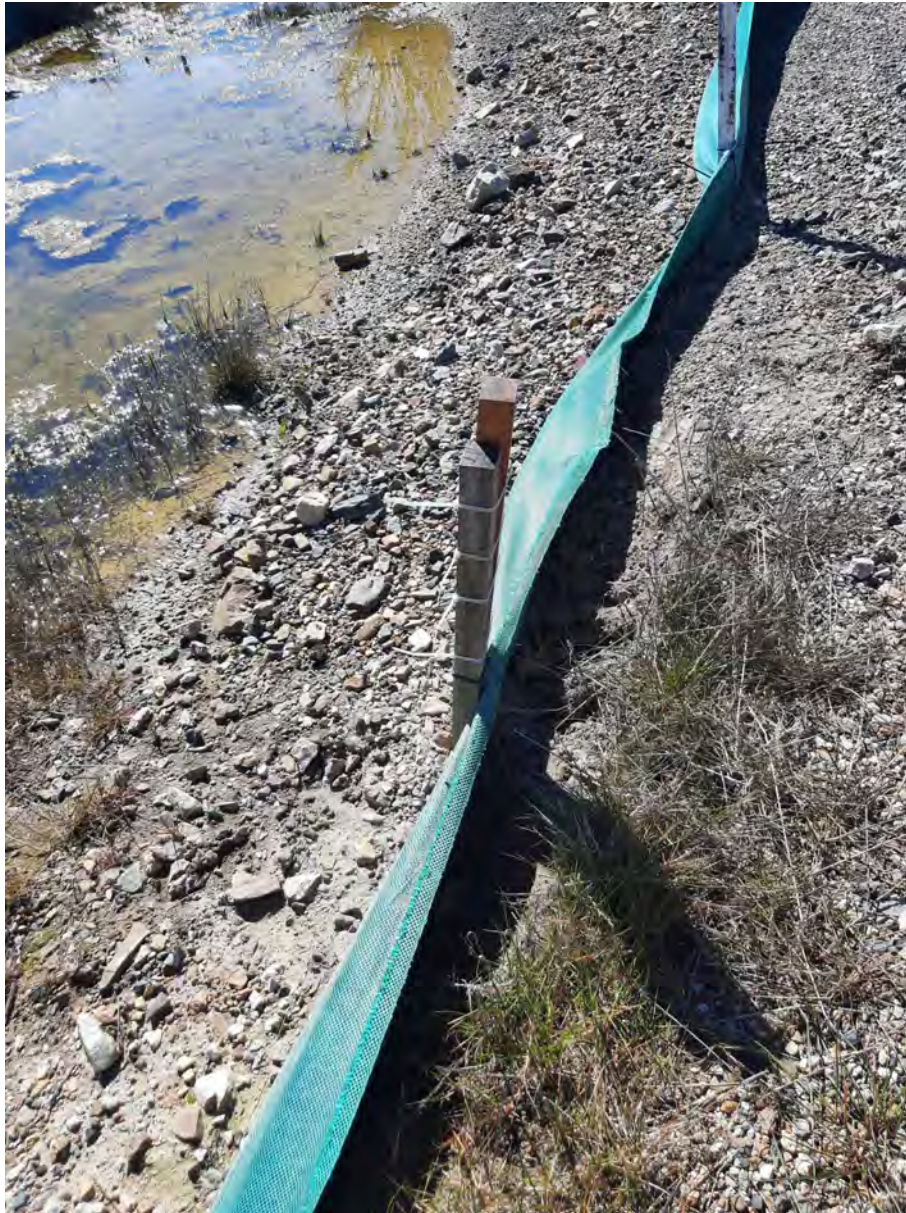
**Photo 19: Damage to sediment fencing in drainage line north of middle culvert had been repaired by UGL staff. (Photo provided by UGL).**
