# Tarago Action Plan Routine Inspection Checklist

| Date: | 20-Nov-24 | Ramboll and UGL RL Environmental |

| Title: | Tarago Rail Yard Inspection | Approved: | Project-Nr.: | Date: |
| Site: | Tarago, NSW | JA | 318001704 | 20 November 2024 |

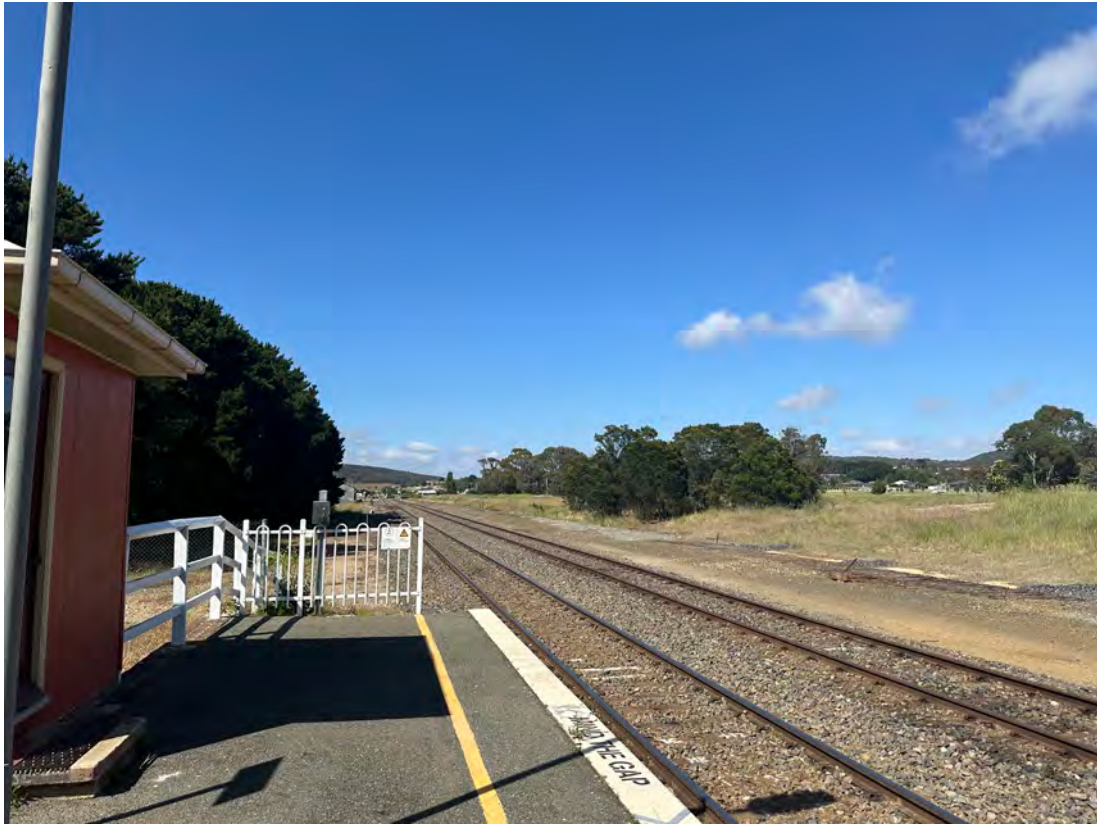
No airborne dust was visible (**Photos 1 - 2**).

Photo 1: Picture at northern end of Tarago railway station platform facing south, no airborne dust visible.

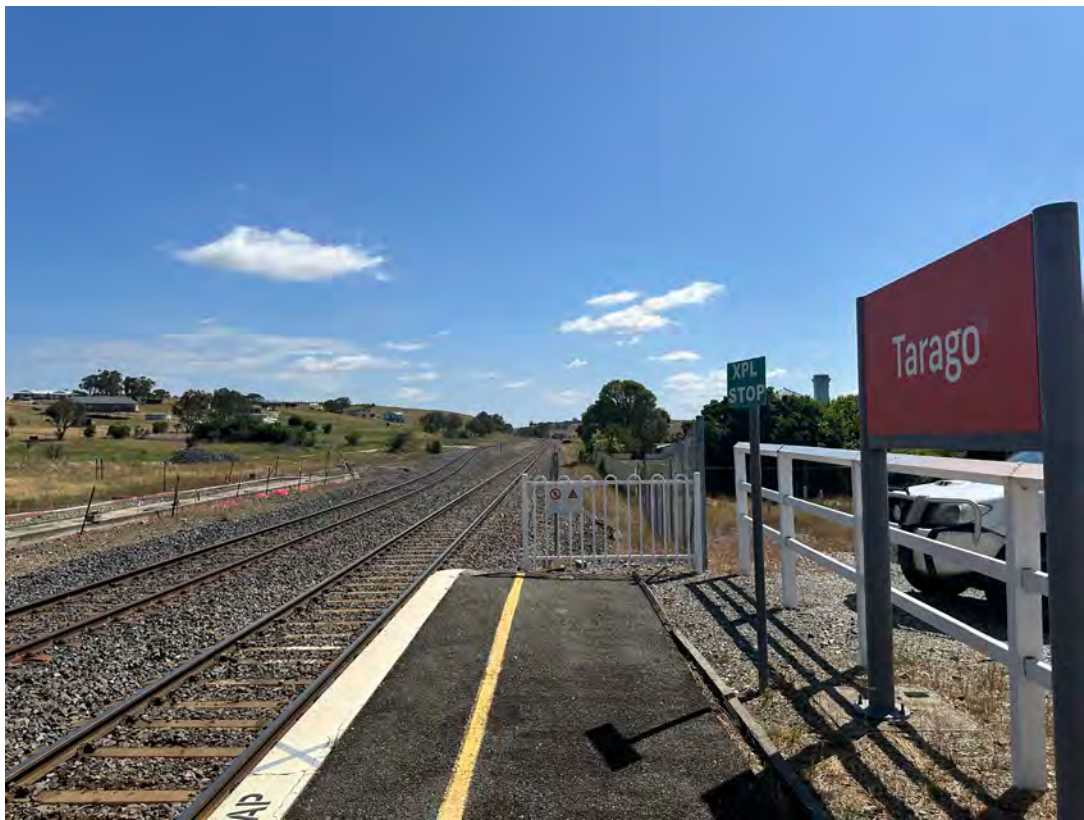
Photo 2: Picture facing north towards Tarago railway station, no airborne dust visible.

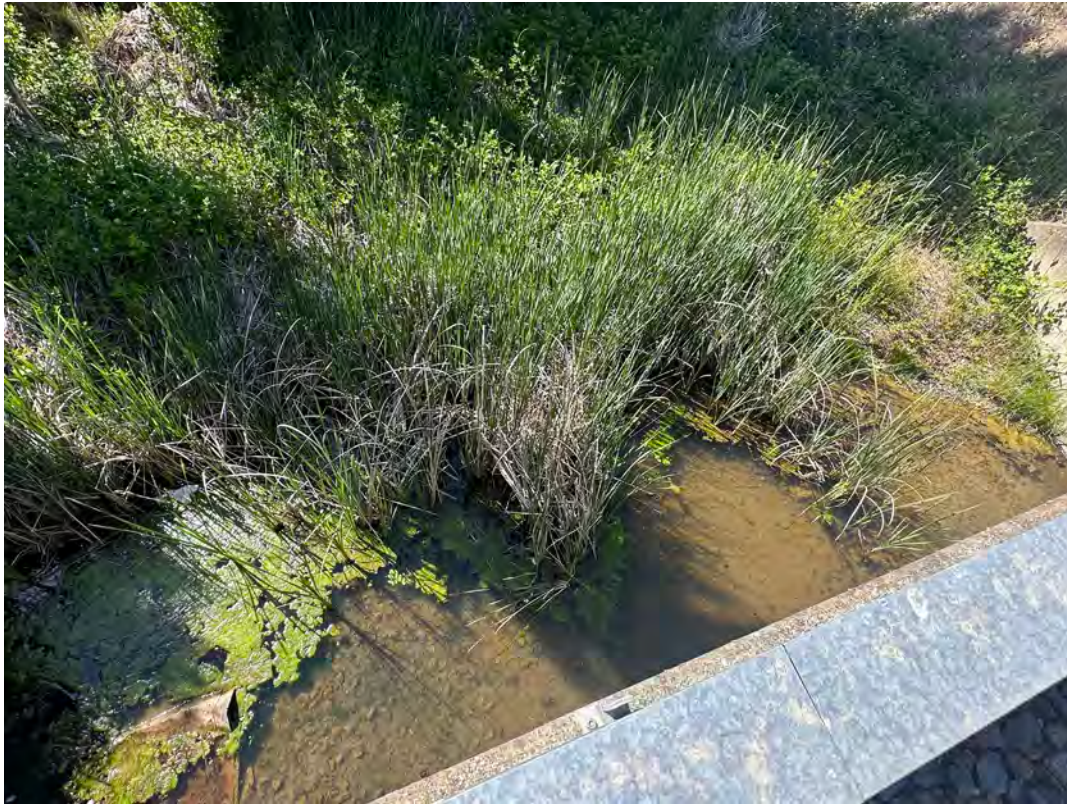
No evidence of sediment run-off observed. Pooled water on site was generally clear with low to no sediment (**Photos 3 and 5**).

No surface water was observed flowing offsite from the southern, middle and northern culverts. Pooled, not flowing, surface water observed at southern and middle culverts (**Photos 3 - 8**). No flowing surface water was observed onsite during the inspection.

**Photo 3: Southern culvert downgradient of railway line with surface water pooled onsite. Green algae present on the surface of water. Surface water was clear with no visible turbidity or suspended solids.**

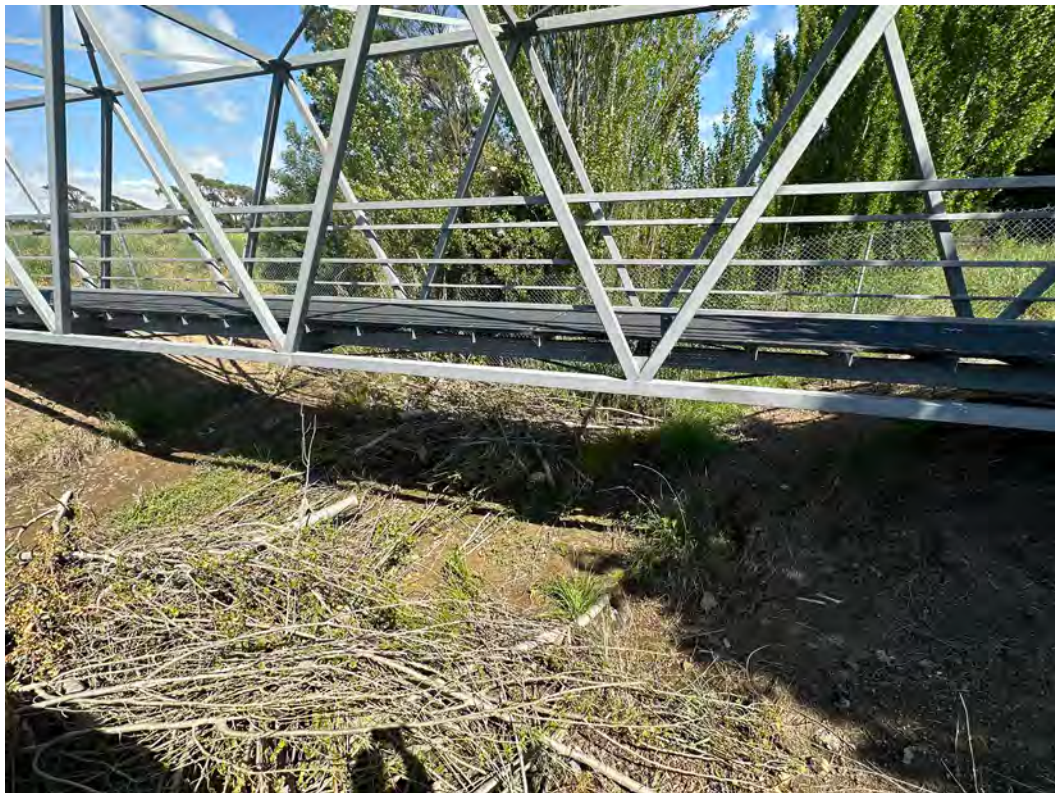
**Photo 4: Downgradient of southern culvert off site. No water flowing off site and causeway was dry.**

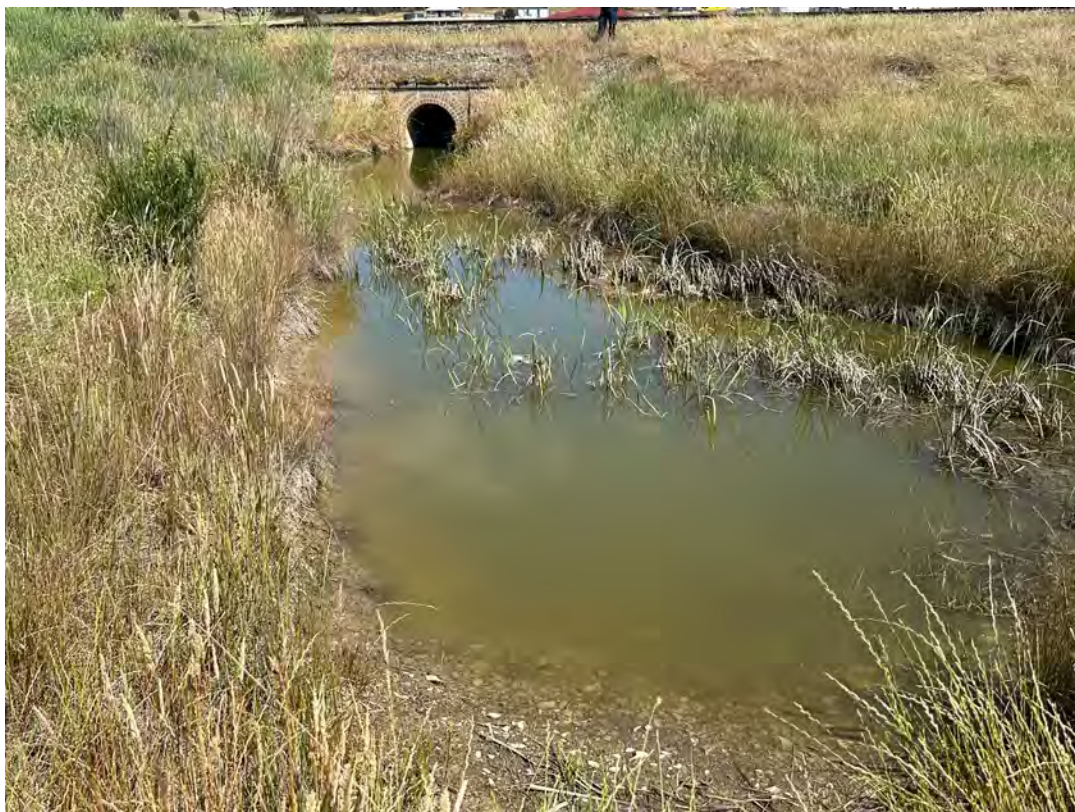
**Photo 5: Downgradient of middle culvert with pooled surface water, not flowing off site. Surface water near culvert was slightly brown with minor visible turbidity.**

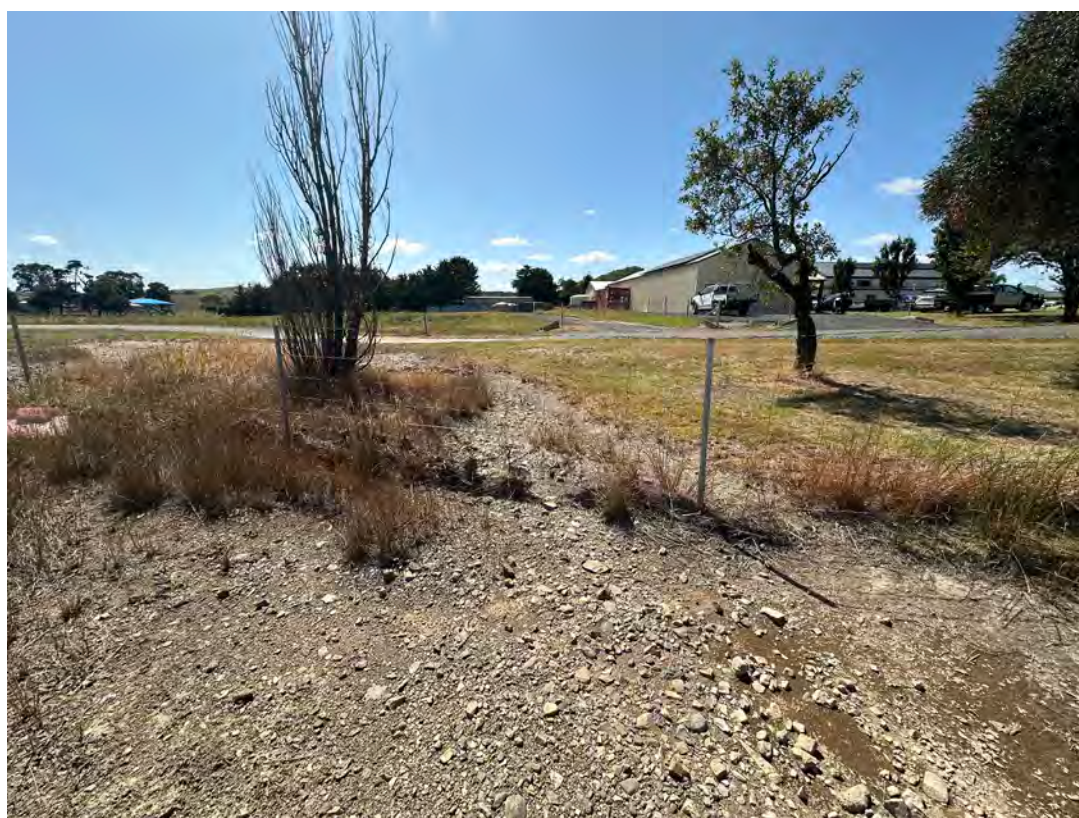
**Photo 6: Downgradient of middle culvert facing south with no surface water flowing off site at fence line.**

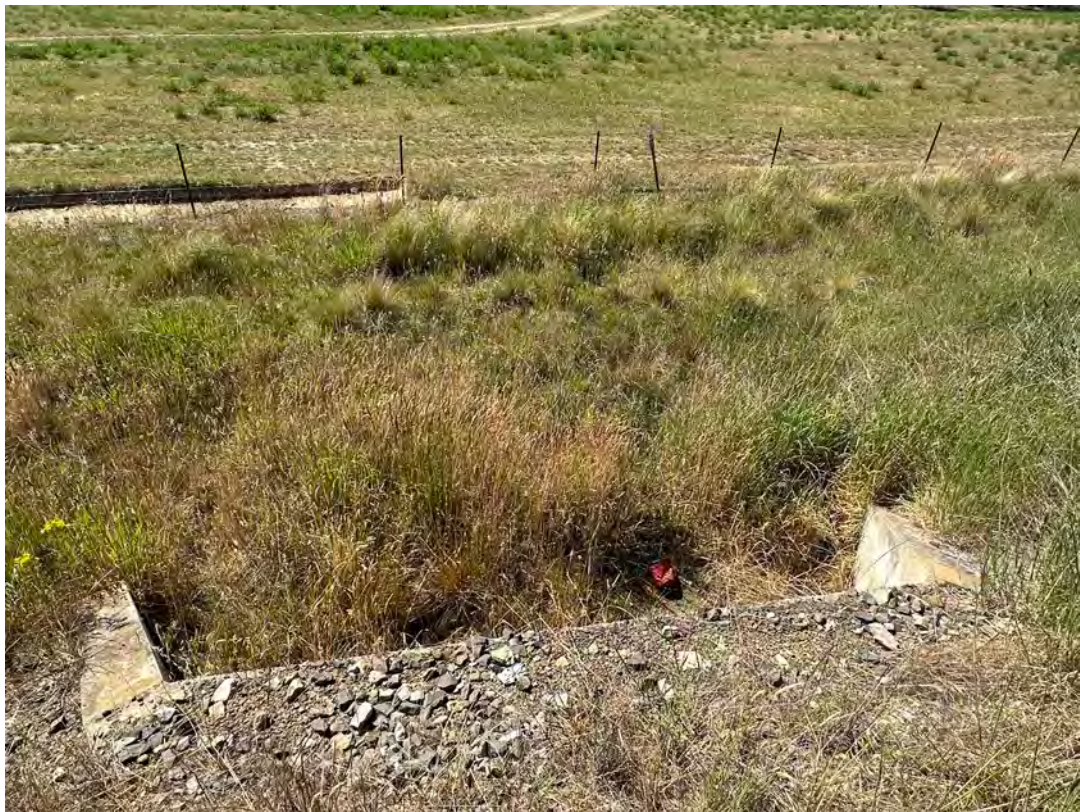
**Photo 7: Downgradient of northernmost culvert with no observed surface water. Trench line had been dug on adjacent property.**

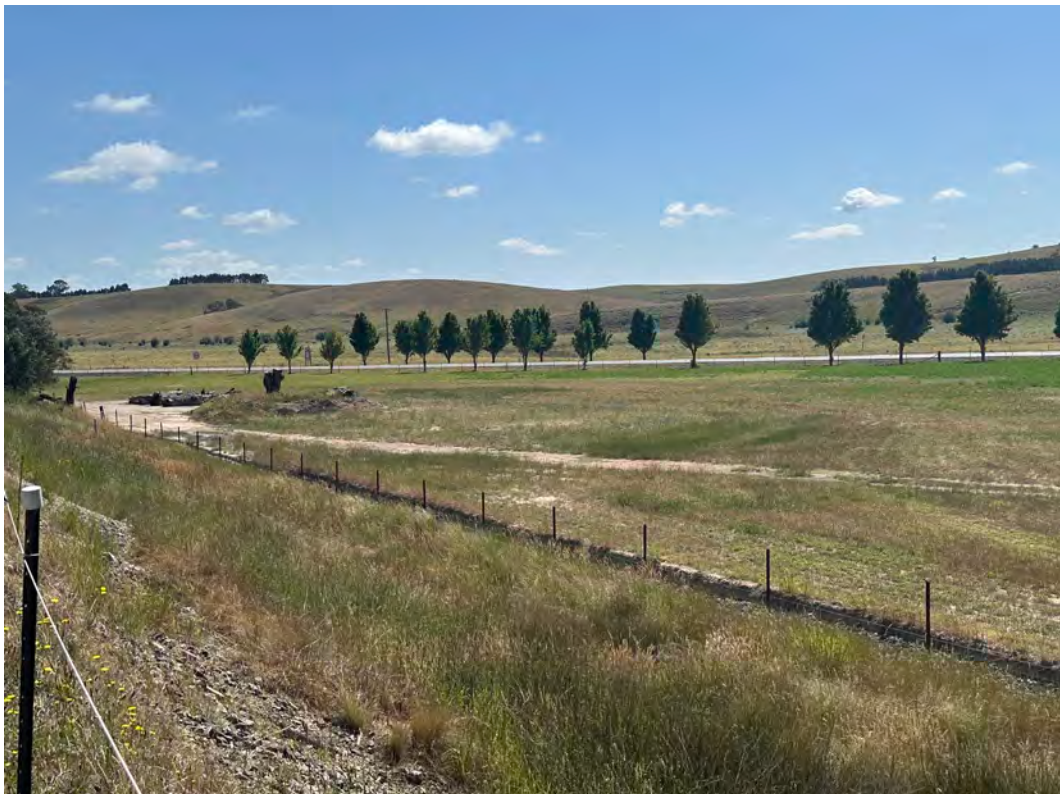
**Photo 8: Property downgradient of northernmost culvert with no observed surface water.**

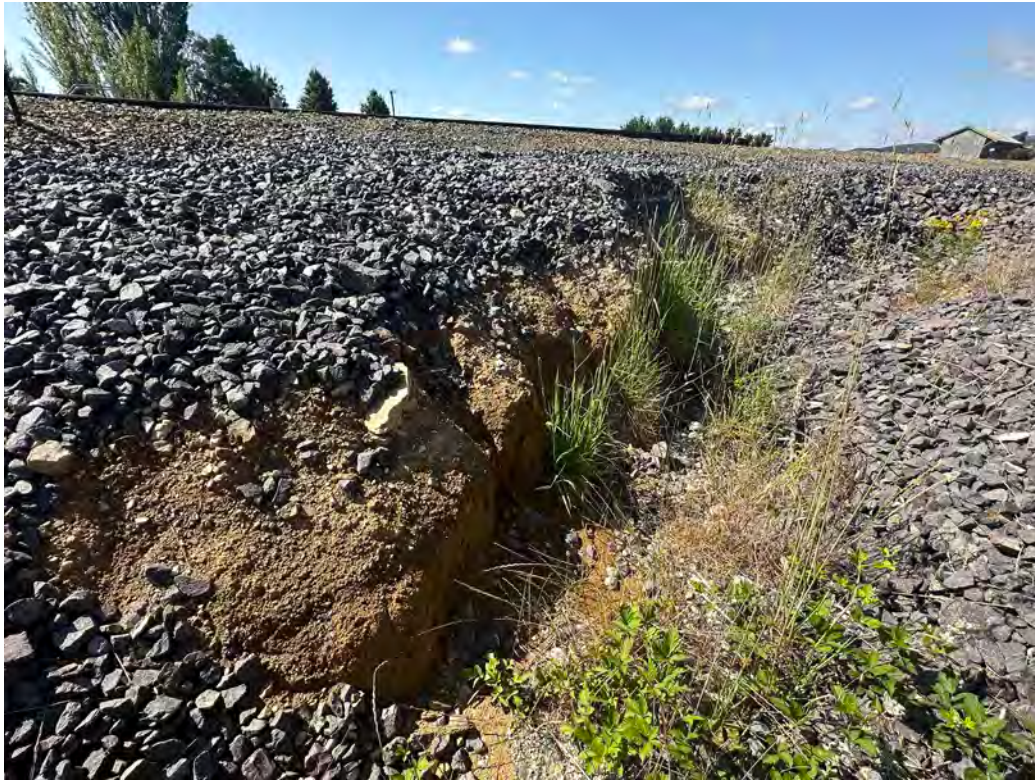
2. Evidence of erosion noted upgradient of the southern most culvert in previous site inspections remains on site but in a stable condition (**Photo 9**). No evidence of sediment was observed in water pooled downgradient onsite at southern culvert during this site inspection. In addition, some minor erosion due to inadequate ground cover was also observed upgradient of the railway line, to the north of the middle culvert (**Photo 13**). Ramboll recommends replacing ground cover material (ballast) if further erosion occurs or sediment is visible in the downstream surface water.

**Photo 9: Southernmost culvert upgradient of the railway line. The erosion due to lack of ground cover observed during multiple previous inspections is still present. More vegetation present.**

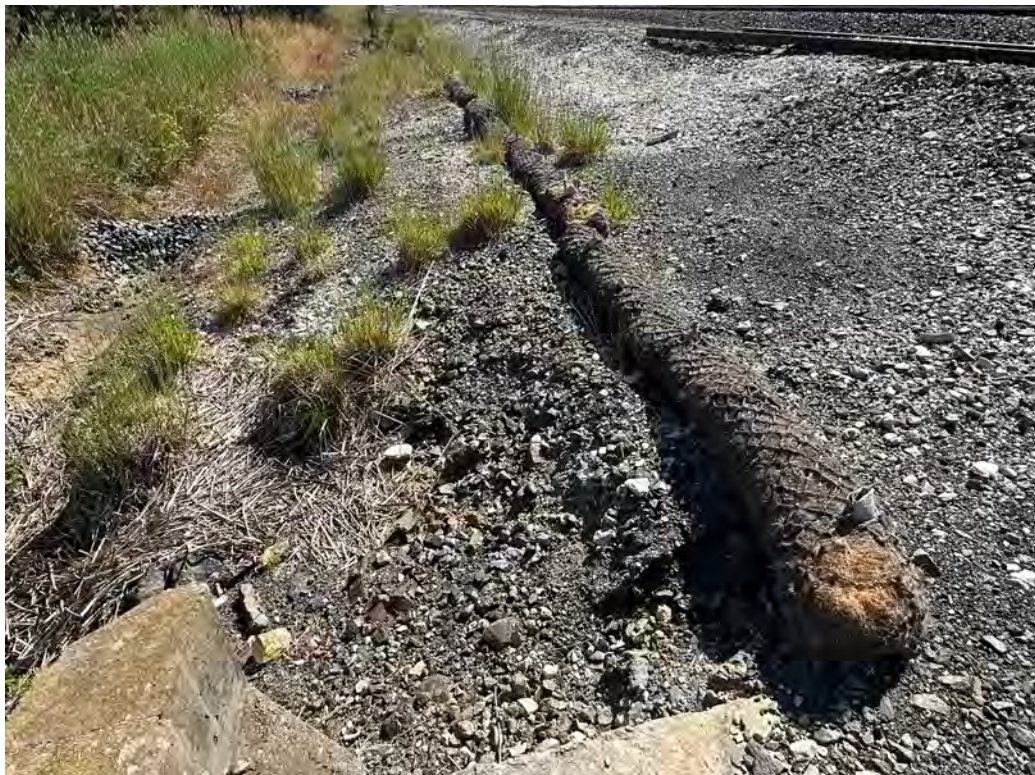
3. Rock armour in drainage channel between southern and middle culverts previously observed to be in average condition has been replenished (**Photo 10**).

**Photo 10: Southernmost culvert upgradient of the railway line. Rock armoury in drainage channel between southern and middle culverts replenished and less sediment and vegetation build up observed.**

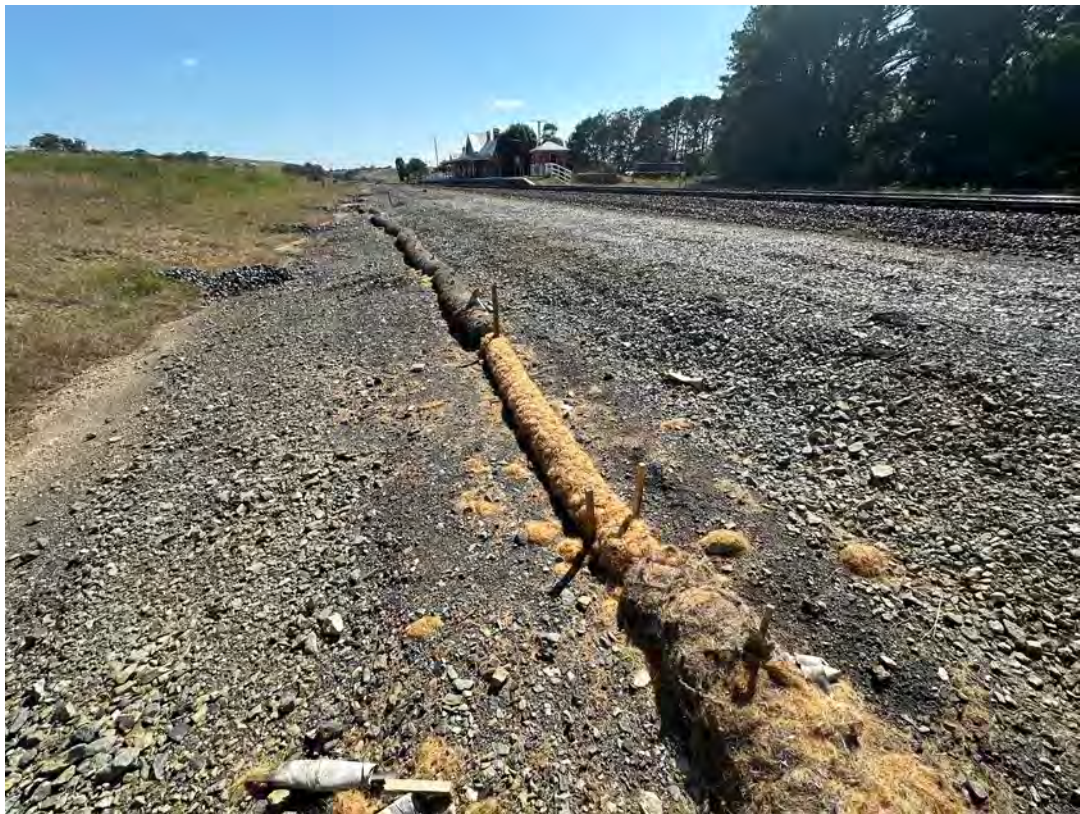
1. Damages to sediment control coir logs located between middle and southern culverts were observed in previous and current inspections. It is suspected the damage has been caused by birds. This was observed to be appropriately maintained and majorly damaged logs were replaced (**Photos 11 and 19**). New coir logs are available on-site, and Ramboll recommends replacing any damaged coir logs that are no longer effective in controlling sediment.

**Photo 11: Damage to sediment control coir logs between southern and middle culverts has been maintained and some logs replaced. Suspected damage caused by birds.**

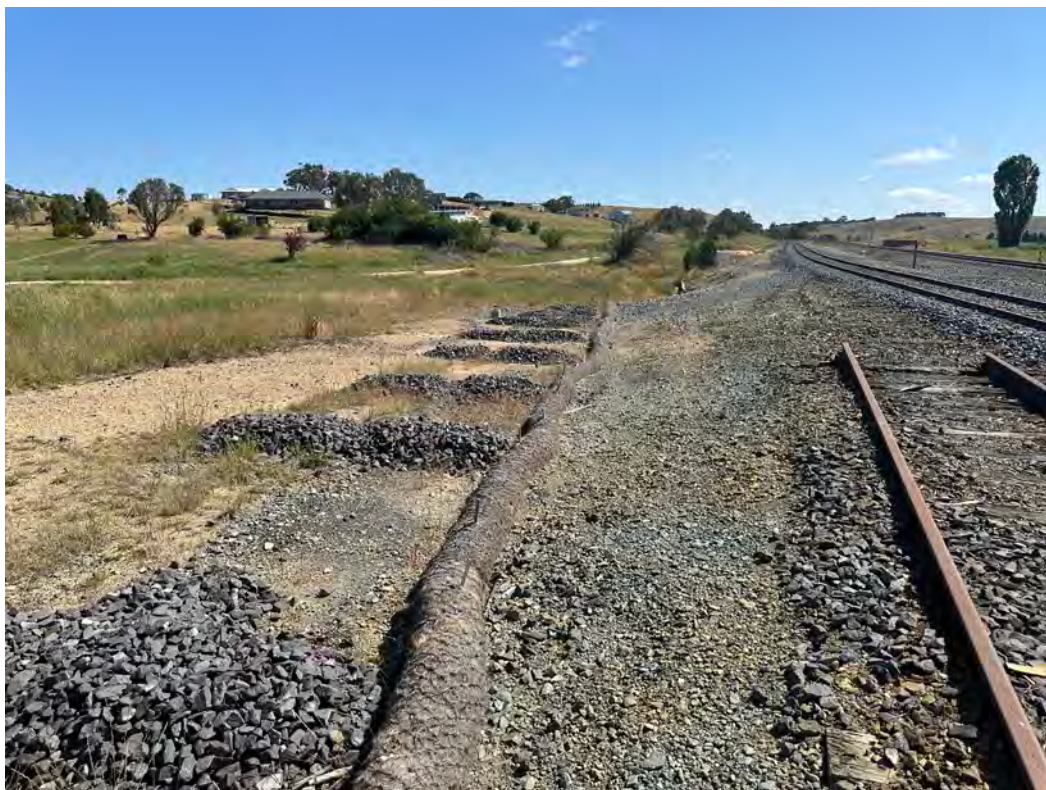
**Photo 12: Rock armoury in drainage channel between southern and middle culverts appears to be in good condition.**

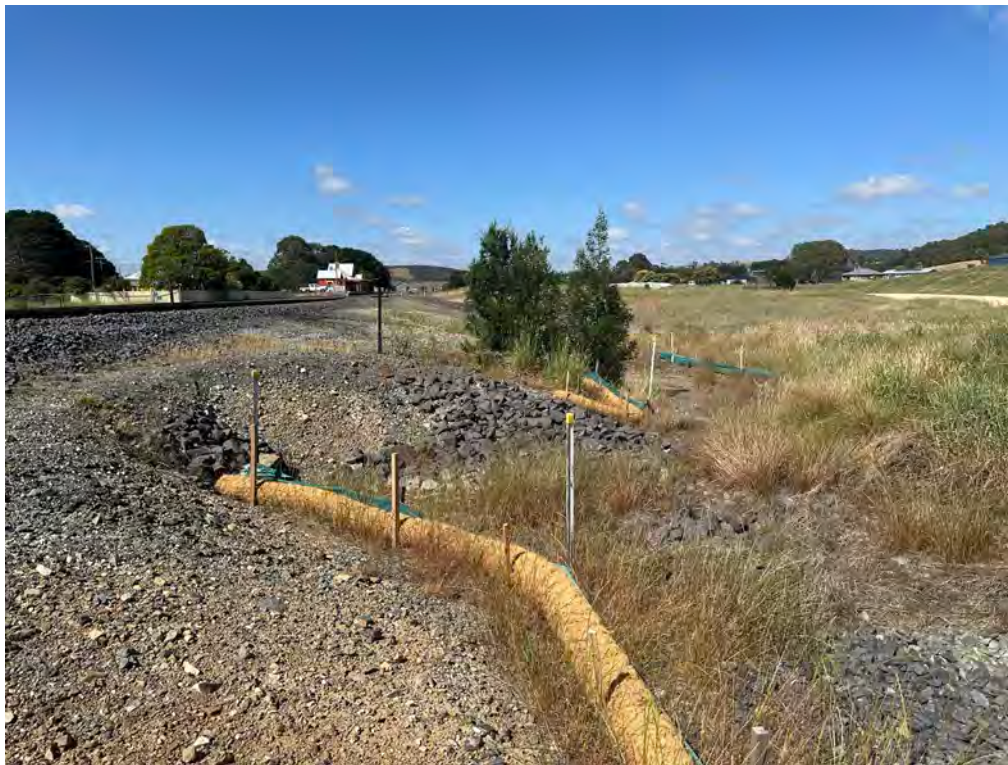
**Photo 13: Upgradient of the railway line, north of the middle culvert, sediment coir logs in good condition. Minor inadequate ground cover observed during the previous inspections remained in a stable condition.**

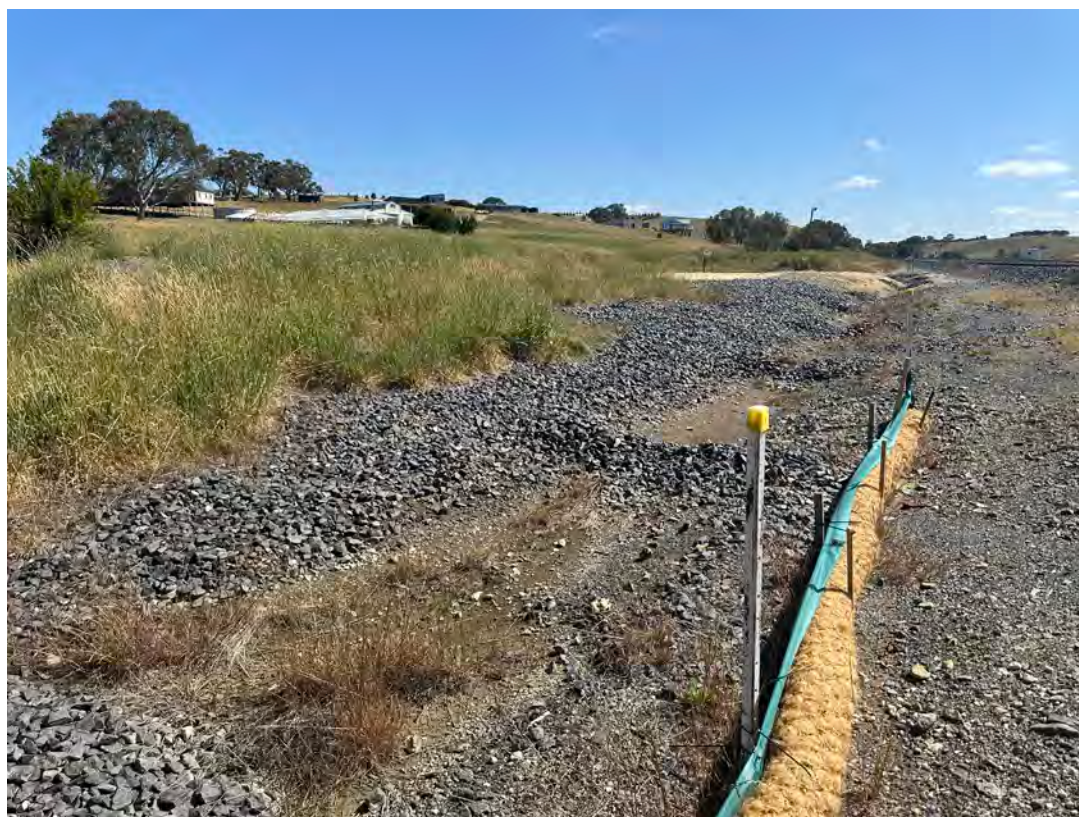
**Photo 14: Rock armoury and sediment coir logs in drainage channel between middle and northern culverts appears to be in good condition.**

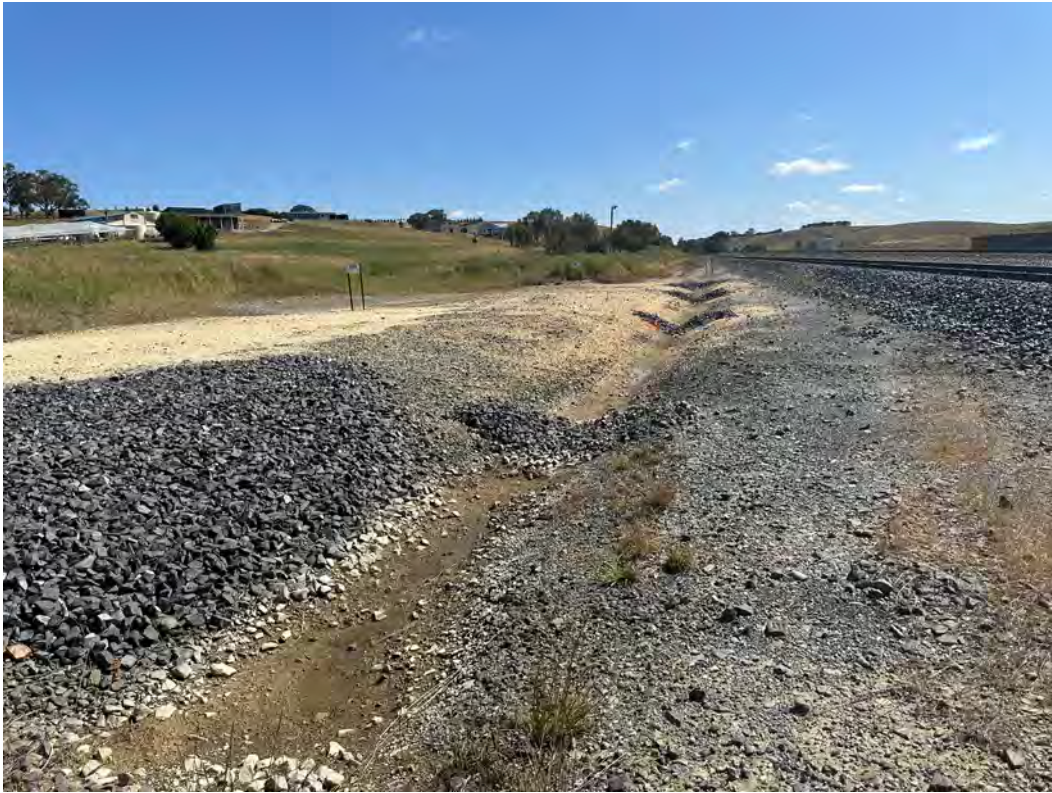
**Photo 15: Rock armoury in drainage channel between middle and northern culverts appears to be in good condition.**

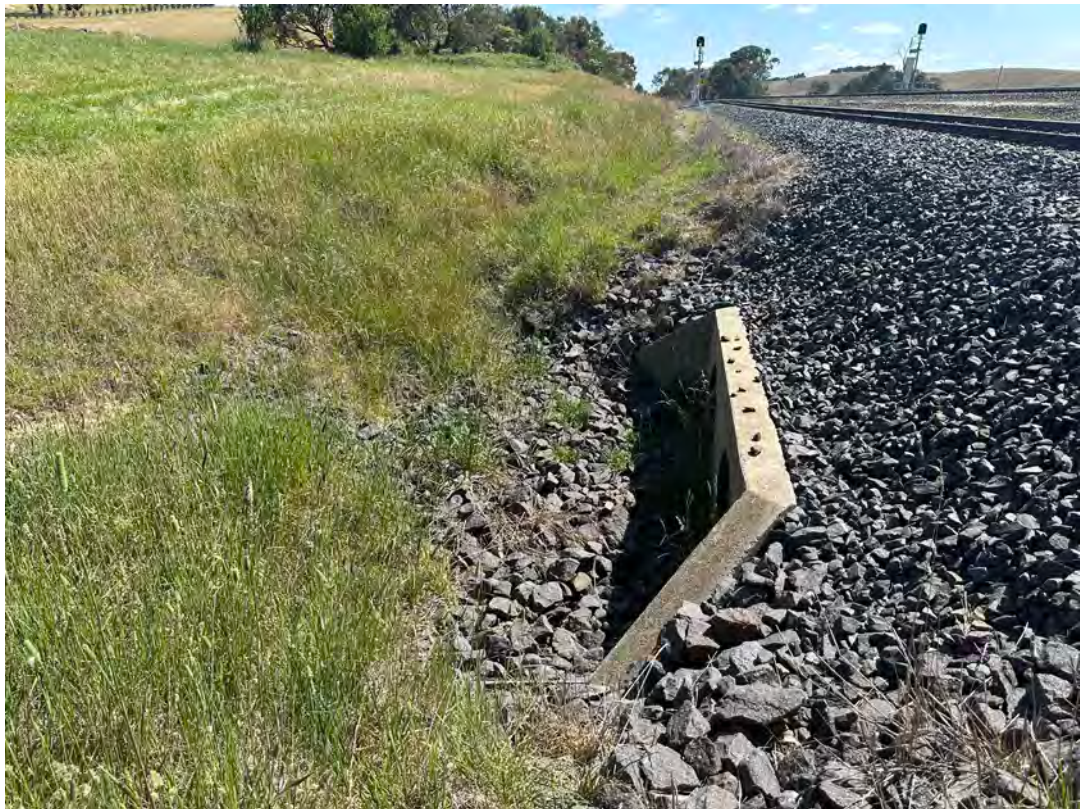
**Photo 16: Upgradient of northernmost culvert with no surface water. No sediment build up was noted on rock armoury.**

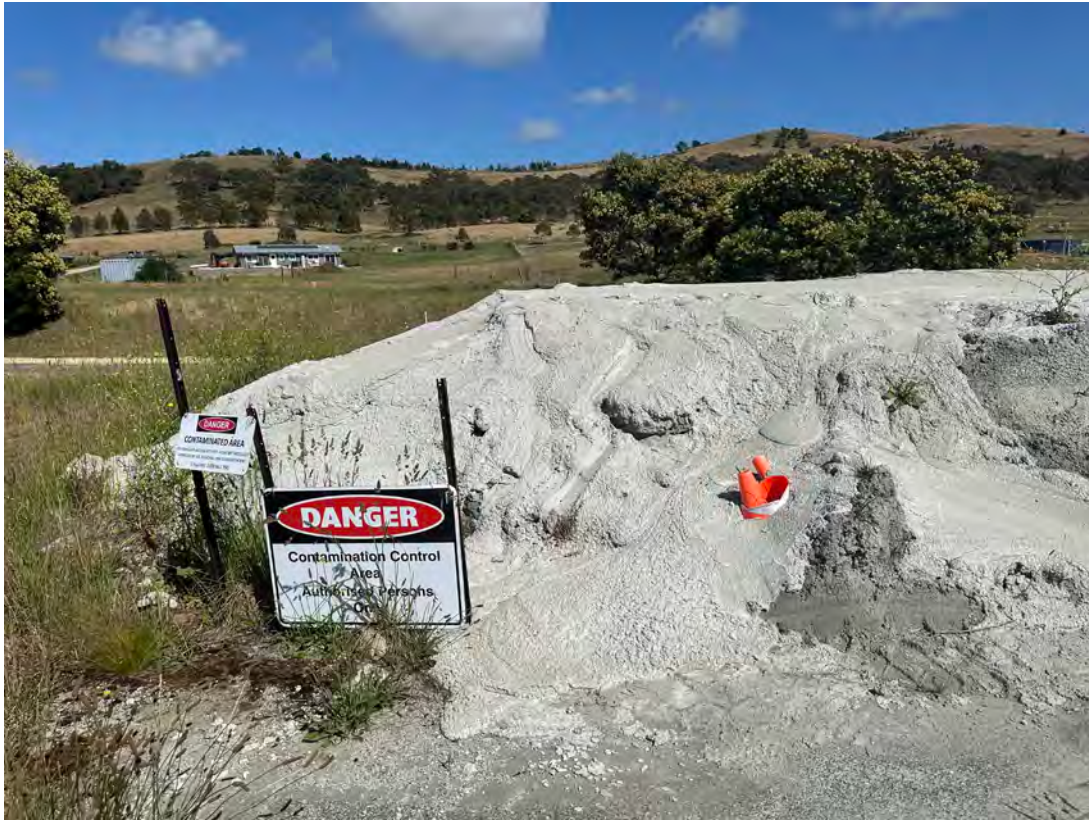
Photo 17: The concrete-capped stockpile is generally in good condition with no new erosion observed.

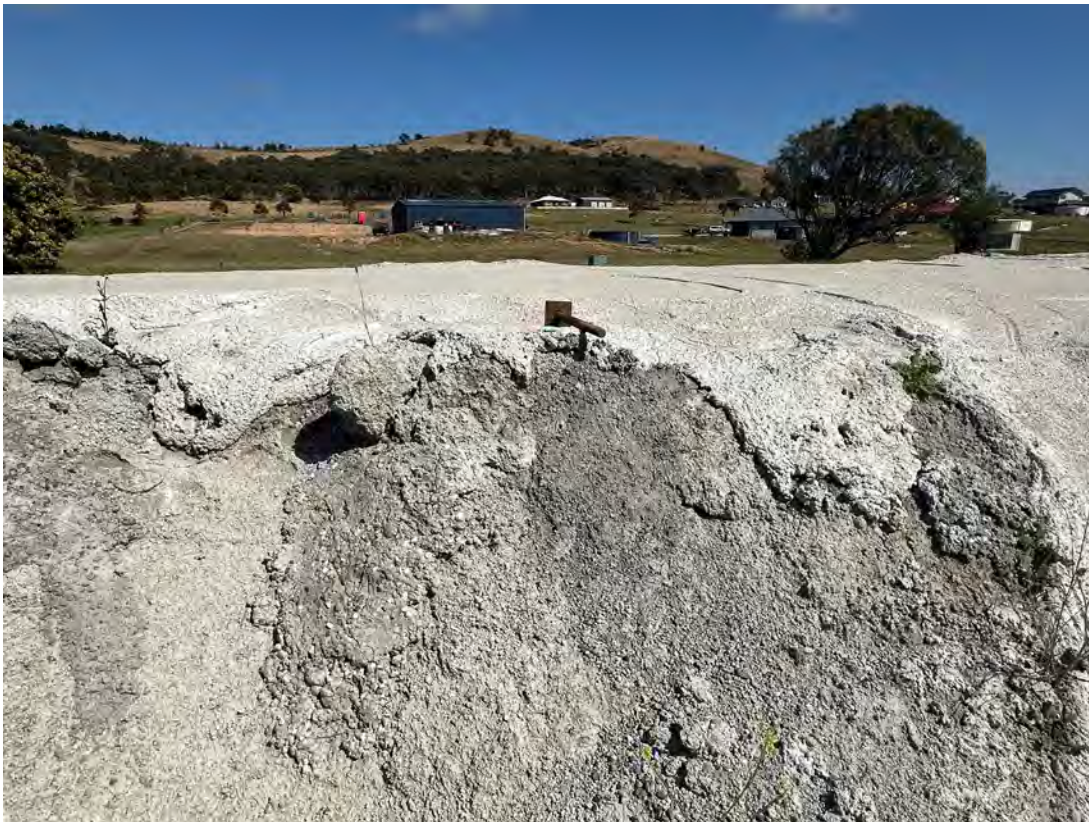
4. The exposure location identified on the concrete capped stockpile in the previous inspection has been patched using a cement mix (**Photo 18**).

| Section | Control | Inspection | | Corrective Action |
|---|---|---|---|---|
| | Are there signs of erosion or sediment run-off on or relating to the existing stockpile? If so record in written form and through photographs and consolidate with this checklist. | Yes. Exposure of geofabric observed during previous inspection has been replaced ( <b>Photo 18</b> ). | | |

Photo 18: Exposed geofabric layer marker on stockpile identified in previous inspection has been filled with cement.

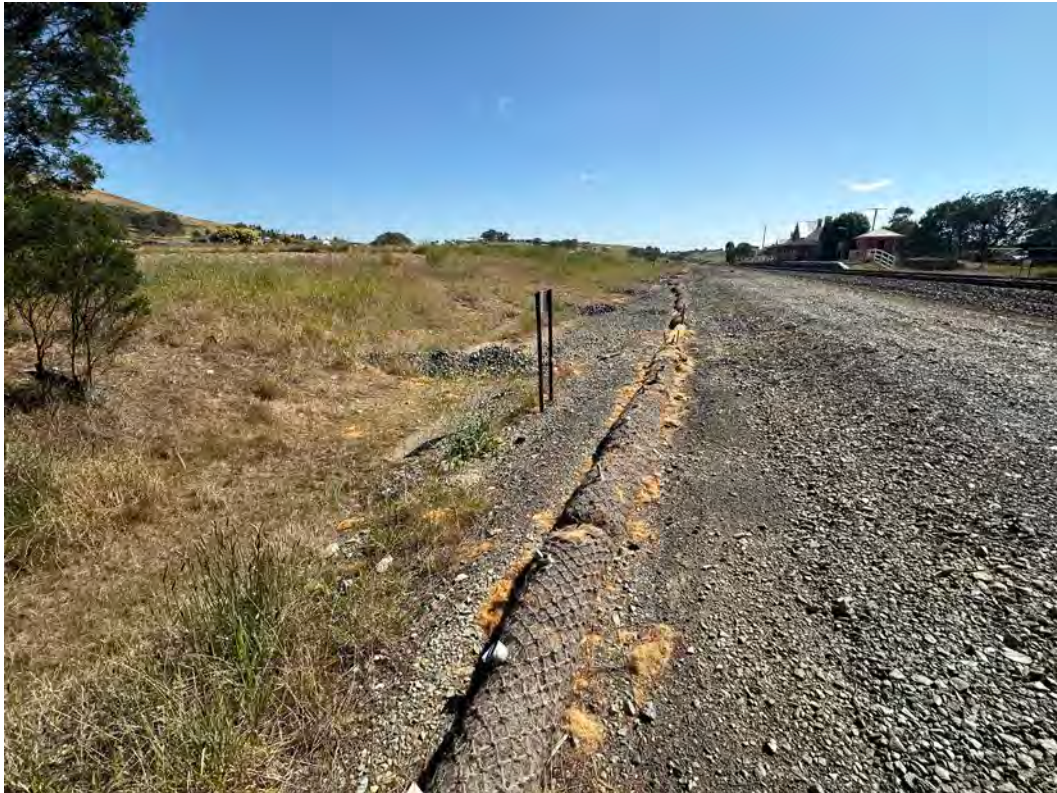
**Photo 19: Minor damage to sediment coir logs between southern and middle curvet. Suspected to be caused by birds.**

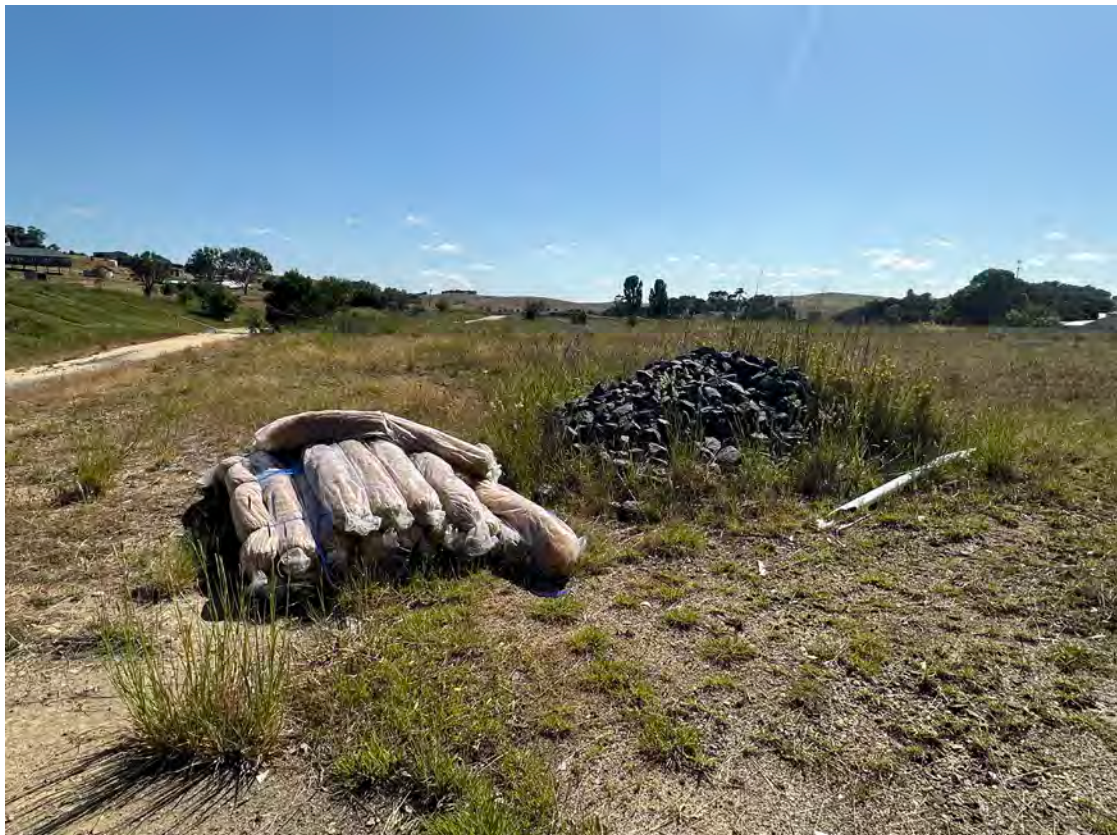
**Photo 20: New sediment coir logs stored on site to replace damaged logs if required.**
