# Routine Site Inspection Form

| Date: | 18-October-2024 | Site Reference: | Bungendore Rail Corridor (CRN Lands) |

| Title: | Bungendore Rail Corridor & Woolshed Siding Inspection | Approved:<br>JA | Project-Nr.:<br>318001704 | Date:<br>18 October 2024 |
| Client: | UGL Regional Linx | | | |

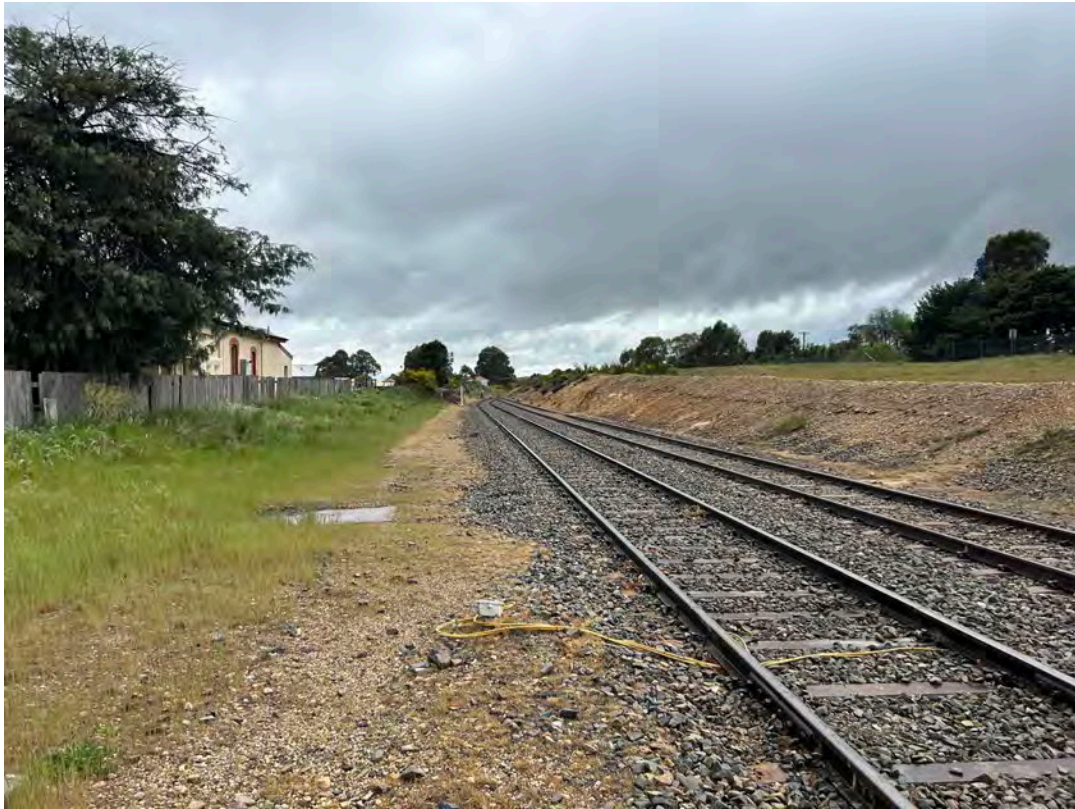
| | Yes | No | Comments/Observations |
|--|---|---|---|
| Is any dust being visibly generated at from the Site? If yes is dust leaving the Site boundary? | | No | No airborne dust was visible ( <b>Photos 1, 2, 3, 4</b> ). |

Photo 1: Dry ground conditions adjacent to railway tracks.

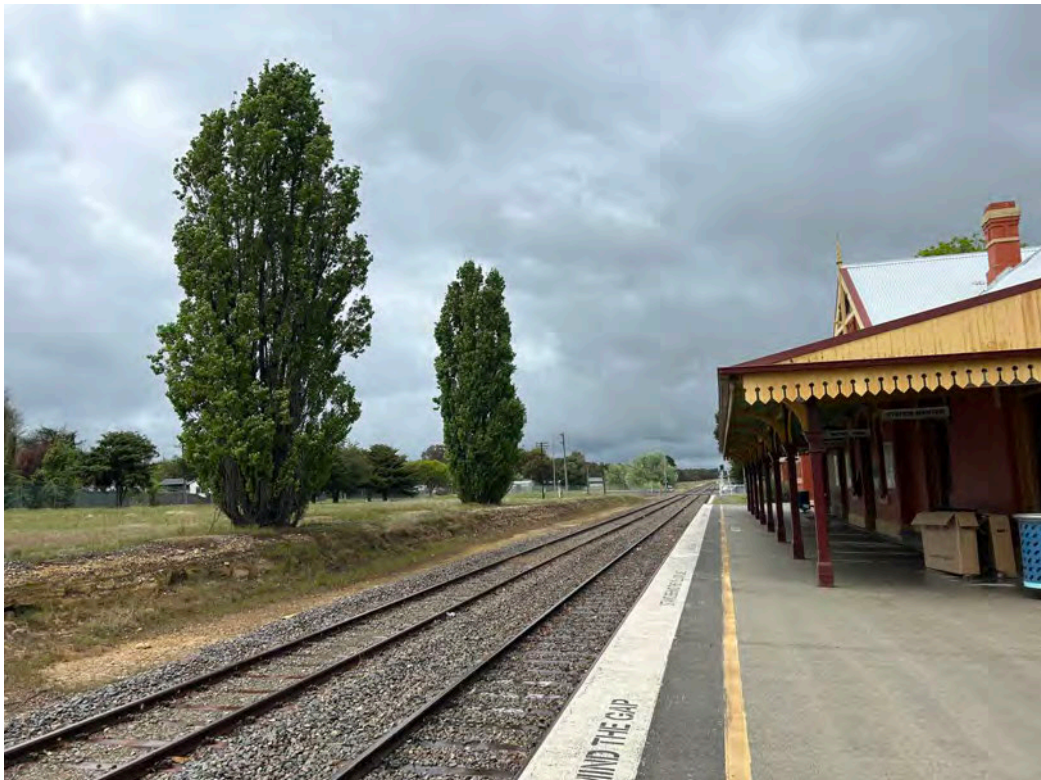
Photo 2: Picture of the station. No airborne dust visible in air.

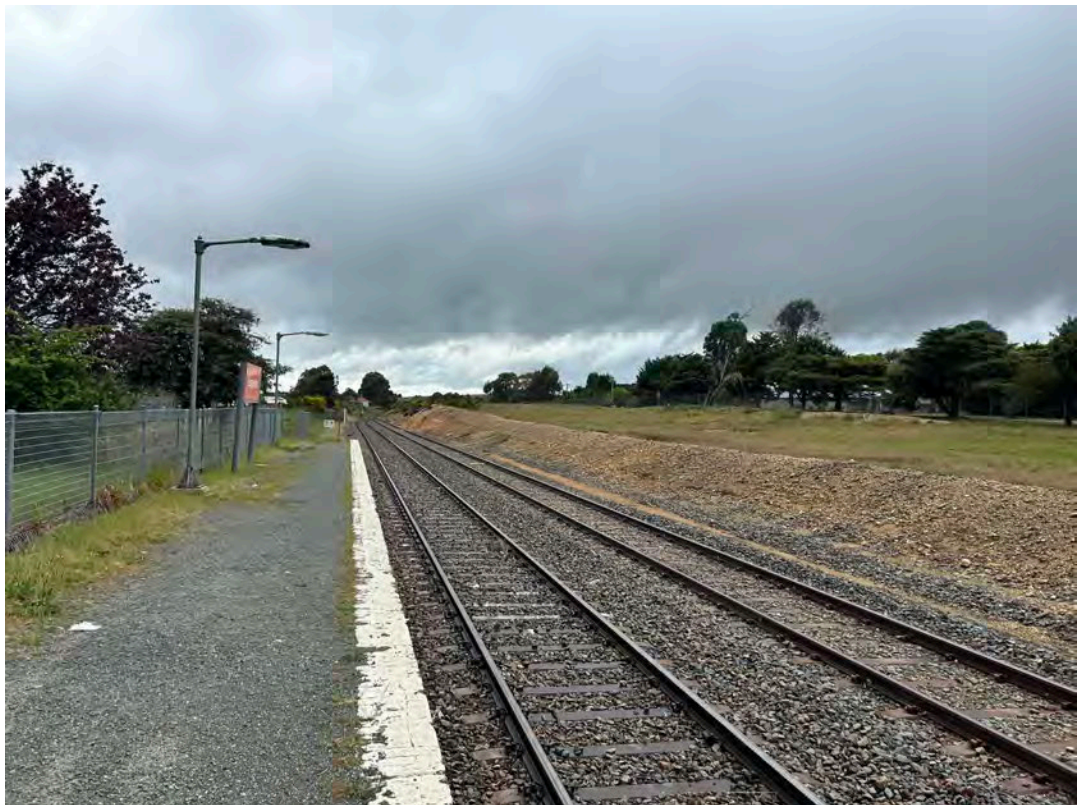
Photo 3: Picture of Bungendore railway station facing south-west. No airborne dust visible in air or on surface at station.

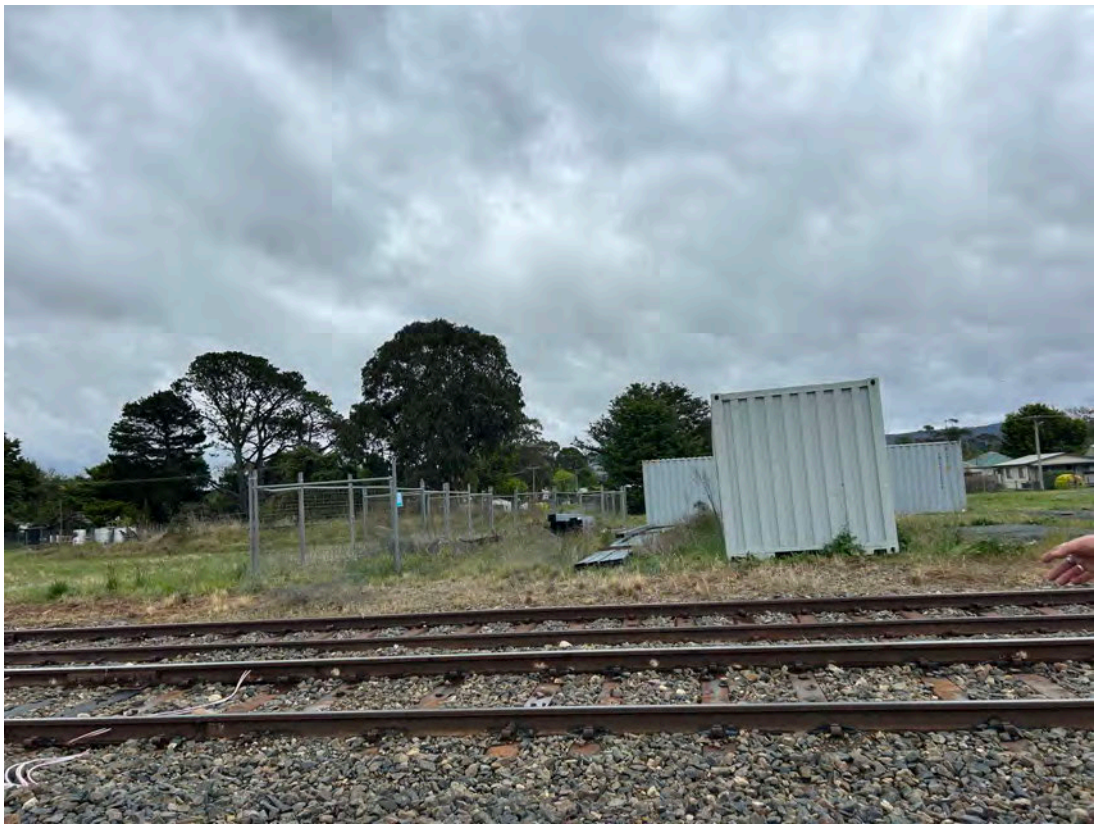
| | Yes | No | Comments/Observations |
|--|---|---|---|
| Is Site fencing secure and intact? | Yes | | Break in fencing, appearing to have been deliberately cut, has been fixed during previous inspections.<br>At the time of inspection no activity was observed at the Bungendore Mens Shed. Site was locked and unoccupied. Fencing near the shed was in good condition. |

Photo 4: Fencing near the Men’s shed appeared to be in good conditions.

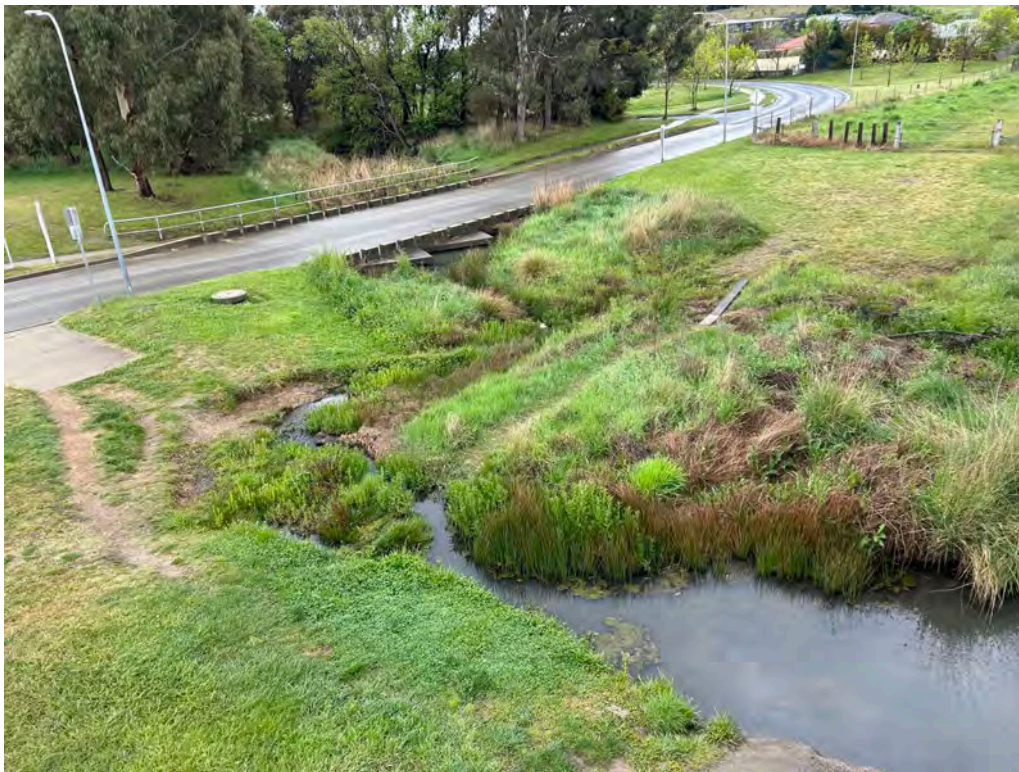
| | Yes | No | Comments/Observations |
|--|---|---|---|
| Is any surface water discharging from site?<br><br>if yes, describe water quality | Yes | | Surface water was discharging from site at the location near Malbon Street Railroad Crossing ( <b>Photos 7 and 8</b> ). Turallo Creek slowly flows through the northern boundary of site and appears low turbidity. No sediment visible on Turallo Terrace Bridge causeway ( <b>Photos 5 and 6</b> ).<br><br>(Circle One)<br>clear/cloudy/turbid/sediment laden |

**Photo 5: Turallo Creek north of Bungendore station at the track overpass near Turallo Terrace. Low turbidity observed in flowing water. No water was observed running over Turallo Terrace bridge. Facing North.**

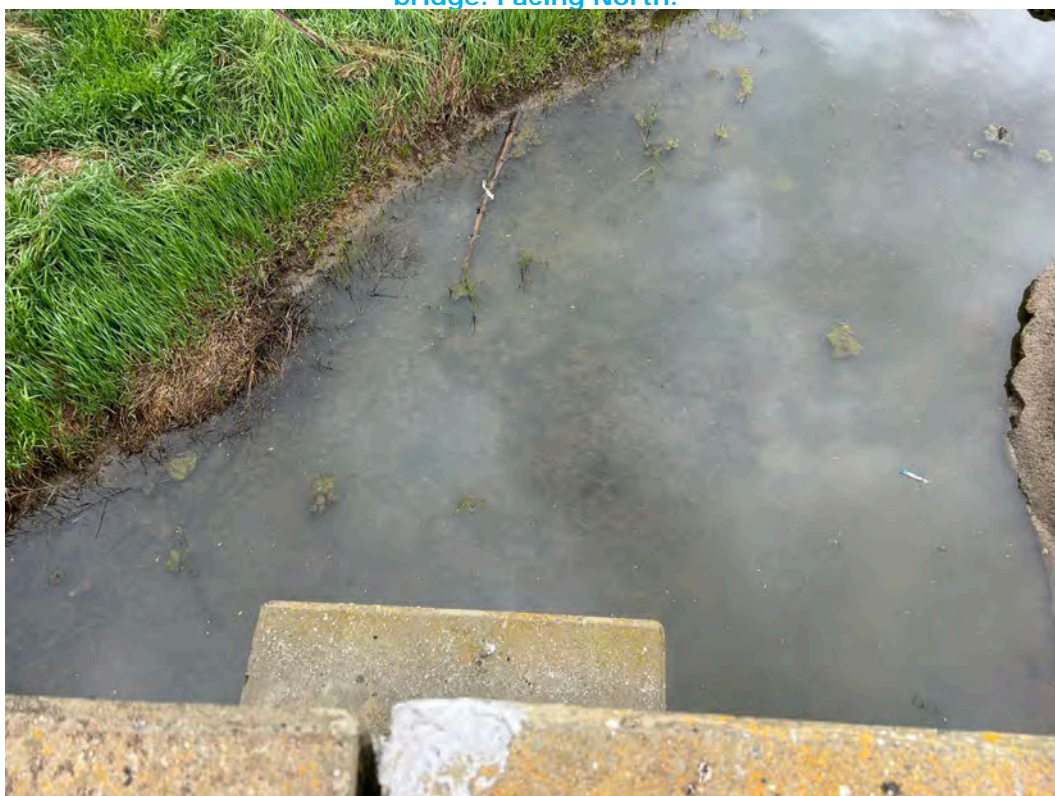
**Photo 6: Turallo Creek with slow flowing water. Low turbidity observed. Facing East.**

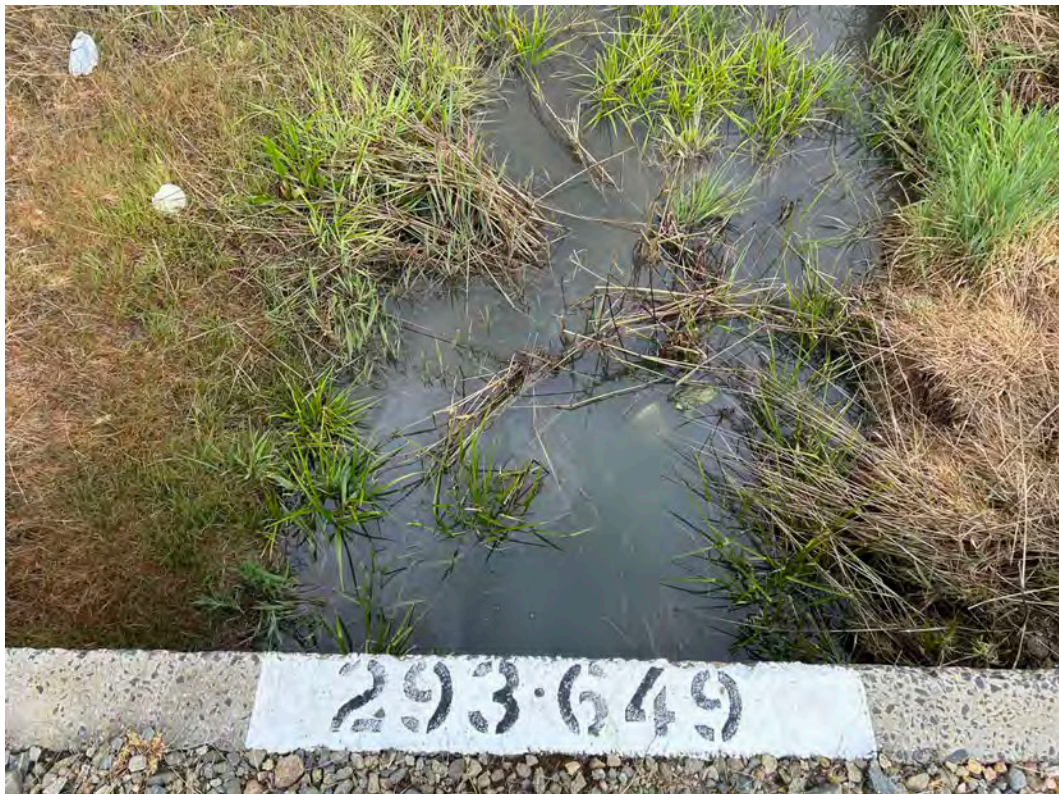
**Photo 7: Downgradient of the fourth culvert near Malbon Street railroad crossing. Pooled water with low turbidity was observed flowing offsite.**

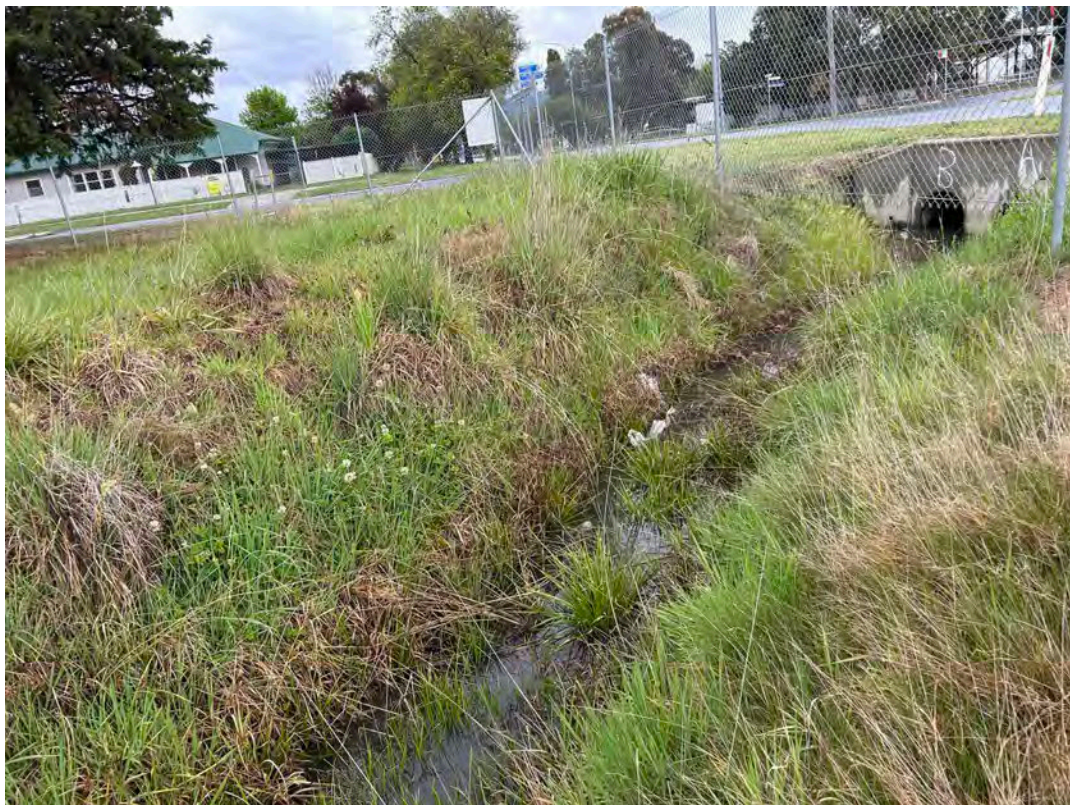
**Photo 8: Downgradient of the fourth culvert near Malbon Street railroad crossing. Water discharging off site was observed. Low turbidity.**

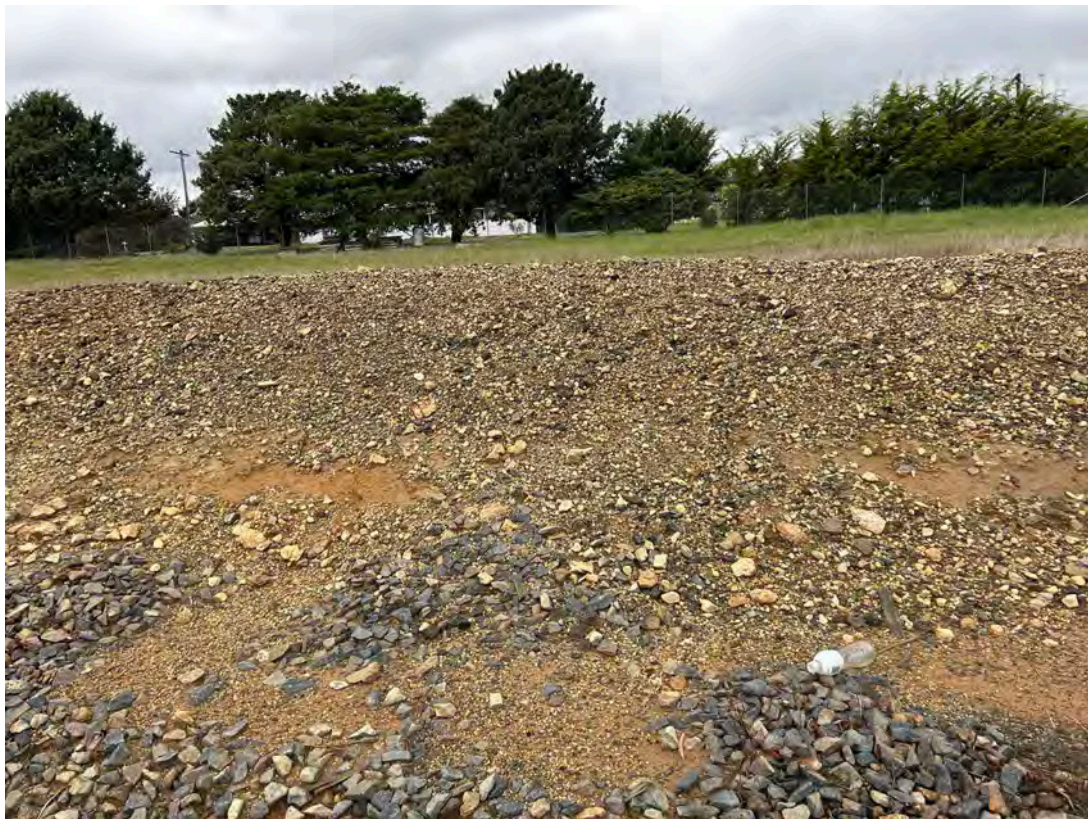
| | Yes | No | Comments/Observations |
|--|---|---|---|
| Are appropriate erosion and sediment controls in place and effective? | Yes | | Evidence of erosion in some places observed in the previous inspections, but unlikely to mobilise contaminated sediment and is not expected to present a risk to the receiving environment. |

Photo 9: Evidence of erosion in some places observed in the previous inspections. Conditions appeared to stable and sediment is unlikely to mobilise and is not expected to present a risk to the receiving environment.
